# Landmarks Board

REQUEST FOR PERMISSION TO DEMOLISH  
530, 536 & 540 E. COMMERCIAL STREET

## FIELD OBSERVATION REPORT

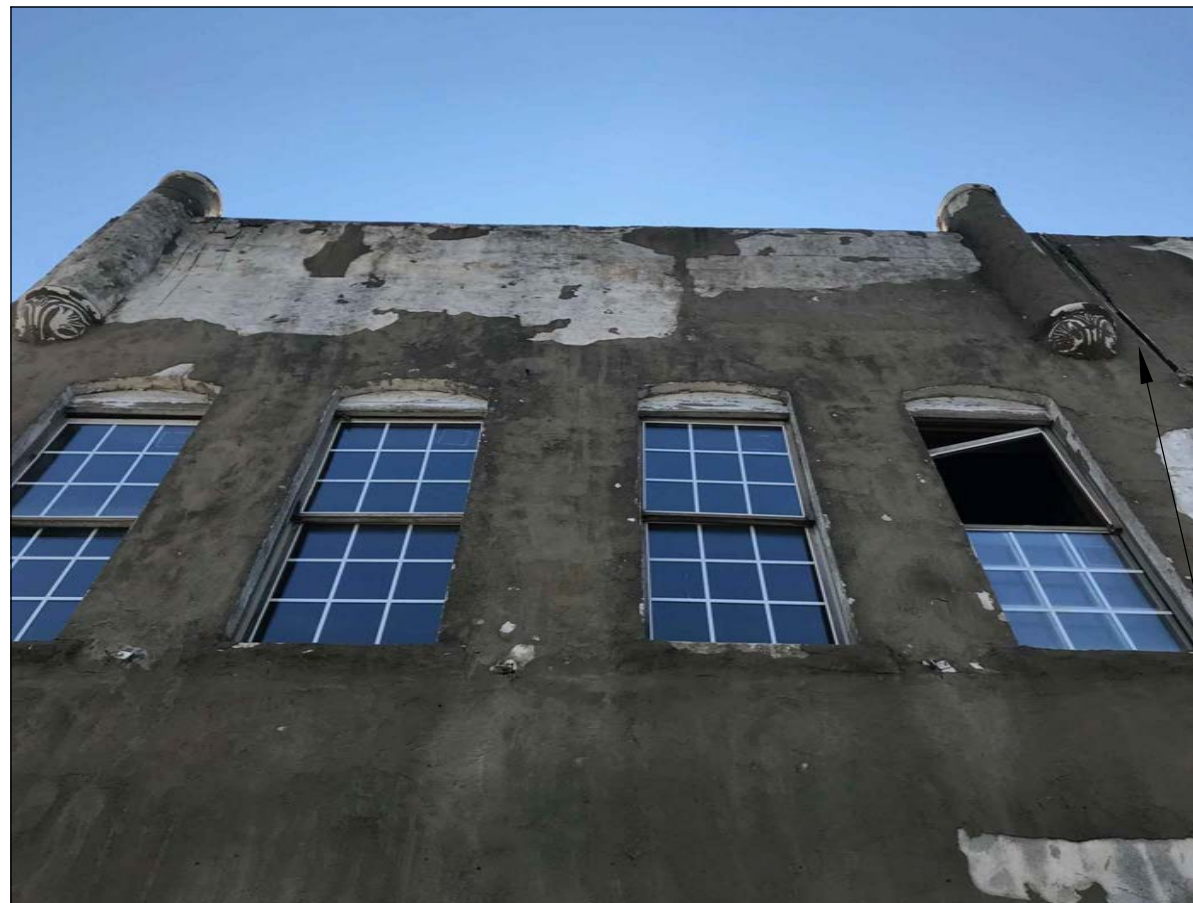
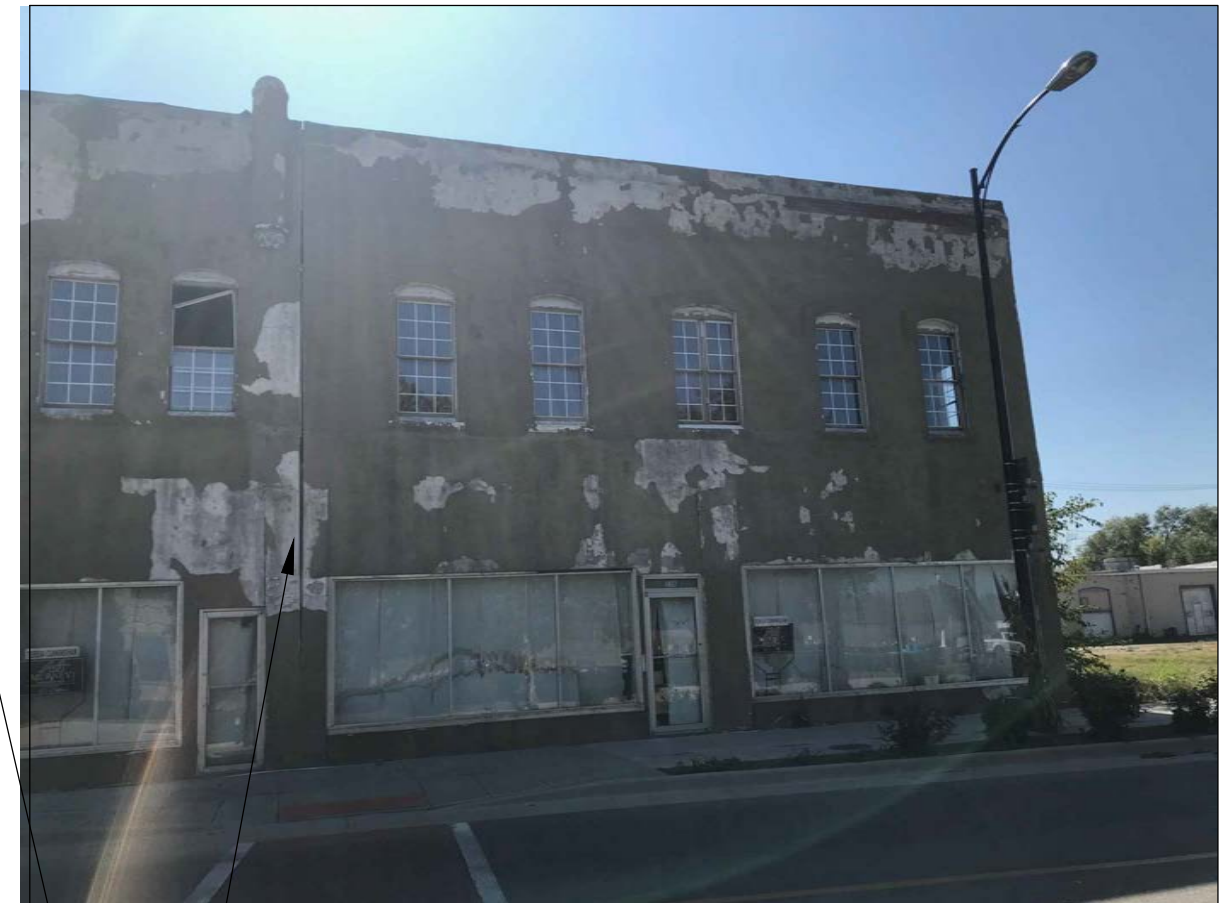
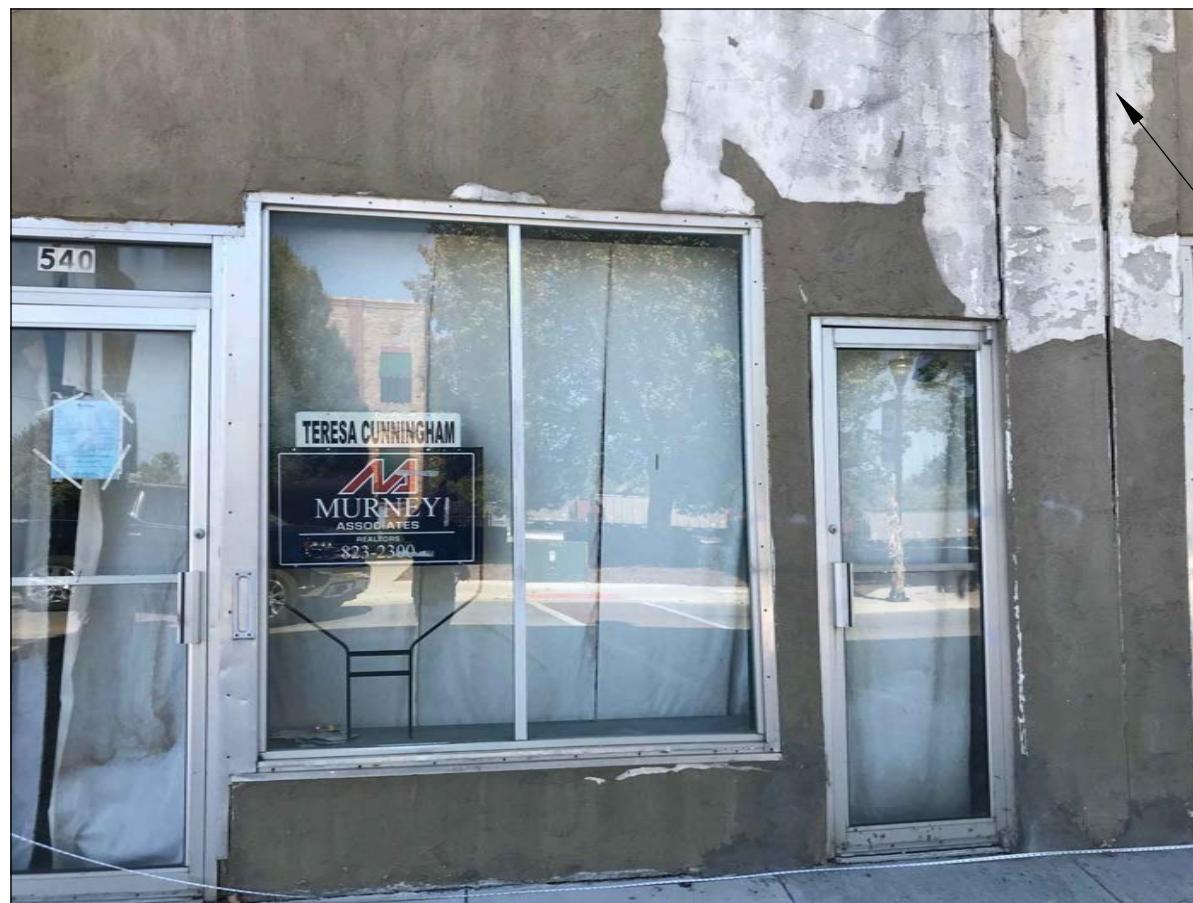
VISIBLE SEPARATION OF STRUCTURE. GAP GROWS WIDER AS IT GOES UP. THE PARAPET WALL/ROOF DECK AND SUPPORTING STRUCTURES ARE SEPARATING. WATER DAMAGE HAS COMPOUNDED THIS DETERIORATION.

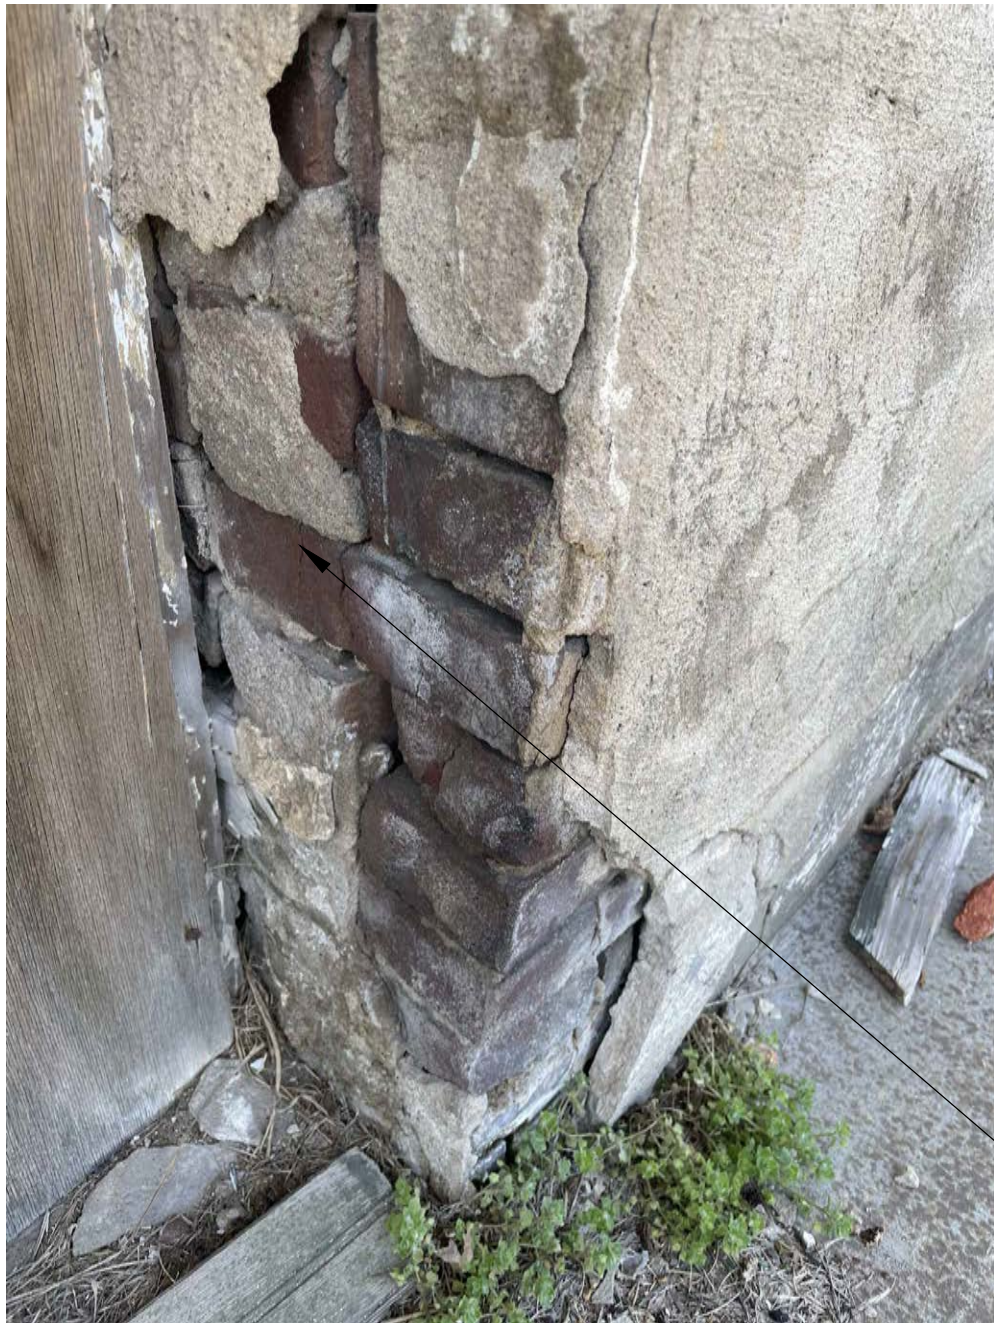
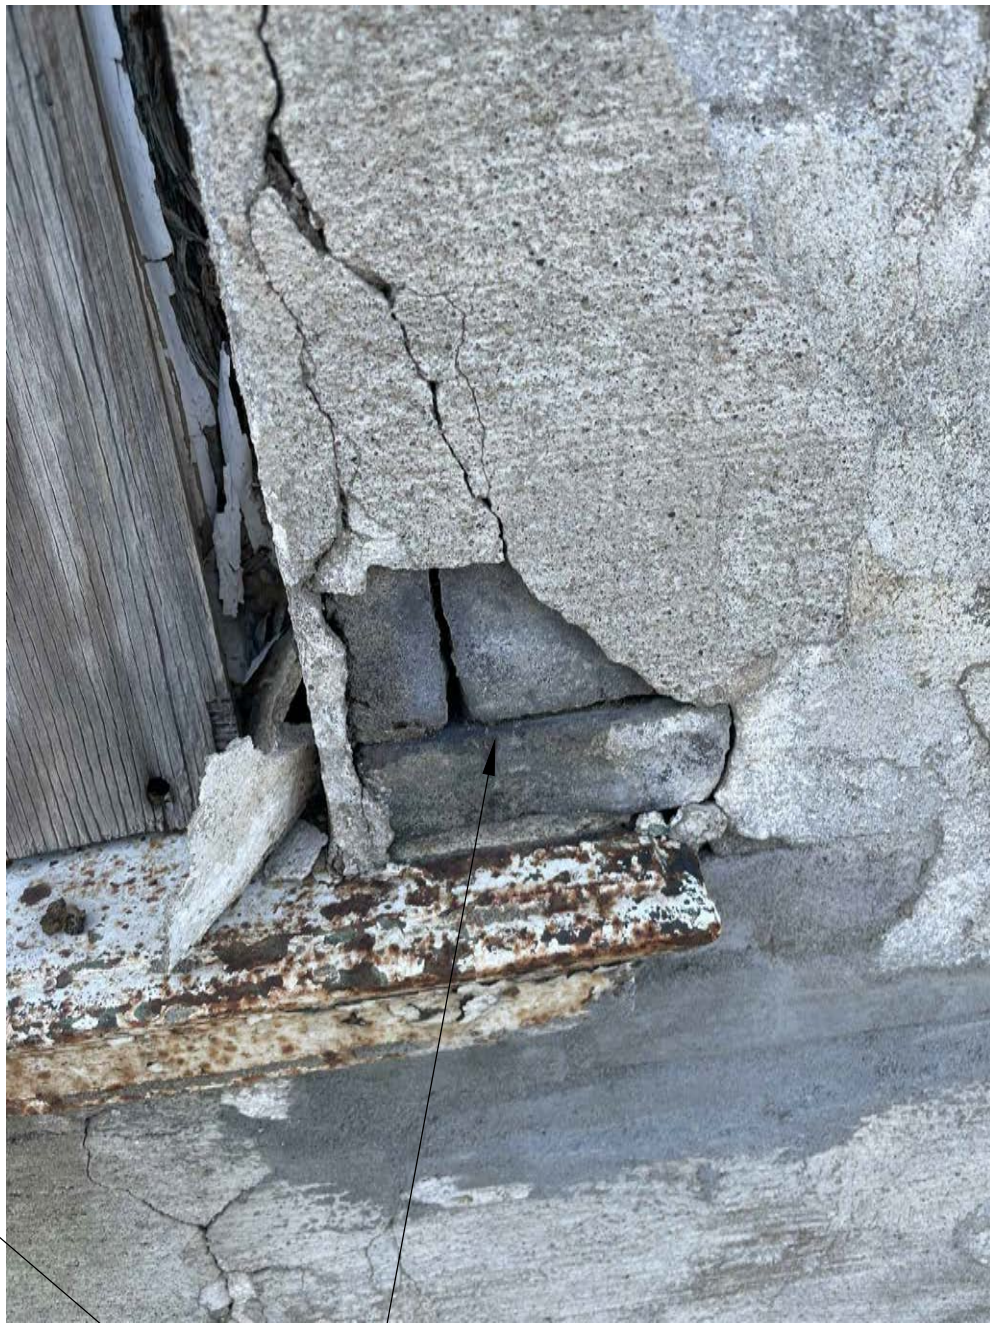
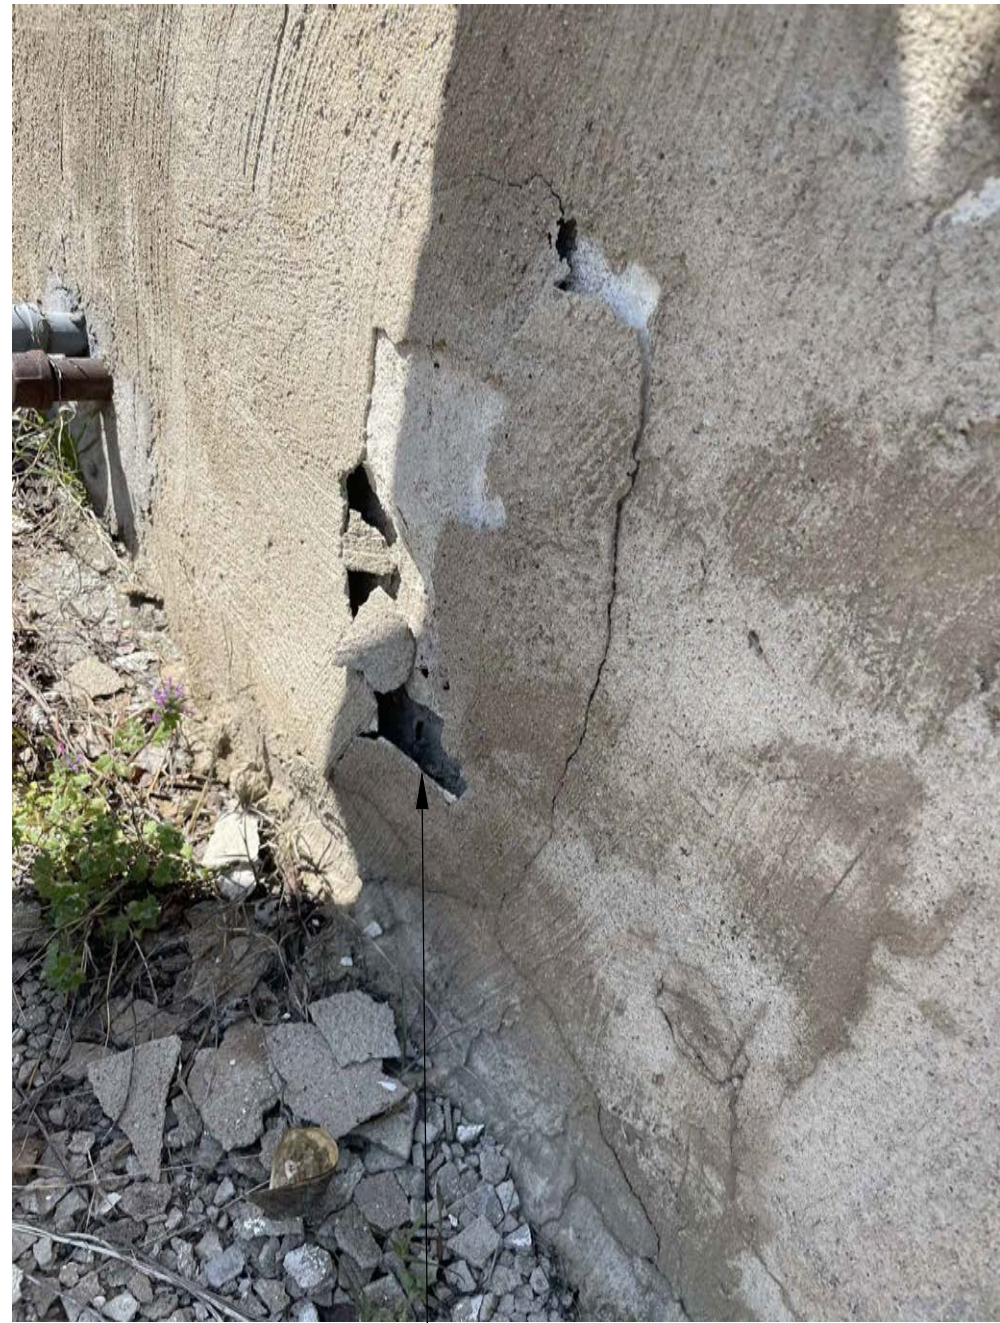
THERE ARE TWO LAYERS OF STUCCO FROM TWO DIFFERENT ERAS OVER EXISTING BRICK. VISIBLE BRICK IS OFTEN MISSING MORTAR JOINTS. DECADES OF MOISTURE, FREEZING AND THAWING HAS CAUSED SUBSEQUENT DAMAGE TO UNDERLYING BRICK. BECAUSE OF THE STATE OF THE EXISTING STUCCO SYSTEM.

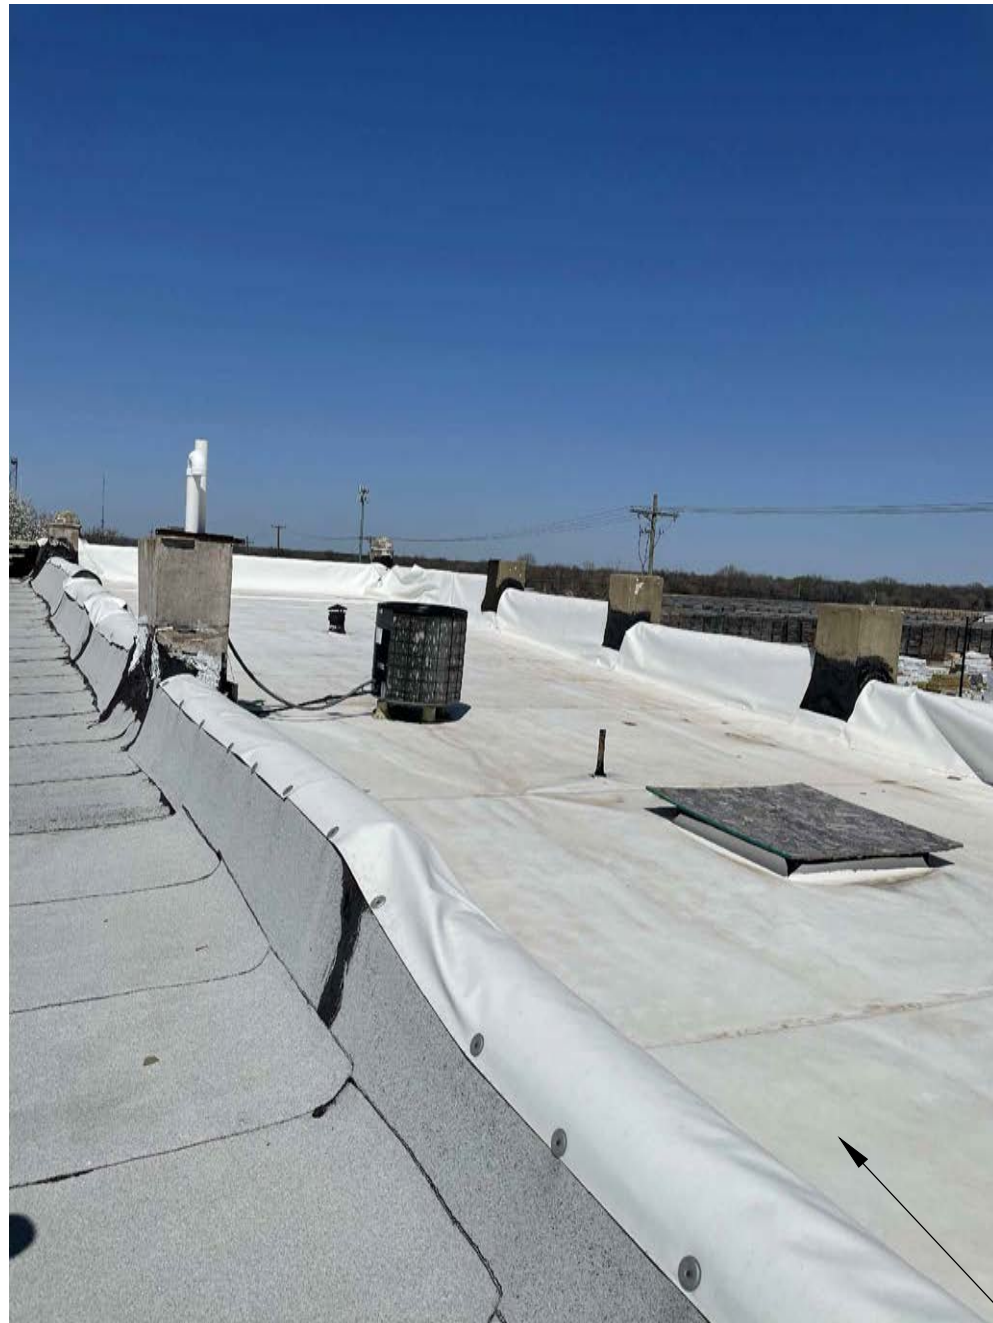
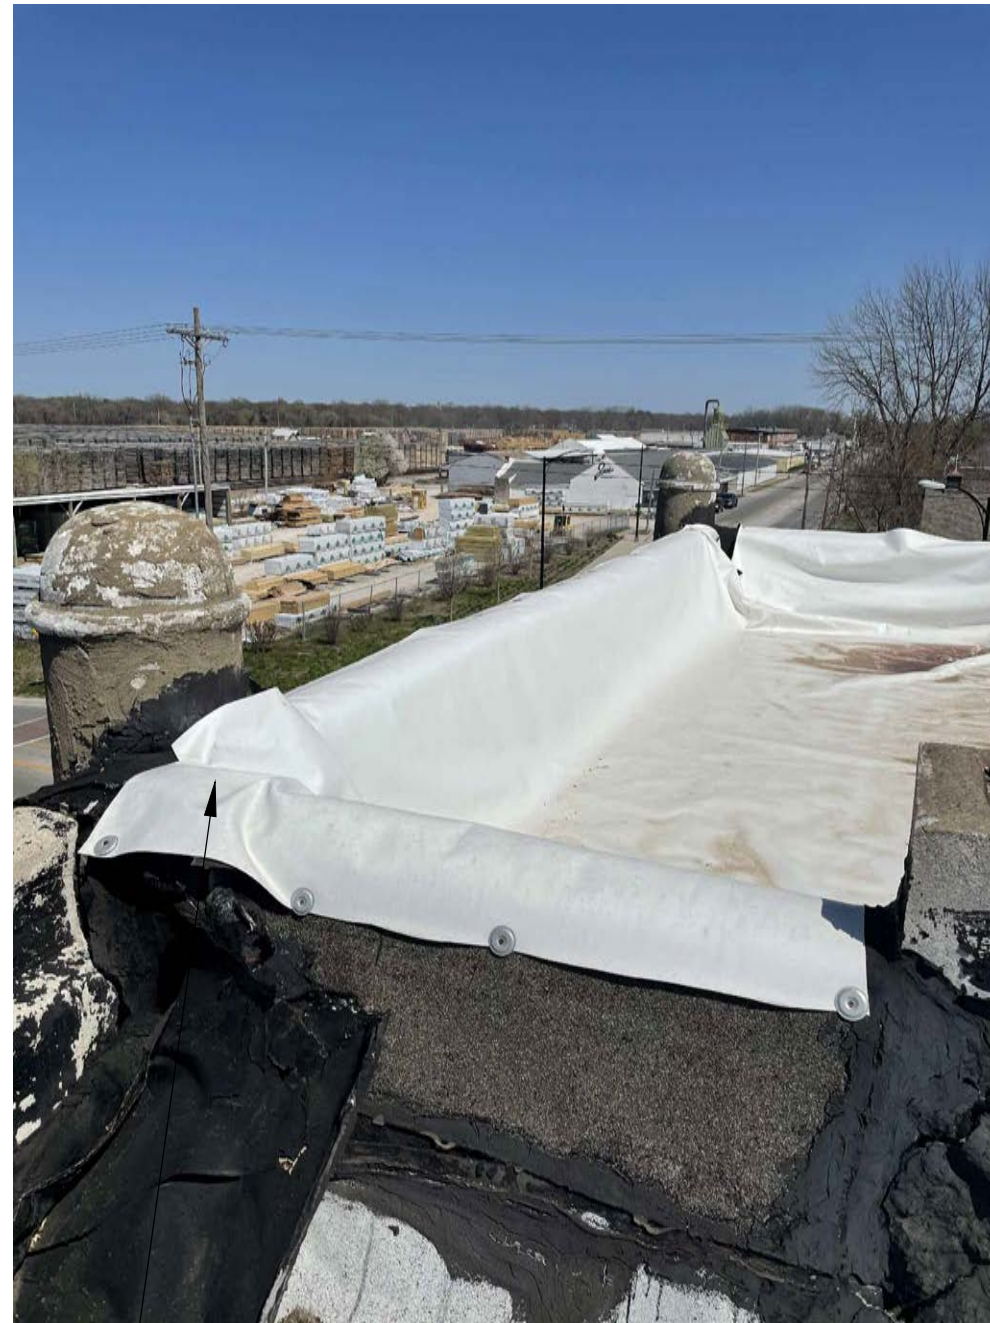
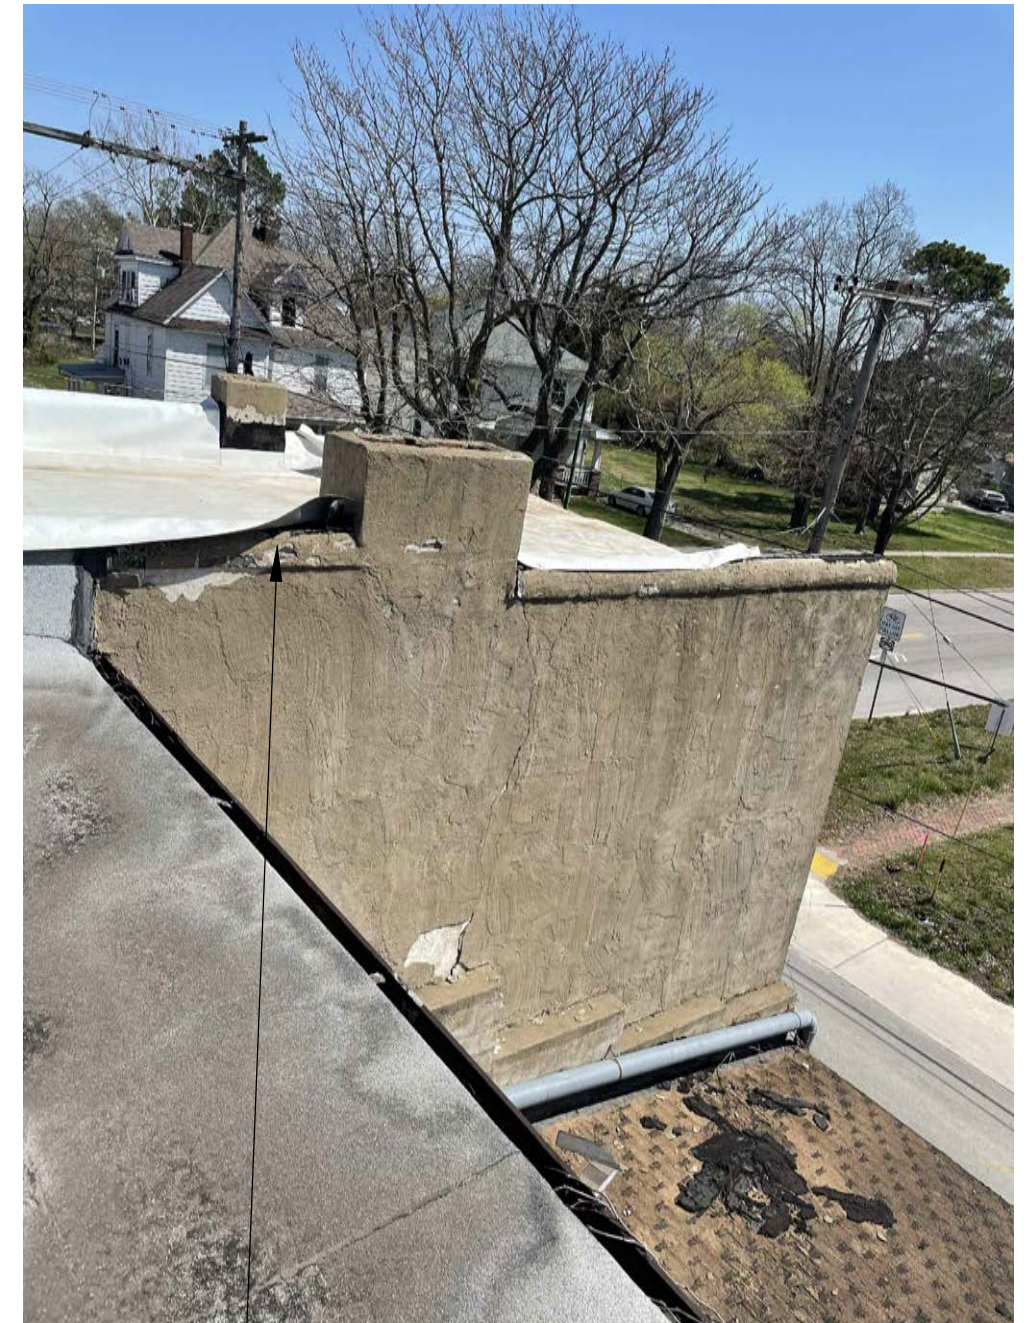
EAST ROOF IS COVERED WITH A TEMPORARY SHEET OF ROOF MEMBRANE, SCREWED TO EXISTING ASPHALT SHINGLES. MULTIPLE PENETRATIONS COMBINED WITH WIND AND RAIN ALLOWED WATER TO CONTINUE TO PENETRATE DAMGED ROOF AREAS. EXISTING SKYLIGHT HAS A PIECE OF ROTTED PLYWOOD COVERING IT WITH NO WATERPROOFING.

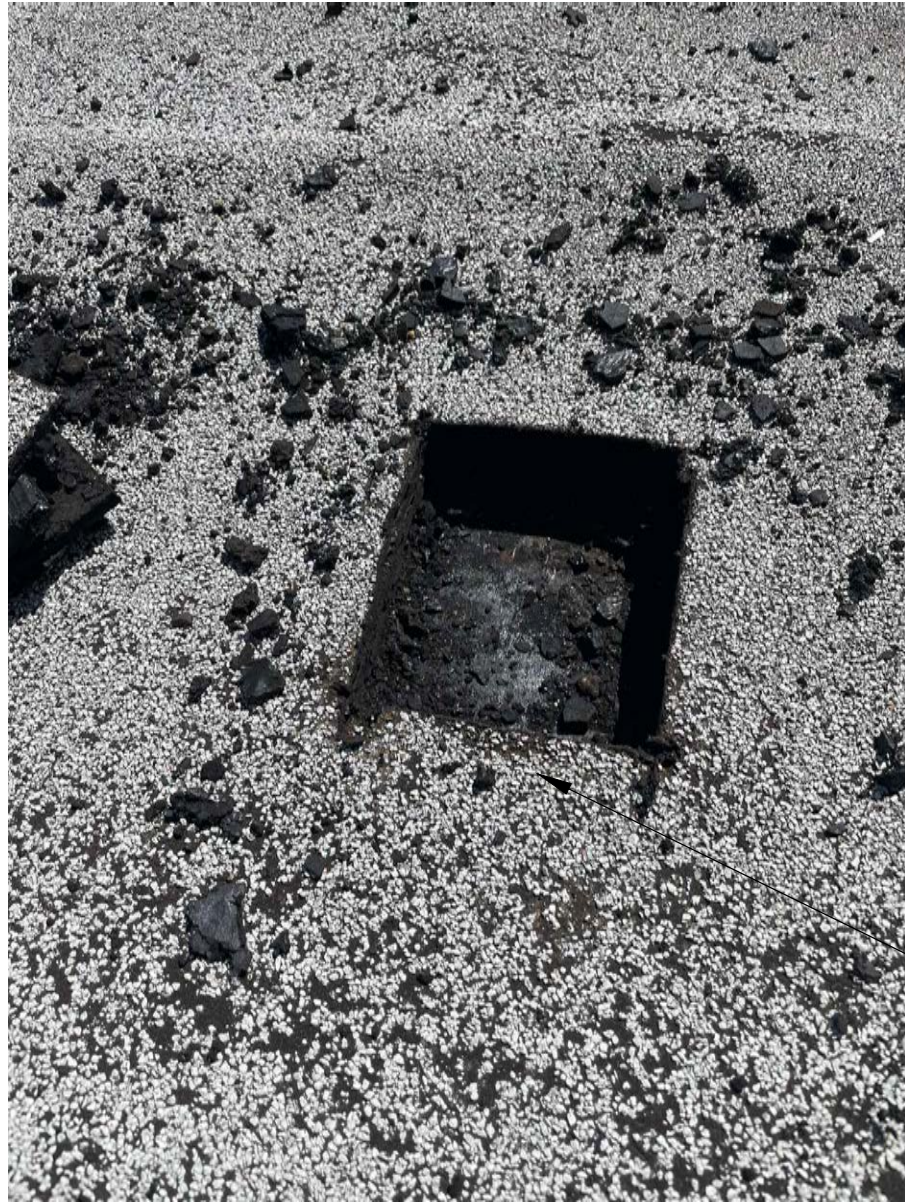
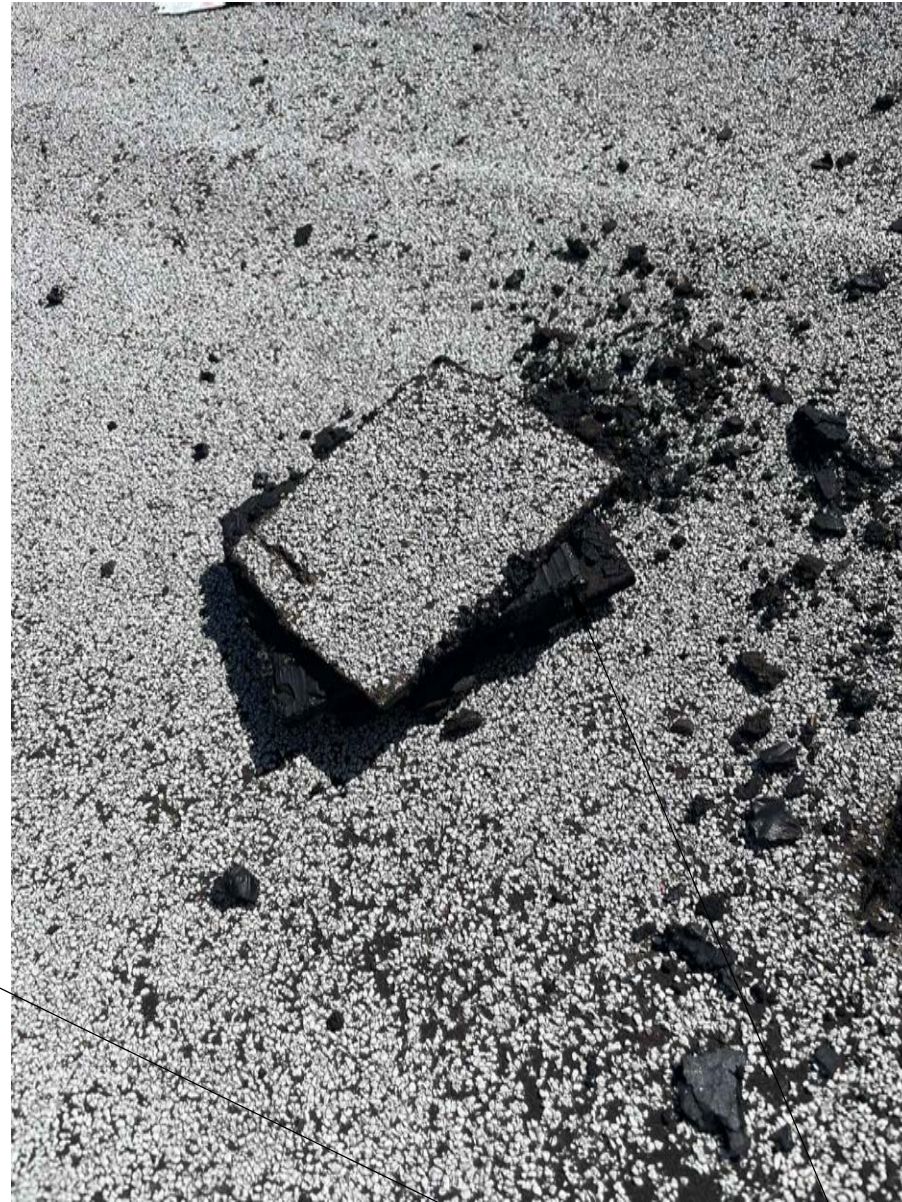
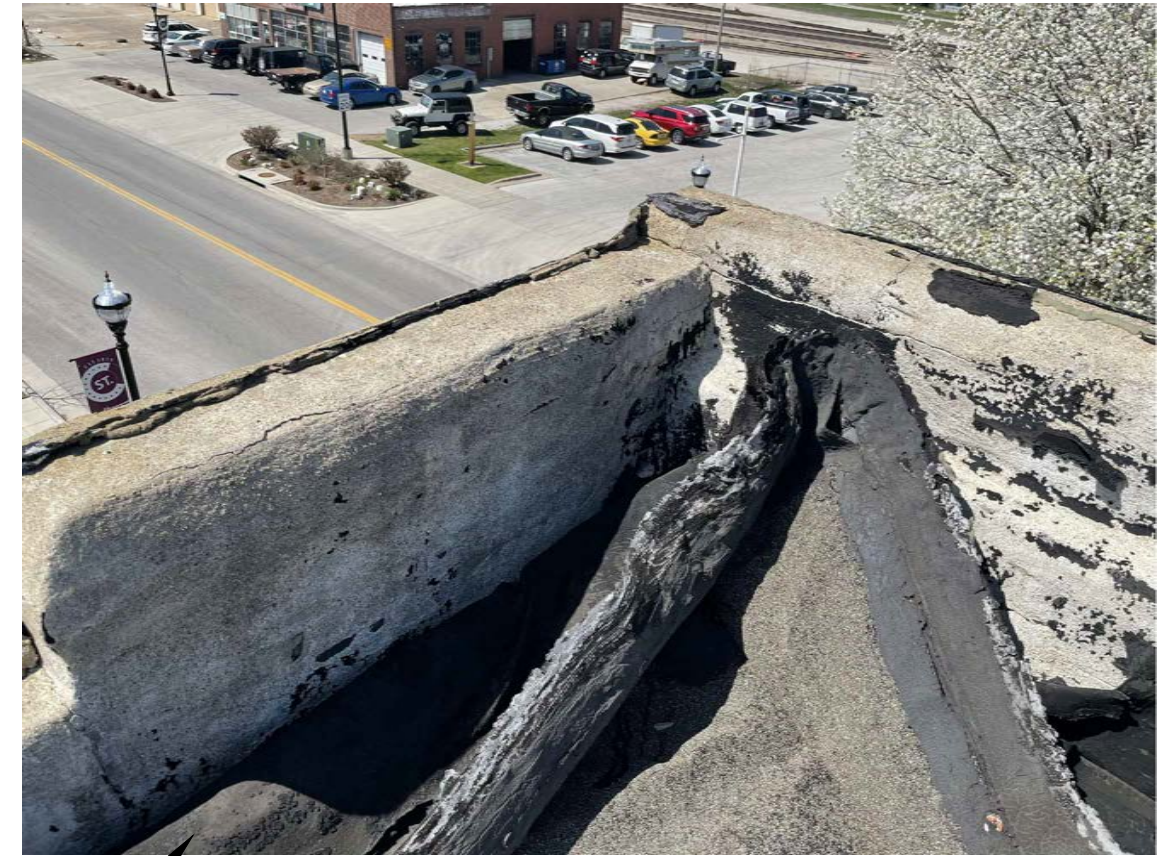
MULTIPLE LAYERS OF EXISTING ROOFING HAVE FAILED OVER TIME AND CAUSED THE EXISTING ROOF STRUCTURE TO BE OVERLOADED. CORE SAMPLE TAKEN SUPPORTS THE PRESENCE OF THESE LAYERS

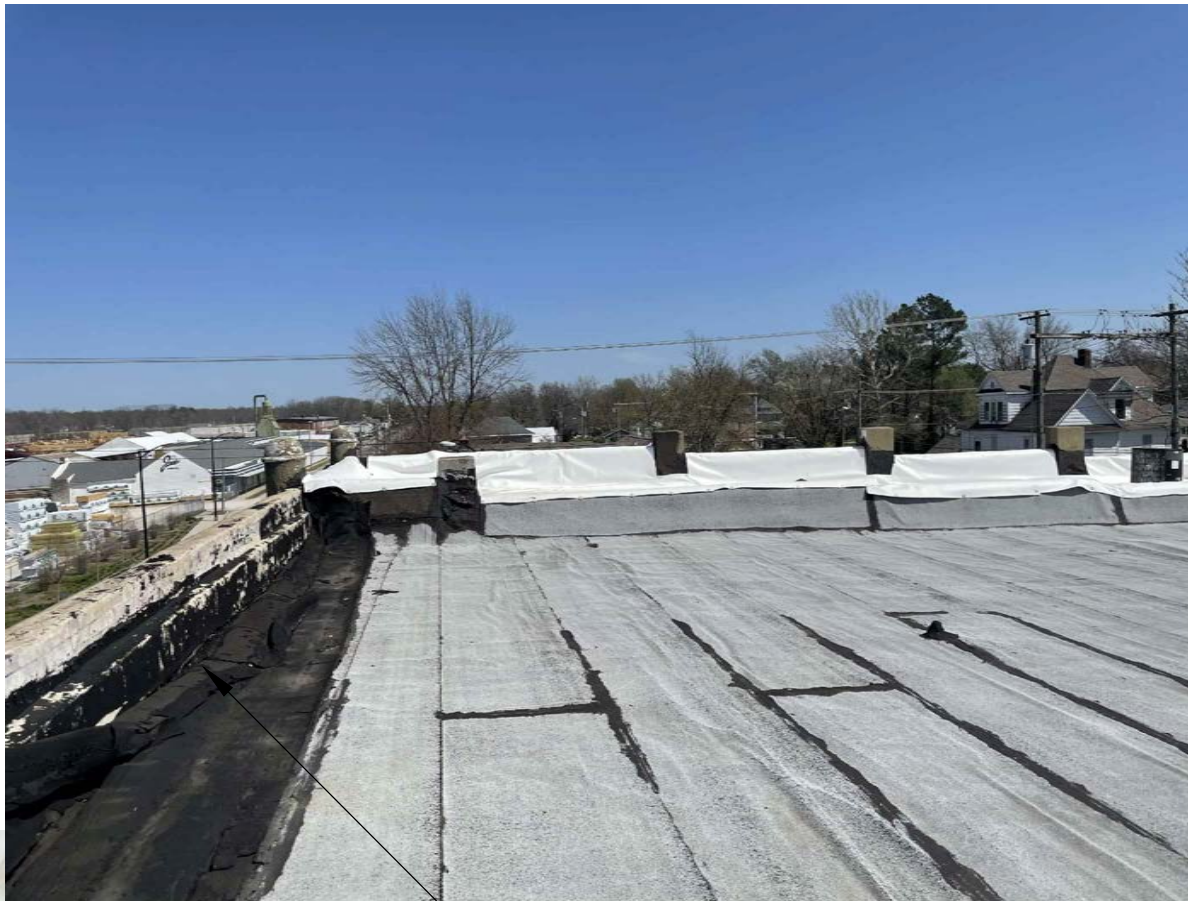
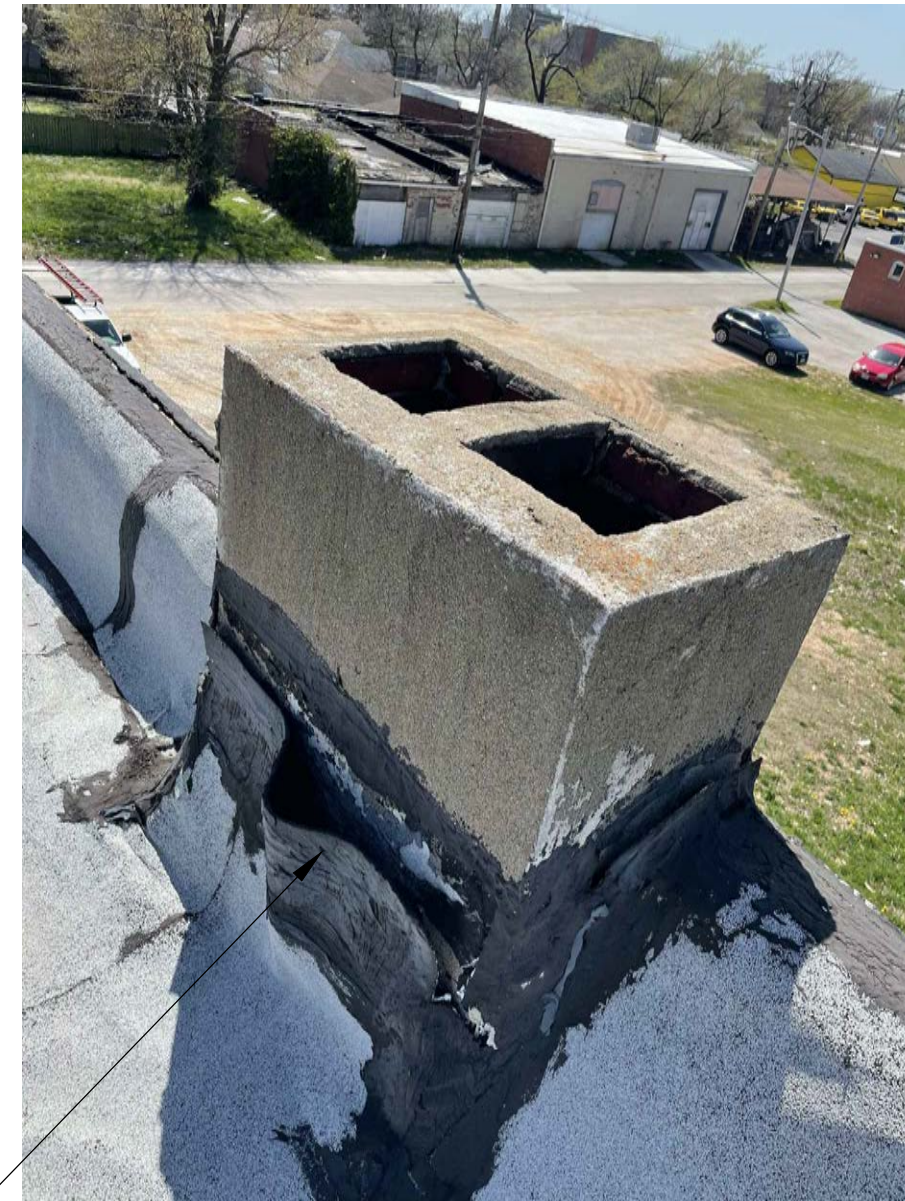
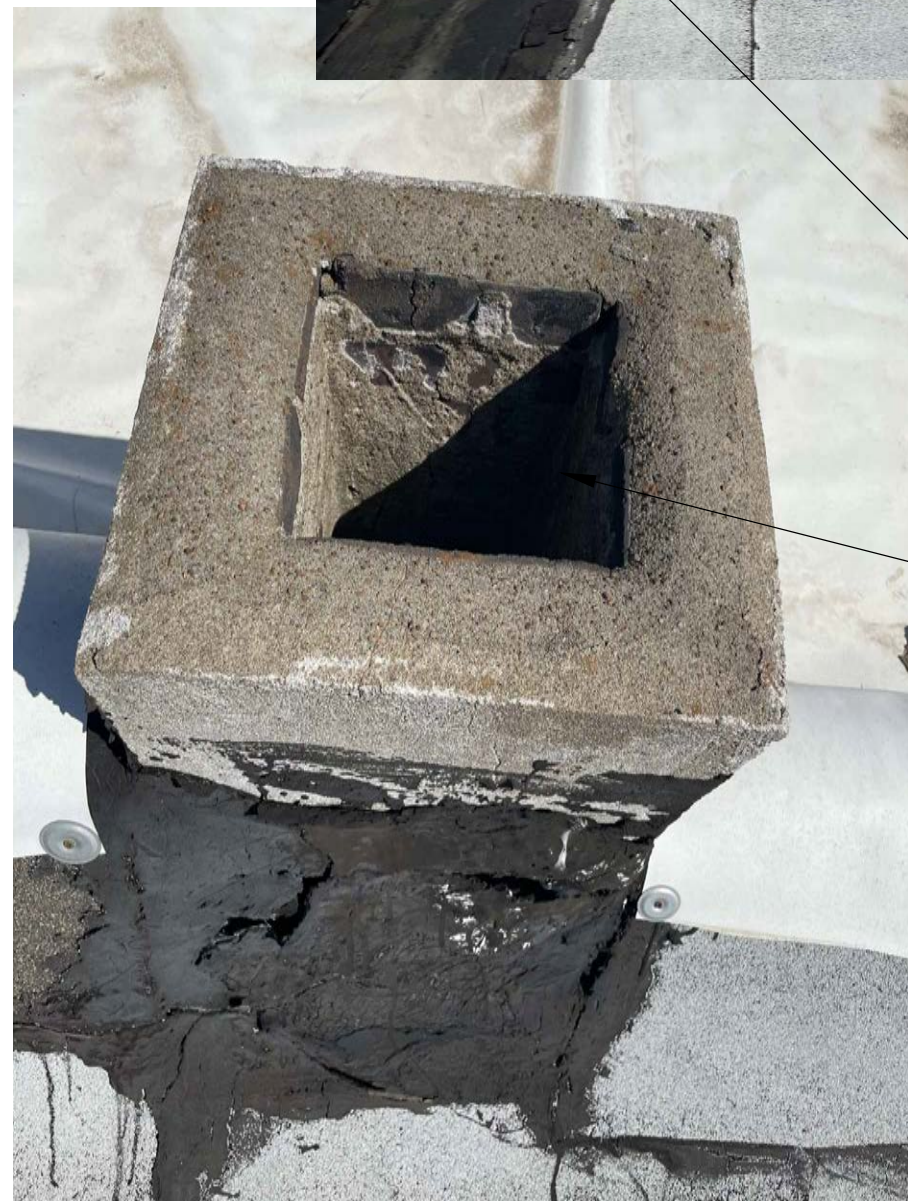
ROOFING HAS DETACHED FROM EXISTING PARAPET WALLS, ALLOWING WATER INFILTRATION. OPEN FLUES ALLOWING WATER INTO WALL CAVITIES.

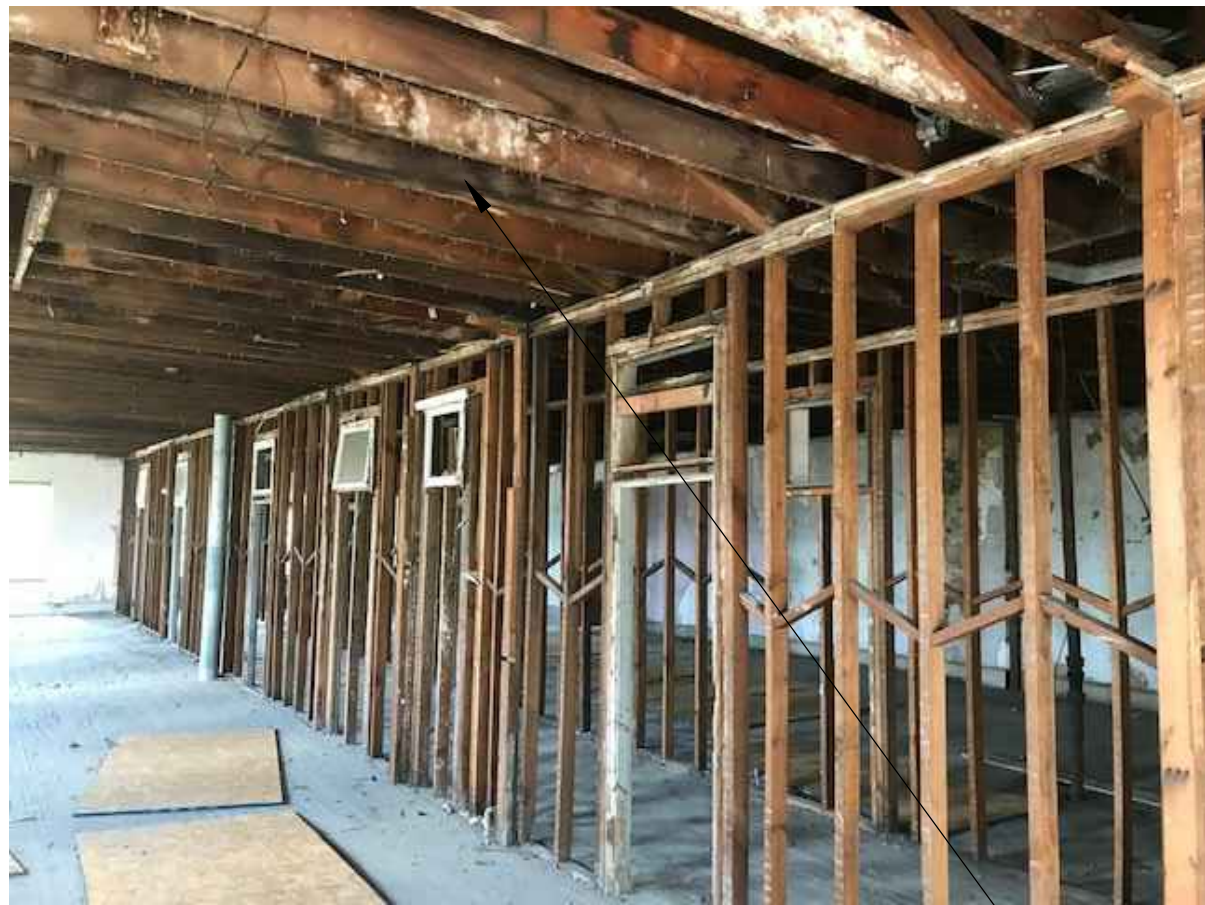
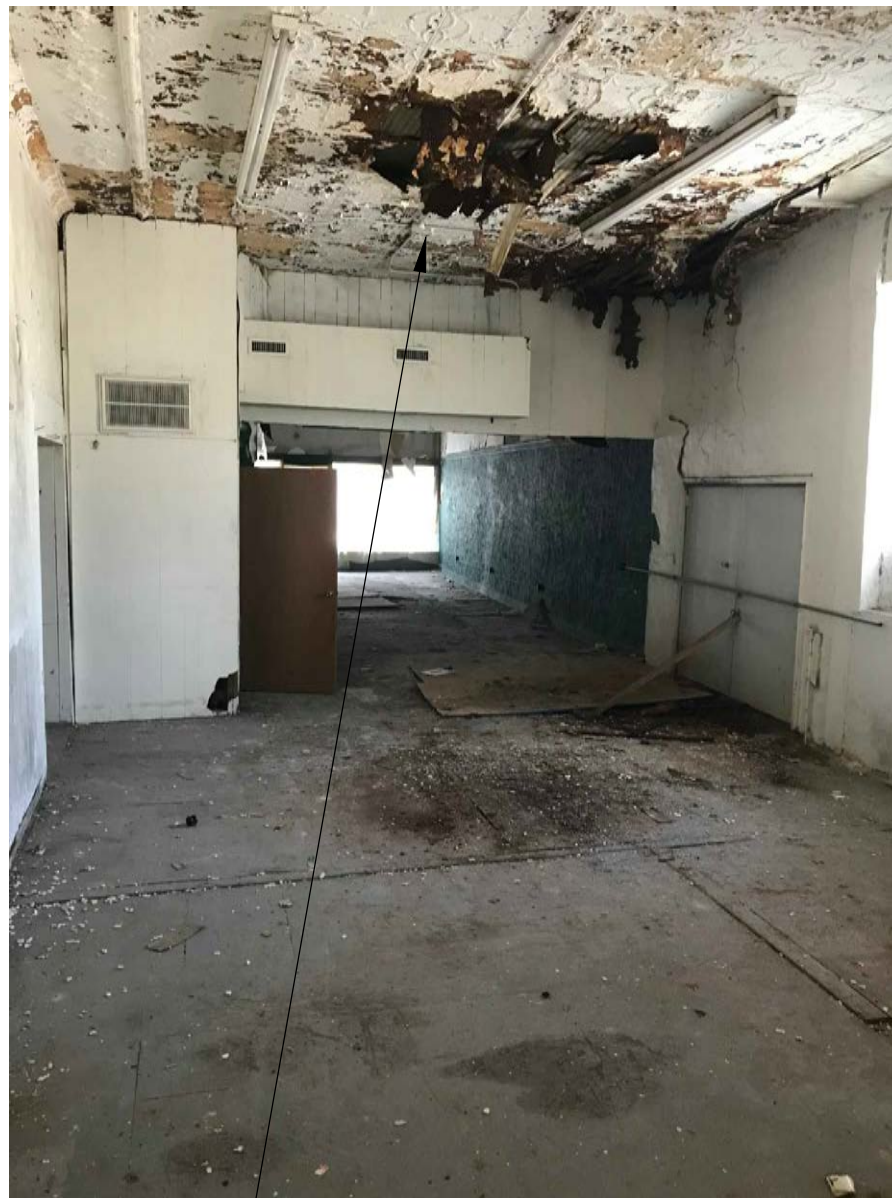
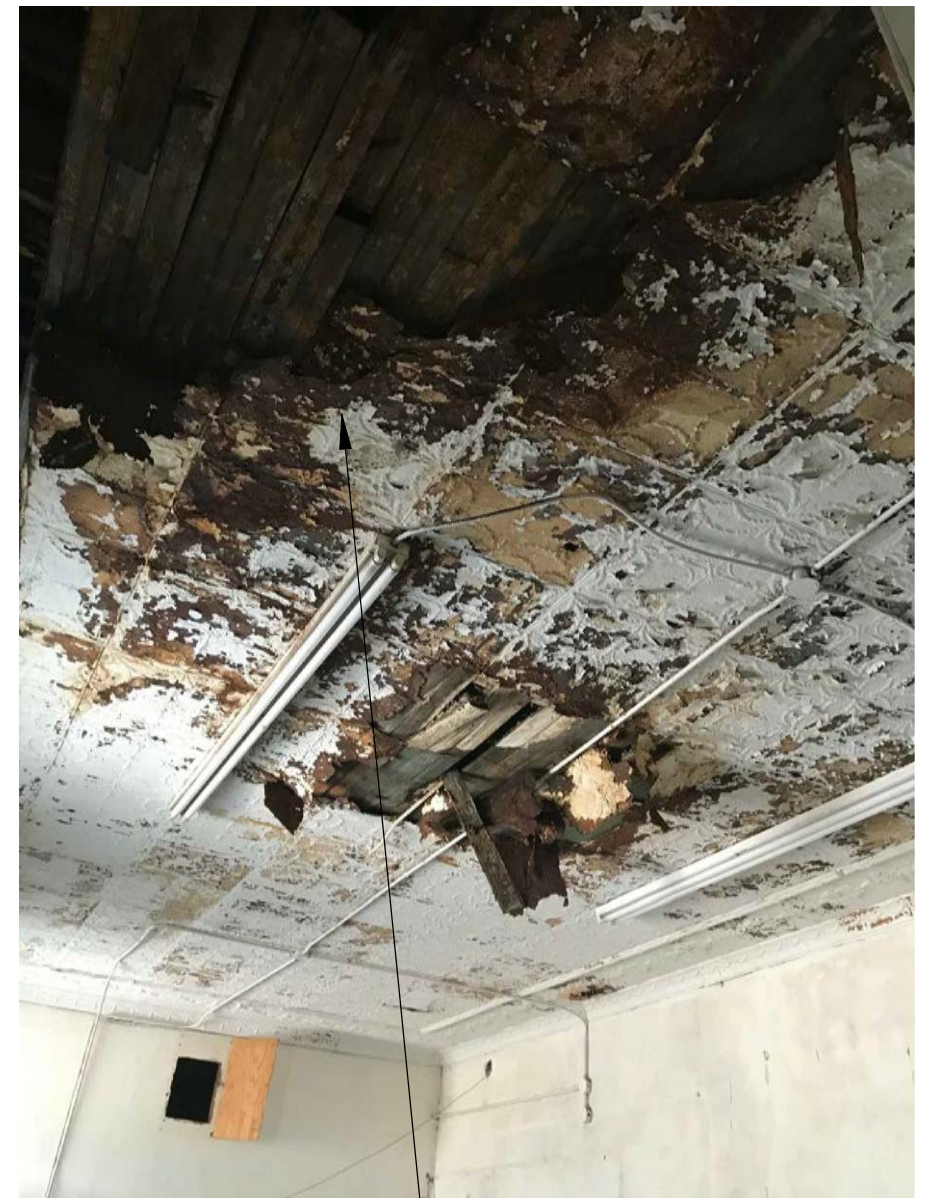
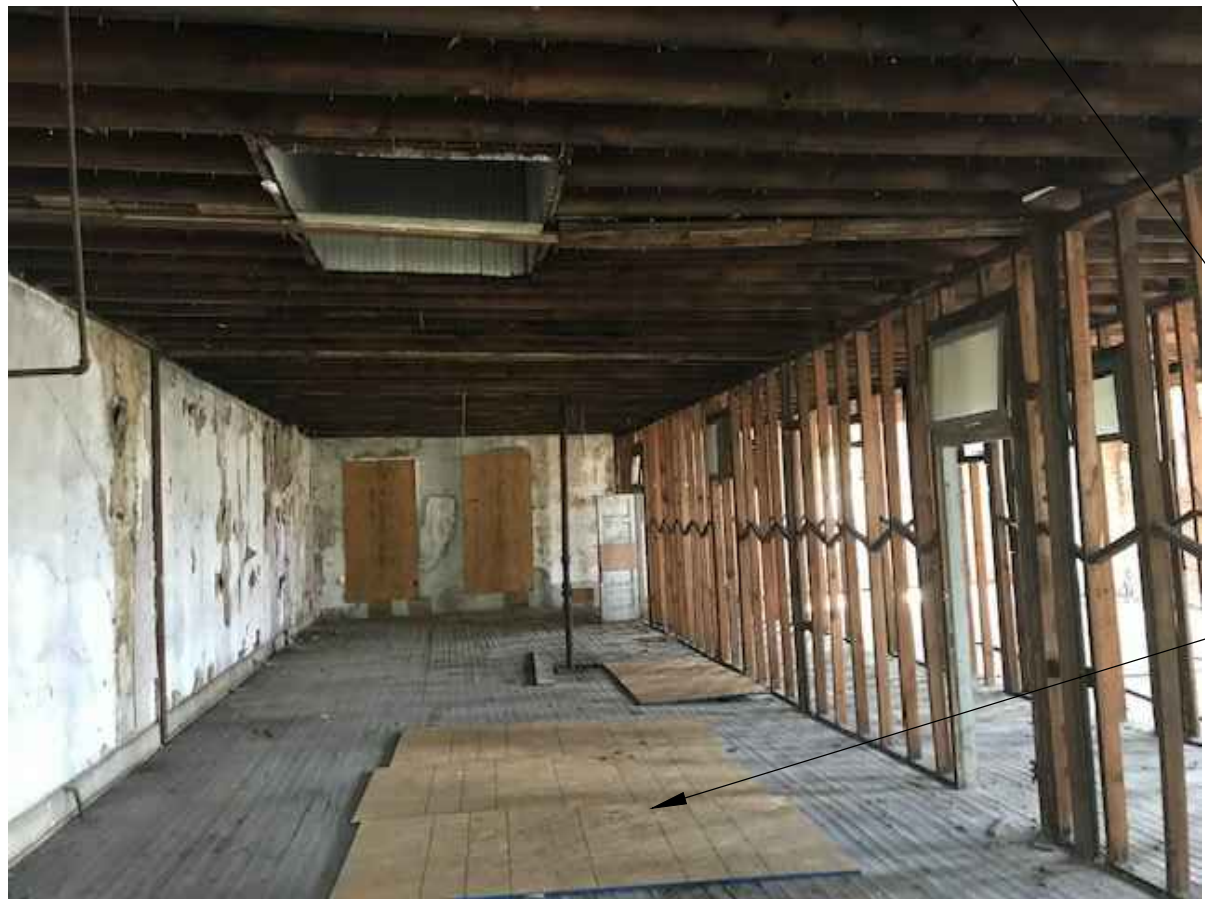
EXISTING STRUCTURE AND SPACES REFLECT YEARS OF WATER DAMAGE. WATER DAMAGE TRANSFERRED FROM ROOF TO SECOND AND FIRST FLOORS, AND CRAWL SPACE. SOME AREAS THAT HAVE COLLAPSED.
