# Landmarks Board

REQUEST FOR PERMISSION TO DEMOLISH  
530, 536 & 540 E. COMMERCIAL STREET

## FIELD OBSERVATION REPORT

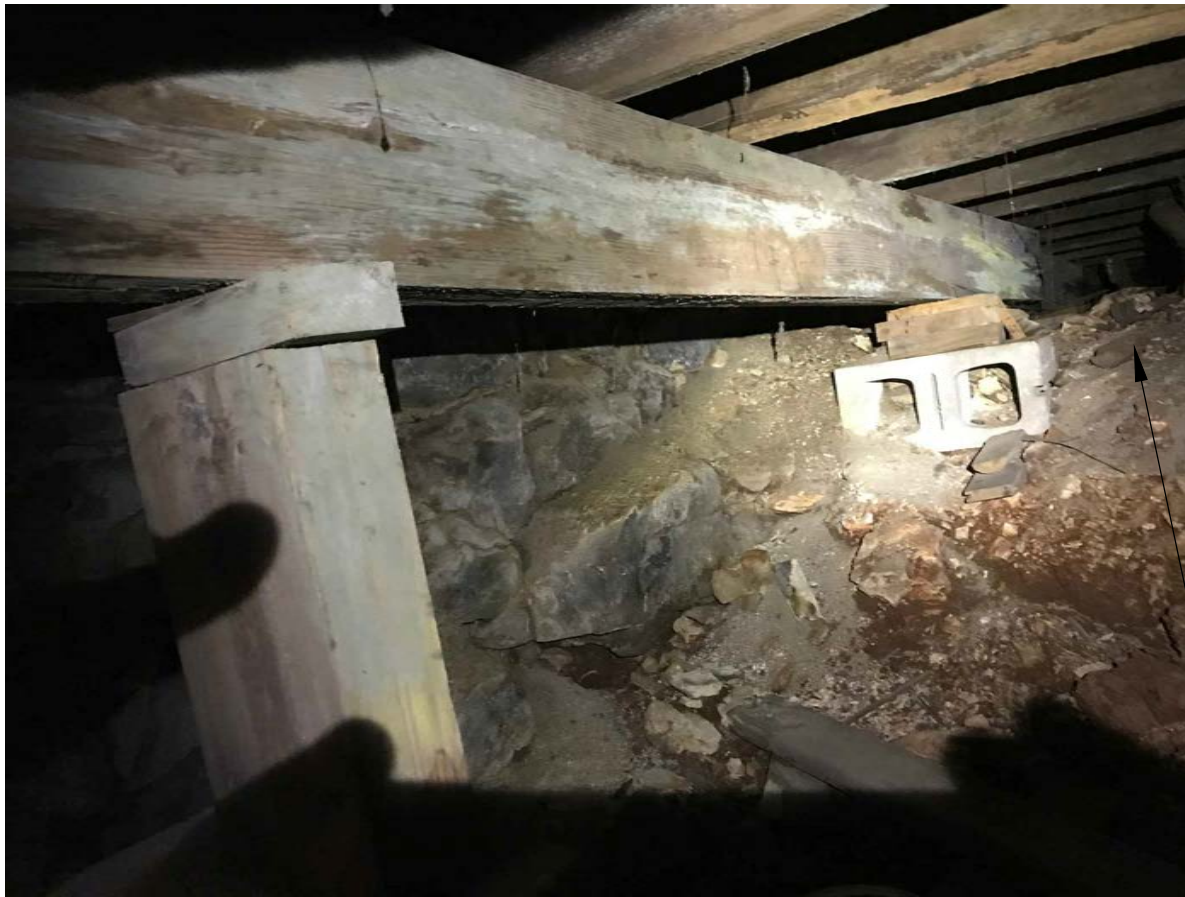
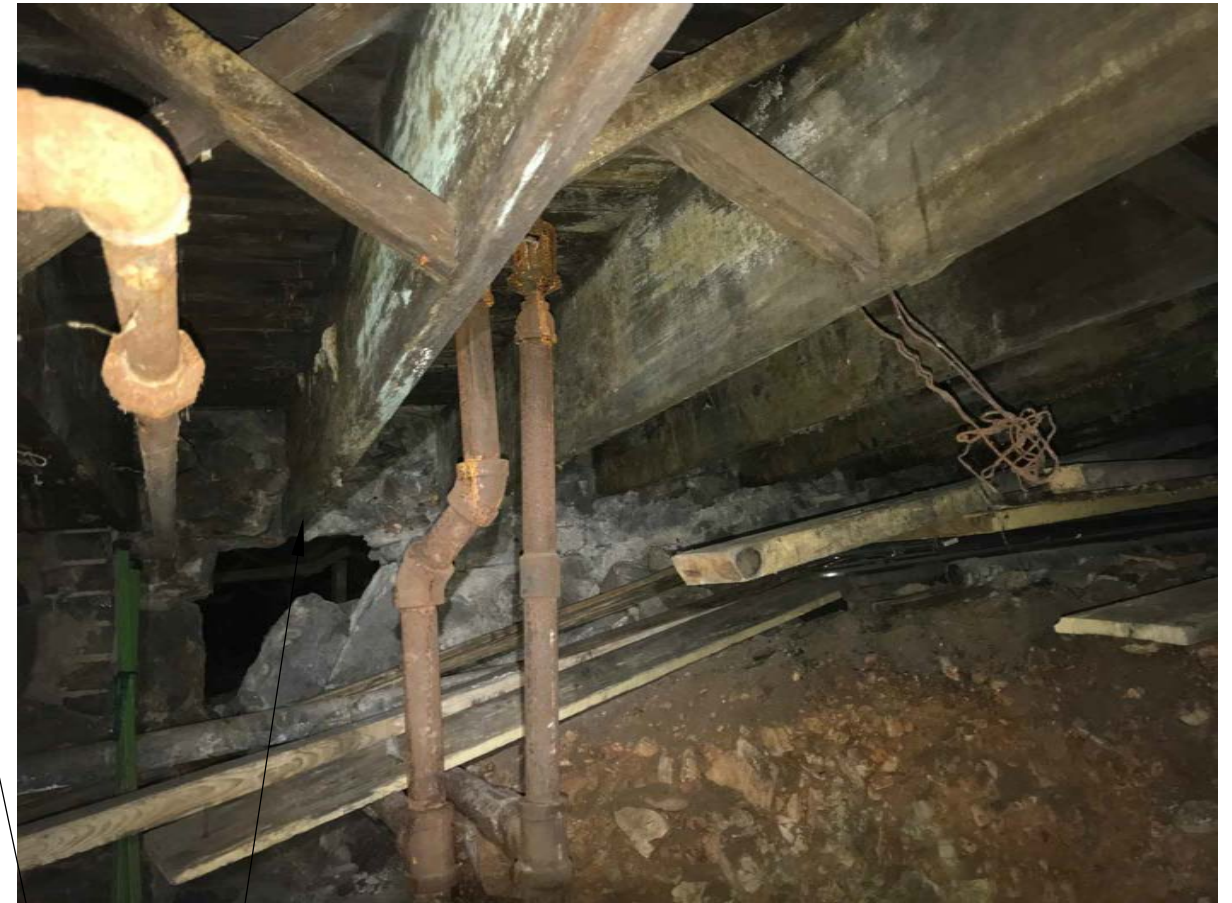
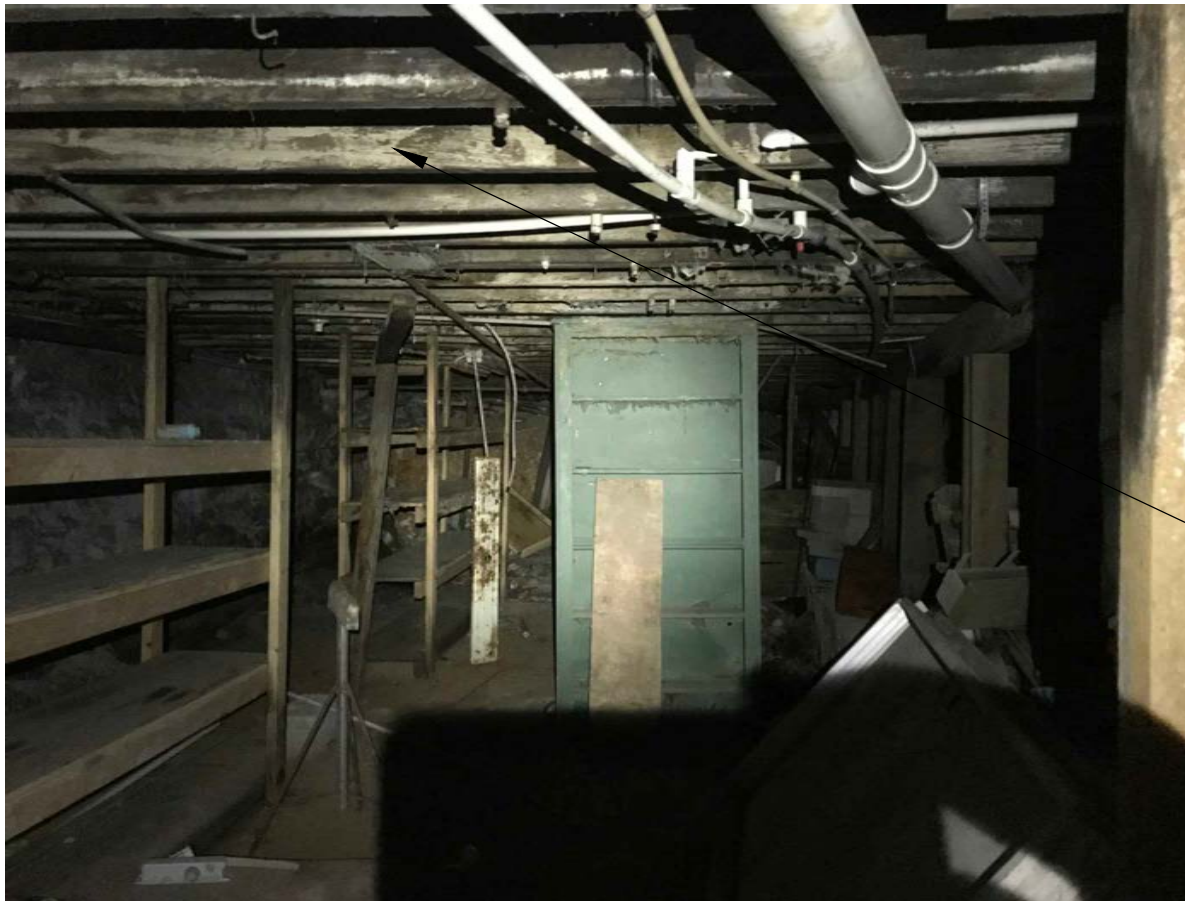
PARTIALLY COLLAPSED FOOTING WALL WITH  
UNSUPPORTED FLOOR JOIST

WATER DAMAGE FRAMING/ STRUCTURAL - NOTE  
DARKENED SAGGING FLOOR JOISTS

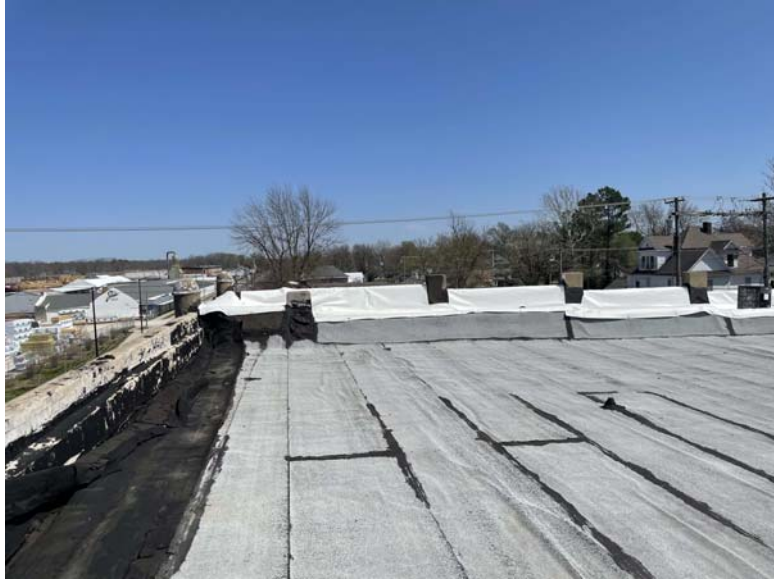
Most of the roofing system along the North side has come unattached to the parapet wall allowing moisture in this area to enter the building.

The existing parapet cap is rounded concrete in most location with no coping cap. This is pretty normal for older building of this period, all attachment between the parapet cap and roofing membrane is installed with pitch and or tar.

- Remove all existing roofing systems down to existing deck. Repair or replace deck as needed.
- Build plywood cants around perimeter of building to get water shedding away from roof to wall joints.

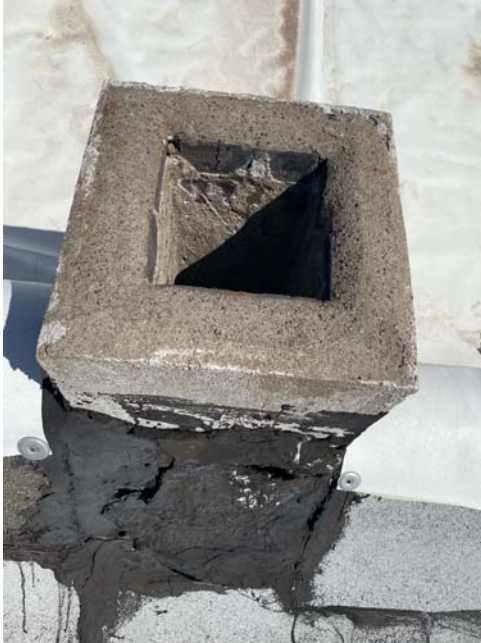
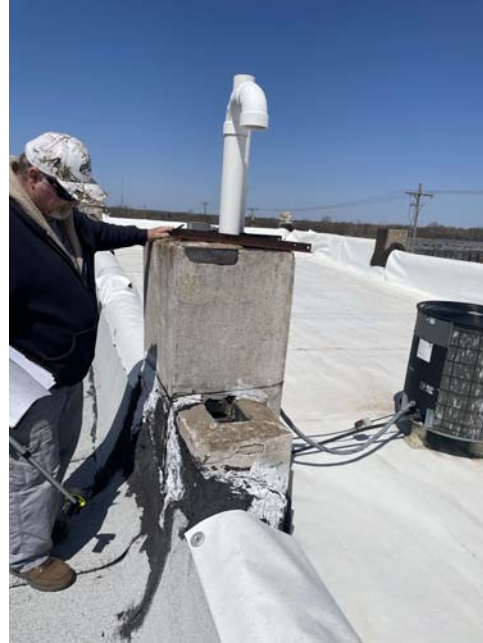
All existing pilasters are hollow with exposed tops allowing the element enter the wall cavities with a select few used for the mechanical system.

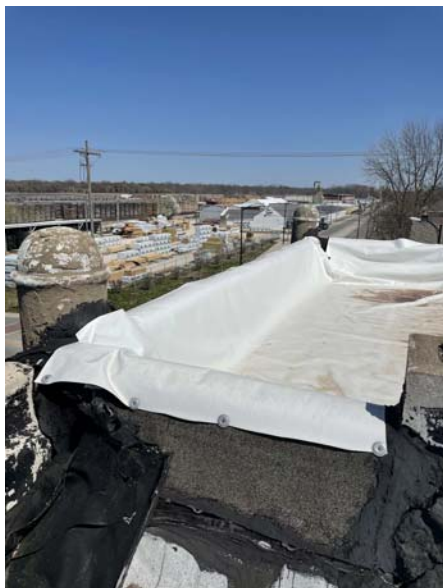
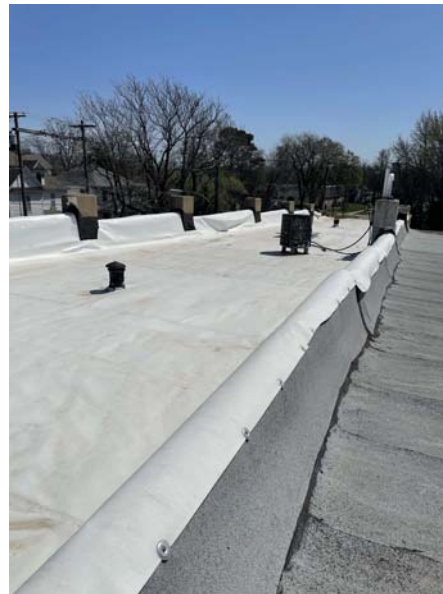
The east roof has been covered with a loose TPO membrane attached around the perimeter with mechanical fasteners. This appears to be a temporary fix to keep the majority of water from entering the roof system, but not tight enough to create a water tight system.

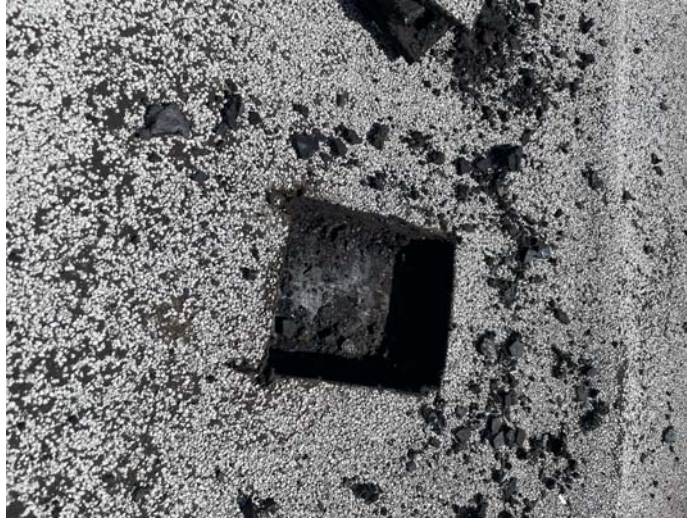
The West section has about 4 old layers of roofing system installed directly over the wood deck. There is currently no insulation on the roof.

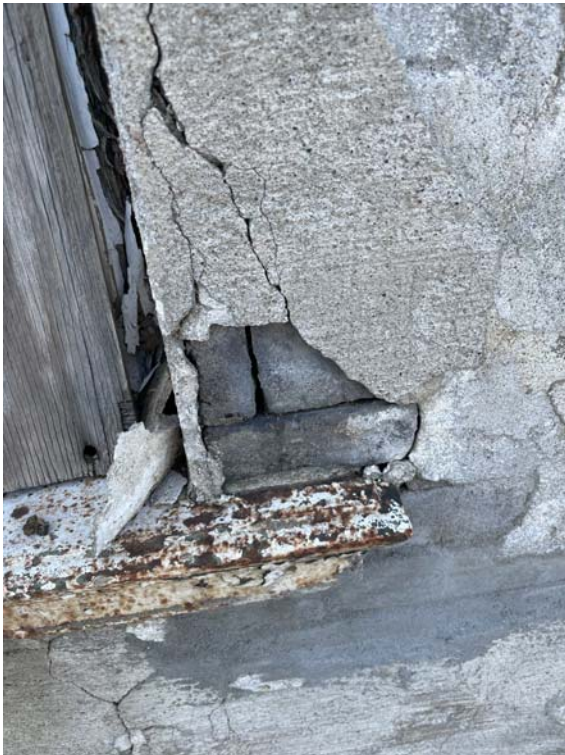
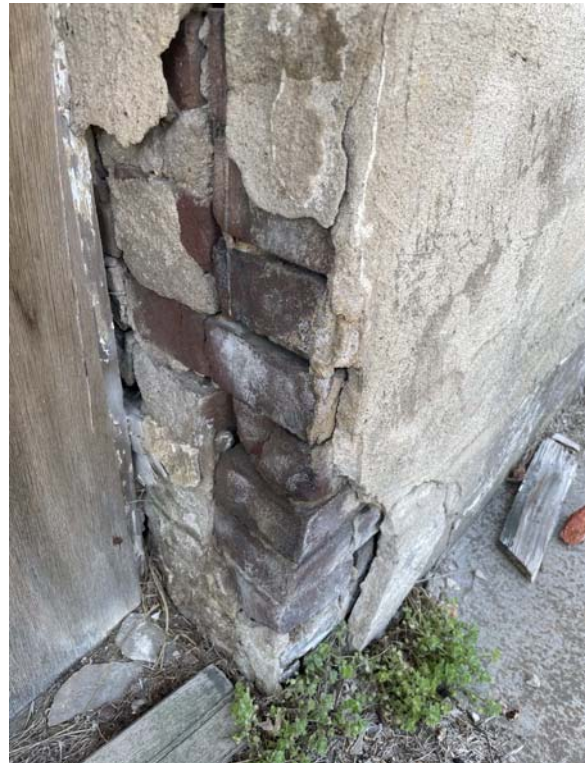
There are visible signs of multiple layers of stucco on the existing masonry walls. This is due to years of patching problem areas. In some areas the existing stucco and lath system is peeling off of the masonry exposing the existing Masonry. Some visible masonry is in good shape and some shows complete deterioration of grout.

- **Removal and Replace only what is required:** In this option the installer would remove all existing stucco that is not solid to the existing masonry wall. This would include areas where the existing lath is peeling off, areas that sound hollow and not secure to the masonry, and areas where the skim coat is flaking off. This would not be all of the existing stucco, but all that is loose or flaking. It is hard to determine how much existing would be removed until performing the job. Then new lath and stucco would be applied to areas where all existing was removed, and a new skim coat

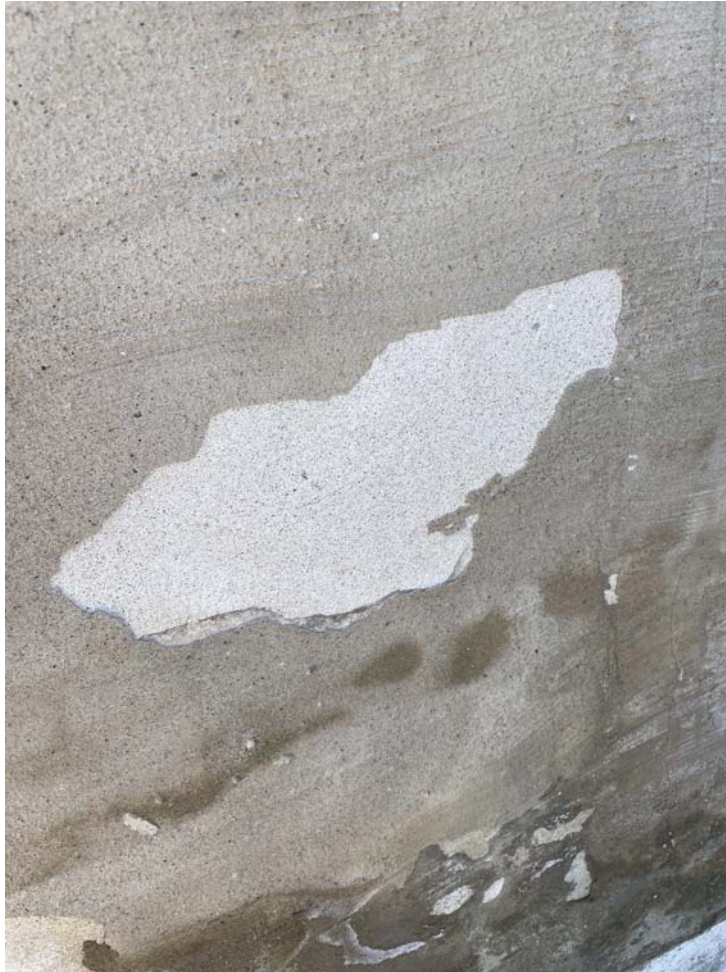
In other areas the base or original stucco is solid but the more recent skim coat is flaking off.

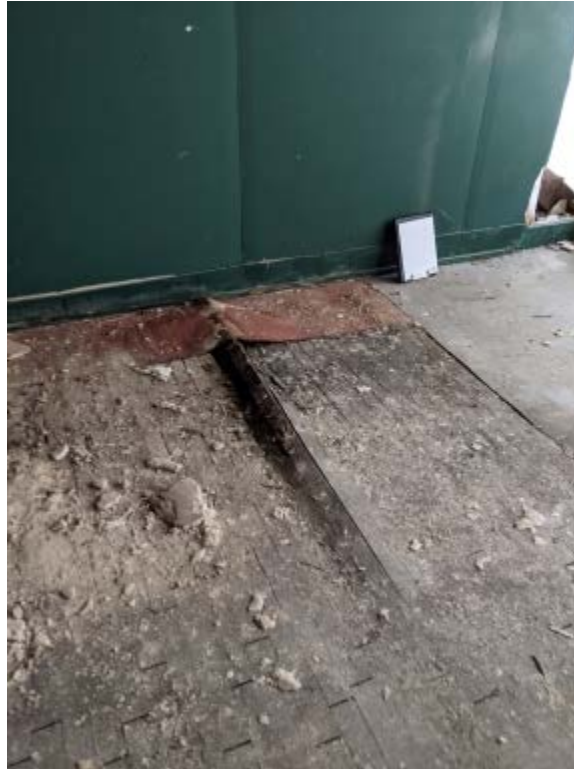
There are many locations on the first floor of the east suite where the floor framing is greatly deteriorated, likely due to moisture problems. Many locations could not be traversed due to the level of damage. Several holes were observed through the floor from this damage. The floor planking has created ridges due to extreme swelling of the wood in some areas. The first-floor framing on the west side did not appear to have the same level of moisture damage, but some damage was still observed. Holes were observed in this floor as well.

**Buckled Floor Planks on First Floor of East Suite**

The majority of the first-floor framing of the east suite will need to be removed and replaced. Most of it is severely damaged and deteriorated beyond the point of remediation. The exact extents of the framing to be replaced is unknown; a more exhaustive examination of the floor framing will need to be done during demolition to make this determination.

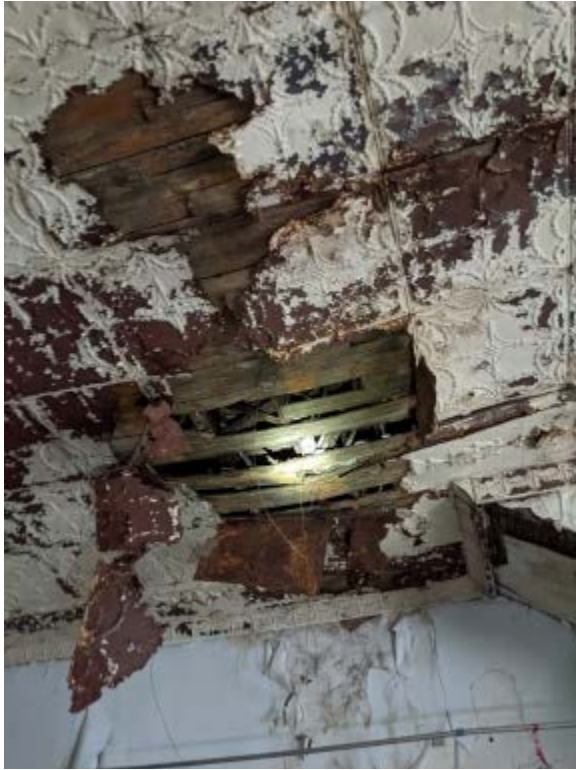
The second floor on the east side contains several large holes that appeared to align with the damage observed on the first floor. Signs of past elevated moisture and bulk water intrusion were observed in the roof framing above these damaged areas. The second-floor framing on the west side did not appear to be damaged as severely as the east but also contains some large holes.

**Hole in Second Floor of East Suite**

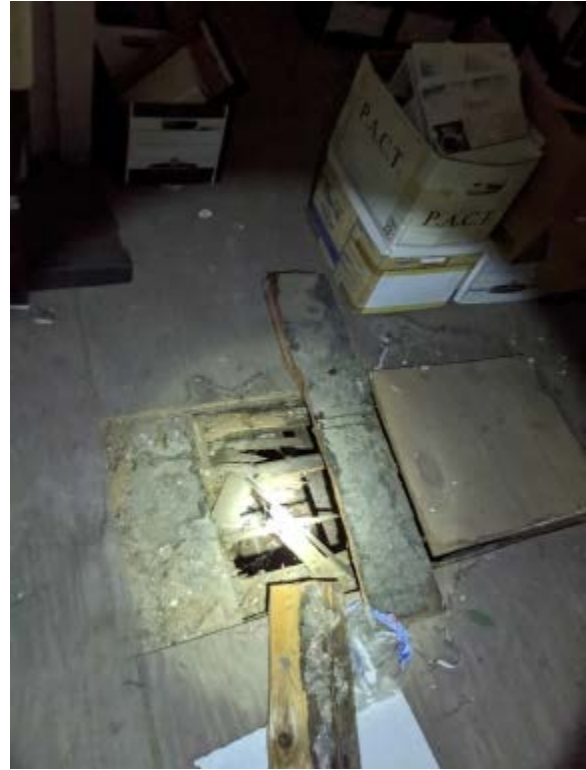
**Hole in First Floor of West Suite**

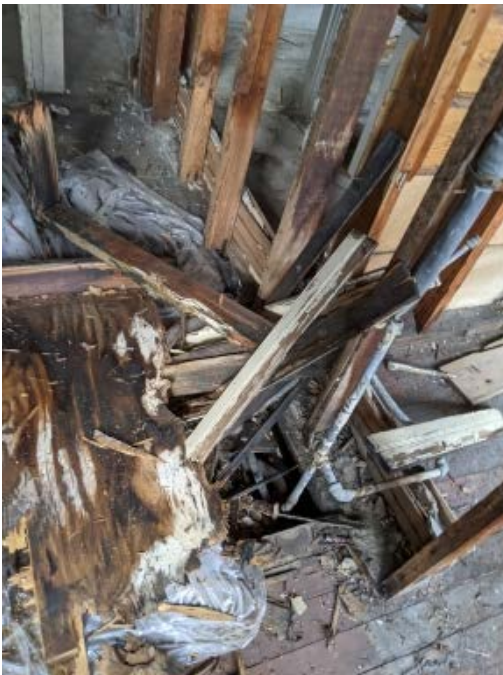
Piles of extremely deteriorated wood framing were observed in several locations on the second floor where the ceiling/roof framing above had collapsed, though no large scale collapse had occurred.

**Pile of Debris on Second Floor of East Suite**

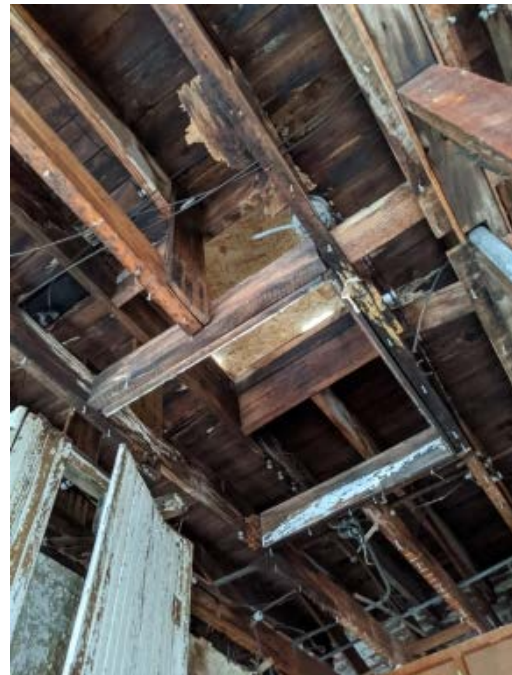
**Deteriorated Roof Framing of East Suite**

Some of the roof trusses will likely need to be reinforced or repaired to support the loads prescribed in the current building code.

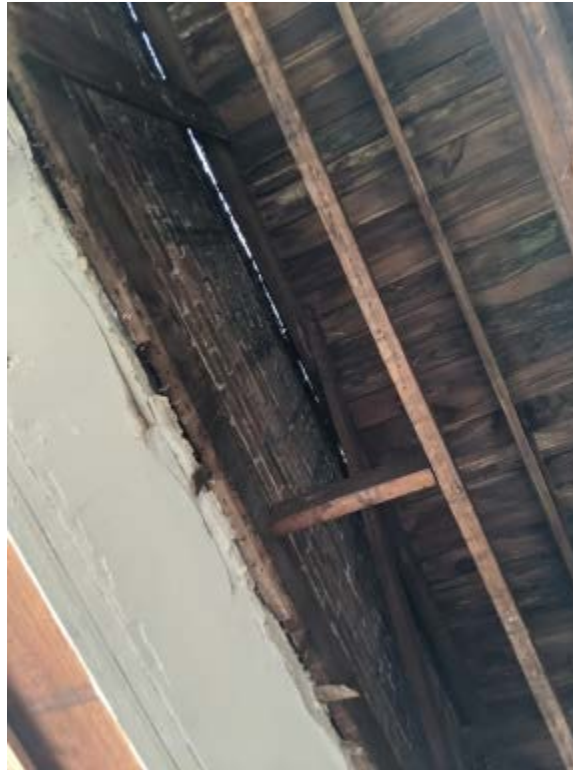
There was a considerable gap observed between the north exterior wall and the roof at the east and west suites. Daylight was visible through this gap and various items like leaves had fallen into this gap and were visible from the inside.

**Horizontal Gap at North Wall and Roof of West Suite**

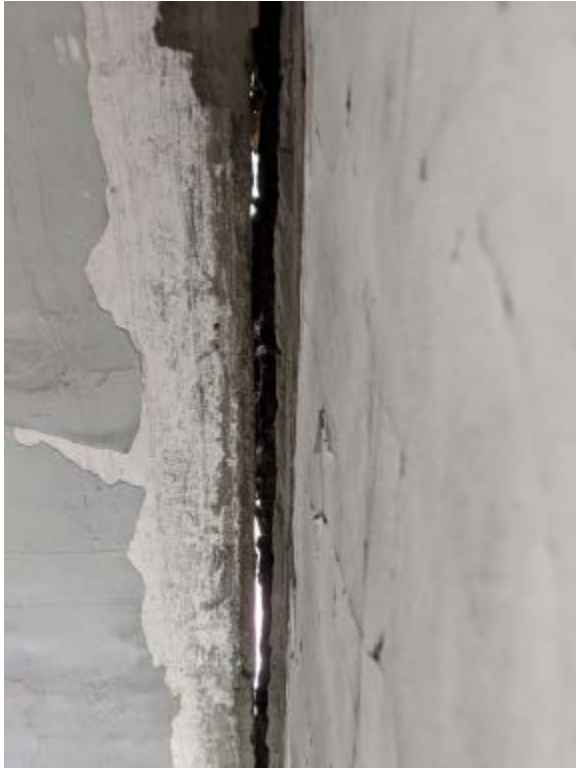
A significant vertical gap was observed between the north wall of the west suite and the demising wall. This gap was estimated to be 3" to 4" wide at the roof level. Daylight and objects across the street were visible through this large gap and miscellaneous building materials and debris were observed within the crevice. The roof framing at the north-east corner of the west suite showed signs of movement away from the demising wall. The wood members appeared to have been pulled out of their respective support pockets in the masonry wall. This created a gap between the roof and the demising wall in this area. The roofing membrane material was visibly pulled away from the parapet wall above the roof level. The south-east corner of this suite did not appear to exhibit similar differential movement.

**Vertical Gap at North Wall of West Suite**

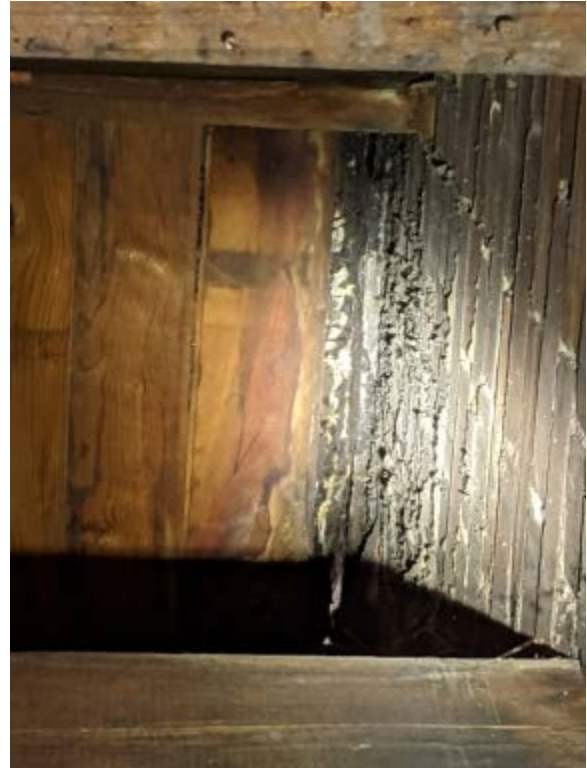
**Exposed Roof Membrane at West Suite**

Many of the structural issues within the building are likely the result of long-term bulk water infiltrating the building through the roof. To stop this water intrusion, the installation of a new roof system is recommended.

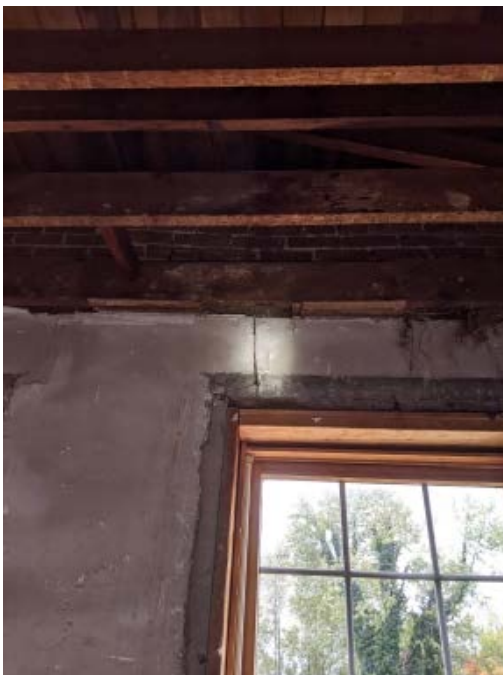
Several cracks were observed in the exterior masonry walls that are likely due to shrinking and swelling of the masonry or differential settlement of the building.

**Crack in Masonry Wall of West Suite**

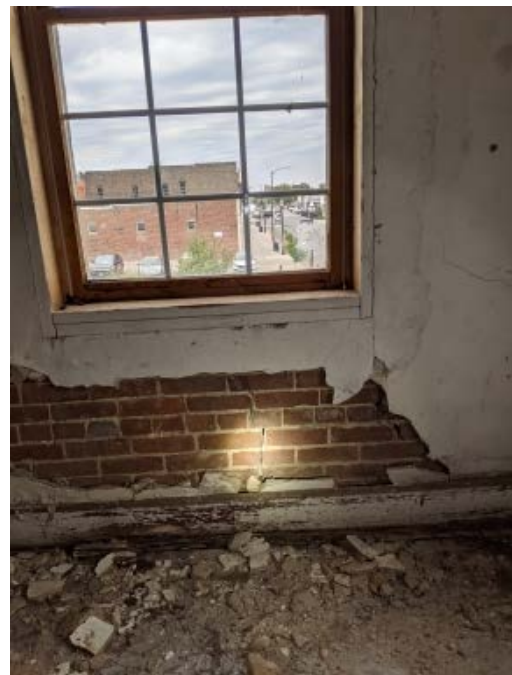
**Crack in Masonry Wall of West Suite**

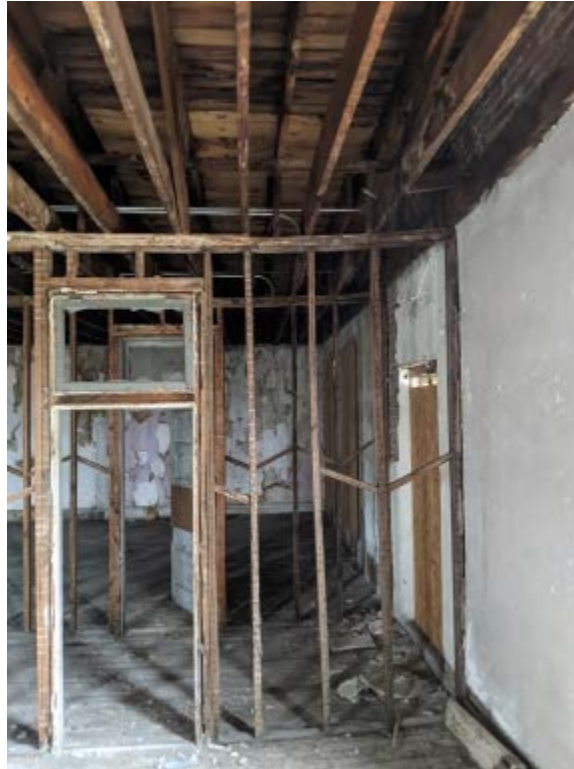
Deterioration and modifications were observed on the load-bearing “hallway” walls on the second floor west suite. A few of the roof trusses at the far south end of the west suite had sagged substantially, due to the damage of the supporting walls below. Significant deflection was observed at the far south end of the multiply beam in the west suite as well. This is likely related to the damage above and potentially due to elevated moisture.

**Damaged Load-Bearing Wall on Second-Floor of West Suite**

The load-bearing walls on the second floor west suite will likely have to be removed or relocated to layout the future residential units. A beam and column line will have to be installed to support the roof framing in place of these existing walls. This new beam and column line will likely align with the existing beam and column line on the first floor. New support framing which does not align with an adequate support structure below will require additional framing following a continuous load path to the foundation of the building.

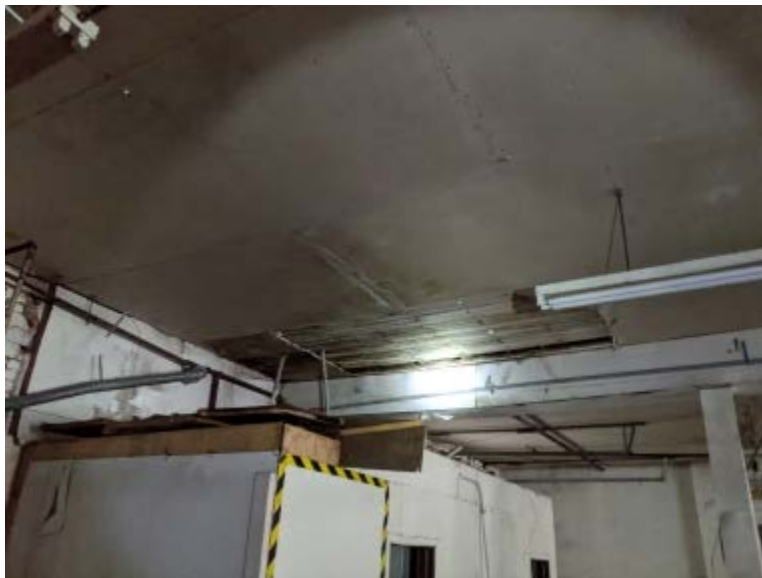
**Deflected Beam at South End of Beam-Column Line at West Suite**

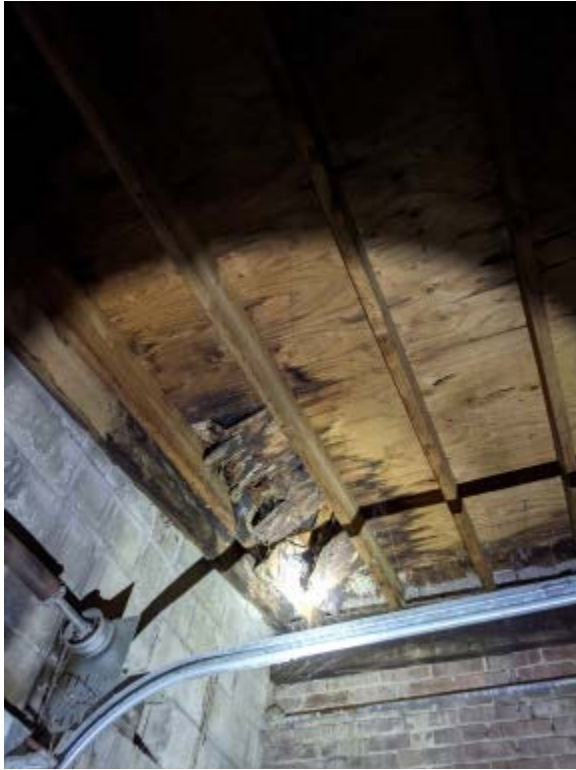
**Deteriorated Roof Framing at Addition**

The removal and replacement of the roof framing over the addition at the south end of the west suite is recommended. Additional waterproofing measures to prevent repeated deterioration of the new roof framing is also recommended.

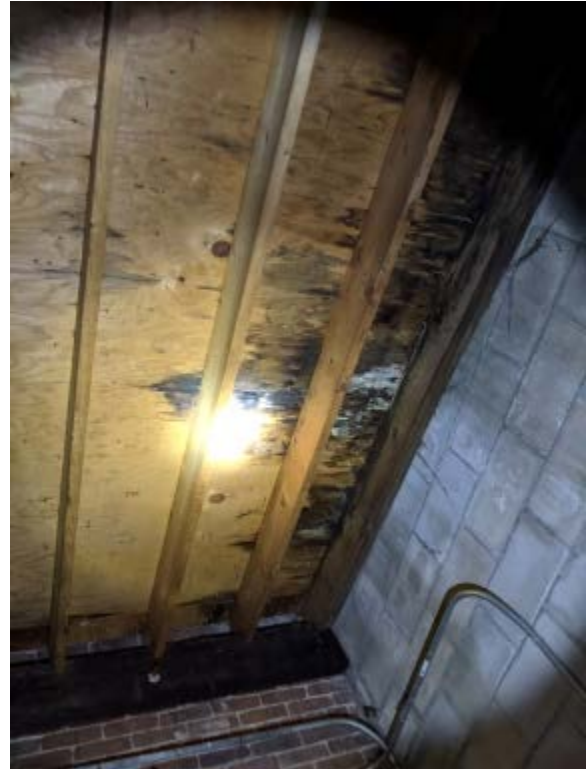
**Deteriorated Roof Framing at Addition**

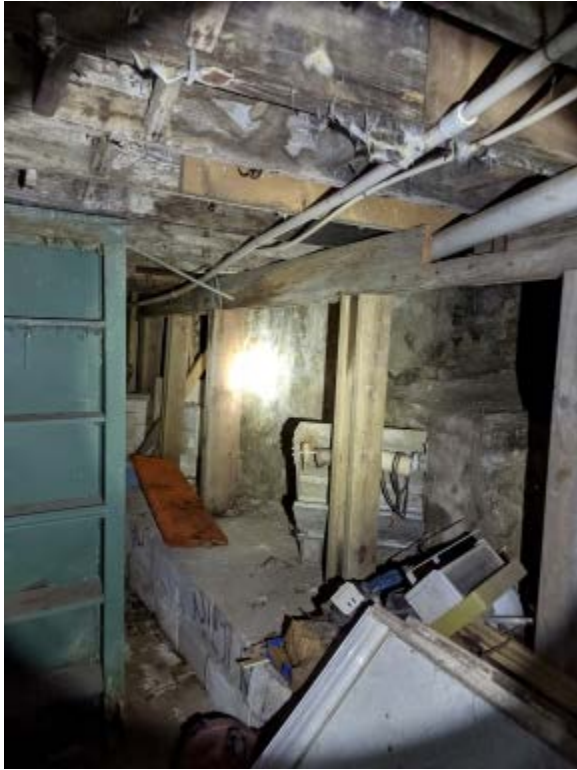
Several miscellaneous braces and temporary supports had been installed in the basement to attempt to support the first-floor framing of the east suite.

**Additional First-Floor Supports in Basement**

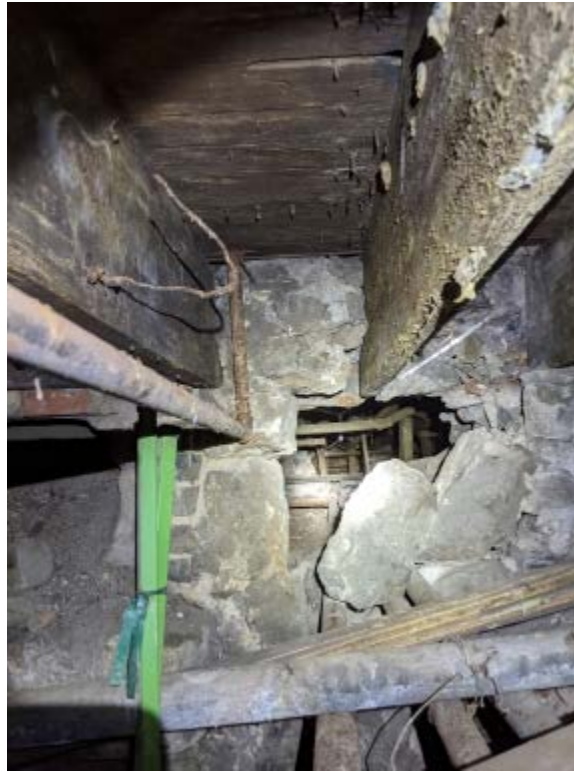
A large hole between the east and west suites was observed within the demising foundation wall that has caused a couple of floor joists to become unsupported.

**Hole in Basement Demising Wall**

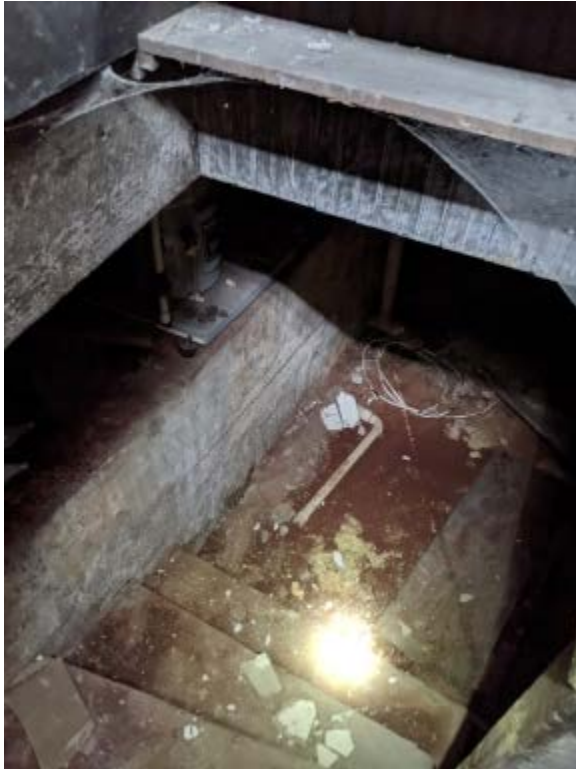
The floor of the basement contains a layer of semi-dry mud and most of the floor framing above was observed with significant moisture damage.

**Muddy Basement Floor**

The water infiltration issues in the basement and crawlspace need to be remediated. Additional investigation is required to determine the exact location and extent of water intrusion before a reliable repair method can be recommended.

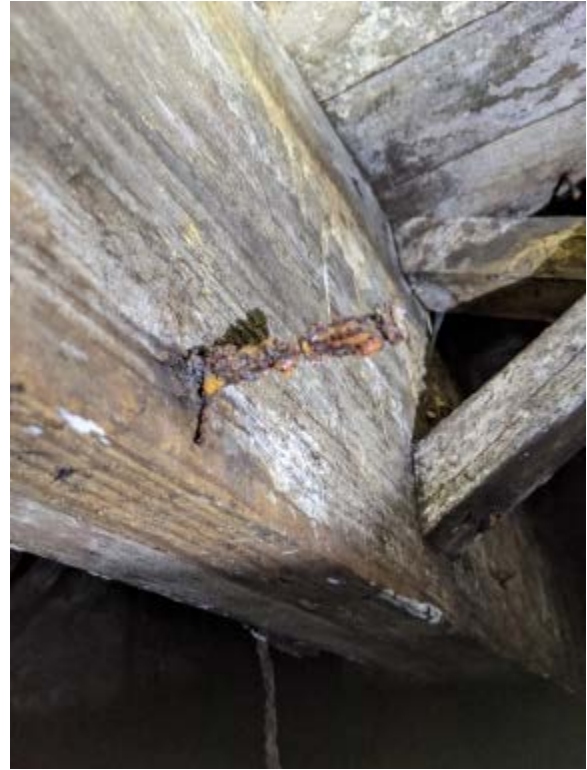
**Rusty Nail from Elevated Moisture**

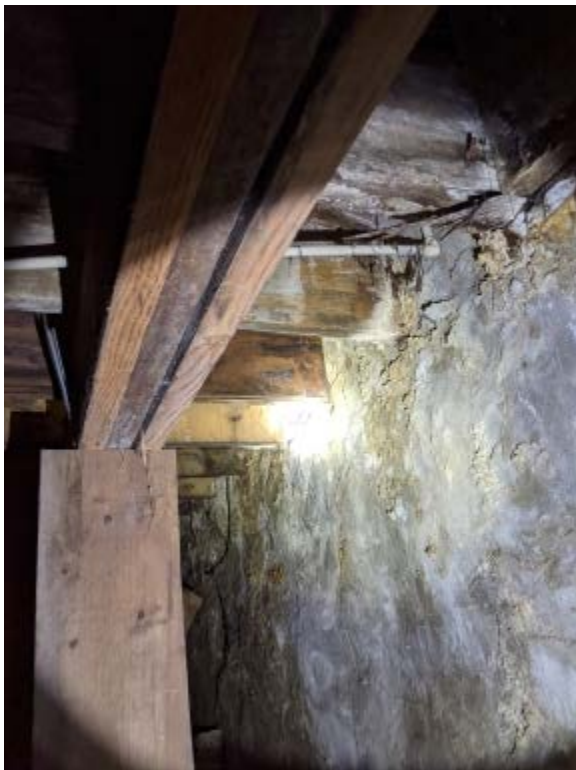
**Moisture Damage in Basement**

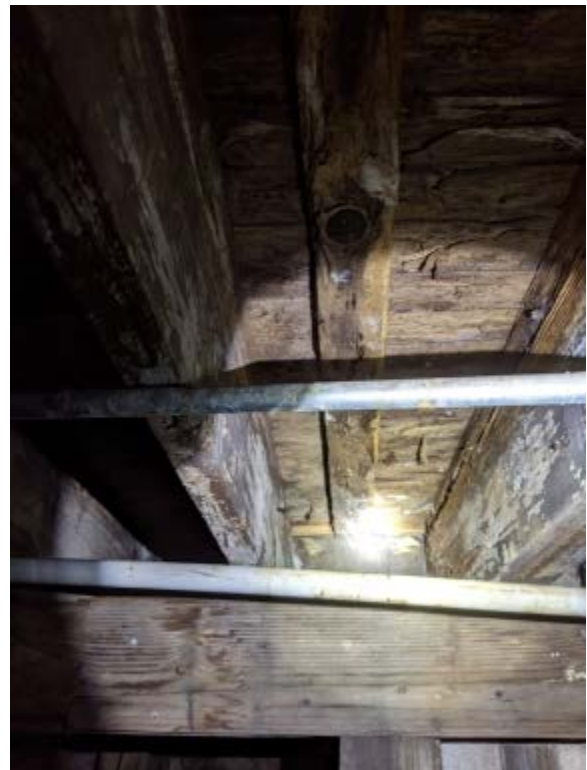
**Moisture Damage in Basement**

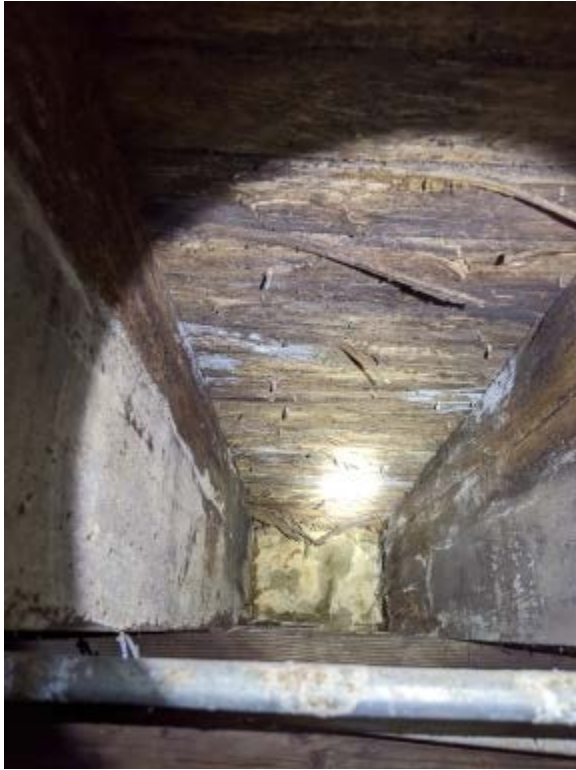
**Moisture Damage in Basement**

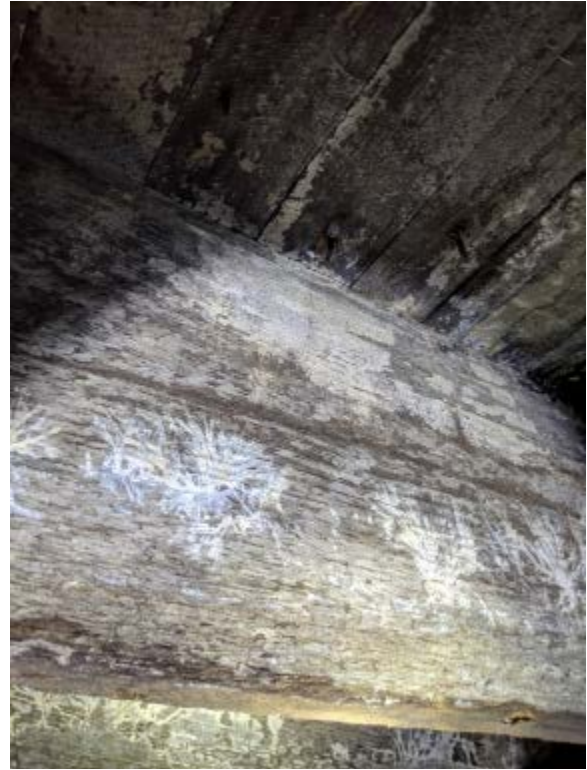
**Organic Growth in Basement**

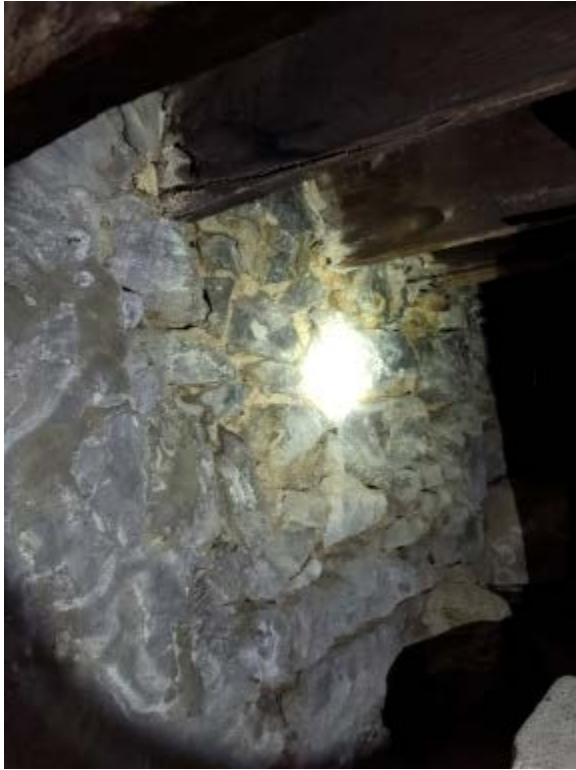
The far east foundation wall near the south-east corner of the extents of the basement appears to have had the majority of the inside mortar layer eroded off by repeated high moisture levels or bulk flowing water.

**Eroded Basement Wall**

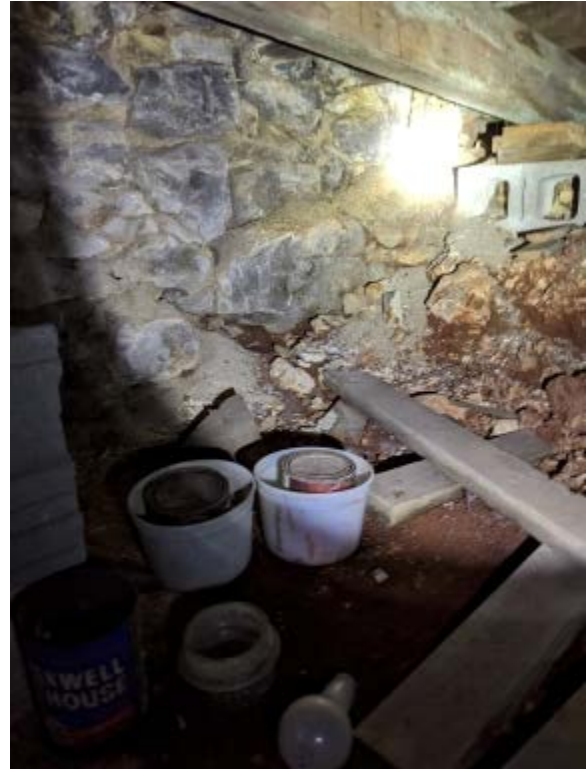
**Eroded Basement Wall**

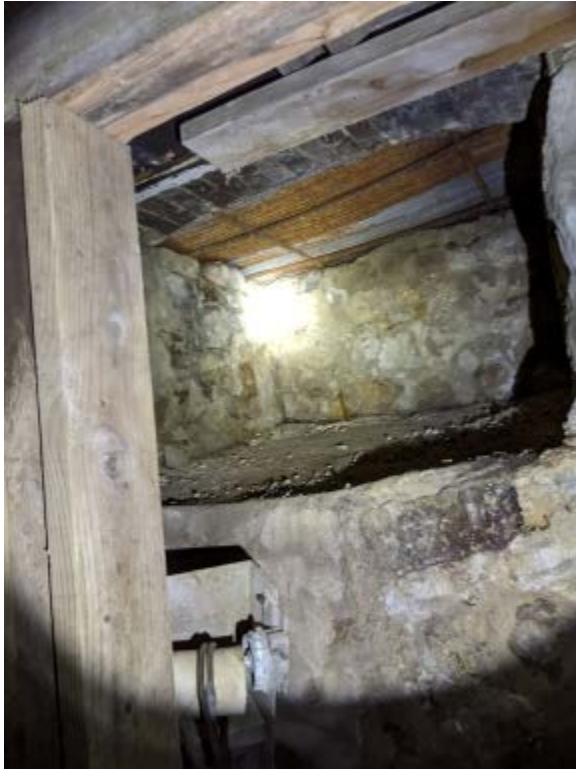
There are two locations at the east wall of the basement where an exterior access pit exists. These two pits are covered by a sidewalk adjacent to the east wall outside the building. Rudimentary support over these pits beneath the sidewalk was visible from the basement. Signs of past water intrusion were observed in these areas and this likely is a primary source of water intrusion into the basement.

**Exterior Access Pit #1 in Basement**

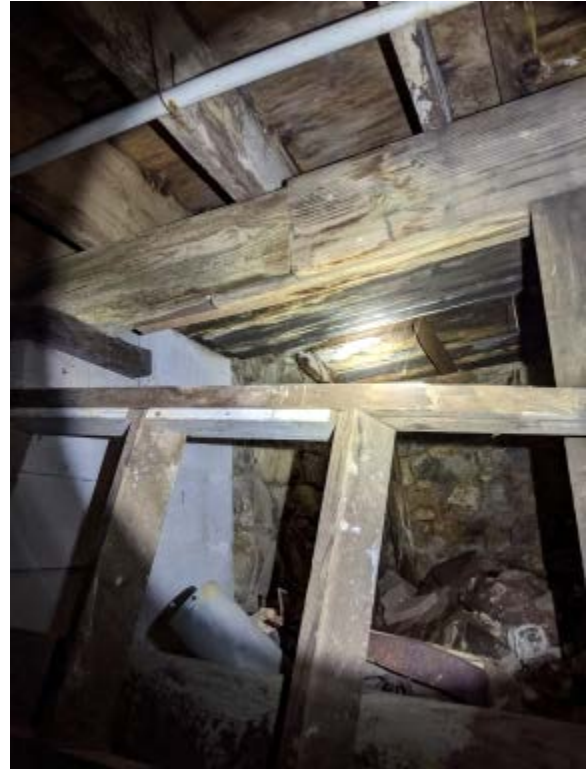
**Exterior Access Pit #2 in Basement**

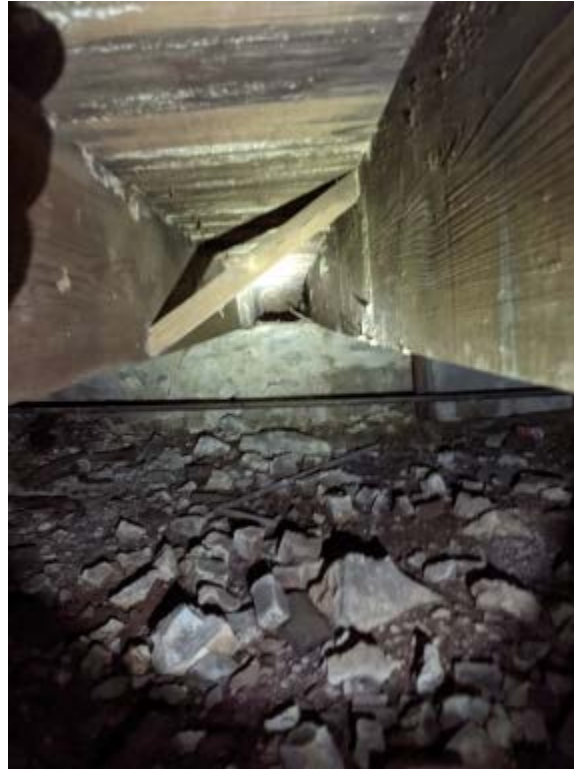
The crawlspace beneath the west suite was partially observed through a hole in the floor framing near the south-east corner of the west suite. At the time of inspection, the moisture level of the crawlspace in this area did not appear to be as high as that beneath the east suite. Several miscellaneous braces and temporary supports had been installed in the basement to attempt to support the first-floor framing of the west suite, although not to the same extent as beneath the east suite.

**Crawlspace at West Suite**

The first-floor framing of the west suite is mostly intact, but will likely need to have two additional pier and girder lines installed in the crawlspace to reduce the span of the floor joists. The floor joists at their current span will not likely support the loads prescribed in the current building code. Additional intermediate supports may need to be installed in the crawlspace on an as-needed basis in areas of localized damage or deterioration.

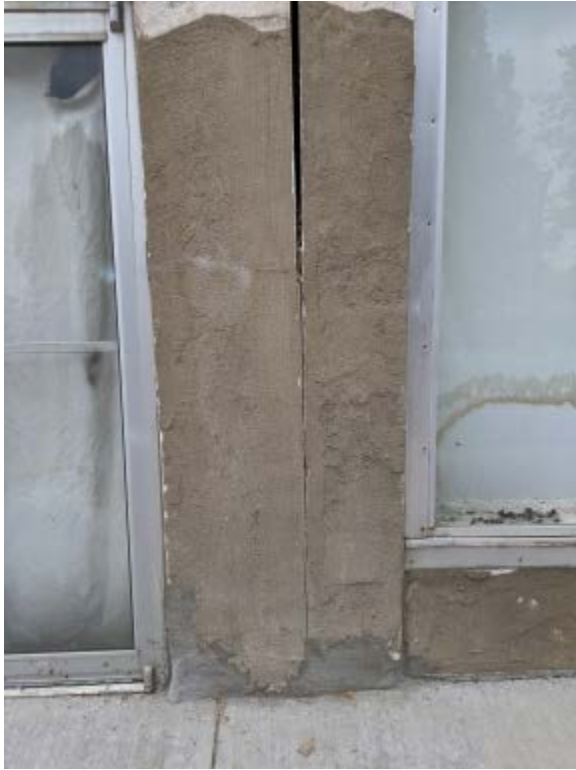
Some cracking was observed within the plaster that coated the exterior of the multi-wythe masonry walls, but the most noteworthy being the large vertical gap between the north wall of the west suite and the demising wall. Debris was observed within the gap from the exterior. This gap was estimated to be 3" to 4" wide at the roof level and the gap became narrower closer to the ground level. The gap was minimal near the base of the wall.

**Vertical Crack in North Wall**

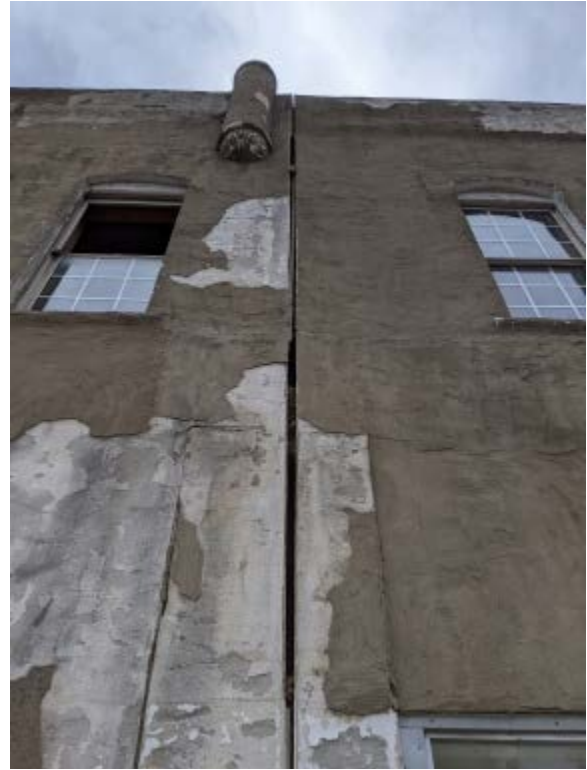
**Vertical Crack in North Wall**
