# Springfield Land Clearance for Redevelopment Authority

**4.1. Blight Report And Redevelopment Plan For The East Cherry Townhomes Redevelopment Area, Generally Located At 1361 And 1365 East Cherry Street; Say You Can, LLC, Applicant**

This Blight Report for the East Cherry Flats Redevelopment Area (this “**Blight Report**”) is being submitted by Say You Can, LLC, a Missouri limited liability company (such entity, or its successors and assigns, is referred to as the “**Developer**”), for the purpose of demonstrating that the Redevelopment Area (as defined below) should be declared blighted pursuant to the LCRA Law. This Blight Report will demonstrate (i) that the Redevelopment Area is a “blighted area” under the LCRA Law due to the predominance of (1) deterioration of site improvements, (2) insanitary and unsafe conditions, (3) obsolete platting, and (4) the existence of conditions which endanger life and property by fire and other causes, and (ii) because of the aforementioned conditions, the Redevelopment Area hinders the provision of housing accommodations, constitutes an economic and social liability, and is a menace to the public health, safety, morals, and welfare in its pr

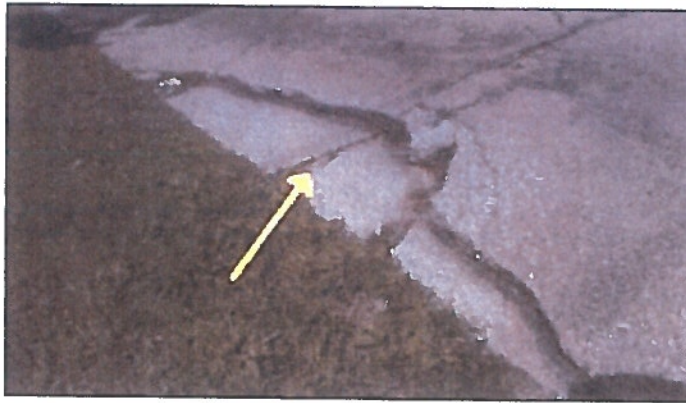
- Major cracks and displacement noted with potential trip hazard; needs repair/replacement.
- Drive is near end of its lifespan.

Drive deteriorated

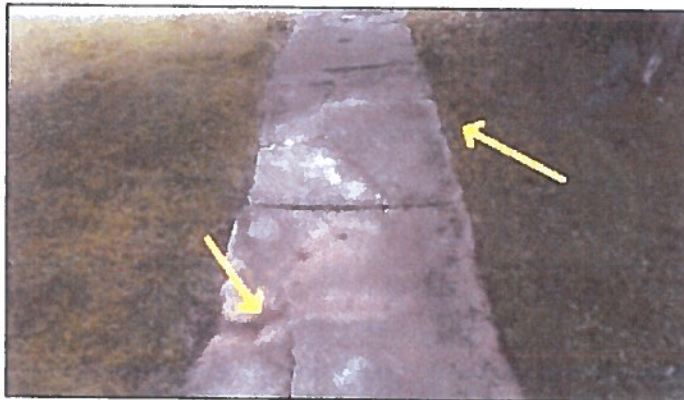
Observations: Major cracks and displacement noted with potential trip hazard; needs repair/replacement.

Sidewalk damaged

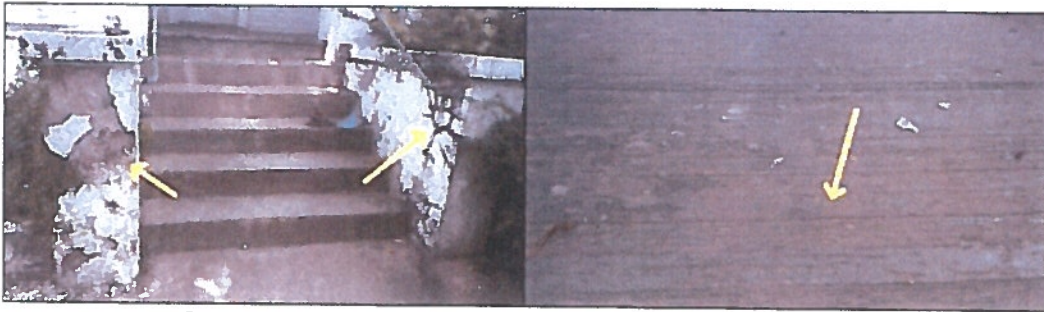
- Concrete walls at front steps are damaged and deteriorating; need full evaluation and repair.
- Not fully visible
- Railing too low at porch (relative to home's age).
- Porch is due to be sealed/painted.
- Footings not visible.
- Porch is not bolted to house (Nailed/screwed); Recommend correction.

Damaged walls

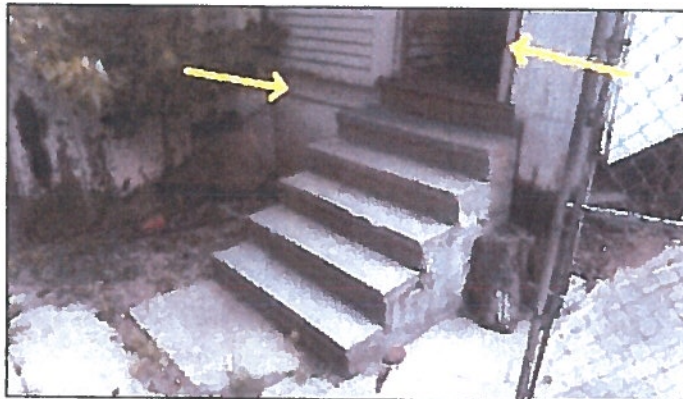
- Handrail needed at front sidewalk and back steps for safety.
- Cracks and deterioration noted

Handrail needed at back steps

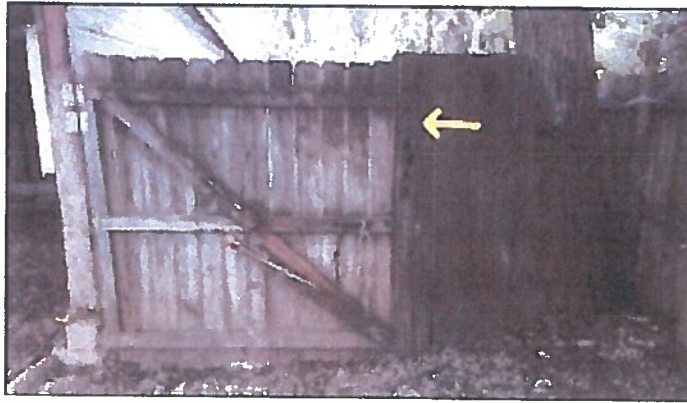
- Noted a couple of cracked/damaged fence pickets.
- Some weathering of wood fence observed.
- Back gate will not close/latch. Needs adjustment/repair.
- Loose/rotted posts observed.
- Nearing end of lifespan
- Not fully visible due to plants.
- Sections of the fence are leaning.

Sagging back gate

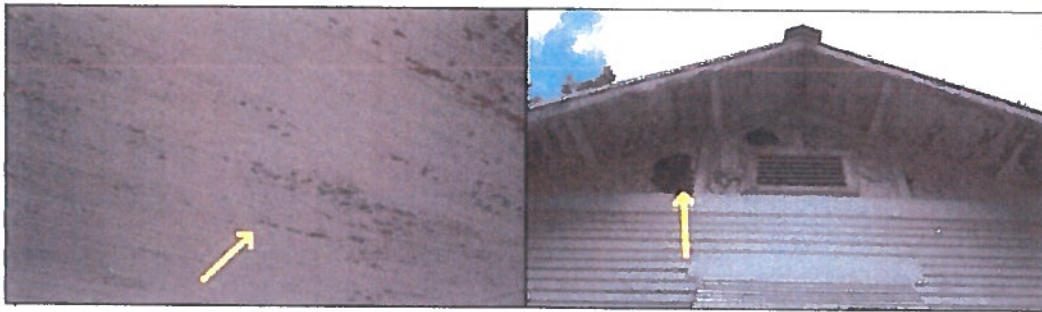
- Observed flaking paint/deterioration on trim, eaves and fascia; needs repair/repainting.
- Damaged asphalt/tar paper noted at gables.

Flaking paint at ceiling of front porch

Holes in asphalt paper on West gable

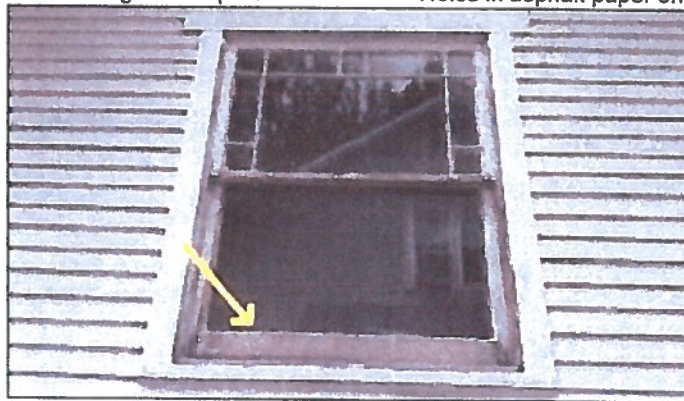
Worn paint

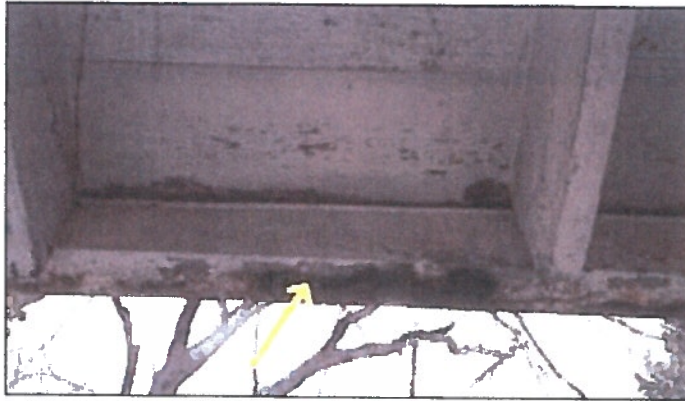
- Guttering is damaged and at the end of it's normal life; needs replacement.

Gutters rusted through

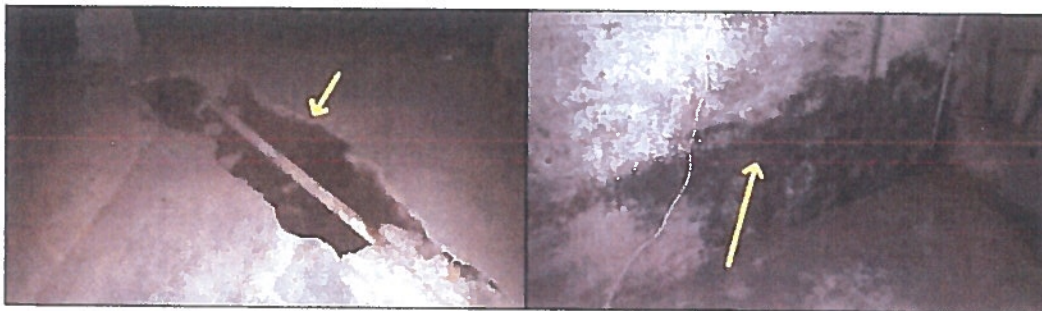
- Common shrinkage cracks observed in foundation stem walls.
- Observed past repair in NE corner.
- Hole in floor needs repair.
- Evidence of past/present water in basement; recommend full evaluation/repair by qualified foundation contractor.

Large hole in concrete floor

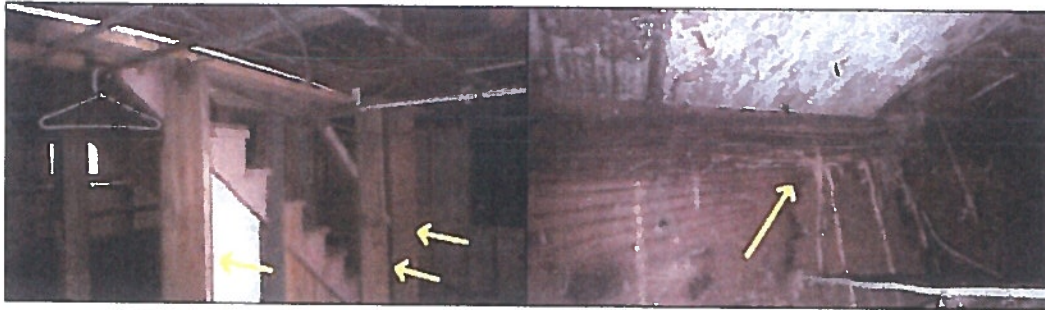
- Anchor bolts were not found.
- Added support noted.
- Moisture stains noted on floor structure below bathroom and utility areas.
- Floor and interior basement stairway poorly supported; needs evaluation/repair by qualified contractor.

Floor and interior basement stairway poorly supported

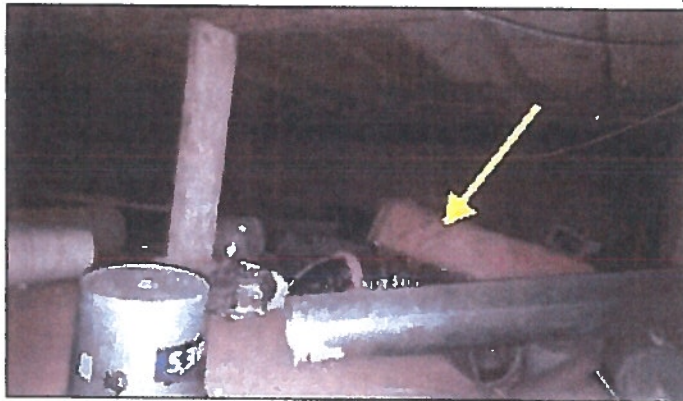
- Crawl space was dry today.
- Observed signs of past moisture along foundation walls.
- Recommend installing a plastic vapor barrier on the ground to prevent moisture from causing abnormal conditions in the future.
- Better control of roof water should help prevent problems in the future.
- Some scrap wood and construction debris needs to be removed from the crawl space.

Construction debris in crawlspace

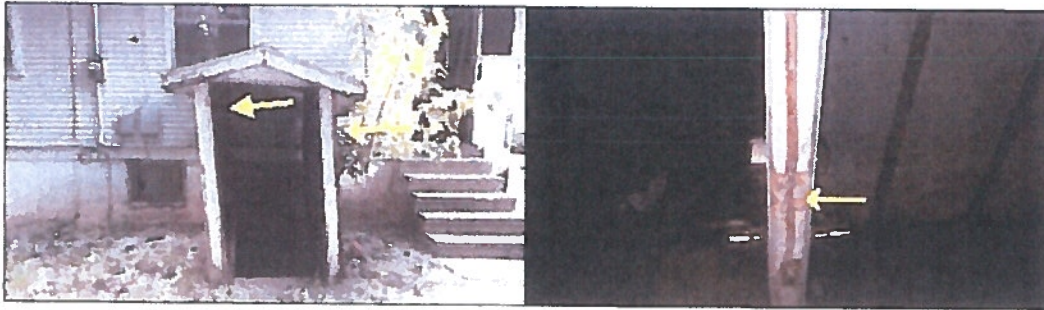
- Basement exterior stairway walls and roof are damaged and leaning; need replacement by qualified contractor.
- Exterior basement door has been damaged and does not close; needs repair.

Stairway covering damaged and leaning

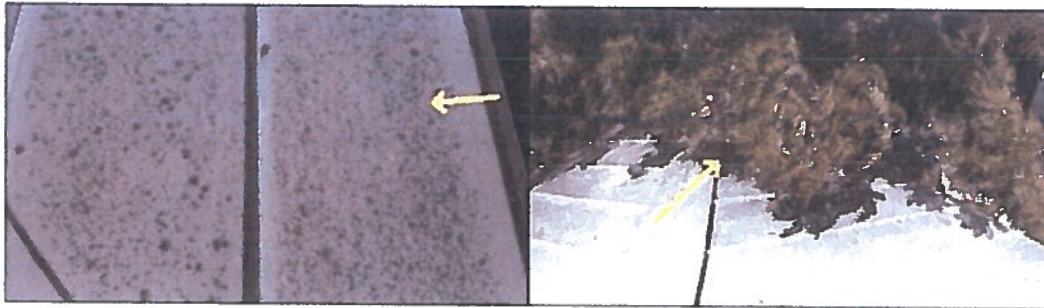
- Appears to be in good condition.
- Observations:
- Trees need to be trimmed away from roof to prevent damage.
- Regular maintenance and inspection advised.
- Observed weathering and moss.

Moss

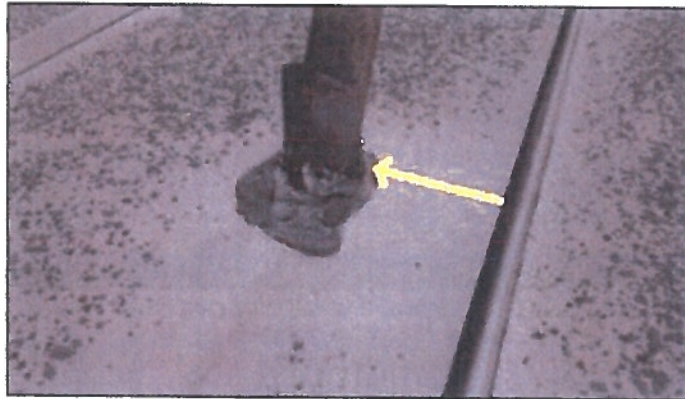
- Heavy sealant/repair observed at chimney flashing, around all roof vents, and flue pipes.
- Signs of past hail noted at metal flue cap(s).
- Sealant needed around kitchen plumbing vent flashing.

Kitchen plumbing vent

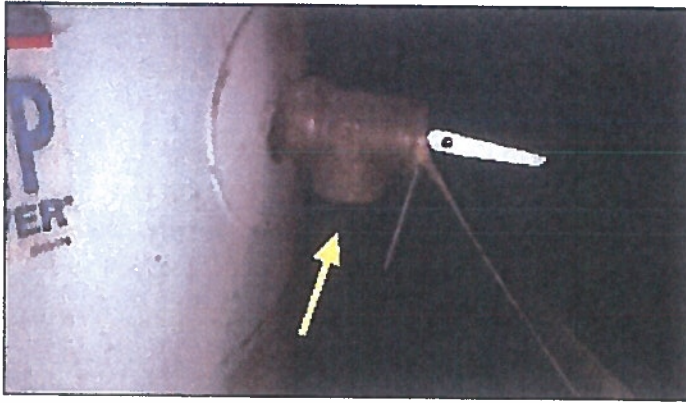
- Combustion air is available
- Vent flue piping is not fully visible
- Shut off valve is missing on the cold water supply above the heater; recommended.
- Heater is at/near the end of its normal life; may need replacing at any time.
- Stains noted around water heater.
- Utilities off, unable to test.
- TPR pipe is missing from valve; needs correction.

TPR pipe is missing from valve.

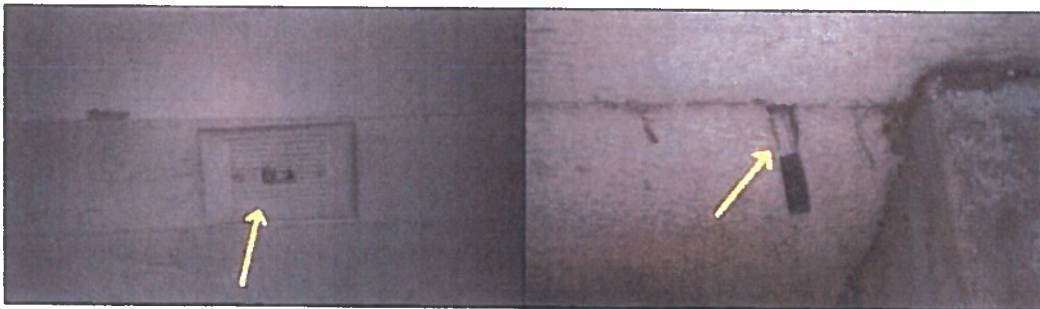
- No exterior receptacles were found • Utilities off, unable to test
- Exposed wire noted near back porch; needs to be removed or properly terminated.

Broken switch at back porch

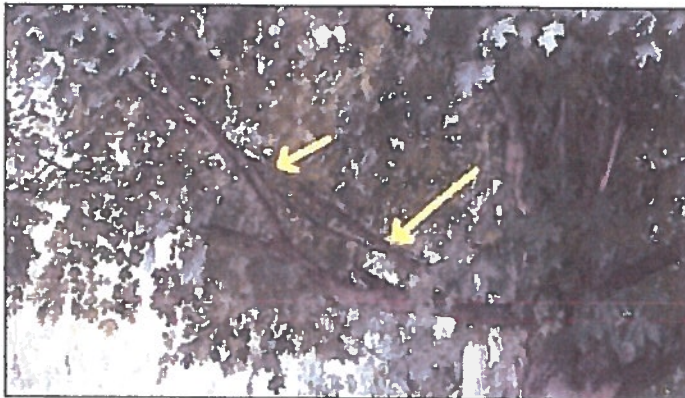
The wiring of the Houses also exhibit unsafe conditions. In particular, in the 1361 House, improper wiring is noted<sup>23</sup> and in the 1365 House, trees touch wires<sup>24</sup> – both of which are fire hazards.

- Ground clamp/system not visible
- Trees touch wires; recommend contacting utility company.

Trees touch wires

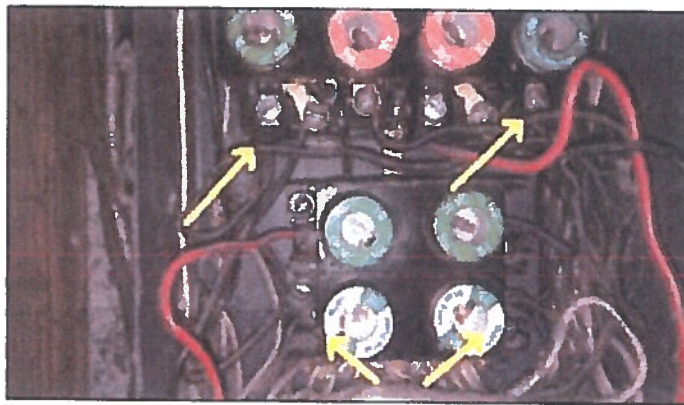
- Electrical system appears outdated by today's standards
- Labels missing
- No space remains in panel for additional circuits.
- Panel covers have been removed; need replacement.
- Double tapped fuses observed - Need repair by qualified electrician.
- Several 20 amp fuses appear to have been replaced with 30 amp; needs evaluation/repair by qualified electrician.

Double tapped fuses

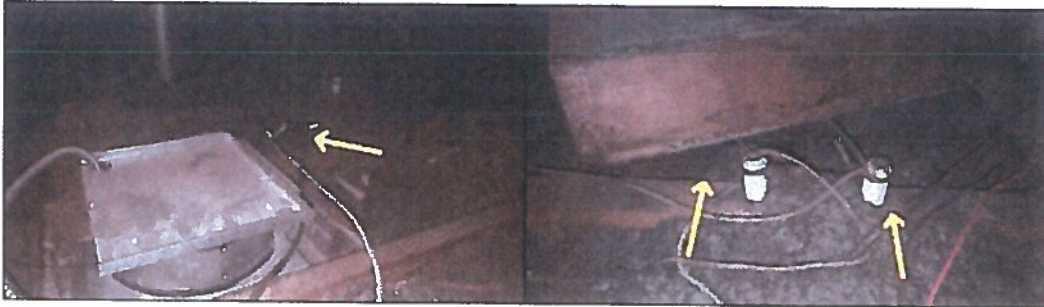
- Doorbell button damaged; needs repair.
- GFCI protection recommended for kitchen and bathrooms
- Missing globes noted and cover plates noted.
- Utilities off, unable to test.
- Exposed splices in attic need to be put in proper junction boxes
- Exposed splices in basement need to be put in proper junction boxes.

Exposed splice near access

Knob and tube wiring noted

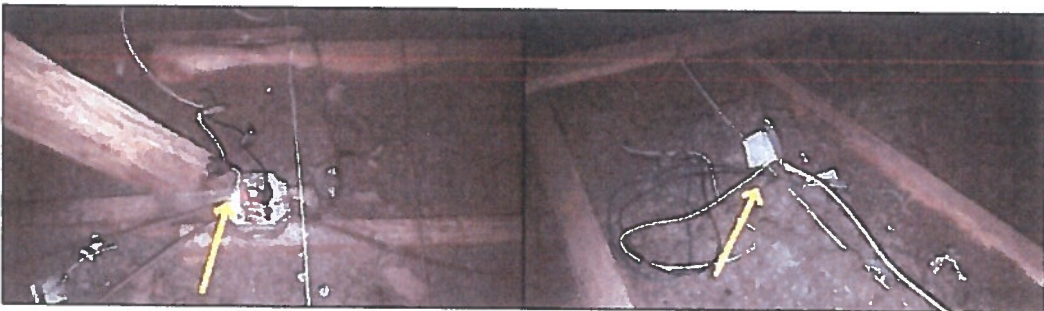
Exposed splice in center of attic

Improper and exposed splice above entry

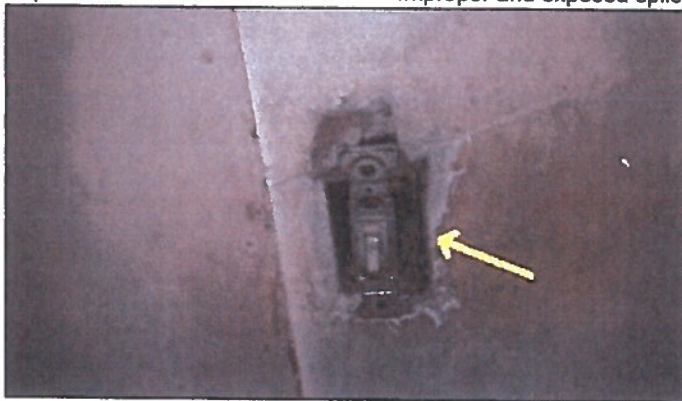
Outlets and switches missing plates in various locations.

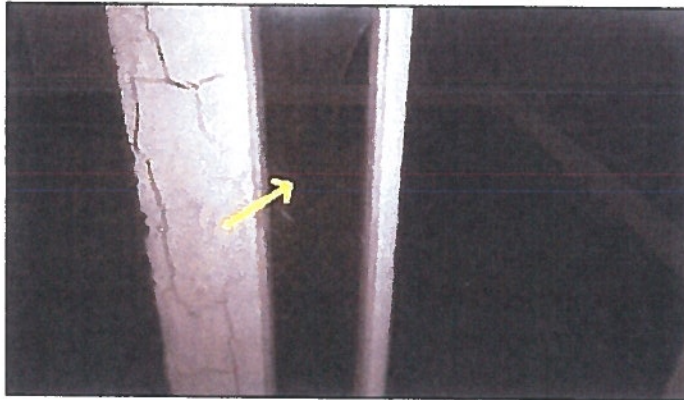
- Several doors do not close properly and have loose hardware; need repair.
- Broken glass observed in living room doors; need repair or replacement.

Broken glass in main living area doors.

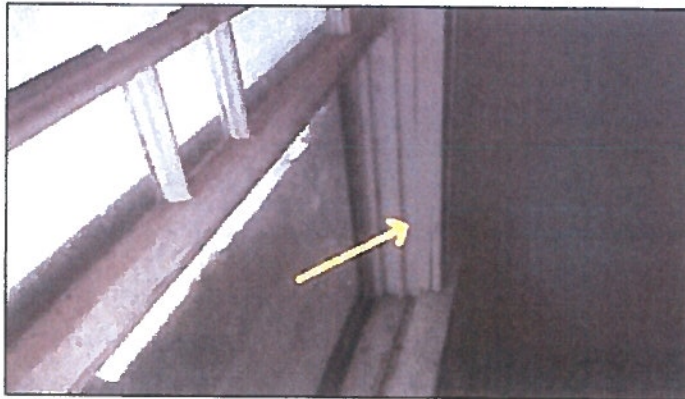
Lower dining room window is missing

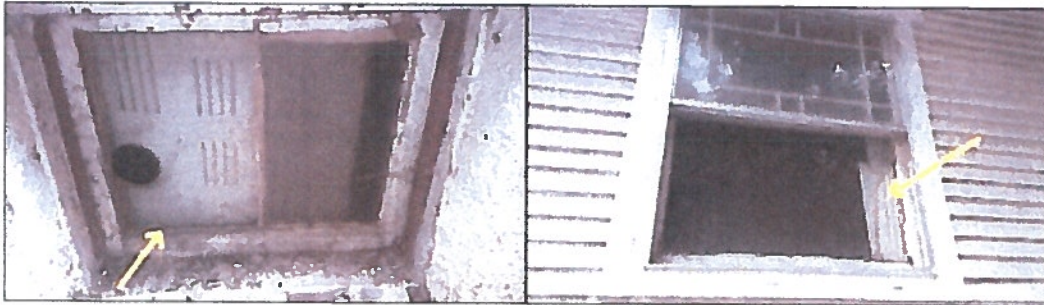
Missing window on back wall of basement

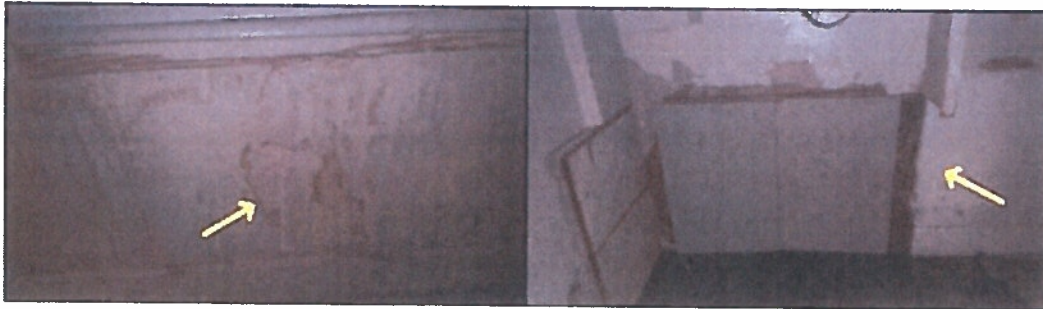
- Walls are in poor condition; need full evaluation, touch up and repair.

Moisture stains and cracks

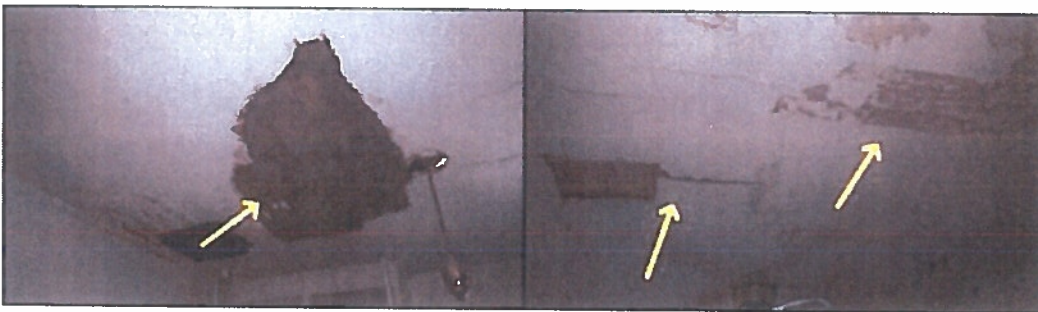
- Common cracks
- Some sagging and damaged areas noted; needs full evaluation and repair by qualified contractor.

Dining room ceiling

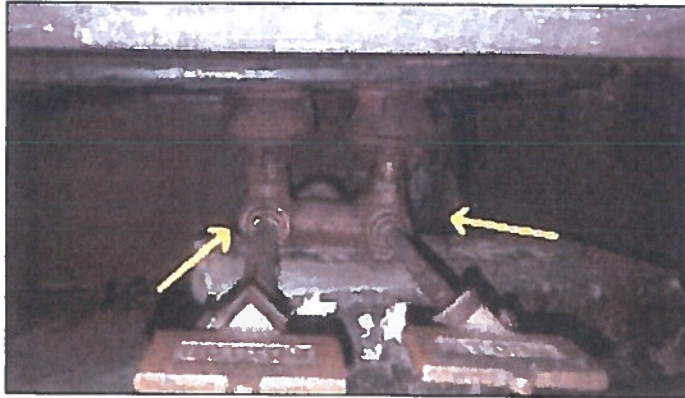
- Gas logs lack pilot and modern safety features; need to be replaced.

Direct gas valves without pilot or automatic shut off.

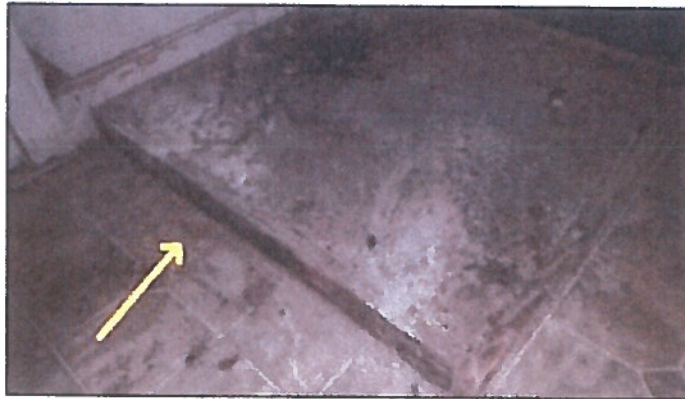
- Hearth and woodstove flue pipe noted in dining room; recommend removal.

Stone/concrete hearth in dining room

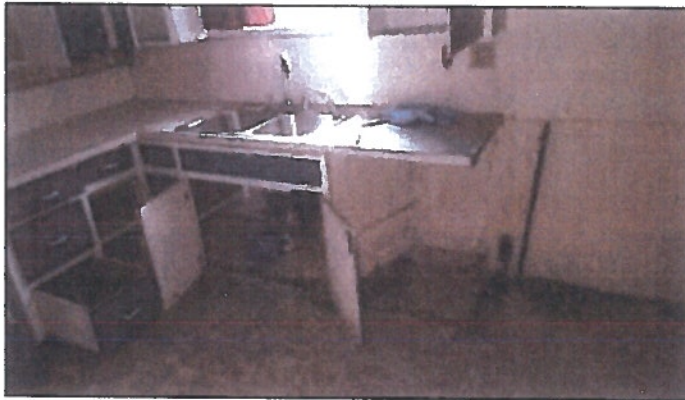
- General condition is poor.

Kitchen is in poor condition overall.

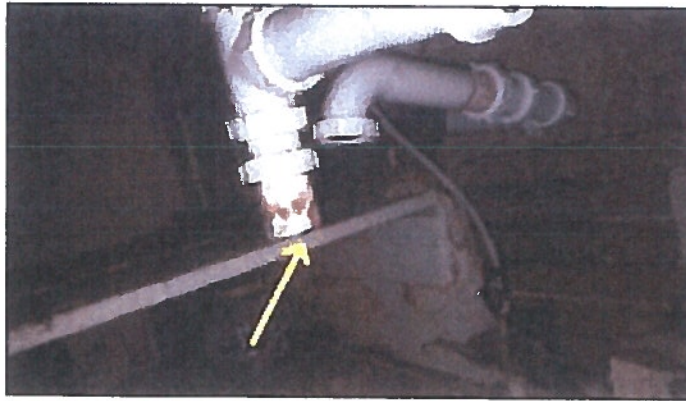
- Moisture stains/damage below sink
- Plumbing disconnected below sink.

Trap has been removed

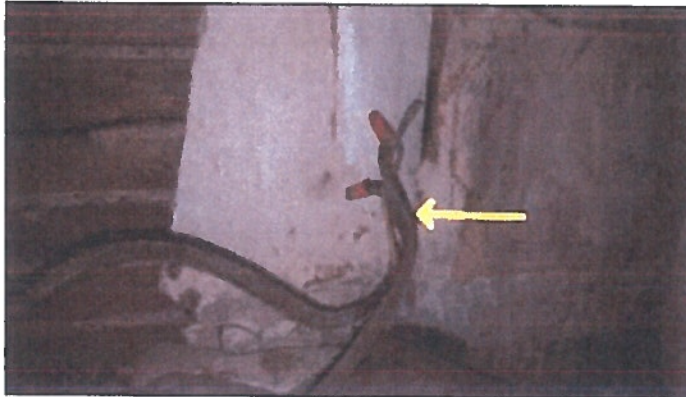
- Near end of lifespan
- Improper wiring noted; splice needs to be put in junction box.

Exposed splice

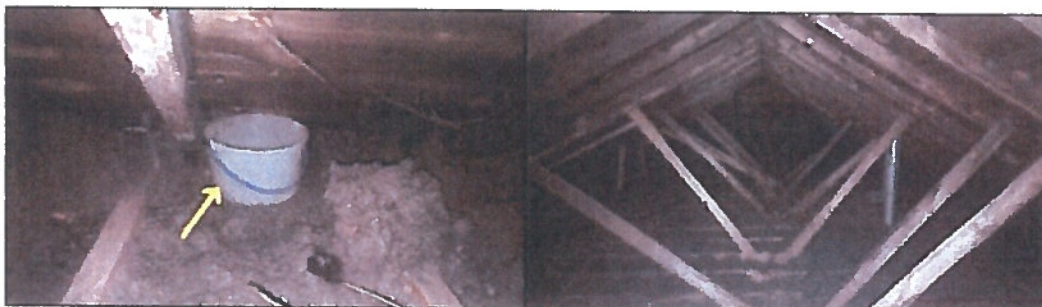
- Entered
- Vents provided
- Roof structure has solid 1x decking.
- Moisture stains observed on roof structure in various locations indicating past leaks (Dry today).
- Access too small, needs correction.

Bucket indicating past leak

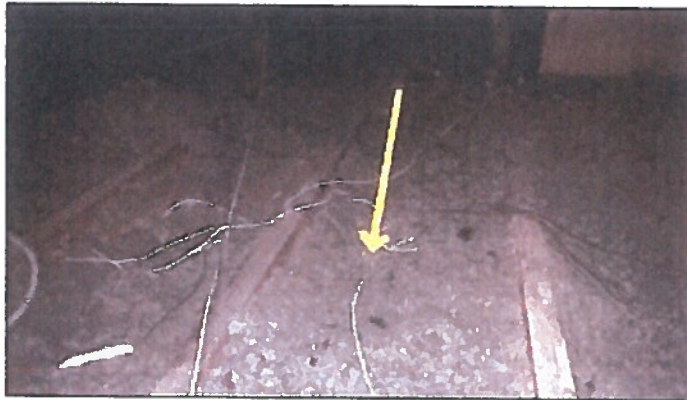
- Attic is poorly insulated; all joists are visible. Recommend adding insulation for energy efficiency.

Attic poorly insulated

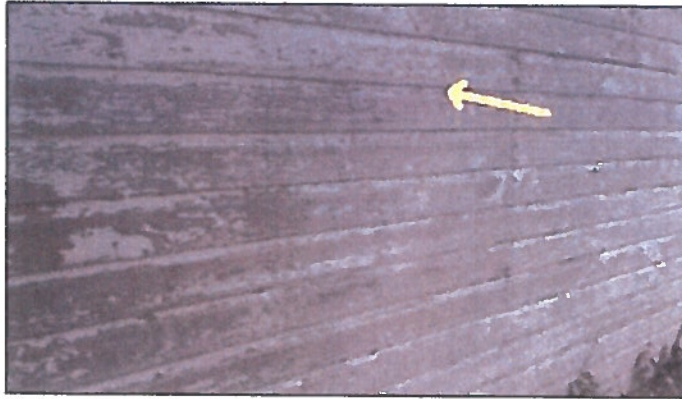
- Not fully visible
- Moisture damage noted; Minor repair needed in various areas.
- Wood to earth contact observed; may provided direct access for termites.

Worn paint on exterior

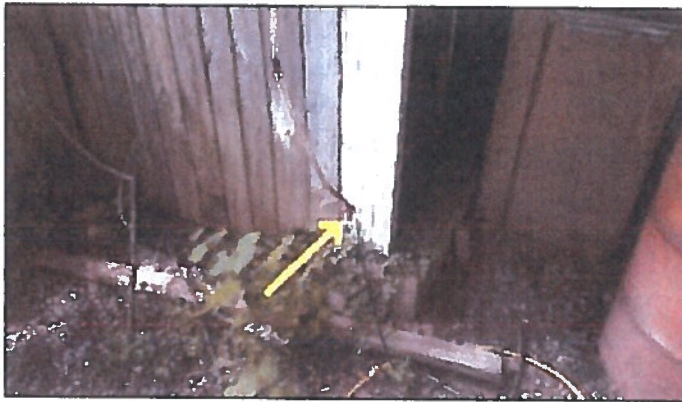
- GFCI protection recommended for garage circuit
- Improper wiring
- Garage electrical is connected to a damaged power cord; needs to be removed or properly wired by a licensed electrician.

Cord with exposed splice powers garage

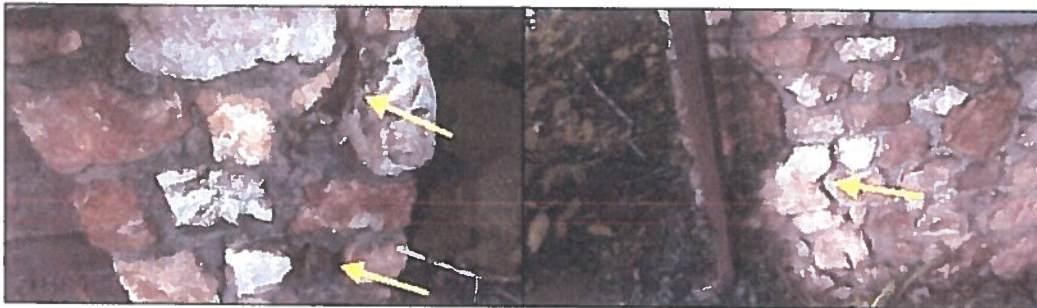
- Stone and mortar missing in various locations; needs full evaluation and repair by qualified mason.
- Common cracks
- Railing too low at porch (relative to home's age).
- Areas of spalling/deterioration observed.
- Flaking paint noted on concrete and wood surfaces.

Stone missing at front steps

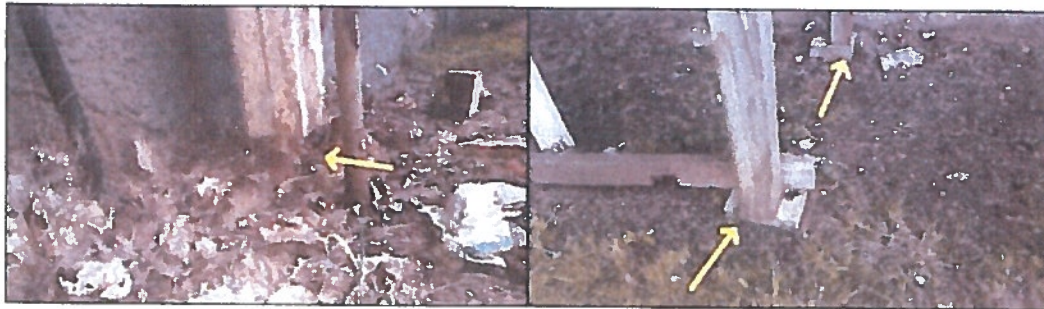
- Steps and handrail are in poor condition; need replacement.
- Handrail recommended at front and NW steps for safety.
- Footings are improper/temporary - Recommend correction with proper poured footing.
- Signs of settlement and loose footing observed; steps/deck to unit 3 need full evaluation and repair by qualified contractor.
- Glass at level of steps up to unit 3; needs to be protected by rail and spindles for safety.

Missing footing below stairway - Unit 3

Improper/temporary footing

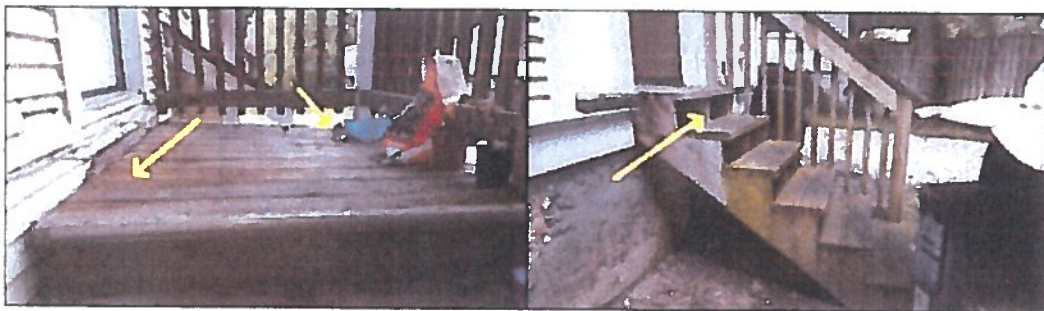
Landing has settled - Unit 3

Handrail missing at back steps

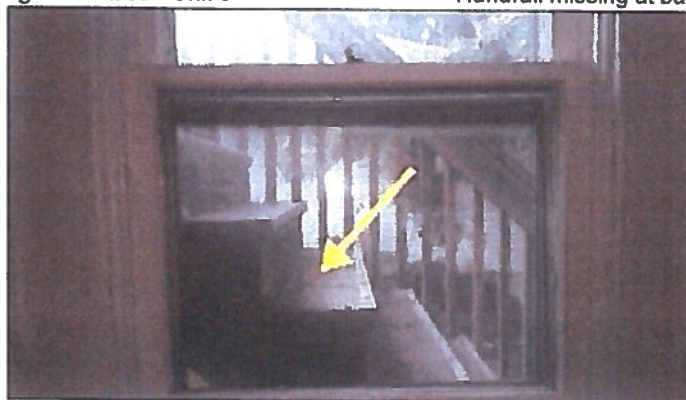
Glass level with steps

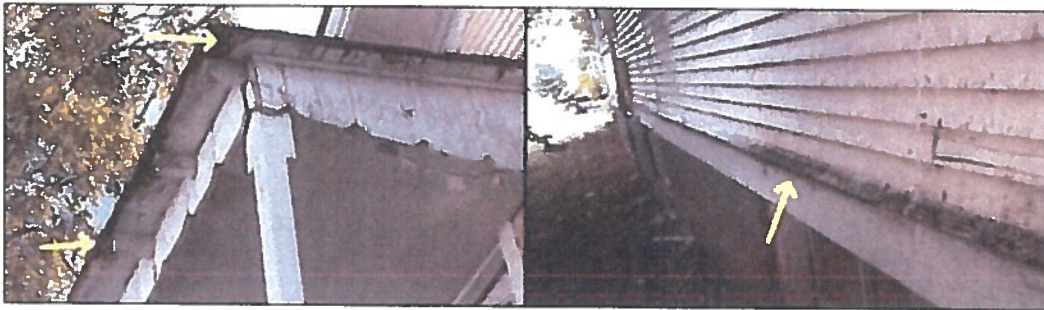
- Observed flaking/worn paint on wood trim; needs to be sealed/painted to prevent further deterioration.
- Eave damage noted, partially above door to unit three.

Deterioration above door to unit three

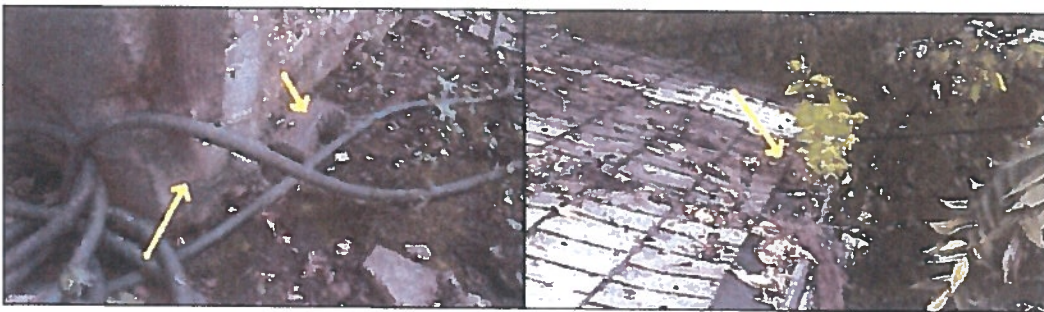
- Sections of gutter guards are missing, gutters are filled with debris and need cleaning for proper drainage.
- Downspout are nearing the end of normal life, consider replacement.
- Damaged/missing downspout elbow noted at NE corner.

Missing downspout elbow

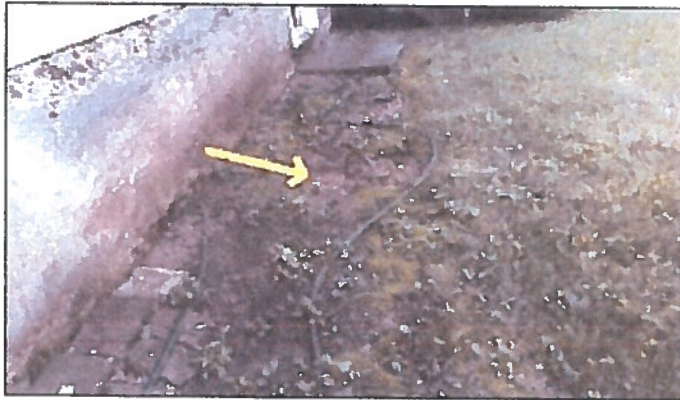
- Extend downspouts for improved drainage and control of roof water.
- Recommend adding soil around foundation to improve drainage.
- Some erosion noted from water running over the guttering.

Erosion from overflowing gutter at back of home

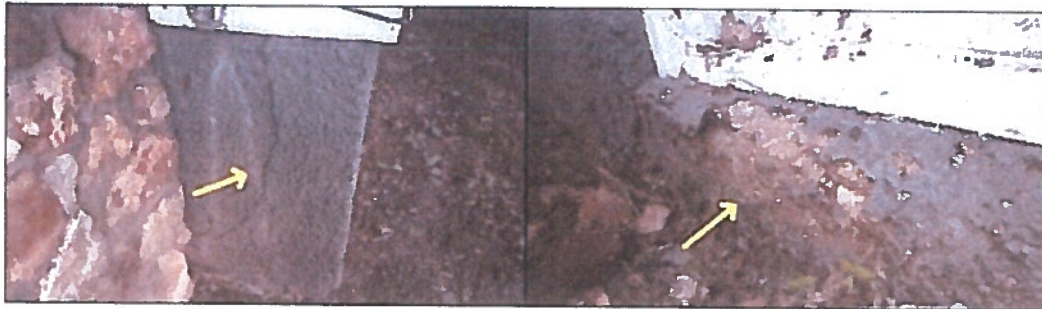
- Trees planted close to structure, not recommended as roots may cause damage to foundation.
- Evidence of past/present water in basement; recommend full evaluation/repair by qualified foundation contractor.
- Typical cracks in basement floor slab.
- Cracks, deterioration and minor displacement noted on the foundation walls; recommend evaluation, sealing and parging by a qualified foundation contractor.

Crack at SE corner (1/2" displacement)

Deterioration on foundation walls, west side pictured.

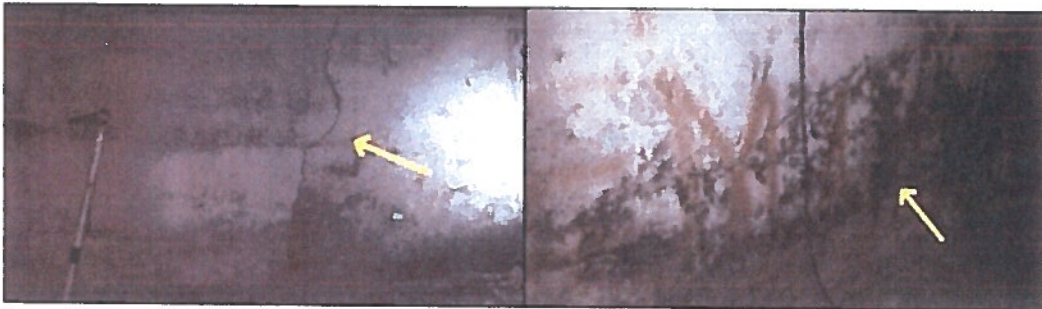
Small crack in SW corner of basement/crawlspace

Stains/fungal growth on SE stem wall.

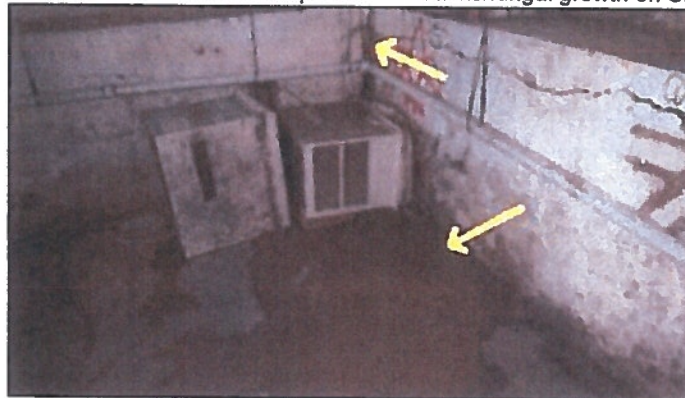
Signs of moisture penetration at NE corner (below downspout)

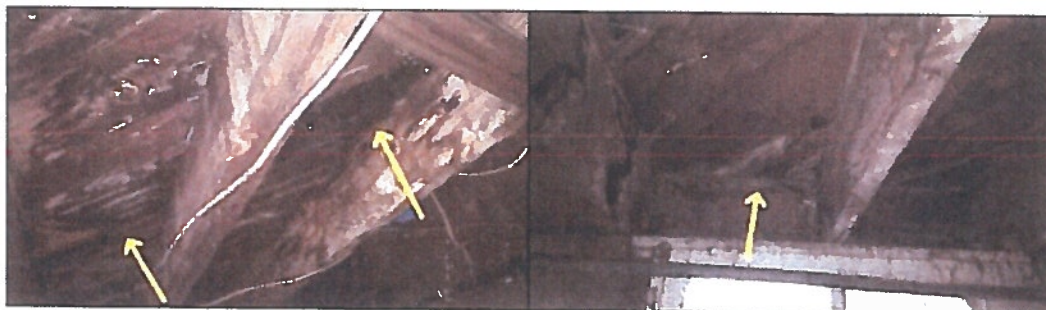
- Anchor bolts were not found.
- Wood to earth contact noted near electrical panel; recommend correction. (Prone to deterioration and may attract termites.)
- Moisture stains/damage noted on floor structure in various locations.
- Some spotty mold growth was observed on the floor structure in a few areas particularly in the Western portion; needs full evaluation and cleaning/removal by a qualified mold contractor.

Fungal growth and damaged subfloor in NW portion of basement

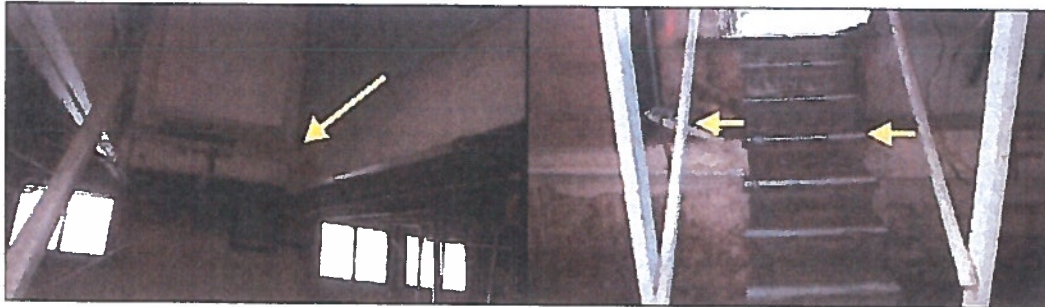
- Lock is broken on door to basement stairway.
- Ceiling height is too low on steps to the basement.
- Stairway is not full width, does not reach handrail and step rise is higher than recommended. Stairway needs full evaluation and repair by qualified contractor.

Interior stairway has been removed and door locked with deadbolt

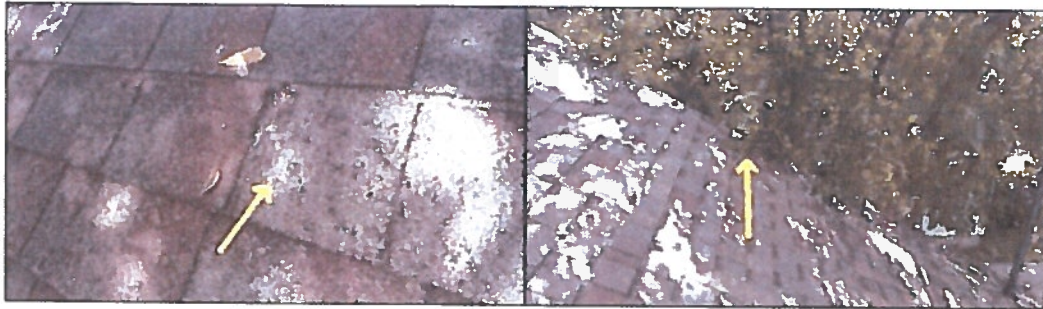
- Waves noted in roof structure
- Trees need to be trimmed away from roof to prevent damage.
- General condition favorable, with signs of weathering and aging; regular maintenance and inspection advised.
- Observed blistering/granular loss.
- Observed weathering and moss on north side and in shaded areas.
- Observed slight signs of past hail.

Moss below trees

Trees touch roof

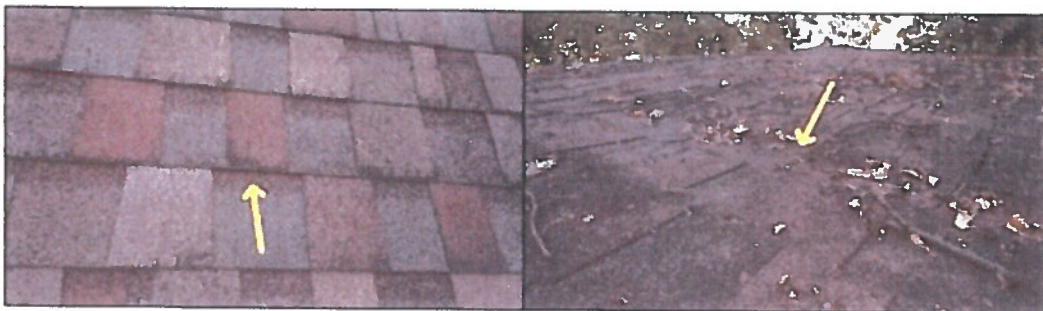
Granular loss and wear

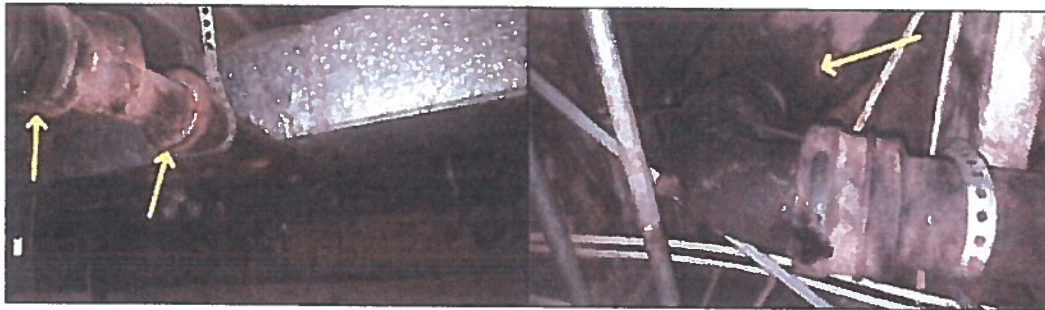
• Several leaks noted on waste lines south of the furnace in the basement; needs full evaluation and repair by qualified plumber.

Several unions leak in basement.

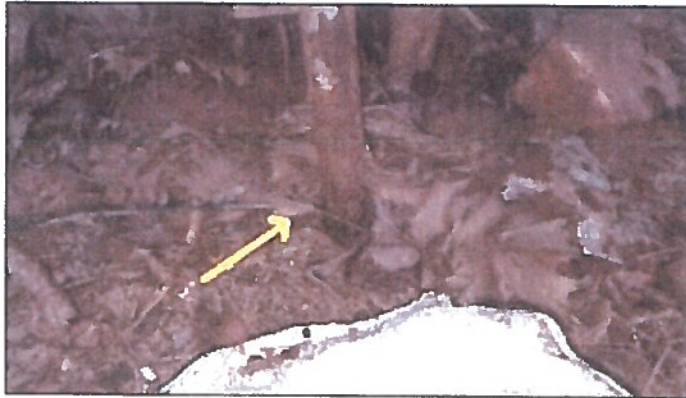
• Heavy rust/corrosion noted at gas main; needs evaluation/repair.

Heavily deteriorated main gas line

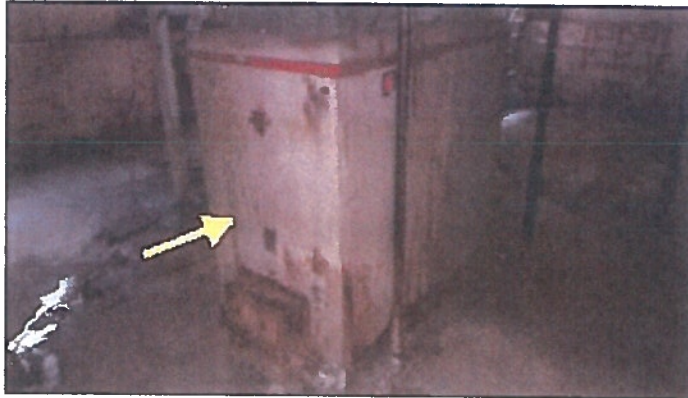
- Observations:
- Unit operated normally today.
  - Noted stains and rust, particularly at lower edge.
  - Dusty inside unit; recommend servicing.
  - Furnace is the original unit and well beyond its normal life, may need replacement. Recommend full evaluation by qualified HVAC technician.

Furnace beyond its normal life.

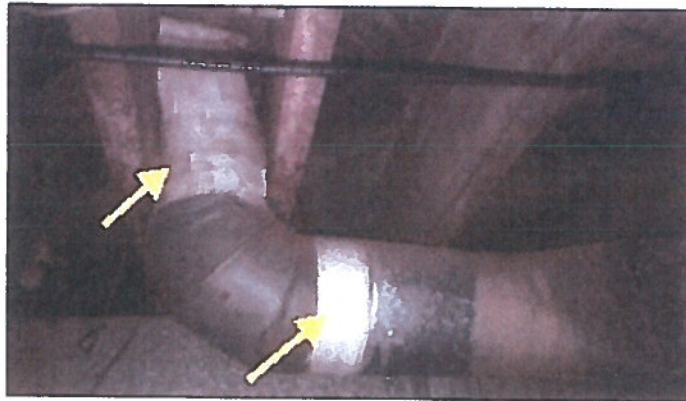
- Recommend ductwork cleaning by a qualified contractor.
- Not fully visible
- Noted tape that likely contains asbestos on outside of ductwork; recommend evaluation by certified asbestos contractor.

Tape on ductwork likely contains asbestos

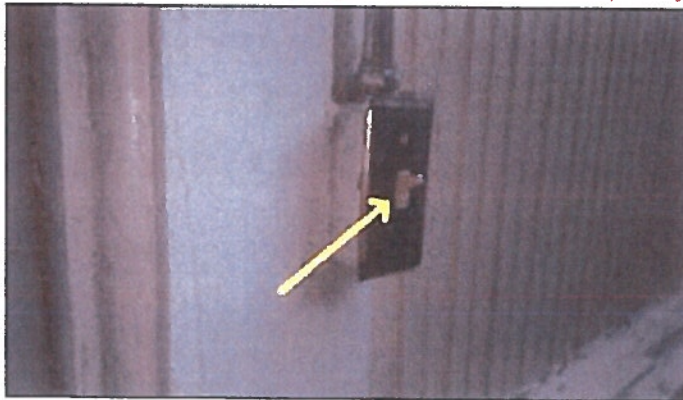
- GFCI protection recommended for exterior outlet
- Several lights did not turn on today (Bulbs or daylight sensor?)
- Indoor type switch installed on NW corner; needs replacement with water proof type

Improper switch

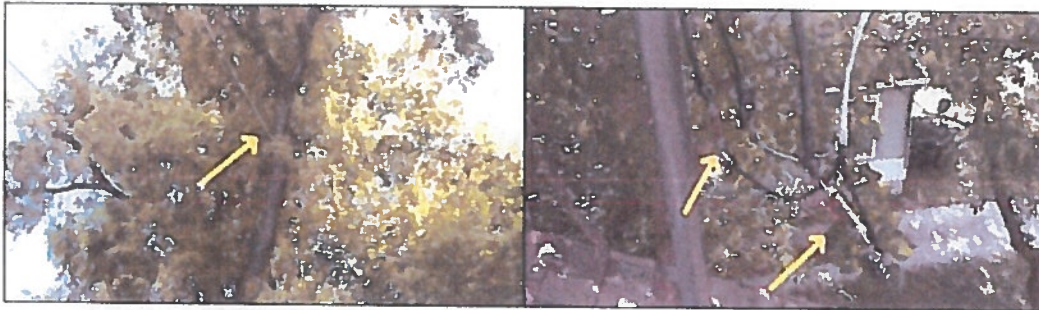
- Ground clamp/system not visible
- Trees touch wires; recommend contacting utility company.
- Wires: Exposed connections noted; recommend correction by utility company.

Trees touch wires

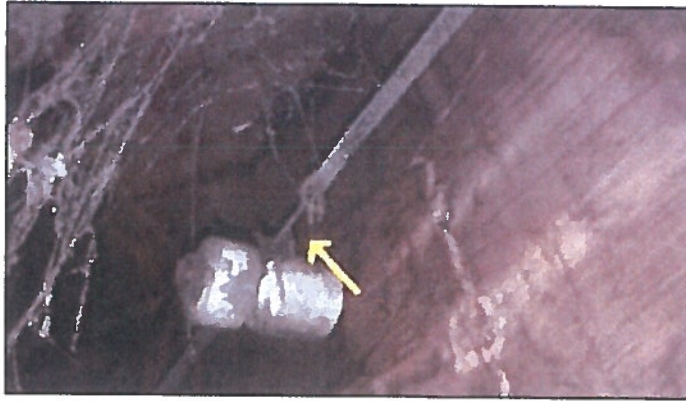
- Deteriorated knob and tube wiring observed in several areas - Recommend evaluation/removal by qualified electrician.

Knob and tube wiring with deteriorated insulator in SE portion of basement.

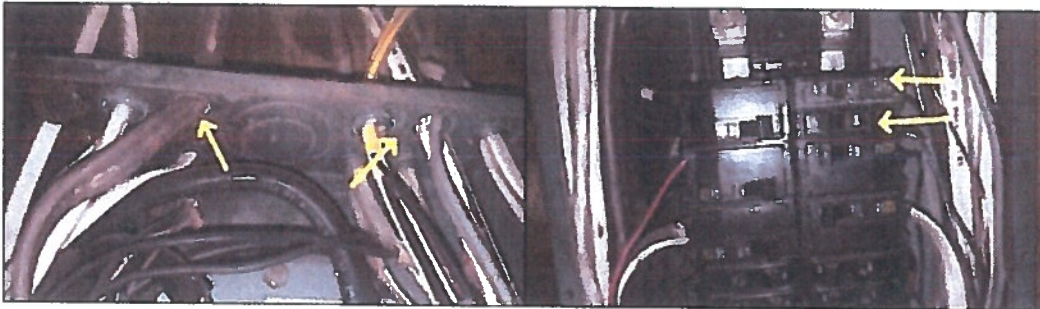
- Electrical system appears outdated by today's standards
- Labels missing
- Seven breakers must be turned off to disconnect power, no more than six are allowed; needs correction.
- Missing bushing/clamp on wires; needs correction.

Missing protective clamps

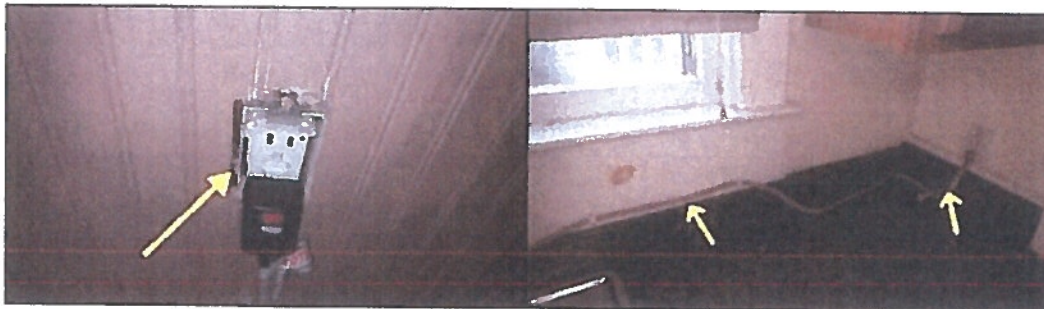
Missing plate in bathroom - Unit 3

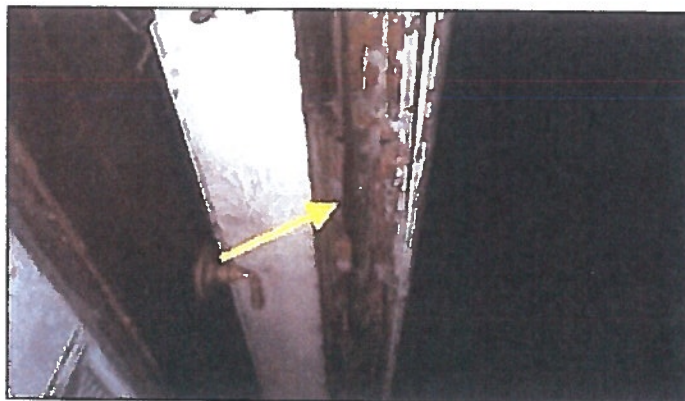
- Front door jamb is damaged and needs repair. Unit 1
- Front screen door is torn. Unit 1

Unit 1 - Front door jamb is damaged

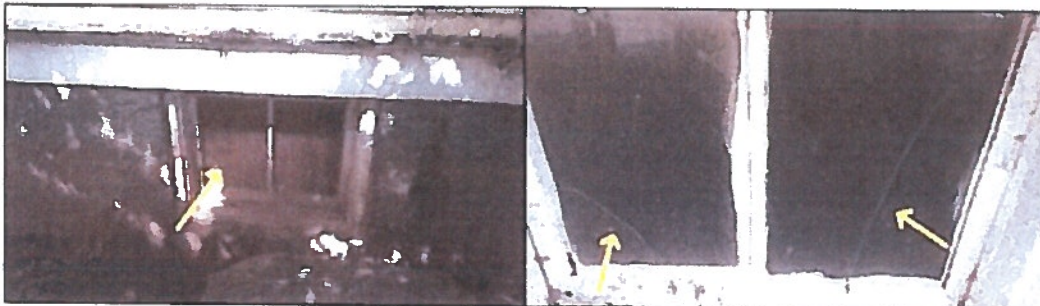
Boarded up basement windows

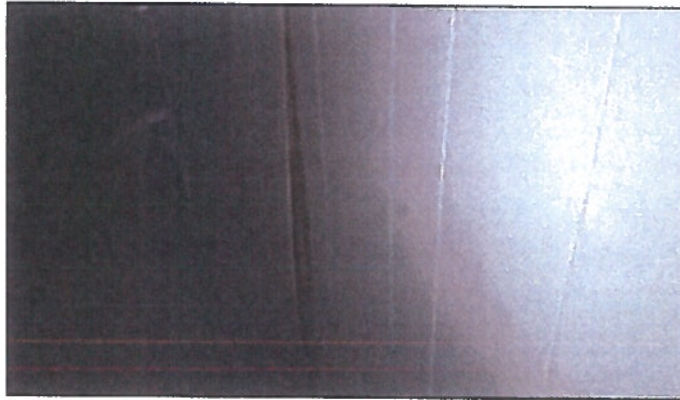
Loose paneling in living room. Unit 1

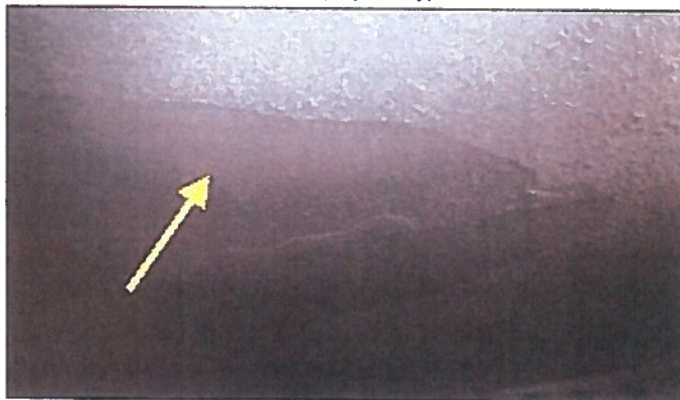
Damage noted - Unit 3

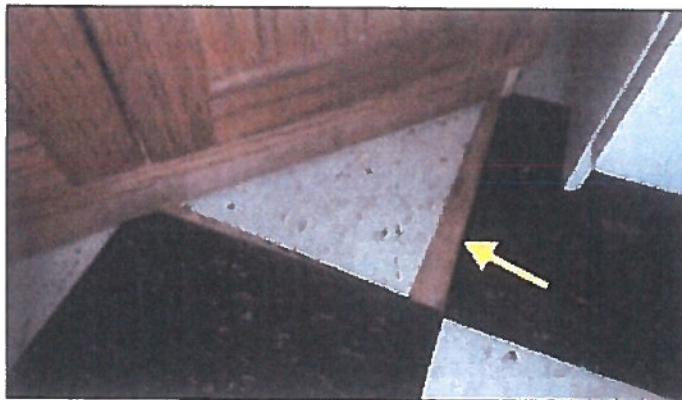
Loose tile below sink - Unit 1

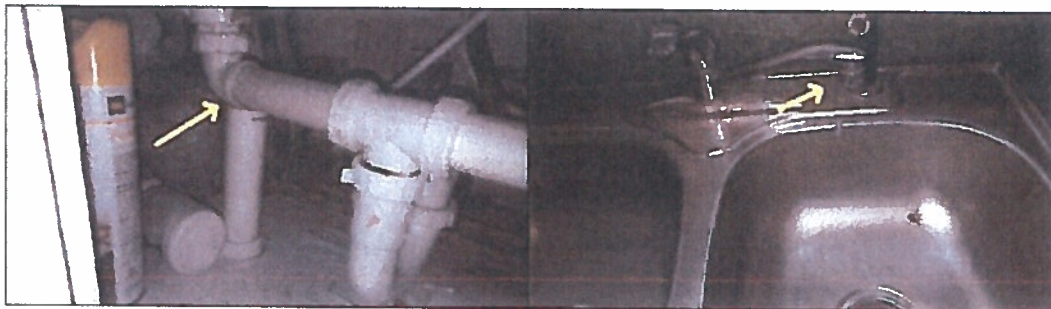
Drain missing fitting and supported by scrap pipe -  
Unit 3

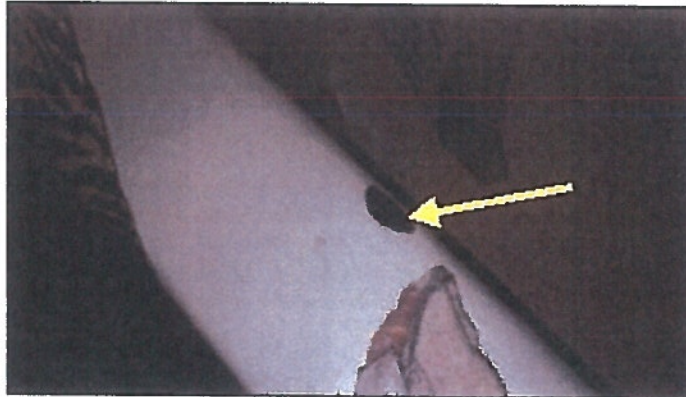
Chipped tub - unit 1
