# Springfield Land Clearance for Redevelopment Authority

**4.1. Blight Report And Redevelopment Plan For The East Cherry Townhomes Redevelopment Area, Generally Located At 1361 And 1365 East Cherry Street; Say You Can, LLC, Applicant**

This Blight Report for the East Cherry Flats Redevelopment Area (this “**Blight Report**”) is being submitted by Say You Can, LLC, a Missouri limited liability company (such entity, or its successors and assigns, is referred to as the “**Developer**”), for the purpose of demonstrating that the Redevelopment Area (as defined below) should be declared blighted pursuant to the LCRA Law. This Blight Report will demonstrate (i) that the Redevelopment Area is a “blighted area” under the LCRA Law due to the predominance of (1) deterioration of site improvements, (2) insanitary and unsafe conditions, (3) obsolete platting, and (4) the existence of conditions which endanger life and property by fire and other causes, and (ii) because of the aforementioned conditions, the Redevelopment Area hinders the provision of housing accommodations, constitutes an economic and social liability, and is a menace to the public health, safety, morals, and welfare in its pr

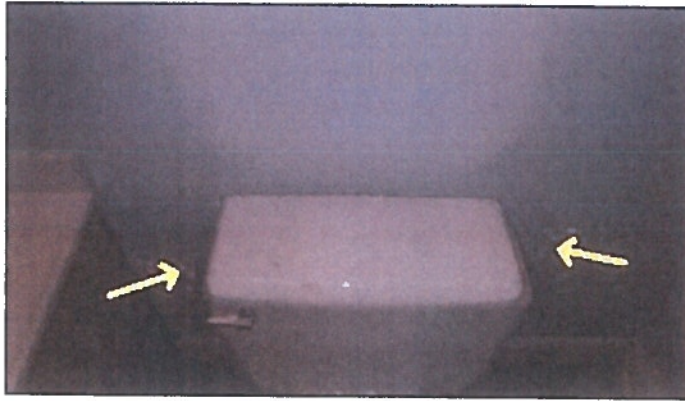
Tank cover too small

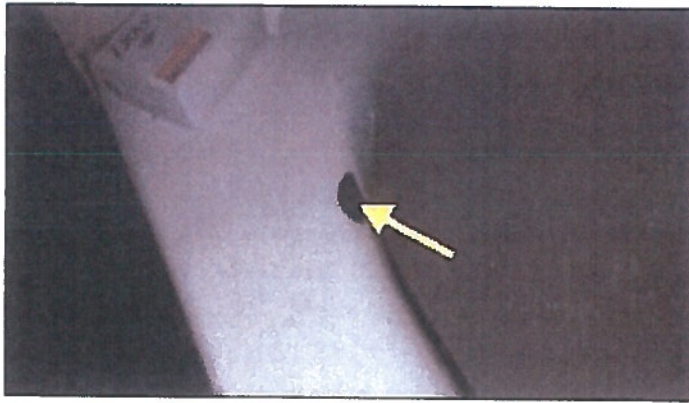
Several chips - Unit 3
