# Springfield Land Clearance for Redevelopment Authority

4.i. **Blight Report And Redevelopment Plan For The East Cherry Townhomes Redevelopment Area, Generally Located At 1361 And 1365 East Cherry Street; Say You Can, LLC, Applicant. Resolution No. 2017-3228**

## Report Summary of Defects

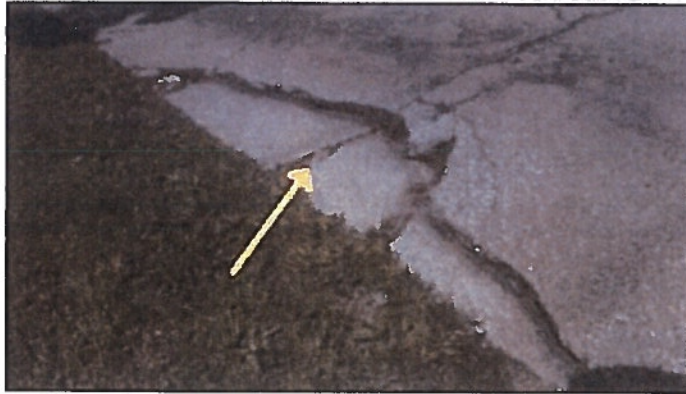
- Major cracks and displacement noted with potential trip hazard; needs repair/replacement.
- Drive is near end of its lifespan.

Drive deterated

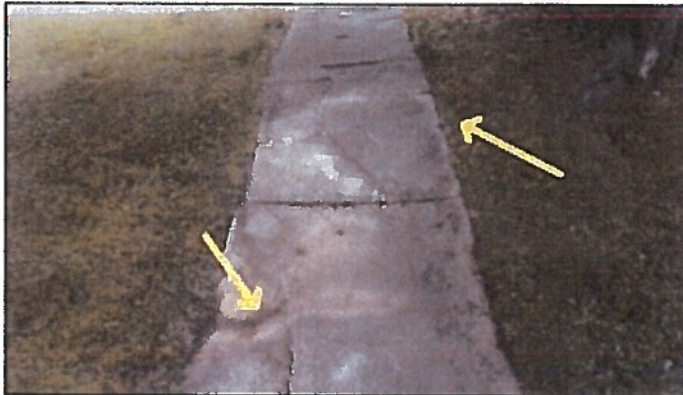
**Observations:** Major cracks and displacement noted with potential trip hazard; needs repair/replacement.

Sidewalk damaged

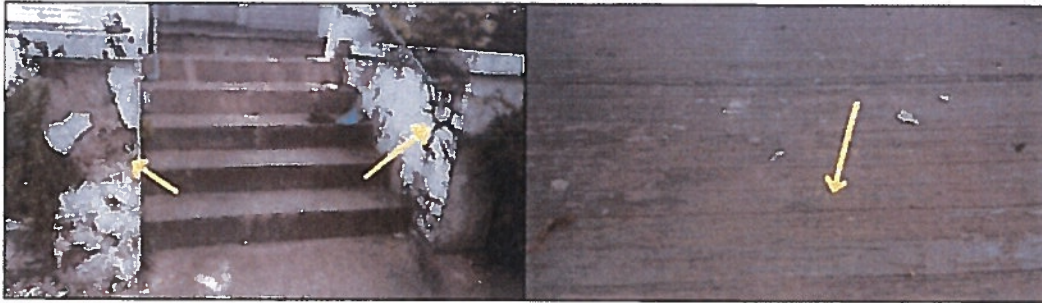
- Concrete walls at front steps are damaged and deteriorating; need full evaluation and repair.
- Not fully visible
- Railing too low at porch (relative to home's age).
- Porch is due to be sealed/painted.
- Footings not visible.
- Porch is not bolted to house (Nailed/screwed); Recommend correction.

Damaged walls

Flaking paint on porches

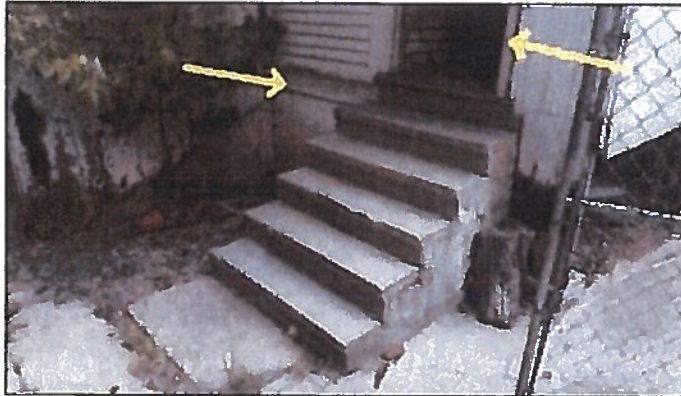
- Handrail needed at front sidewalk and back steps for safety.
- Cracks and deterioration noted

Handrail needed at back steps

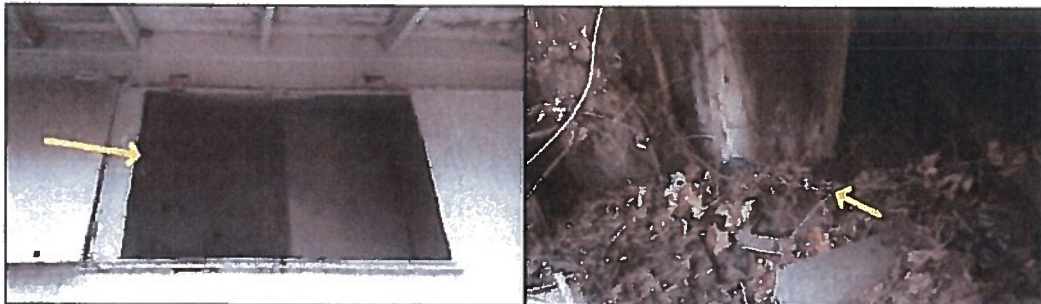
- Floor is sloped away from home, appears to have settled.
- Unheated/Cooled
- Exterior door is missing
- Wood to earth contact noted, not recommended as this may provide direct access for termites.

Missing shutter noted

Wood to earth contact

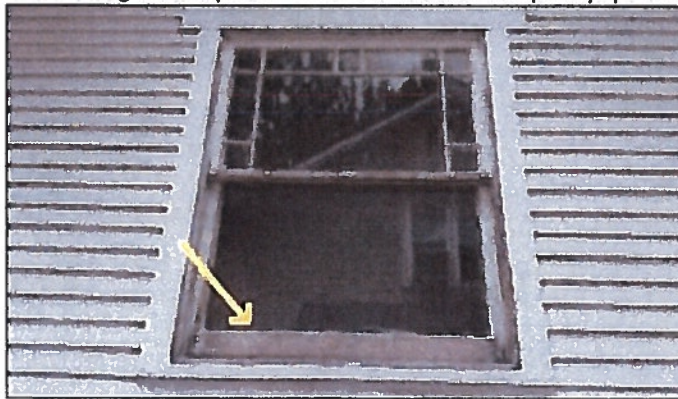
Holes in asphalt paper on West gable

Worn paint

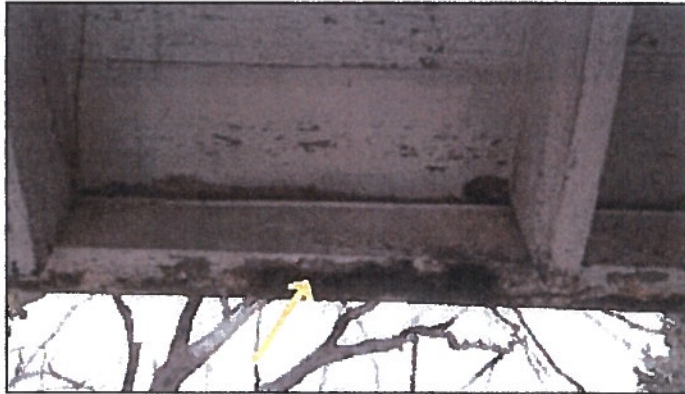
- Guttering is damaged and at the end of its normal life; needs replacement.

Gutters rusted through

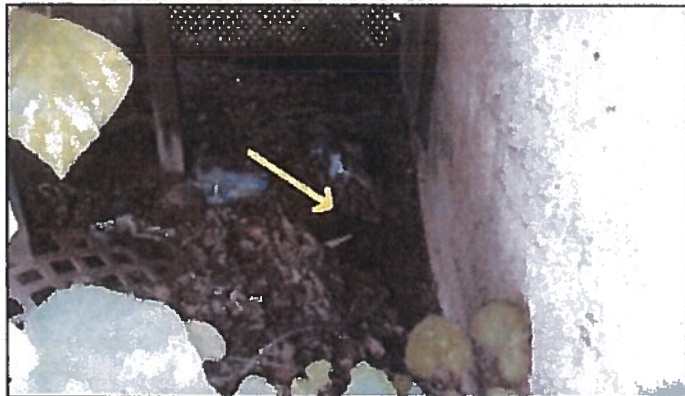
- Appears to drain fairly well.
- Overgrown landscaping noted; recommend trimming.
- Some erosion noted from water running over the guttering.
- Poor drainage noted below front porch; needs soil added.

Poor drainage below front porch

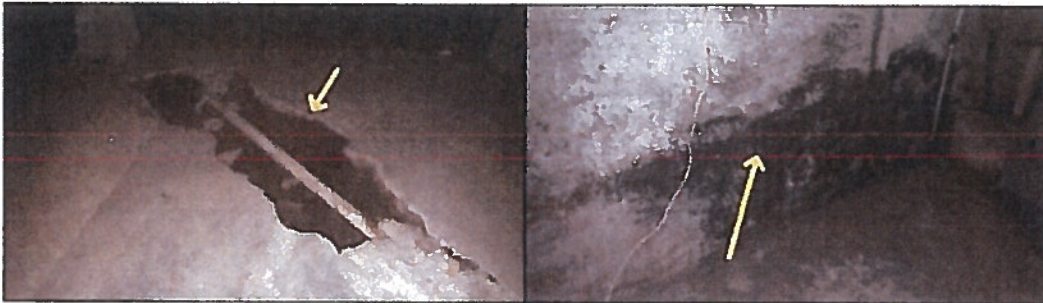
- Common shrinkage cracks observed in foundation stem walls.
- Observed past repair in NE corner.
- Hole in floor needs repair.
- Evidence of past/present water in basement; recommend full evaluation/repair by qualified foundation contractor.

Large hole in concrete floor

Area of past repair

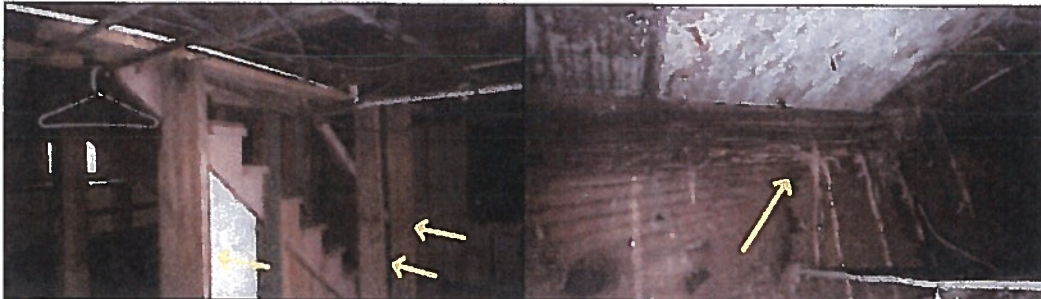
- Anchor bolts were not found.
- Added support noted.
- Moisture stains noted on floor structure below bathroom and utility areas.
- Floor and interior basement stairway poorly supported; needs evaluation/repair by qualified contractor.

Floor and interior basement stairway poorly supported

Signs of termite damage near exterior stairway.  
(Full termite report available if requested.)

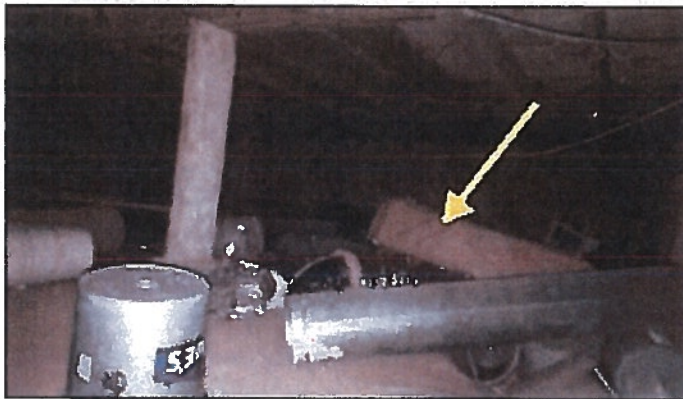
- Crawl space was dry today.
- Observed signs of past moisture along foundation walls.
- Recommend installing a plastic vapor barrier on the ground to prevent moisture from causing abnormal conditions in the future.
- Better control of roof water should help prevent problems in the future.
- Some scrap wood and construction debris needs to be removed from the crawl space.

Construction debris in crawlspace

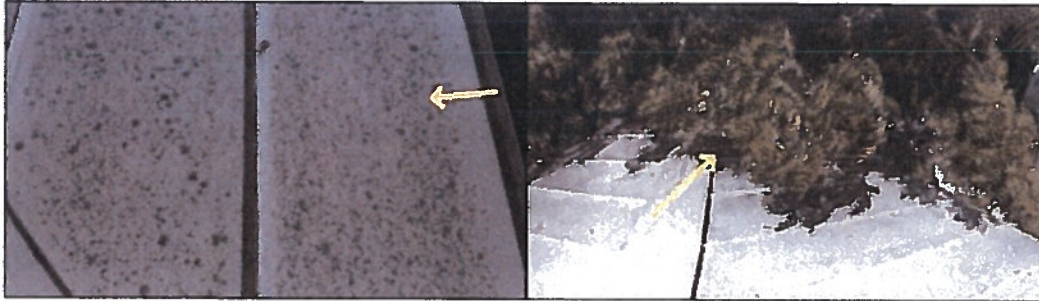
- Trees need to be trimmed away from roof to prevent damage.
- Regular maintenance and inspection advised.
- Observed weathering and moss.

Moss

Trees need trimming

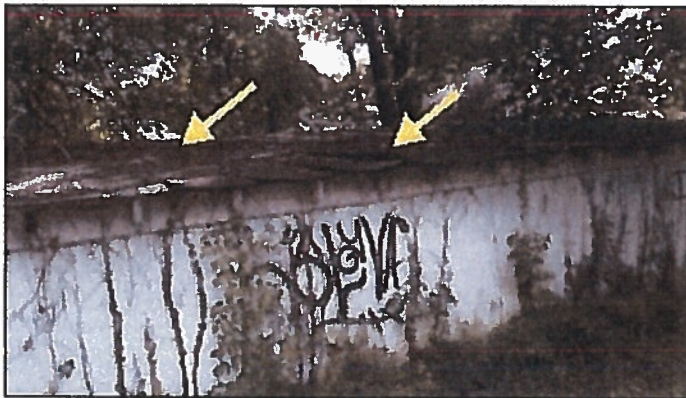
- Garage roof is loose and near/past the end of its lifespan; needs replacement.

Garage roof in poor condition and covered with branches/debris

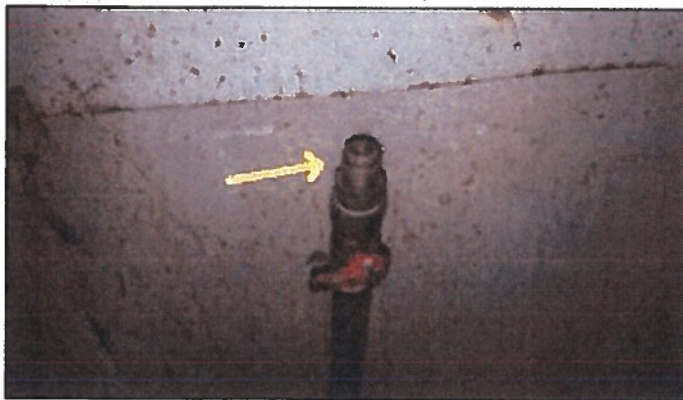
- Not fully visible
- Moderate rust/corrosion
- Near end of lifespan
- Pipes lack proper support and large quantity of abandoned gas line is connected to system; needs full evaluation and repair by qualified plumber.
- Gas line for stove is open; needs to be capped for safety.

Open gas line behind stove

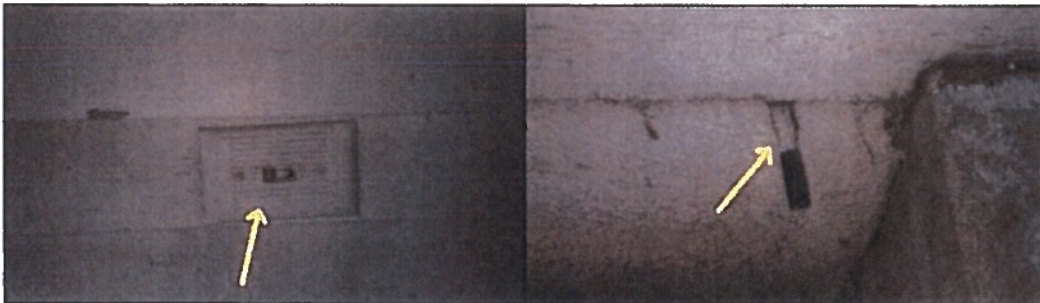
- No exterior receptacles were found • Utilities off, unable to test.
- Exposed wire noted near back porch; needs to be removed or properly terminated.

Broken switch at back porch

Exposed wire near back porch

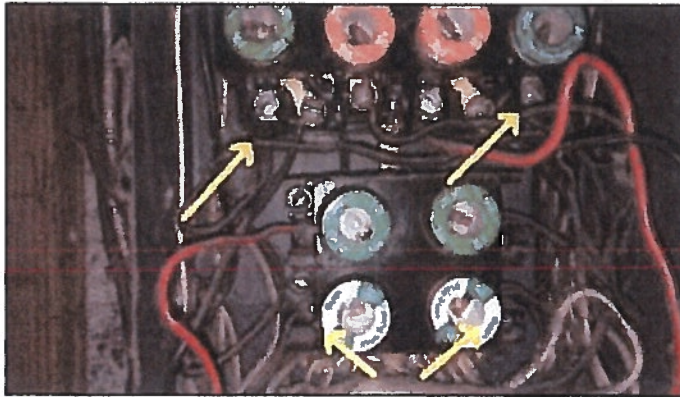
- Electrical system appears outdated by today's standards
- Labels missing
- No space remains in panel for additional circuits.
- Panel covers have been removed; need replacement.
- Double tapped fuses observed - Need repair by qualified electrician.
- Several 20 amp fuses appear to have been replaced with 30 amp; needs evaluation/repair by qualified electrician.

Double tapped fuses

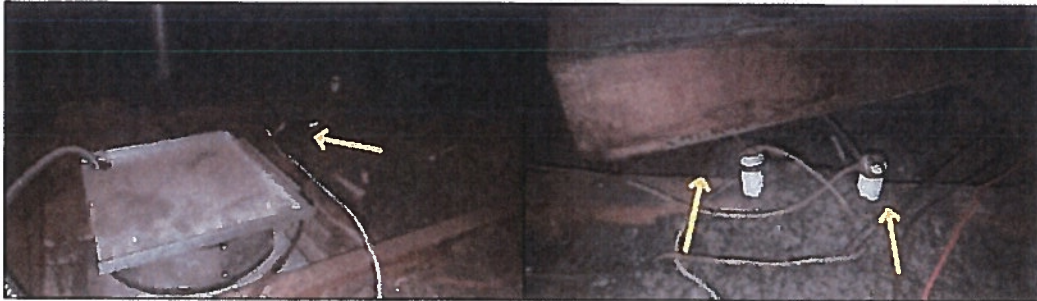
- Doorbell button damaged; needs repair.
- GFCI protection recommended for kitchen and bathrooms
- Missing globes noted and cover plates noted.
- Utilities off, unable to test.
- Exposed splices in attic need to be put in proper junction boxes
- Exposed splices in basement need to be put in proper junction boxes.

Exposed splice near access

Knob and tube wiring noted

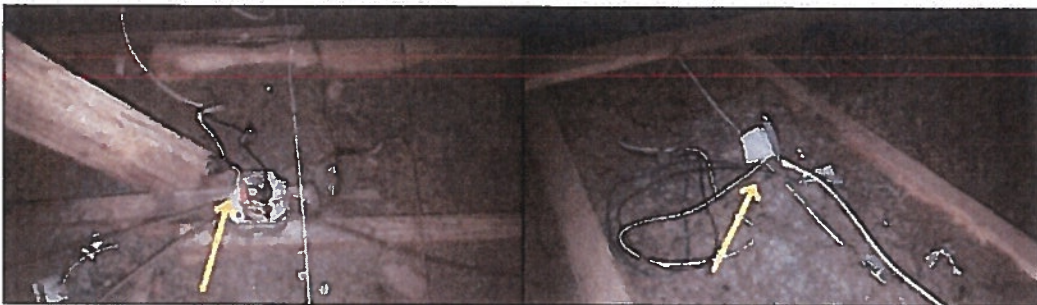
Exposed splice in center of attic

Improper and exposed splice above entry

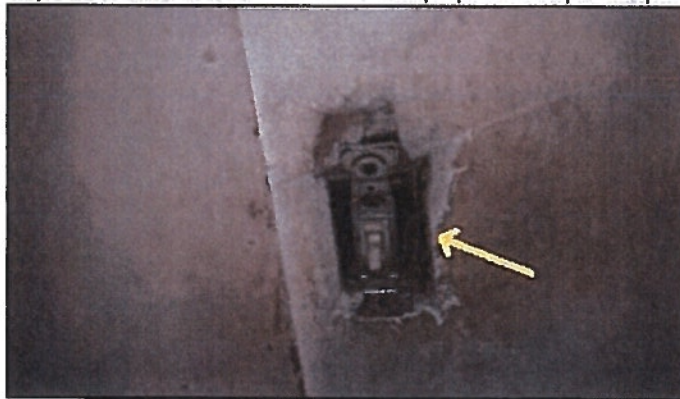
Outlets and switches missing plates in various locations.

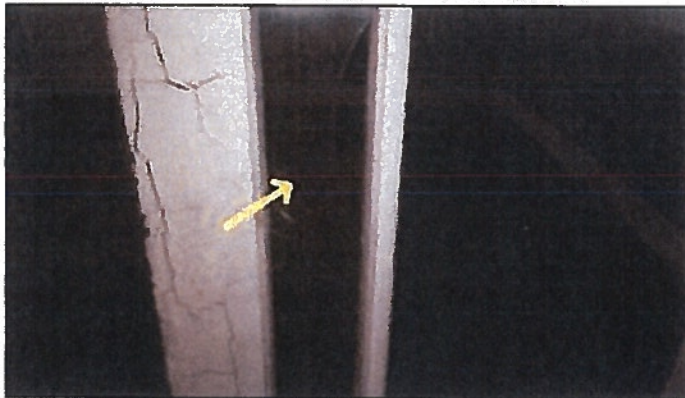
- Several doors do not close properly and have loose hardware; need repair.
- Broken glass observed in living room doors; need repair or replacement.

Broken glass in main living area doors.

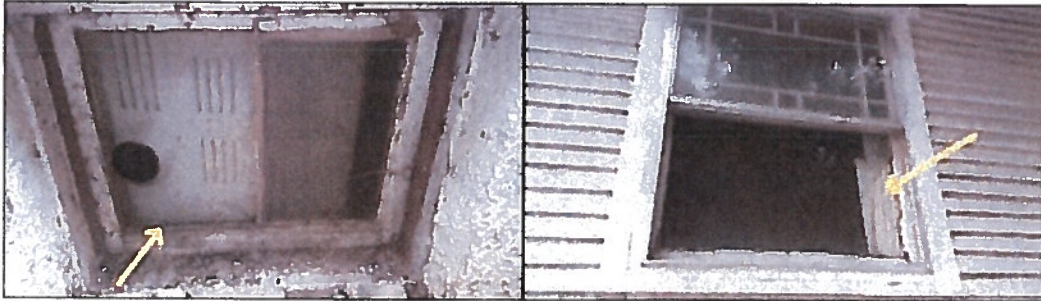
Missing window on back wall of basement

North window on East side is broken

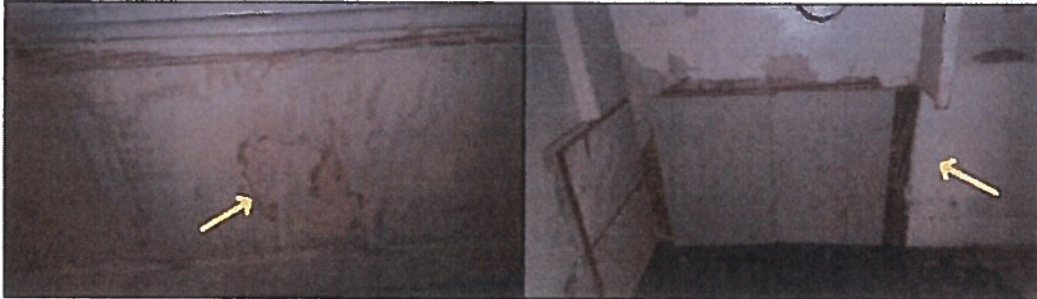
- Walls are in poor condition; need full evaluation, touch up and repair.

Moisture stains and cracks

Missing plaster

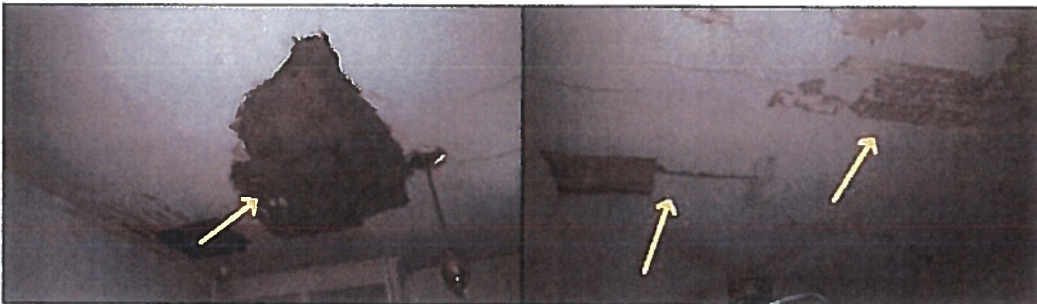
- Common cracks
- Some sagging and damaged areas noted; needs full evaluation and repair by qualified contractor.

Dining room ceiling

North bedroom

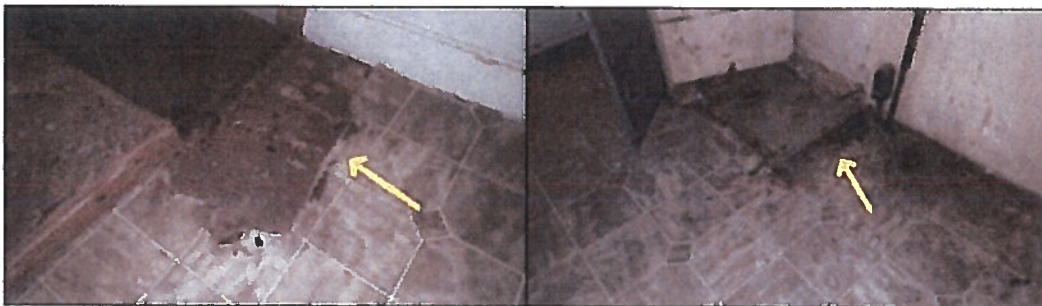
- Uneven areas in the floor noted.
- Stained/damaged flooring observed in various areas.
- Wood flooring is due to be refinished.

Dining room floor

Kitchen

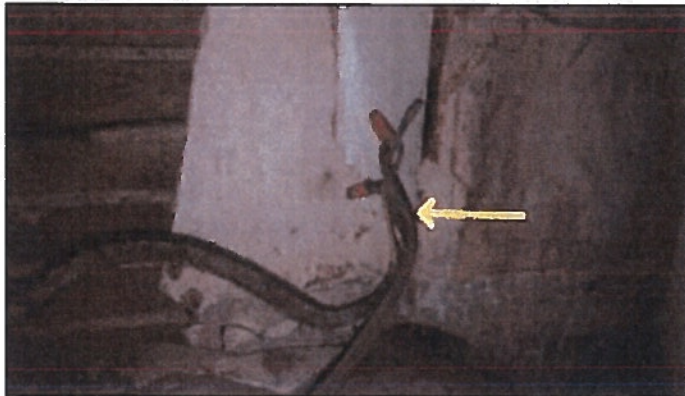
- Near end of lifespan
- Improper wiring noted; splice needs to be put in junction box.

Exposed splice

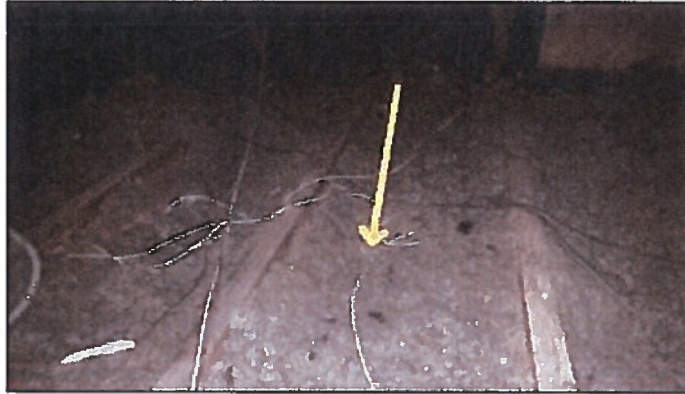
- Attic is poorly insulated; all joists are visible. Recommend adding insulation for energy efficiency.

Attic poorly insulated

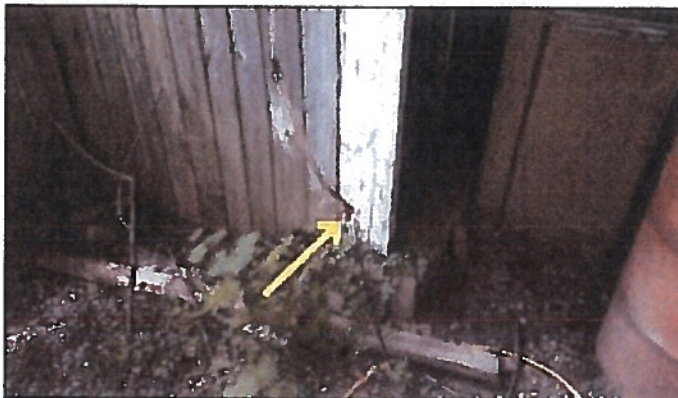
- GFCI protection recommended for garage circuit
- Improper wiring
- Garage electrical is connected to a damaged power cord; needs to be removed or properly wired by a licensed electrician.

Cord with exposed splice powers garage

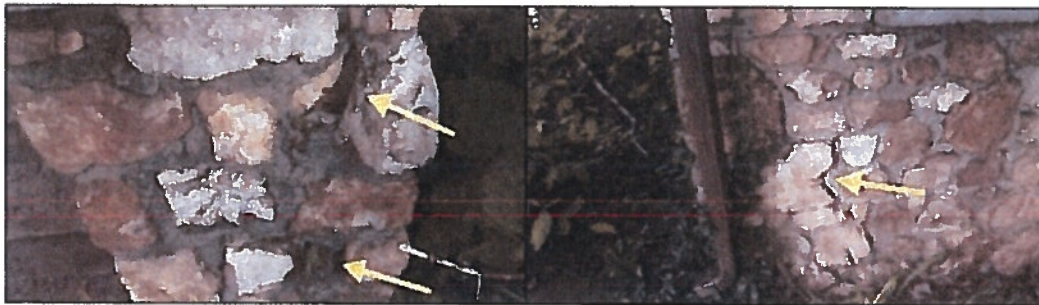
- Stone and mortar missing in various locations; needs full evaluation and repair by qualified mason.
- Common cracks
- Railing too low at porch (relative to home's age).
- Areas of spalling/deterioration observed.
- Flaking paint noted on concrete and wood surfaces.

Stone missing at front steps

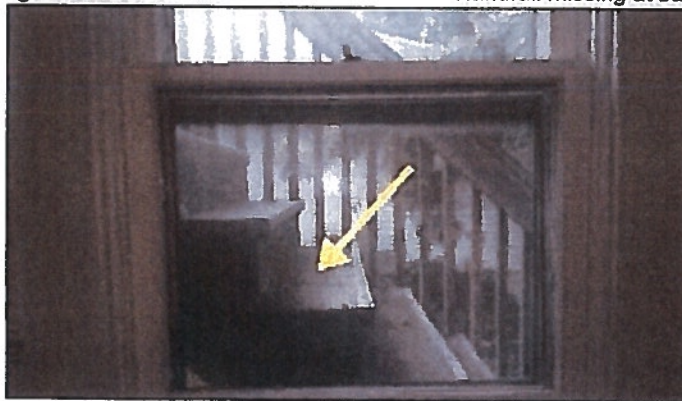
Handrail missing at back steps

Glass level with steps

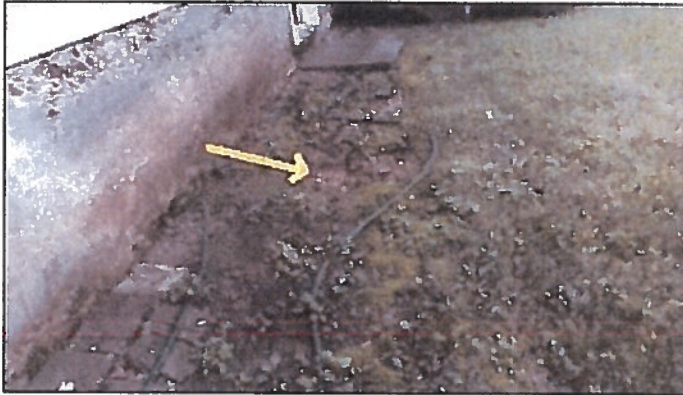
- Extend downspouts for improved drainage and control of roof water.
- Recommend adding soil around foundation to improve drainage.
- Some erosion noted from water running over the guttering.

Erosion from overflowing gutter at back of home

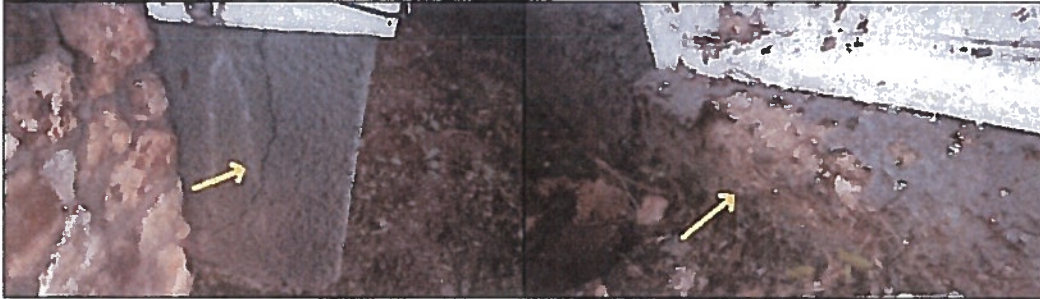
- Trees planted close to structure, not recommended as roots may cause damage to foundation.
- Evidence of past/present water in basement; recommend full evaluation/repair by qualified foundation contractor.
- Typical cracks in basement floor slab.
- Cracks, deterioration and minor displacement noted on the foundation walls; recommend evaluation, sealing and parging by a qualified foundation contractor.

Crack at SE corner (1/2" displacement)

Deterioration on foundation walls, west side pictured.

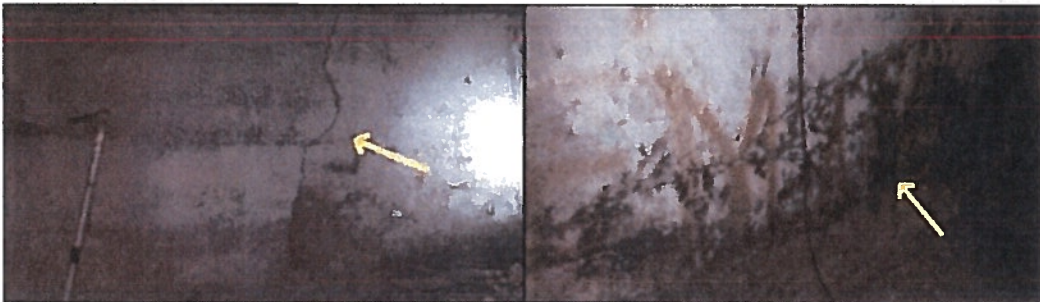
Small crack in SW corner of basement/crawlspace

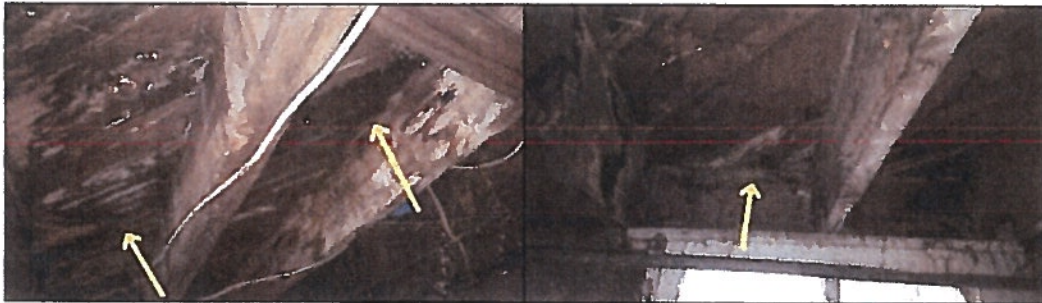
- Anchor bolts were not found.
- Wood to earth contact noted near electrical panel; recommend correction. (Prone to deterioration and may attract termites.)
- Moisture stains/damage noted on floor structure in various locations.
- Some spotty mold growth was observed on the floor structure in a few areas particularly in the Western portion; needs full evaluation and cleaning/removal by a qualified mold contractor.

Fungal growth and damaged subfloor in NW portion of basement

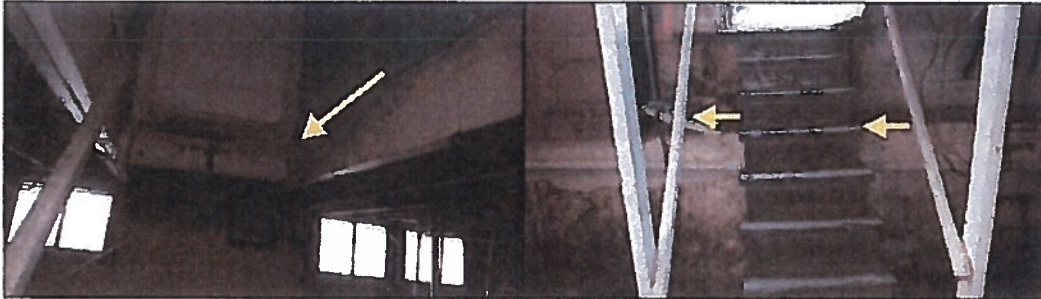
- Lock is broken on door to basement stairway.
- Ceiling height is too low on steps to the basement.
- Stairway is not full width, does not reach handrail and step rise is higher than recommended. Stairway needs full evaluation and repair by qualified contractor.

Interior stairway has been removed and door locked with deadbolt

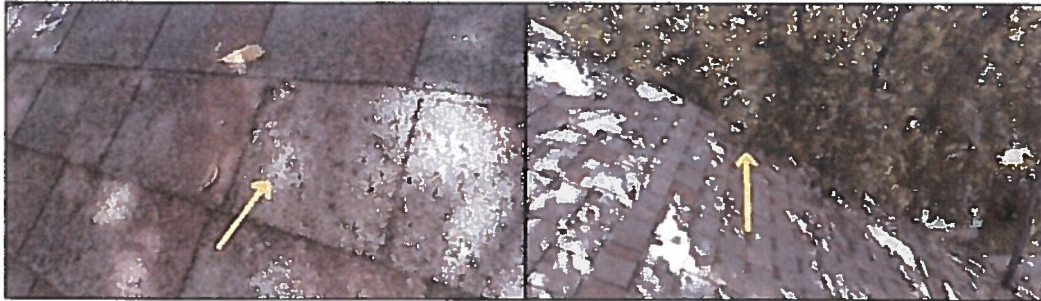
- Waves noted in roof structure
- Trees need to be trimmed away from roof to prevent damage.
- General condition favorable, with signs of weathering and aging; regular maintenance and inspection advised.
- Observed blistering/granular loss.
- Observed weathering and moss on north side and in shaded areas.
- Observed slight signs of past hail.

Moss below trees

Trees touch roof

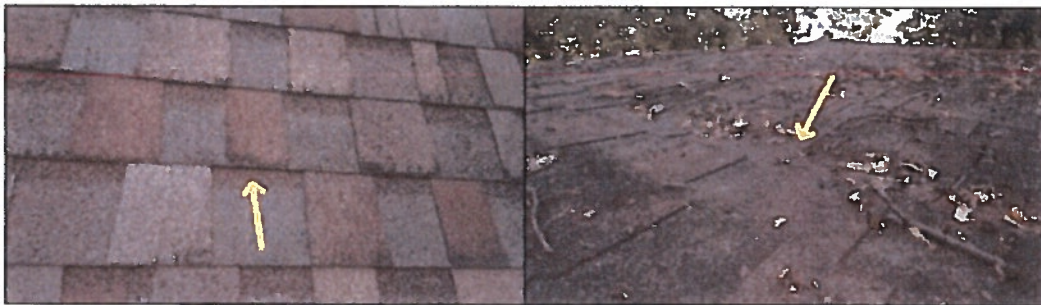
Granular loss and wear

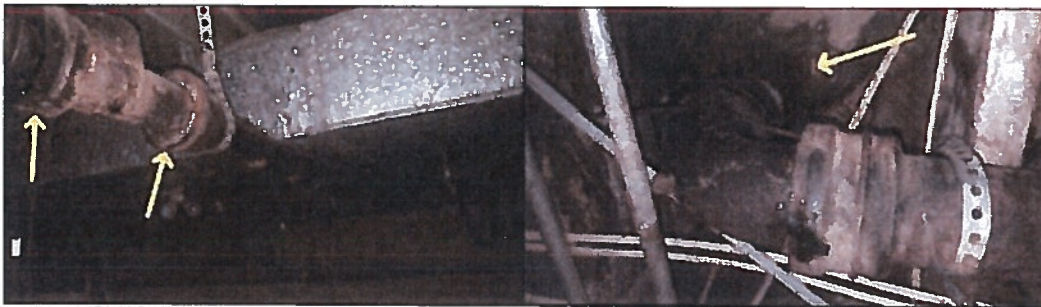
• Several leaks noted on waste lines south of the furnace in the basement; needs full evaluation and repair by qualified plumber.

Several unions leak in basement.

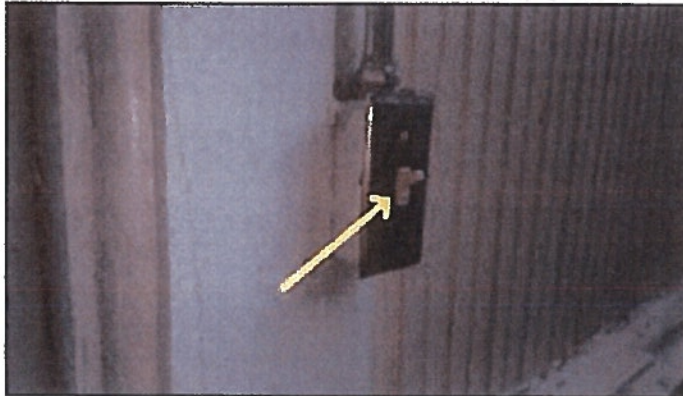
- GFCI protection recommended for exterior outlet
- Several lights did not turn on today (Bulbs or daylight sensor?)
- Indoor type switch installed on NW corner; needs replacement with water proof type

Improper switch

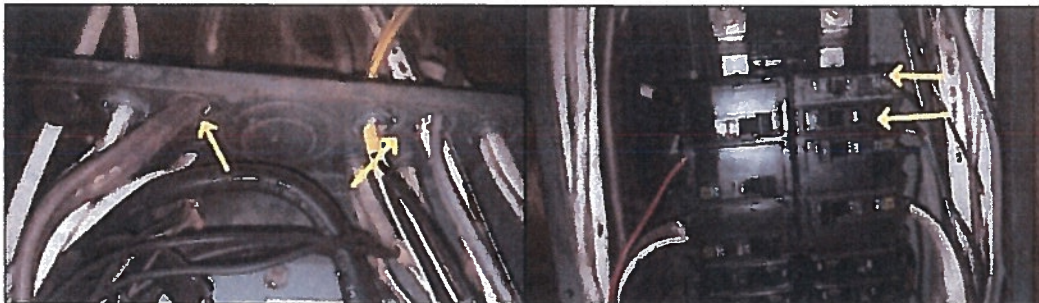
- Electrical system appears outdated by today's standards
- Labels missing
- Seven breakers must be turned off to disconnect power, no more than six are allowed; needs correction.
- Missing bushing/clamp on wires; needs correction.

Missing protective clamps

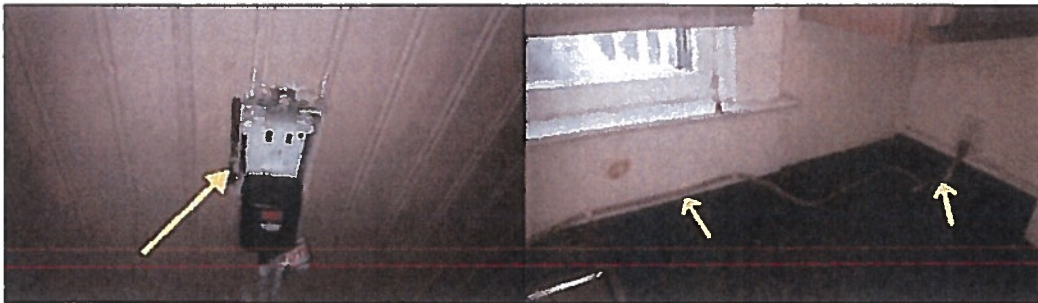
- GFCI outlets functioned properly.
- Several 3-Prong outlets did not test properly grounded.
- Many lights did not function when tested today (bulbs?).
- Missing globes noted in various locations
- An extension cord has been permanently installed at kitchen counter on unit 2; needs replacement with proper outlet.

Missing plate in bathroom - Unit 3

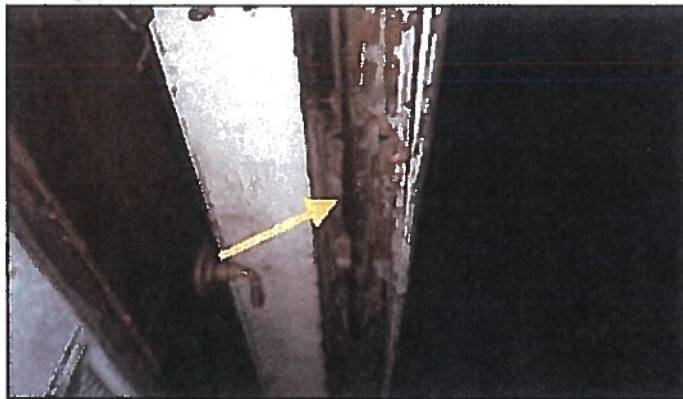
- Front door jamb is damaged and needs repair. Unit 1
- Front screen door is torn. Unit 1

Unit 1 - Front door jamb is damaged

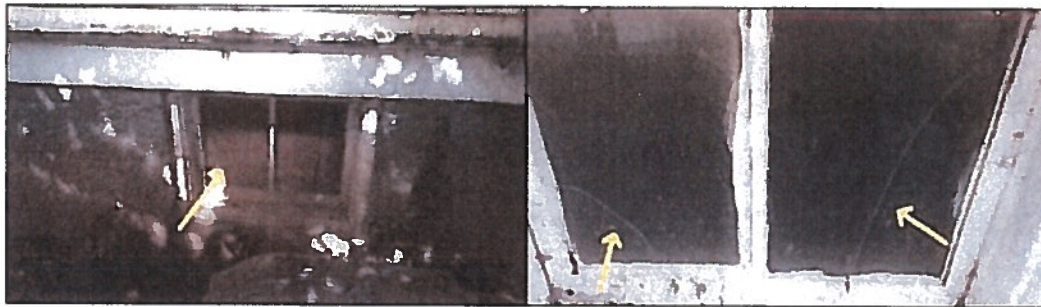
- Several windows appear to be painted shut and would not open.
- Several windows had broken ropes and do not stay open without assistance.
- Several screens were missing/not installed.
- Observed cracked glass at SE basement window and above kitchen sink in Unit 2; need replacement.

Boarded up basement windows

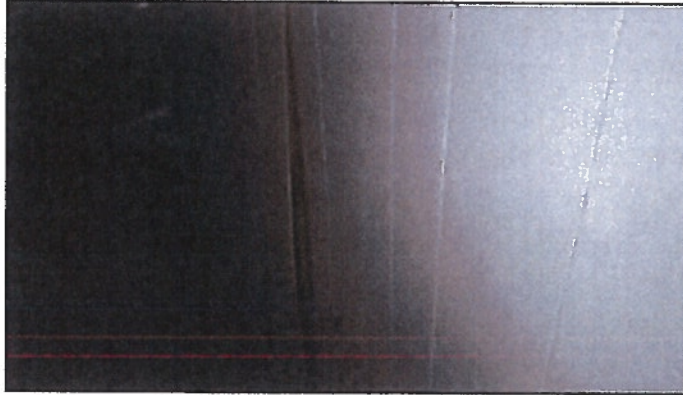
- Touch up and minor repair needed in various areas.
- Common settlement cracks observed

Loose paneling in living room. Unit 1

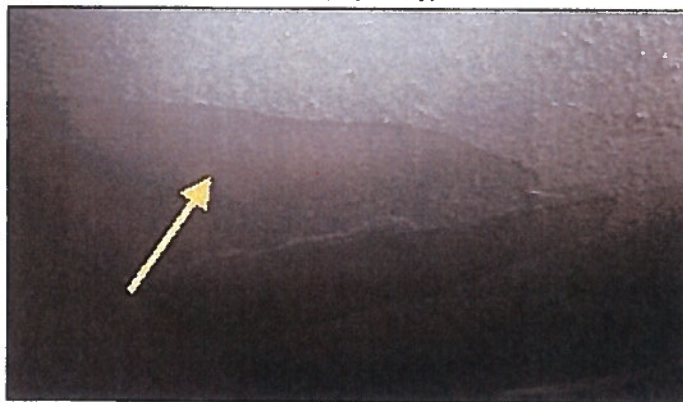
- Appears serviceable
- Common cracks
- Repairs noted
- Moisture stains observed in various locations (Dry today)

Damage noted - Unit 3

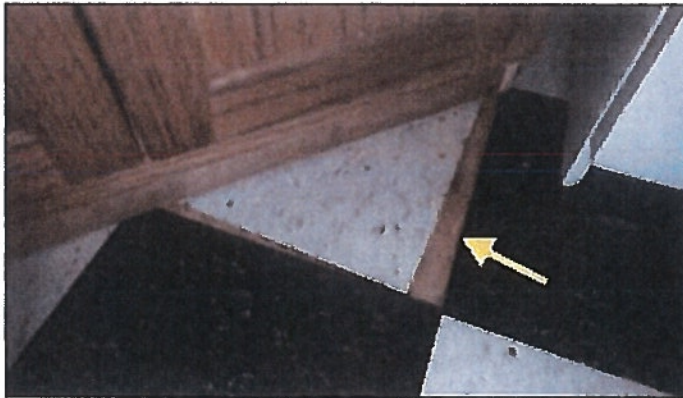
- General condition appears serviceable
- Minor wear/damage
- Floor damage/loose tile in unit 1

Loose tile below sink - Unit 1

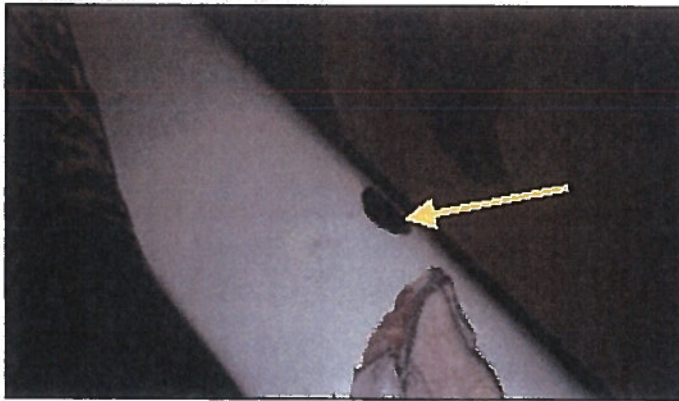
- Caulk needed at tub to enclosure connection
- Drain stopper missing; needs replacement. Unit 1

Chipped tub - unit 1

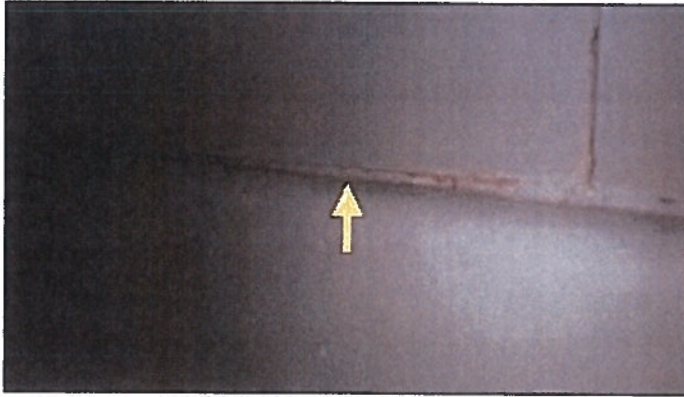
- Appears serviceable
- Enclosure is loose; needs repair.

Loose panel needs securing - Unit 1

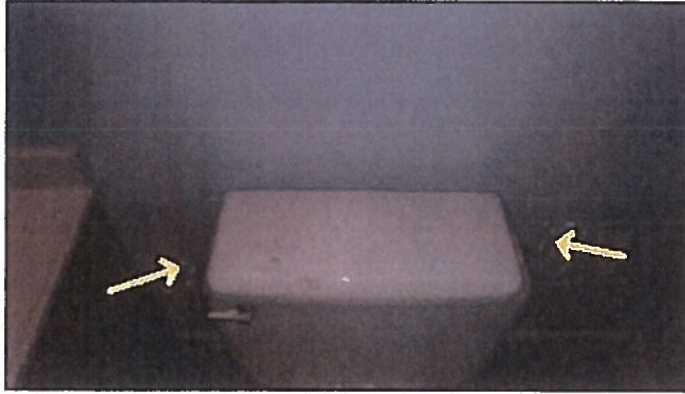
- Toilet tank is loose and cover is improper size; needs repair. Unit 2

Tank cover too small

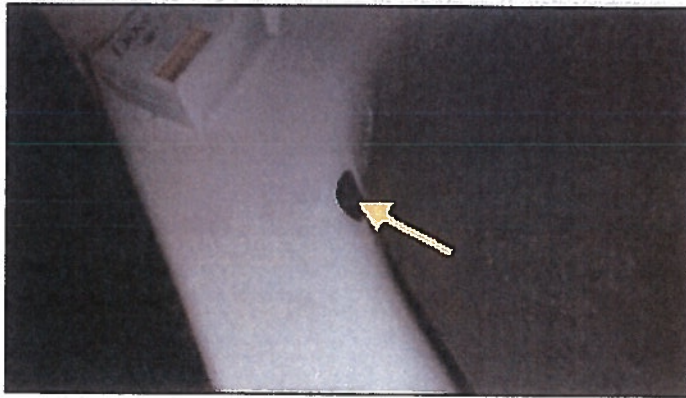
- Tub is damaged/chipped; needs repair.

Several chips - Unit 3

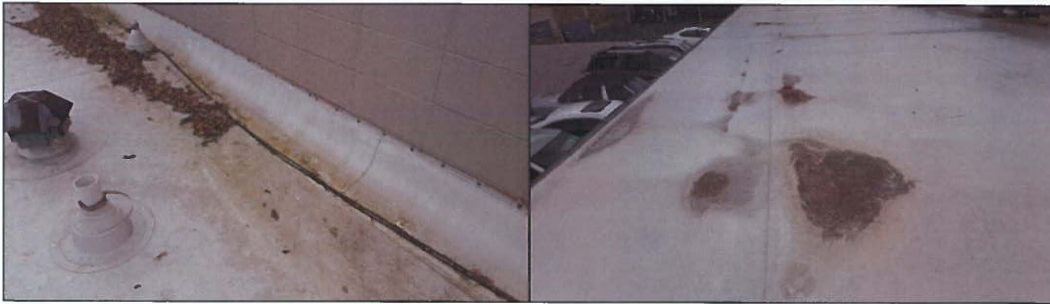
Signs of ponding/poor drainage at rear addition roof

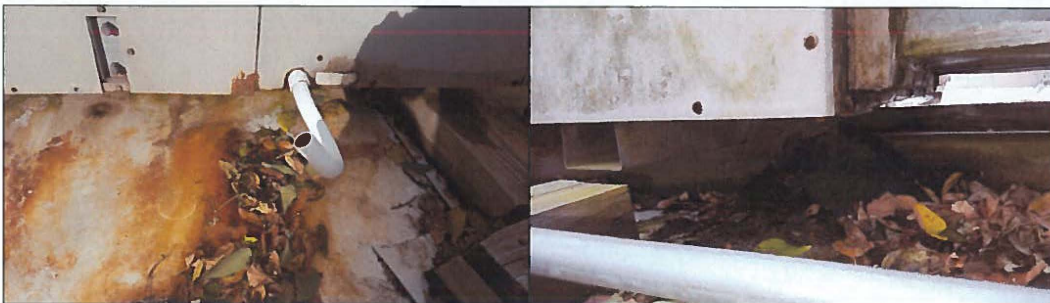
Condensation drains onto roof AC 3

Condensation leak AC 3

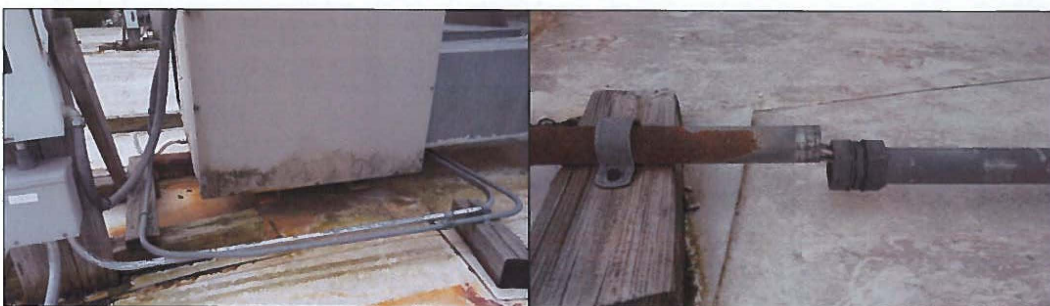
Condensation leaking from bottom of unit AC 3

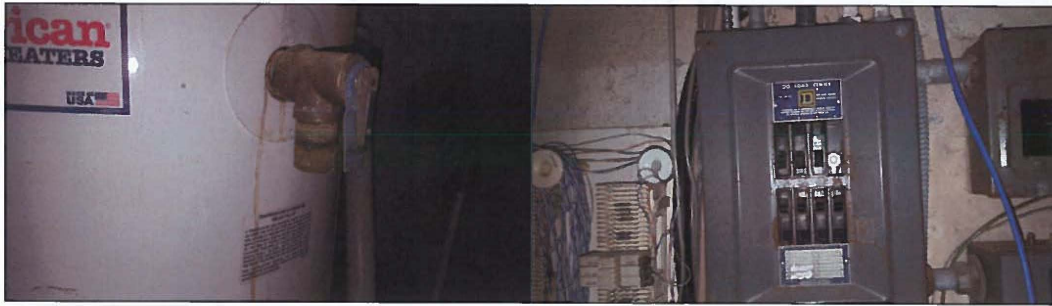
Missing TPR pipe at front water heater

Openings in panel in basement

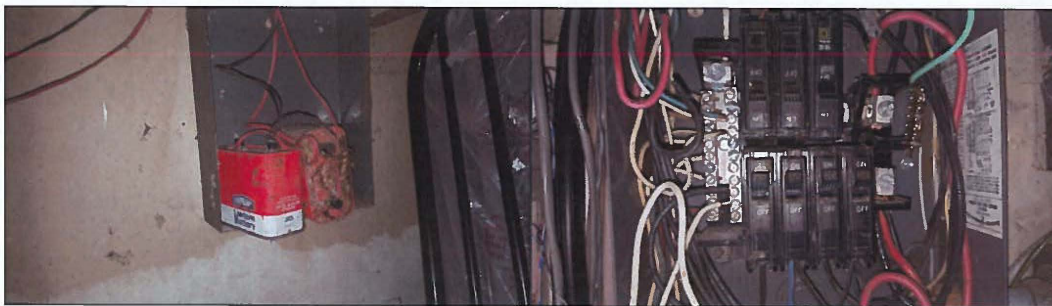
Heavy corrosion on emergency lighting battery in basement.

Double tapped circuits

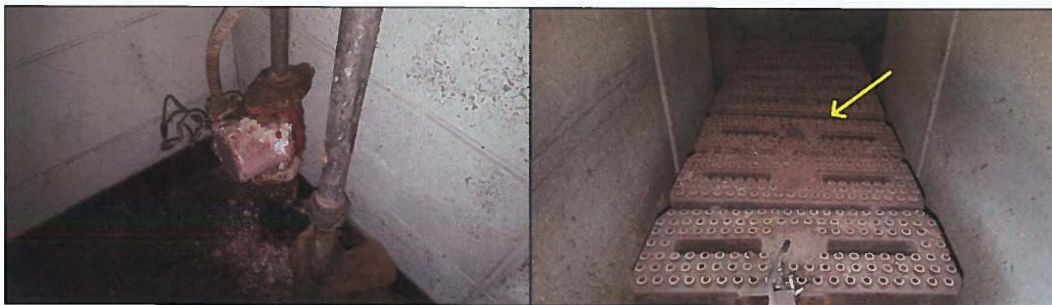
Heavy corrosion on water recirculation pump in boiler room

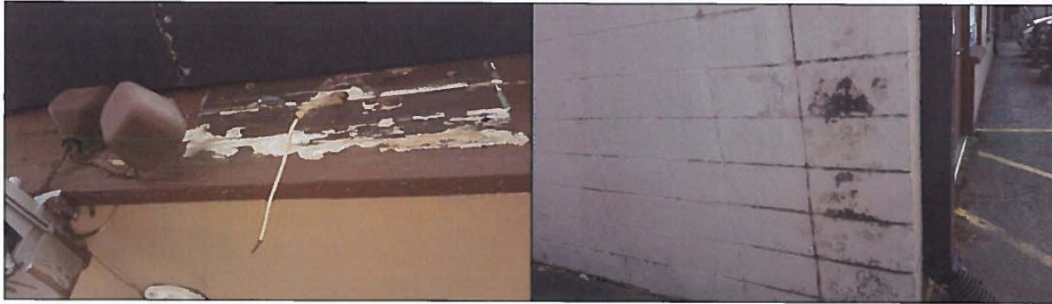
Exposed bare wires on West exterior

Moisture stains/damage at rear of building

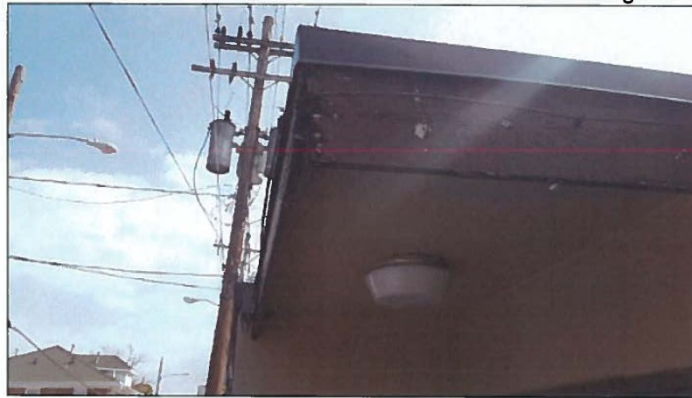
Damaged fascia at back of addition

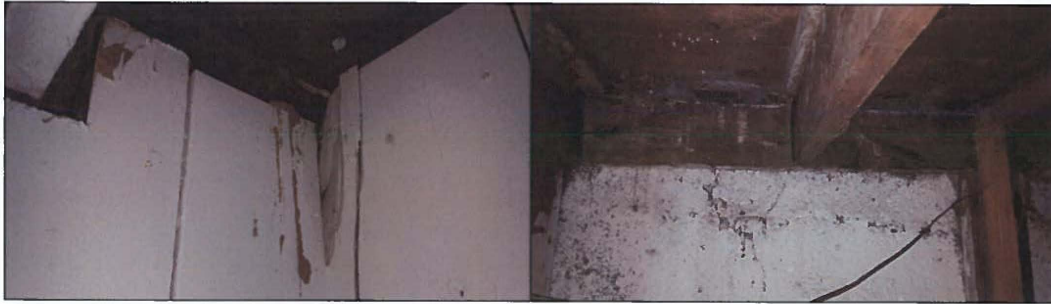
Termite shelter tubes near basement stairway

Moisture stains below back door

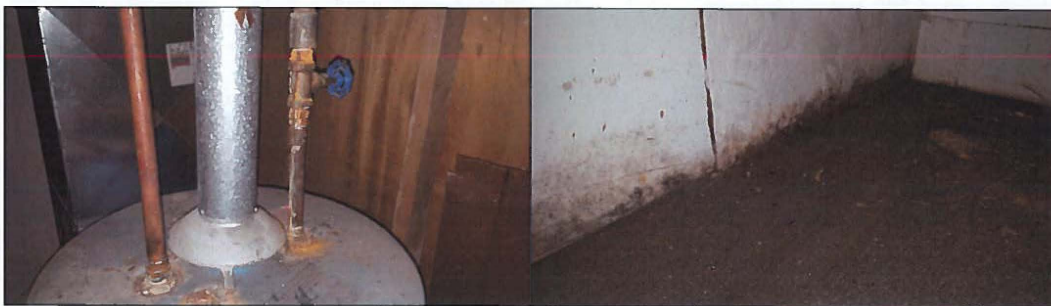
Corrosion at water heater supply

Mold/fungal growth at basement walls

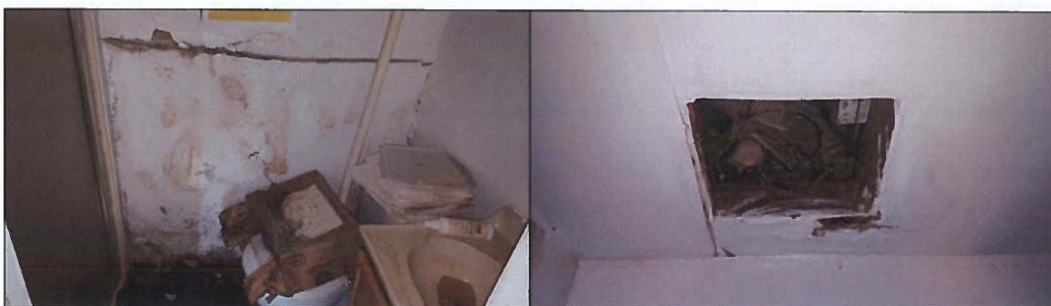
Heavy moisture damage in basement bath

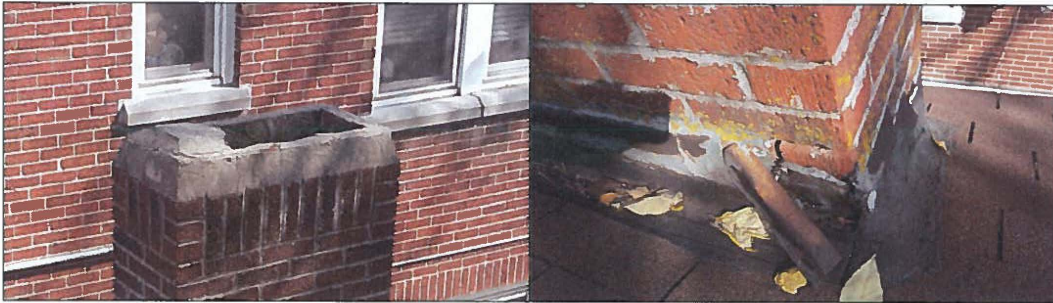
Damaged crown at East chimney

Damaged flashing at east chimney

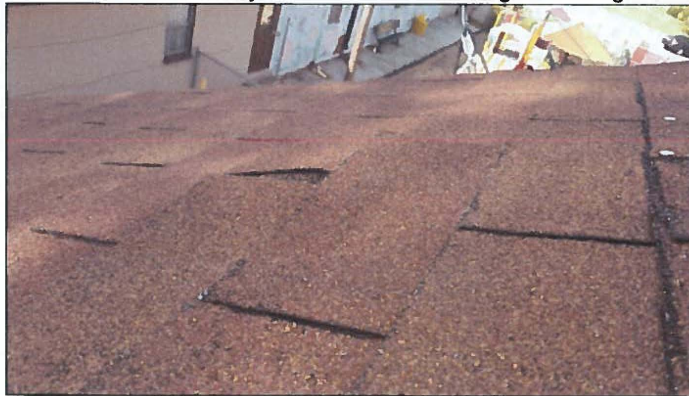
Raised shingles at North end of ridge

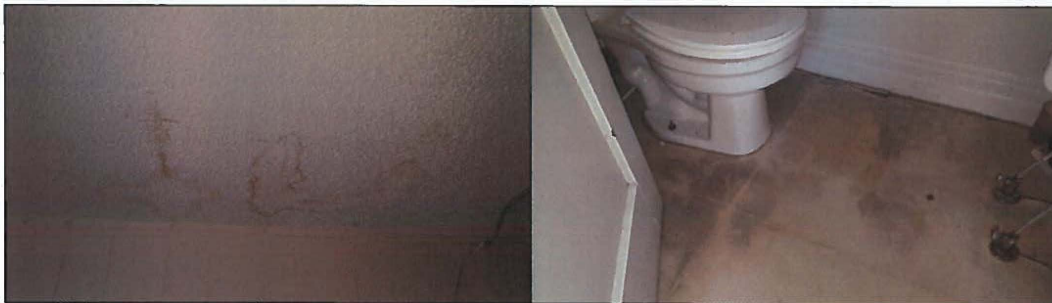
Moisture Damage/Stains ceiling - Unit H

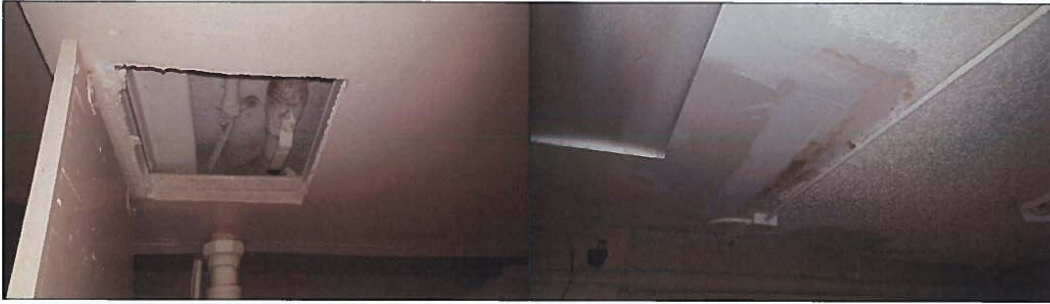
Main water shut off - Basement TV room East wall Moisture damage and sagging ceiling - Basement Game room

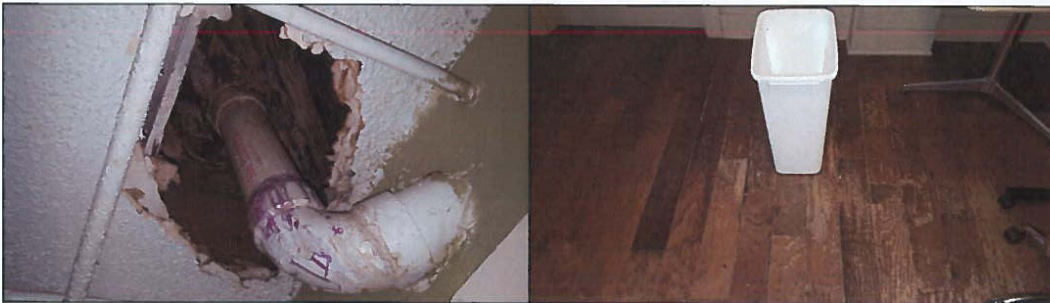
Mold fungal growth and moisture damage - Game room bath Bucket and moisture damage - Learning center

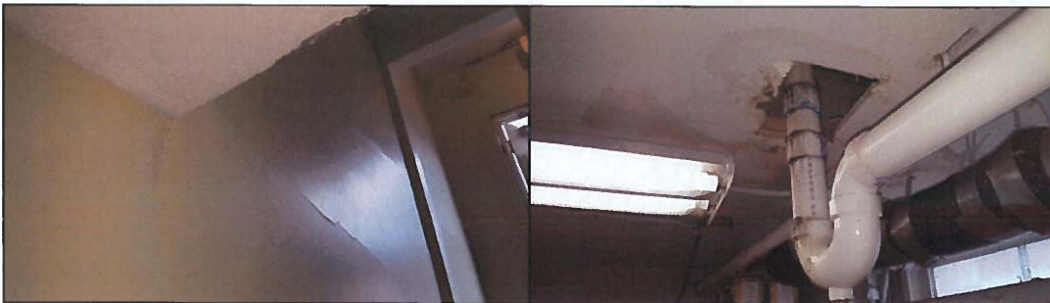
Loose plaster - North basement stairway

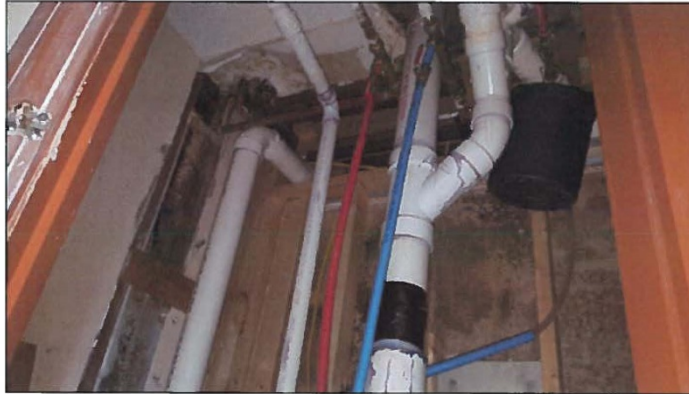
Mold and Improper plumbing repairs - Oasis room closet
