*SPRINGFIELD LAND CLEARANCE FOR REDEVELOPMENT AUTHORITY*

*Tuesday, July 11, 2017 at 4:00 p.m.*

**4.II. Blight Report And Redevelopment Plan For The 1325/1329 East Cherry Redevelopment Area, Located At 1325 East Cherry Street; Roza Capital Group, LLC, Applicant**

**EXHIBIT B**  
**PICTURES OF THE BLIGHTING CONDITIONS**

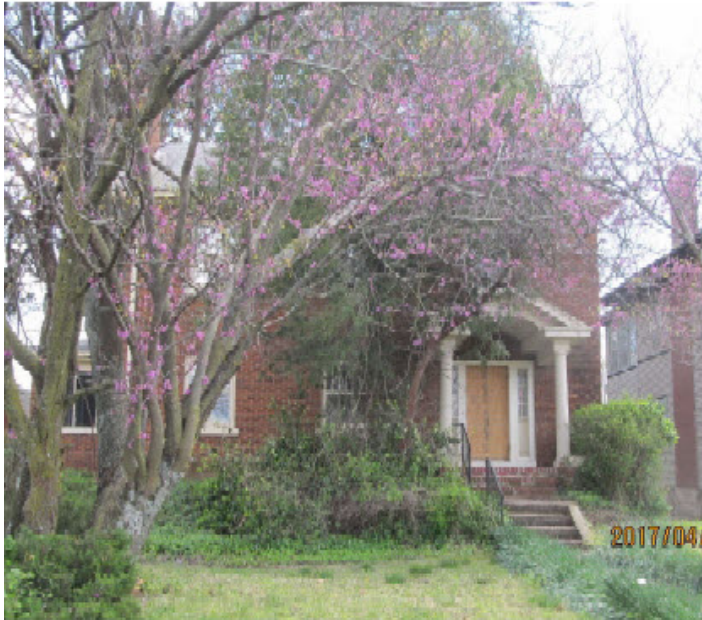
**B-1) Vegetation is overgrowing, which has attracted vagrants.**

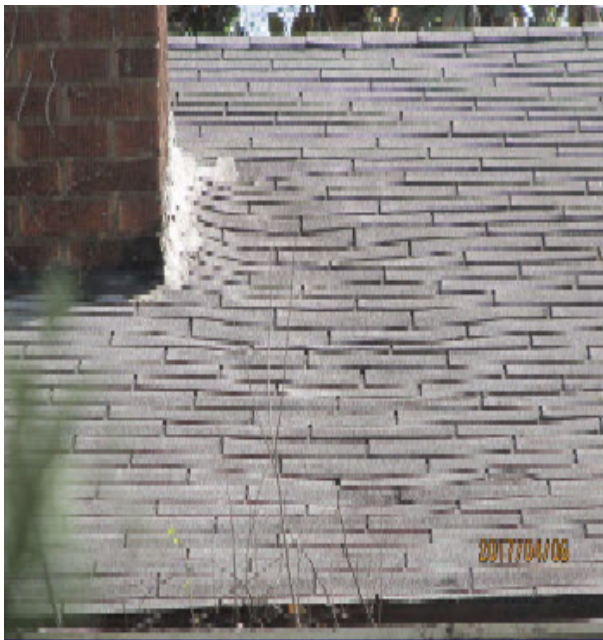
**B-6) Roofing and shingles are not draining properly due to underling roof decking and roof joist, which are not structurally in tack.**

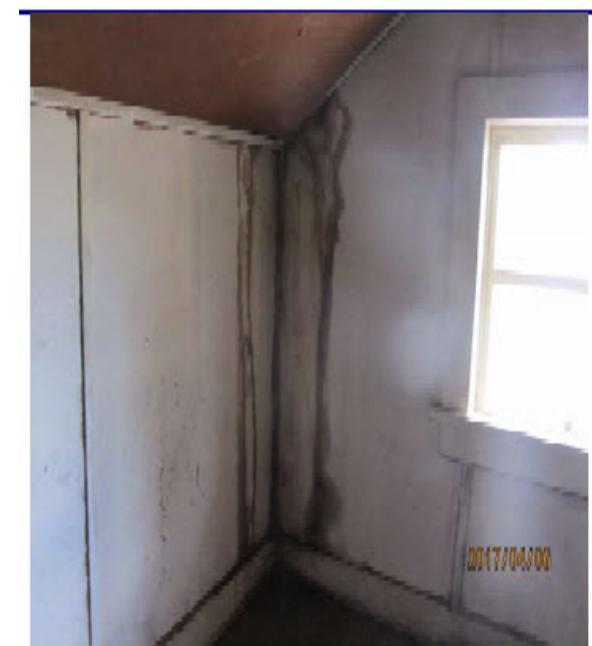
**B-7) Roofing and shingles are not draining properly causing water damage, mildew, and mold in the interior of house.**

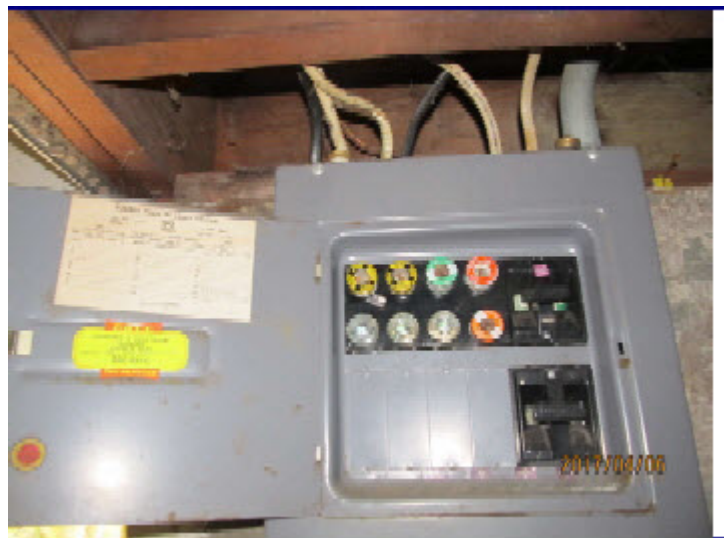
**B-11) Electrical Fuse Box is outdated and is at High Risk of causing a fire.**

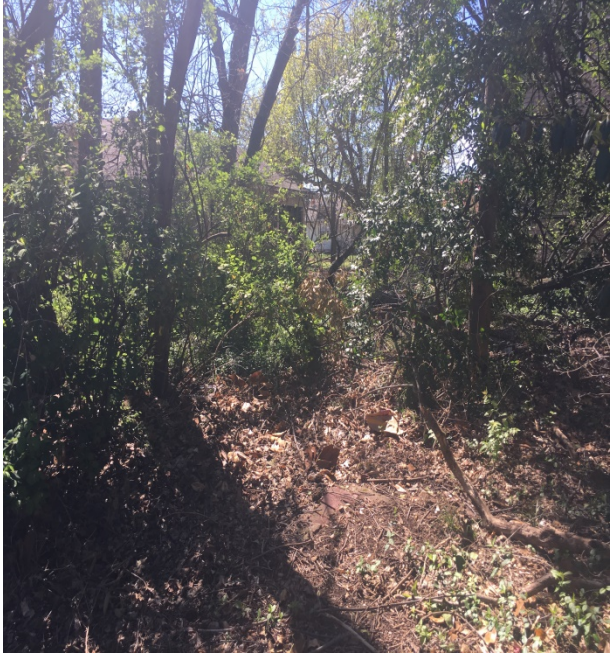
**B-16) Unwarranted vegetation and overgrow can cause critters, snakes, and other species to populate the yard.**

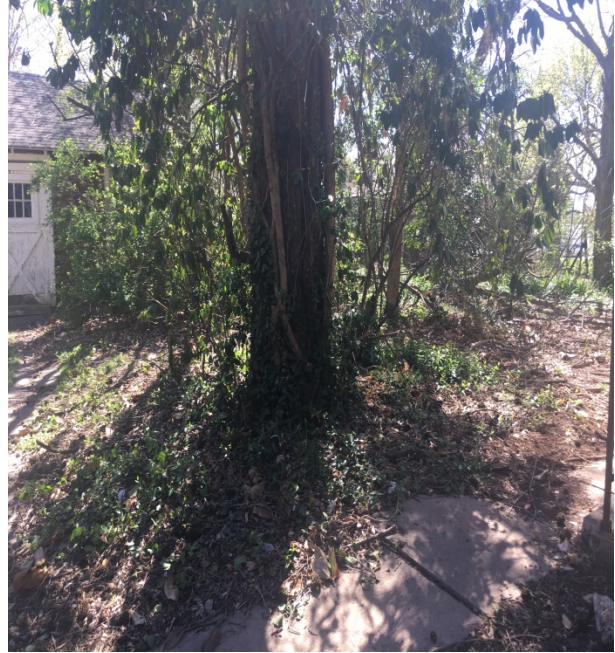
**B-17) Overgrowth of vegetation and unmaintained tree growth can cause major harm to property and human life, as limbs continually break and fall.**

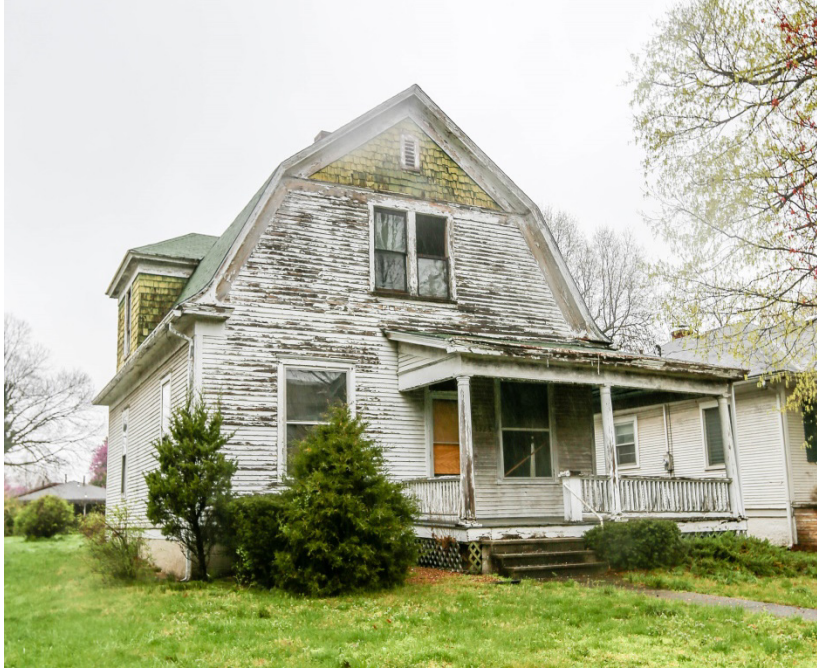
**B-1.1) Peeling old paint is prevalent around the exterior of the house trim. Houses built prior to 1978 are at High Risk of having Lead Paint, which can cause serious Health Concerns when peeling, chipping, and cracking, thus exposing the Lead dust.**

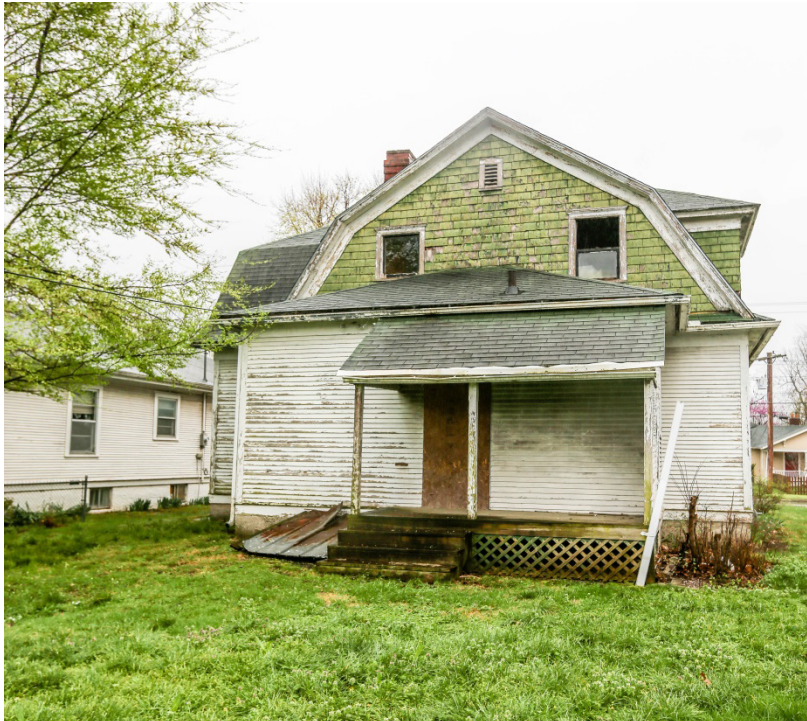
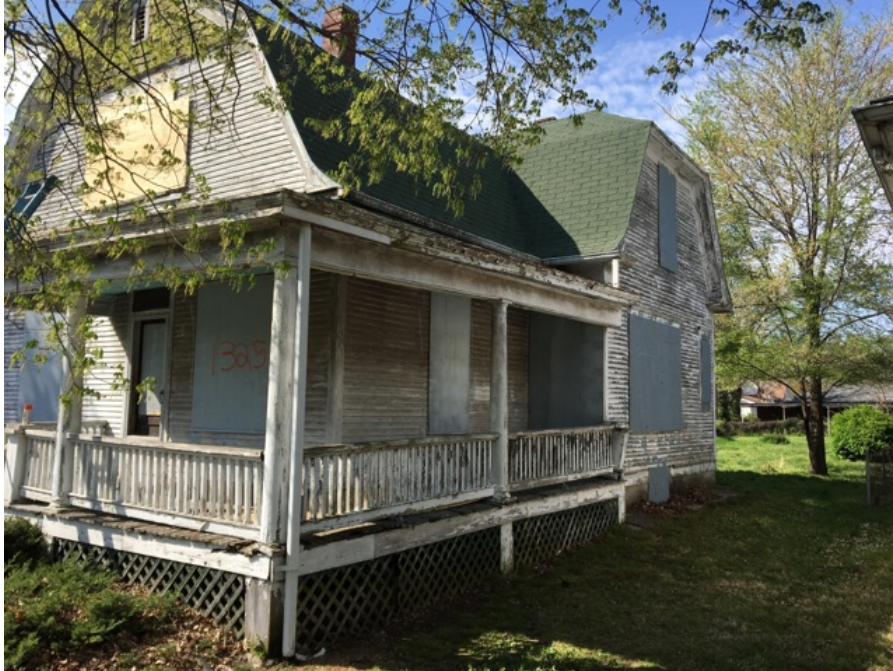
**B-1.2) Vagrants and Trespasser's have broken in and therefore the house is now in process of board up, *per city code.***

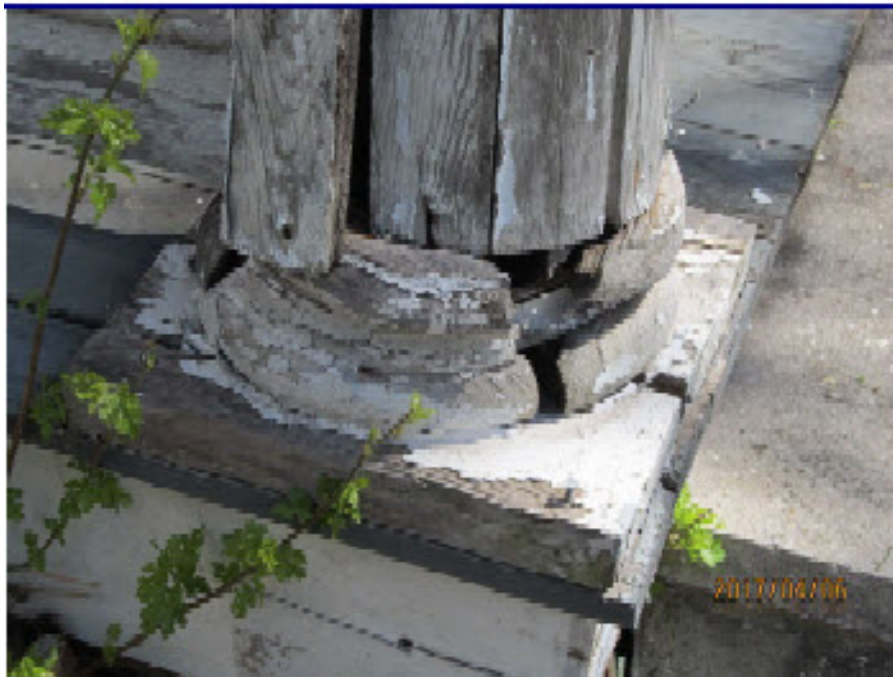
**B-1.3) Structural Columns are decaying and has caused an sever structural porch danger.**

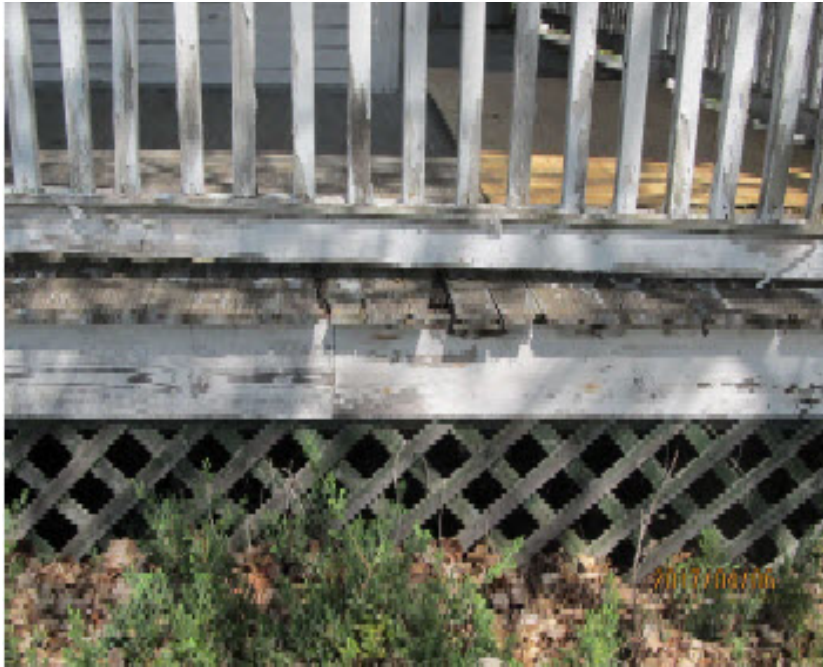
**B-1.4) Porch flooring is rotted through and dangerous to the structure falling in.**

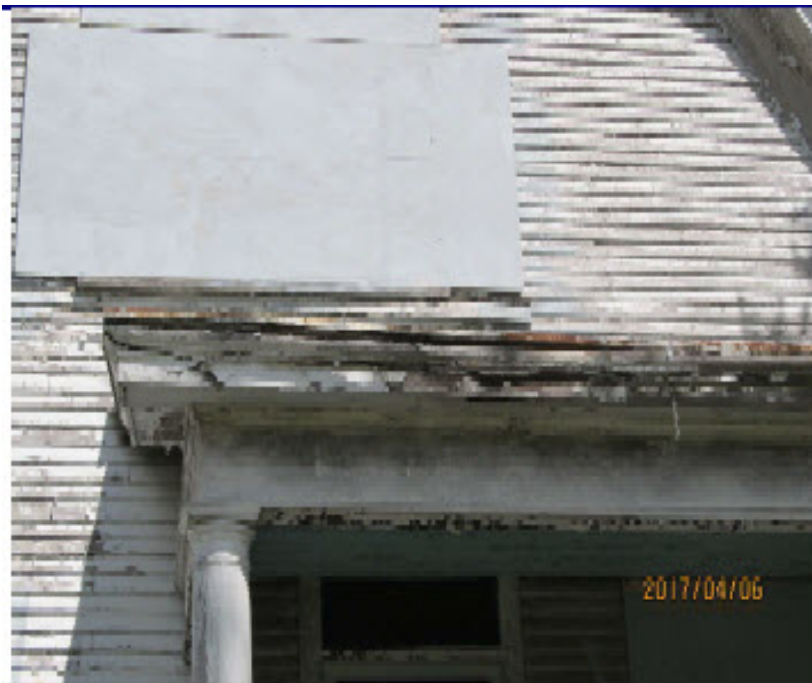
**B-1.6) Guttering around the house is deteriorating and causing water damage to soffits areas and structural damages to porch.**

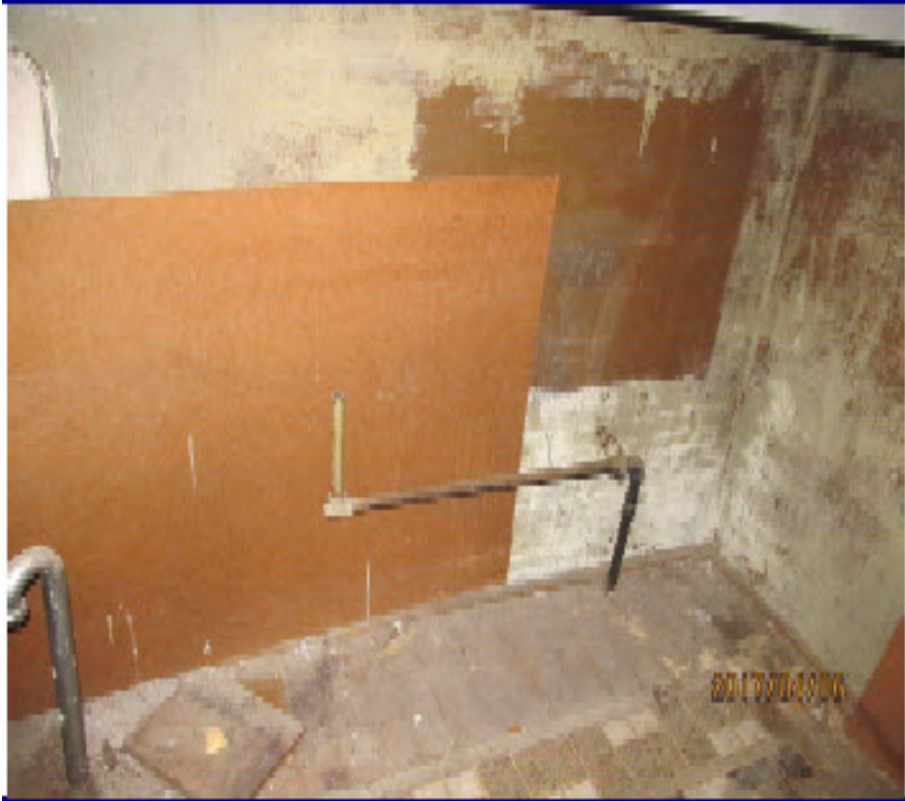
**B-1.5) The Kitchen cabinets appear to have been removed and possible stolen from the house by vagrants.**

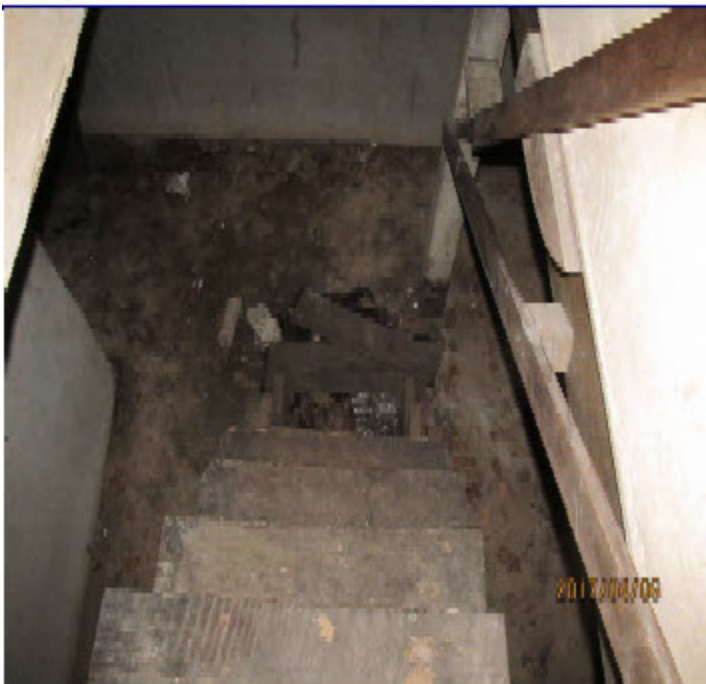
**B-1.11) Stairs going to basement are unsafe due to missing treads and rotten through at the bottom of stairs.**

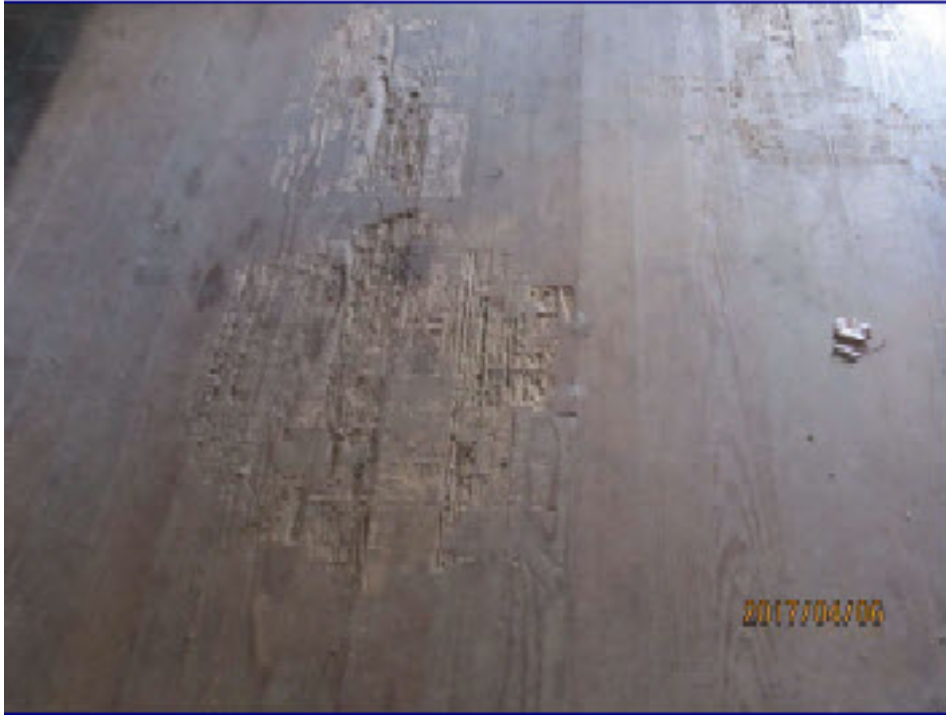
**B-1.12) Termites have caused structural damages in the flooring and wood framing structure.**

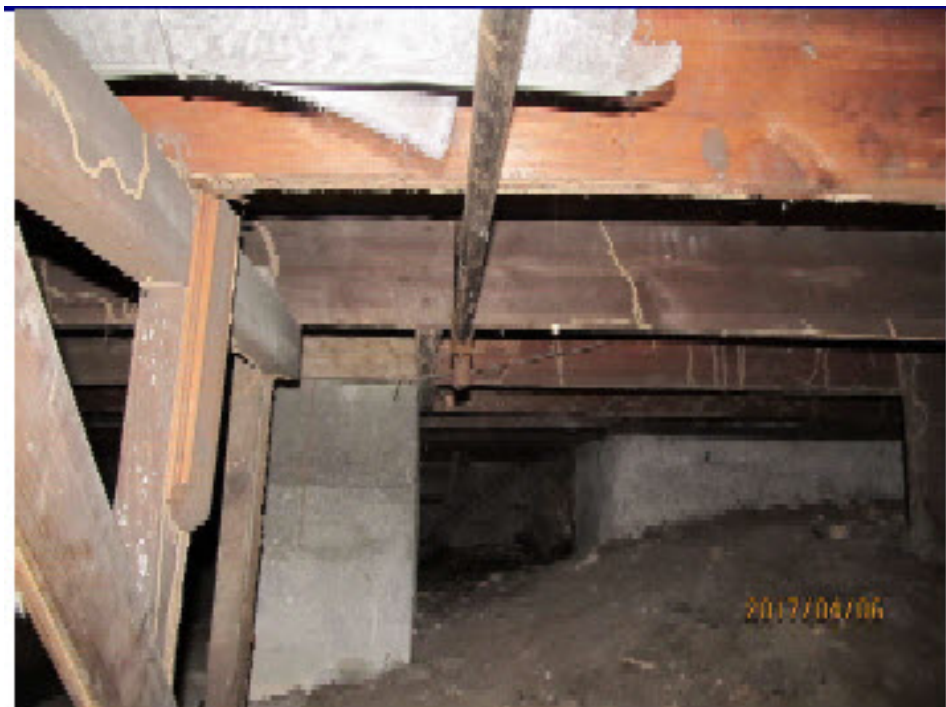
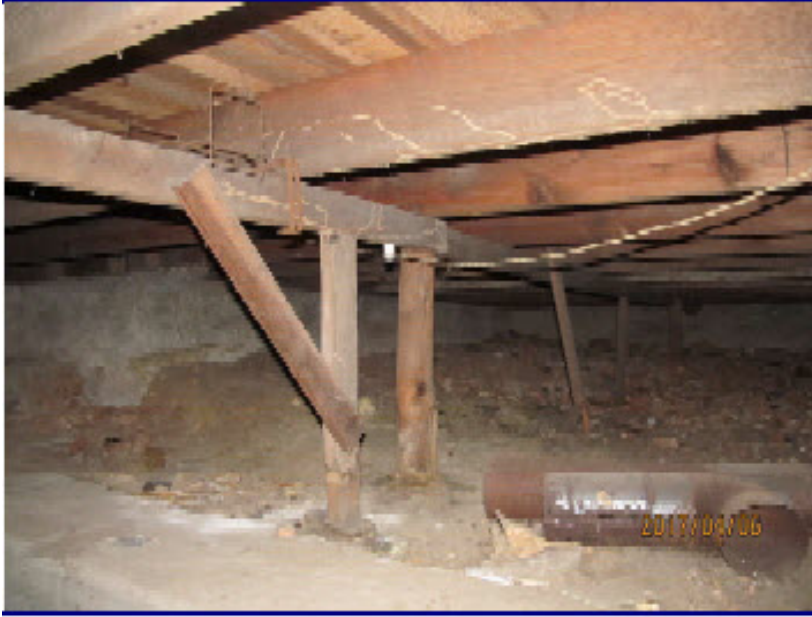
**B-1.13) Girders and structural beams are undersized for weight of existing structure.**

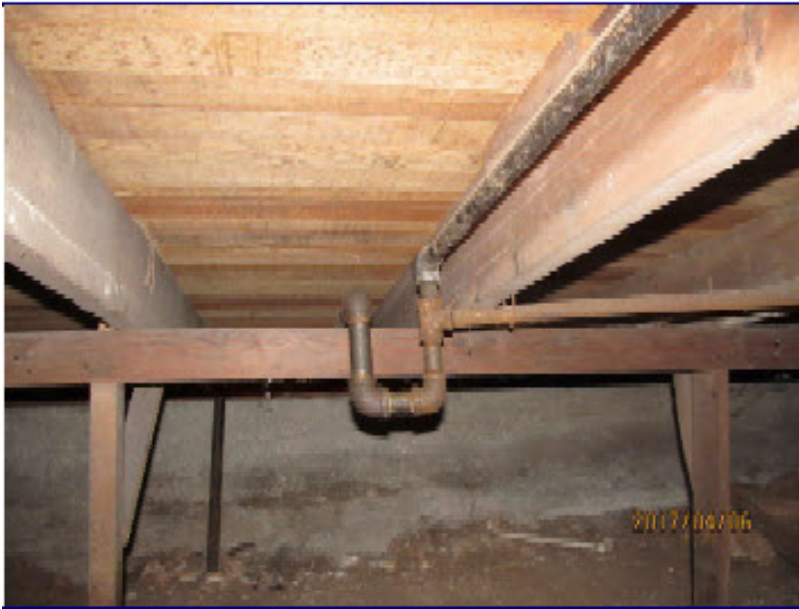
**B-1.14) Metal Gas piping is corrosive and may be leaking gas into the house.**

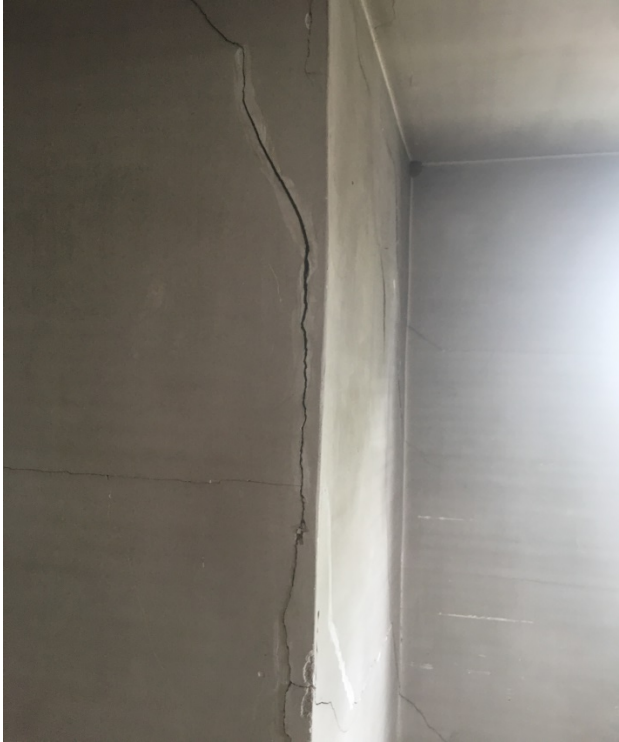
**B-1.15) Structural cracks and structural issues are seen throughout the house.**

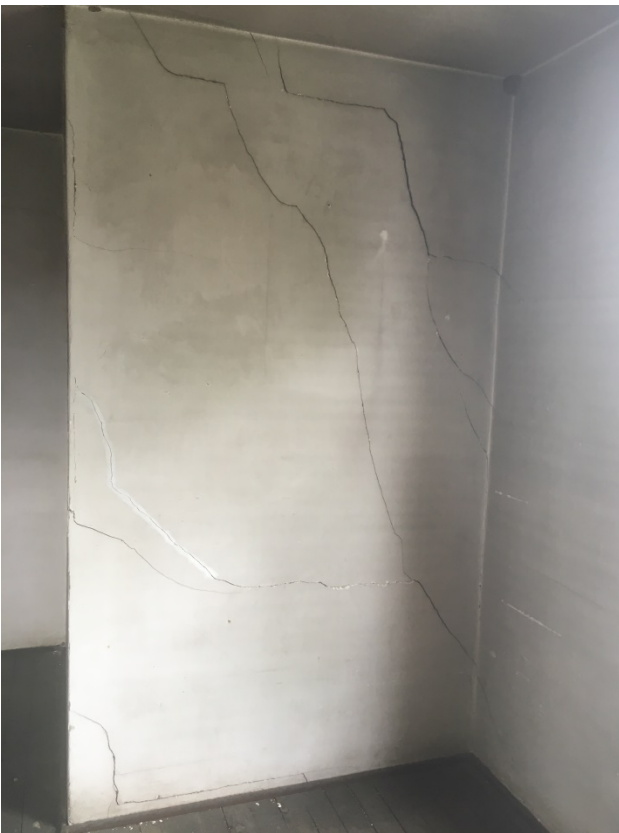
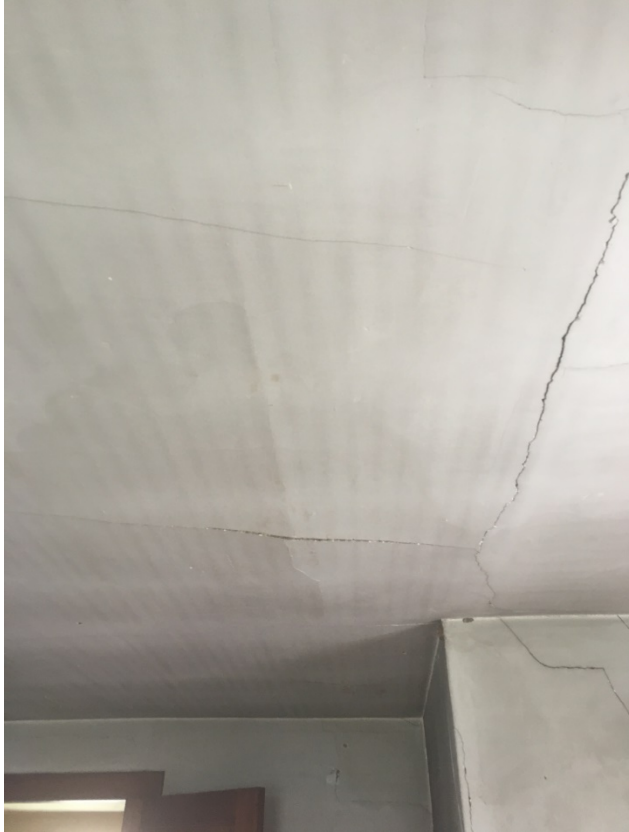
**B-1.16) Structural cracks and structural issues are seen throughout the house.**

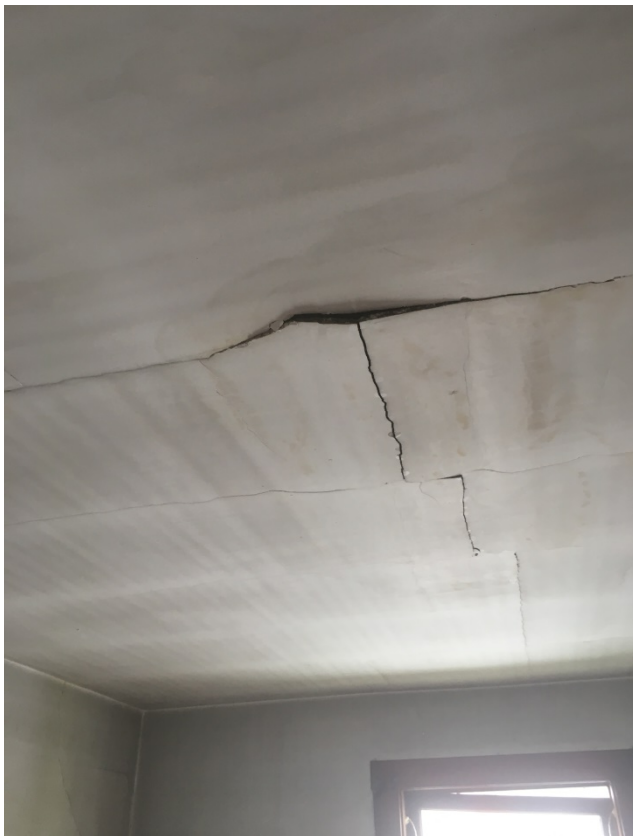
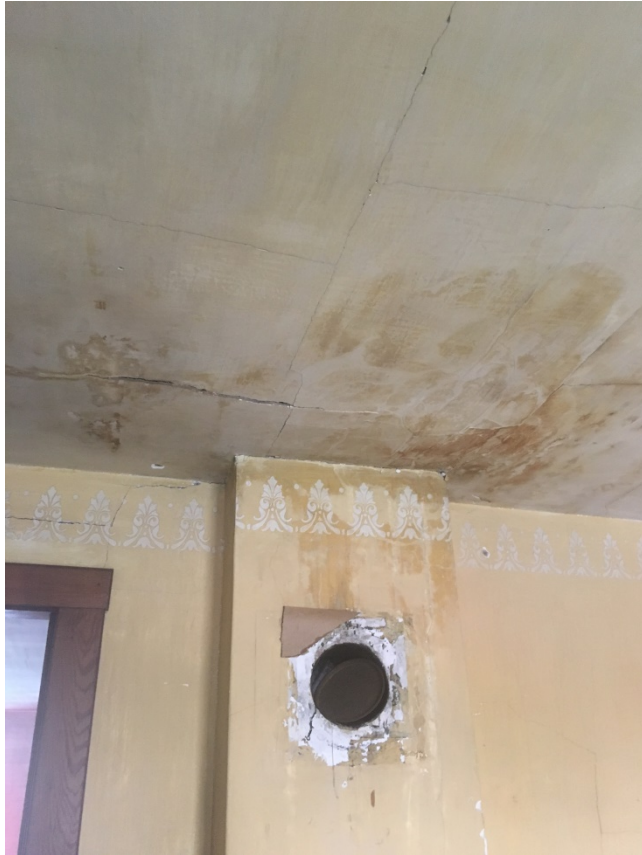
**B1.17) Dilapidated roofing has caused major interior damages traveling down through both floors.**

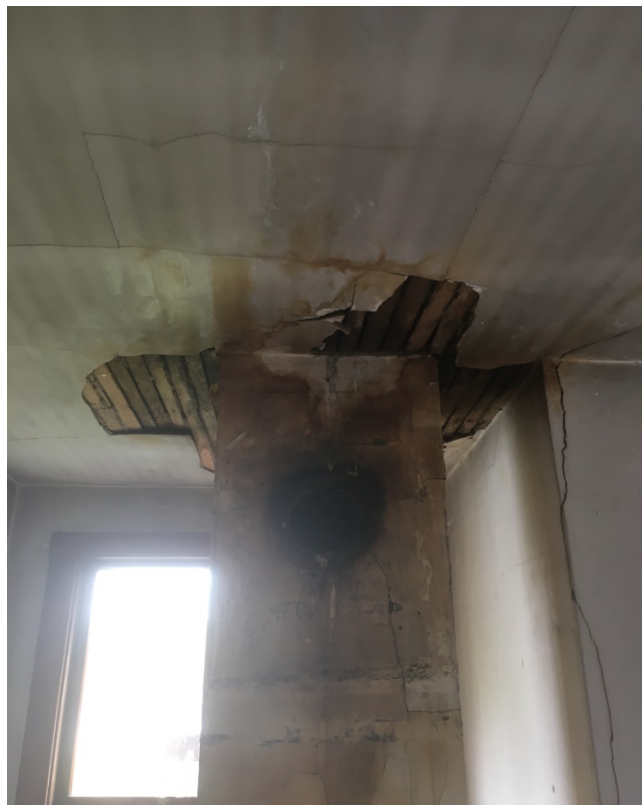
**B-1.18) Dilapidated roofing has caused major interior damages around the fireplace.**

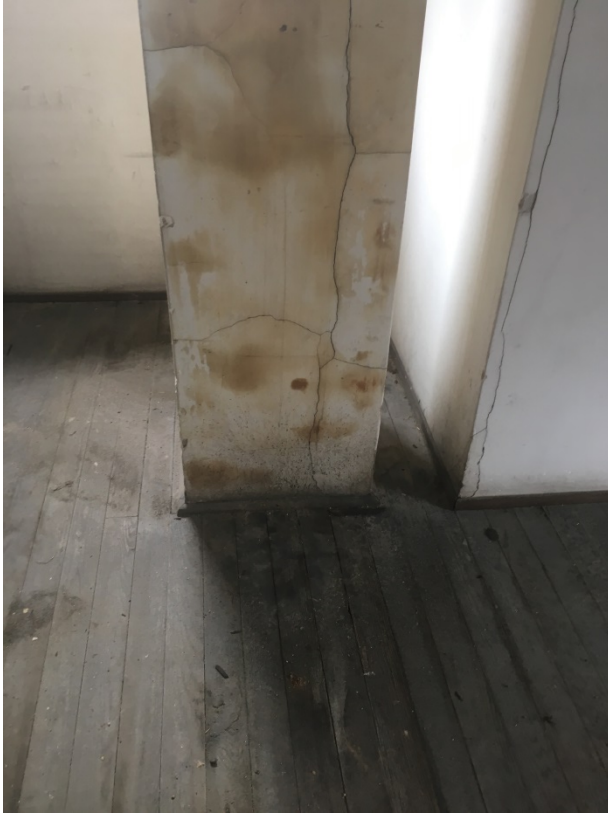
**B-1.19) Dilapidated roofing has caused major interior damages traveling down through both floors.**

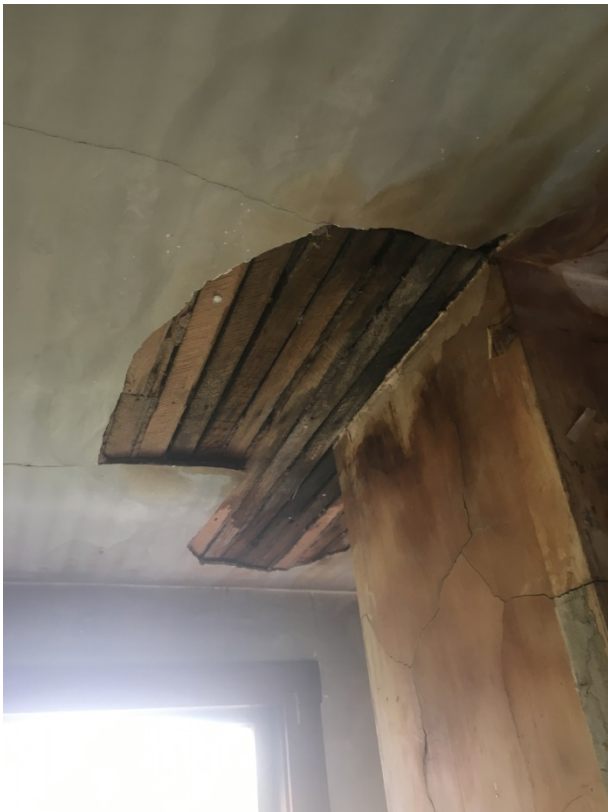
**B-1.20) Dilapidated roofing has caused major interior damages around the fireplace.**

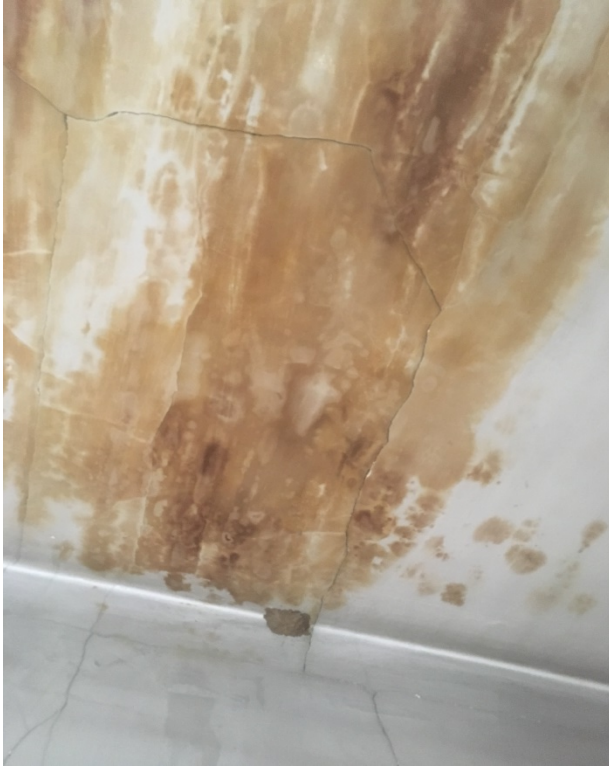
**B-1.21) Dilapidated roofing has caused major interior damages to the structure and ceilings**

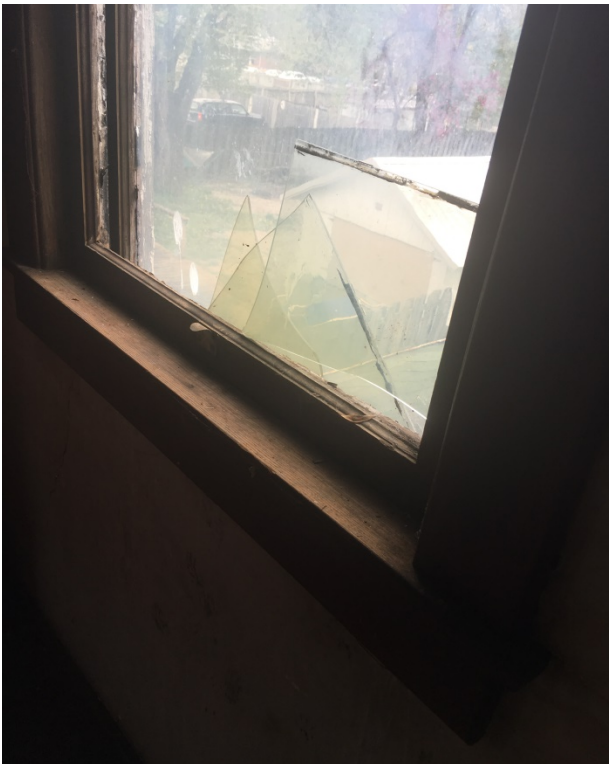
**B-1.22) Broken windows and missing window sashes allow weather and vagrants into the house.**

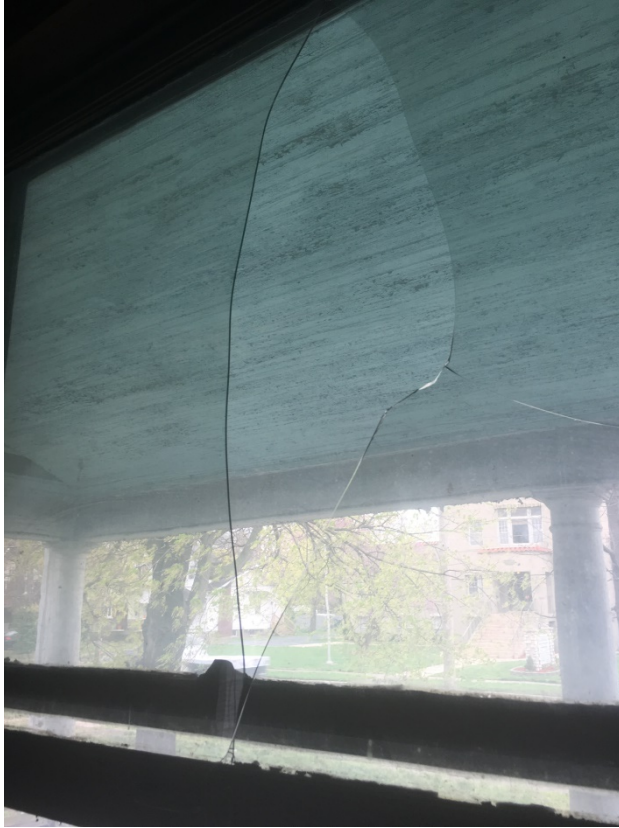
**B-1.23) Broken windows and missing window sashes allow weather and vagrants into the house.**

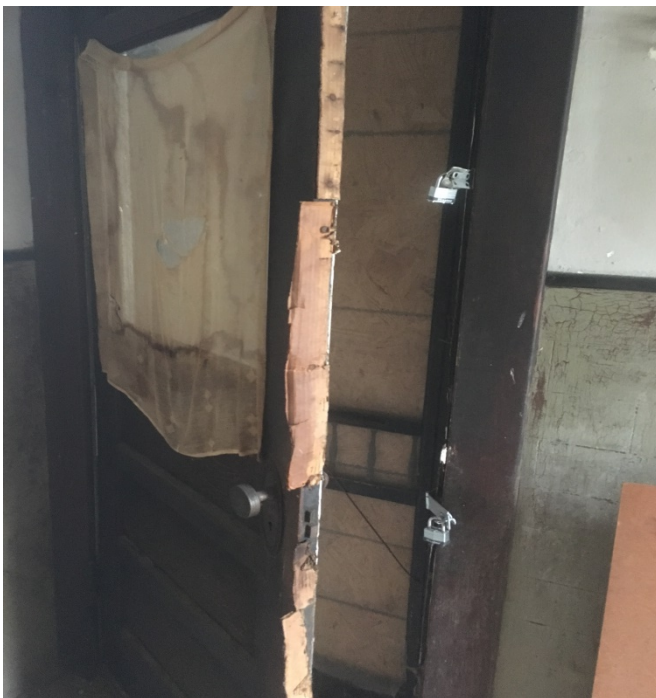
**B-1.24) Vagrants and Trespasser's have broken in and therefore the house is now in process of board up, *per city code*.**

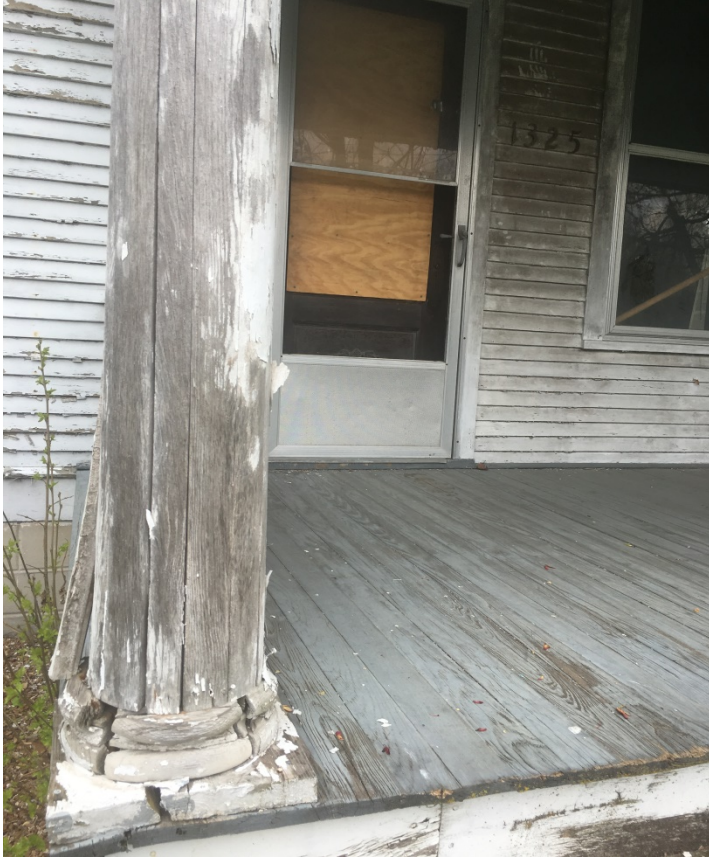
**B-1.25) Structural Columns are decaying and has caused an sever structural porch danger.**

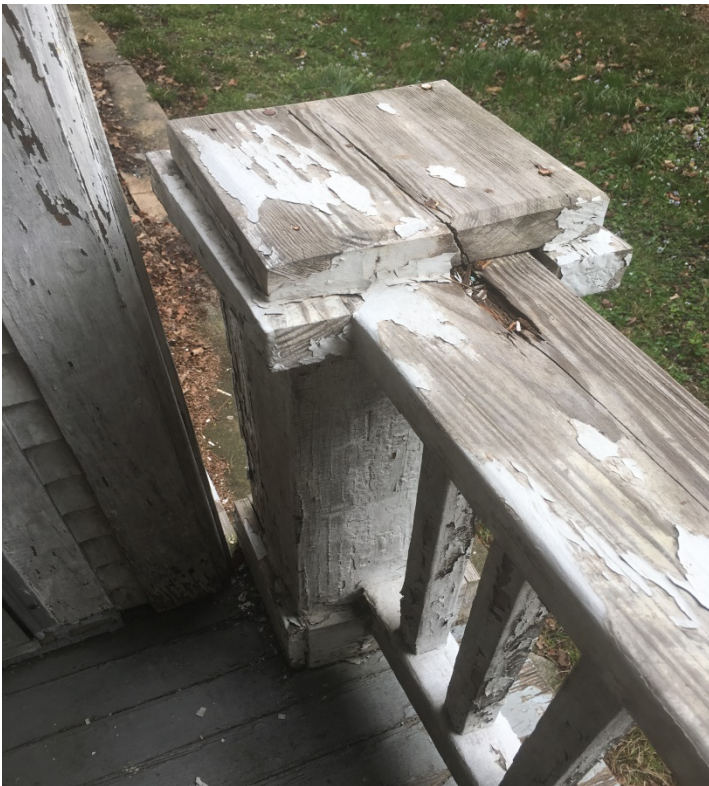
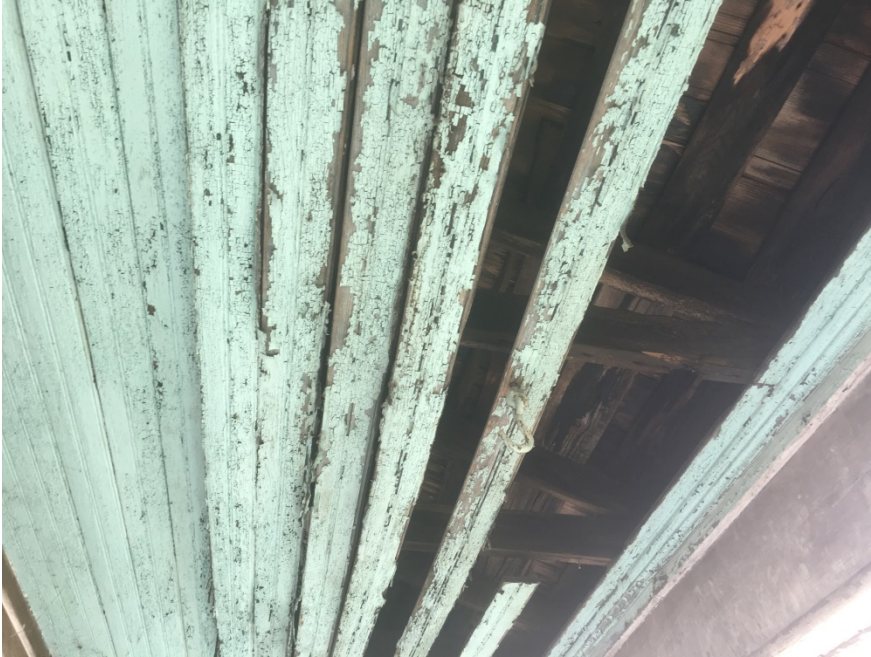
**B-1.26) Missing porch ceiling can welcome unwanted critters, snakes and wasp into the house.**

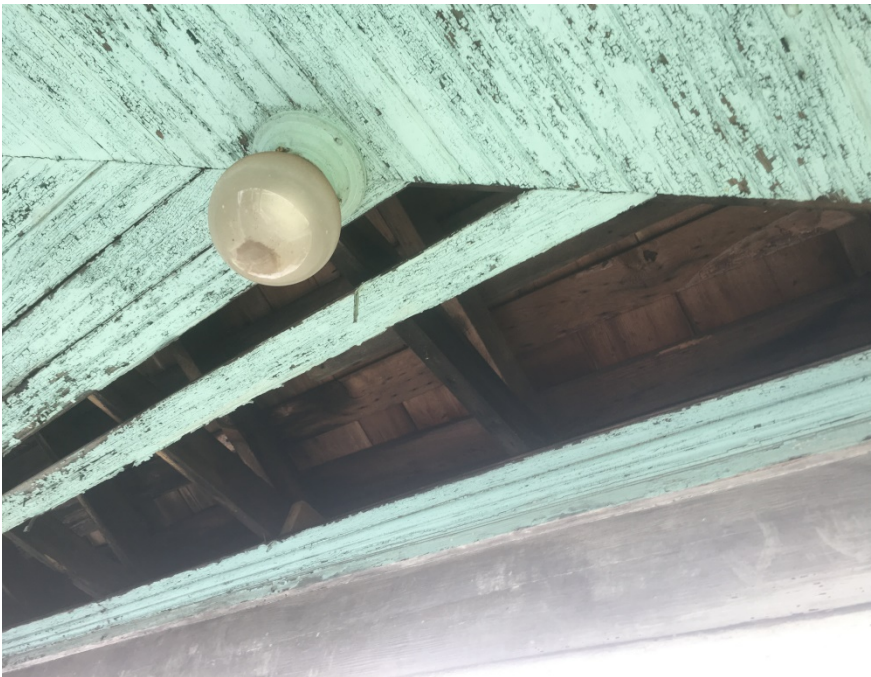
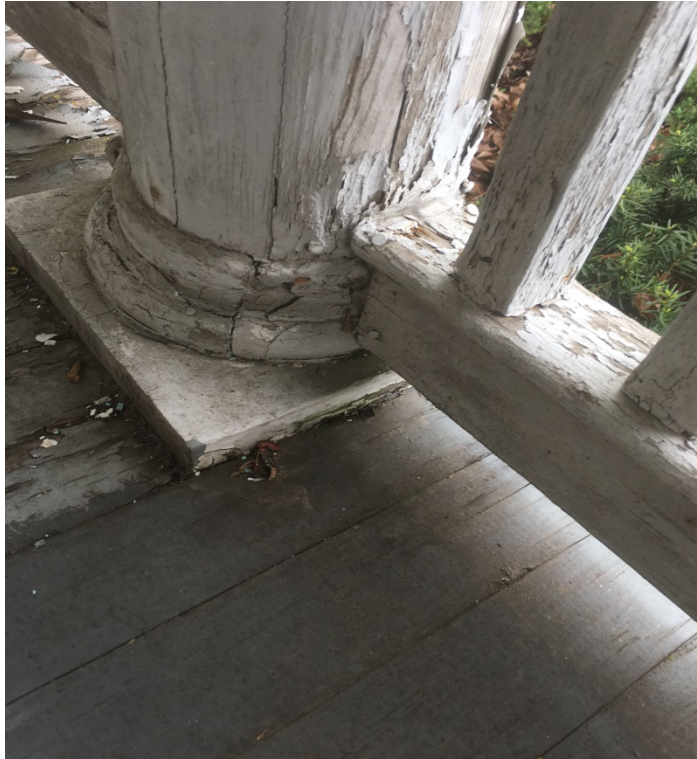
**B-1.27) Structural Columns are decaying and has caused an sever structural porch danger.**

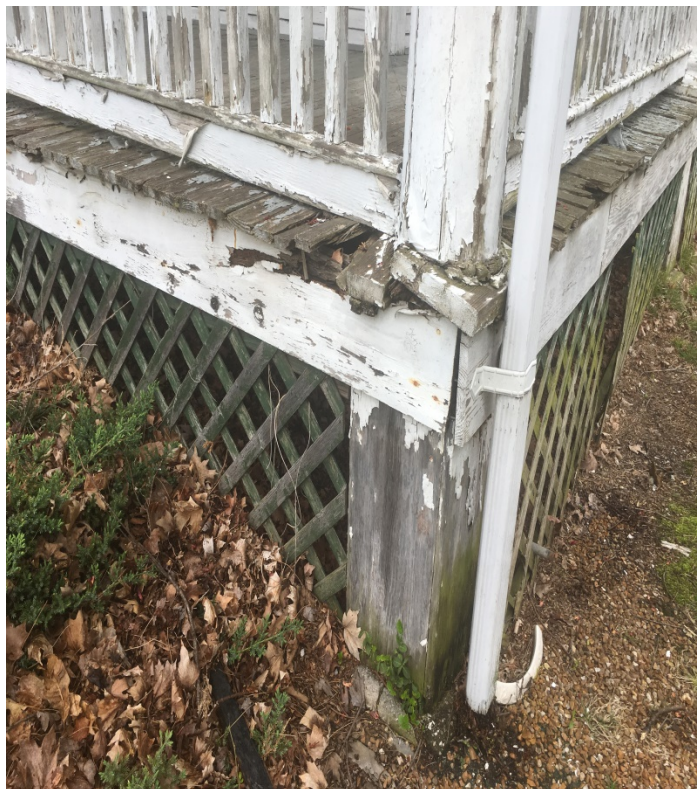
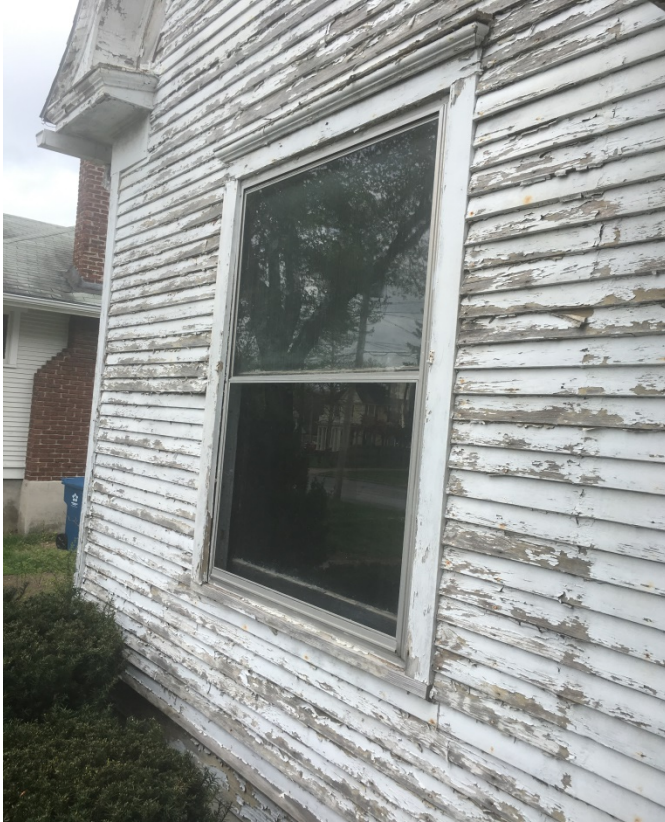
**B-1.28) Peeling old paint is prevalent around the exterior of the house trim. Houses built prior to 1978 are at High Risk of having Lead Paint, which can cause serious Health Concerns when peeling, chipping, and cracking, thus exposing the Lead dust.**

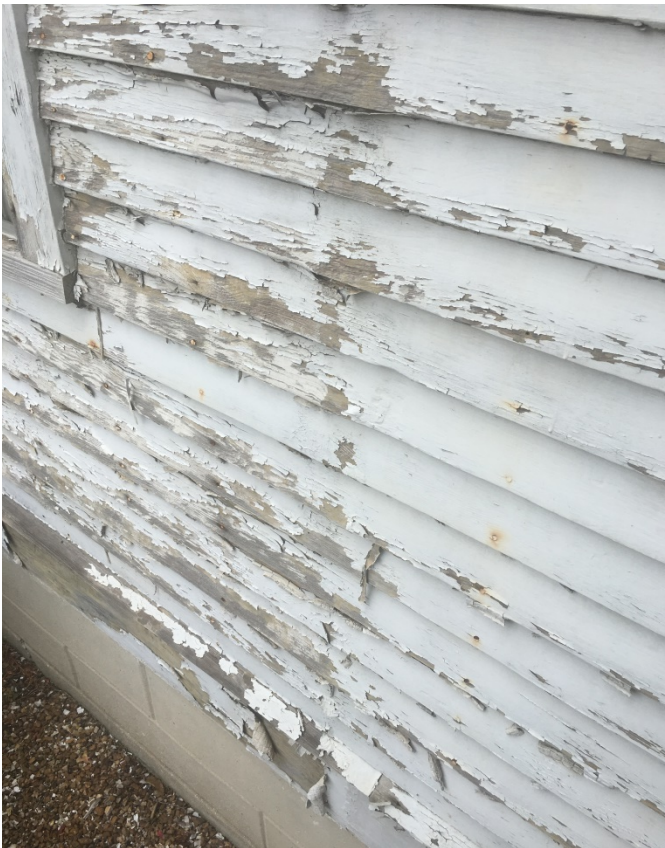
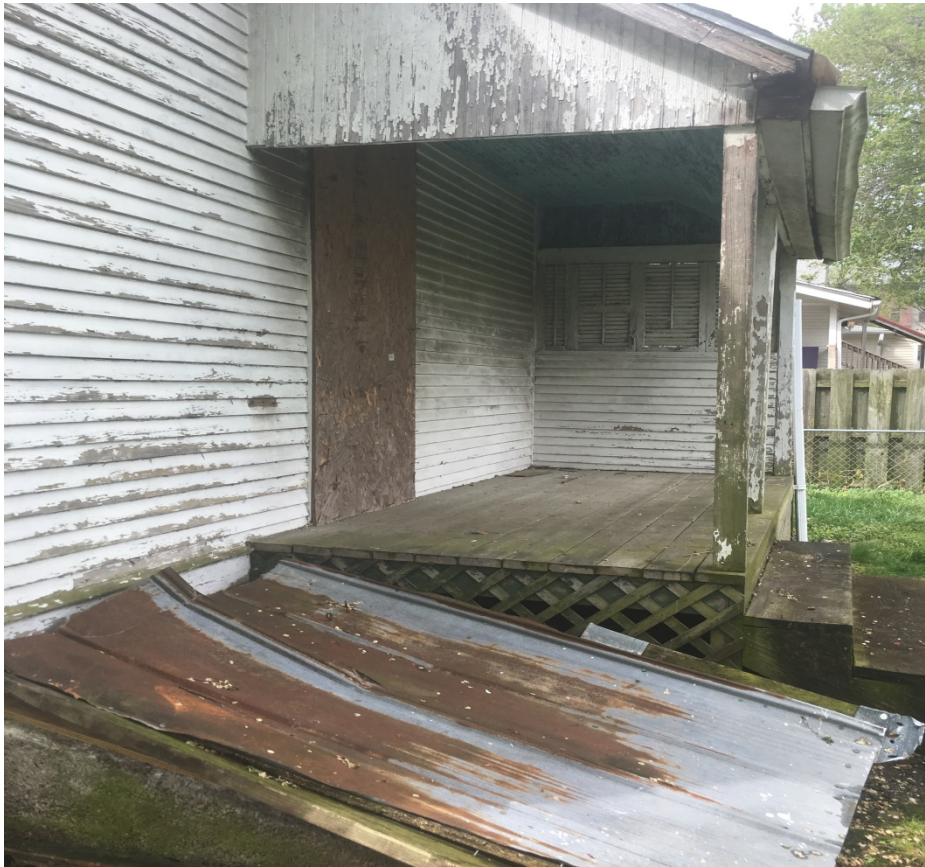
**B-1.29) Vagrants and Trespasser's have broken in and therefore the house is now in process of board up, *per city code.***

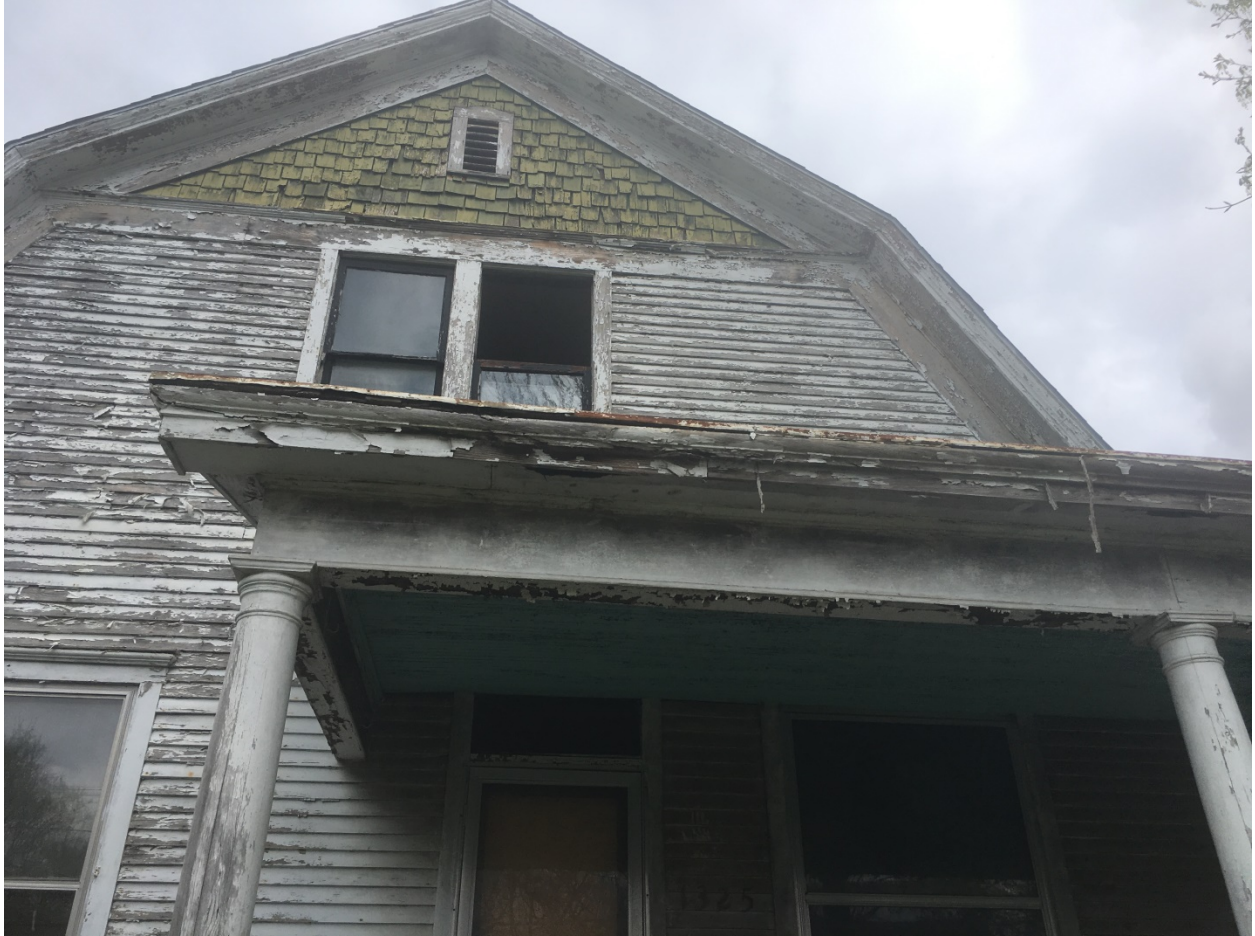
**B-1.30) Guttering around the house is deteriorating and causing water damage to soffits areas and interior mildew.**
