*SPRINGFIELD LAND CLEARANCE FOR REDEVELOPMENT AUTHORITY*

*Tuesday, July 11, 2017 at 4:00 p.m.*

**4.II. Blight Report And Redevelopment Plan For The 1325/1329 East Cherry Redevelopment Area, Located At 1325 East Cherry Street; Roza Capital Group, LLC, Applicant**

**EXHIBIT B**  
**PICTURES OF THE BLIGHTING CONDITIONS**

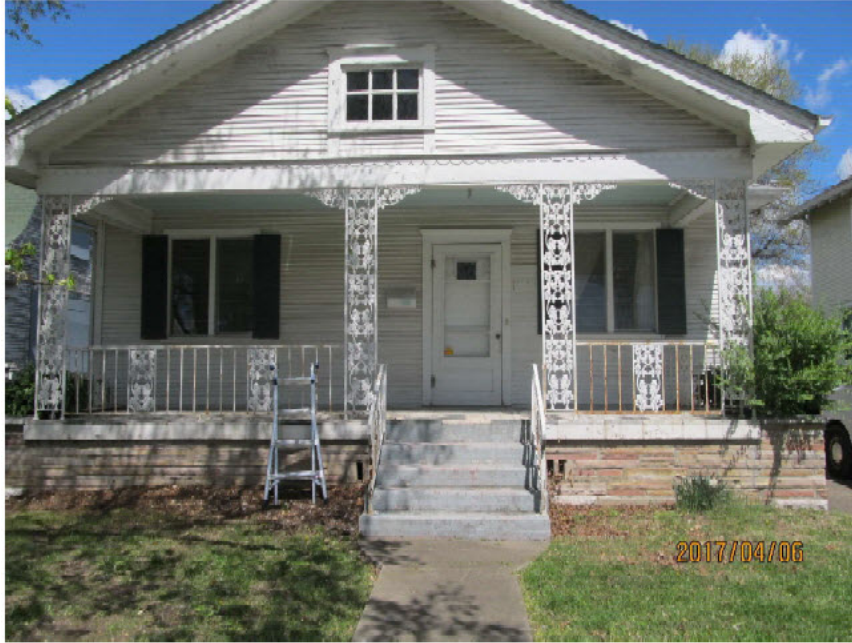
**B-2.1) Vagrants and Trespasser's have broken in and therefore the house is now in process of board up, *per city***

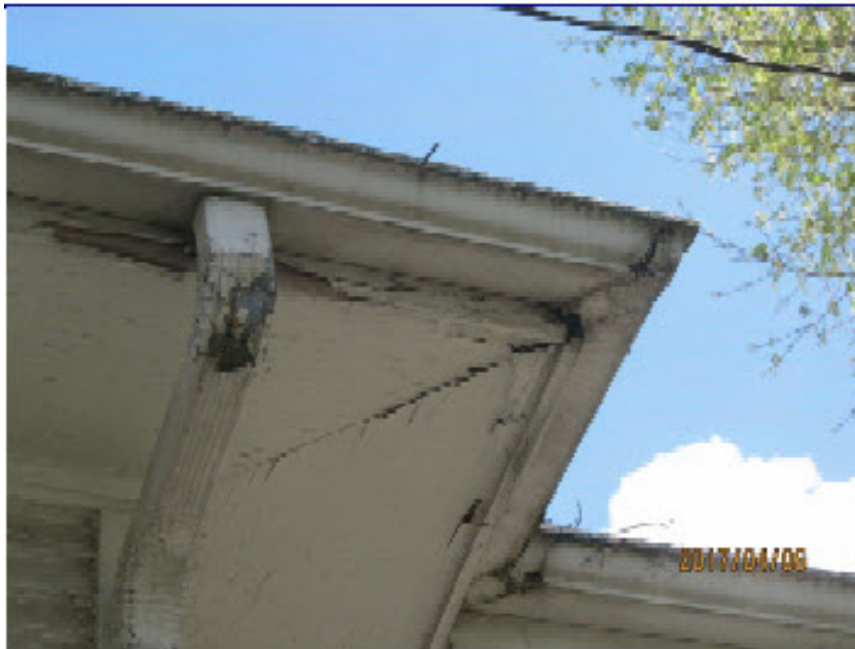
**B-2.2) Guttering around the house is deteriorating and causing water damage to soffits areas and interior mildew.**

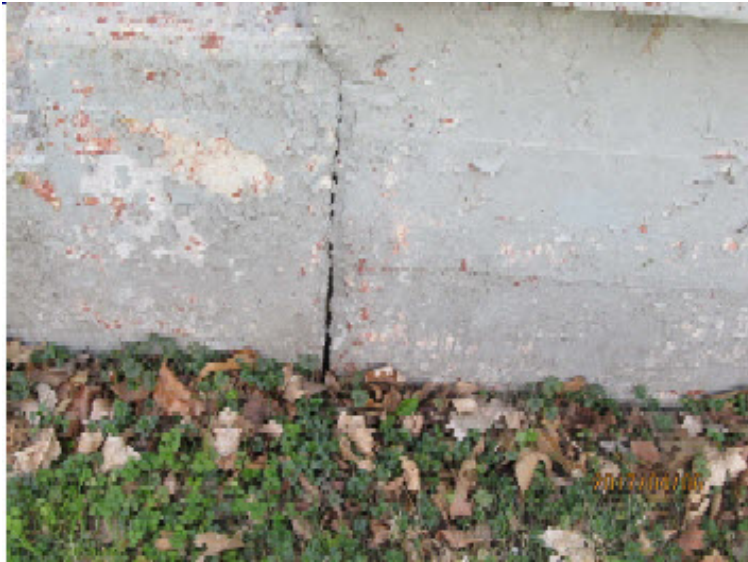
**B-2.3) Cracks in the foundation are causing structural issues.**

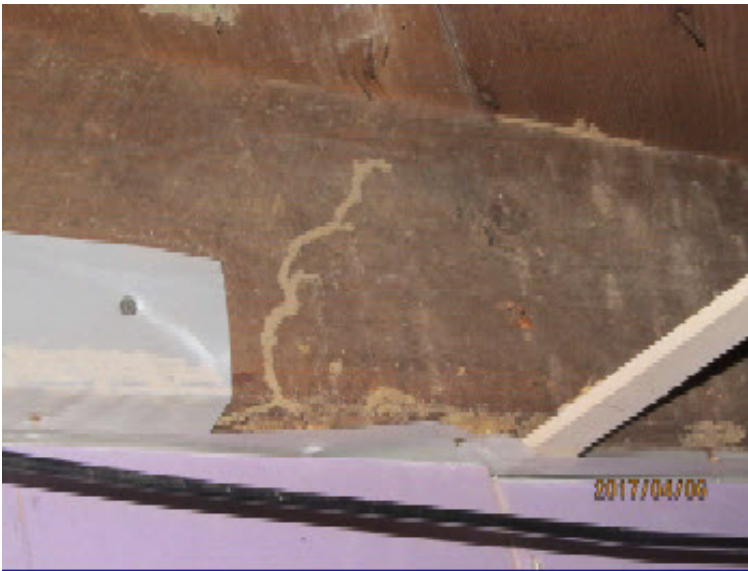
**B-2.4) Termites have caused structural damages in the flooring and wood framing structure.**

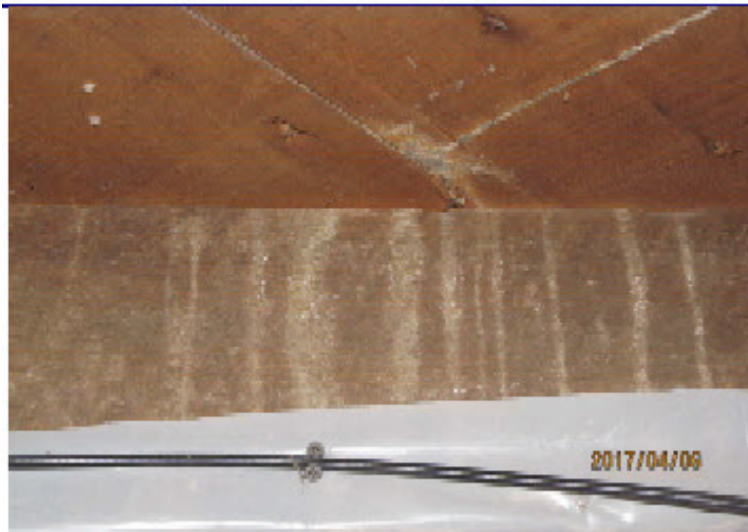
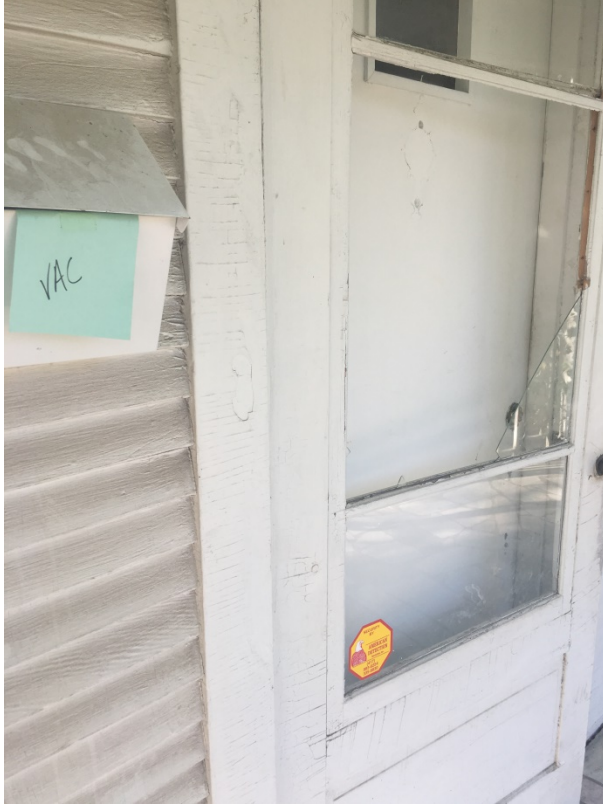
**B-2.5) Vagrants and Trespasser's have broken in and therefore the house is now in process of board up, *per city code.***

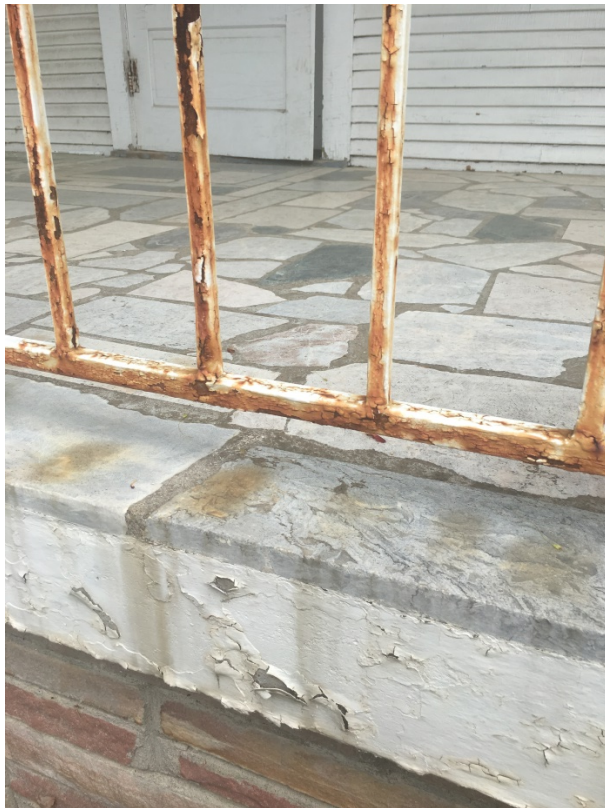
**B-2.6) Structural Columns are decaying and has caused an sever structural porch danger.**

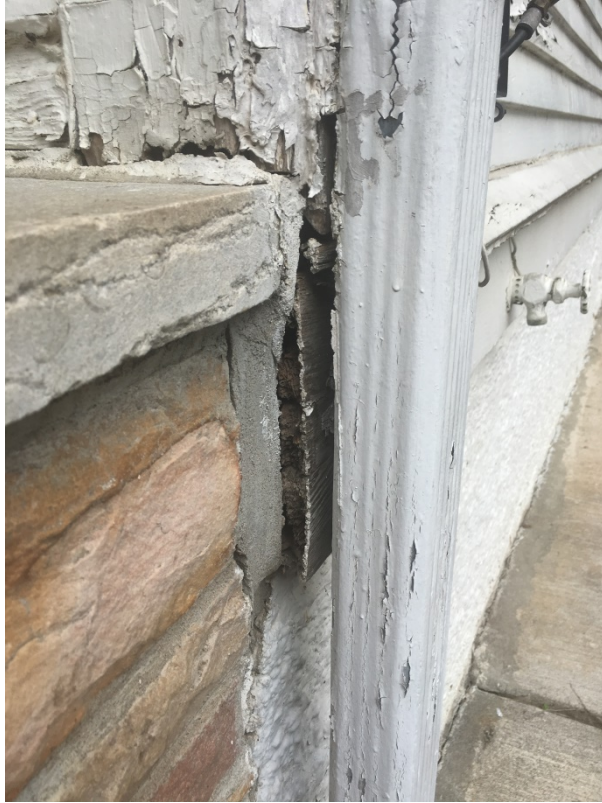
**B-2.7) Cracks in the foundation are causing structural issues causing the rim joist to fall off the foundation wall.**

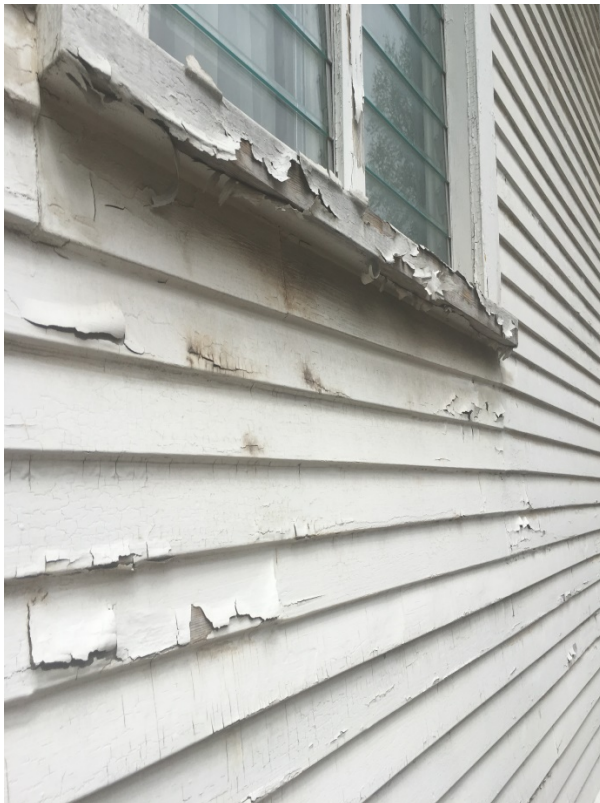
**B-2.8) Peeling old paint is prevalent around the exterior of the house trim. Houses built prior to 1978 are at High Risk of having Lead Paint, which can cause serious Health Concerns when peeling, chipping, and cracking, thus exposing the Lead dust.**

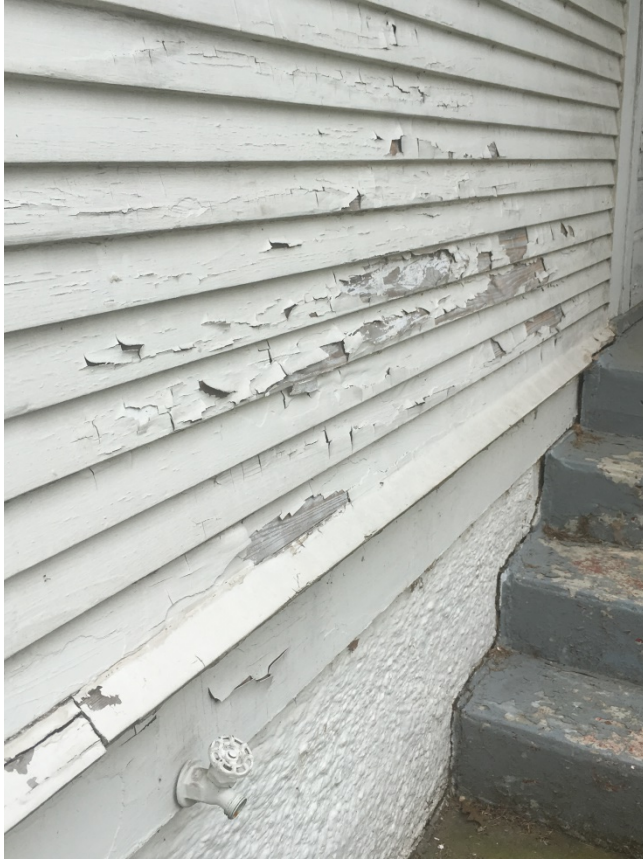
**B-2.9) Peeling old paint is prevalent around the exterior of the house trim. Houses built prior to 1978 are at High Risk of having Lead Paint, which can cause serious Health Concerns when peeling, chipping, and cracking, thus exposing the Lead dust.**

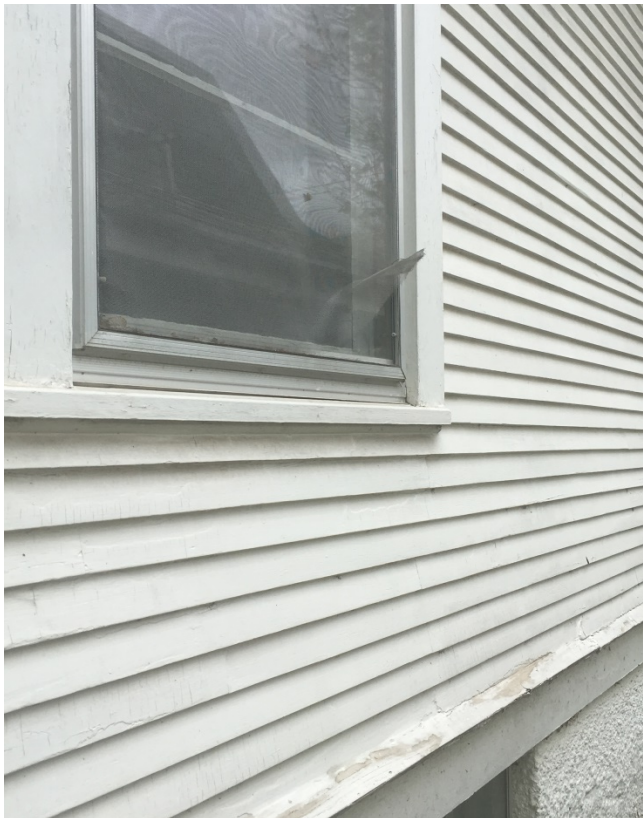
**B-2.10) Broken windows and missing window sashes allow weather and vagrants into the house.**

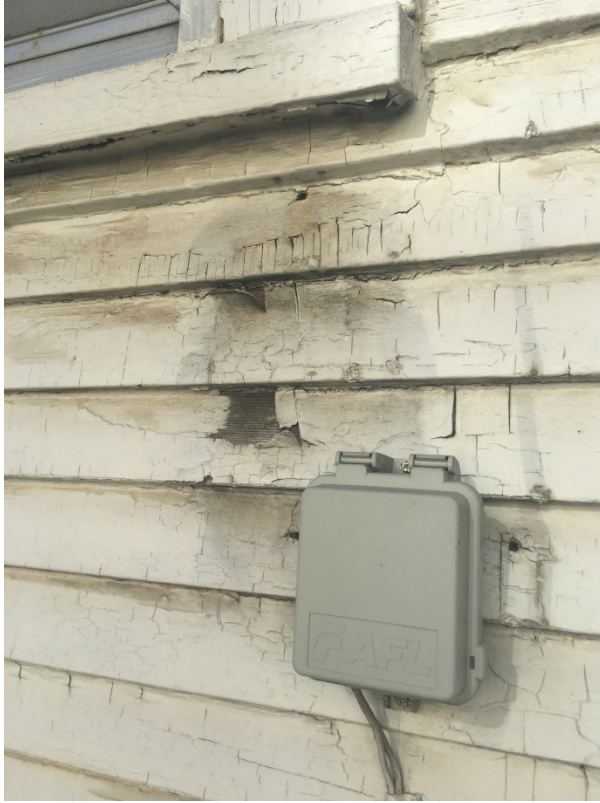
**B-2.11) Signs for Mildew and Mold are appearing on window sills and can cause health hazards.**

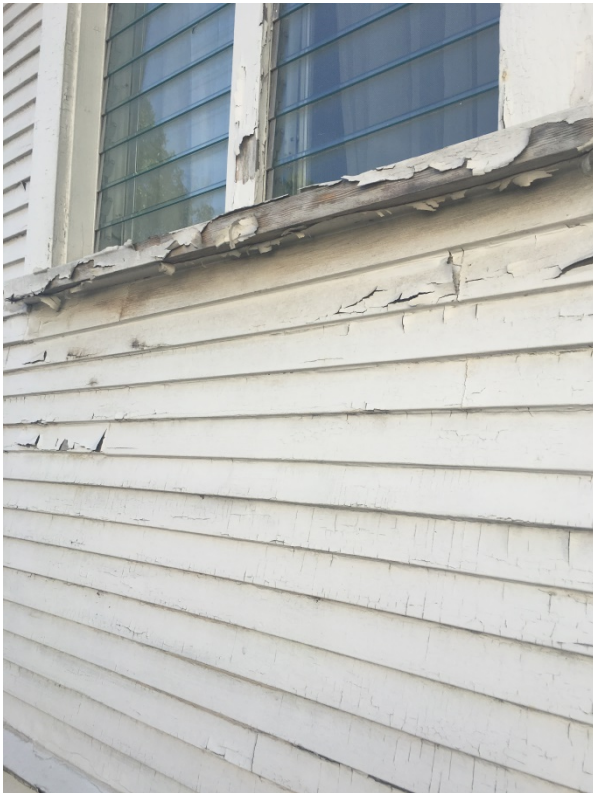
**B-2.12) Peeling old paint is prevalent around the exterior of the house trim. Houses built prior to 1978 are at High Risk of having Lead Paint, which can cause serious Health Concerns when peeling, chipping, and cracking, thus exposing the Lead dust.**

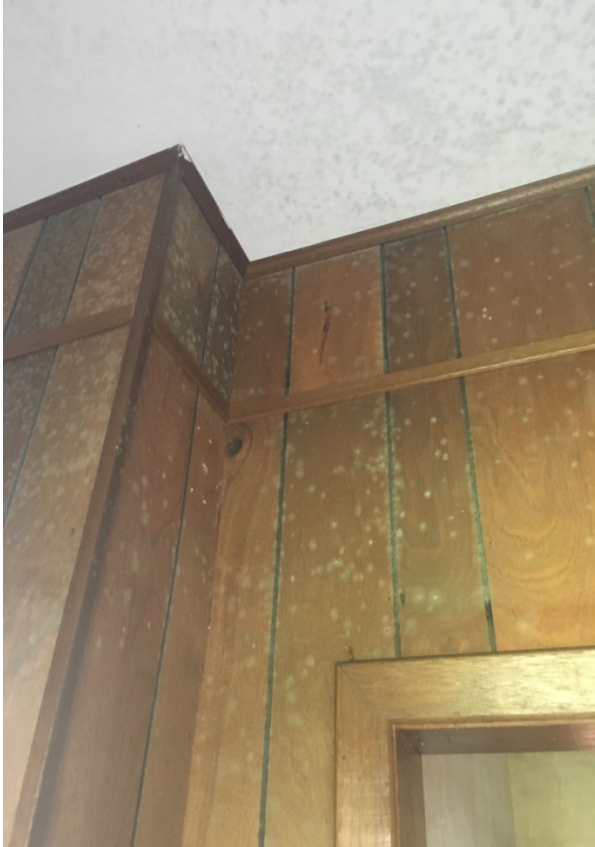
**B-2.13) Signs for Mildew and Mold are appearing on all interior walls and ceilings and can cause health hazards.**

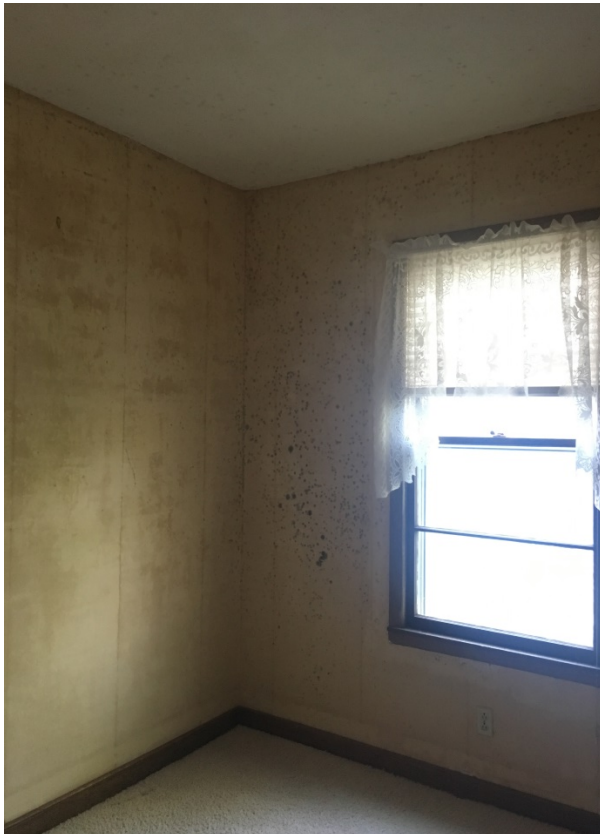
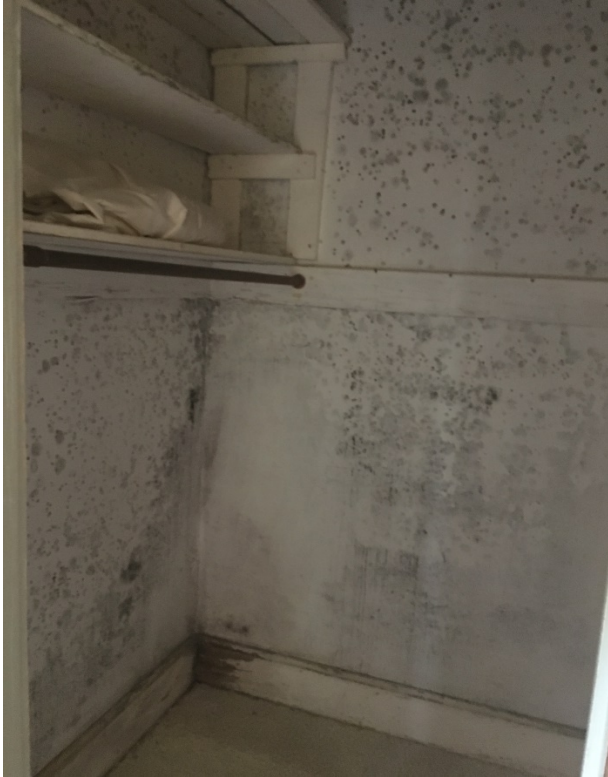
**B-2.14) Signs for Mildew and Mold are appearing in the closets can cause health hazards.**

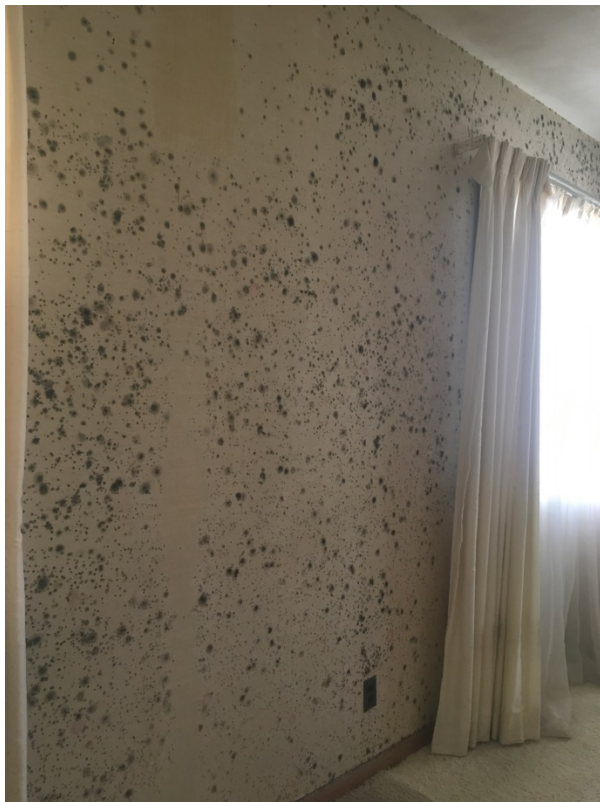
**B-2.15) Signs for Mildew and Mold are appearing on all interior walls and ceilings and can cause health hazards.**

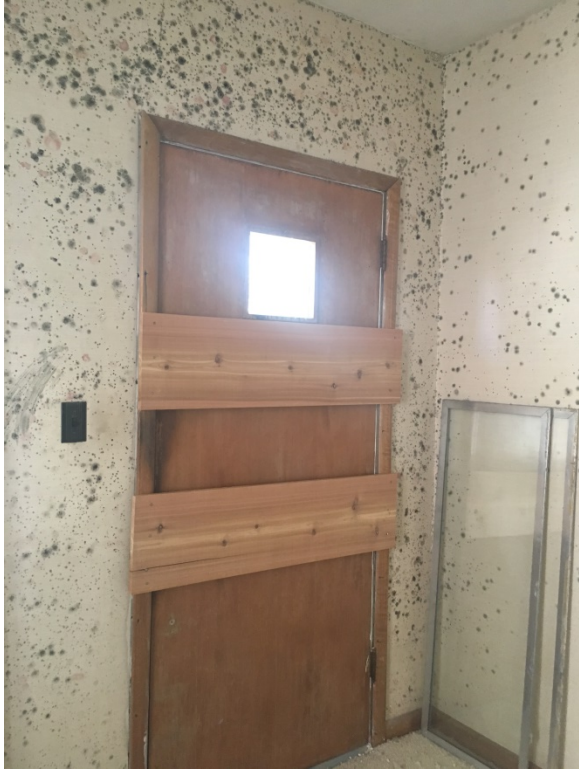
**B-2.16) Signs for Mildew and Mold are appearing on all interior walls and ceilings and can cause health hazards.**

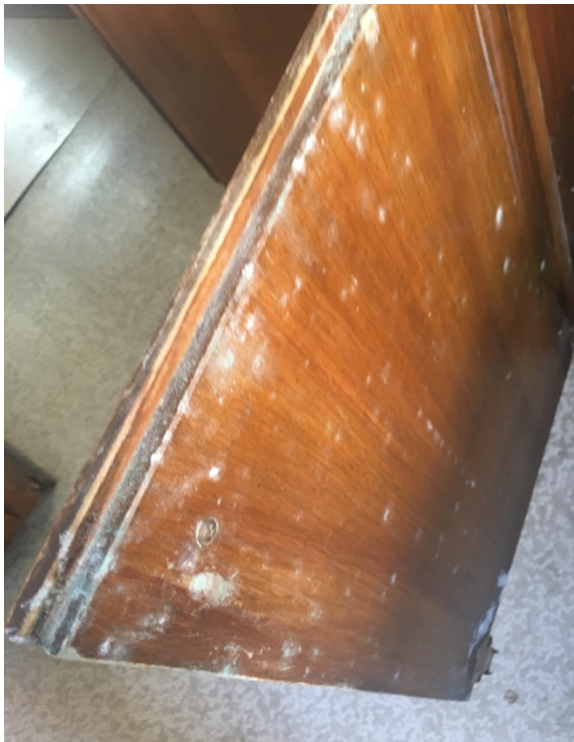
**B-2.17) Signs for Mildew and Mold are appearing on all cabinets and in the pantry can cause health hazards.**

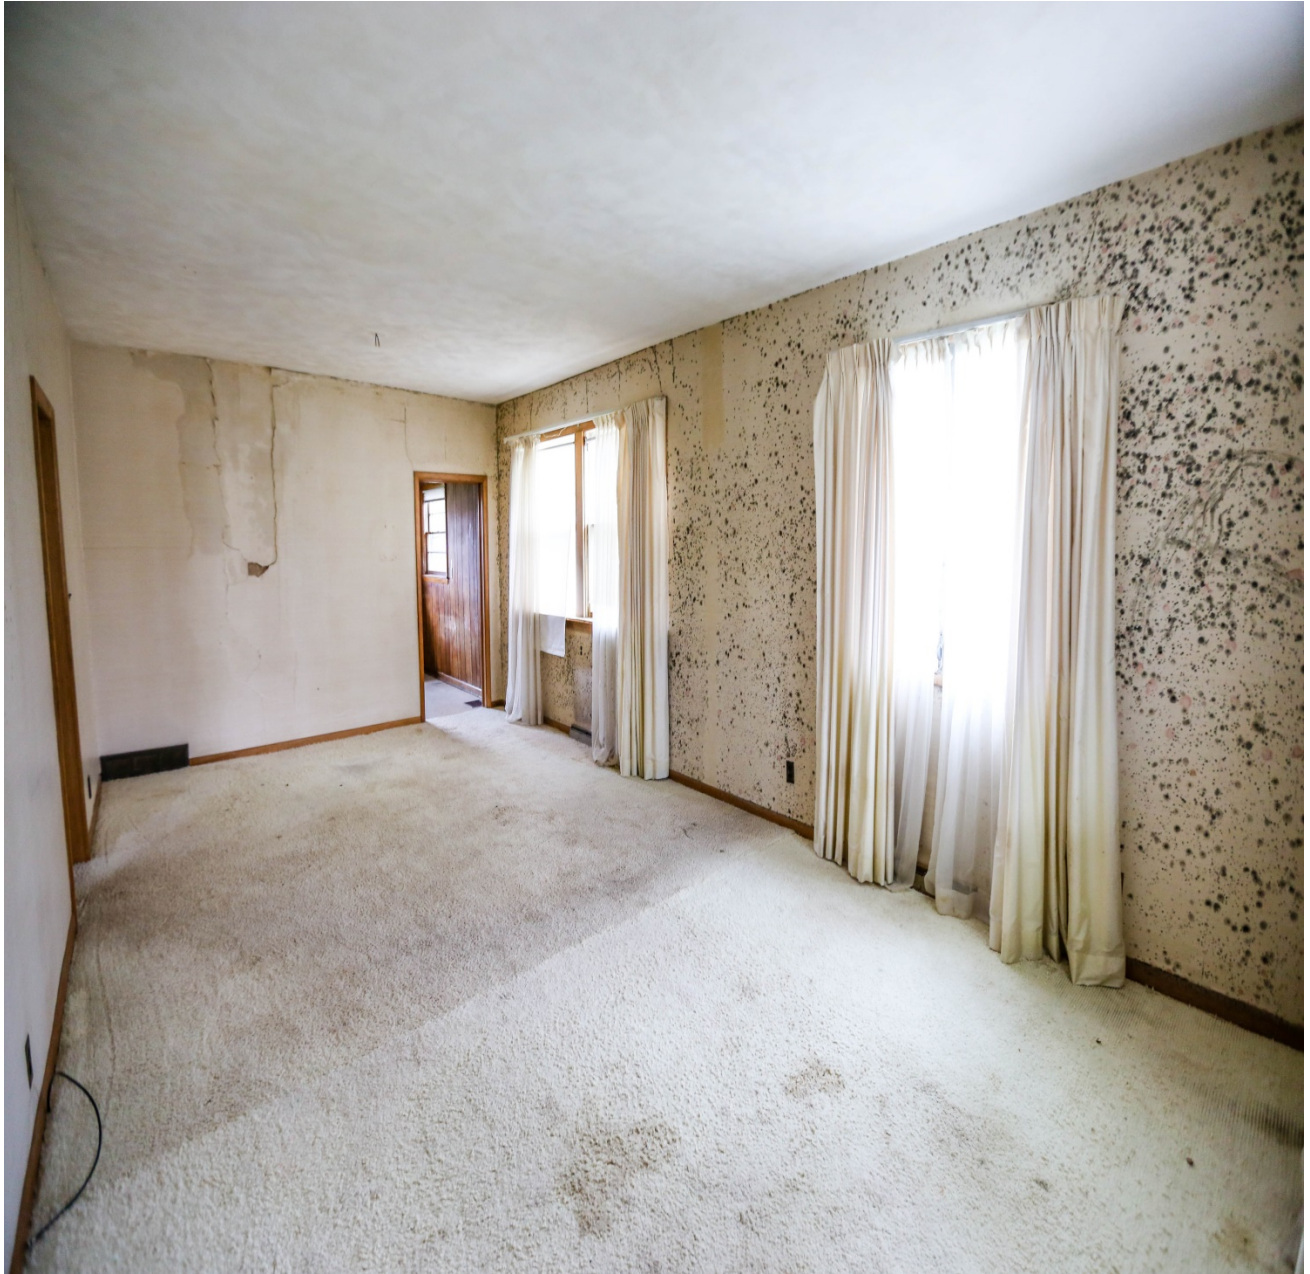
**B-2.18) Signs for Mildew and Mold are appearing on all interior walls and ceilings and can cause health hazards.**

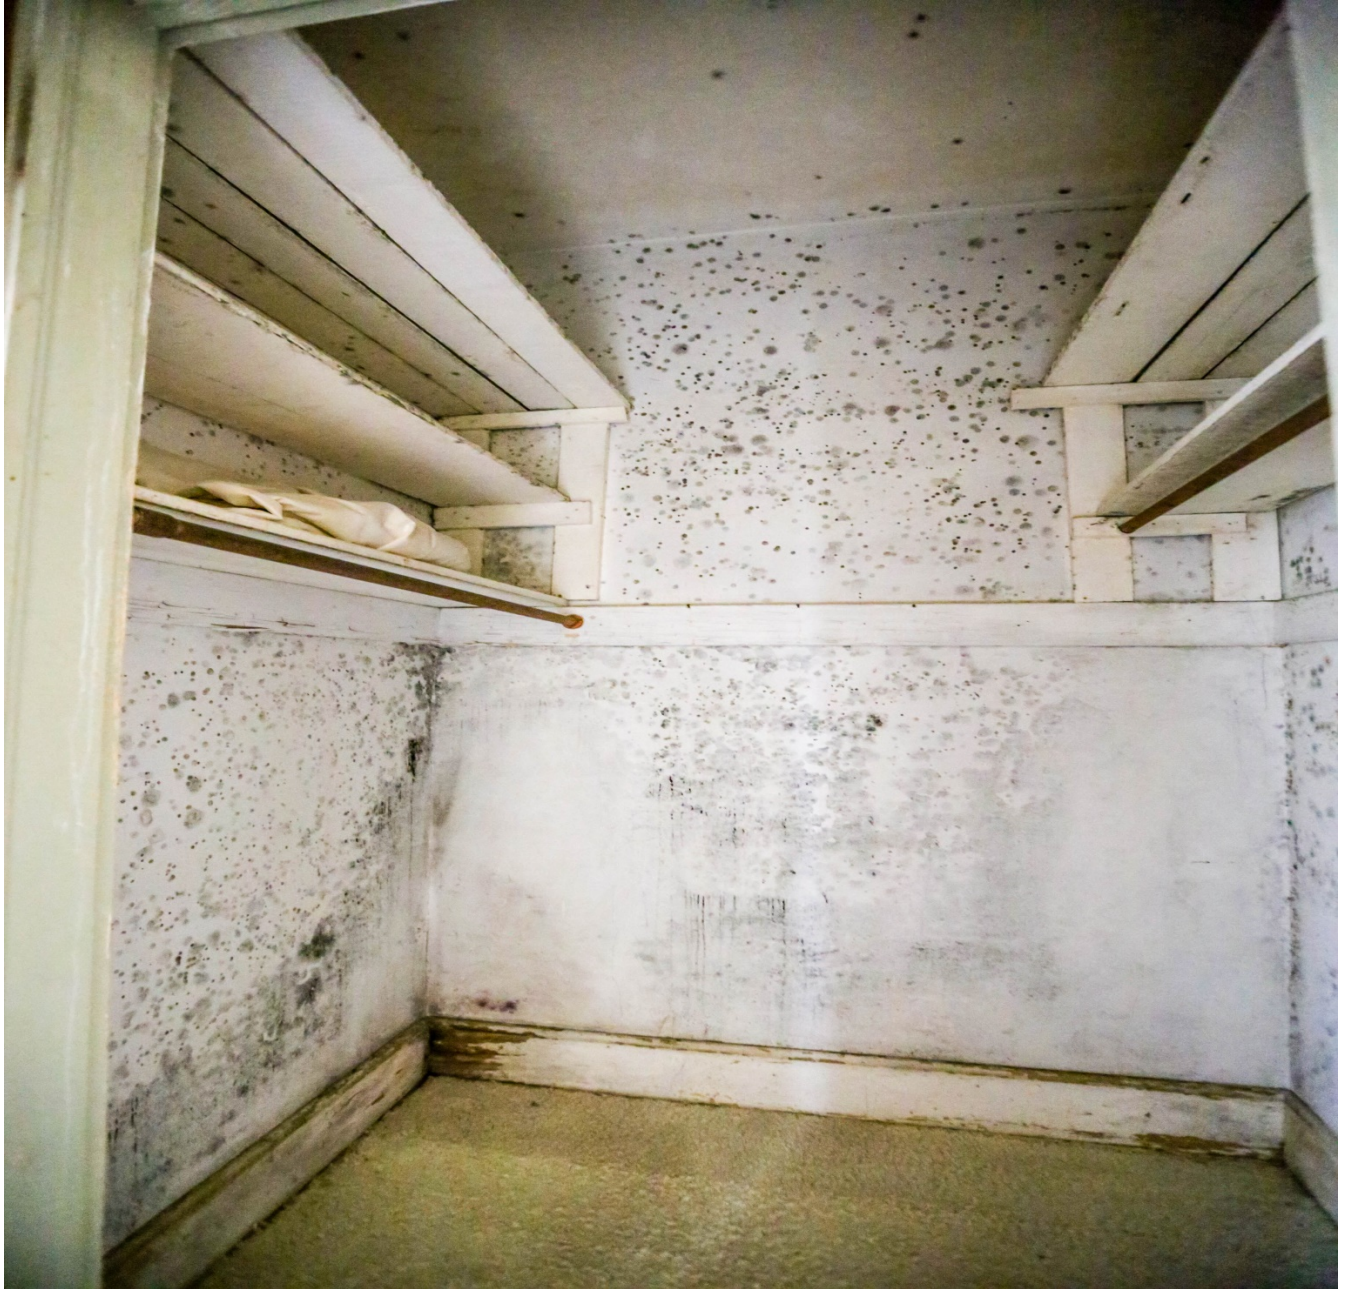
**B-2.19) Signs for Mildew and Mold are appearing in the closets can cause health hazards.**

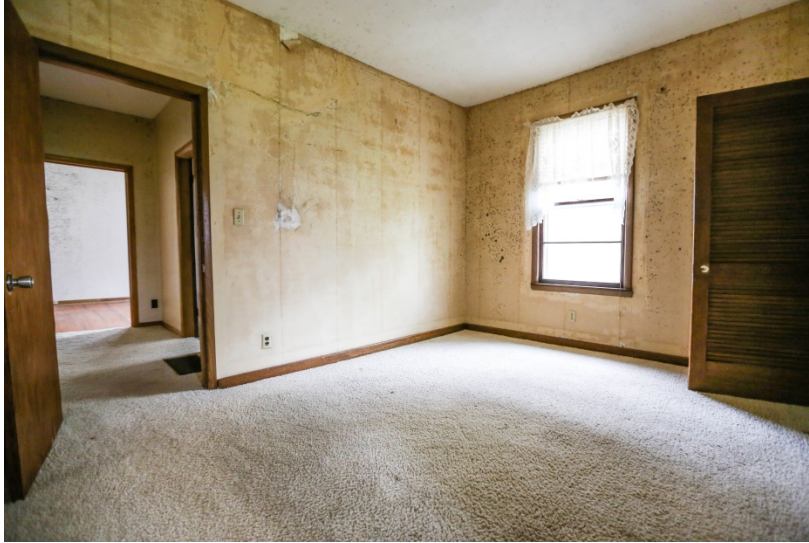
**B-2.20) Signs for Mildew and Mold are appearing on all walls and ceilings and can cause health hazards.**

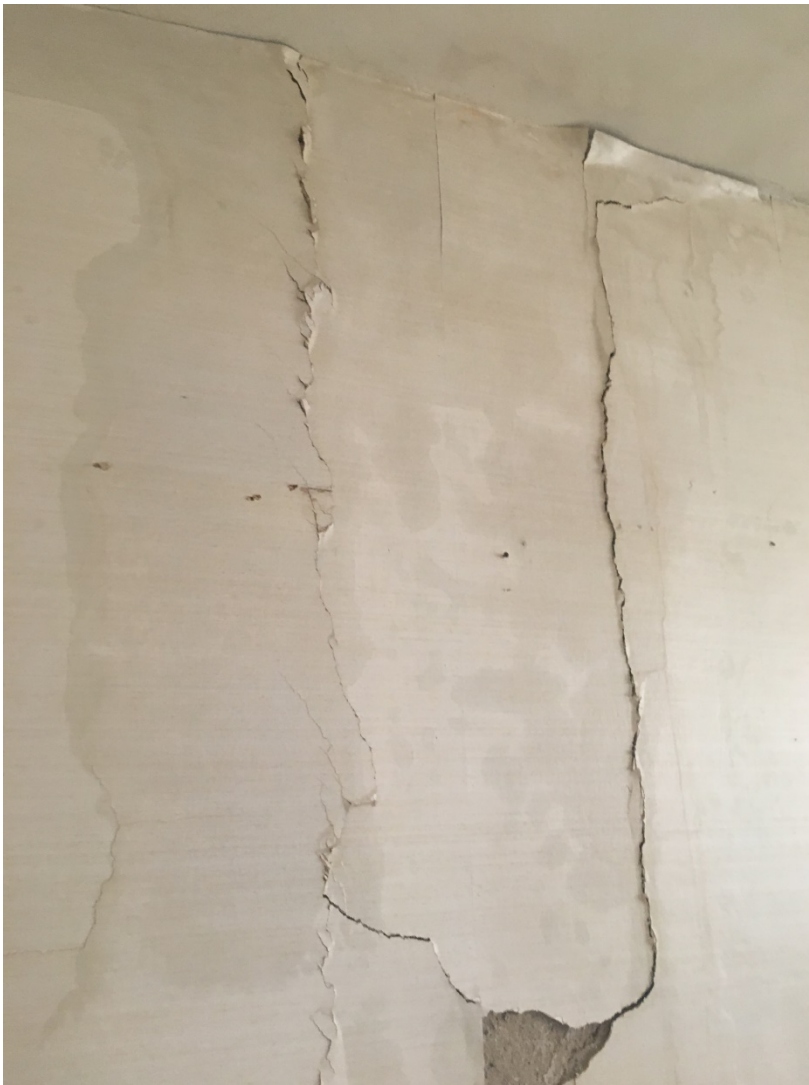
**B-2.21) Structural cracks and structural issues are seen throughout the house.**

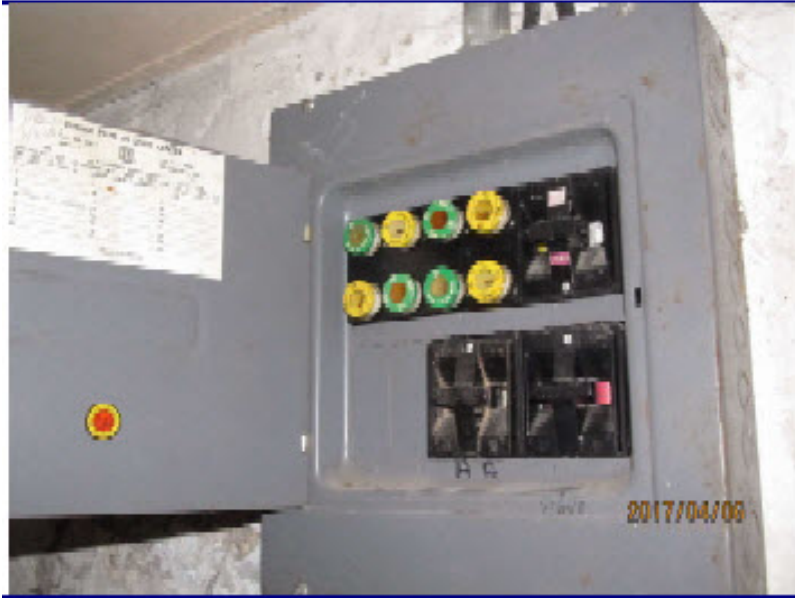
**B-2.22) Electrical Fuse Box is outdated and is at High Risk of causing a fire.**

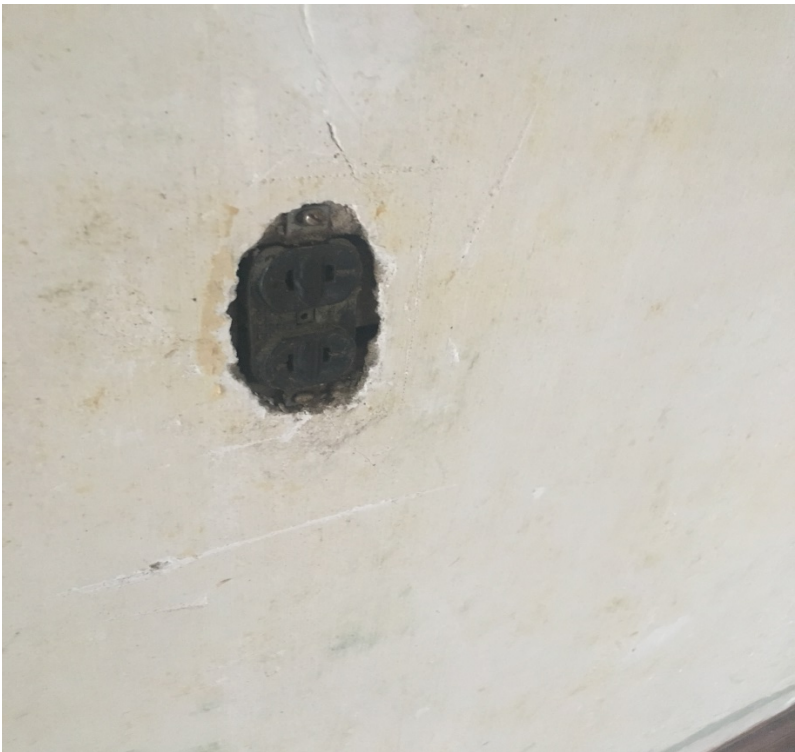
**B-2.23) Electrical outlet has no grounding plug and there is signs of outdated and improper wiring throughout the house.**

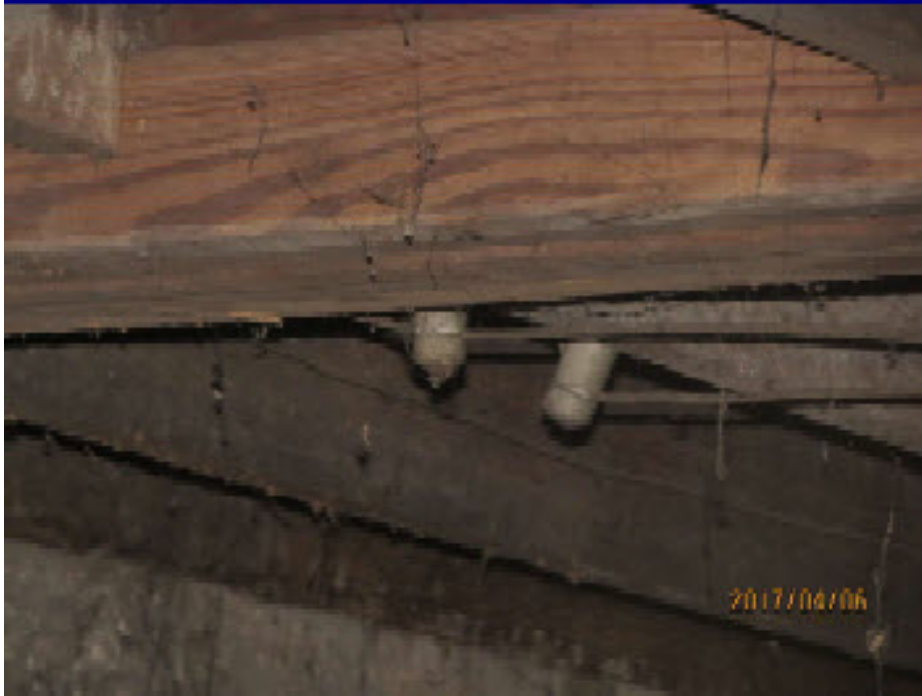
**B-2.24) Electrical knob and tube is exposed below lath and plaster. The outdated wiring is at High Risk of causing a fire.**

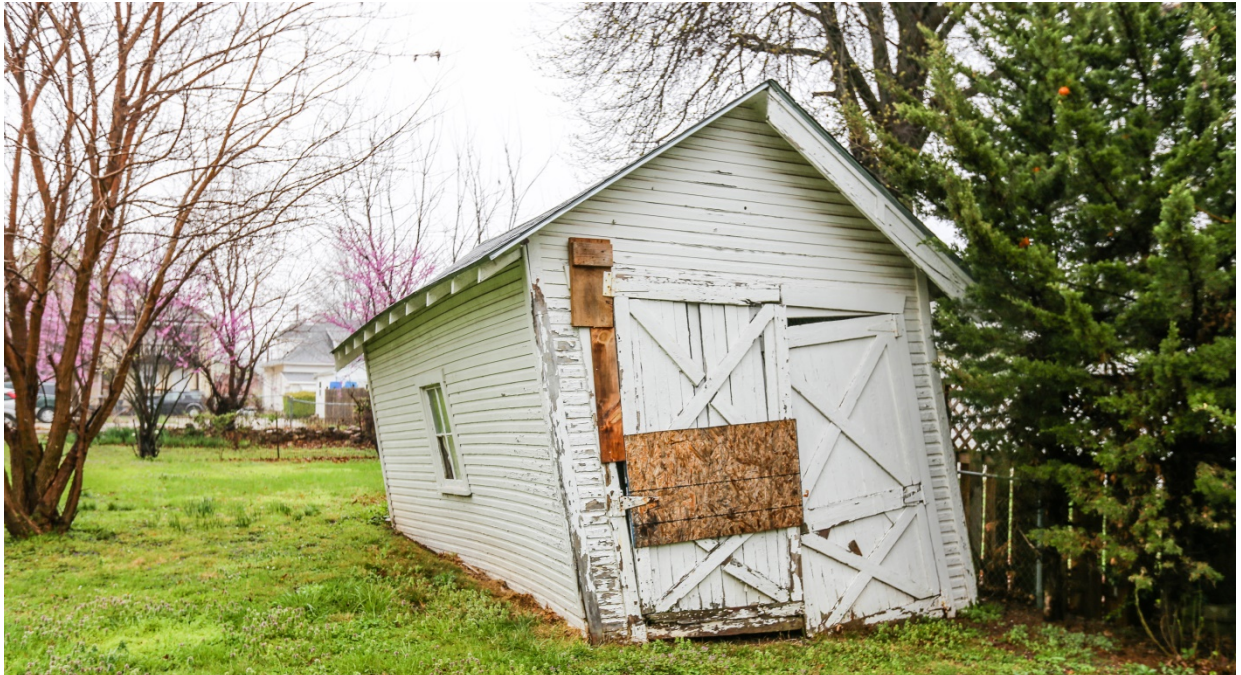
**B-3.1) Exterior structure garage is falling over and unsecured. Vagrants have broken into the structure.**
