# **Springfield Land Clearance for Redevelopment Authority**

### **4.II. Blight Report & Redevelopment For East Cherry Street Pocket Neighborhood**

#### *A1 Home Inspection* Property Inspection Report

1361 E Cherry St, Springfield, MO 65802  
Inspection prepared for: Elm House LLC  
Date of Inspection: 8/18/2016 Time: 2:00 p.m.  
Age of Home: 1920 Size: 1,408 sf. +/- (Several additions noted)  
Weather: Partly cloudy and 75 degrees

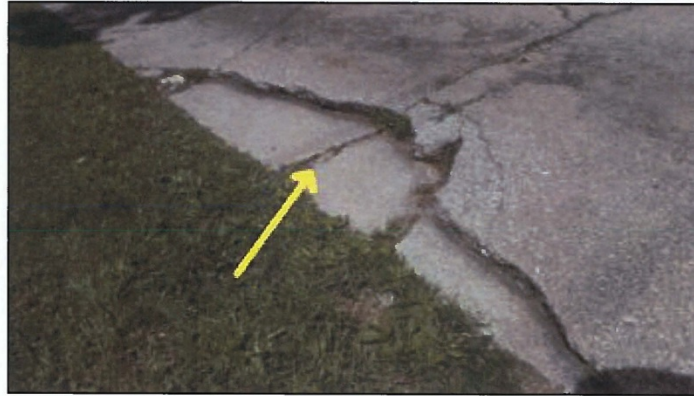
- Major cracks and displacement noted with potential trip hazard; needs repair/replacement.
- Drive is near end of its lifespan.

Drive deteriorated

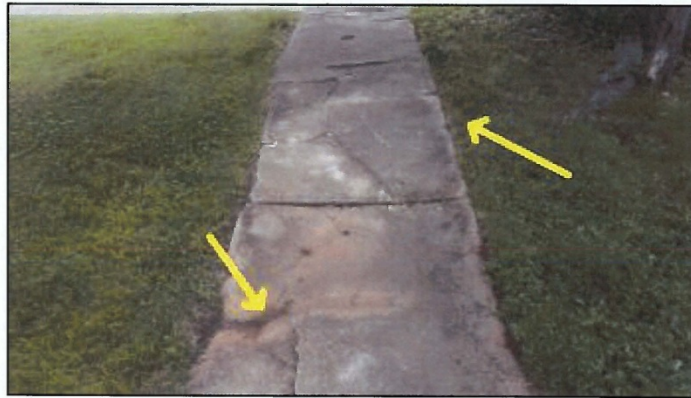
Observations: Major cracks and displacement noted with potential trip hazard; needs repair/replacement.

Sidewalk damaged

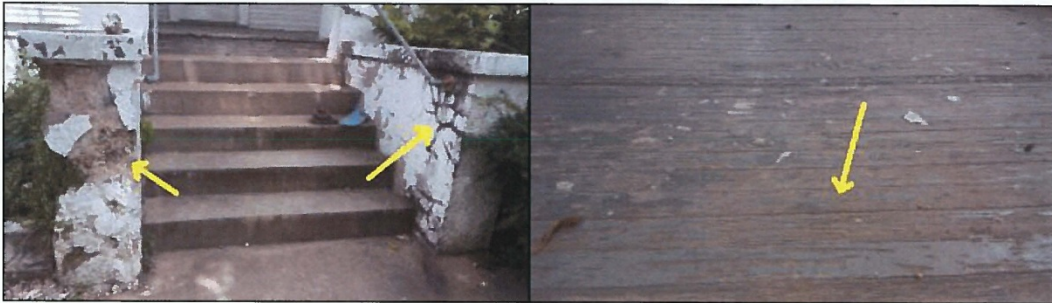
- Concrete walls at front steps are damaged and deteriorating; need full evaluation and repair.
- Not fully visible
- Railing too low at porch (relative to home's age).
- Porch is due to be sealed/painted.
- Footings not visible.
- Porch is not bolted to house (Nailed/screwed); Recommend correction.

Damaged walls

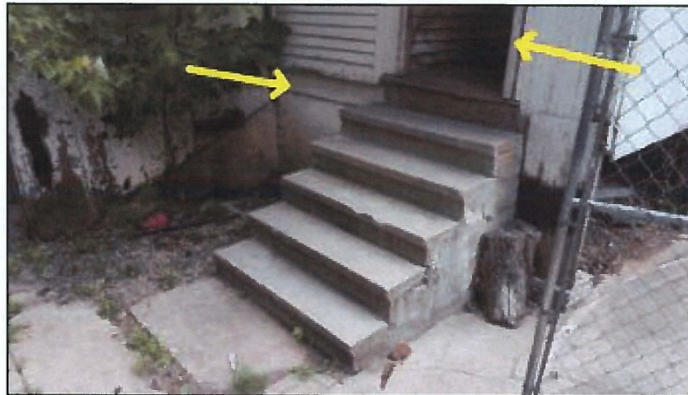
- Handrail needed at front sidewalk and back steps for safety.
- Cracks and deterioration noted

Handrail needed at back steps

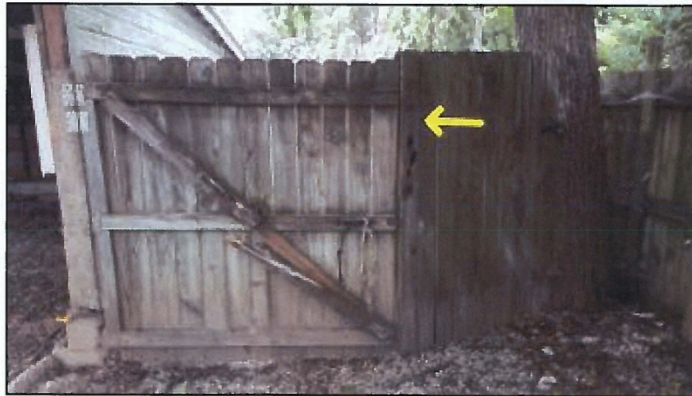
- Noted a couple of cracked/damaged fence pickets.
- Some weathering of wood fence observed.
- Back gate will not close/latch. Needs adjustment/repair.
- Loose/rotted posts observed.
- Nearing end of lifespan
- Not fully visible due to plants.
- Sections of the fence are leaning.

Sagging back gate

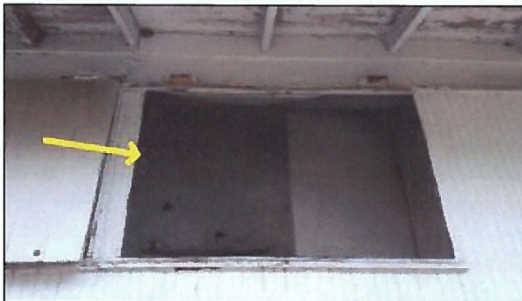
Missing shutter noted

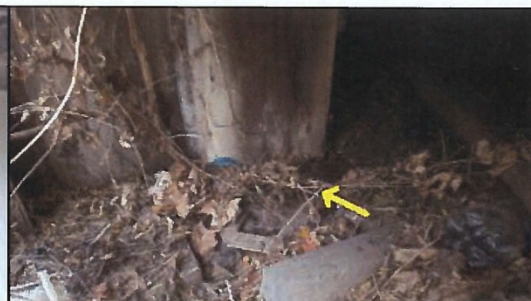
- Floor is sloped away from home, appears to have settled.
- Unheated/Cooled
- Exterior door is missing
- Wood to earth contact noted, not recommended as this may provide direct access for termites.

Wood to earth contact

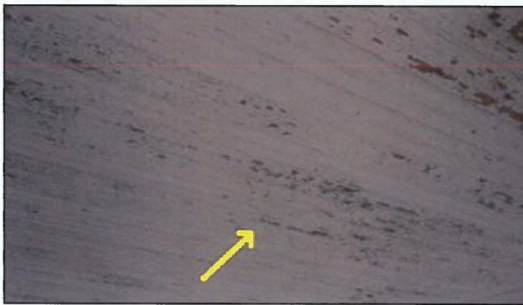
- Observed flaking paint/deterioration on trim, eaves and fascia; needs repair/repainting.
- Damaged asphalt/tar paper noted at gables.

Flaking paint at ceiling of front porch

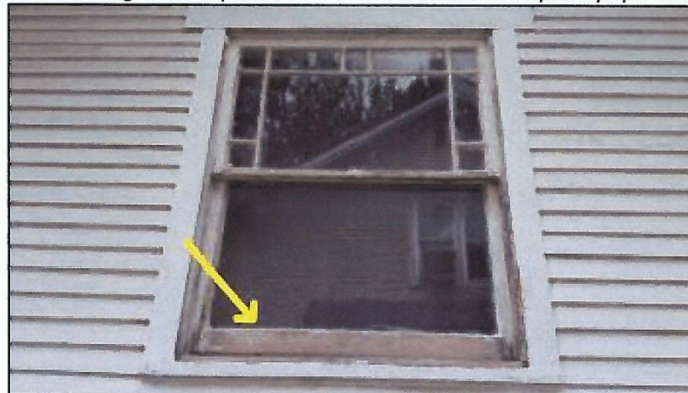
Worn paint

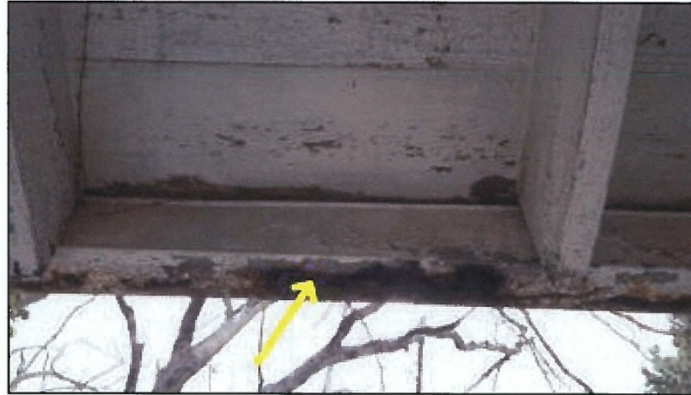
- Guttering is damaged and at the end of it's normal life; needs replacement.

Gutters rusted through

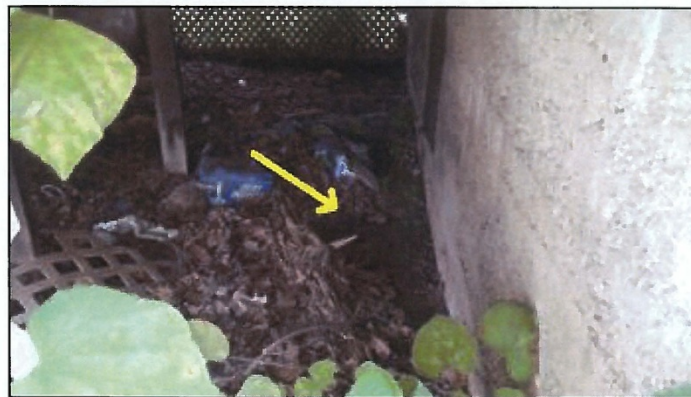
- Appears to drain fairly well.
- Overgrown landscaping noted; recommend trimming.
- Some erosion noted from water running over the guttering.
- Poor drainage noted below front porch; needs soil added.

Poor drainage below front porch

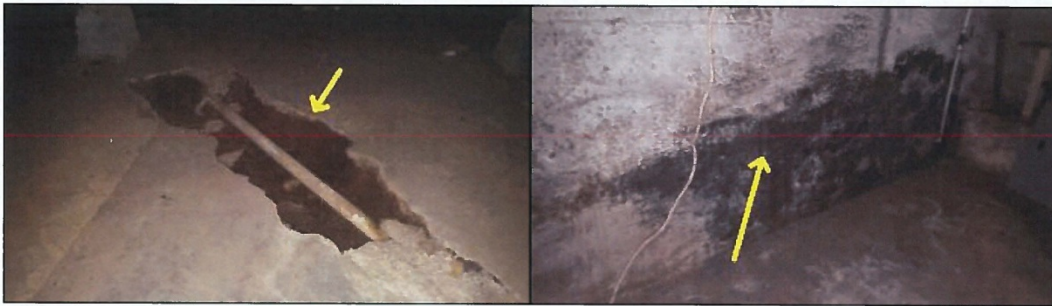
- Common shrinkage cracks observed in foundation stem walls.
- Observed past repair in NE corner.
- Hole in floor needs repair.
- Evidence of past/present water in basement; recommend full evaluation/repair by qualified foundation contractor.

Large hole in concrete floor

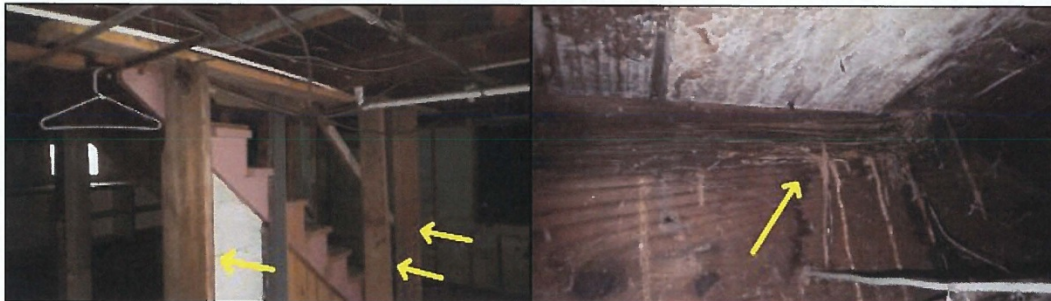
- Anchor bolts were not found.
- Added support noted.
- Moisture stains noted on floor structure below bathroom and utility areas.
- Floor and interior basement stairway poorly supported; needs evaluation/repair by qualified contractor.

Floor and interior basement stairway poorly supported

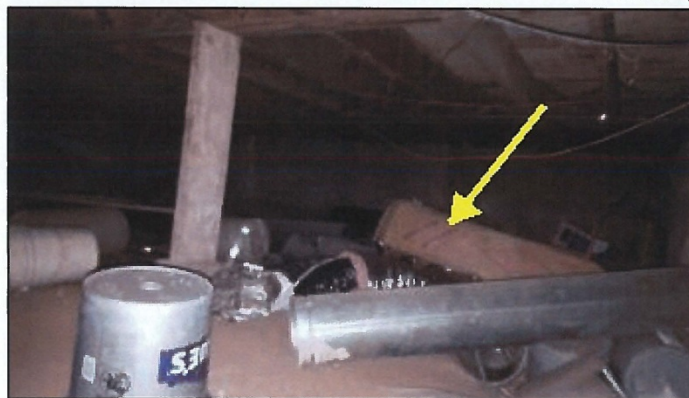
- Crawl space was dry today.
- Observed signs of past moisture along foundation walls.
- Recommend installing a plastic vapor barrier on the ground to prevent moisture from causing abnormal conditions in the future.
- Better control of roof water should help prevent problems in the future.
- Some scrap wood and construction debris needs to be removed from the crawl space.

Construction debris in crawlspace

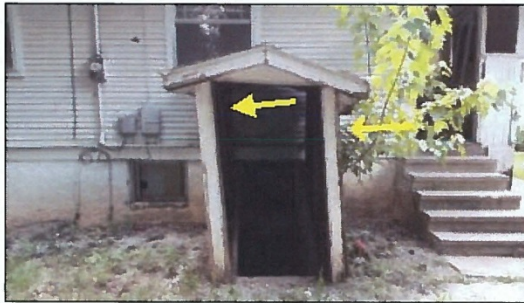
- Basement exterior stairway walls and roof are damaged and leaning; need replacement by qualified contractor.
- Exterior basement door has been damaged and does not close; needs repair.

Stairway covering damaged and leaning

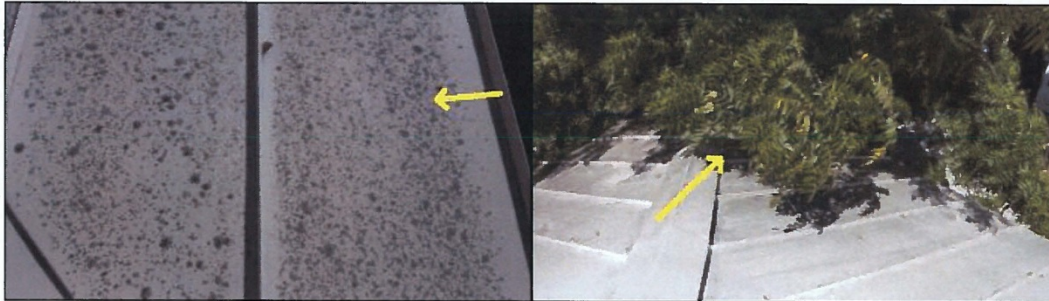
- Appears to be in good condition.
- Observations:
- Trees need to be trimmed away from roof to prevent damage.
- Regular maintenance and inspection advised.
- Observed weathering and moss.

Moss

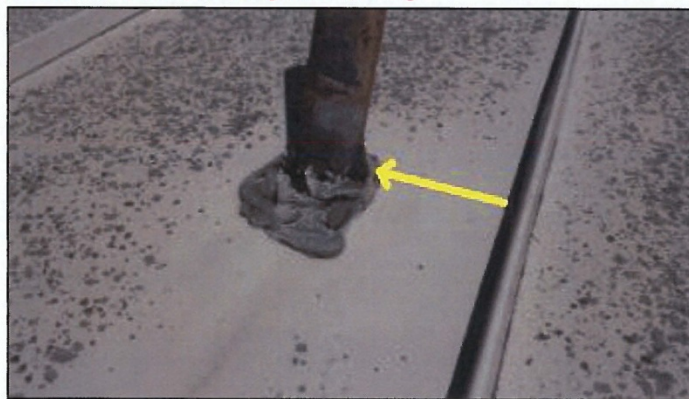
- Heavy sealant/repair observed at chimney flashing, around all roof vents, and flue pipes.
- Signs of past hail noted at metal flue cap(s).
- Sealant needed around kitchen plumbing vent flashing.

Kitchen plumbing vent

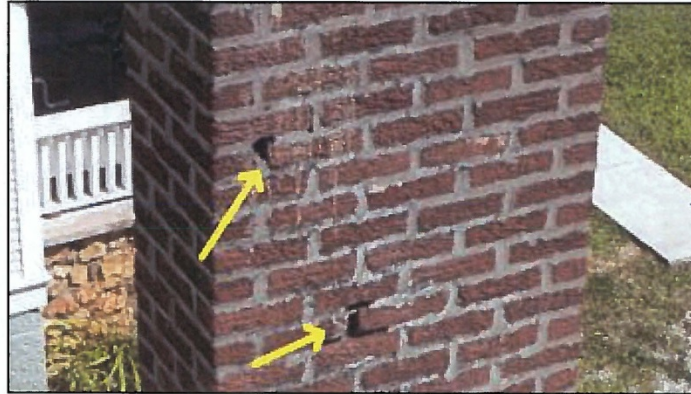
- Rain cap/spark screen installed.
- Mortar missing; needs to be repaired/tuckpointed by a professional. Recommend coating brick with a waterproofing sealer.

Missing mortar

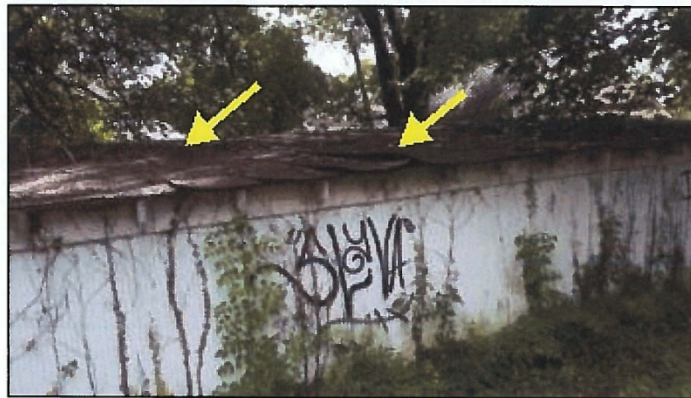
- Garage roof is loose and near/past the end of its lifespan; needs replacement.

Garage roof in poor condition and covered with branches/debris

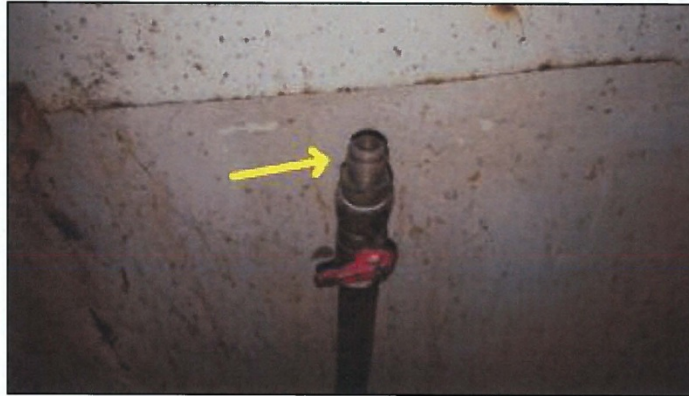
- Not fully visible
- Moderate rust/corrosion
- Near end of lifespan
- Pipes lack proper support and large quantity of abandoned gas line is connected to system; needs full evaluation and repair by qualified plumber.
- Gas line for stove is open; needs to be capped for safety.

Open gas line behind stove

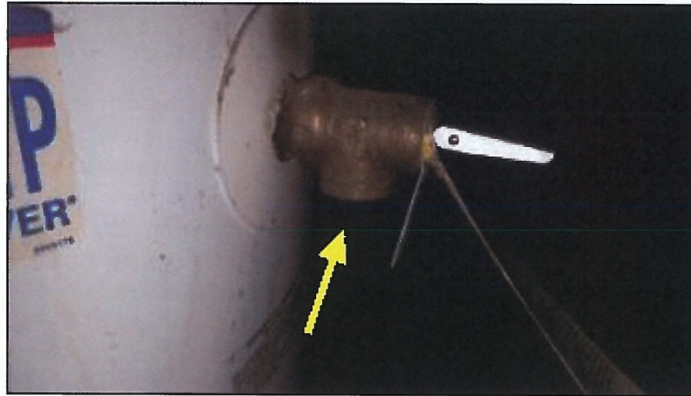
- Combustion air is available
- Vent flue piping is not fully visible
- Shut off valve is missing on the cold water supply above the heater; recommended.
- Heater is at/near the end of its normal life; may need replacing at any time.
- Stains noted around water heater.
- Utilities off, unable to test.
- TPR pipe is missing from valve; needs correction.

TPR pipe is missing from valve.

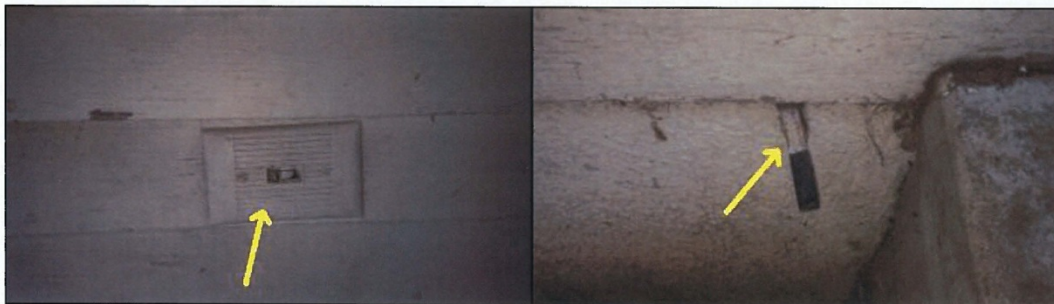
- No exterior receptacles were found • Utilities off, unable to test.
- Exposed wire noted near back porch; needs to be removed or properly terminated.

Broken switch at back porch

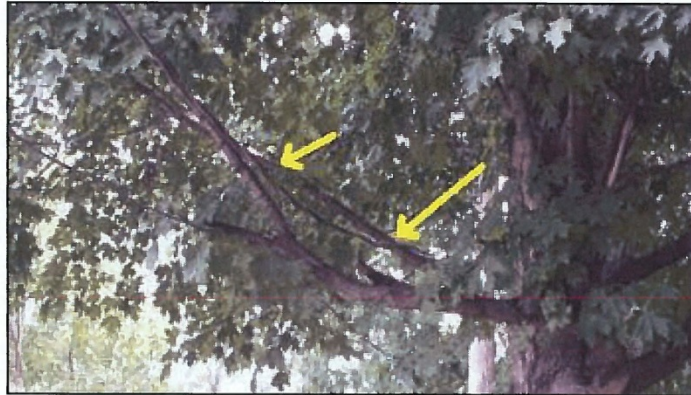
The wiring of the Houses also exhibit unsafe conditions. In particular, in the 1361 House, improper wiring is noted<sup>23</sup> and in the 1365 House, trees touch wires<sup>24</sup> – both of which are

- Ground clamp/system not visible
- **Trees touch wires; recommend contacting utility company.**

Trees touch wires

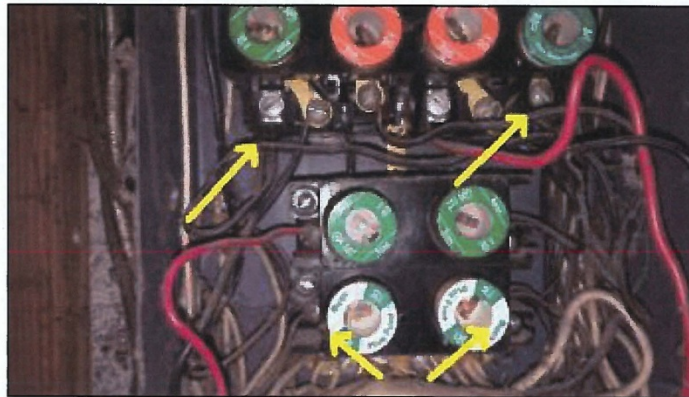
- Electrical system appears outdated by today's standards
- Labels missing
- No space remains in panel for additional circuits.
- Panel covers have been removed; need replacement.
- Double tapped fuses observed - Need repair by qualified electrician.
- Several 20 amp fuses appear to have been replaced with 30 amp; needs evaluation/repair by qualified electrician.

Double tapped fuses

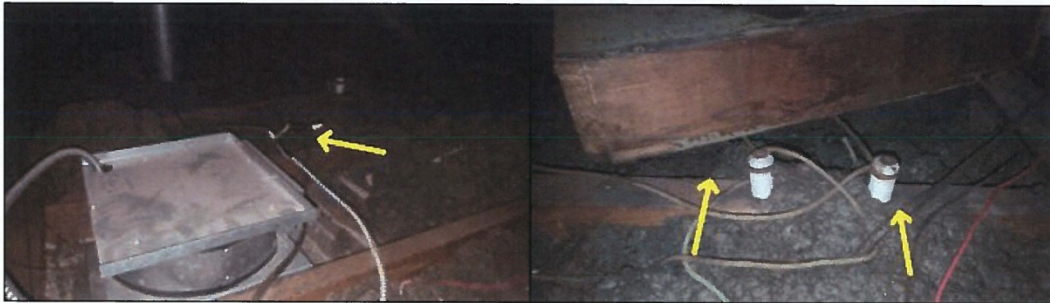
- Doorbell button damaged; needs repair.
- GFCI protection recommended for kitchen and bathrooms
- Missing globes noted and cover plates noted.
- Utilities off, unable to test.
- Exposed splices in attic need to be put in proper junction boxes
- Exposed splices in basement need to be put in proper junction boxes.

Exposed splice near access

Knob and tube wiring noted

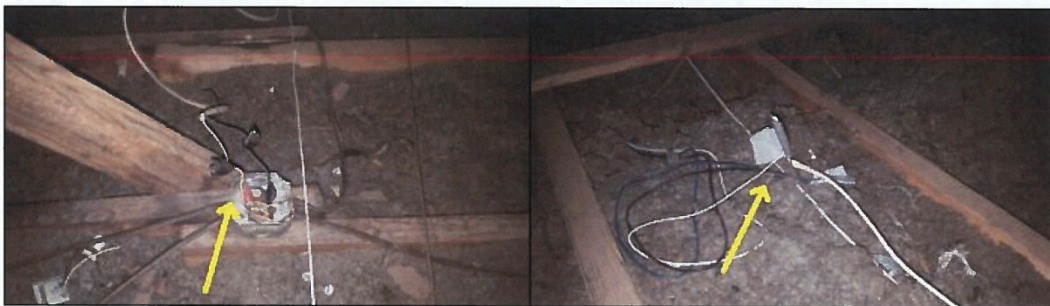
Exposed splice in center of attic

Improper and exposed splice above entry

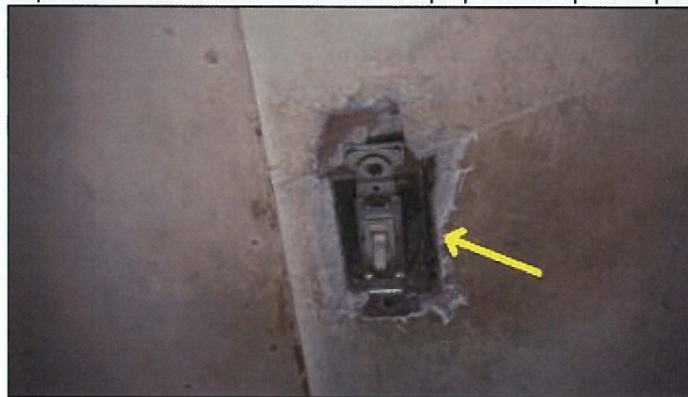
Outlets and switches missing plates l'm various locations.

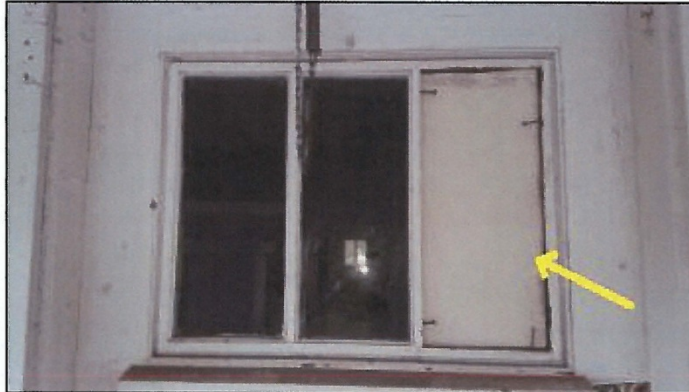
- Hardware is loose
- Weather stripping is missing
- Glass missing; needs repair.

Missing glass at front door

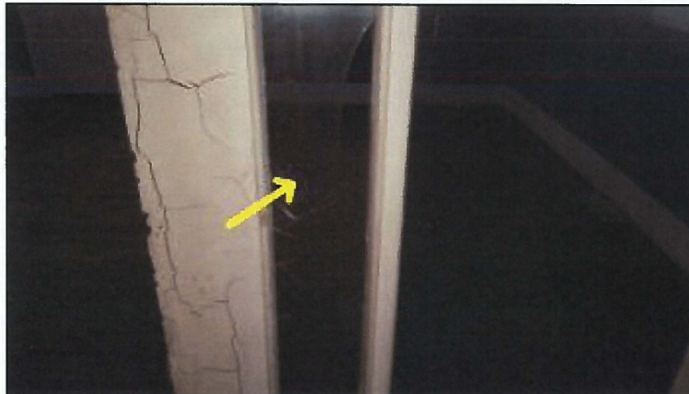
- Several doors do not close properly and have loose hardware; need repair.
- Broken glass observed in living room doors; need repair or replacement.

Broken glass in main living area doors.

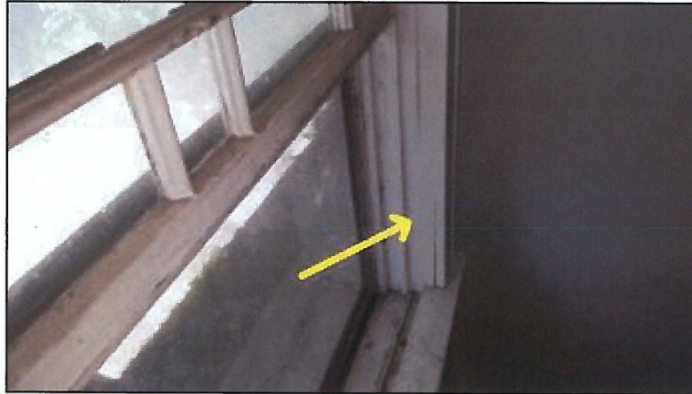
Lower dining room window is missing

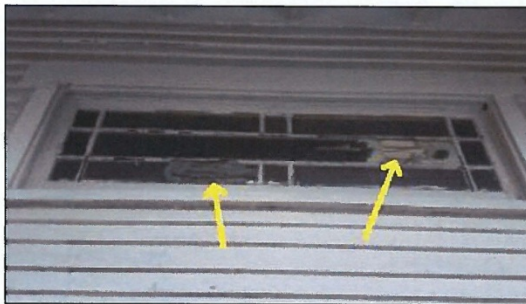
- Several windows appear to be painted shut and would not open.
- Several windows had broken ropes and will not stay open without assistance.
- Several screens were missing/not installed.
- Missing latch hardware noted in various locations.
- Dining room and three basement windows were missing; need replacement.
- Four broken windows noted on mail level of home; need replacement.

Broken window on West side

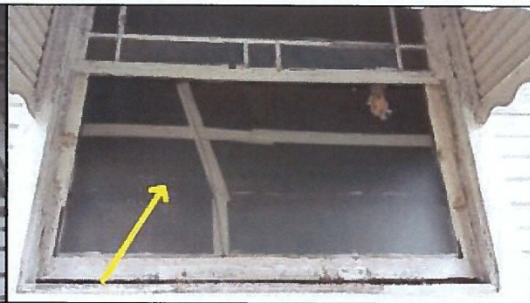
Broken window on West side

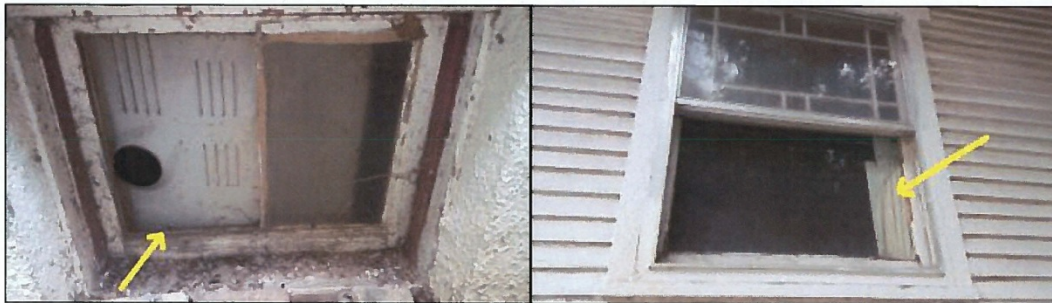
Missing window on back wall of basement

North window on East side is broken

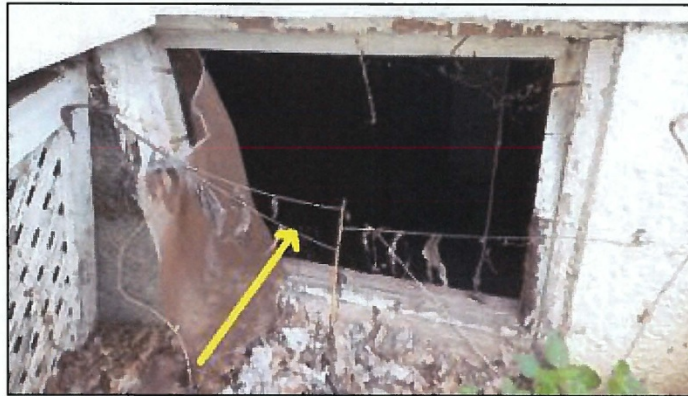
Missing basement window bear back porch.

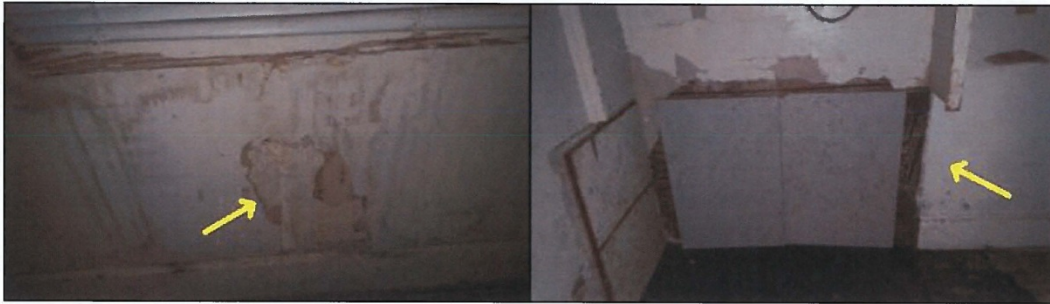
- Walls are in poor condition; need full evaluation, touch up and repair.

Moisture stains and cracks

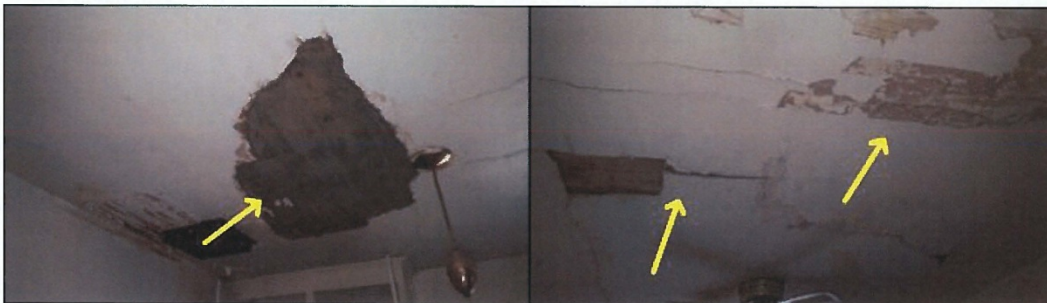
Dining room ceiling

- Common cracks
- Some sagging and damaged areas noted; needs full evaluation and repair by qualified contractor.

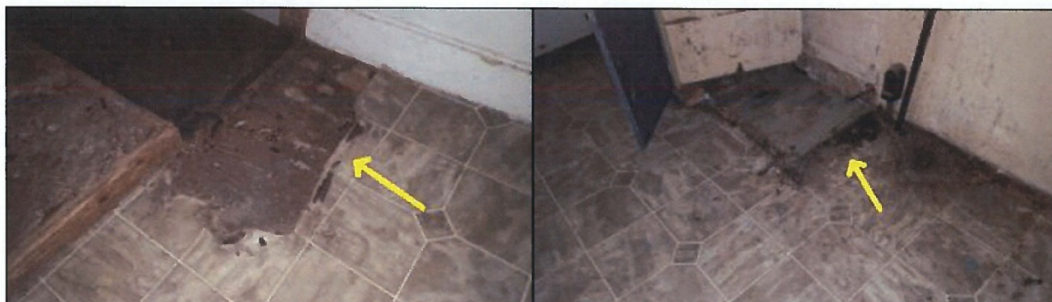
Dining room floor

- Uneven areas in the floor noted.
- Stained/damaged flooring observed in various areas.
- Wood flooring is due to be refinished.

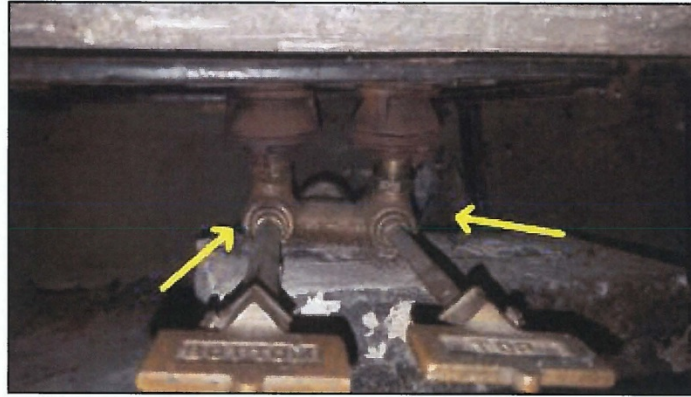
- Gas logs lack pilot and modern safety features; need to be replaced.

Direct gas valves without pilot or automatic shut off.

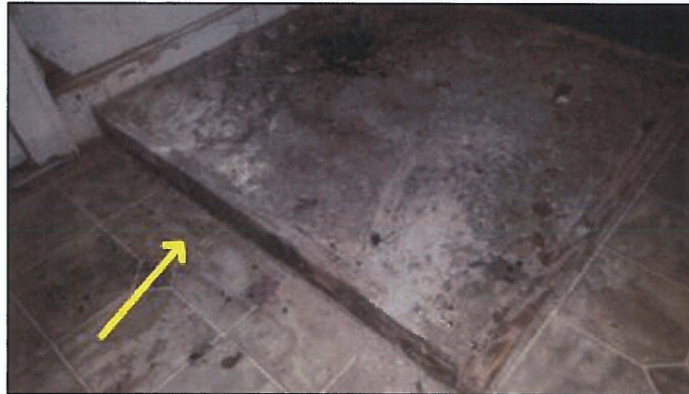
- Hearth and woodstove flue pipe noted in dining room; recommend removal.

Stone/concrete hearth in dining room

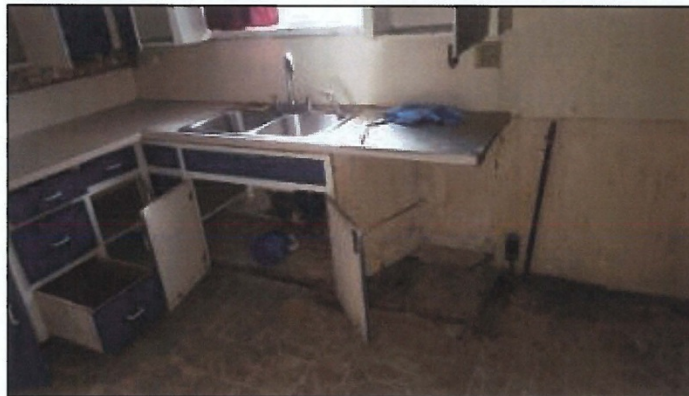
- General condition is poor.

Kitchen is in poor condition overall.

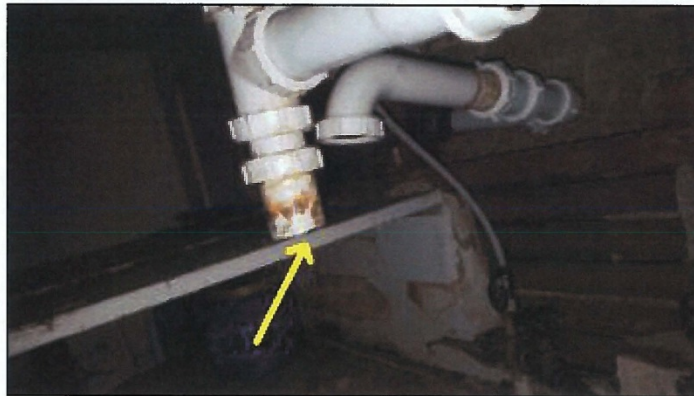
- Moisture stains/damage below sink
- Plumbing disconnected below sink.

Trap has been removed

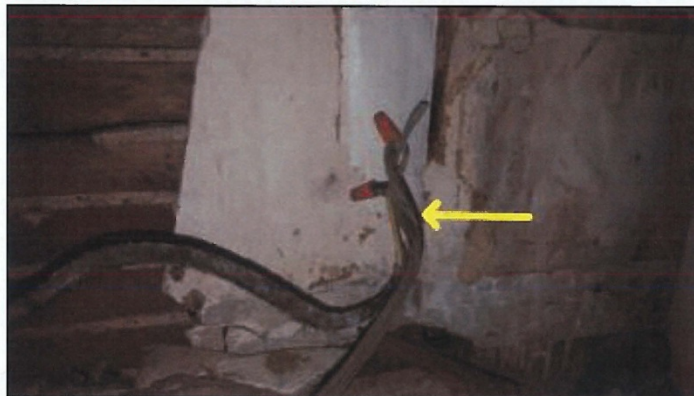
- Near end of lifespan
- Improper wiring noted; splice needs to be put in junction box.

Exposed splice

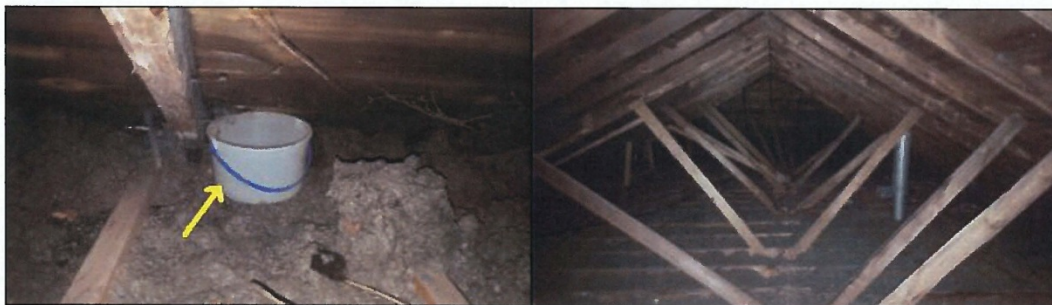
- Entered
- Vents provided
- Roof structure has solid 1x decking.
- Moisture stains observed on roof structure in various locations indicating past leaks (Dry today).
- Access too small, needs correction.

Bucket indicating past leak

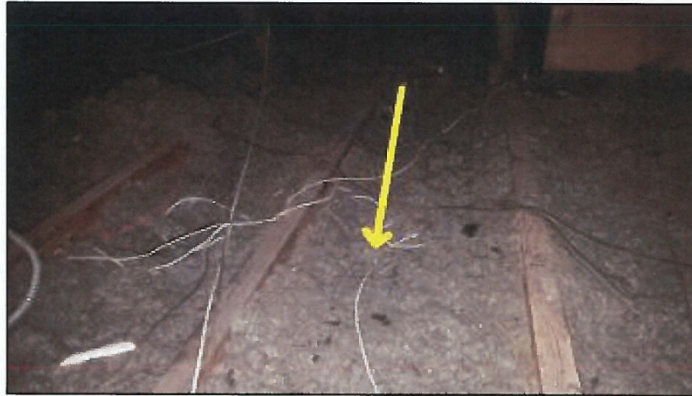
- Attic is poorly insulated; all joists are visible. Recommend adding insulation for energy efficiency.

Attic poorly insulated

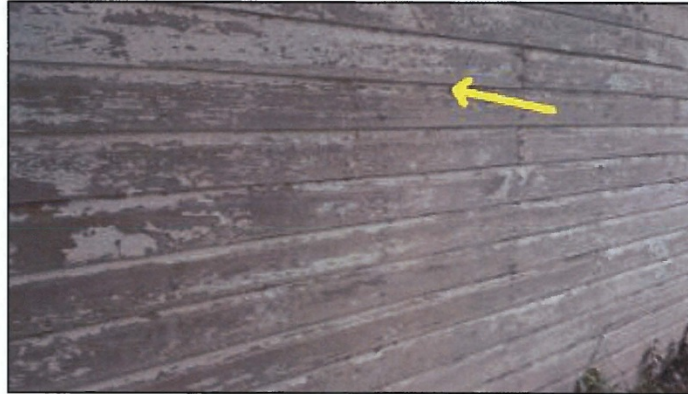
- Not fully visible
- Moisture damage noted; Minor repair needed in various areas.
- Wood to earth contact observed; may provided direct access for termites.

Worn paint on exterior

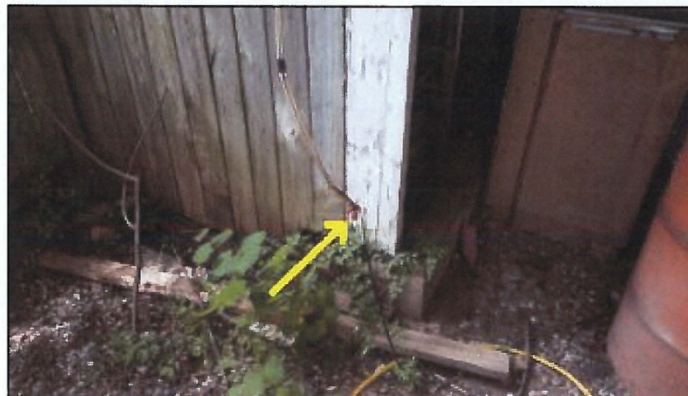
- GFCI protection recommended for garage circuit
- Improper wiring
- Garage electrical is connected to a damaged power cord; needs to be removed or properly wired by a licensed electrician.

Cord with exposed splice powers garage

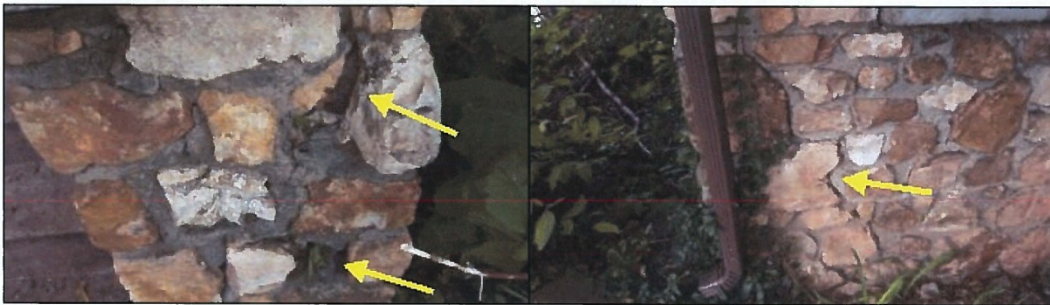
- Stone and mortar missing in various locations; needs full evaluation and repair by qualified mason.
- Common cracks
- Railing too low at porch (relative to home's age).
- Areas of spalling/deterioration observed.
- Flaking paint noted on concrete and wood surfaces.

Stone missing at front steps

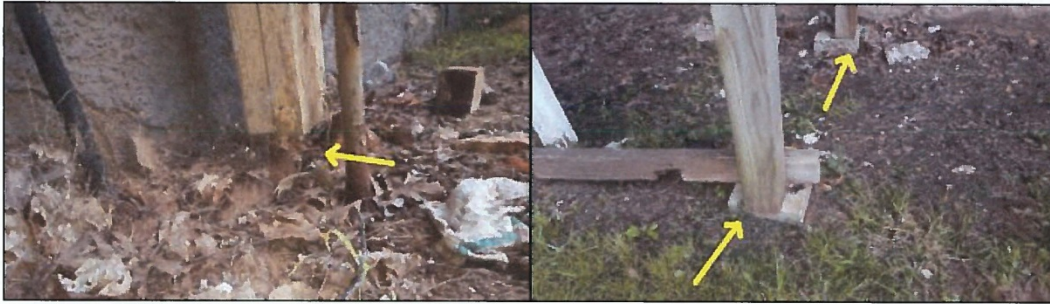
- Steps and handrail are in poor condition; need replacement.
- Handrail recommended at front and NW steps for safety.
- Footings are improper/temporary - Recommend correction with proper poured footing.
- Signs of settlement and loose footing observed; steps/deck to unit 3 need full evaluation and repair by qualified contractor.
- Glass at level of steps up to unit 3; needs to be protected by rail and spindles for safety.

Missing footing below stairway - Unit 3

Improper/temporary footing

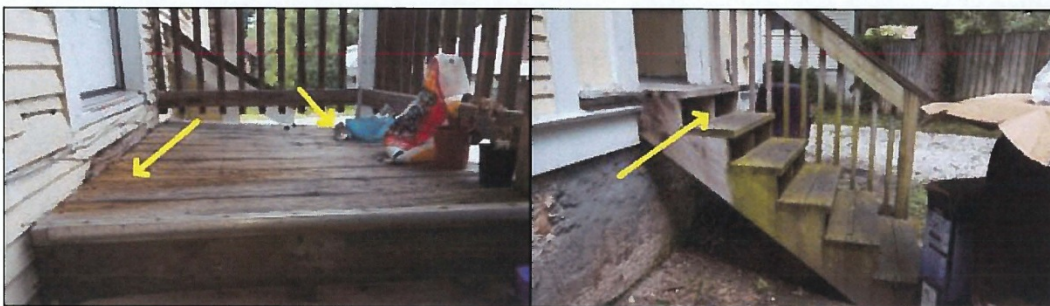
Landing has settled - Unit 3

Handrail missing at back steps

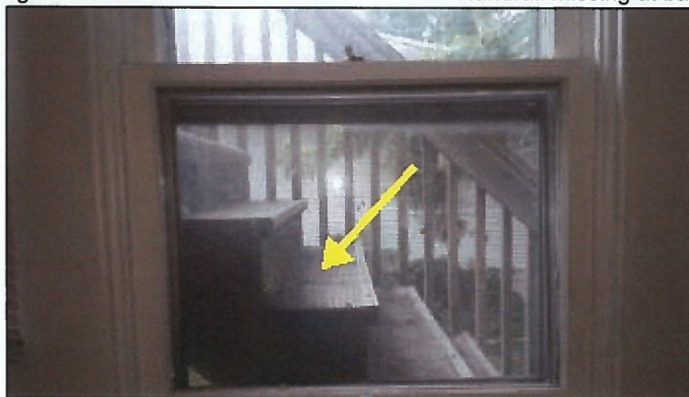
Glass level with steps

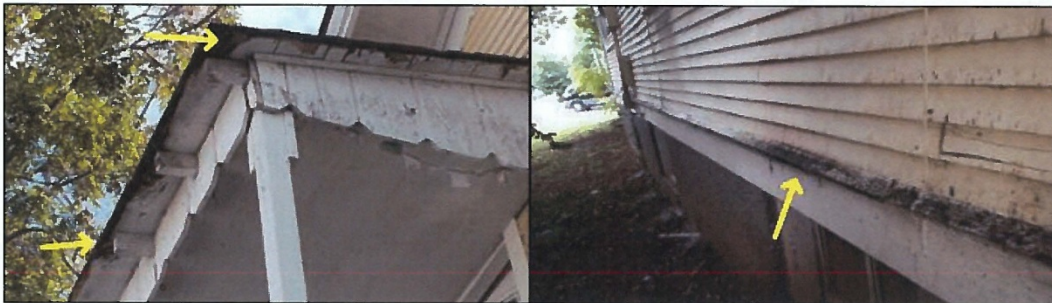
- Observed flaking/worn paint on wood trim; needs to be sealed/painted to prevent further deterioration.
- Eave damage noted, partially above door to unit three.

Deterioration above door to unit three

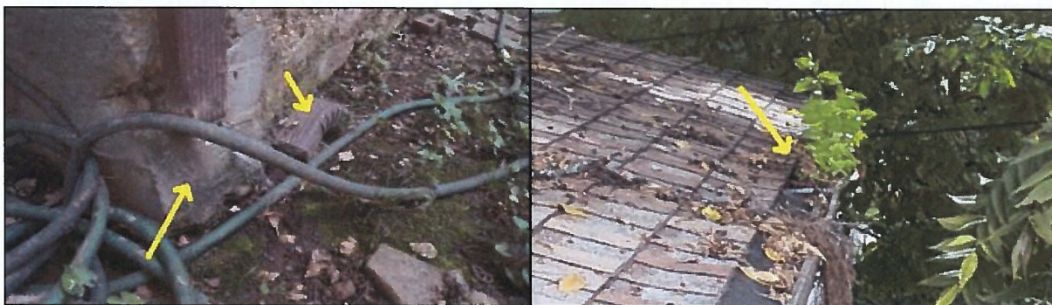
- Sections of gutter guards are missing, gutters are filled with debris and need cleaning for proper drainage.
- Downspout are nearing the end of normal life, consider replacement.
- Damaged/missing downspout elbow noted at NE corner.

Missing downspout elbow

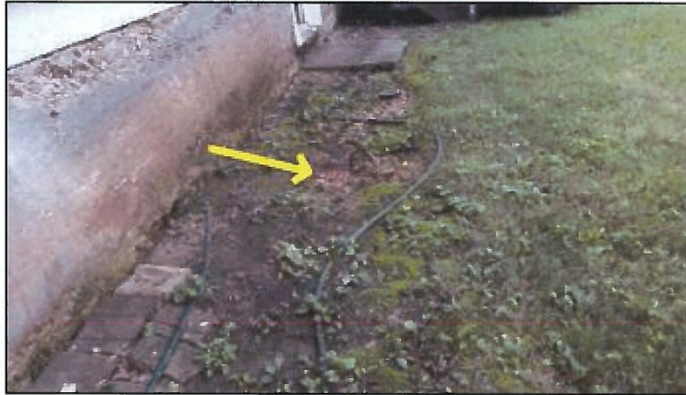
- Extend downspouts for improved drainage and control of roof water.
- Recommend adding soil around foundation to improve drainage.
- Some erosion noted from water running over the guttering.

Erosion from overflowing gutter at back of home

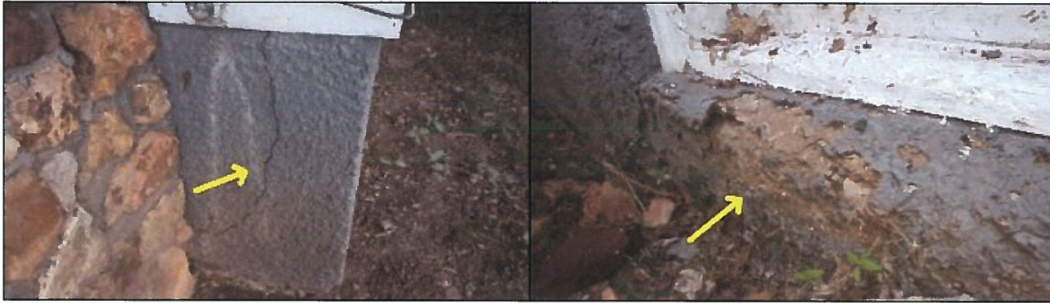
- Trees planted close to structure, not recommended as roots may cause damage to foundation.
- Evidence of past/present water in basement; recommend full evaluation/repair by qualified foundation contractor.
- Typical cracks in basement floor slab.
- Cracks, deterioration and minor displacement noted on the foundation walls; recommend evaluation, sealing and parging by a qualified foundation contractor.

Crack at SE corner (1/2" displacement)

Deterioration on foundation walls, west side pictured.

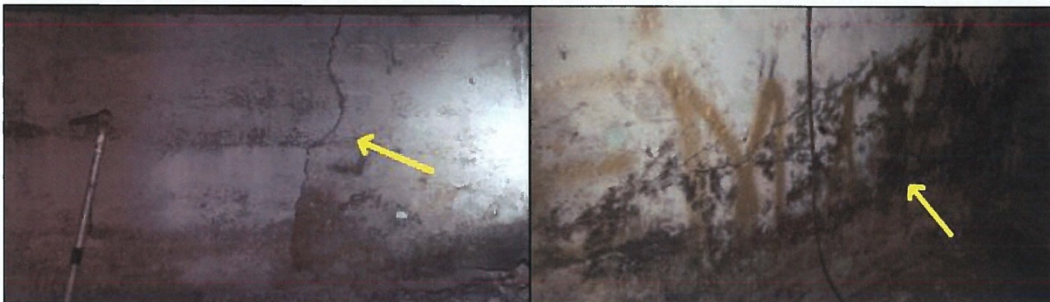
Small crack in SW corner of basement/crawlspace

Stains/fungal growth on SE stem wall.

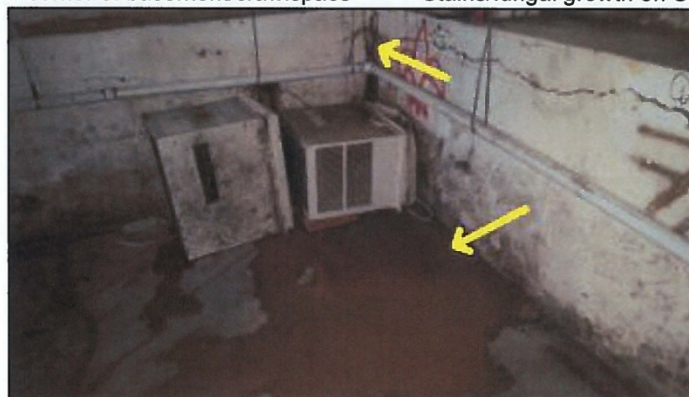
Signs of moisture penetration at NE corner (below downspout)

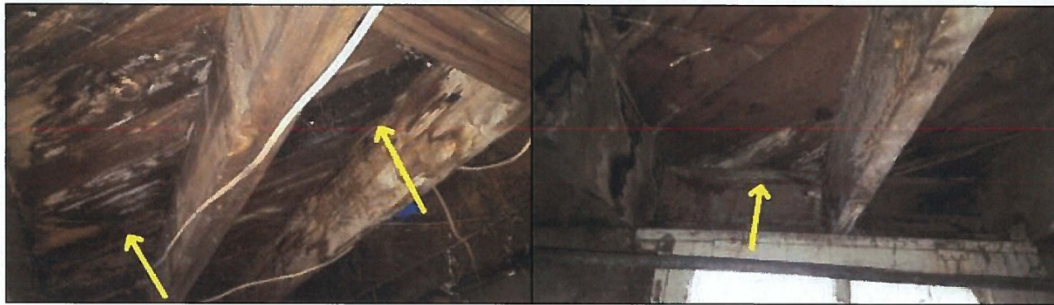
- Anchor bolts were not found.
- Wood to earth contact noted near electrical panel; recommend correction. (Prone to deterioration and may attract termites.)
- Moisture stains/damage noted on floor structure in various locations.
- **Some spotty mold growth was observed on the floor structure in a few areas particularly in the Western portion; needs full evaluation and cleaning/removal by a qualified mold contractor.**

Fungal growth and damaged subfloor in NW portion of basement

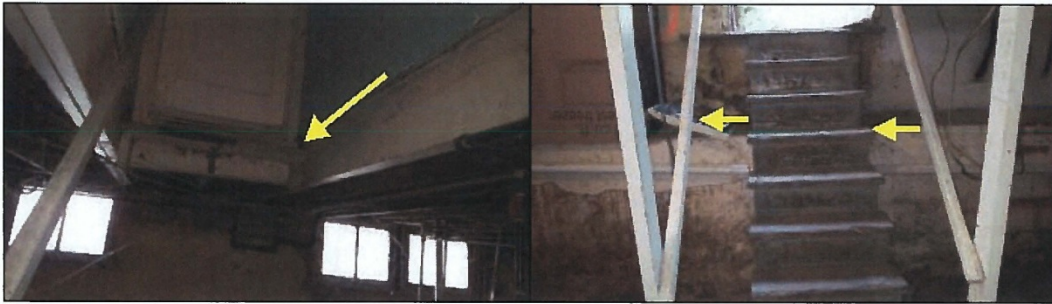
- Lock is broken on door to basement stairway.
- Ceiling height is too low on steps to the basement.
- **Stairway is not full width, does not reach handrail and step rise is higher than recommended. Stairway needs full evaluation and repair by qualified contractor.**

Interior stairway has been removed and door locked with deadbolt

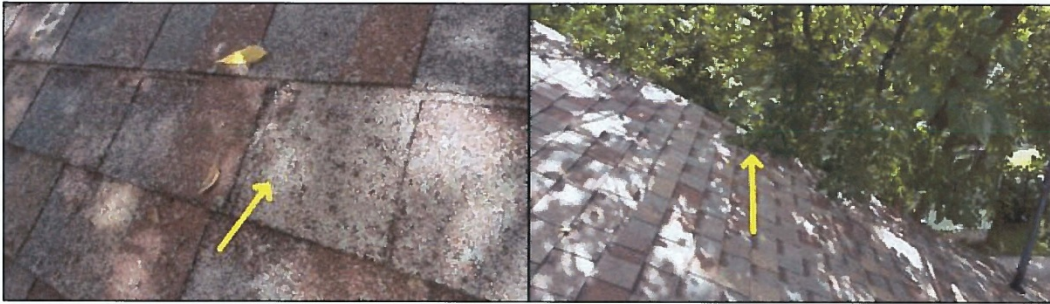
- Waves noted in roof structure
- Trees need to be trimmed away from roof to prevent damage.
- General condition favorable, with signs of weathering and aging; regular maintenance and inspection advised.
- Observed blistering/granular loss.
- Observed weathering and moss on north side and in shaded areas.
- Observed slight signs of past hail.

Moss below trees

Trees touch roof

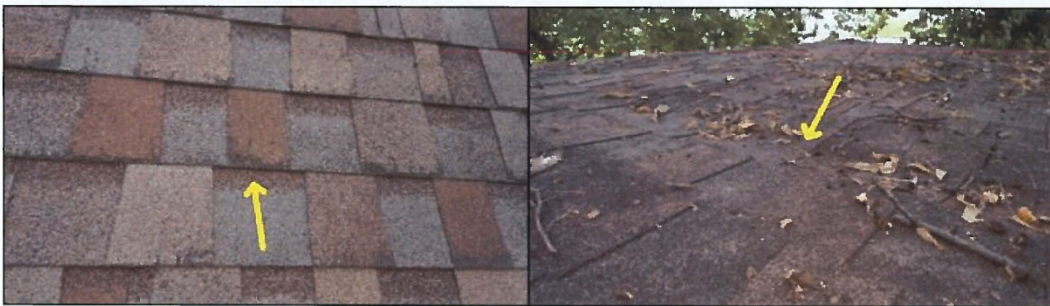
Granular loss and wear

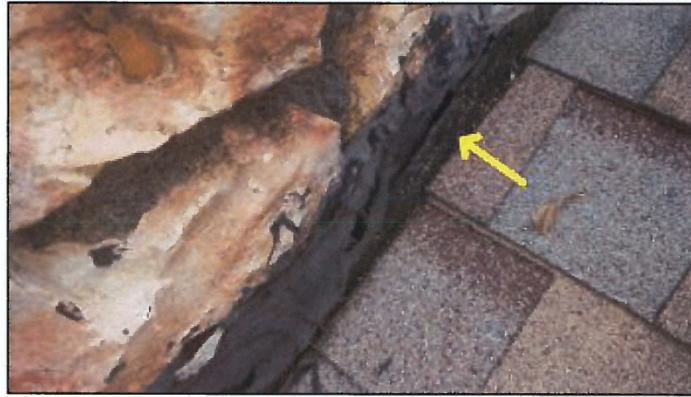
- plumbing flashings appear serviceable
- Not fully visible
- Caulk noted at electrical mast
- Heavy patching/repair observed at chimney flashing.
- Counter flashings at the chimney flashings are improper and loose; needs securing/repair.

Improper and loose flashing at front chimney

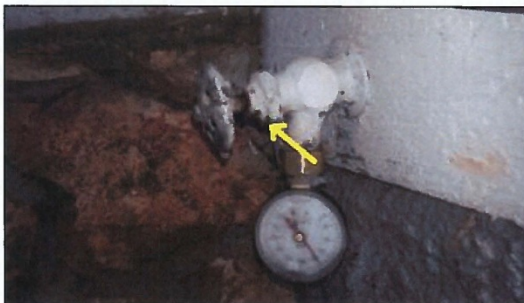
Front faucet leaks under pressure

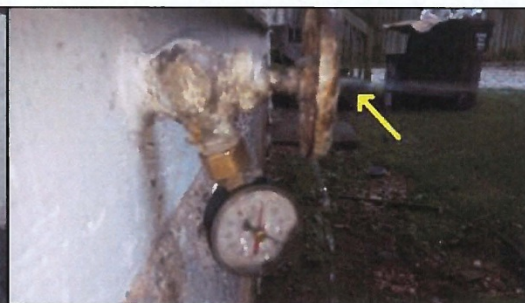
Rear faucet leaks

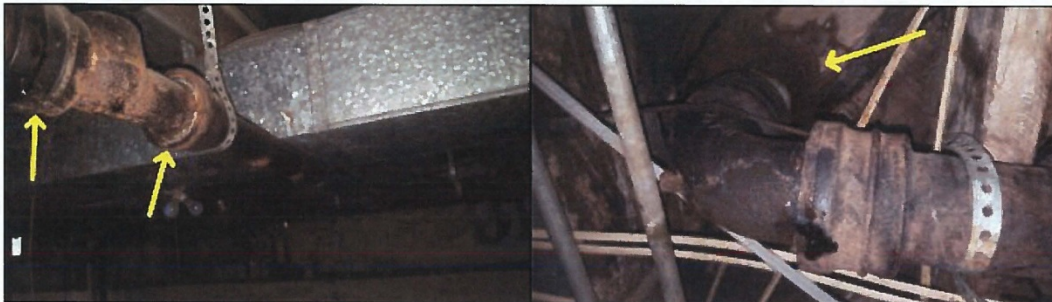
Several unions leak in basement.

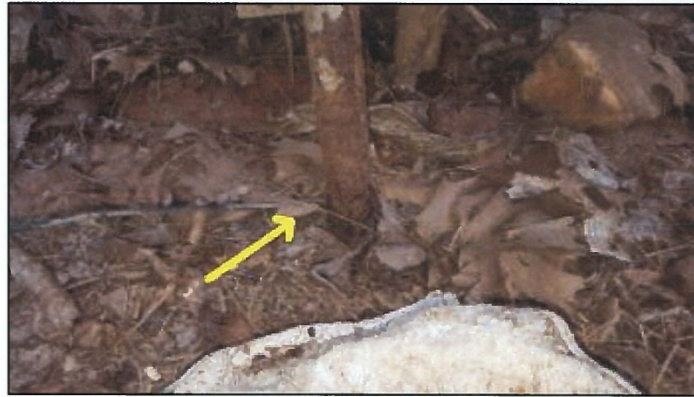
Heavily deteriorated main gas line
