## Springfield Art Museum

## HVAC Assessment

## Roof Assessment Report 2024

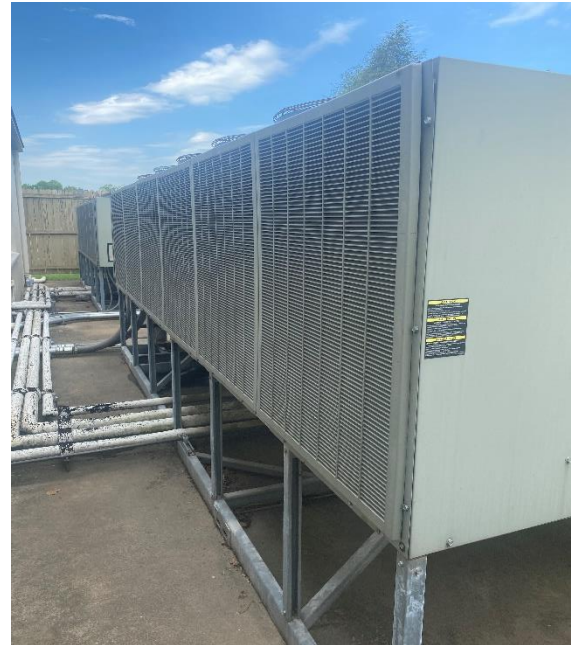
-Coils have had multiple repairs and are brittle.

-Chiller 2 Circuit 2 needs solenoid replaced **\$10,000**

\*It is my opinion that the Chiller plant needs replacement during the remodel project.

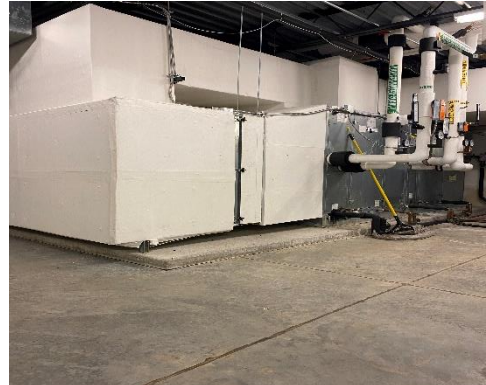
## Air Handlers:

- Good condition
- Has had a new coil installed.
- Bearings have no issues.
- Replacement cost - **\$80,000.00** Based on \$5 per CFM @ 16,000cfm potential.

\*Estimated life expectancy 10 years w/ proper maintenance

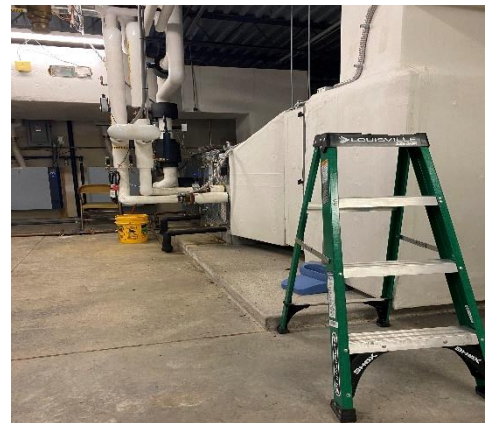
### Fresh Air unit:

- Good condition
- Bearings have no issues.
- Drain pan in good shape.
- Replacement cost - **\$66,000.00** Based on \$5 per CFM @ 13,200cfm potential.

\*Estimated life expectancy 10 years w/ proper maintenance

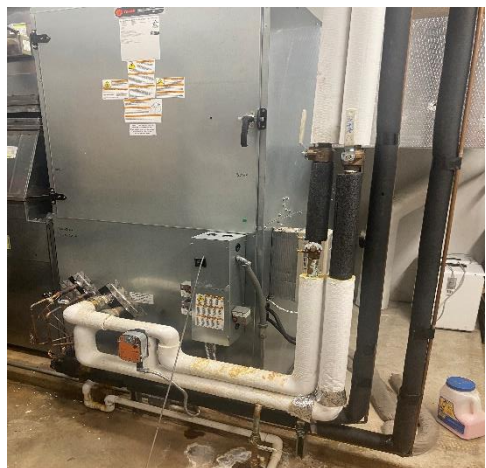
### Musgrave Wing:

- Good condition
- Bearings have no issues.
- Drain pan in good shape.
- Replacement cost - **\$20,000.00** Based on \$5 per CFM @ 4,000cfm potential.

\*Estimated life expectancy 8 years w/ proper maintenance

**\*Not tied into chiller loop**

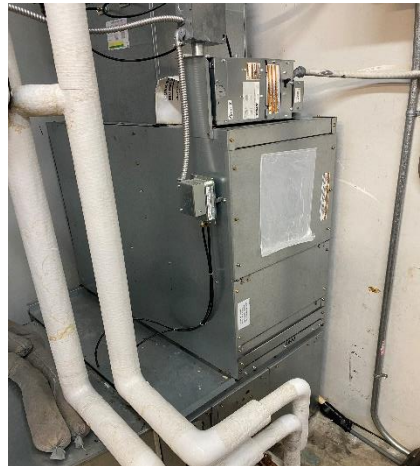
## Musgrave Restrooms:

- Good condition
- Bearings have no issues.
- Drain pan in good shape.
- Replacement cost - **\$10,000.00** Based on \$5 per CFM @ 2,000cfm potential.

\*Estimated life expectancy 6 years w/ proper maintenance

**\*Not tied into chiller loop**

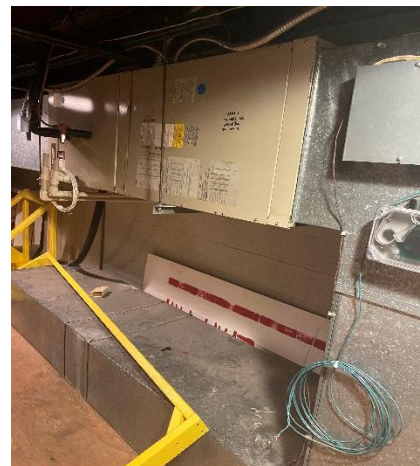
## Lower Vault:

- Passable condition
- Bearings have high pitched noise with a slight wobble.
- Drain pan in good shape.
- Replacement cost estimate- **\$10,000.00** Based on \$5 per CFM @ 2,000cfm potential.

\*Estimated life expectancy 3 years

**\*Recommend replacement during project**

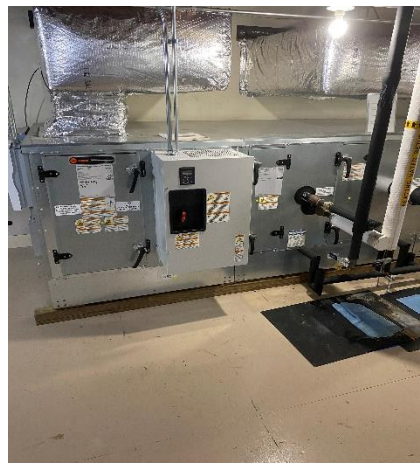
## Weisel/Kelly:

- Good condition
- Bearings have no issues.
- The drain pan is rusted but not through.
- Replacement cost estimate - **\$15,000.00** Based on \$5 per CFM @ 3,000cfm potential.

\*Estimated life expectancy 10 years w/ proper maintenance

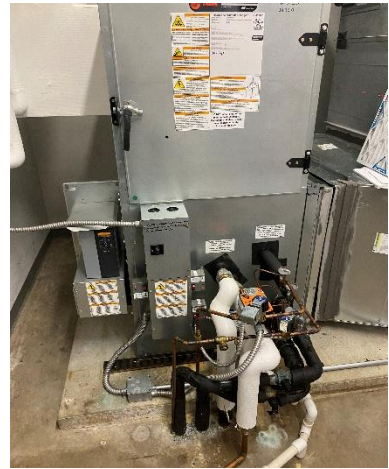
## Upper Vault:

- Good condition
- Bearings have been replaced but are making a grinding noise.
- Drain pan in good shape.
- Replacement cost estimate - **\$8,000.00** Based on \$5 per CFM @ 1,600cfm potential.

\*Estimated life expectancy 8 years w/ proper maintenance

**\*Not tied into chiller loop**

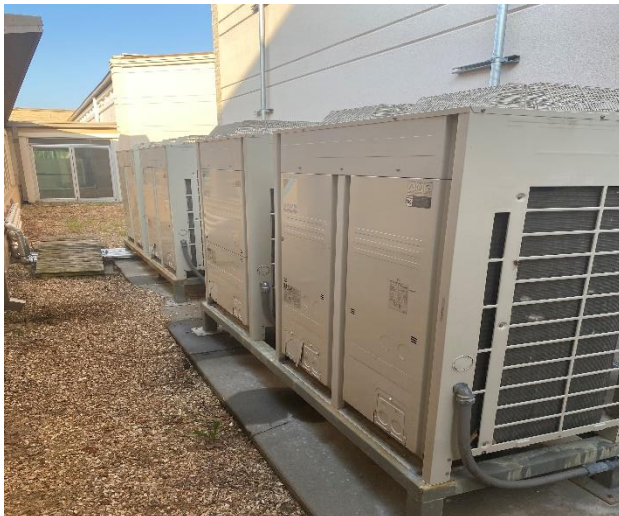
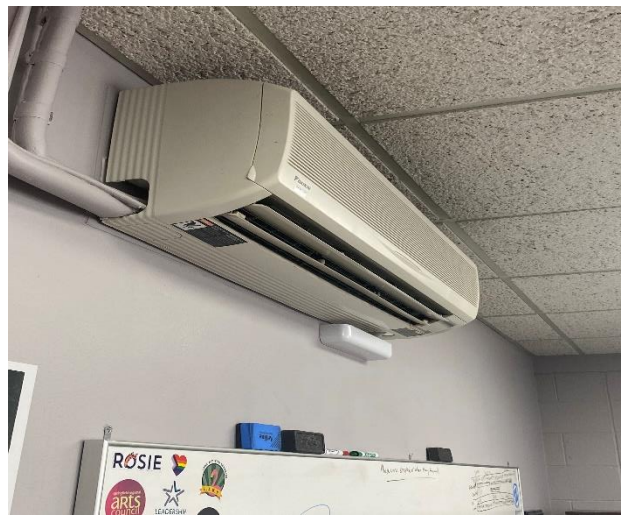
## Daikins:

- Working condition
- Many complaints.
- Unable to maintain environment.
- Do not recommend keeping.

**\*Not tied into chiller loop**

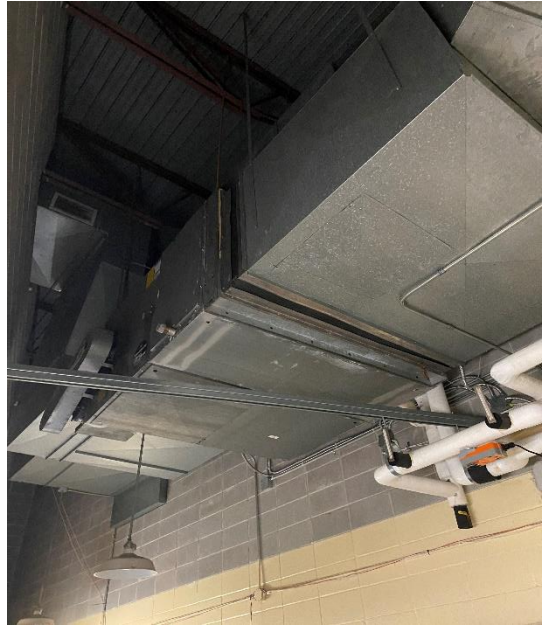
## Auditorium units:

- Condition – Not operating at this time.
- Leaking valves
- Bearings need to be replaced.
- Repair estimate = **\$5,000 each unit**
- Replacement cost estimate = **\$15,000.00** per unit. Based on \$5 per CFM @ 3,000cfm potential.

\*Recommend replacement during remodel

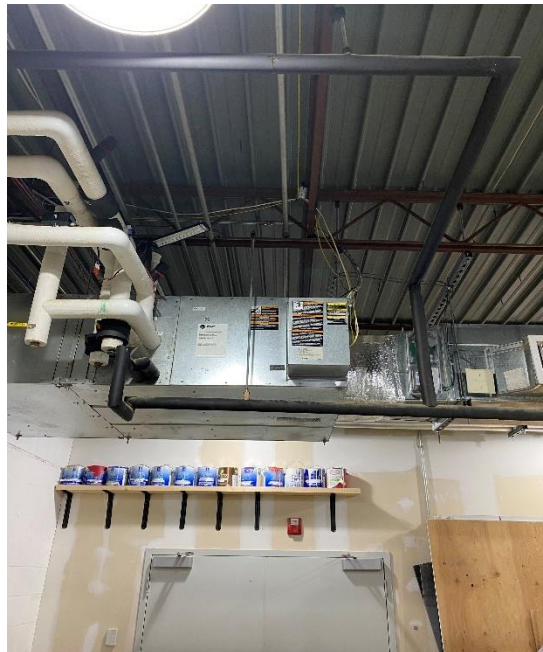
### Shop FCU:

- Good Condition
- No Issues at this time
- Replacement cost estimate = **\$6,000.00** Based on \$5 per CFM @ 1,200cfm potential.

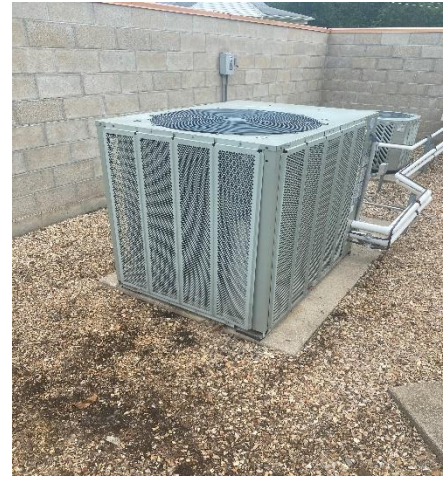
- Good condition
- Compressor has been replaced.
- Fan motor has been replaced.
- Replacement cost = **\$6,000.00**

\*Estimated life expectancy 10 years w/ proper maintenance

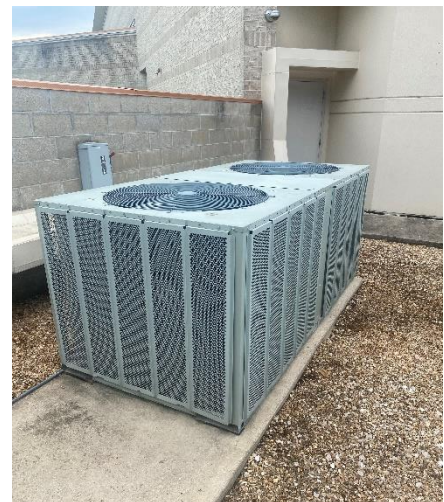
### Musgrave Wing-

- Good condition
- VFD and contactors have been replaced.
- Fan motor has been replaced.
- Replacement cost = **\$8,000.00**

\*Estimated life expectancy 10 years w/ proper maintenance

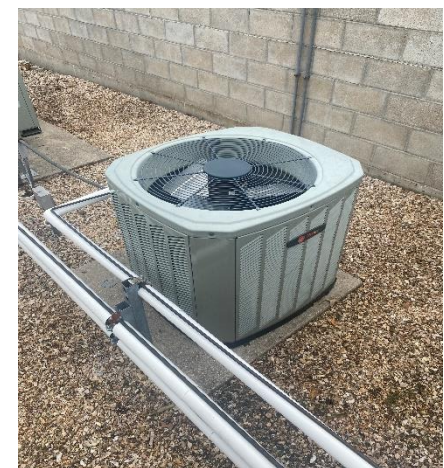
### Musgrave Restrooms-

- Good condition
- Pressure switches have been replaced.
- Fan motor has been replaced.
- New TXV
- Replacement cost = **\$3,000.00**

\*Estimated life expectancy 8 years w/ proper maintenance

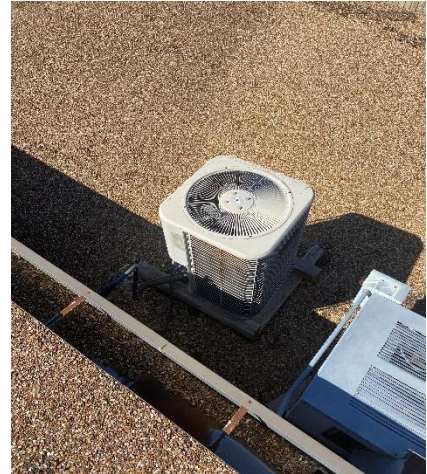
## Back of House-

- Condition - working
- End of Life
- Replacement cost = \$4,000.00

\*Estimated life expectancy 0 years Recommend replacement.

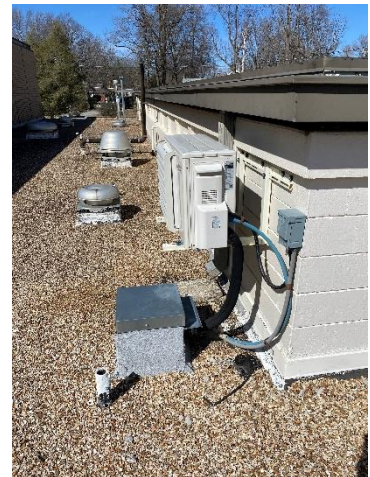
### Security Office-

- Good condition
- Replacement cost = \$4,500.00

\*Estimated life expectancy 10 years w/ proper maintenance

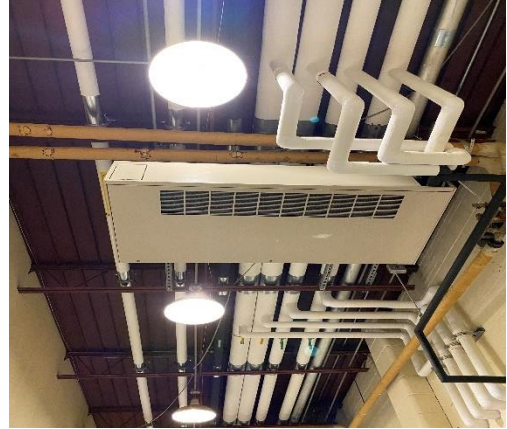
## Frame Shop FCU:

- Does not currently work.
- Replacement estimate **\$2,500.00**

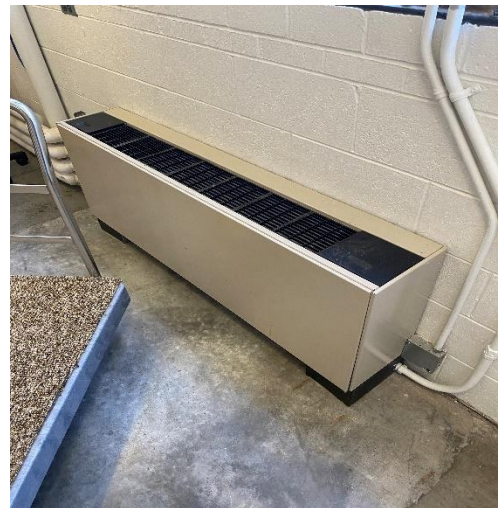
## Back of House FCU:

- Good condition
- Older unit/ Past life
- Replacement estimate **\$2,500.00**

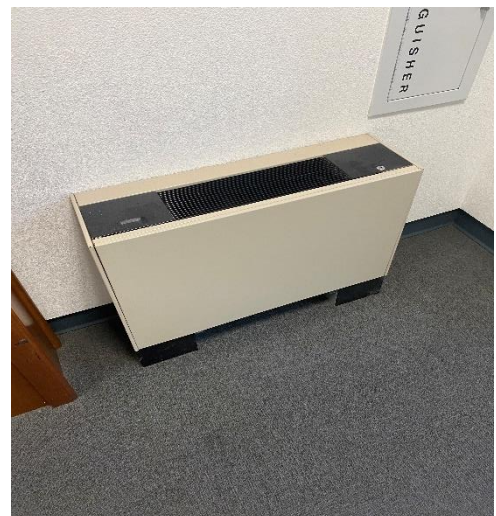
## West Hall FCU:

- Good condition
- Older unit/ Past life
- Replacement estimate **\$1,500.00**

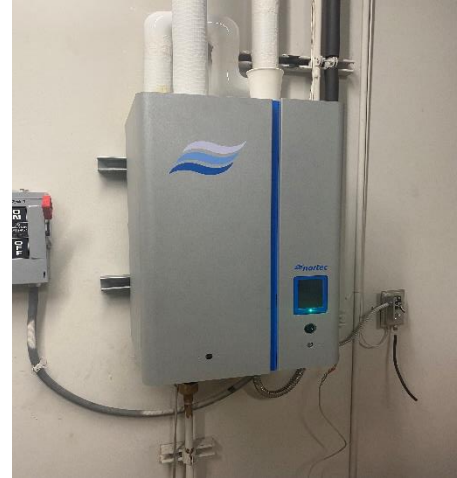
### Musgrave Wing:

- Most of the components have been replaced on this unit. It requires tank replacements during PM's. This unit is working properly.
- Estimated life – 5 years before parts are discontinued.
- Replacement Price - **\$8,000**

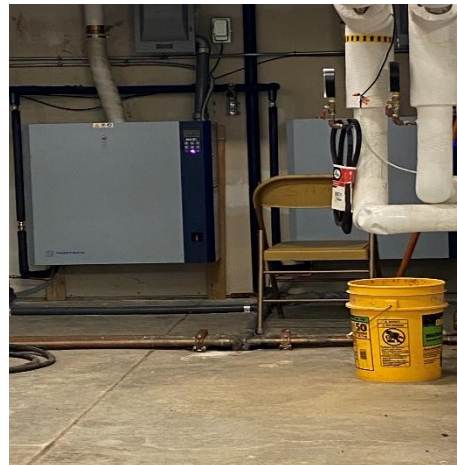
### New Wing:

- Good condition
- New tanks in both units.
- Heating elements need to be replaced.
- New temp sensors installed.
- Replacement cost - **\$20,000.00**

\*Estimated life expectancy 8 years w/ proper maintenance

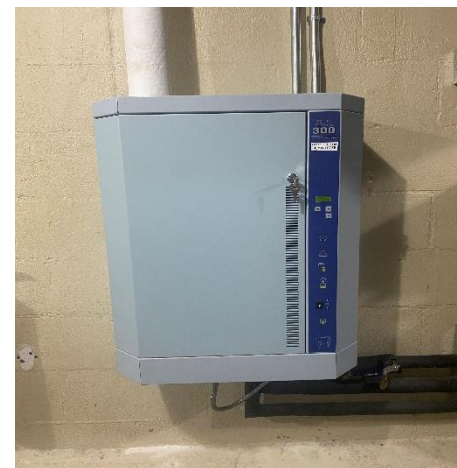
### Weisel/Kelly:

- Good condition
- Has cleanable tank
- Will need to replace the heating elements soon.
  - o New elements = \$800
- New unit **\$4,000.00**

\*Estimated life expectancy 8 years w/ proper maintenance

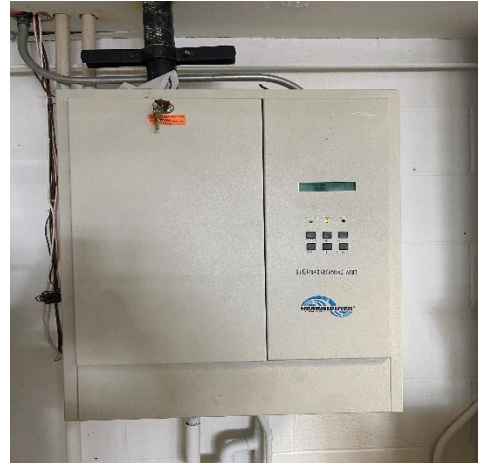
## Lower Vault:

- Working condition
- End of life /Parts discontinued.
- Replace as soon as possible.
- Replacement = **\$4,000.00**

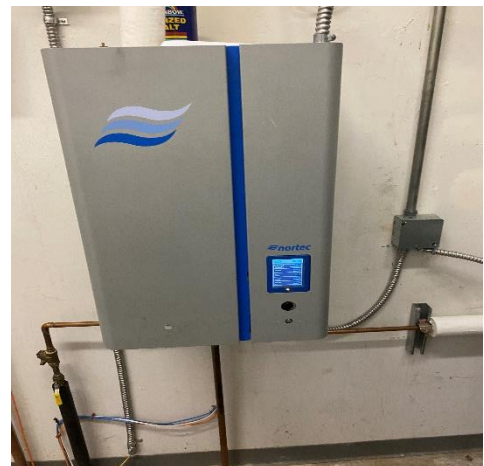
## Upper Vault:

- Most of the components have been replaced on this unit. It requires tank replacements during PM's. This unit is working properly.
- Estimated life – 5 years before parts are discontinued.
- Replacement Price - **\$4,000.00**

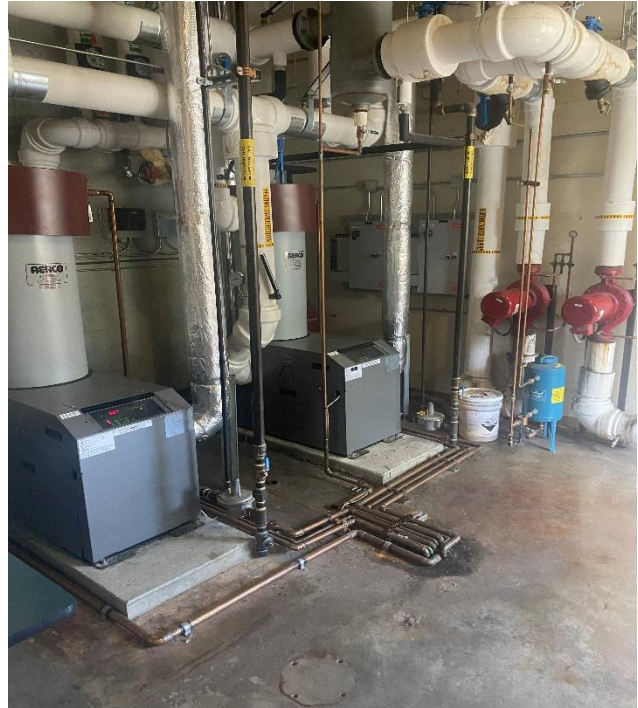
- Current condition Good
- Constant breakdowns
- Both have had the ignition boards and sensors replaced.
- Parts are expensive.
- Replacement cost for both **\$60,000.00**

\*Estimated life – 5 years before parts are discontinued and hard to find.

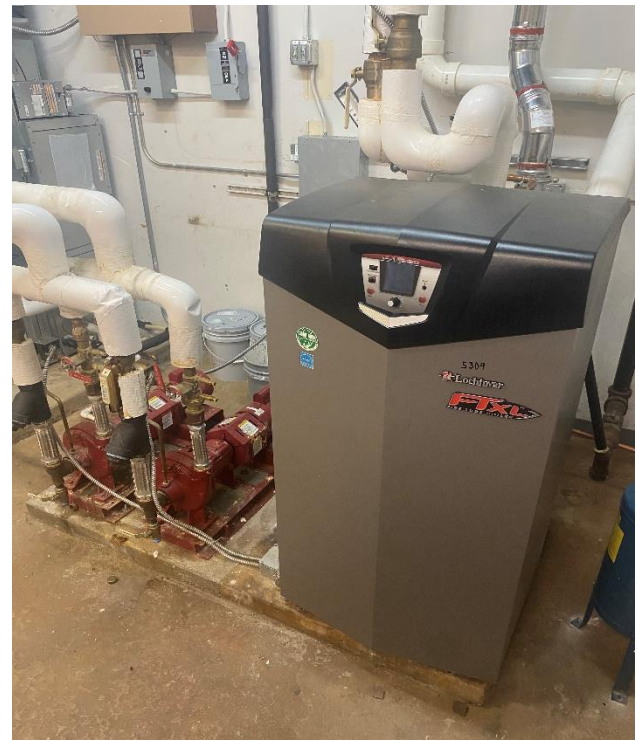
### Lochinvar FTXL:

- Condition – Good
- No issues at this time
- Replacement cost = **\$10,000.00**

\*Estimated life – 8 years before parts are discontinued and hard to find.

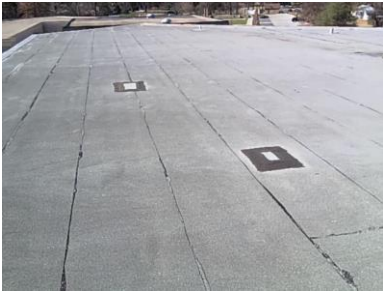
| Roof | Previous repairs | |

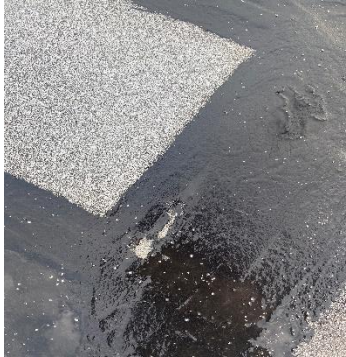
| Roof | Failing repair | |

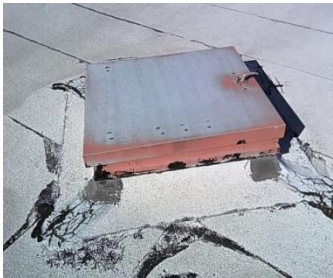
| Roof | Roof access is rusted, needs to be painted | |

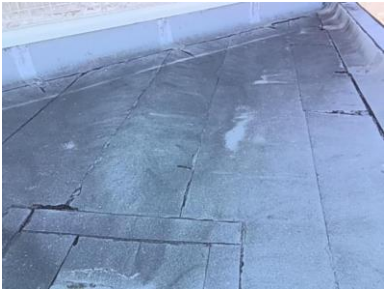
| Roof | Blister | |

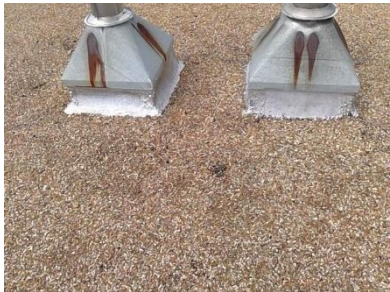
| Roof | Slight rusting on exhausts | |

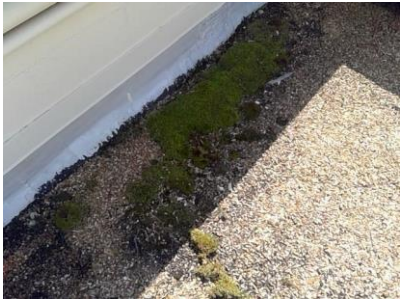
| Month Ending: | March | Roof: | Roof E Mechanical/Shop | | | |
|---|---|---|---|---|---|---|
| Field of Roof | Inspect Roofing material is free from rips, tears, holes, soft areas, and any other deficiencies. Make sure there are no plants/weeds growing on roof. | | Fair | | | A couple soft areas. Moss growing on roof |

| Roof | Moss growing in some areas | |

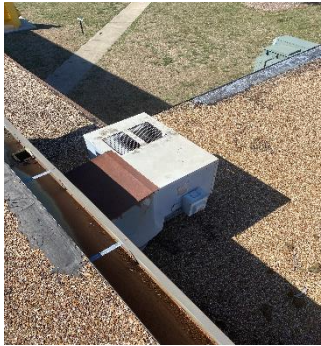
| Roof | Old HVAC units need to be replaced | |

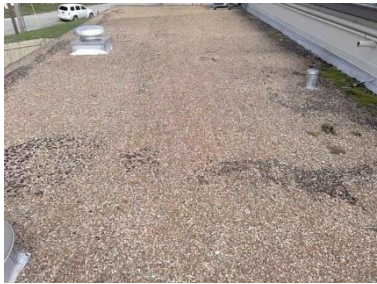
| Roof | A couple soft areas | |

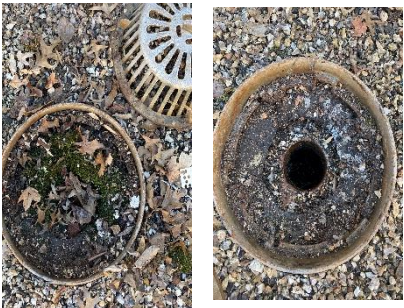
| Roof | Roof drain was clogged, cleaned out during inspection | |

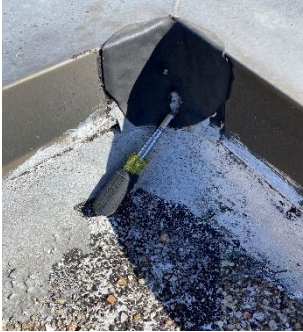
| Roof | Hole in corner patch | |

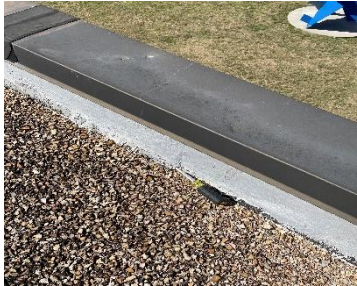
| Roof | Hole in flashing | |

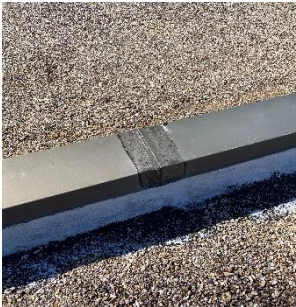
| Roof | Coping seams are failing | |

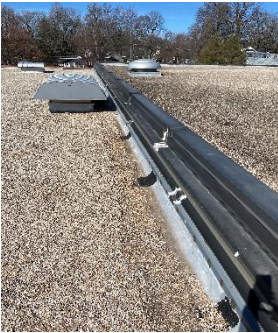
| Roof | Multiple repairs to the flashing | |

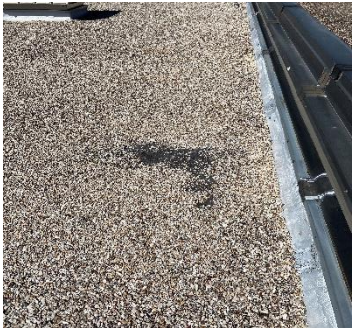
| Roof | A couple soft areas | |
