# Springfield Land Clearance for Redevelopment Authority

**4.III. Blight Report And Redevelopment Plan For The East Cherry Flats Redevelopment Area**

Documents: [EAST CHERRY FLATS BLIGHT REPORT AND REDEVELOPMENT PLAN.PDF](#)

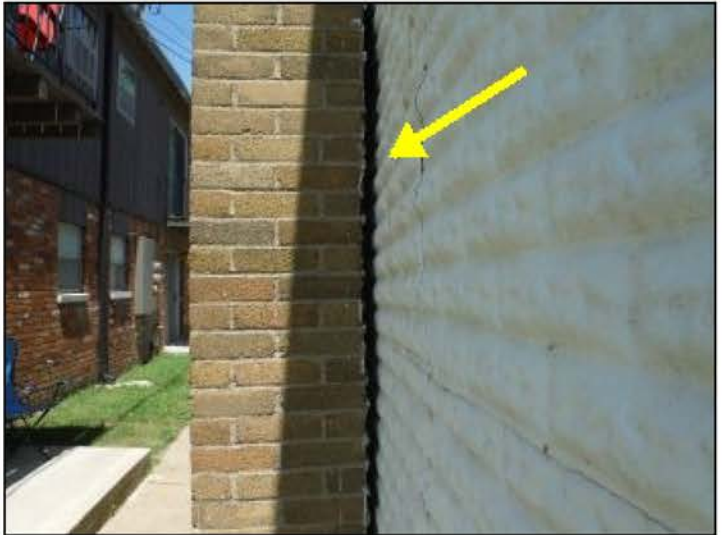
Deteriorated masonry, note gaps at wall and rusted steel anchoring

1-2" gap noted

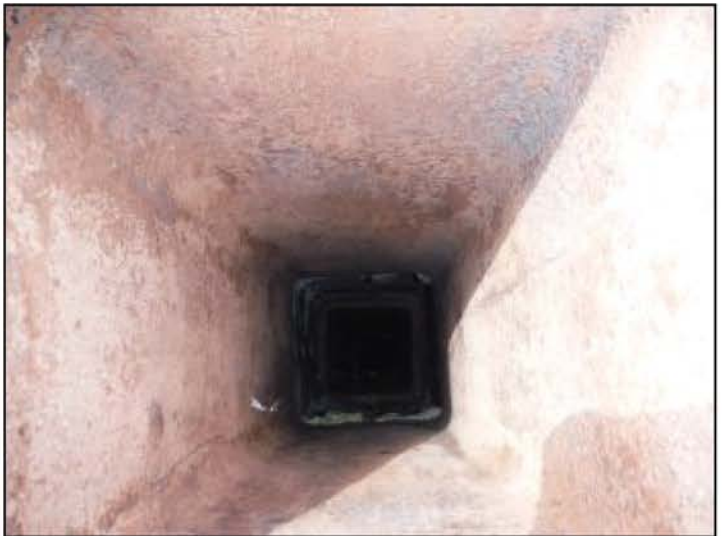
Horizontal cracks are sure sign of settling out of plumb

Flue is clean

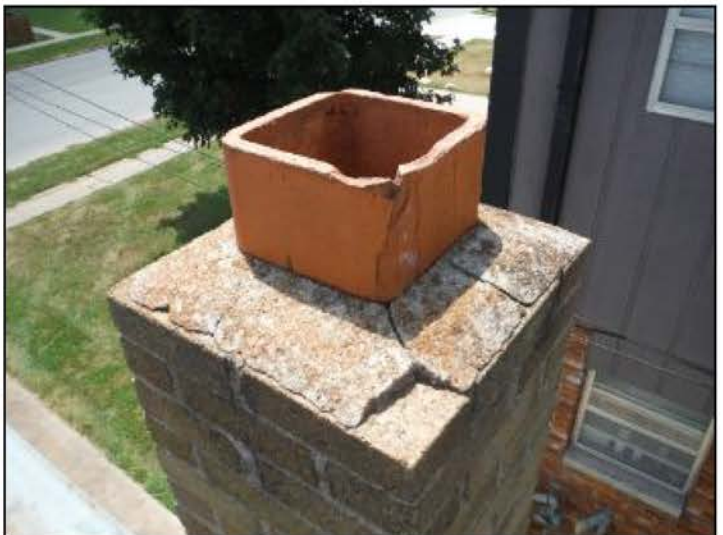
Missing rain cap and screen, water and birds can enter

Refer to mason, deteriorated crown and top tile noted

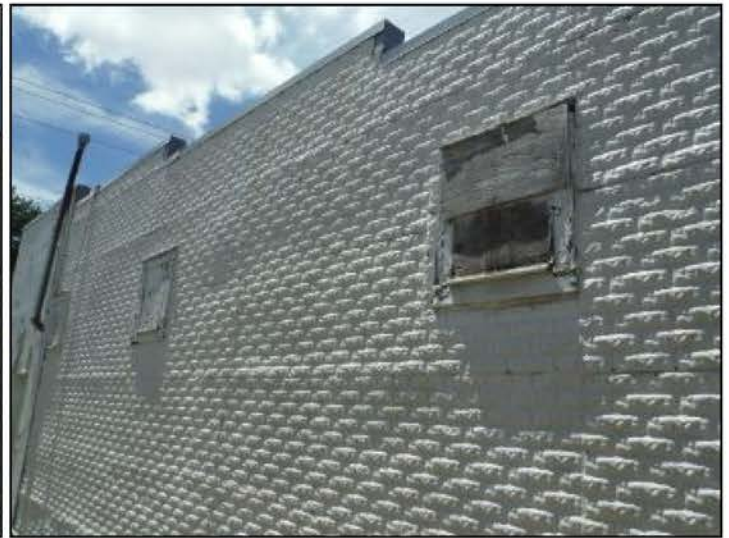
Damaged siding needs repair, moisture entering wall/s

Recovered siding

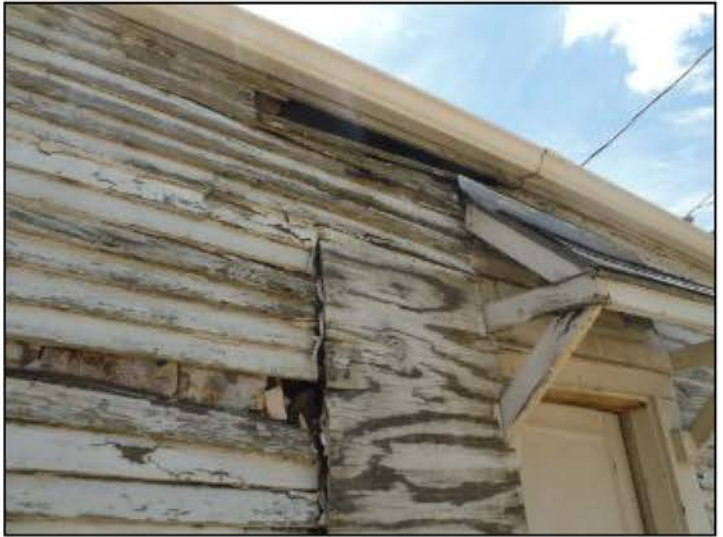
Vehicle damage is likely

Closeup of deteriorated wood siding at back

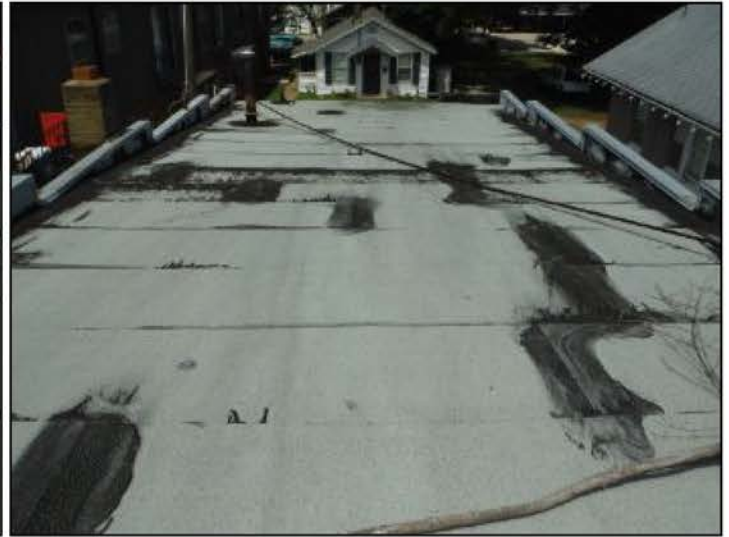
At end of life, needs stripping and replacement  
ASAP

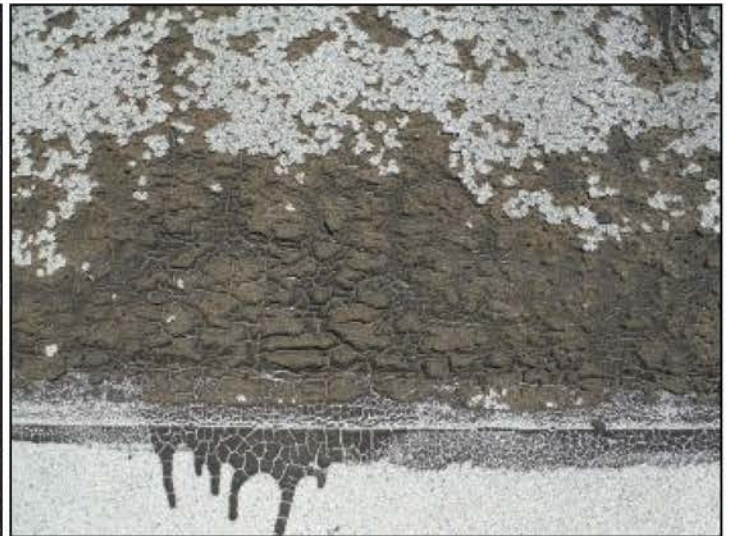
At end of life, needs replacement when reroofed

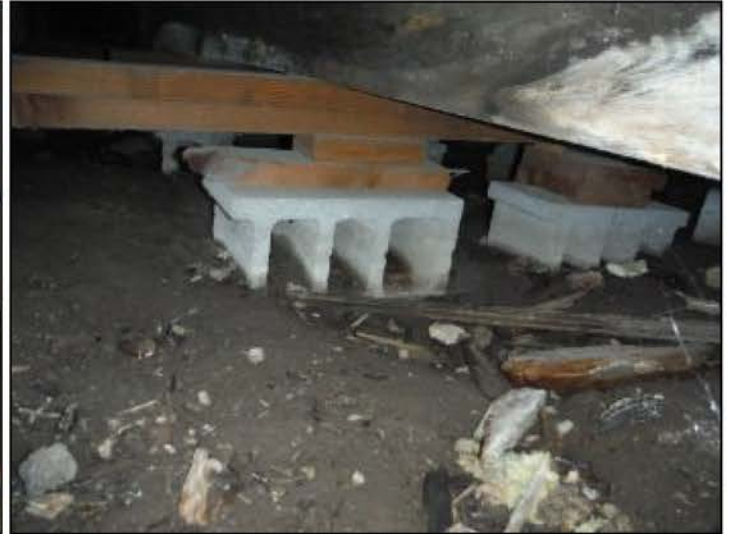
Skirting/siding conceals access at back

Too low to crawl, this view from damage/hole

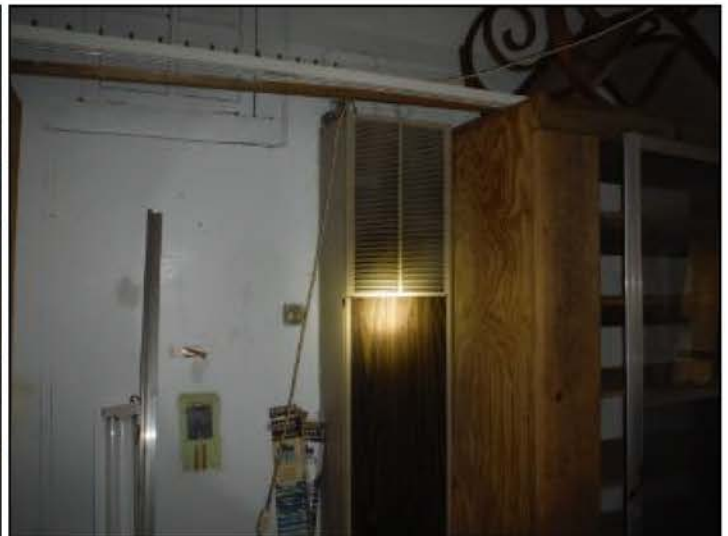
Untested older unit needs upgrade/replacement

Untested, gas off

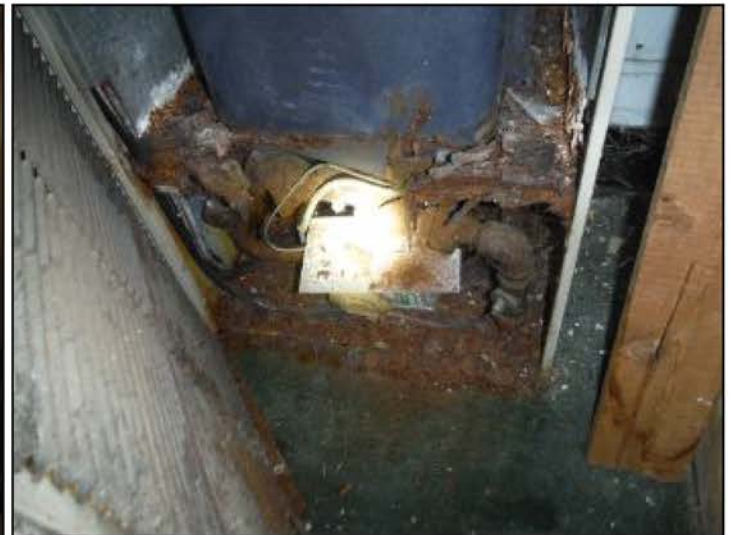
Old rusty unit needs to be replaced

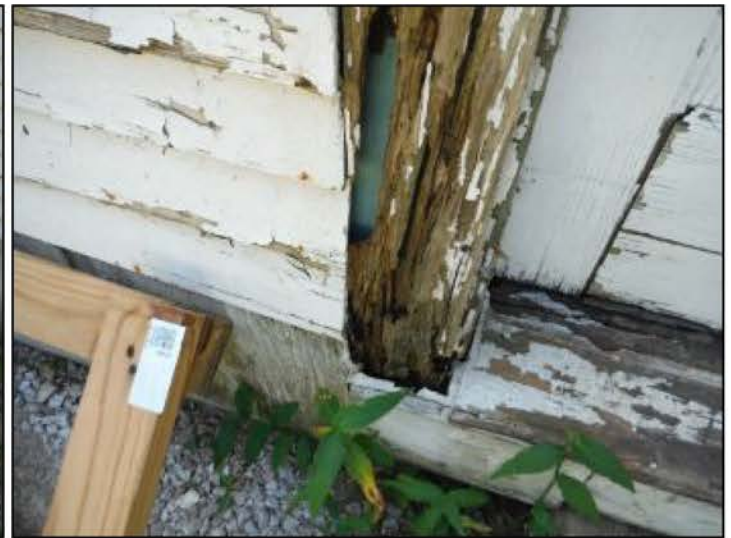
Trip hazards at back door, no proper stoop

Rotted

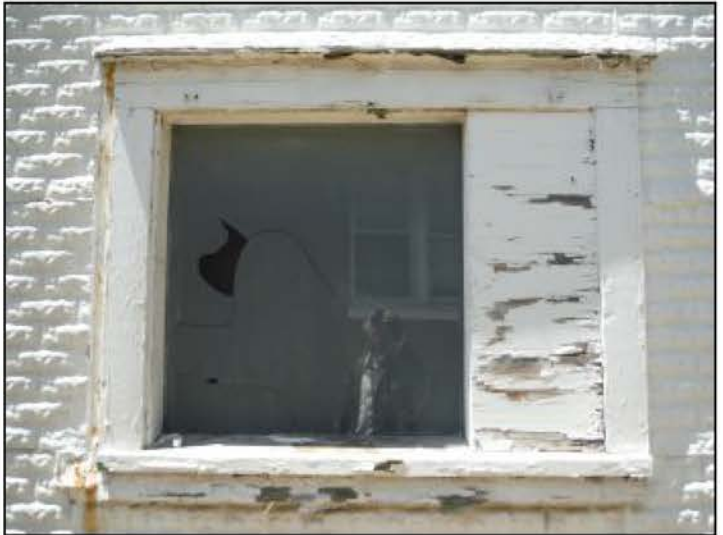
Boarded up

Broken unit/s are potential liability

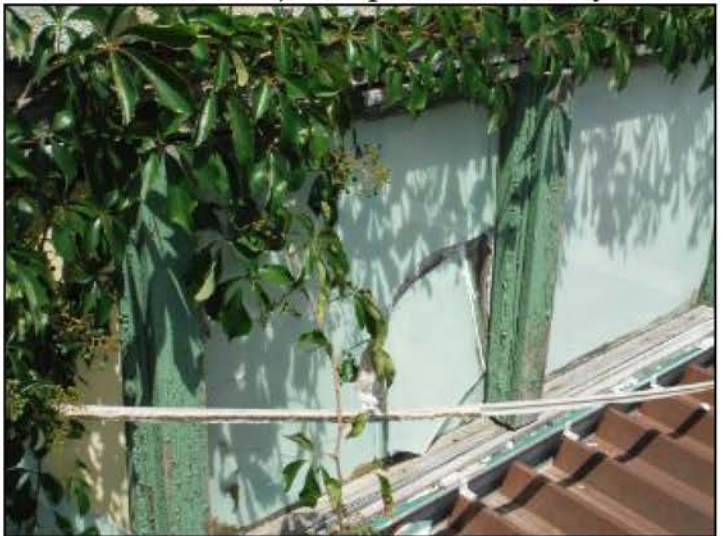
Broken unit/s are potential liability

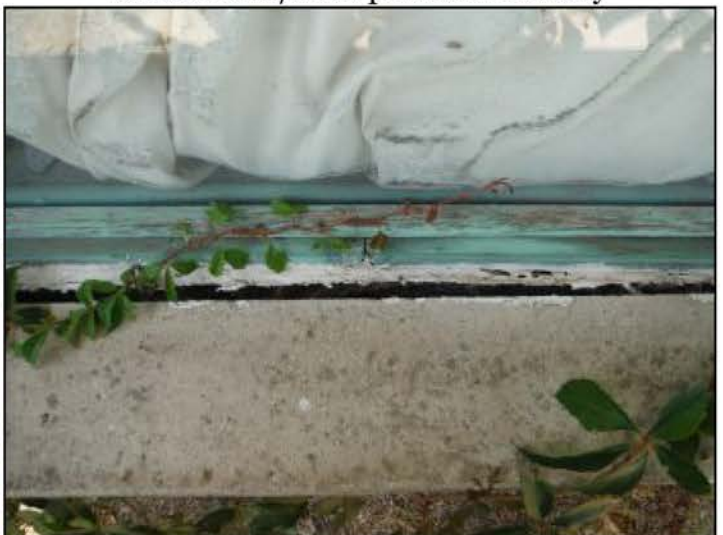
Foliage limits access

Broken unit/s are potential liability

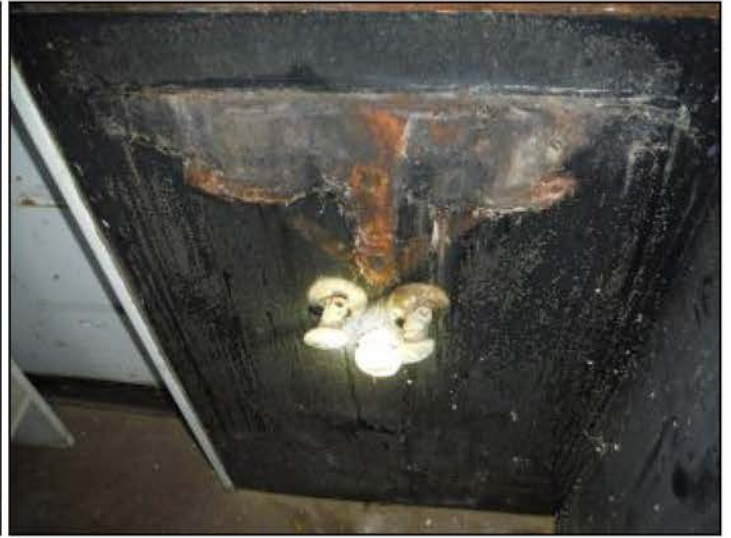
Damaged drywall

Some storage is hazardous (broken glass in photo)

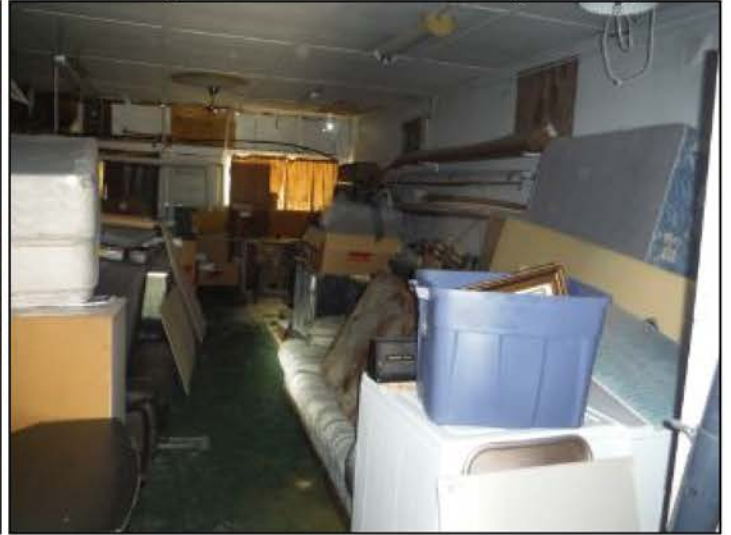
Some storage is hazardous

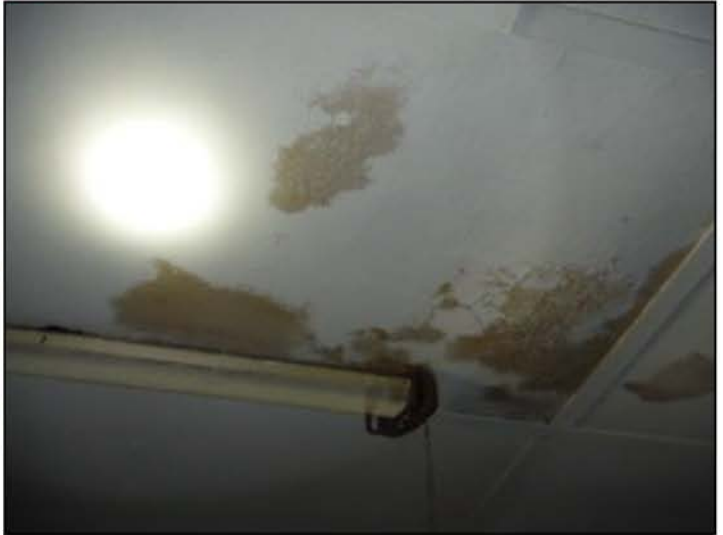
Numerous stains

Stains and water damaged ceiling, sign of roof issues

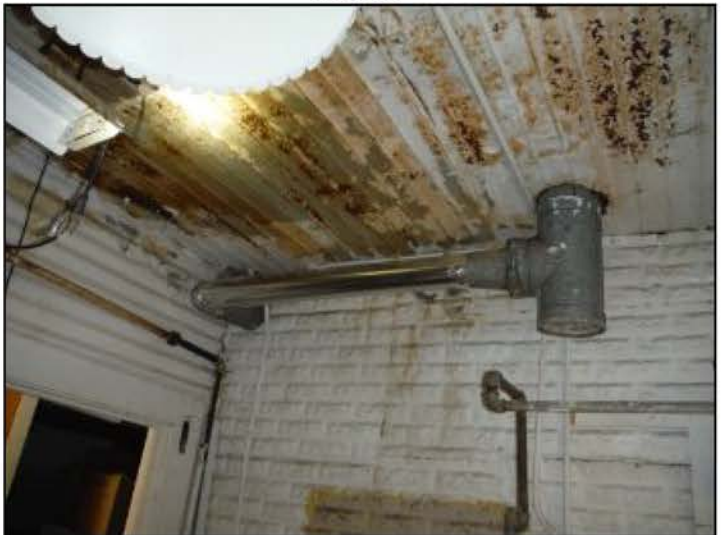
Stains and water damaged ceiling, sign of roof issues

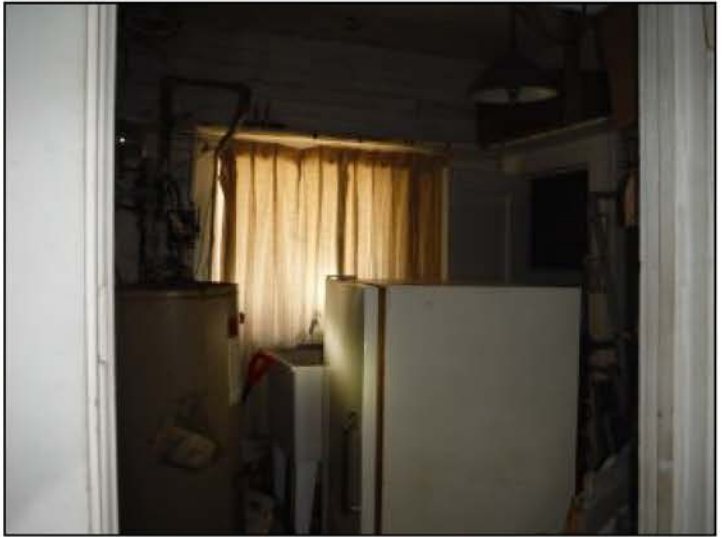
Damaged at back door

Most concealed by storage

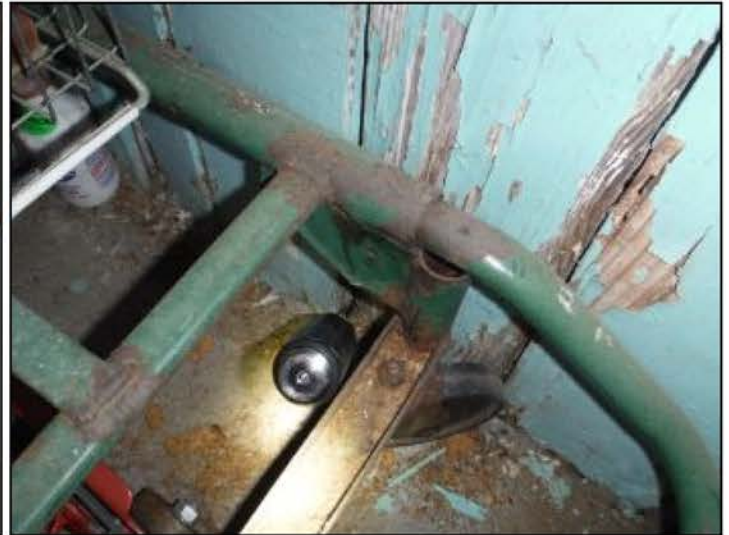
Uneven/cracked concrete floor noted

Rot measured at wood walls of screened porch

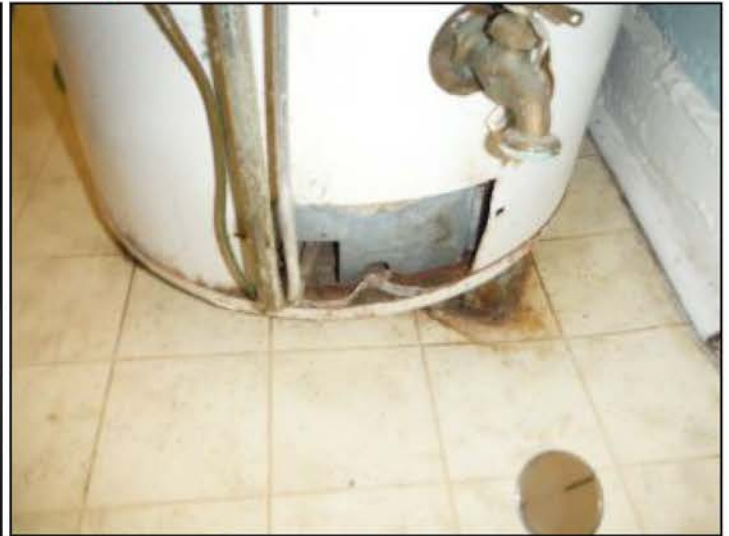
Backdraft measured, is persistent, refer to plumber for repair ASAP (health and safety hazard)

Avoid combustible storage, burns room/conditioned air, less efficient

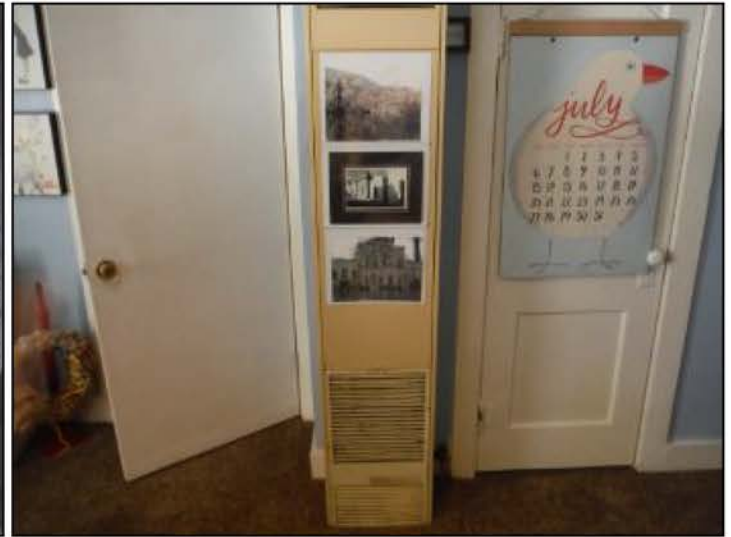
Carpet floor not prudent

Older wall heater has limited economic lifespan, is fuel inefficient, hazardous and obtrusive

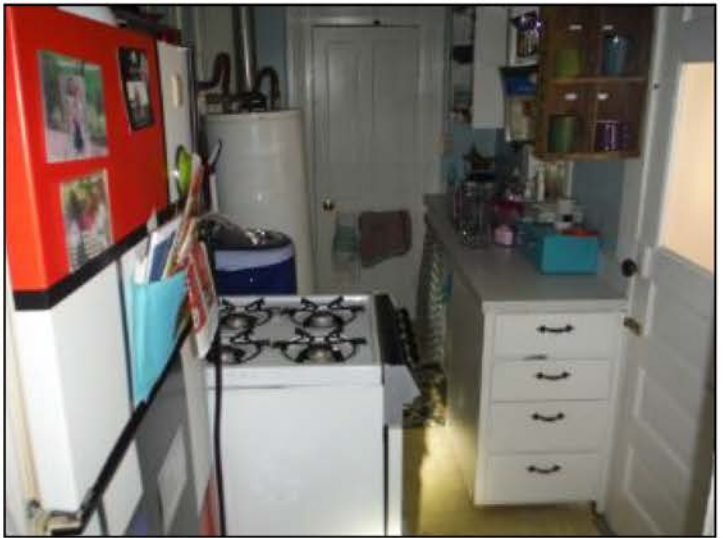
Missing cabinet doors

Primitive kitchen, minimal cabinetry, galleyu style

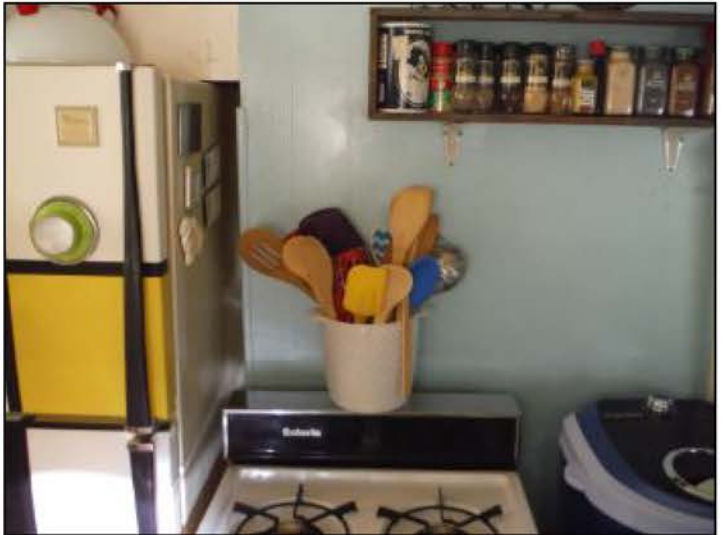
Did not self light, safety hazard, needs immediate repair

No exhaust hood at gas range, is this legal?

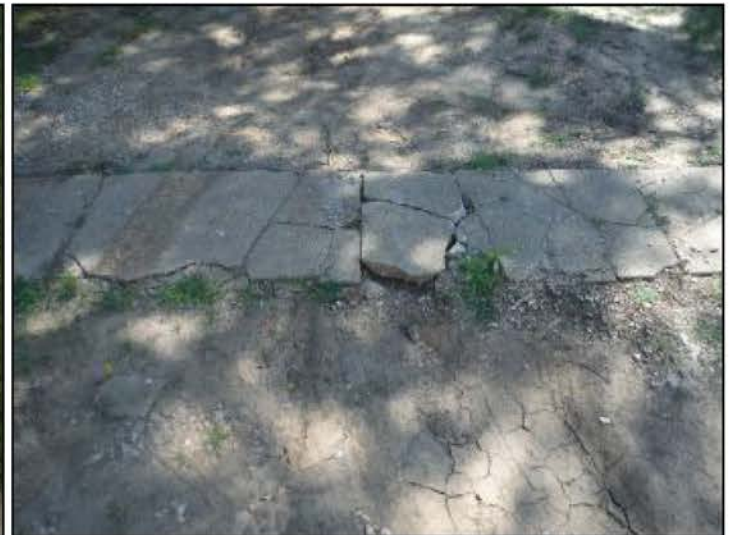
Common and larger cracks with lifting/settling to 1-2 inches, trip hazards

Older/deteriorated concrete walks are at/near end of normal life

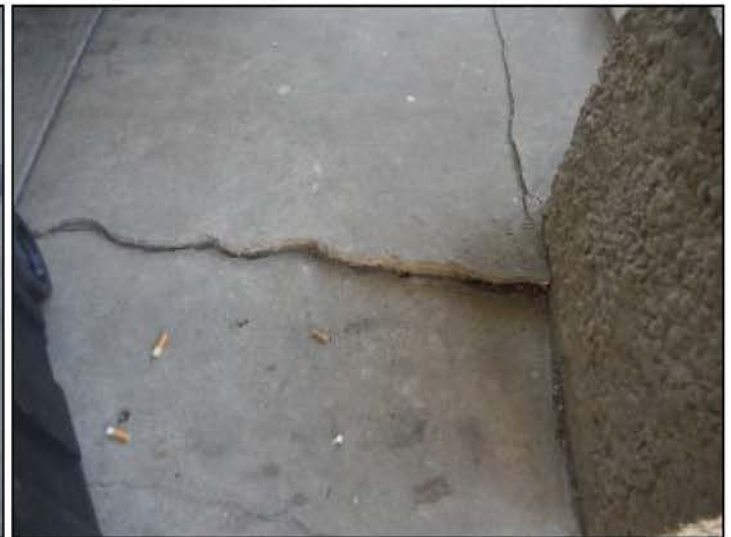
Serviceable concrete is cracked and settled (apx. one inch, both sides)

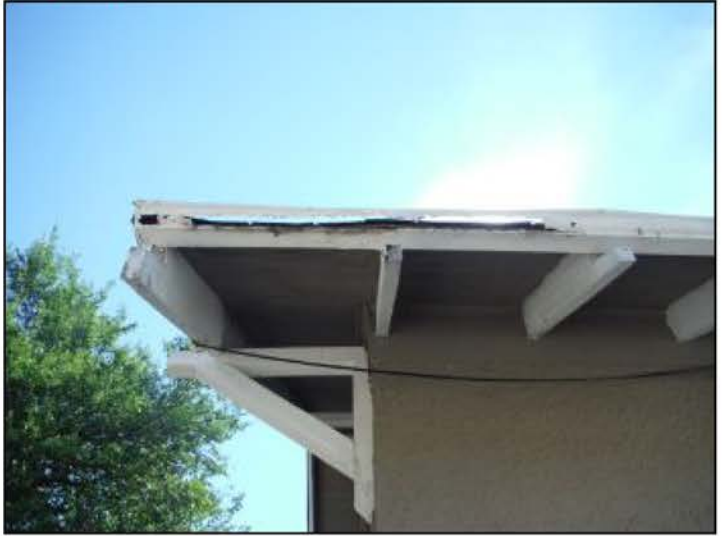
Rusted/damaged/incomplete guttering needs removal/replacement

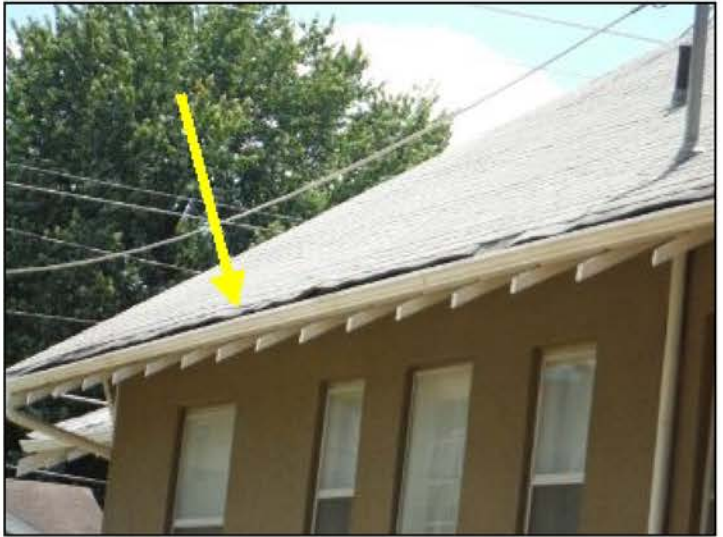
Refer to qualified roofer to do maintenance, replace missing shingles, seal flashing as needed

Unsightly curl at eaves/gutters noted (no drip edge flashing, shingles unsupported)

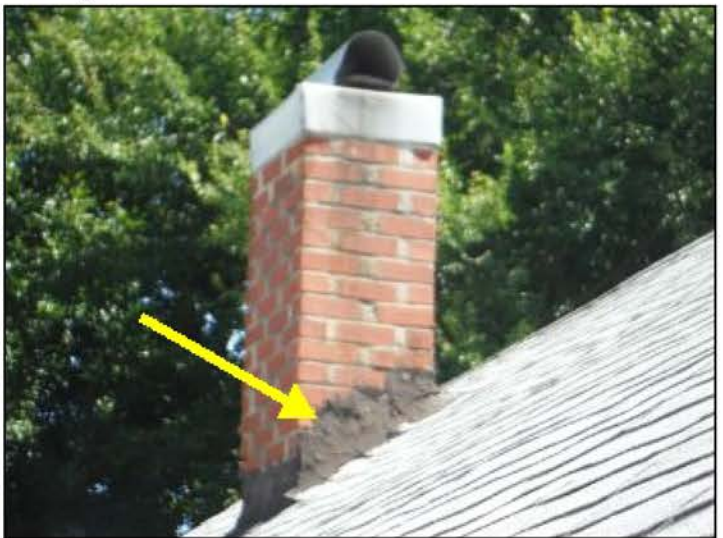
Periodic inspections recommended, reseal penetrations and transitions as needed

Mastic coated chimney flashing needs periodic recoating

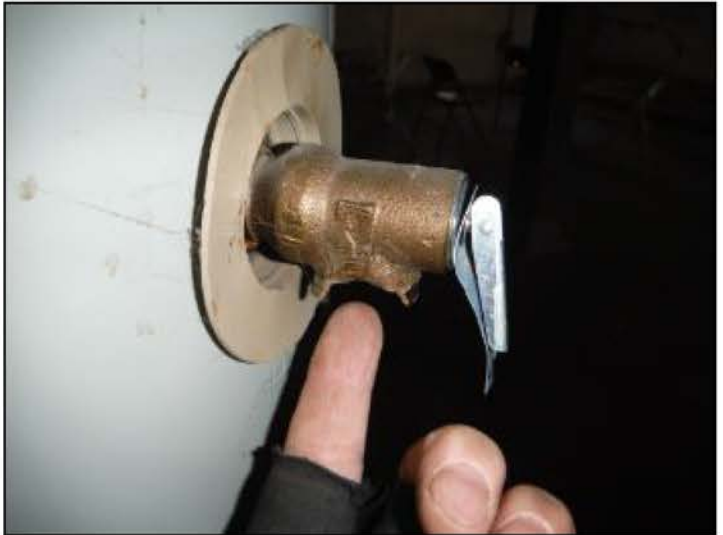
Old standard, burns basement air, suggest upgrade

Missing overflow pipe at TPR valve

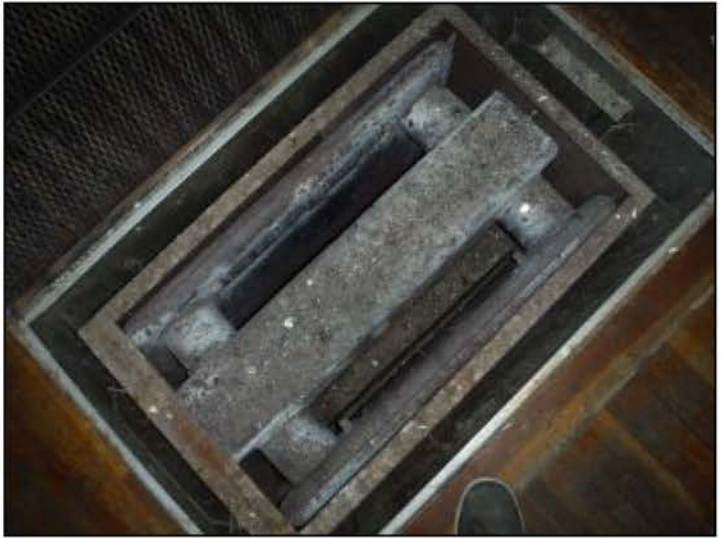
Dated system needs upgrading when central air conditioning is to be installed

Recommend regular cleaning by HVAC technician

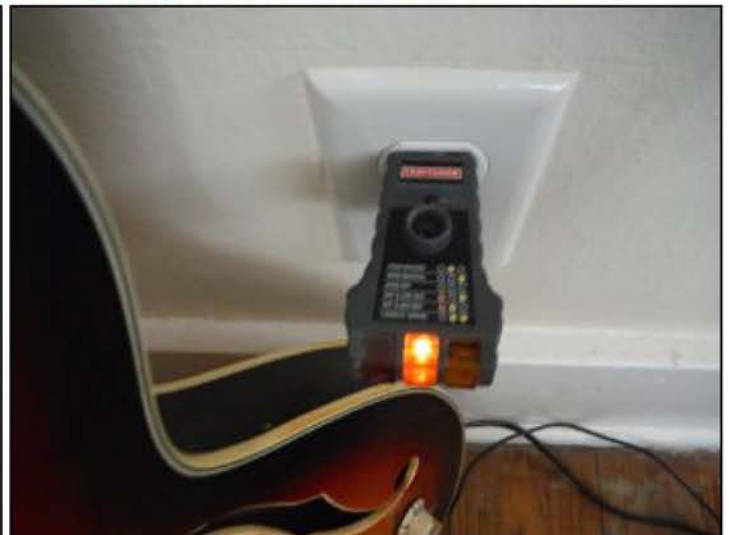
Some push button switches have mercury in them

Ungrounded/miswired (reverse polarity) outlet/s found, suggest all be checked and corrected

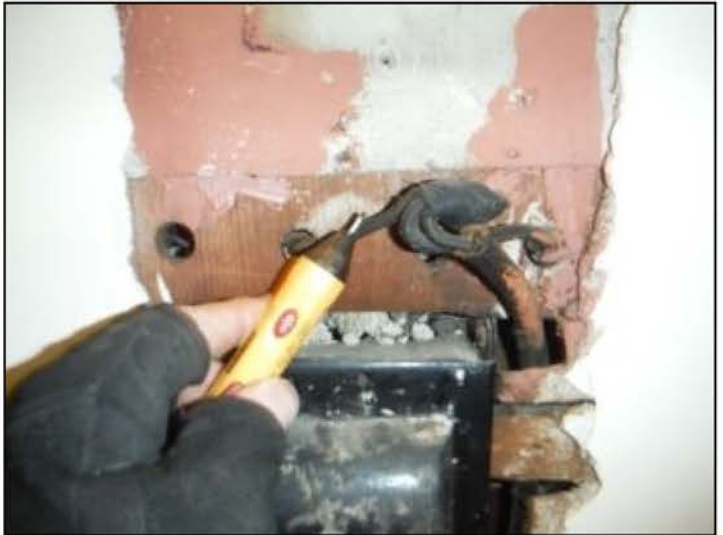
Ungrounded/miswired (reverse polarity) outlet/s found, suggest all be checked and corrected

Unsecured wiring (exposed wiring/splices/open junction boxes) observed at basement stairwell, refer to electrician to cleanup/secure

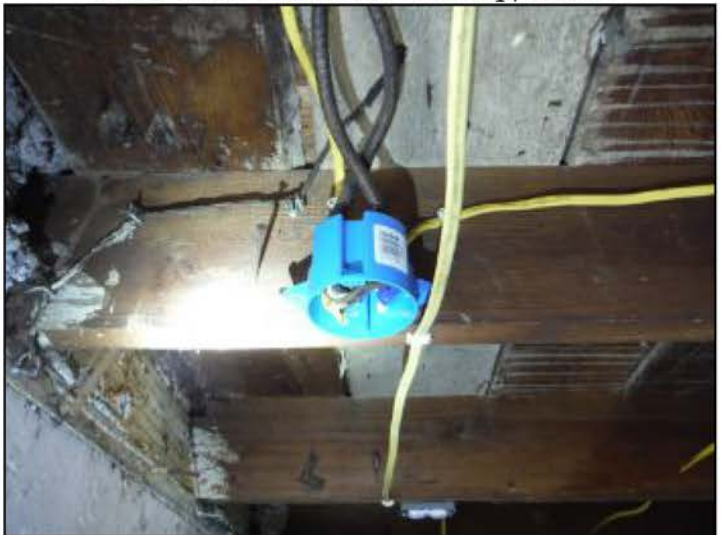
Unsecured wiring (exposed wiring/splices/open junction boxes) observed at basement and attic, refer to electrician to cleanup/secure

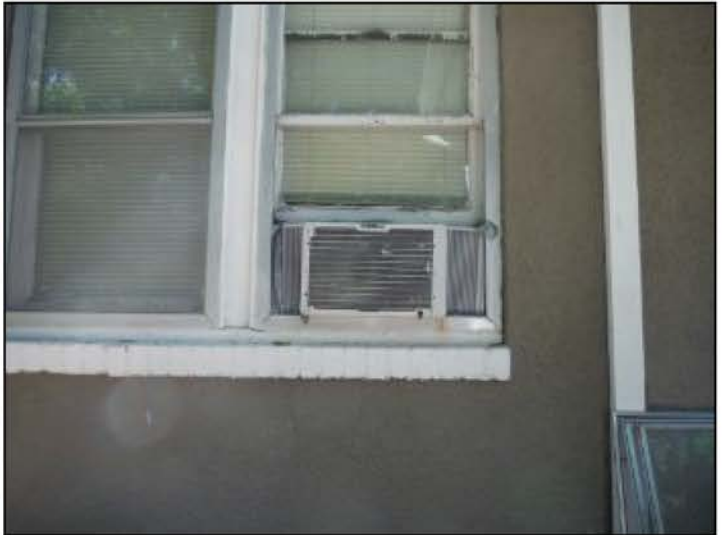
Refer to window specialist, need either upgraded with replacement windows or much overdue maintenance for serviceability

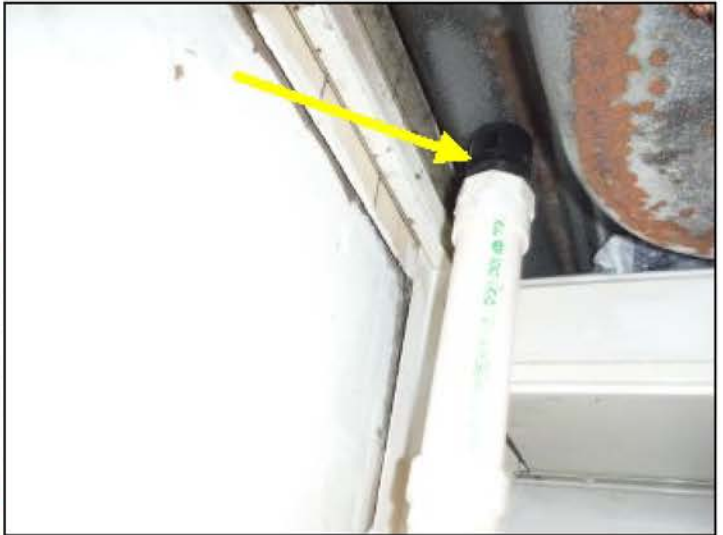
Leak/s at supply/faucet below, refer to plumber

Leak/s at supply/faucet below, refer to plumber Note pro vent below, ess trap noted (old standard)

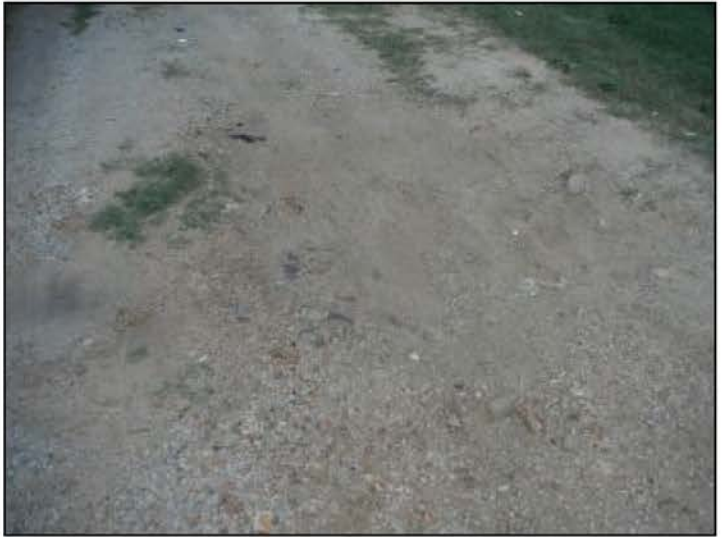
Deteriorated approach at shared driveway

Eroded gravel at shared drive

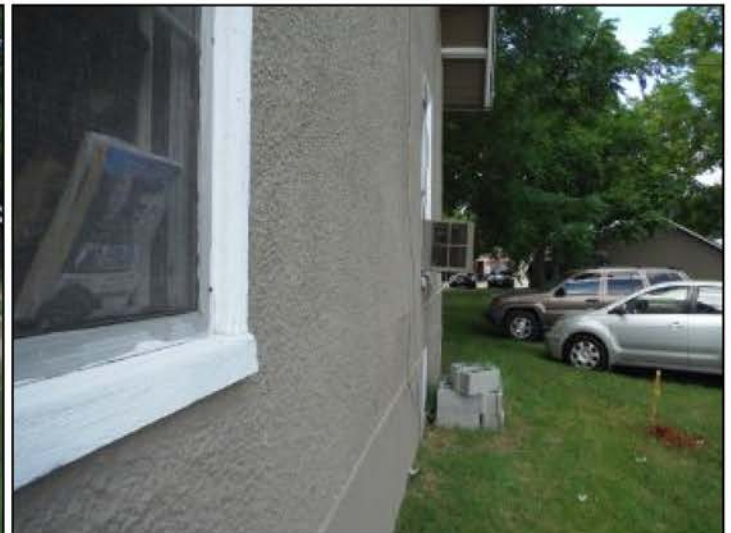
Common cracks at stucco

Loose/bulged at east side, refer to qualified stucco plasterer

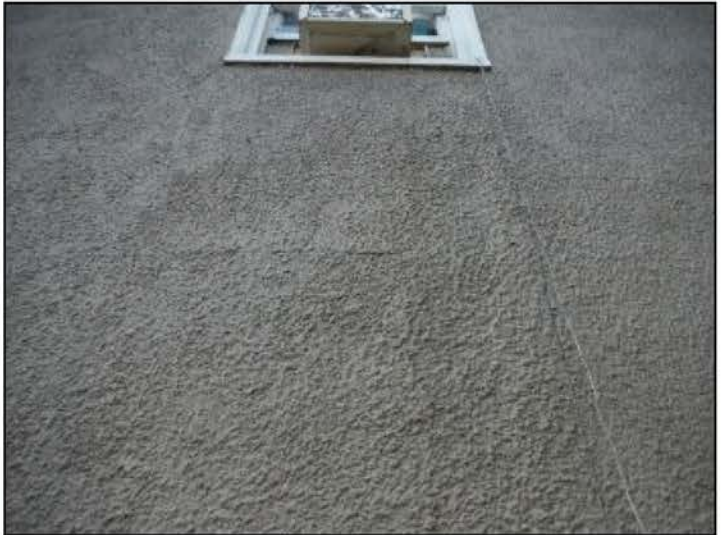
Loose/bulged at east side, refer to qualified stucco plasterer (closeup)

Loose/bulged at east side, refer to qualified stucco plasterer

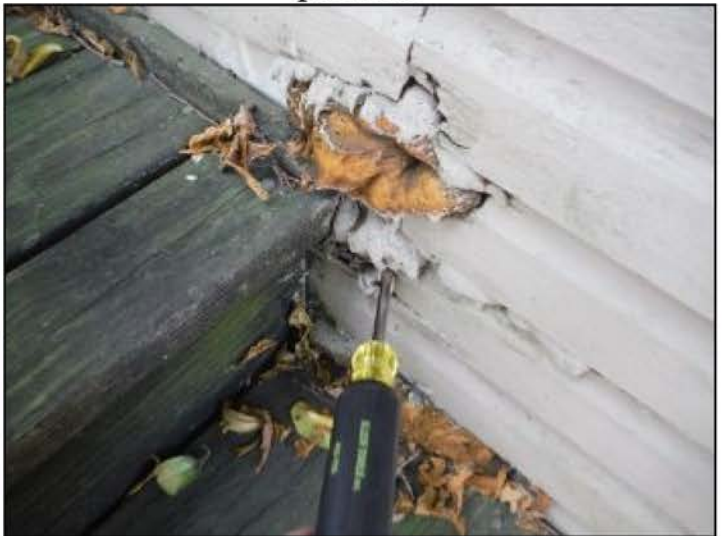
Missing wood lap siding at back eave

Rotted siding observed

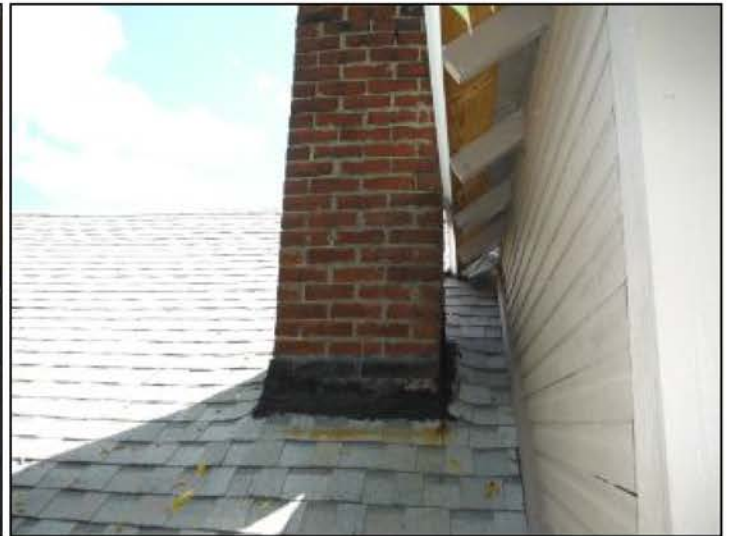
Refer to qualified roofer to seal/repair/maintain pipe/transition/chimney flashing

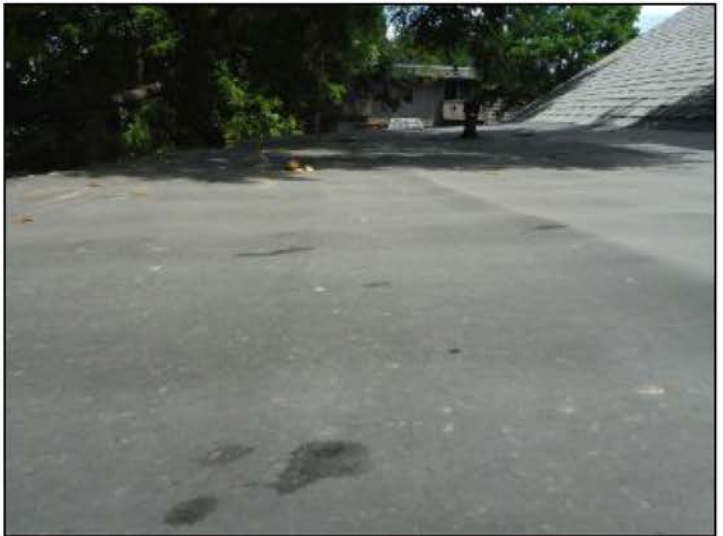
Tree limbs need trimming

Spongy, stains are sign of ponding

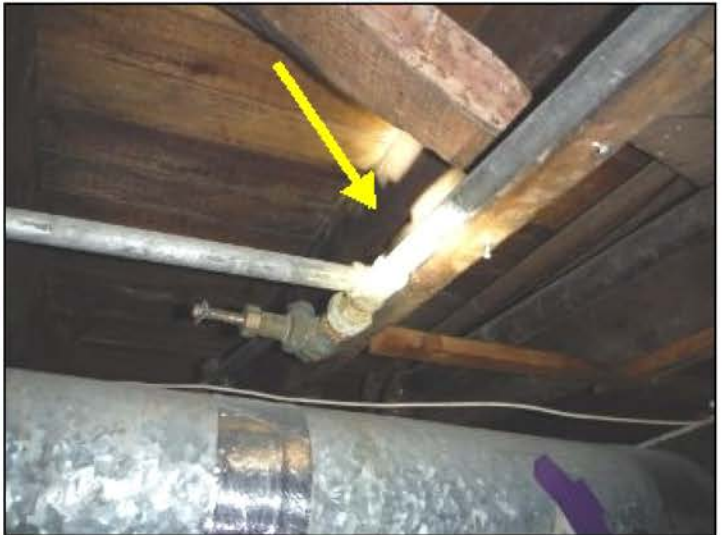
Untested abandoned shower in basement

Leaking at basement, refer to plumber

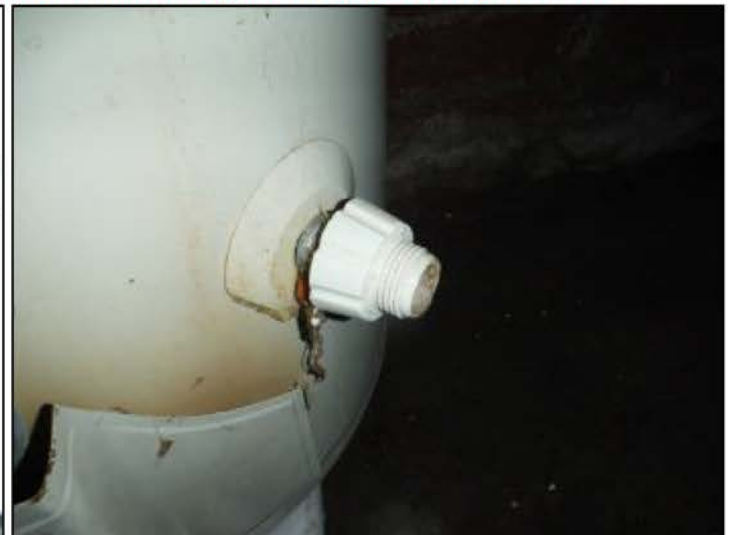
Rusted older unit has limited life

Tank drain valve leaks, needs a cap

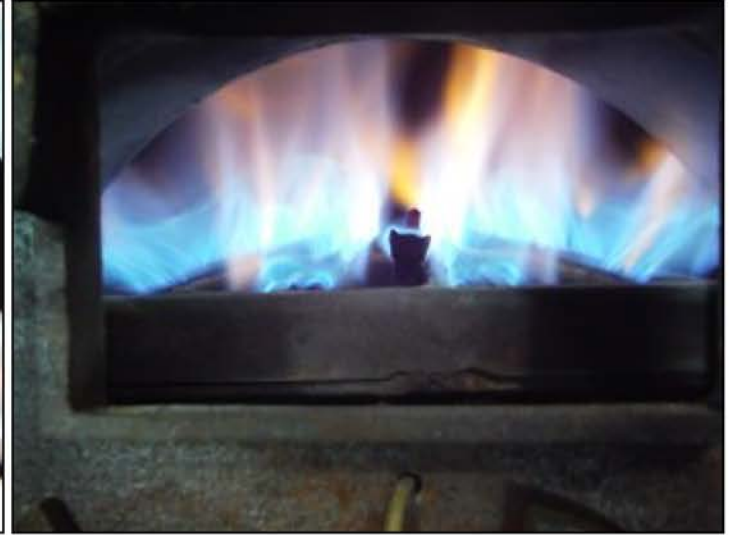
Rusty barrel type heat exchanger might be 50% efficient

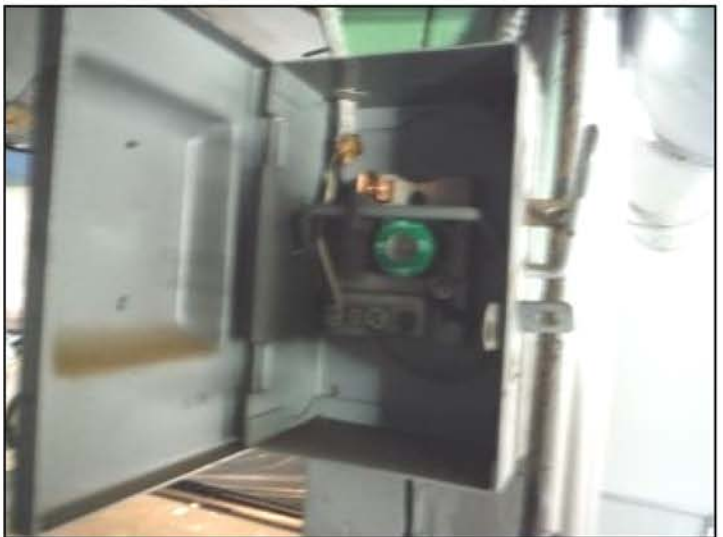
One 220 Volt breaker is weak, missing bridge,  
refer to electrician

Furnace fused disconnect not child safe

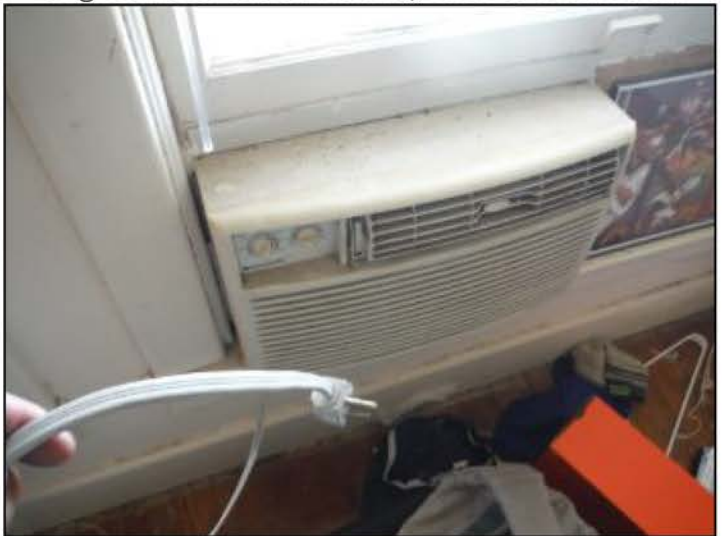
Ungrounded outlets found, refer to electrician

This A/C unit requires extension cord, no outlet nearby

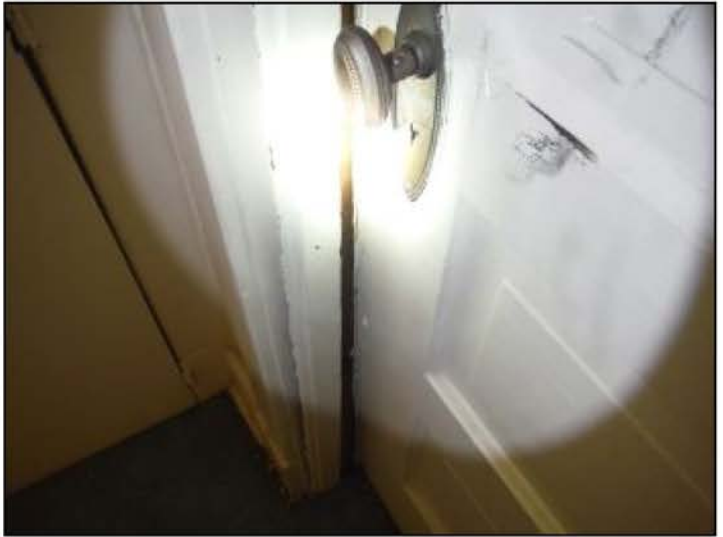
Damaged upstairs unit

Some rub or do not latch

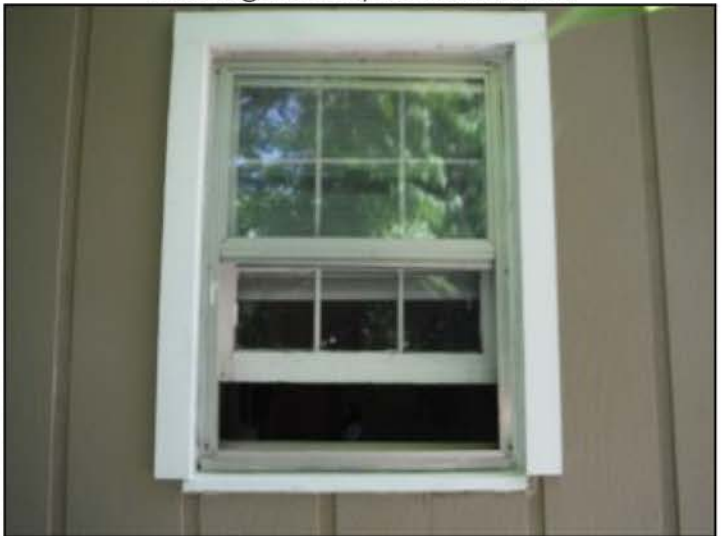
Recommend replacement of older wood units, missing storms/screens noted

Keep screens in upstairs windows to reduce child fall out risk

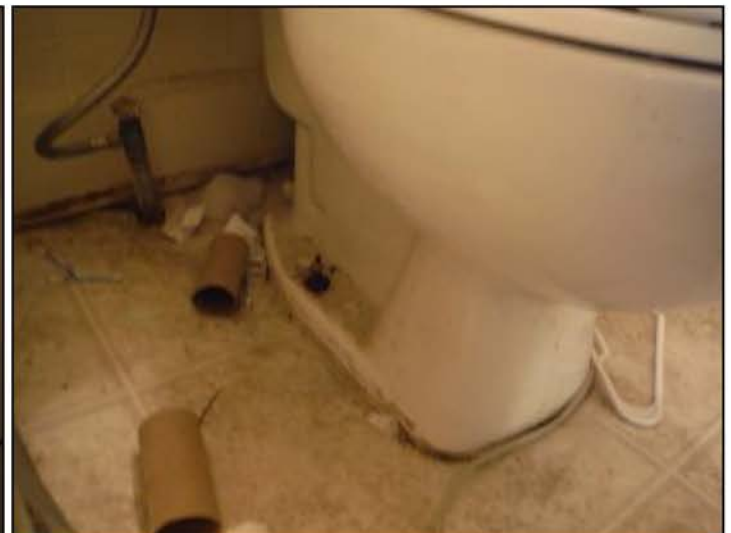
Damaged tank lid

Loose at floor, needs resetting by plumber
