# **Springfield Land Clearance for Redevelopment Authority**

**Blight Report**  
**Stillwell Columns Redevelopment**

#### Stillwell Columns

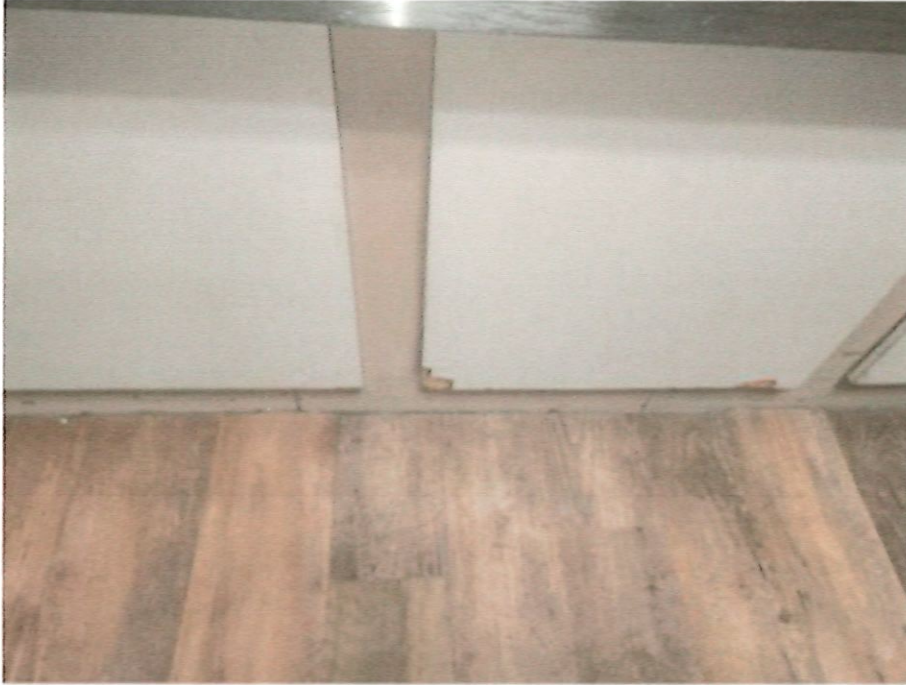
Interior replacement of flooring and side panels needed

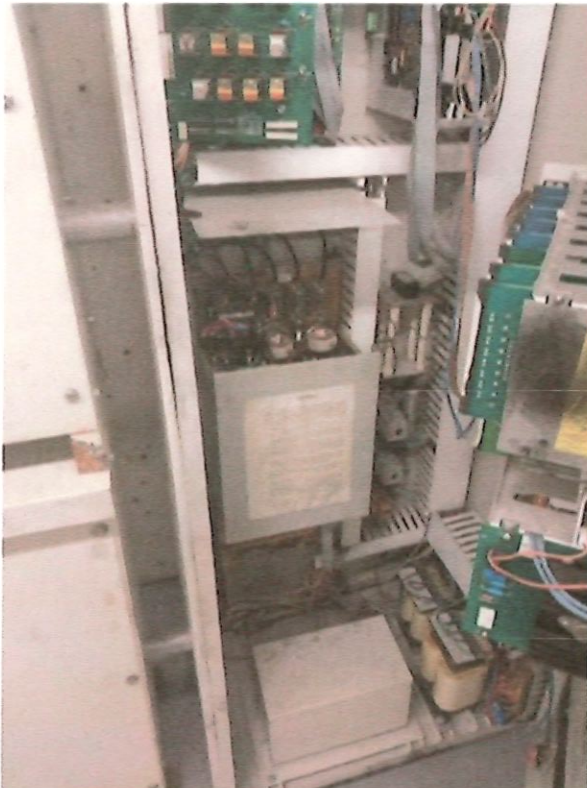
Elevator panel at Stilwell Columns

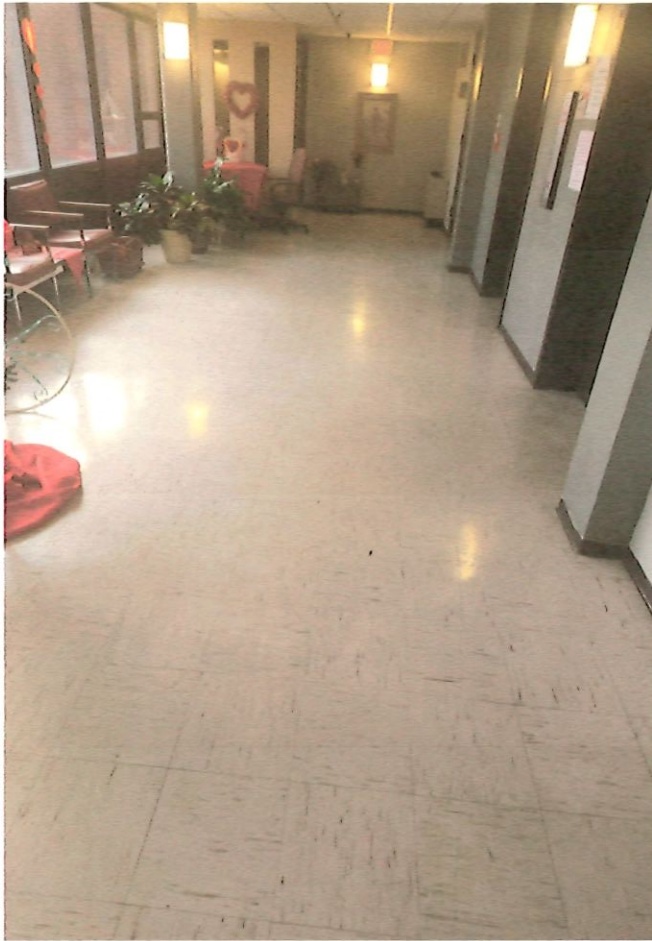
Several areas of the flooring in the building tested positive for asbestos, including public and private spaces. These areas will be abated and removed or encapsulated as required by law.

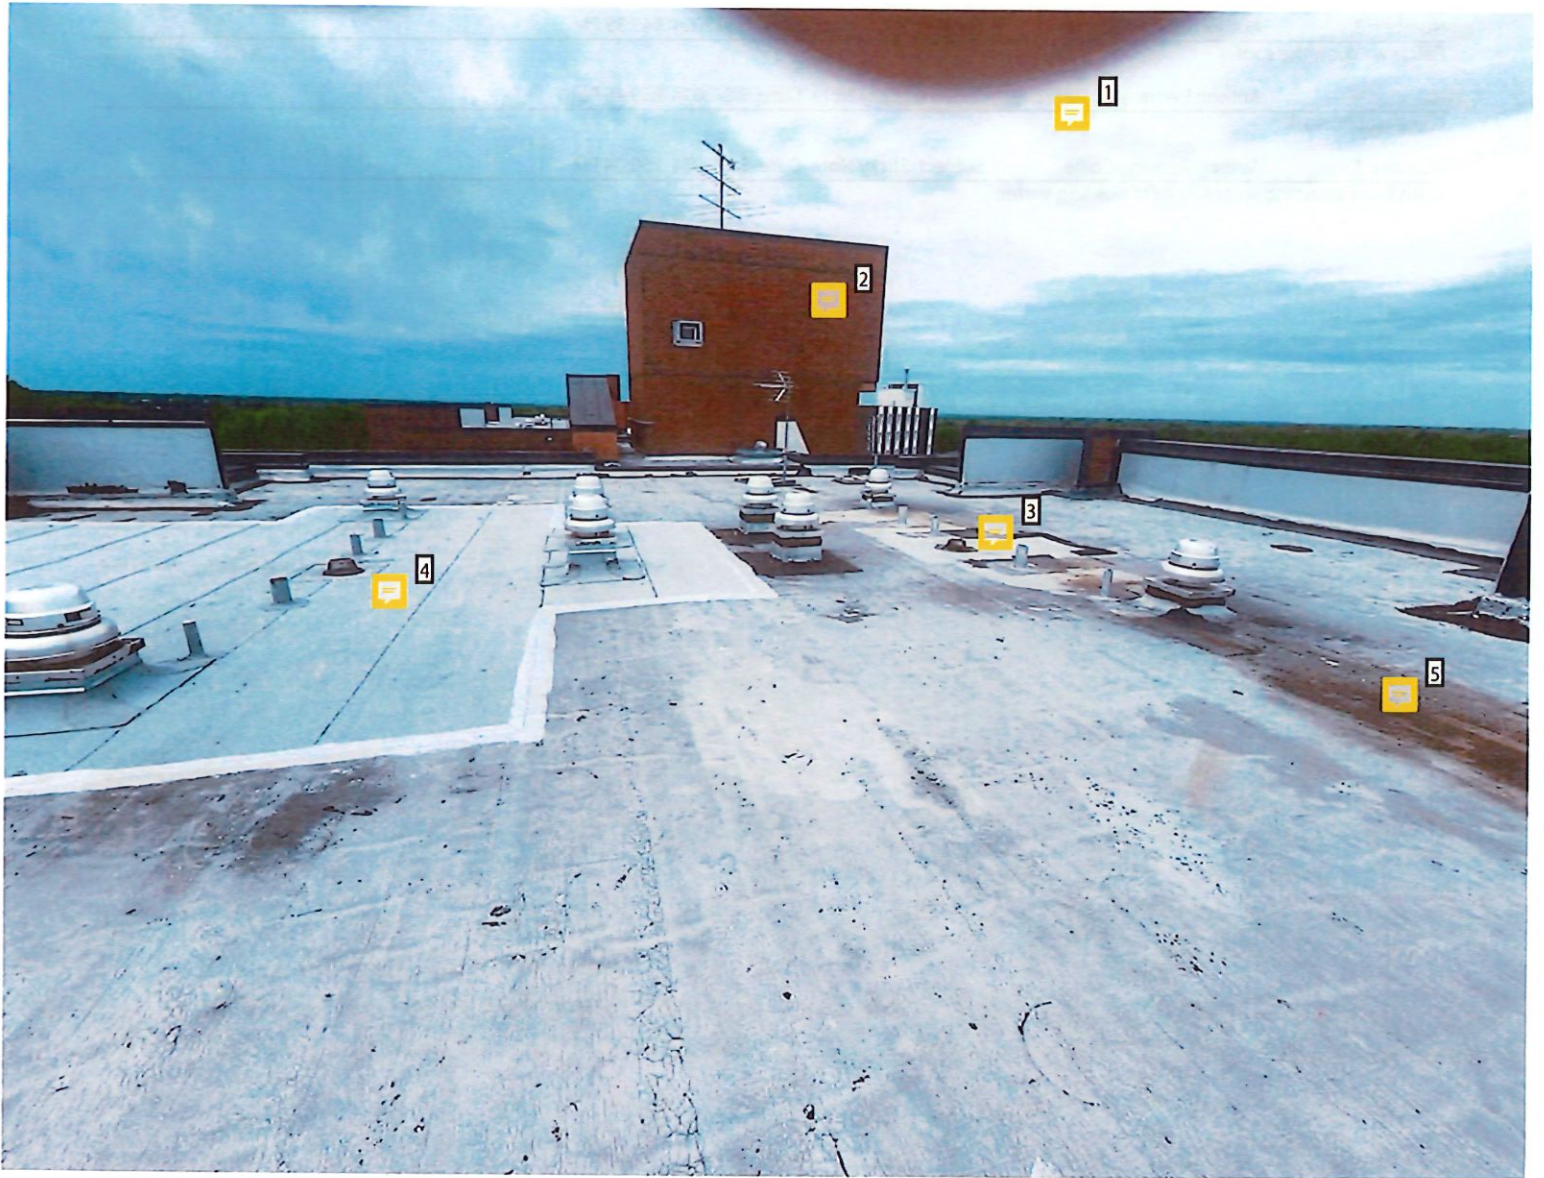
Page: 1

| East side of the roof of Stillwell Columns | | | |
| Patch work on the roof | | | |
| Large patch work | | | |
| Stain from standing water- Roof is holding water. | | | |

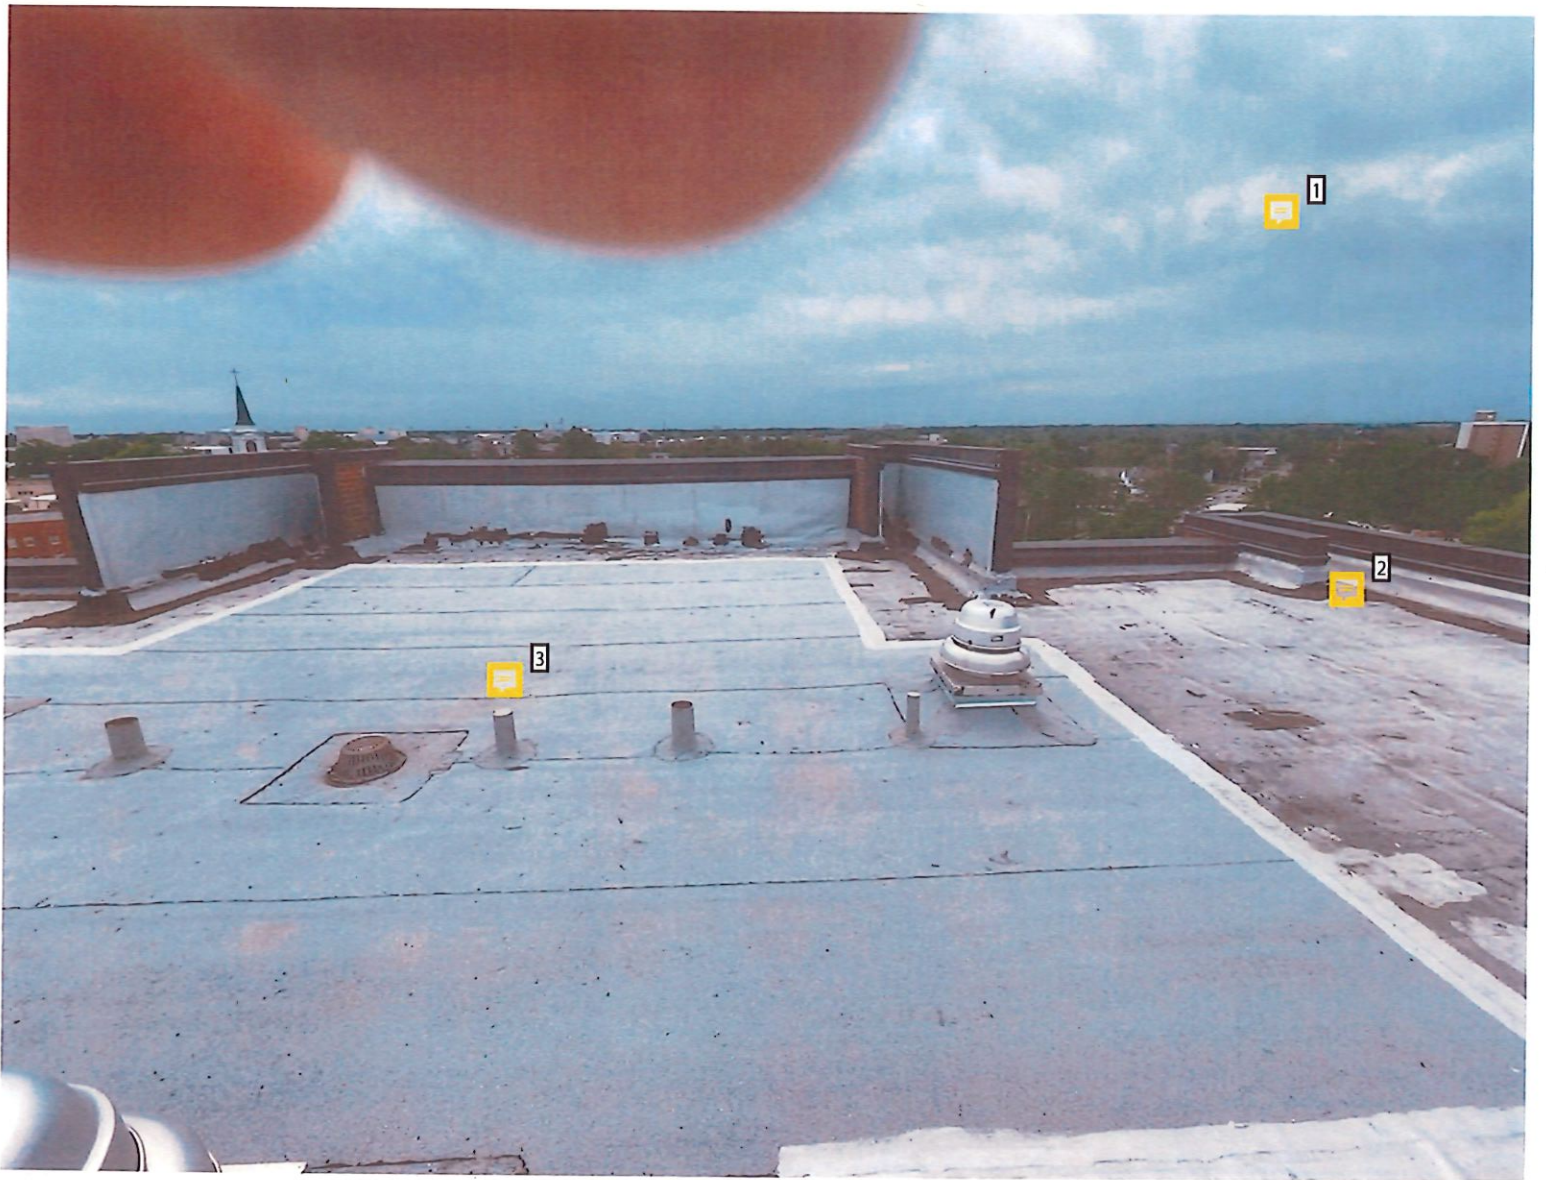
Page: 2

| East side of the roof- | | | |
| Tar areas | | | |
| Another large patch job | | | |

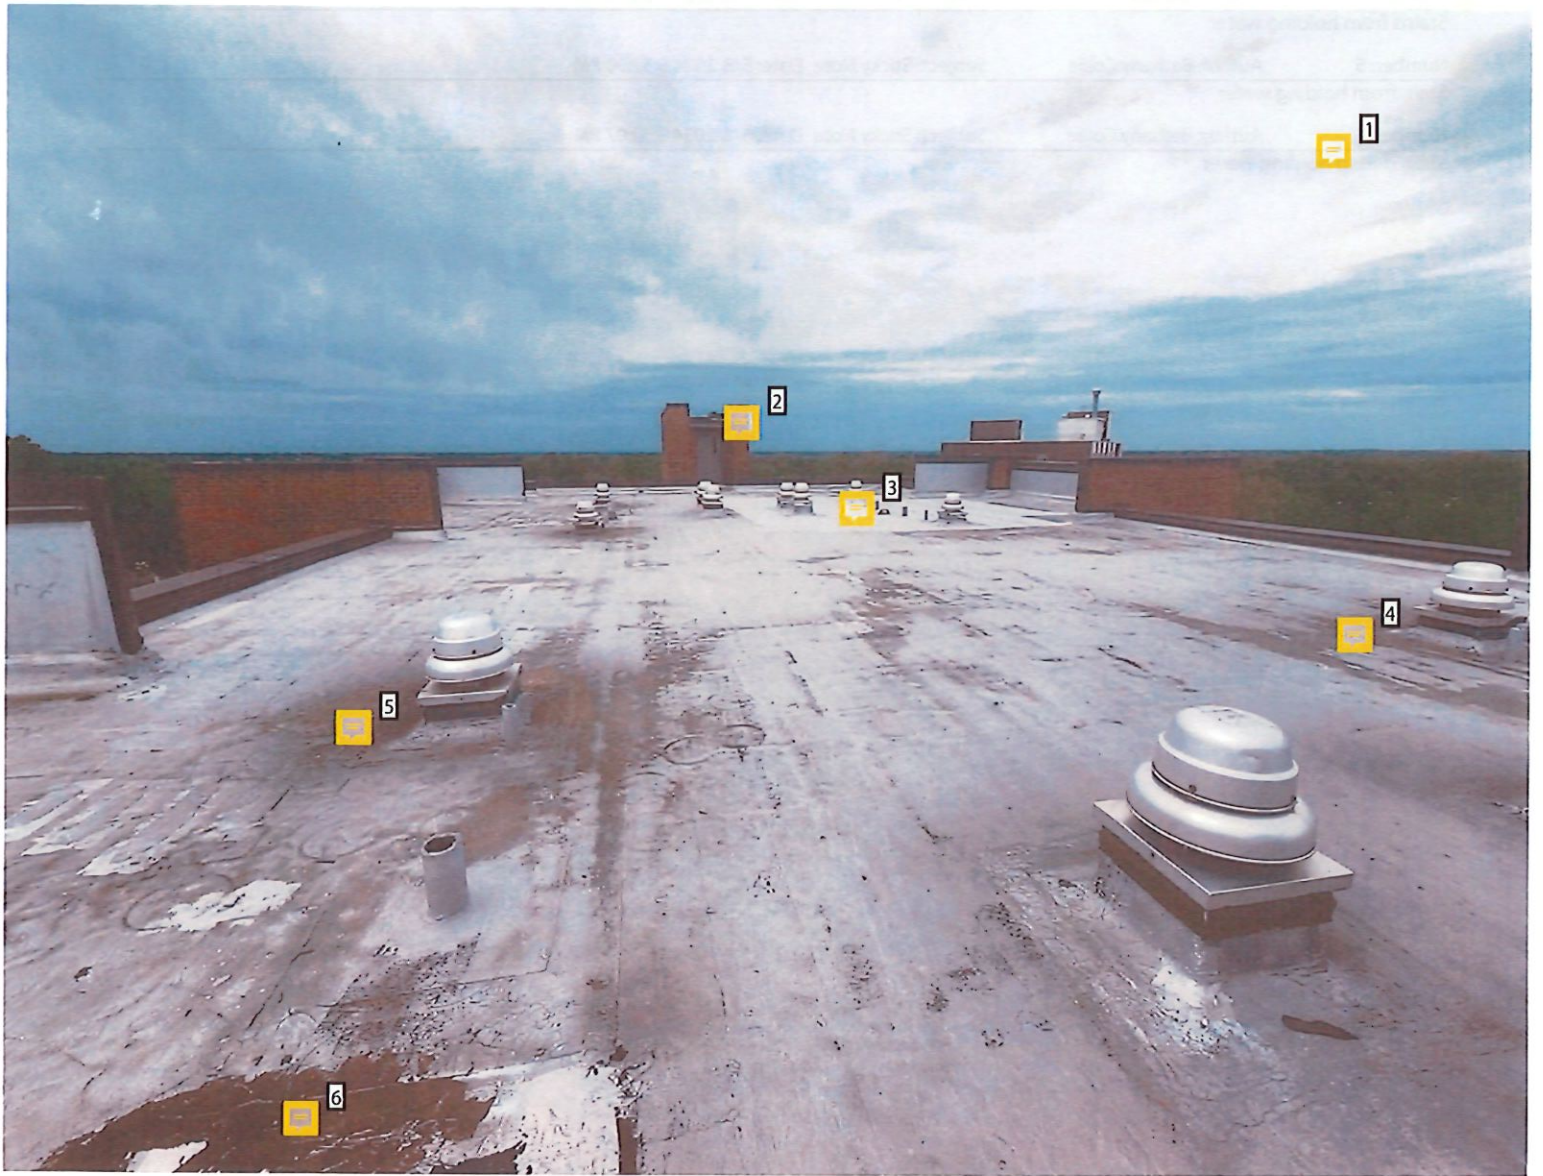
## Page: 3

| Large patch job | | | |
| Stains from holding water | | | |
| Stain from holding water | | | |
| Stain due to holding water | | | |

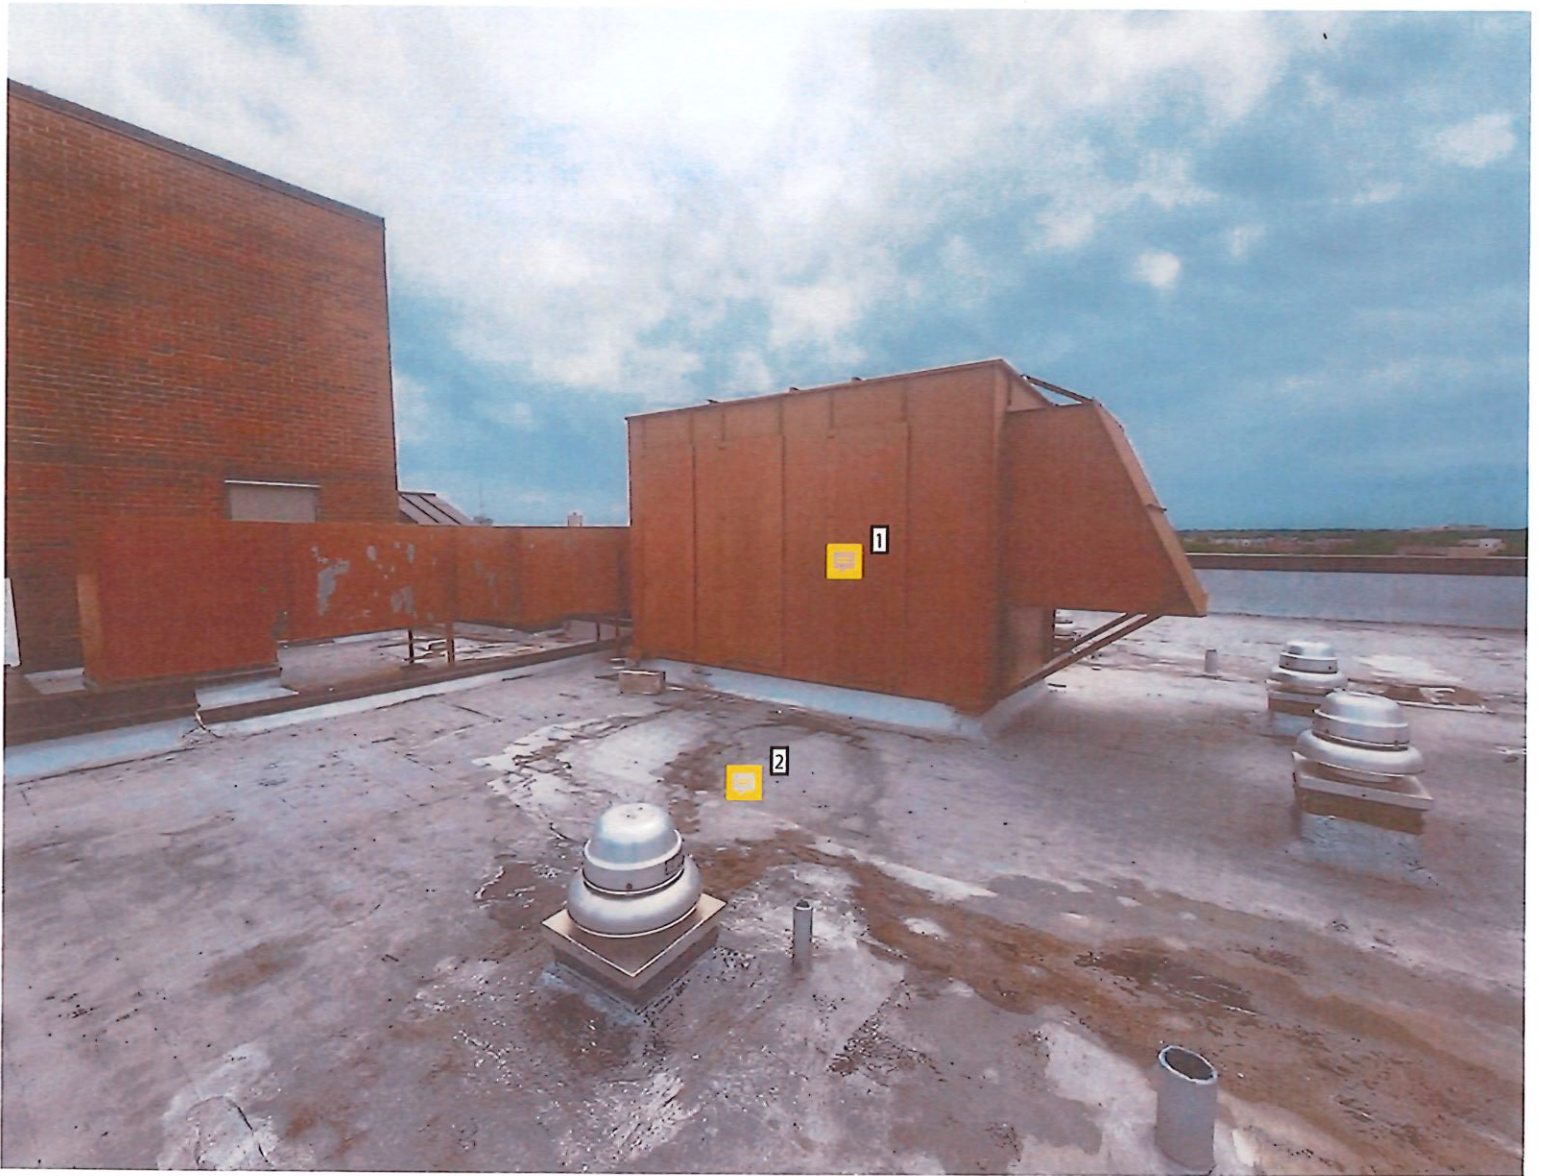
| | Air handler- controls common areas throughout the building | | | |
| | Condensation water running from the air handler | | | |

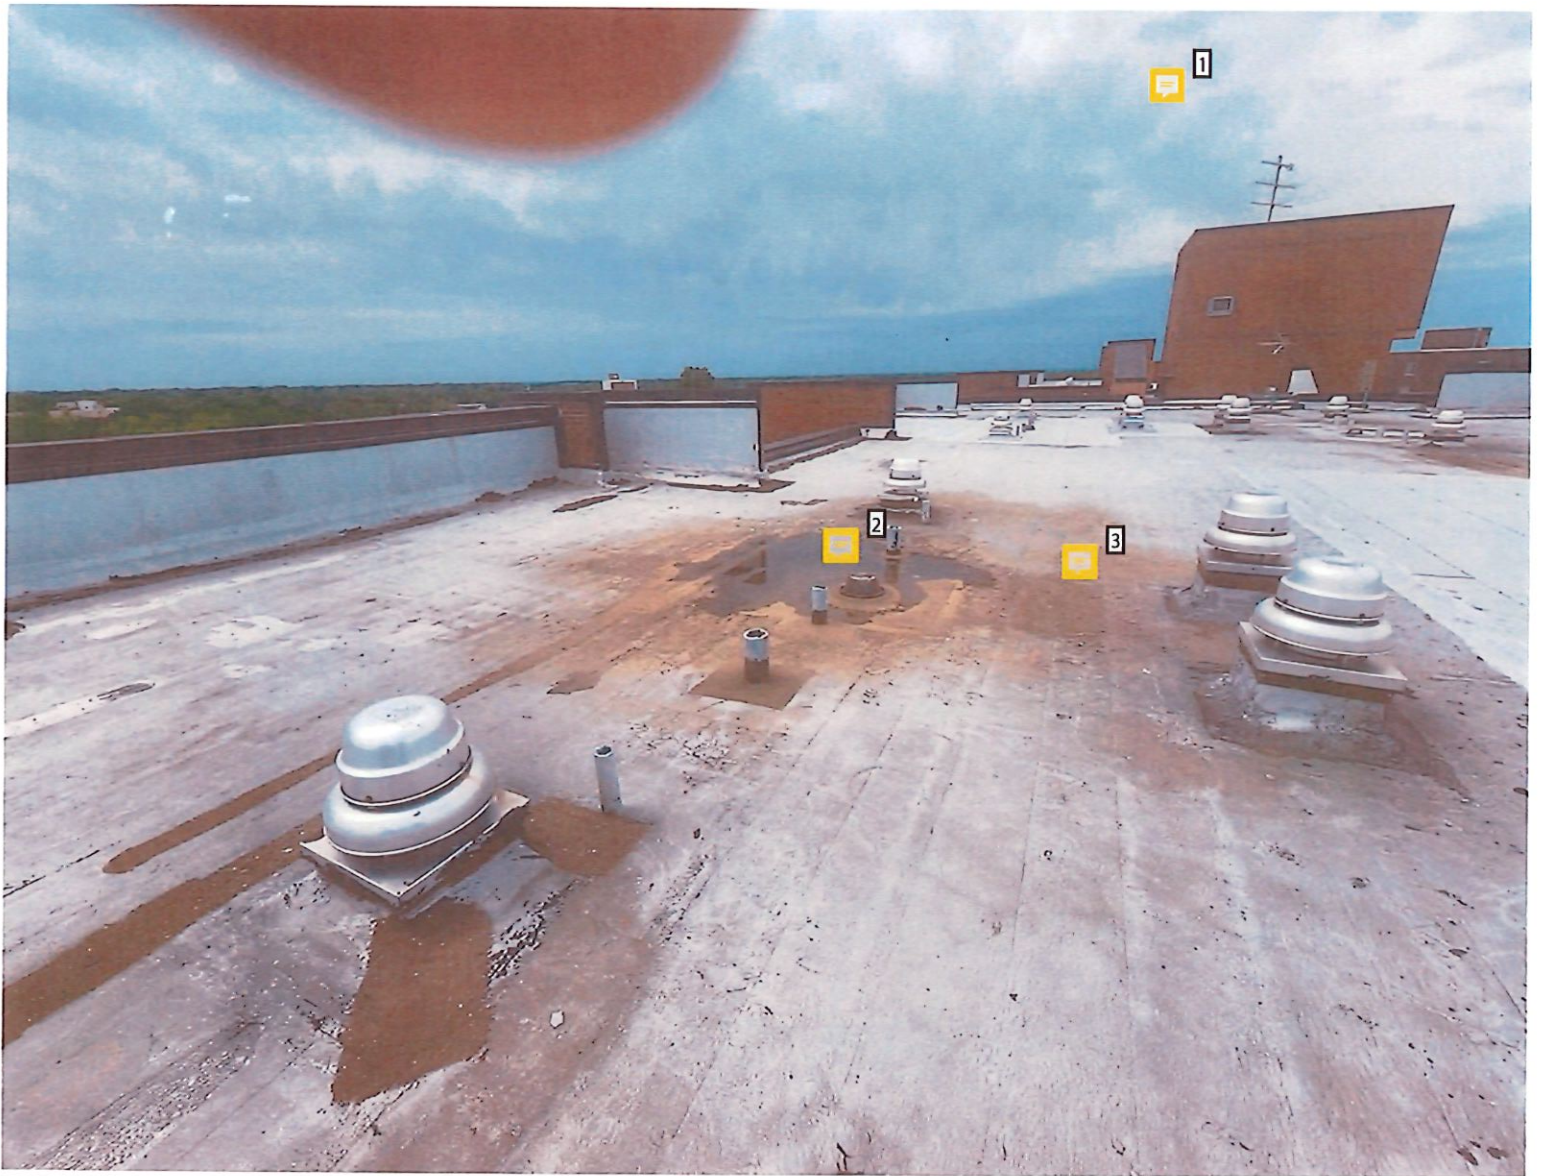
## Page: 5

| Standing water | | | |
| Stains from standing water | | | |

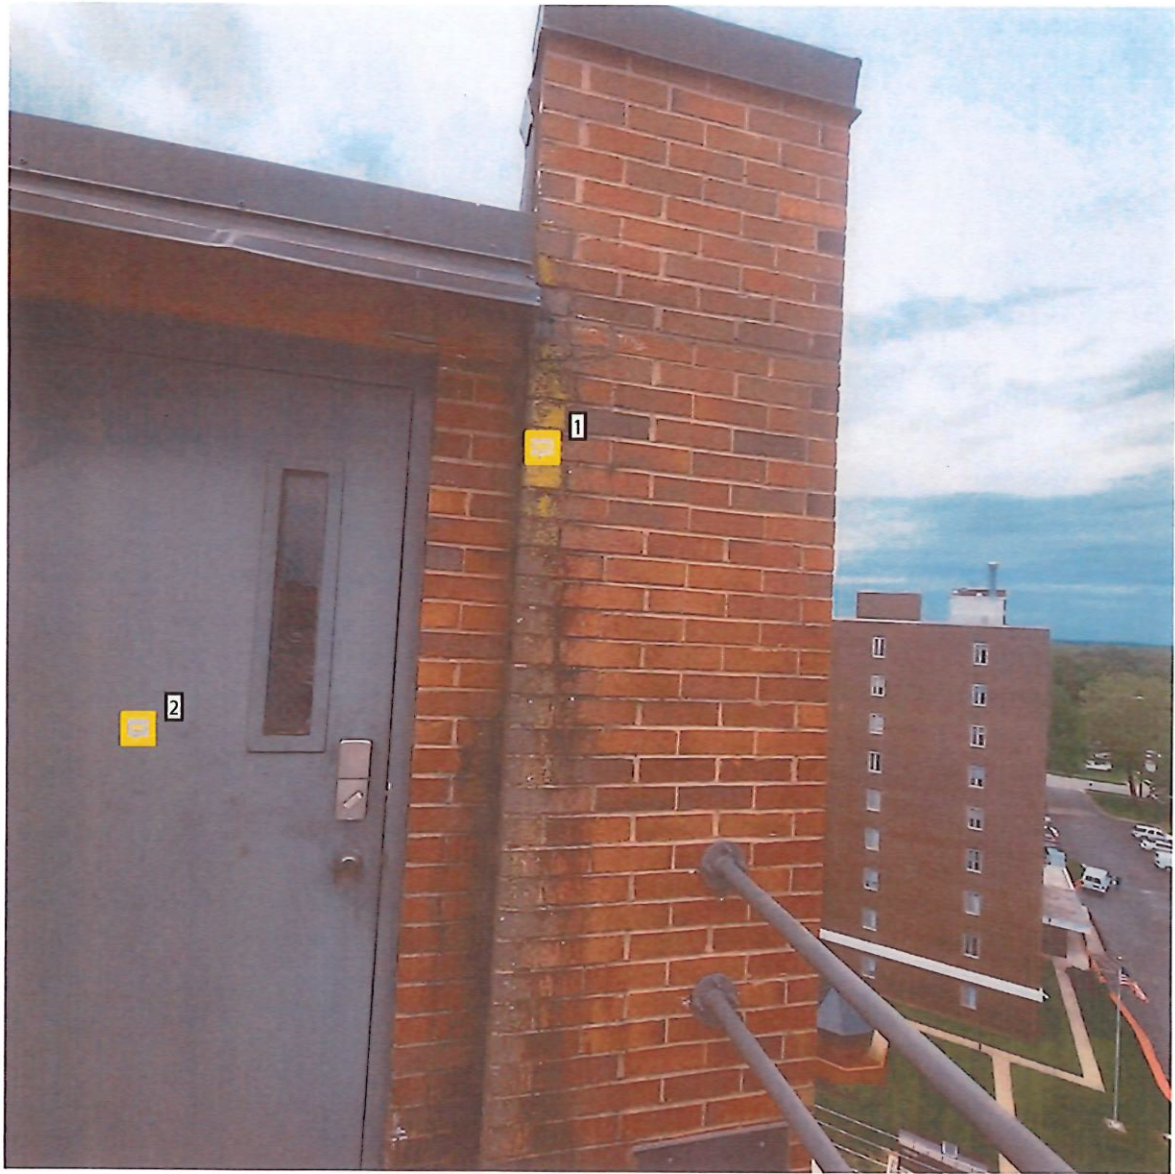
Page: 6

| damage due to leaks- flashing not installed correctly- roof is leaking | | | |

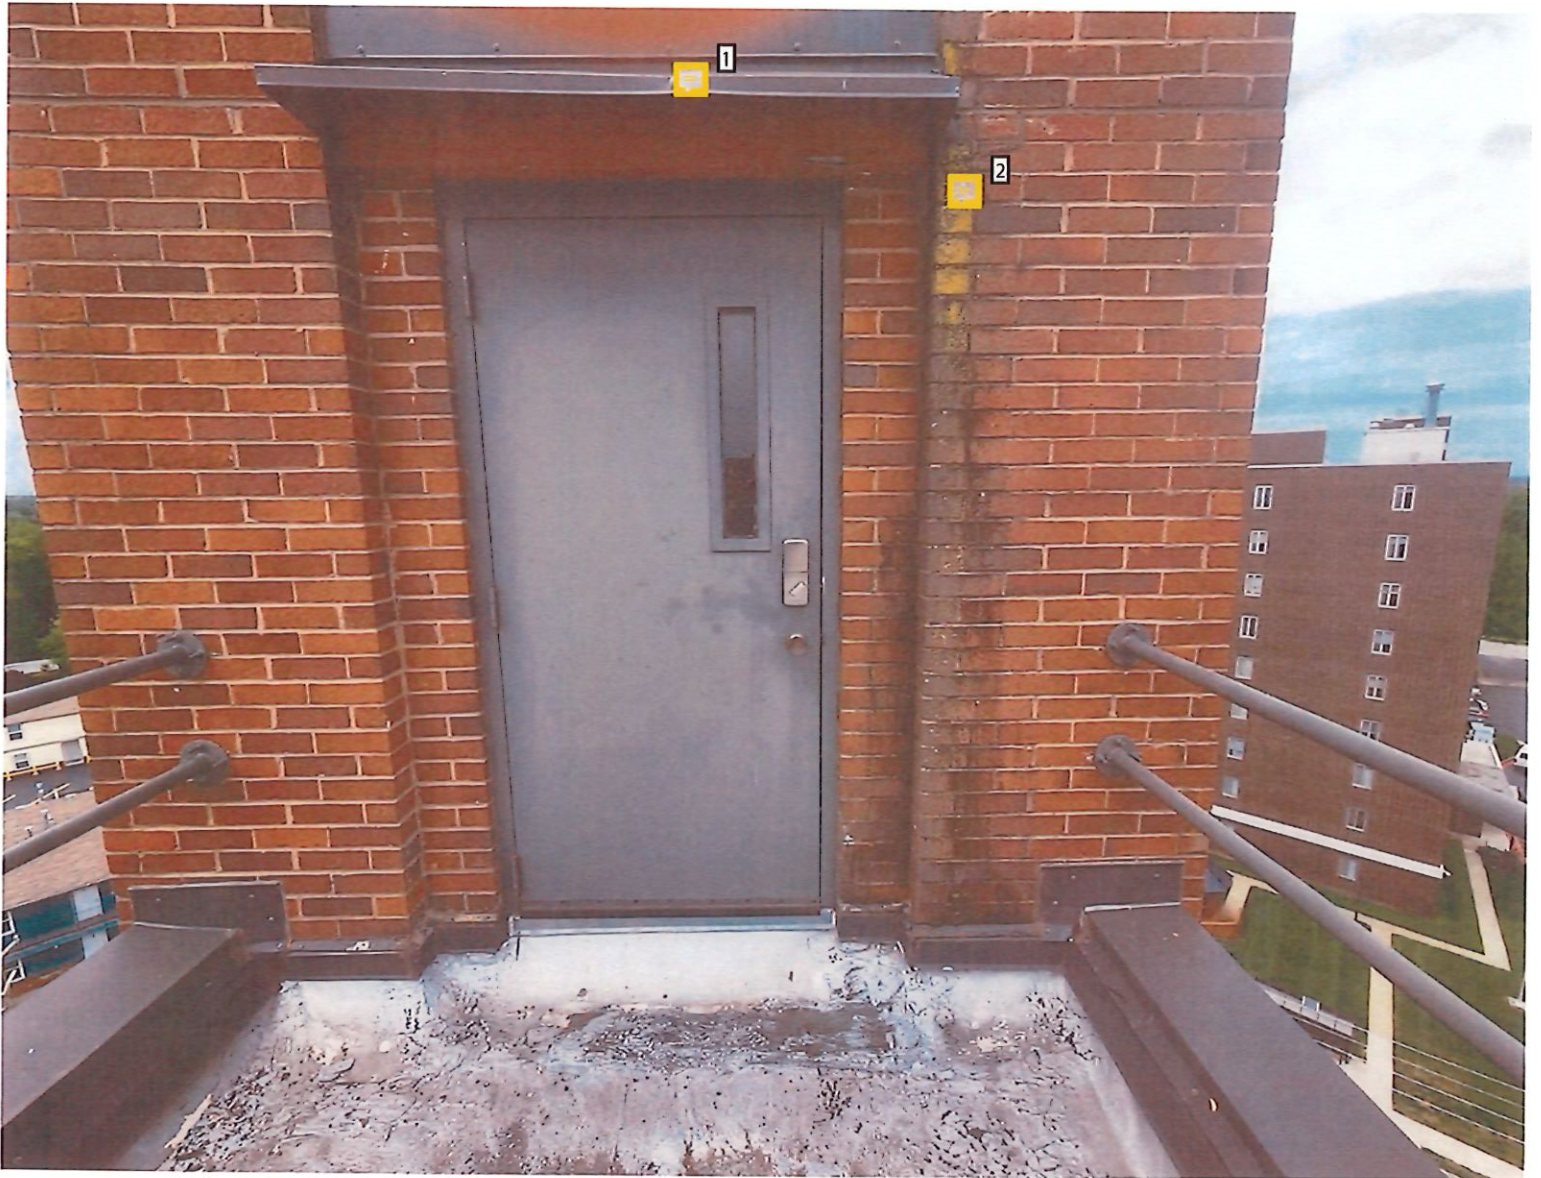
| Dent in the awning | | | |
| damage due to leaks | | | |

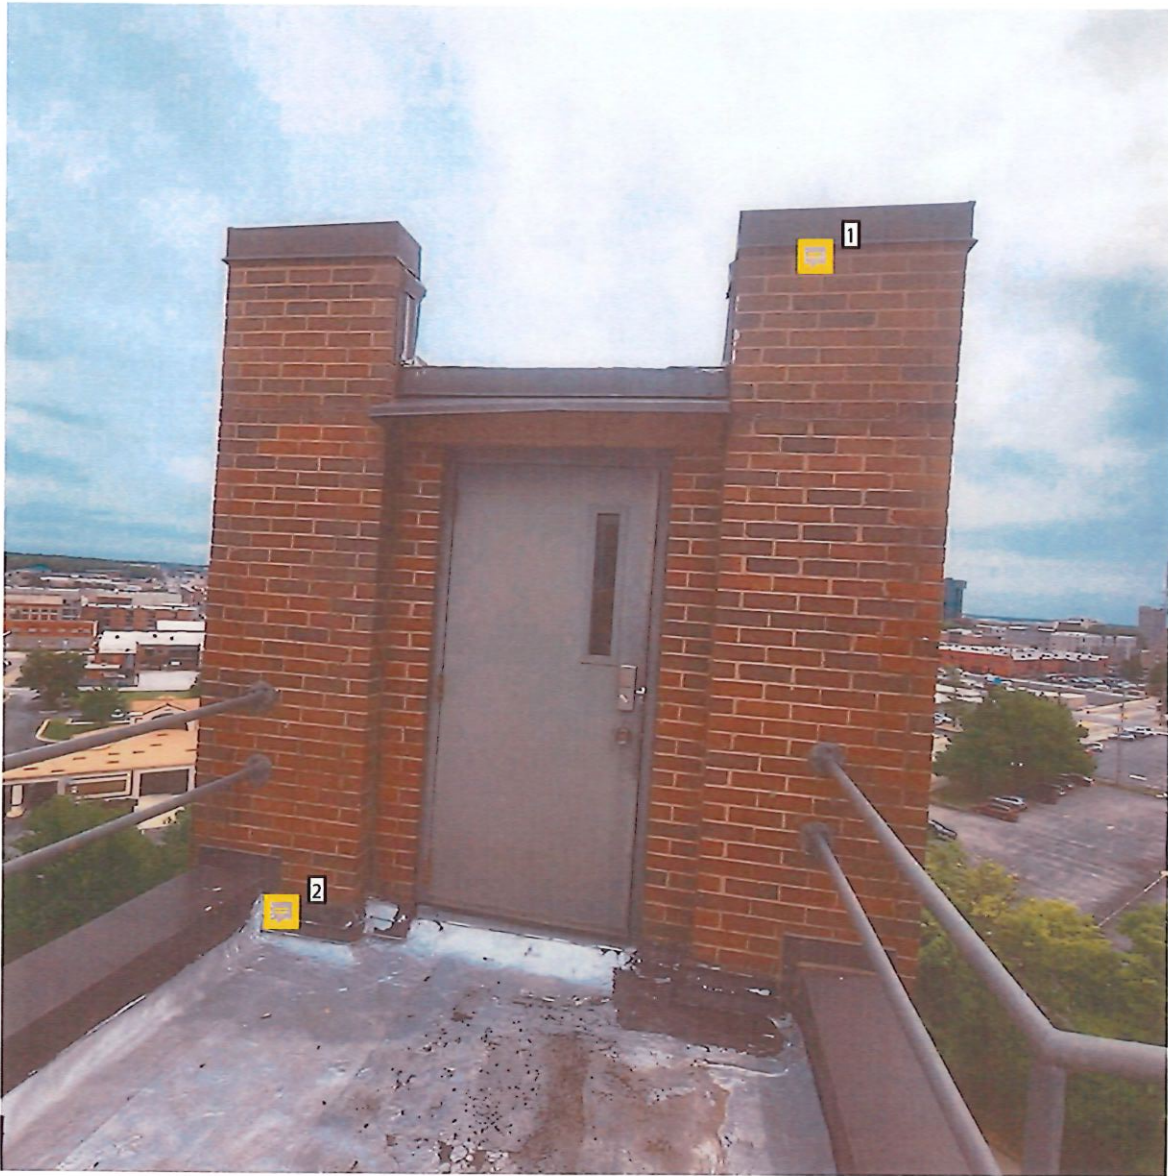
| leaks inside of the building here | | | |

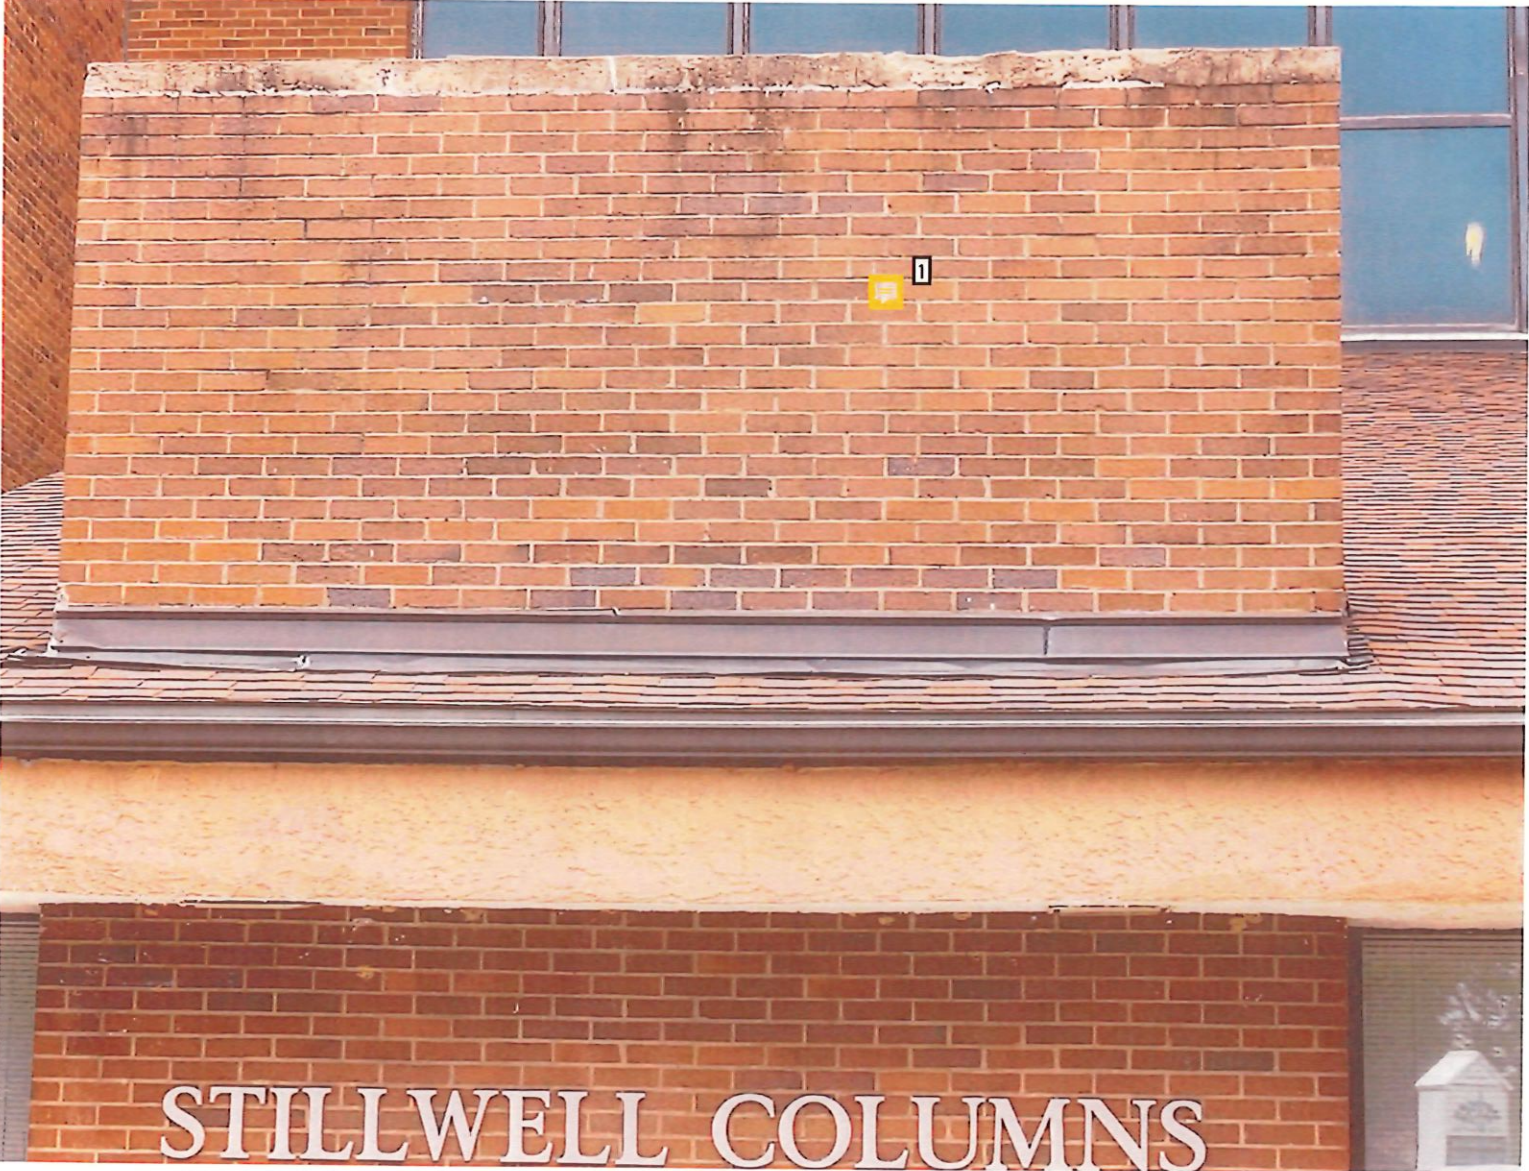
| chimney for the fireplace- leaks<br>flashing is incorrectly installed | | | |

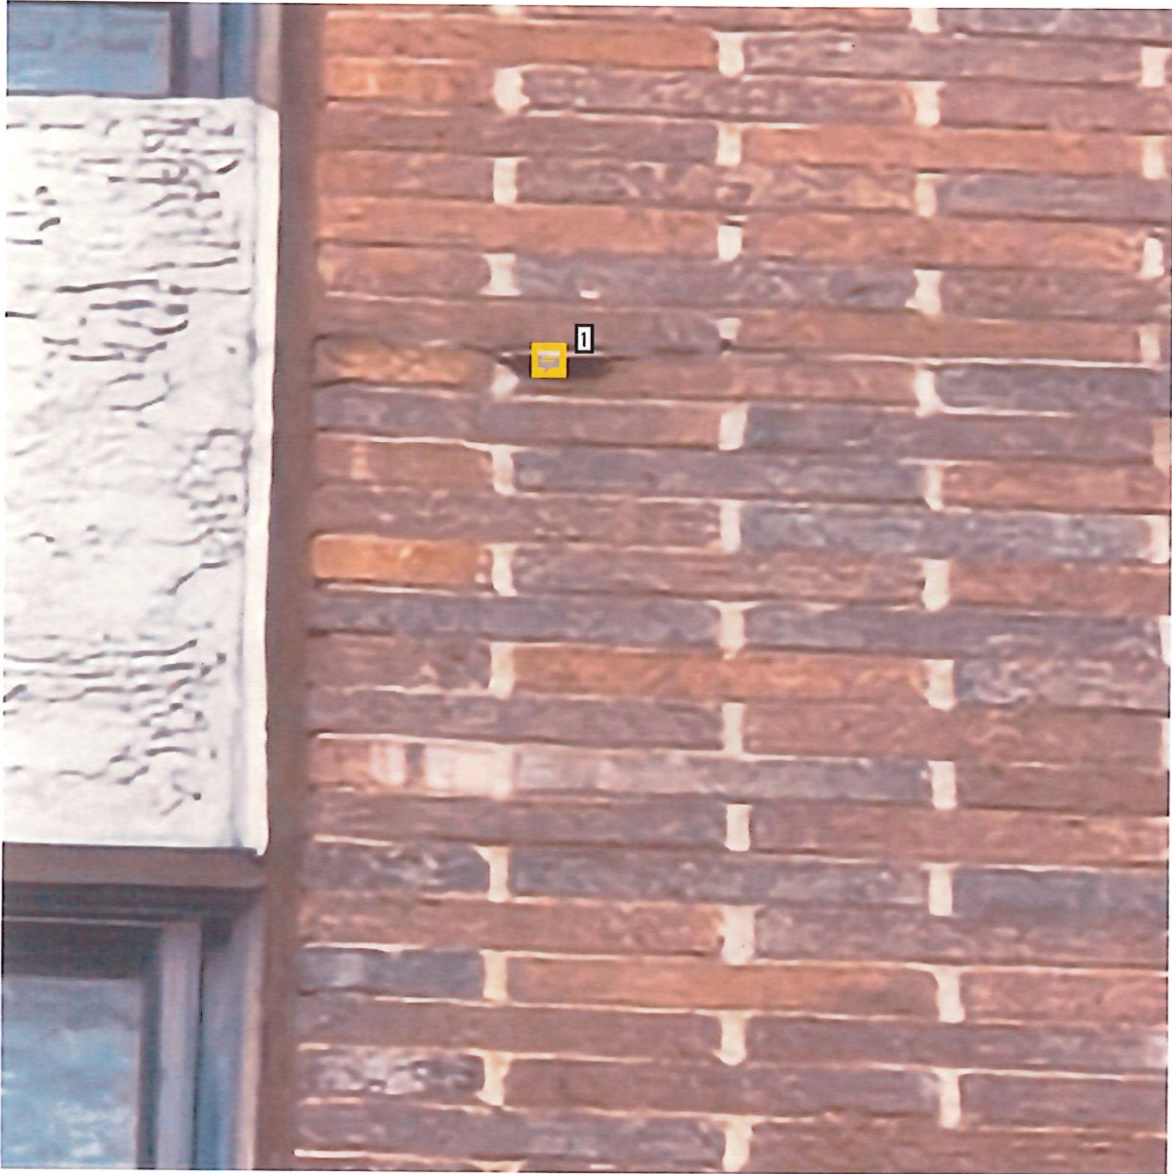
Number: 1      Author: Bethany.Collie      Subject: Sticky Note      Date: 5/8/2024 3:58:38 PM  
missing a piece of exterior wall brick- south exterior wall

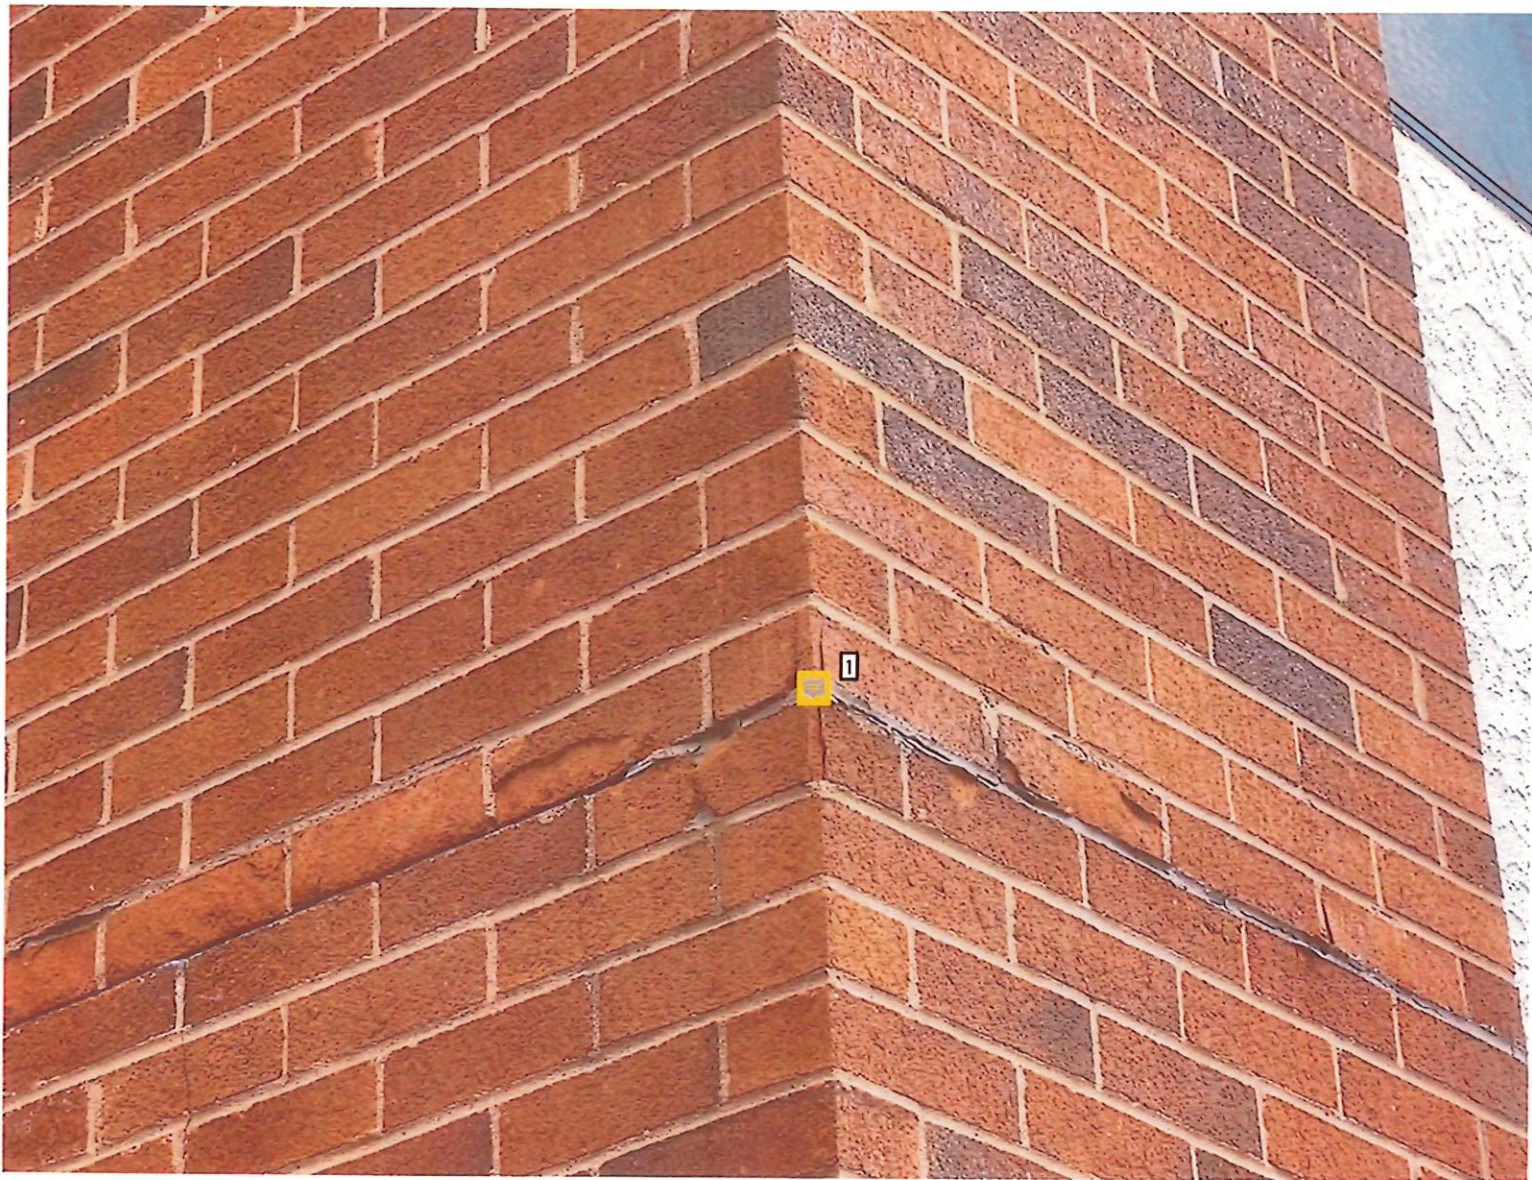
| south exterior wall- deterioration of the bricks | | | |

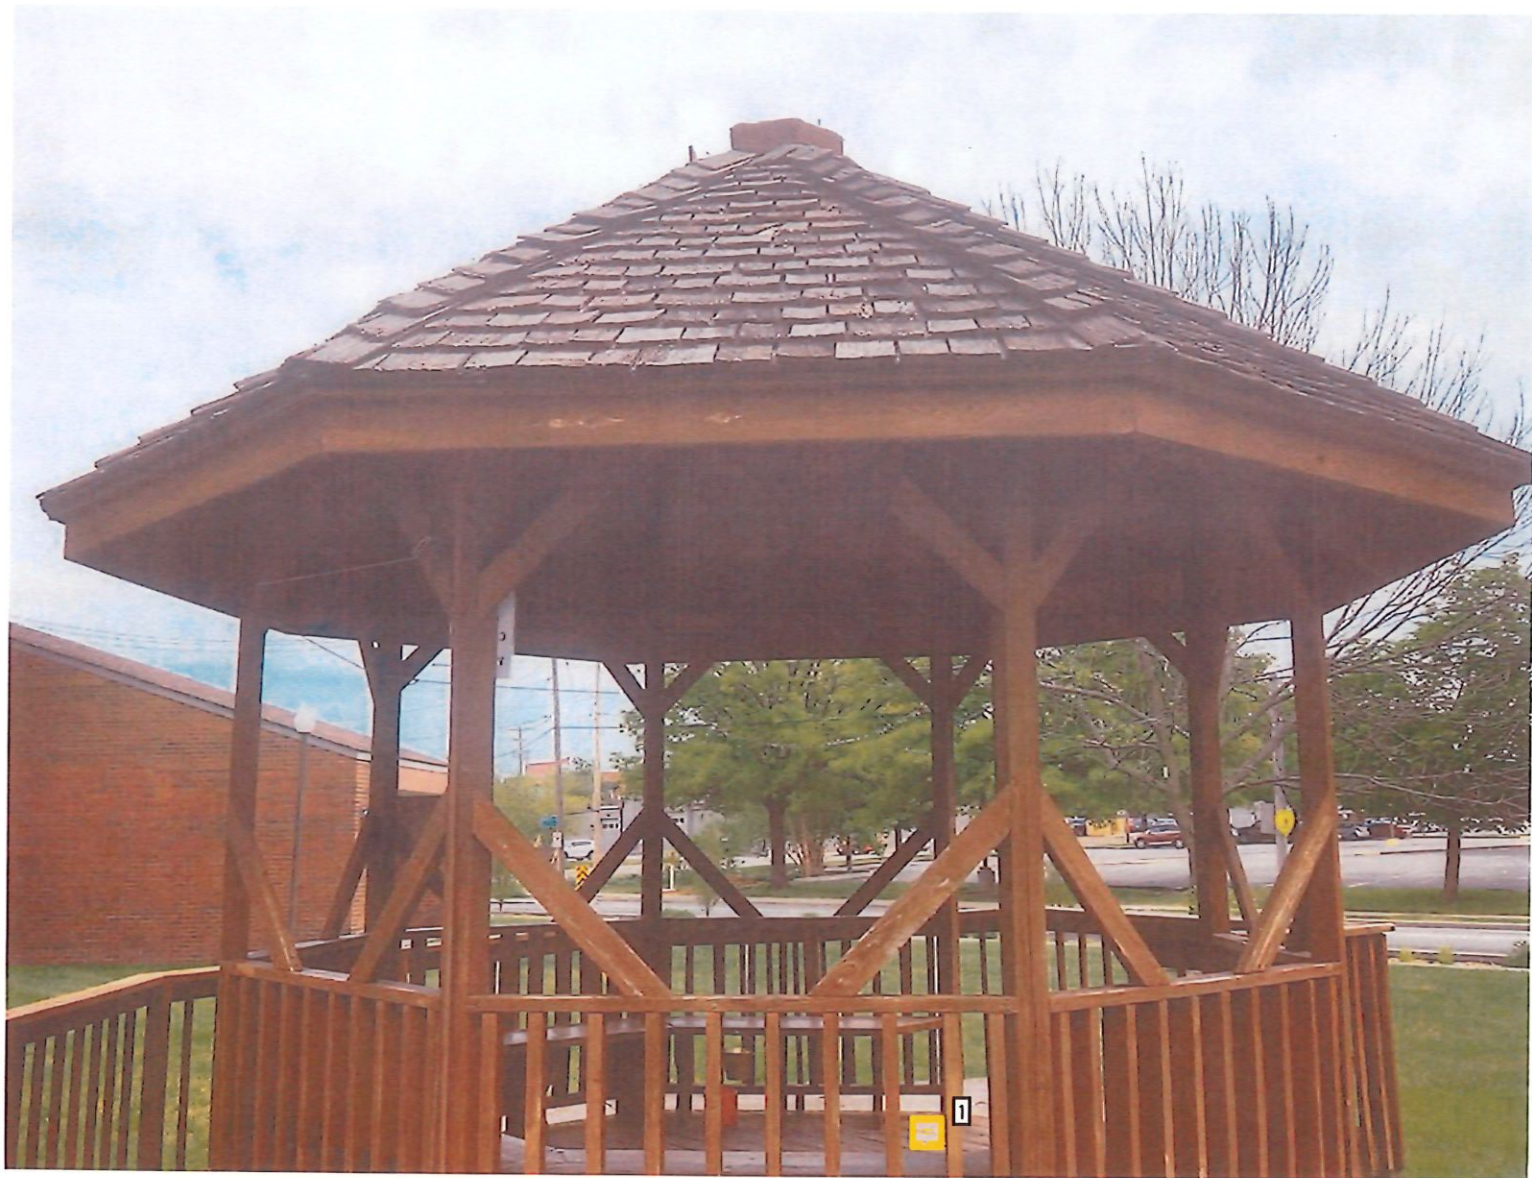
| Decking is in rough shape- needs to be sanded and stained- needs a metal roof | | | |
