# **Springfield Land Clearance for Redevelopment Authority**

**Blight Report**  
**Stillwell Columns Redevelopment**

#### Stillwell Columns

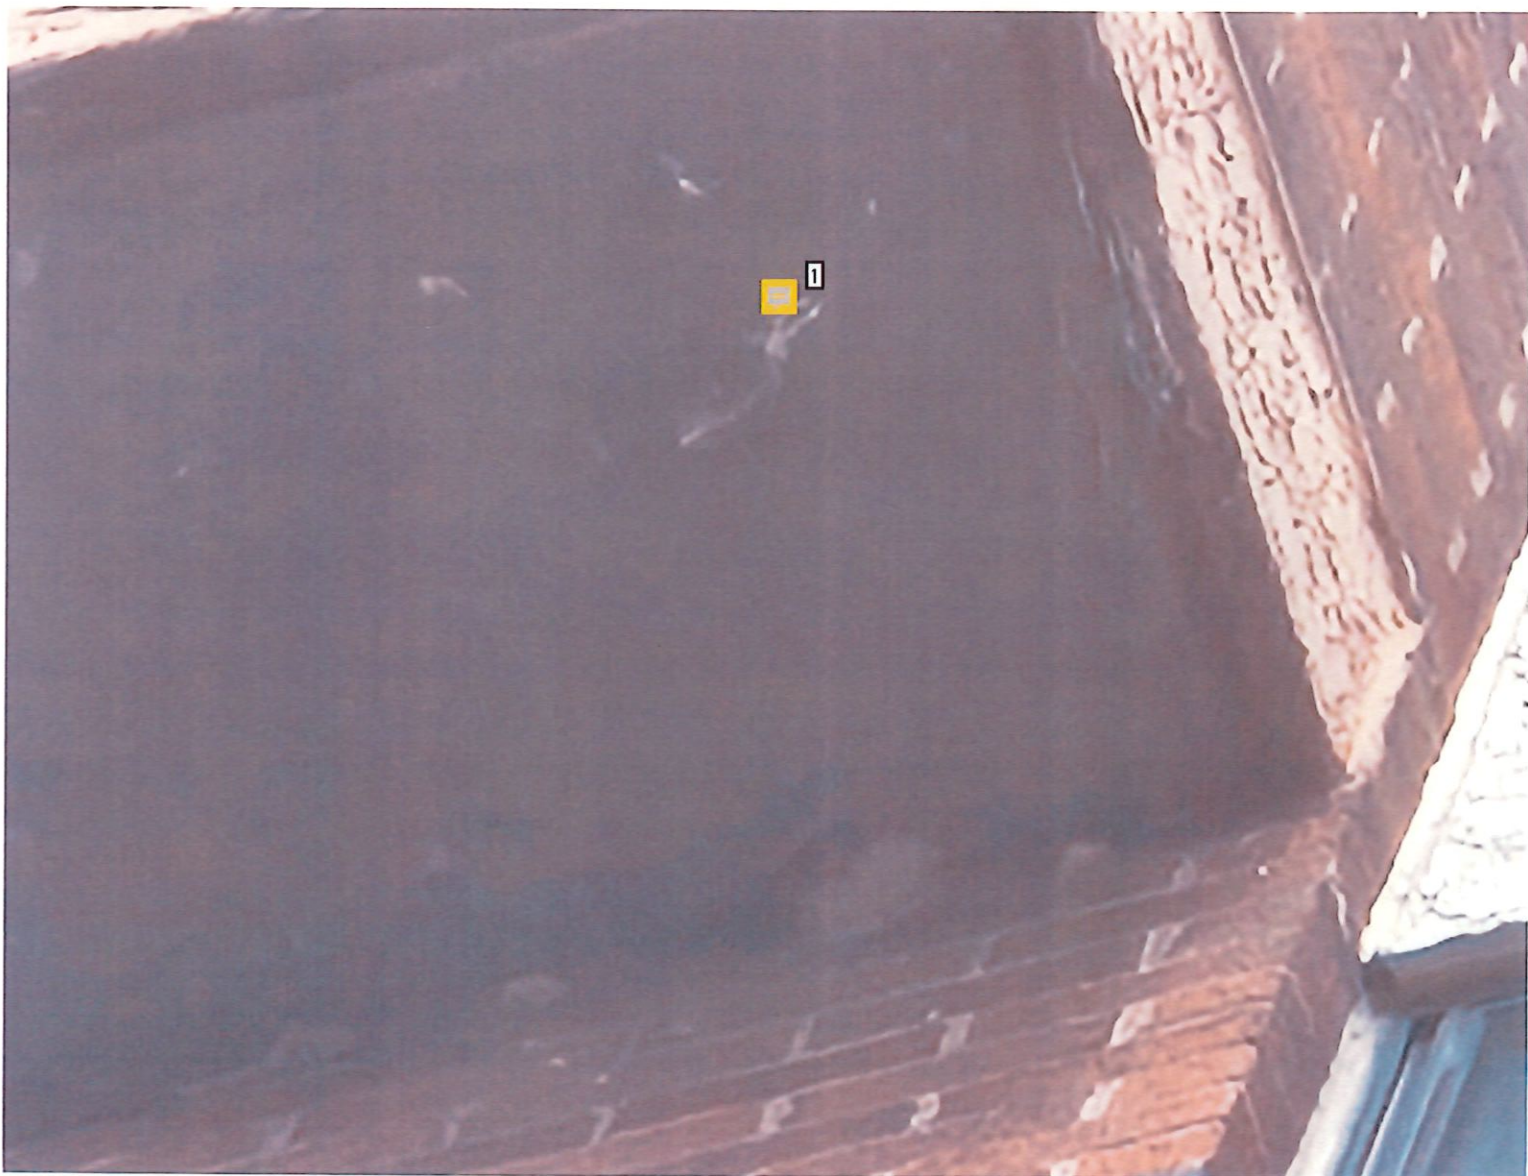
Another over hang on the south end of the building- missing the bottom plate

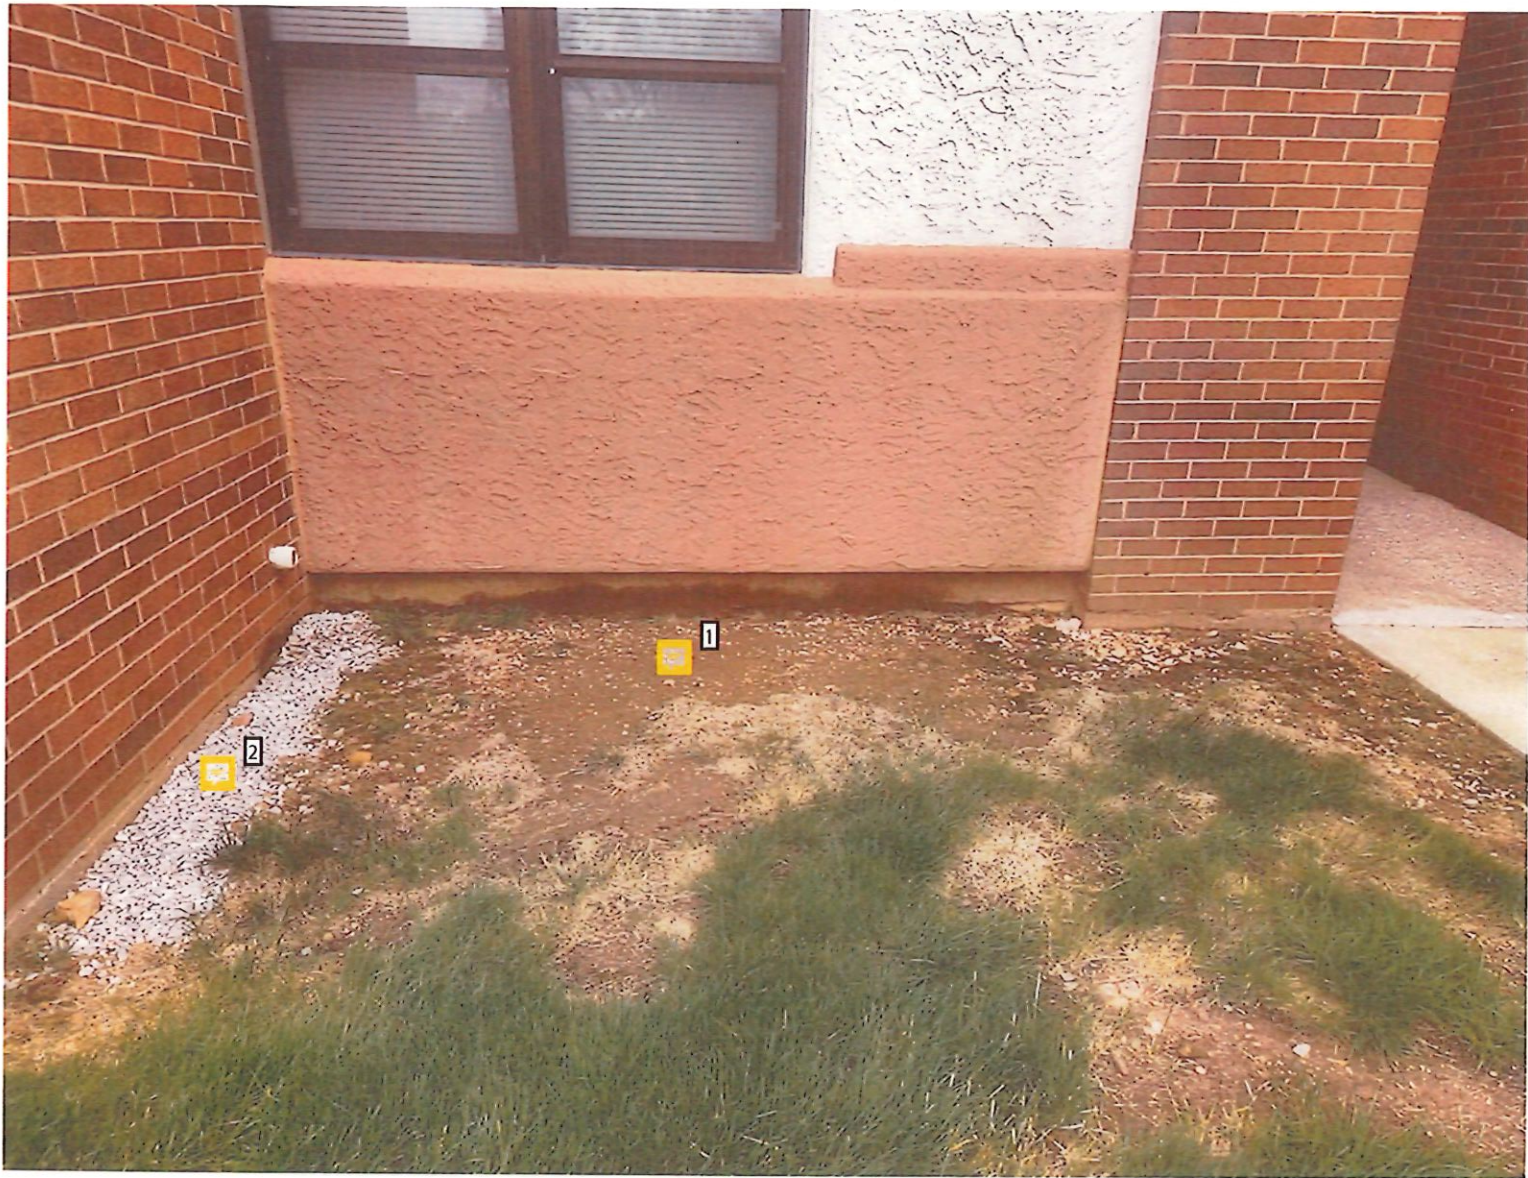
| | Poor landscaping | | | |
| | french ditch for the condensation to drain | | | |

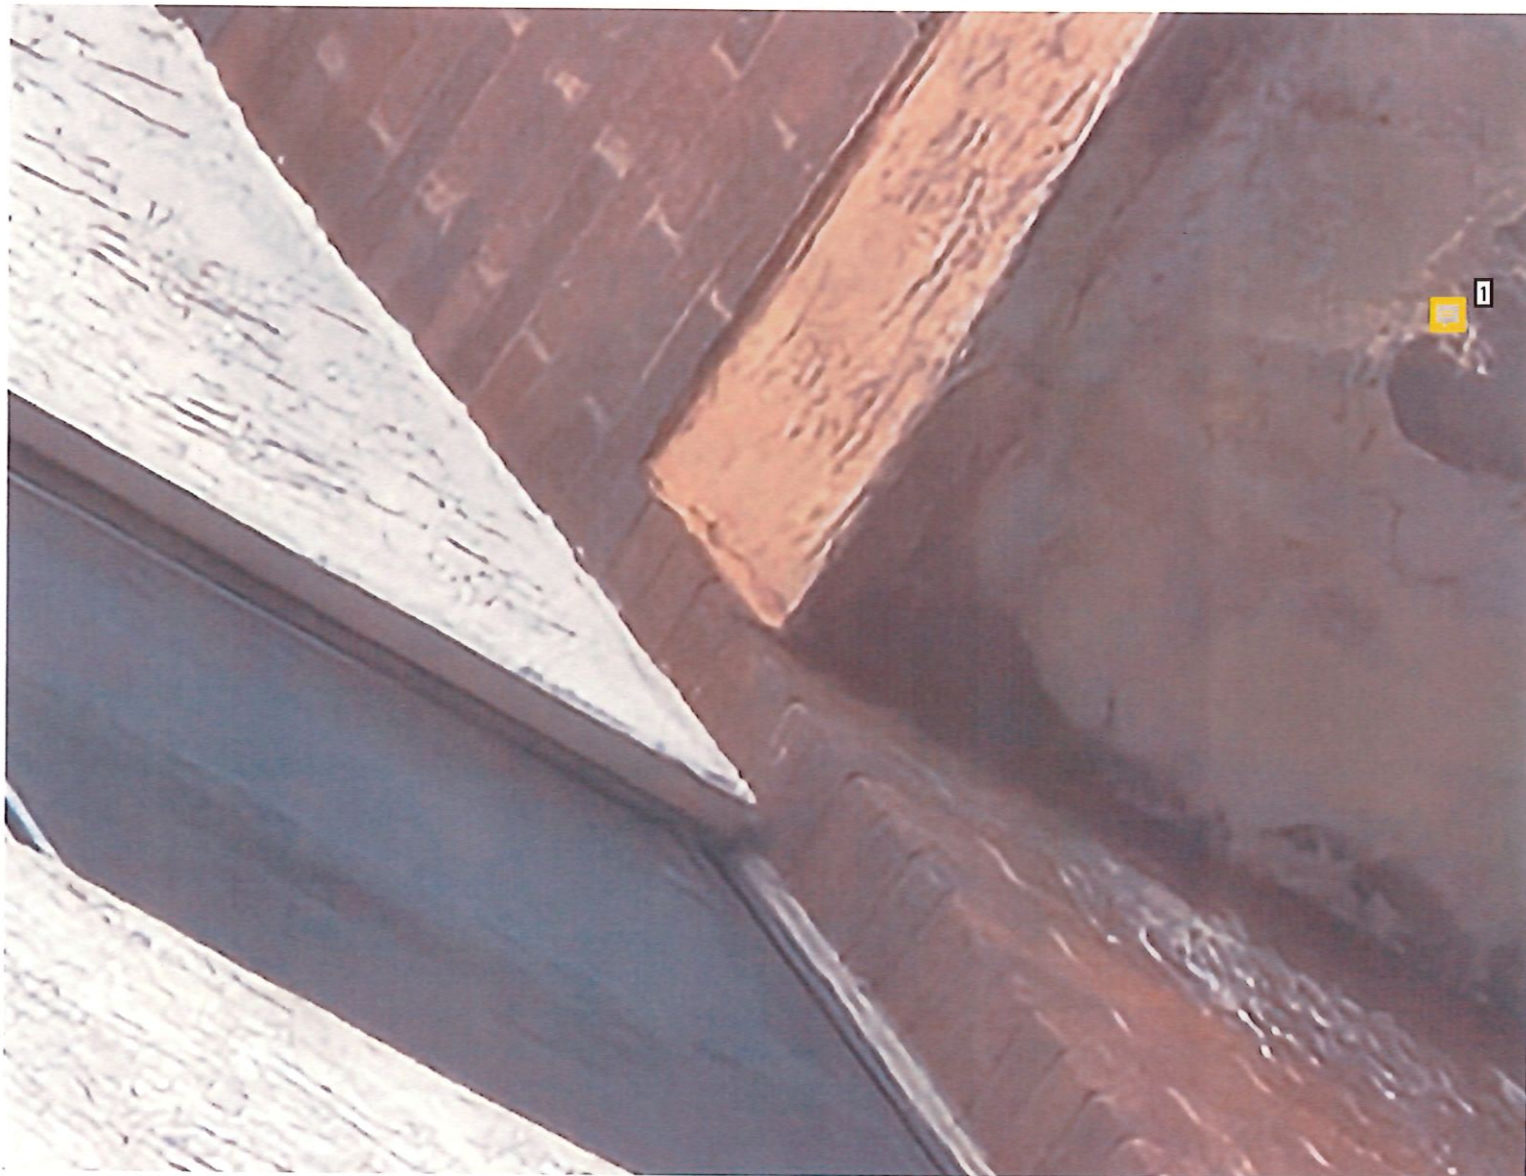
Number: 1      Author: Bethany.Collie      Subject: Sticky Note      Date: 5/8/2024 4:03:46 PM  
bottom of the overhang is busted and/or missing

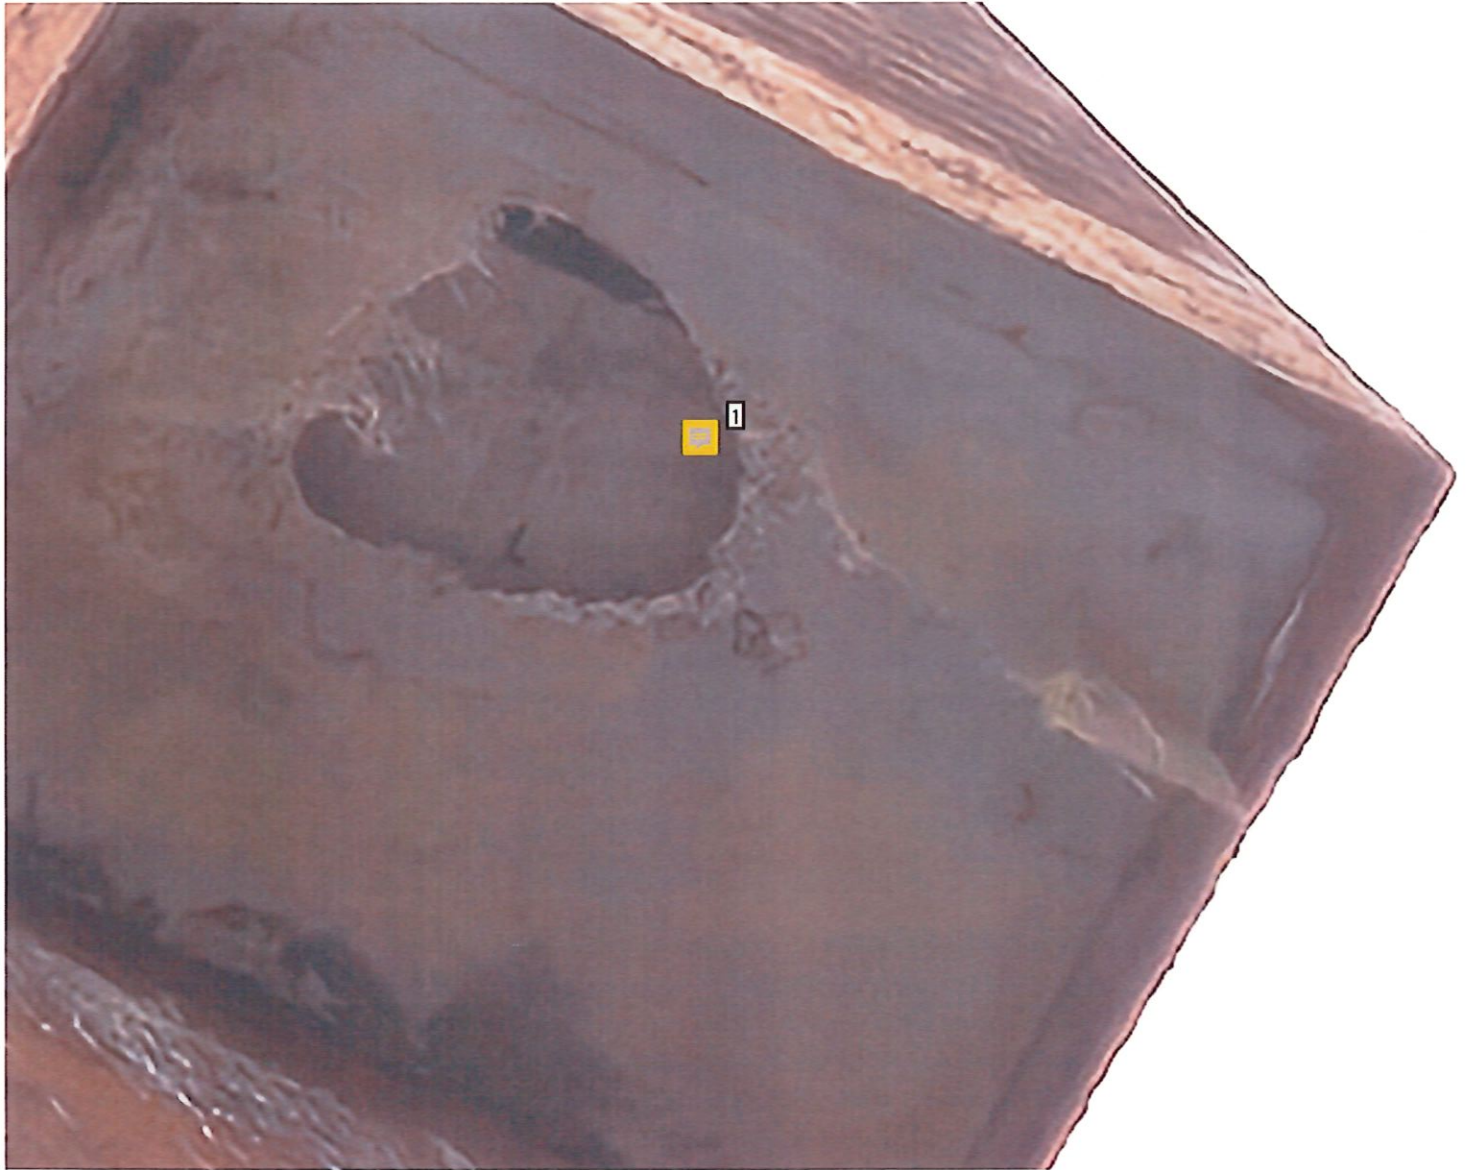
Number: 1      Author: Bethany.Collie      Subject: Sticky Note      Date: 5/8/2024 4:04:04 PM  
Same area as previous picture from a better angle

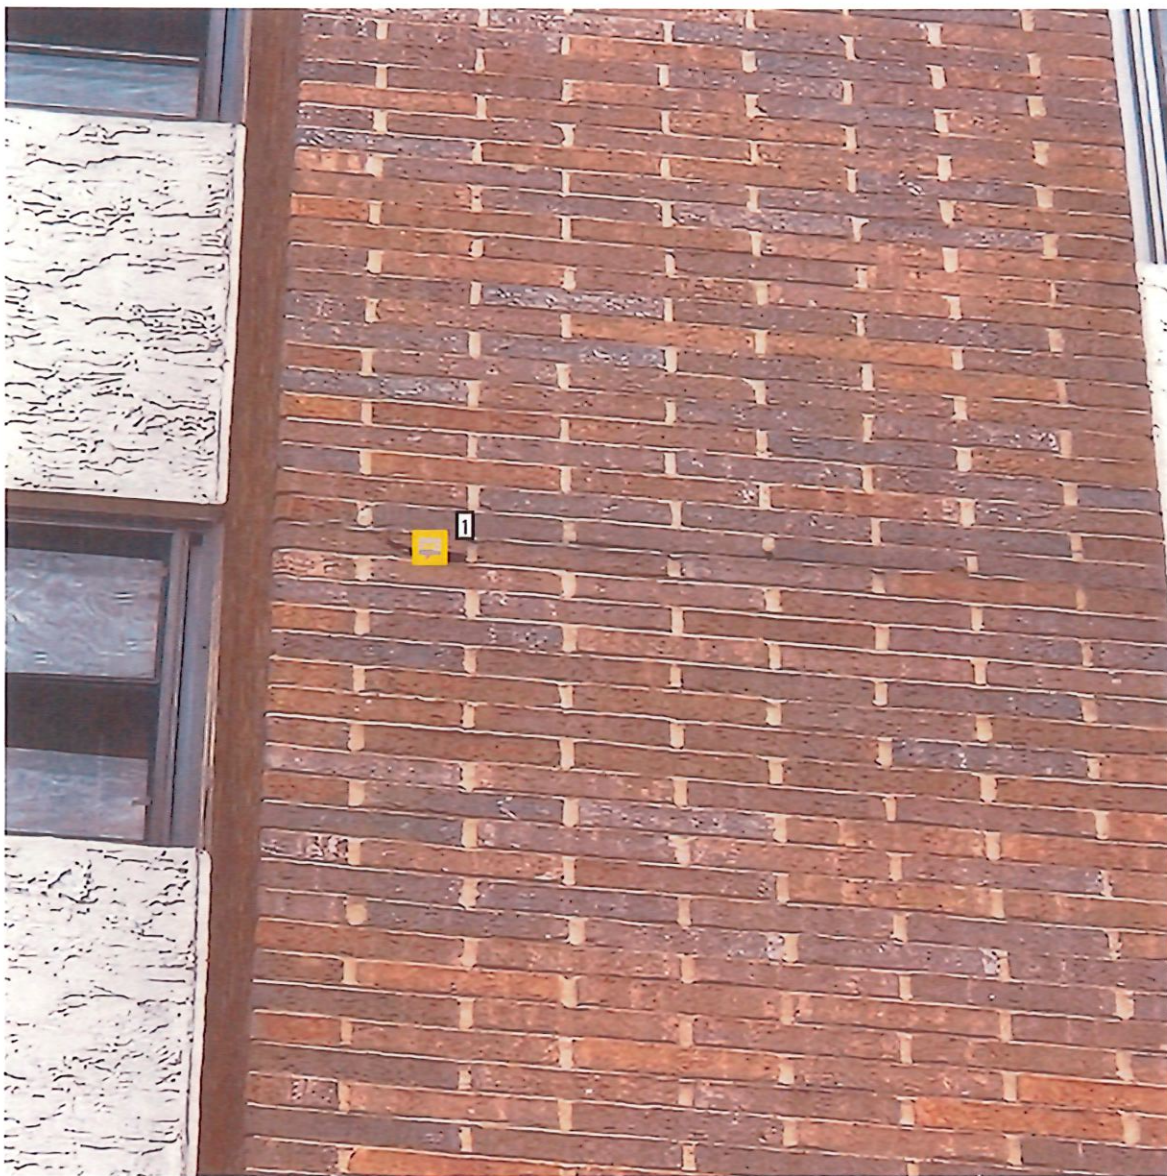
Number: 1      Author: Bethany.Collie      Subject: Sticky Note      Date: 5/8/2024 4:04:33 PM  
Brick deterioration in the middle of the south wall

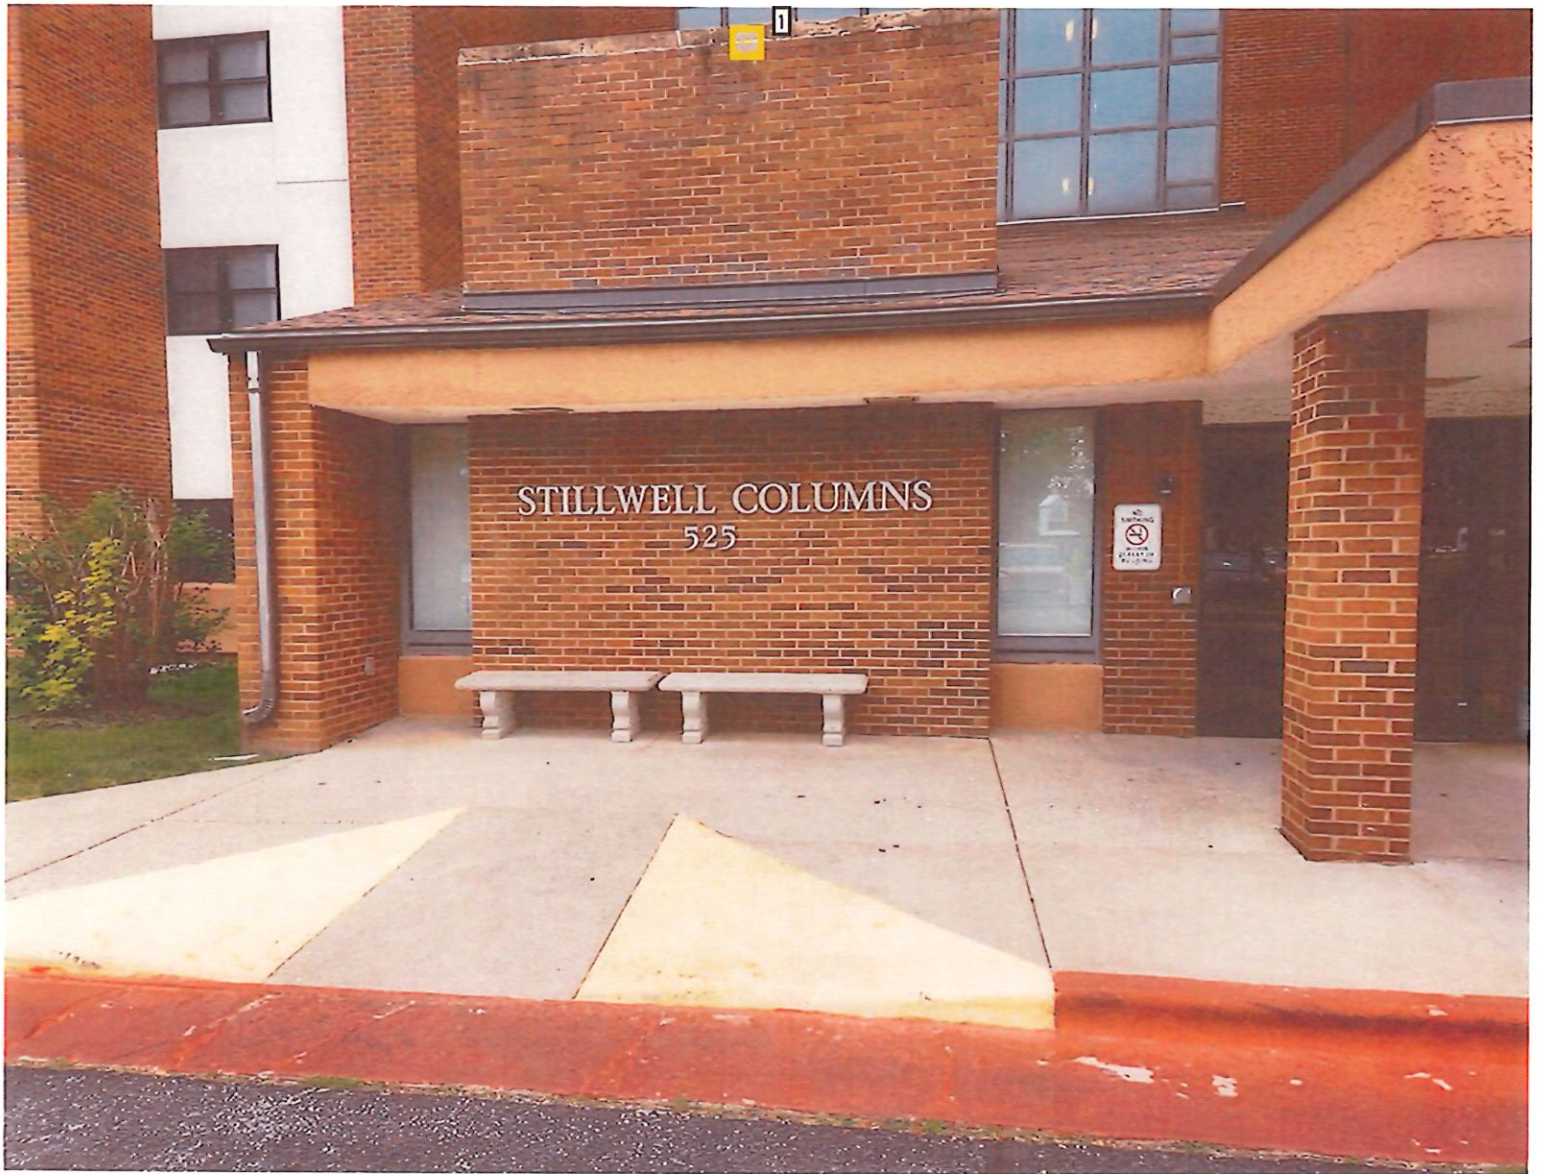
Number: 1      Author: Bethany.Collie      Subject: Sticky Note      Date: 5/8/2024 4:04:58 PM  
Chimney- leaks, flashing installed incorrectly

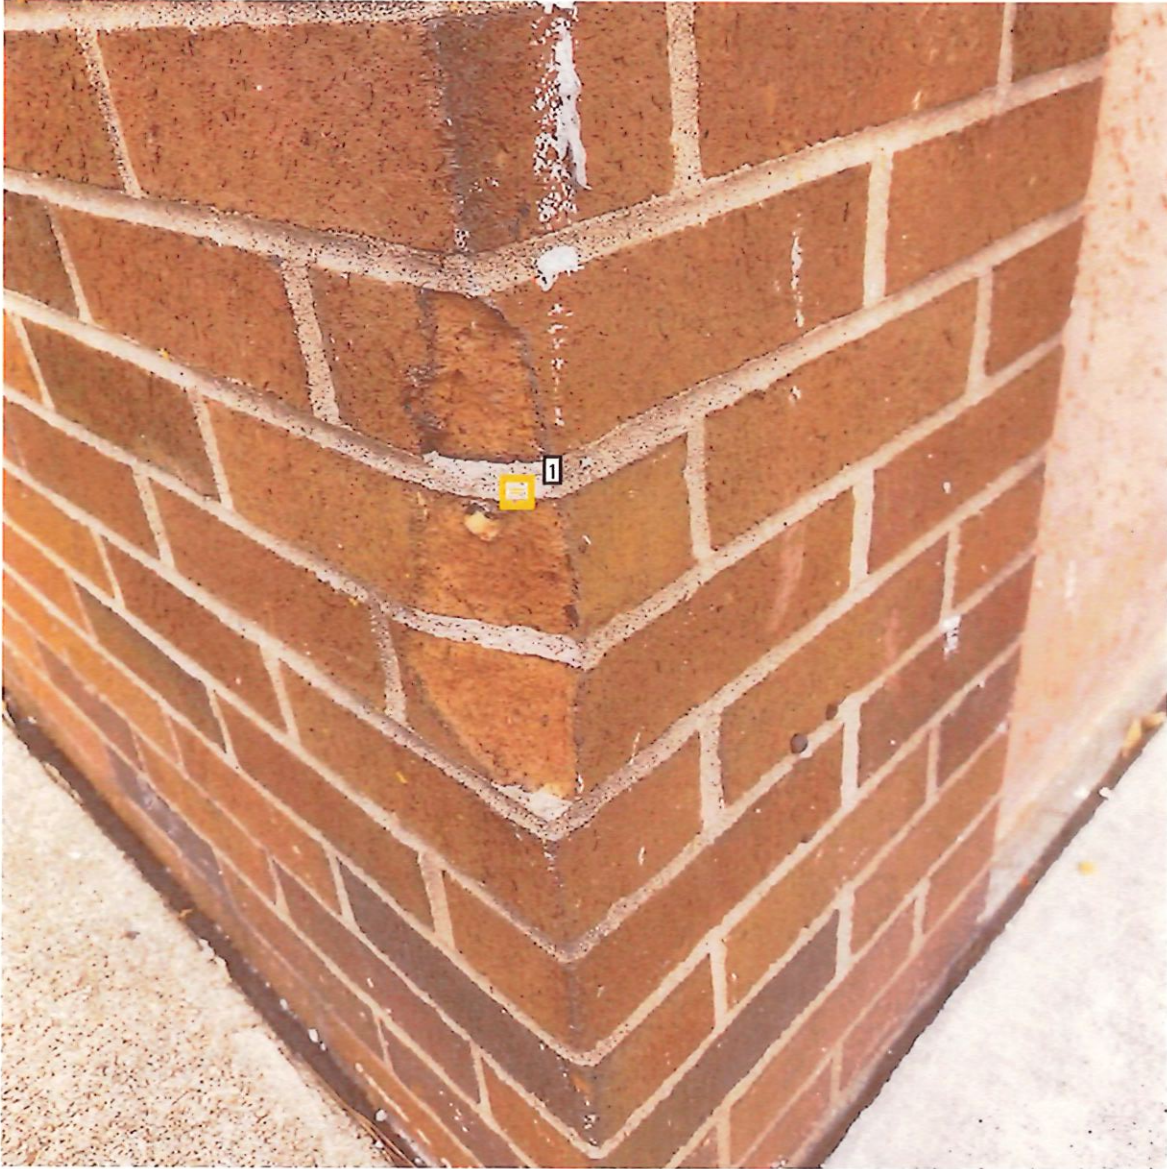
| Brick deterioration or busted | | | | |

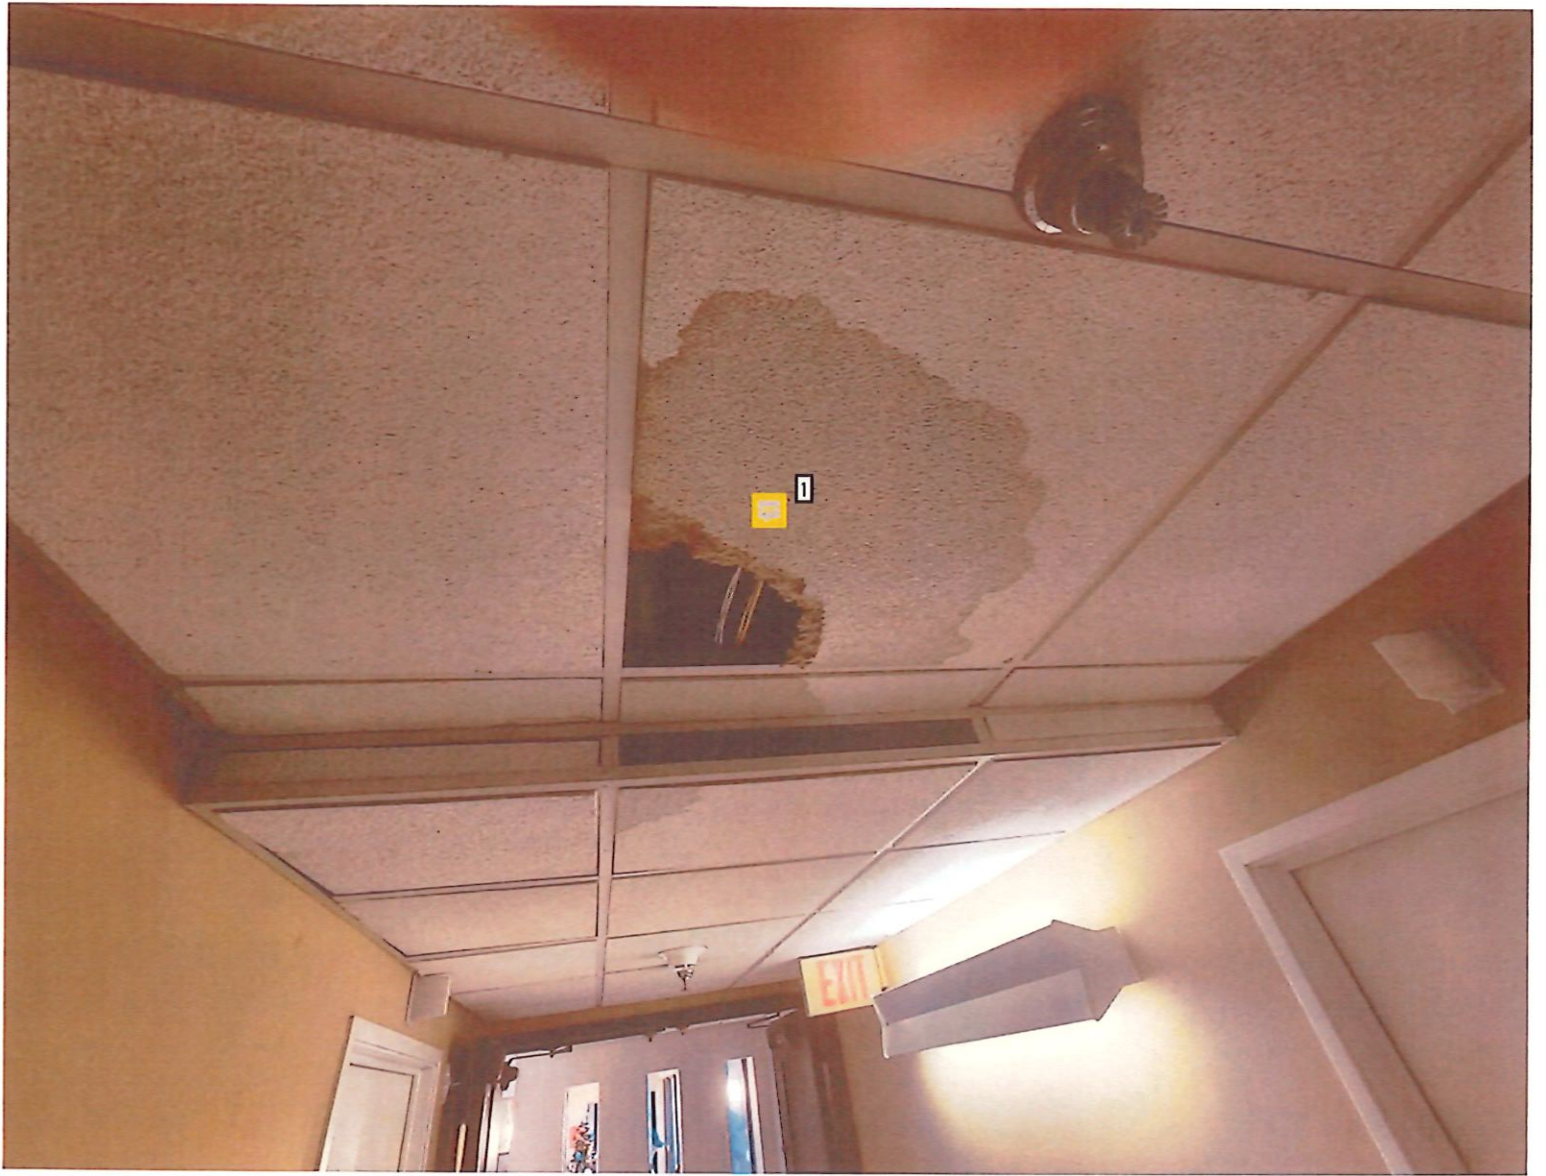
Number: 1 Author: Bethany.Collie Subject: Sticky Note Date: 5/8/2024 4:05:48 PM  
Damaged tile- 9th floor due to leak from the air handler on the roof

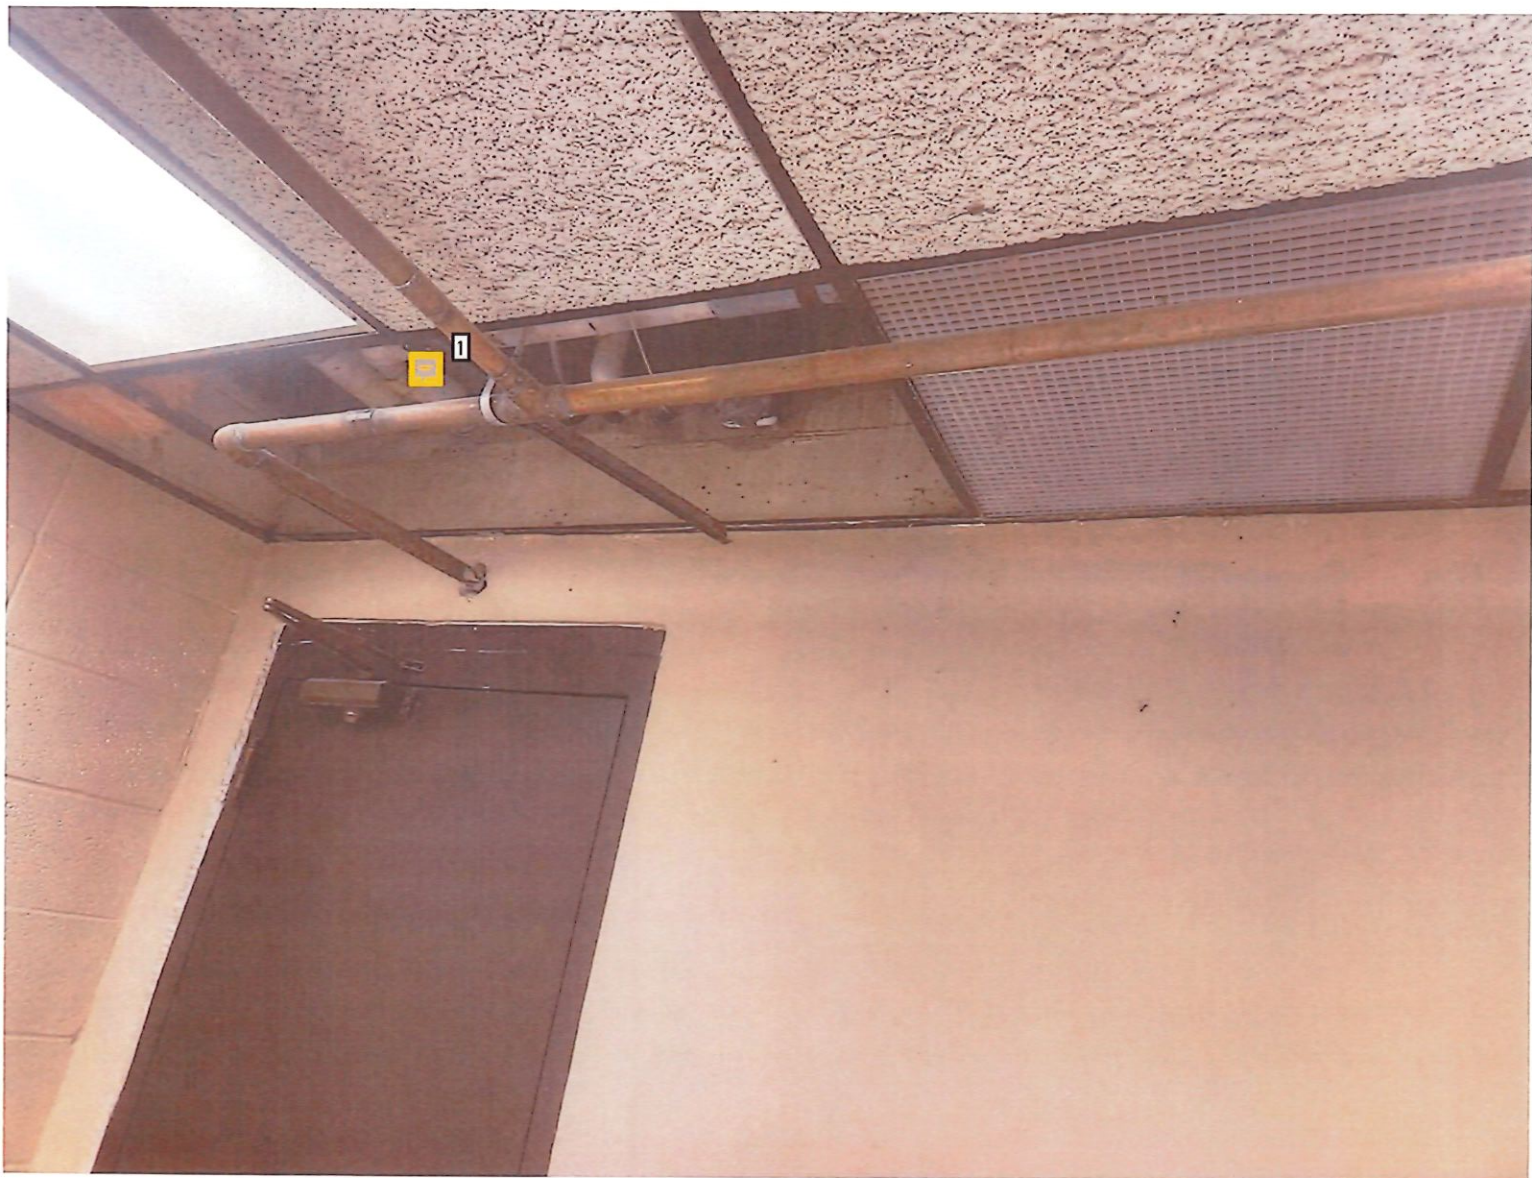
Number: 1      Author: Bethany.Collie      Subject: Sticky Note      Date: 5/8/2024 4:06:18 PM  
damage due to leak from a slanted shingle roof on the south east end of the building

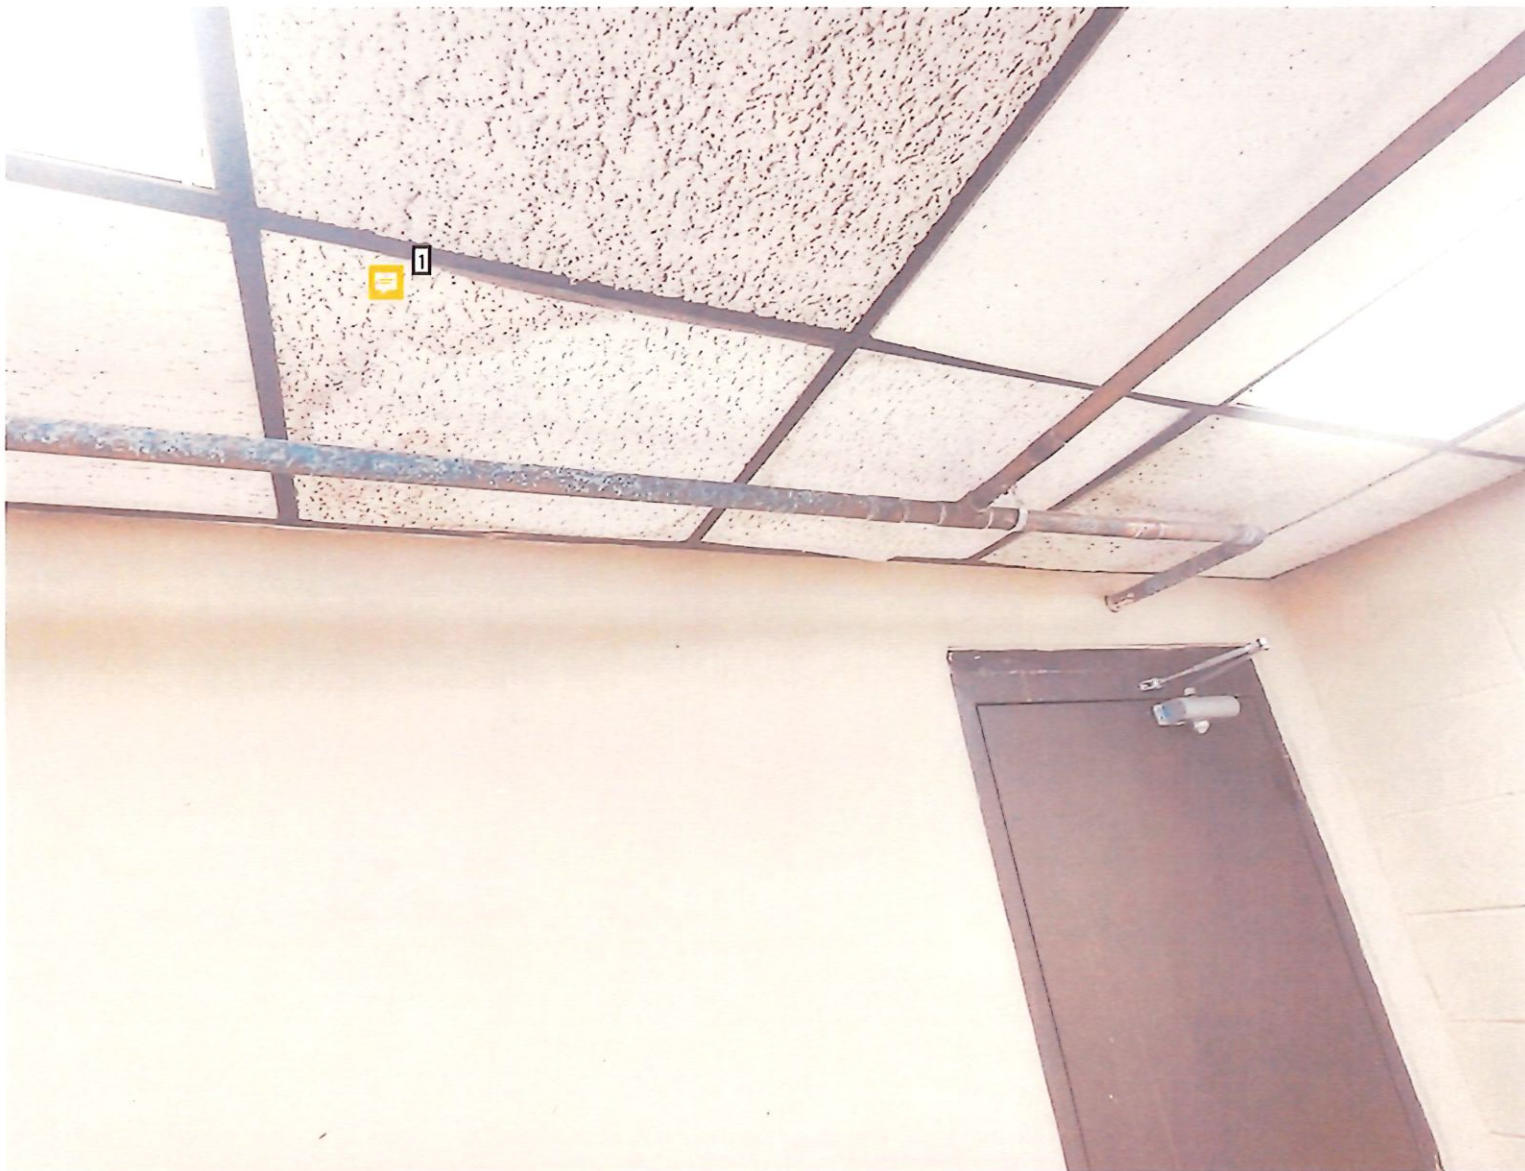
Number: 1      Author: Bethany.Collie      Subject: Sticky Note      Date: 5/8/2024 4:06:34 PM  
damage from a leak on the north east end of a slanted roof

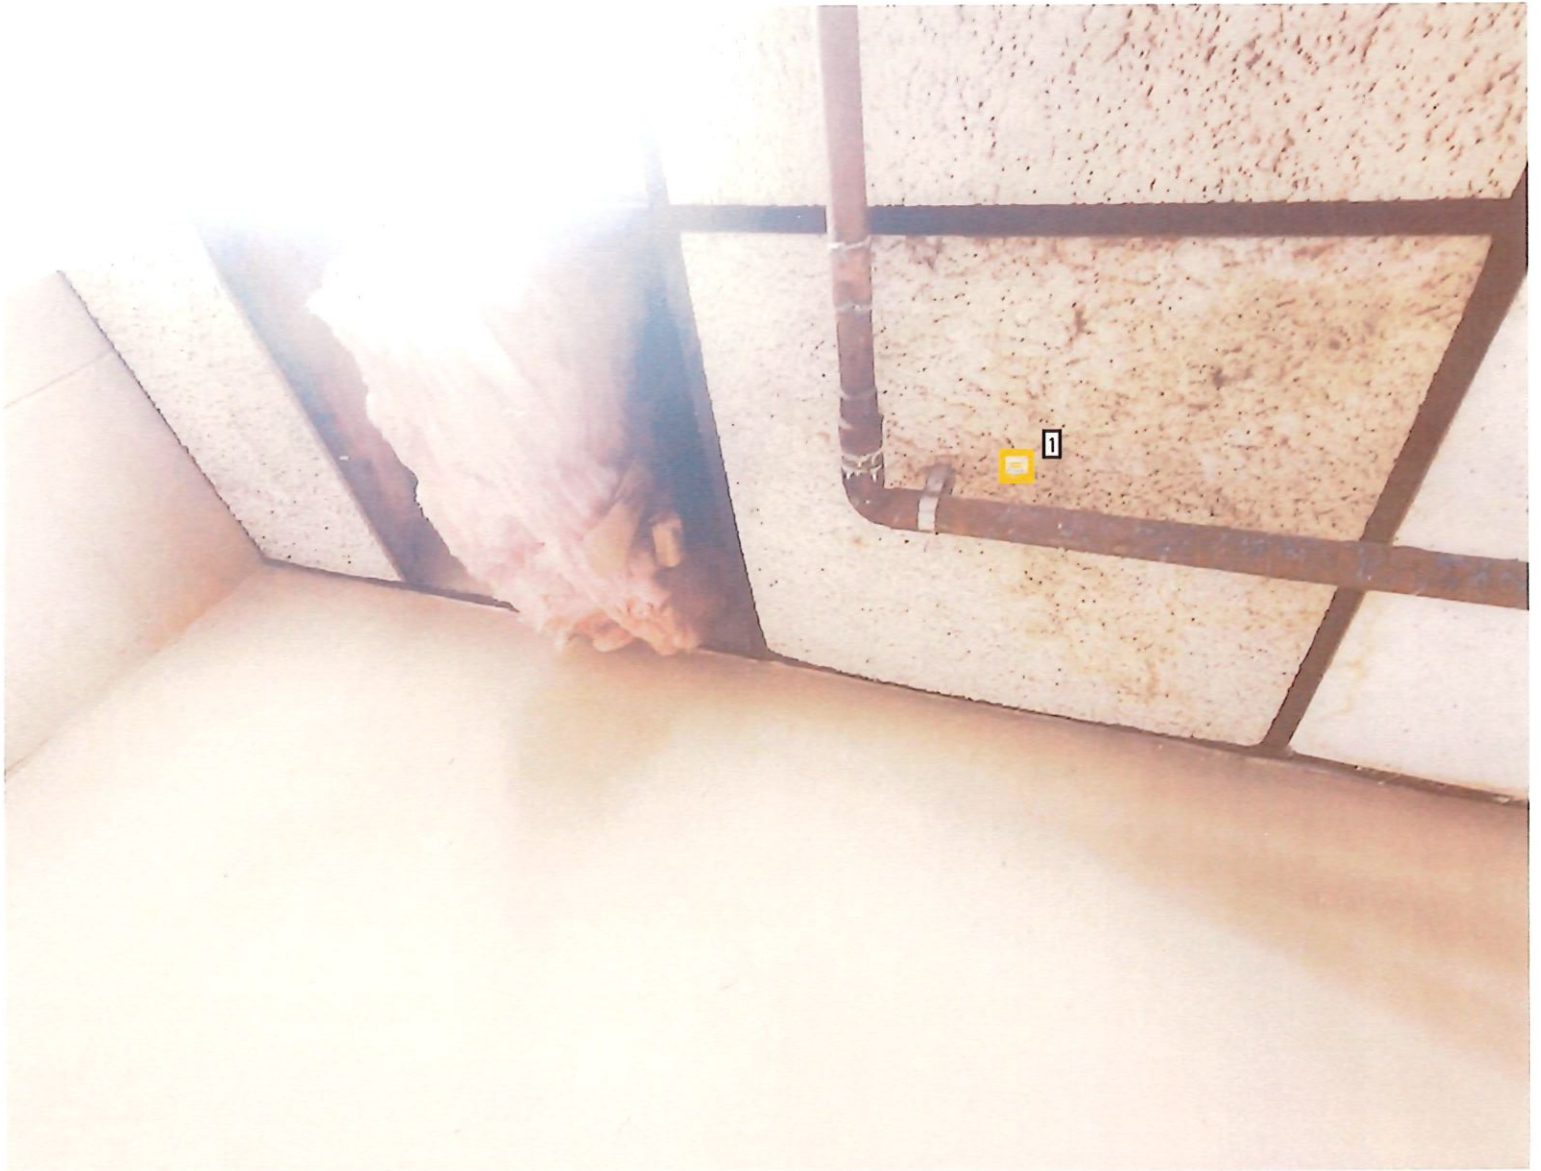
Number: 1 Author: Bethany.Collie Subject: Sticky Note Date: 5/8/2024 4:06:55 PM  
Damage from roof leak on the north end of the building

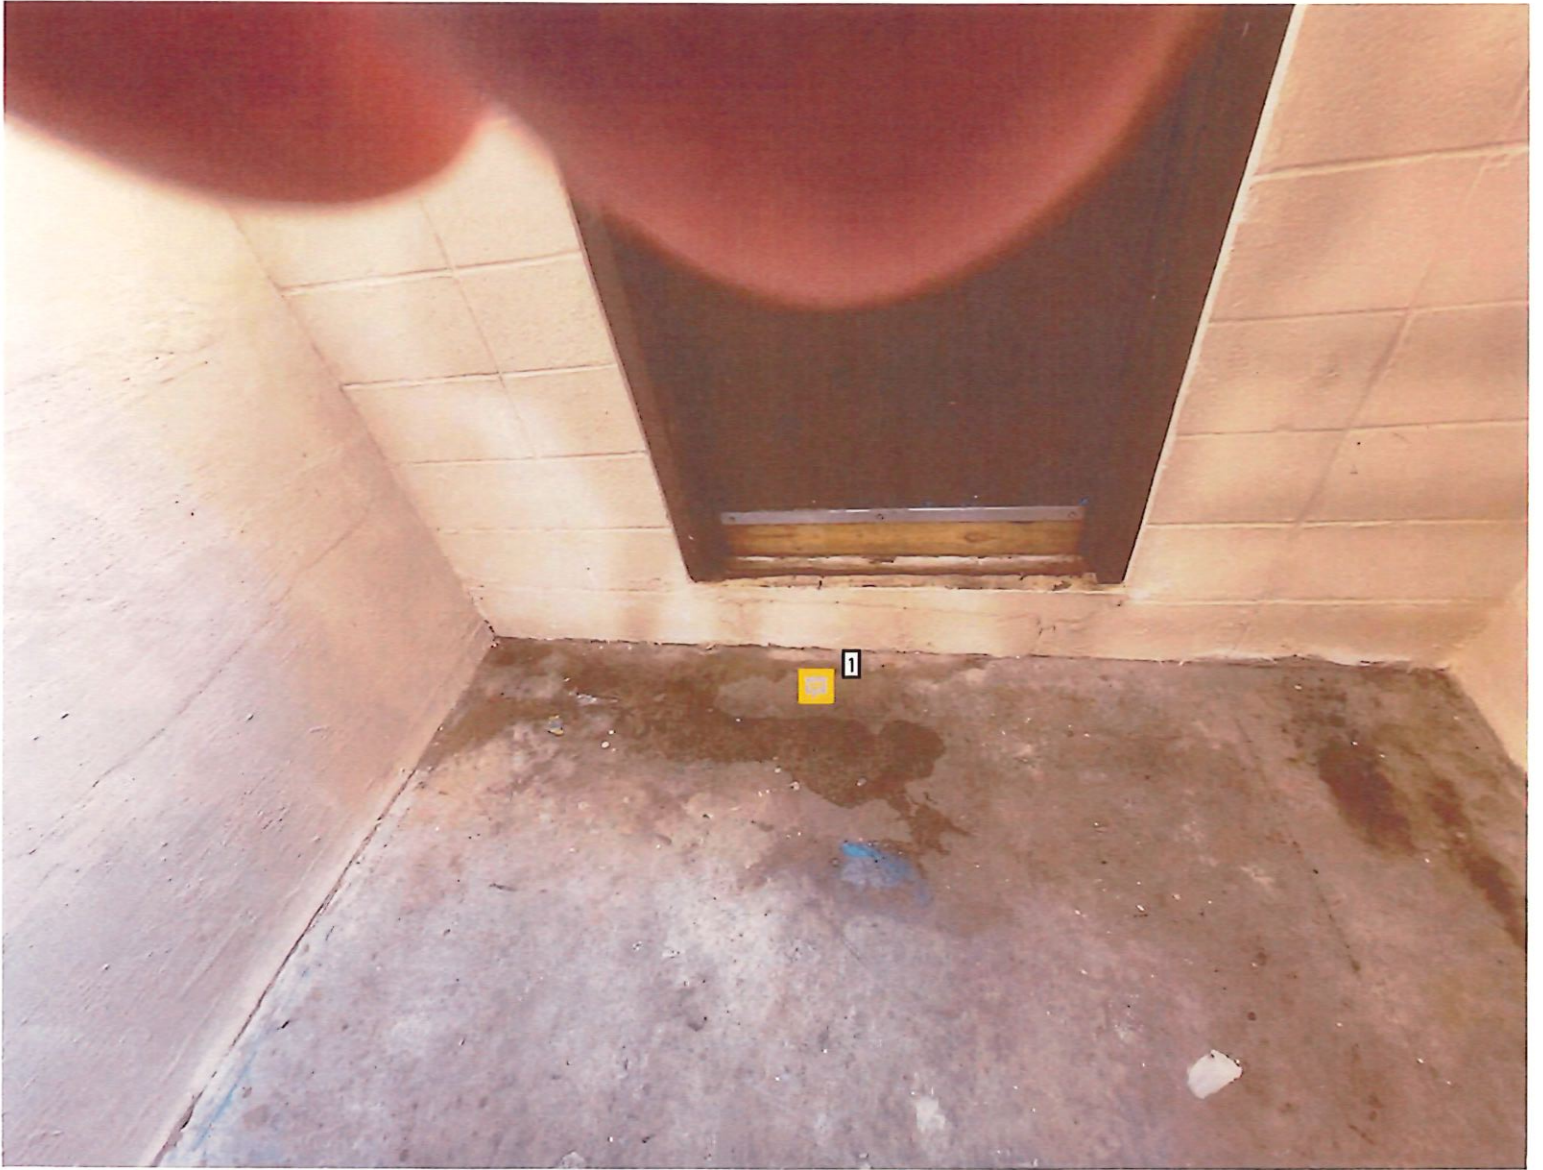
Number: 1      Author: Bethany.Collie      Subject: Sticky Note      Date: 5/8/2024 4:07:20 PM  
East side stairwell-9th floor- leak

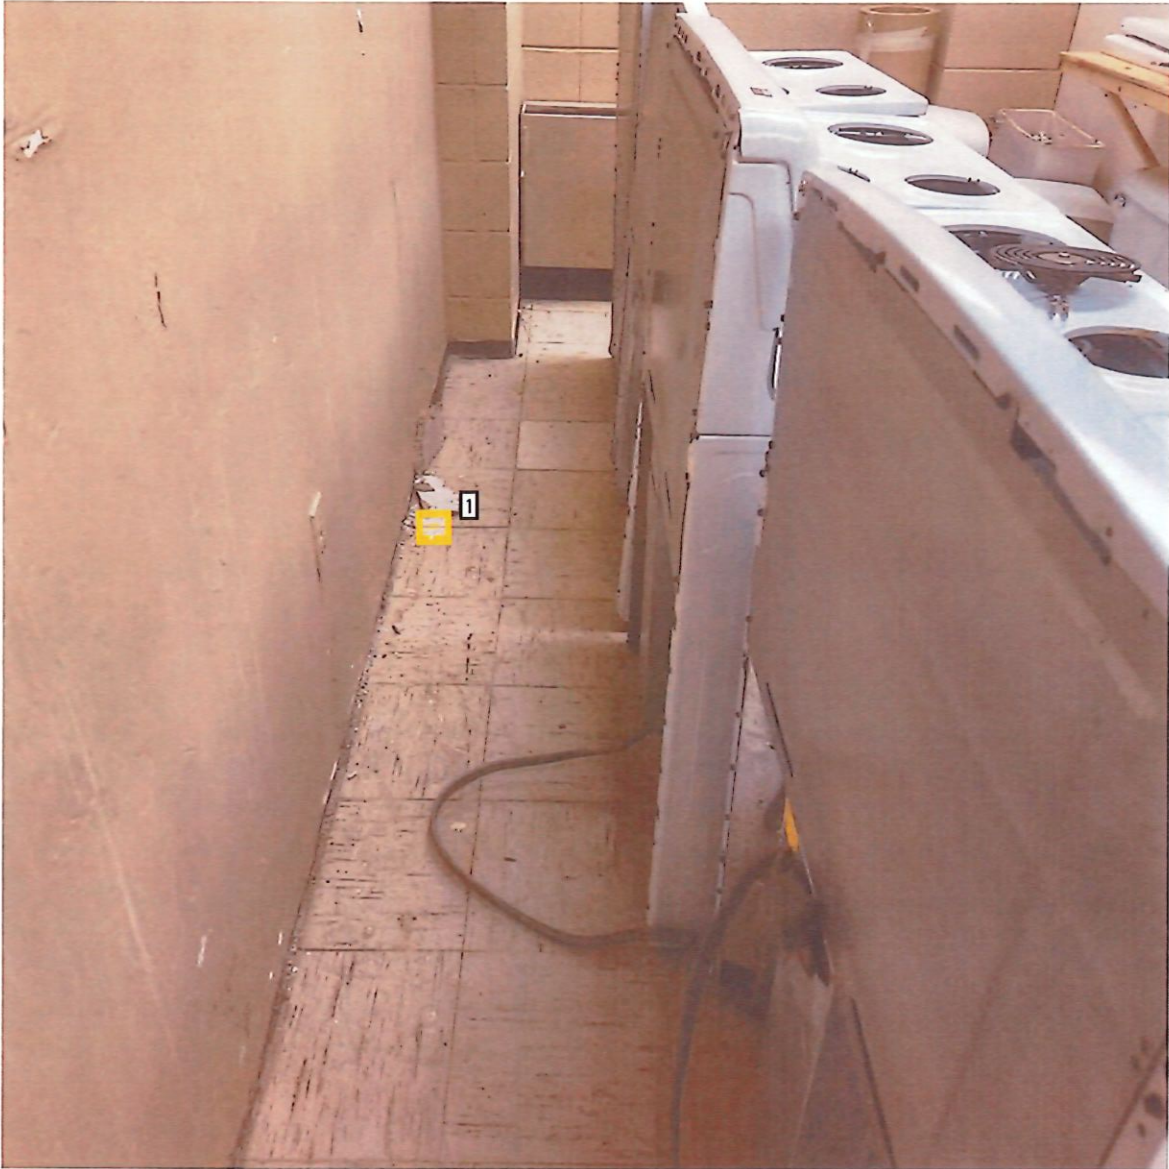
Number: 1      Author: Bethany.Collie      Subject: Sticky Note      Date: 5/8/2024 4:07:44 PM  
Damage due to roof leak on the south end of the building
