# **Springfield Land Clearance for Redevelopment Authority**

**Blight Report**  
**Stillwell Columns Redevelopment**

#### Stillwell Columns

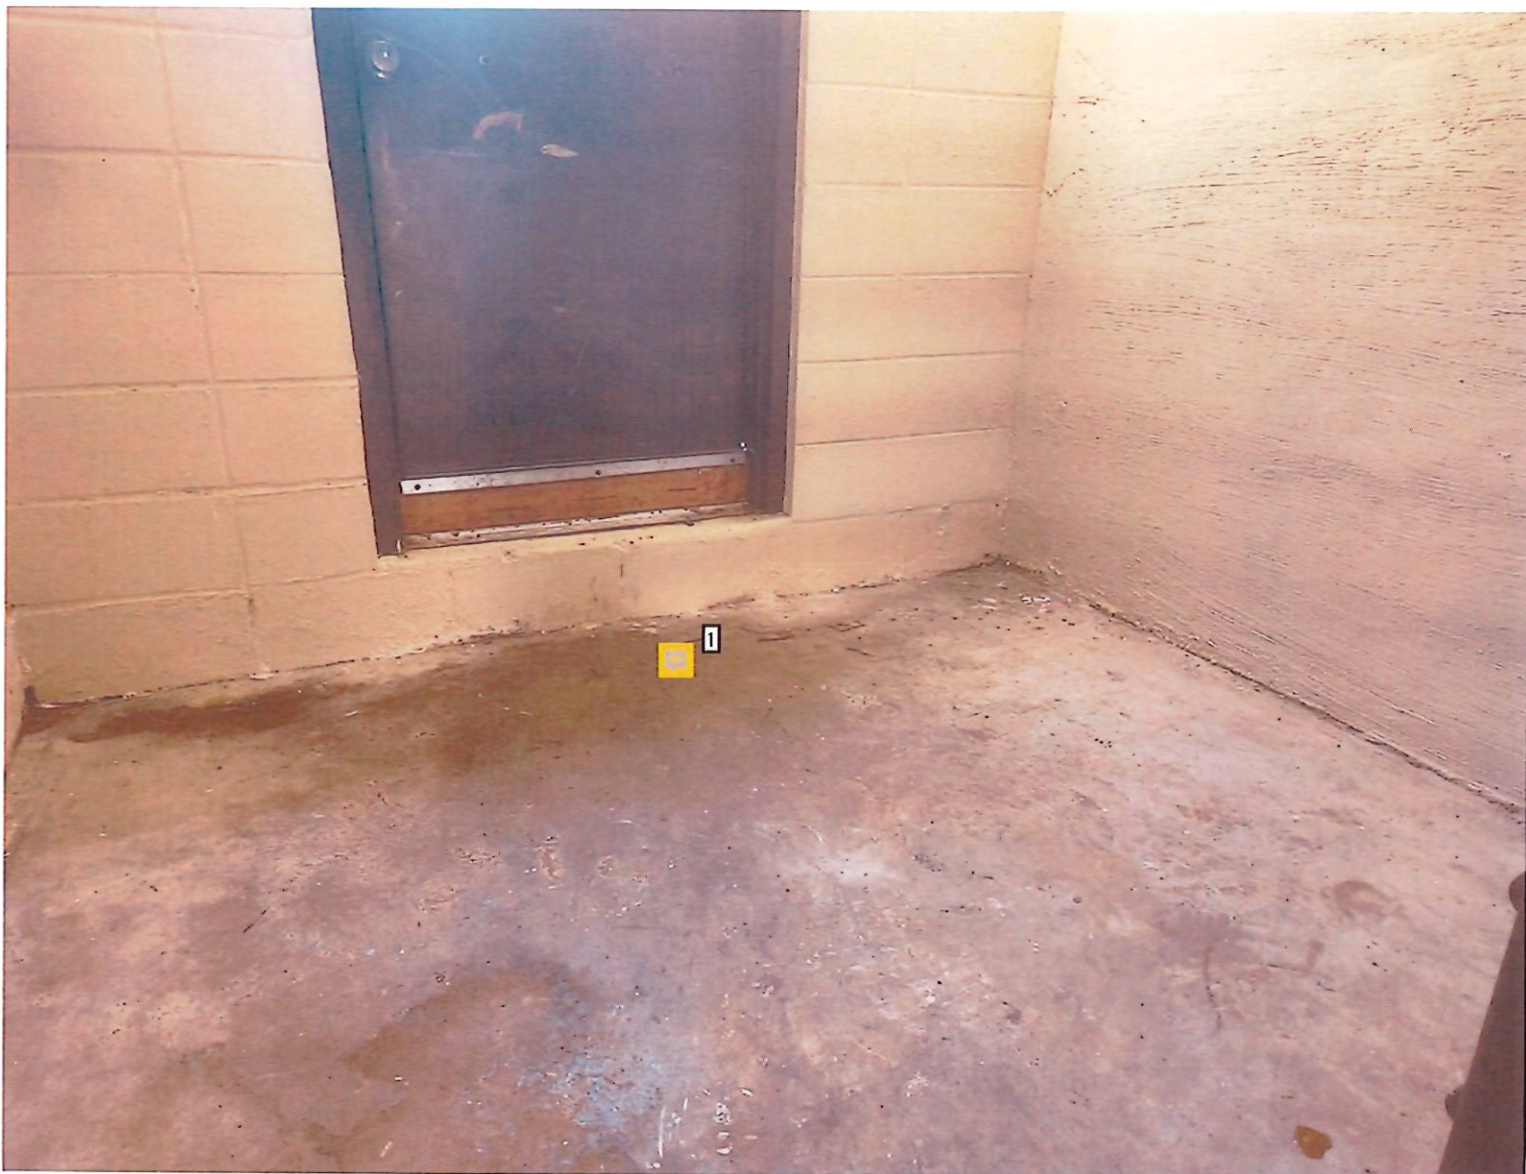
Number: 1      Author: Bethany.Collie      Subject: Sticky Note      Date: 5/8/2024 4:08:08 PM  
West end stairwell-9th floor- water leaking into the building

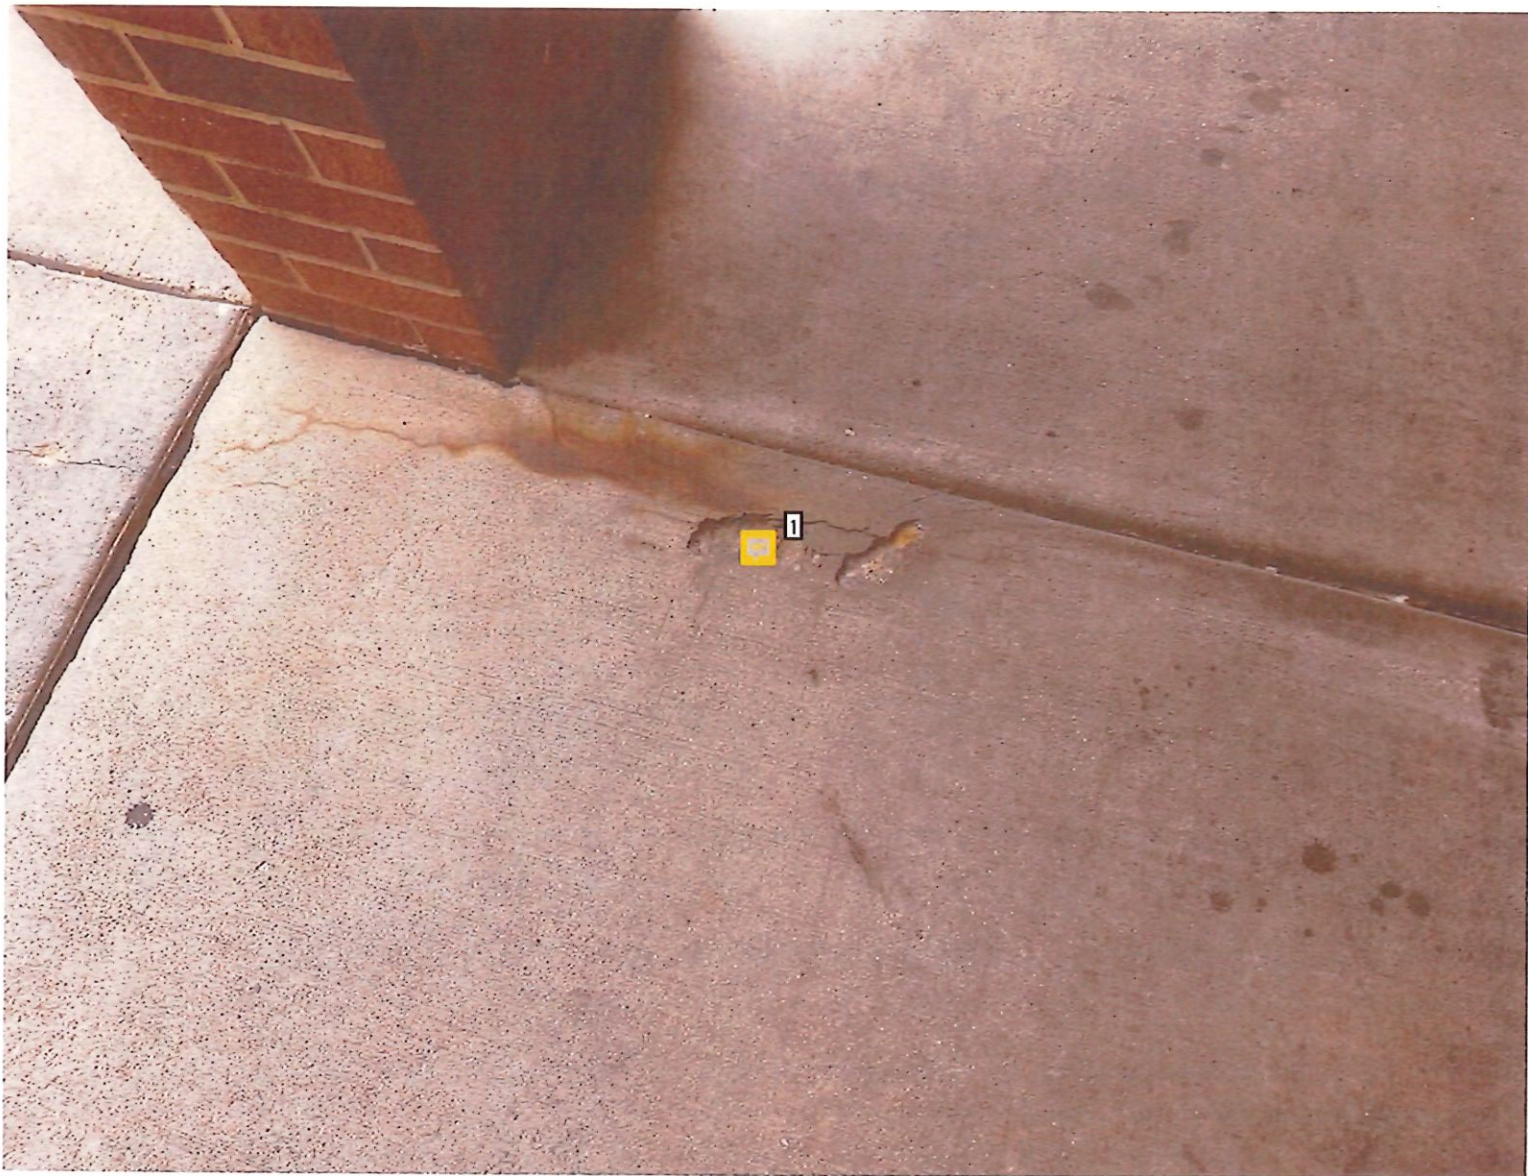
| Deterioration of the sidewalk at the main entrance on the north end | | | |

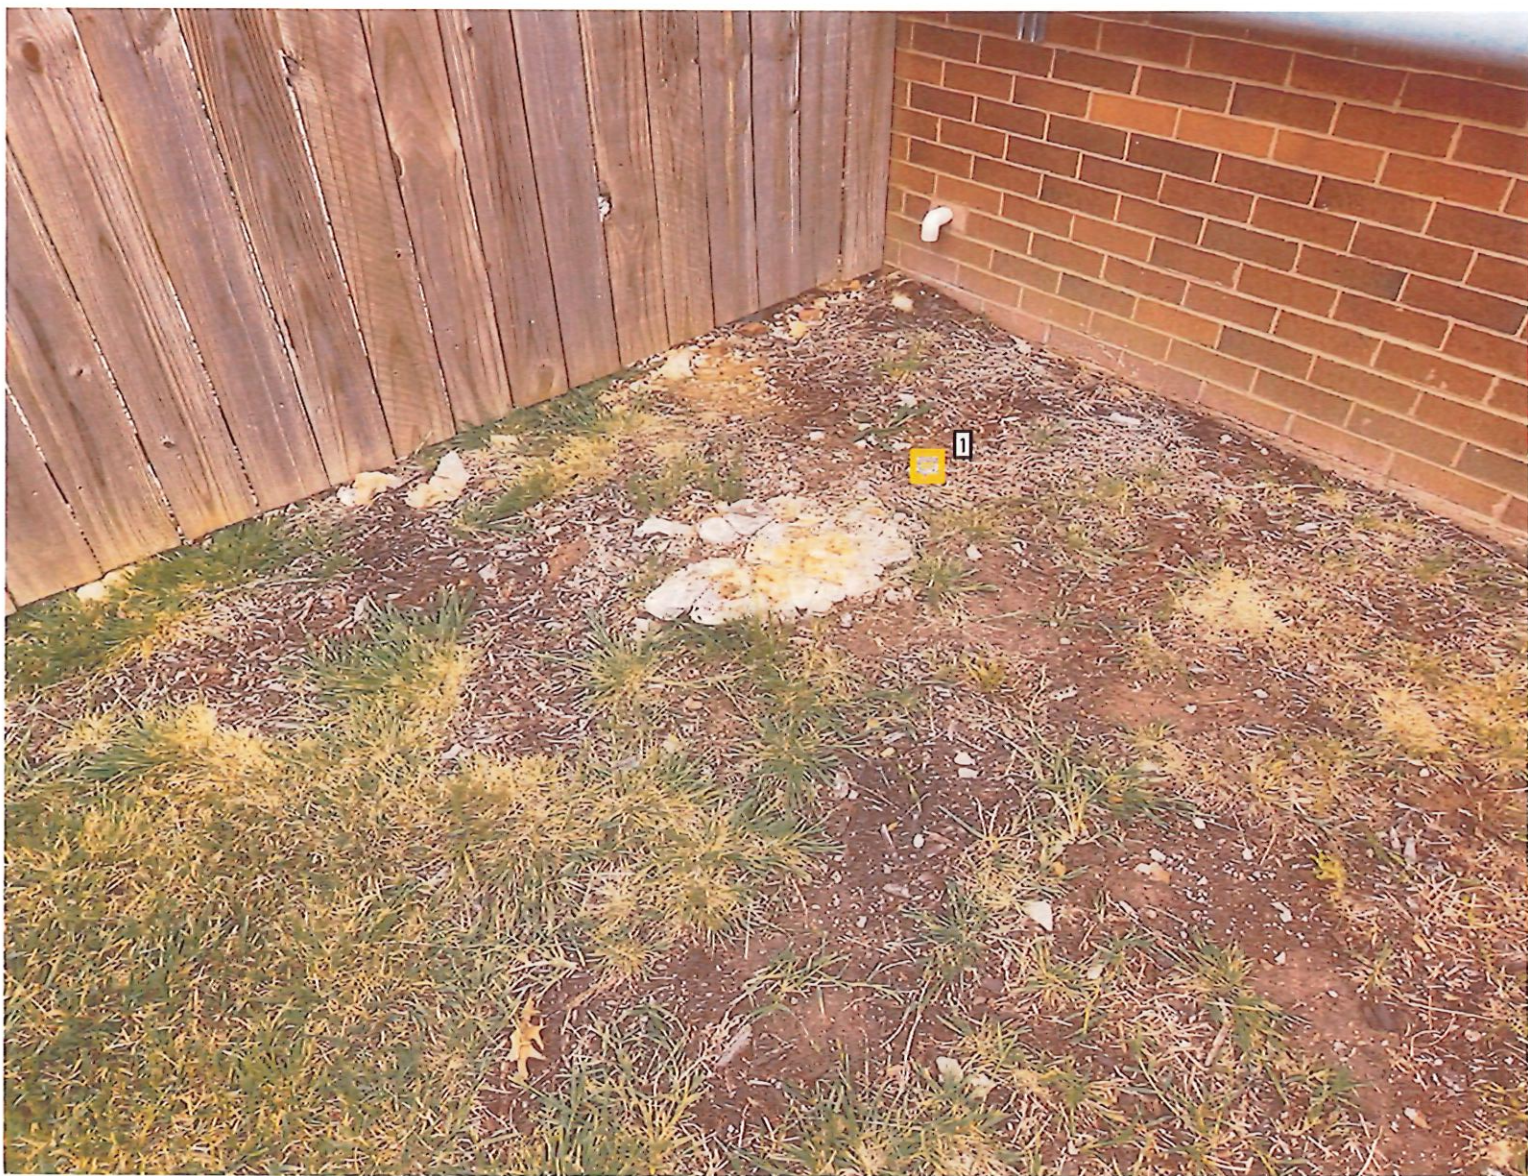
| Stump that needs to be removed on Southwest end of the building - needs landscaping | | | | |

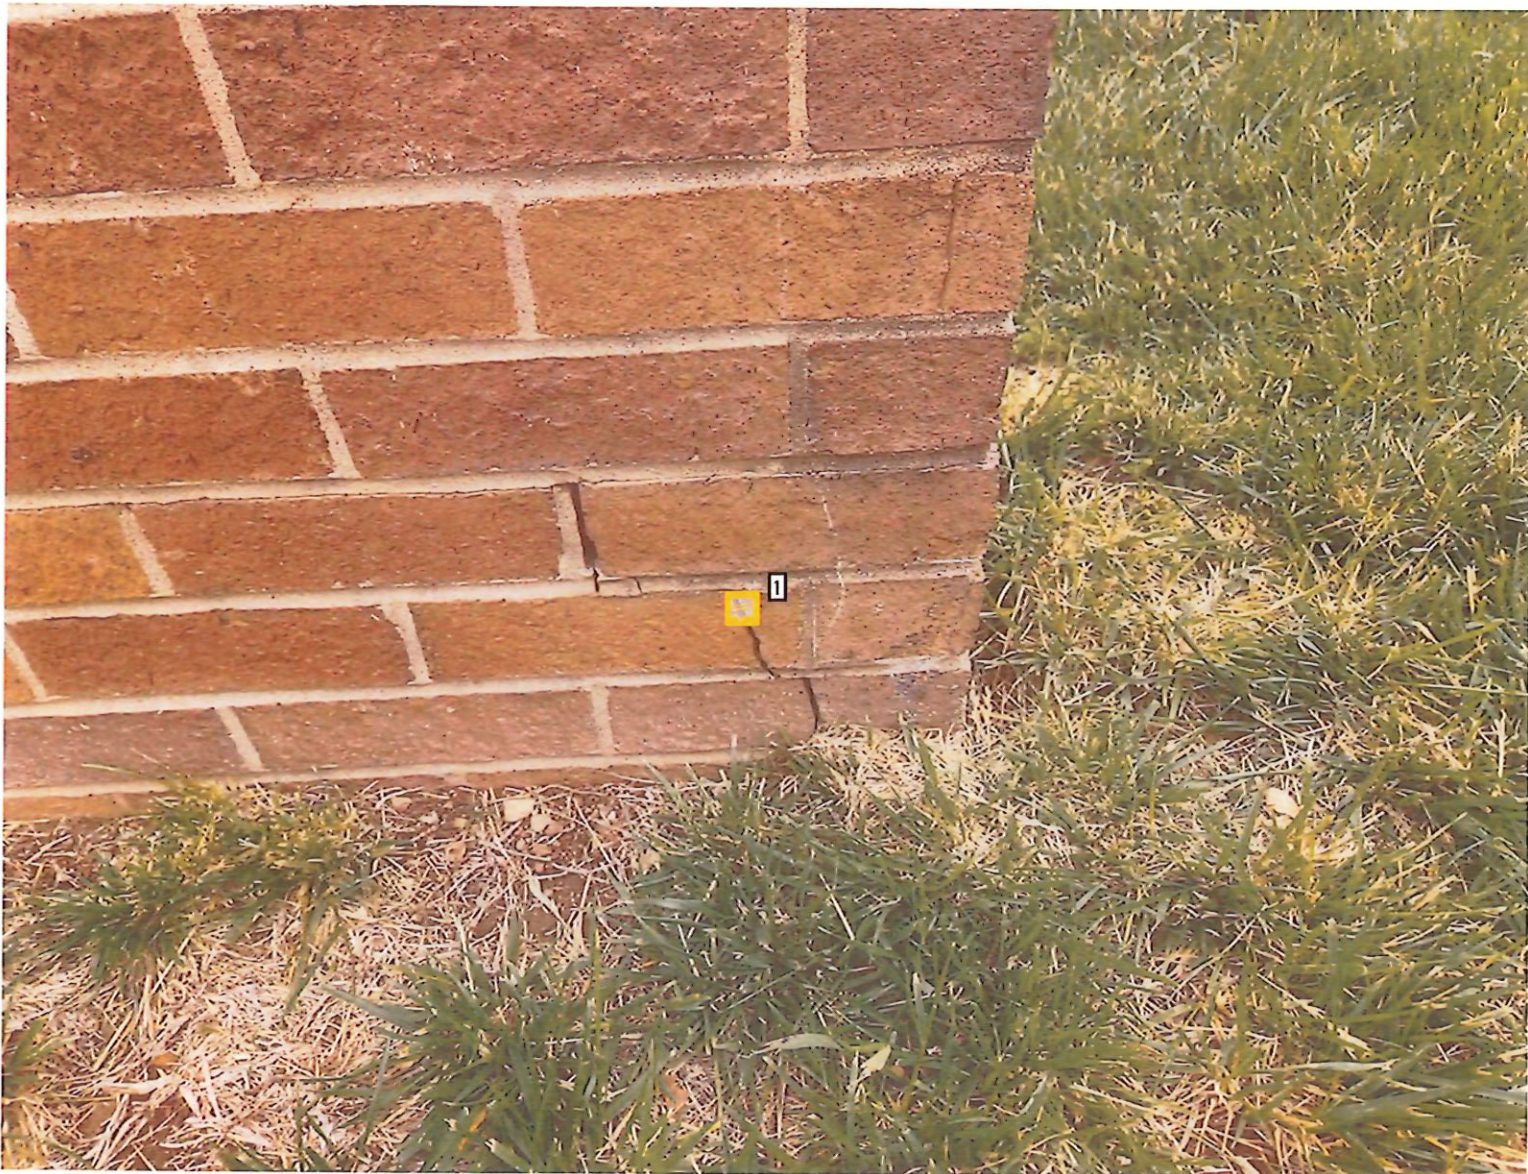
Number: 1      Author: Bethany.Collie      Subject: Sticky Note      Date: 5/8/2024 4:10:03 PM  
Brick deterioration on the Southwest end of the building

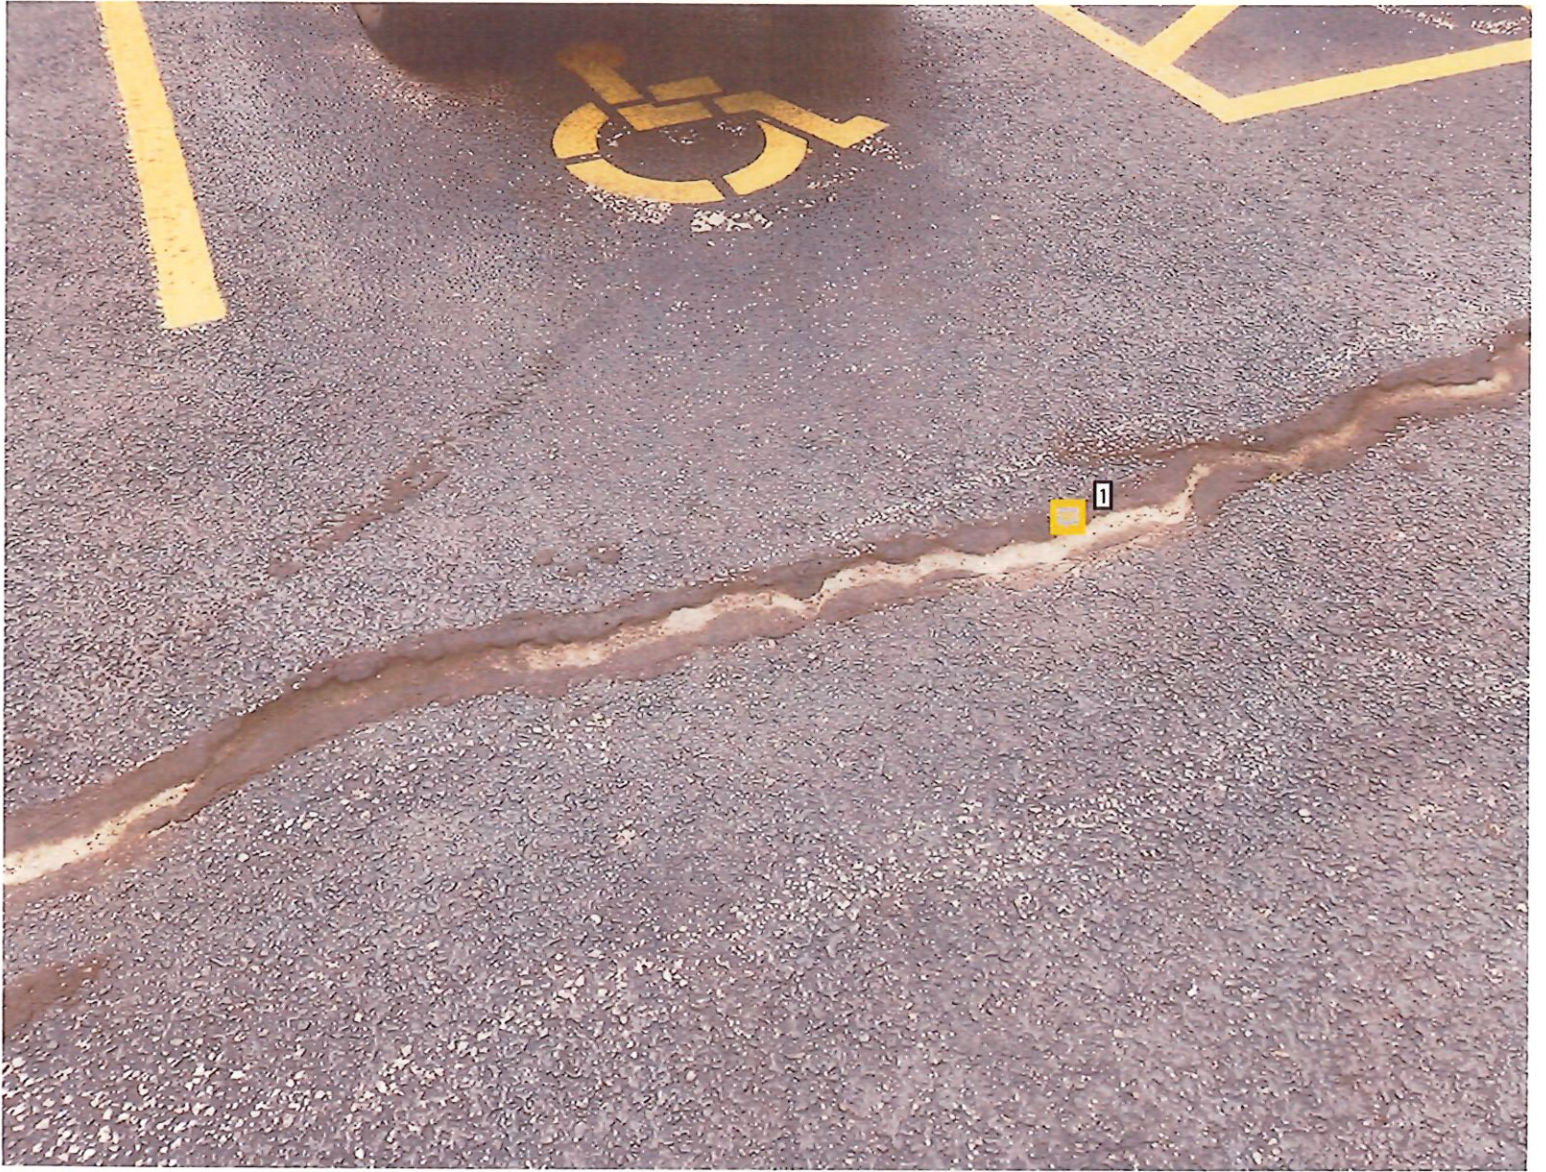
Number: 1 Author: Bethany.Collie Subject: Sticky Note Date: 5/8/2024 4:10:44 PM  
Parking lots- asphalt- needs to be relayed- cracks and uneven.

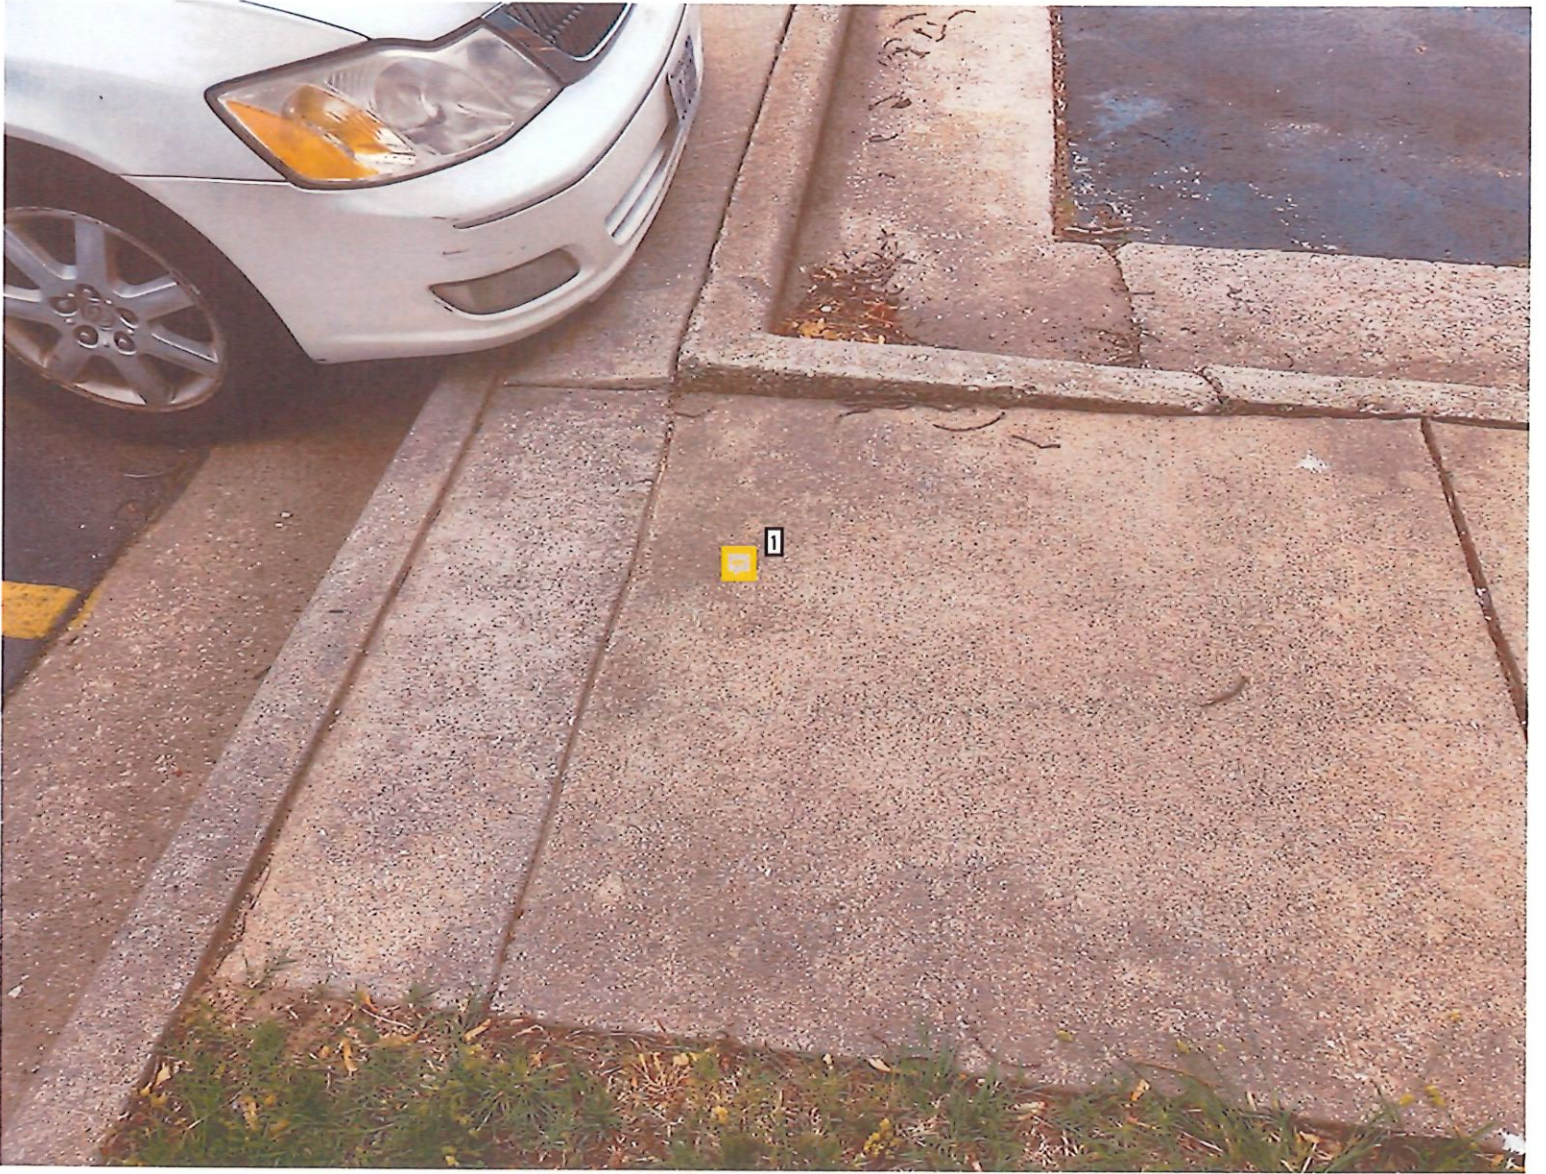
Number: 1      Author: Bethany.Collie      Subject: Sticky Note      Date: 5/8/2024 4:11:08 PM  
Uneven side walk- curb is too high or the sidewalk is too low- major tripping hazard

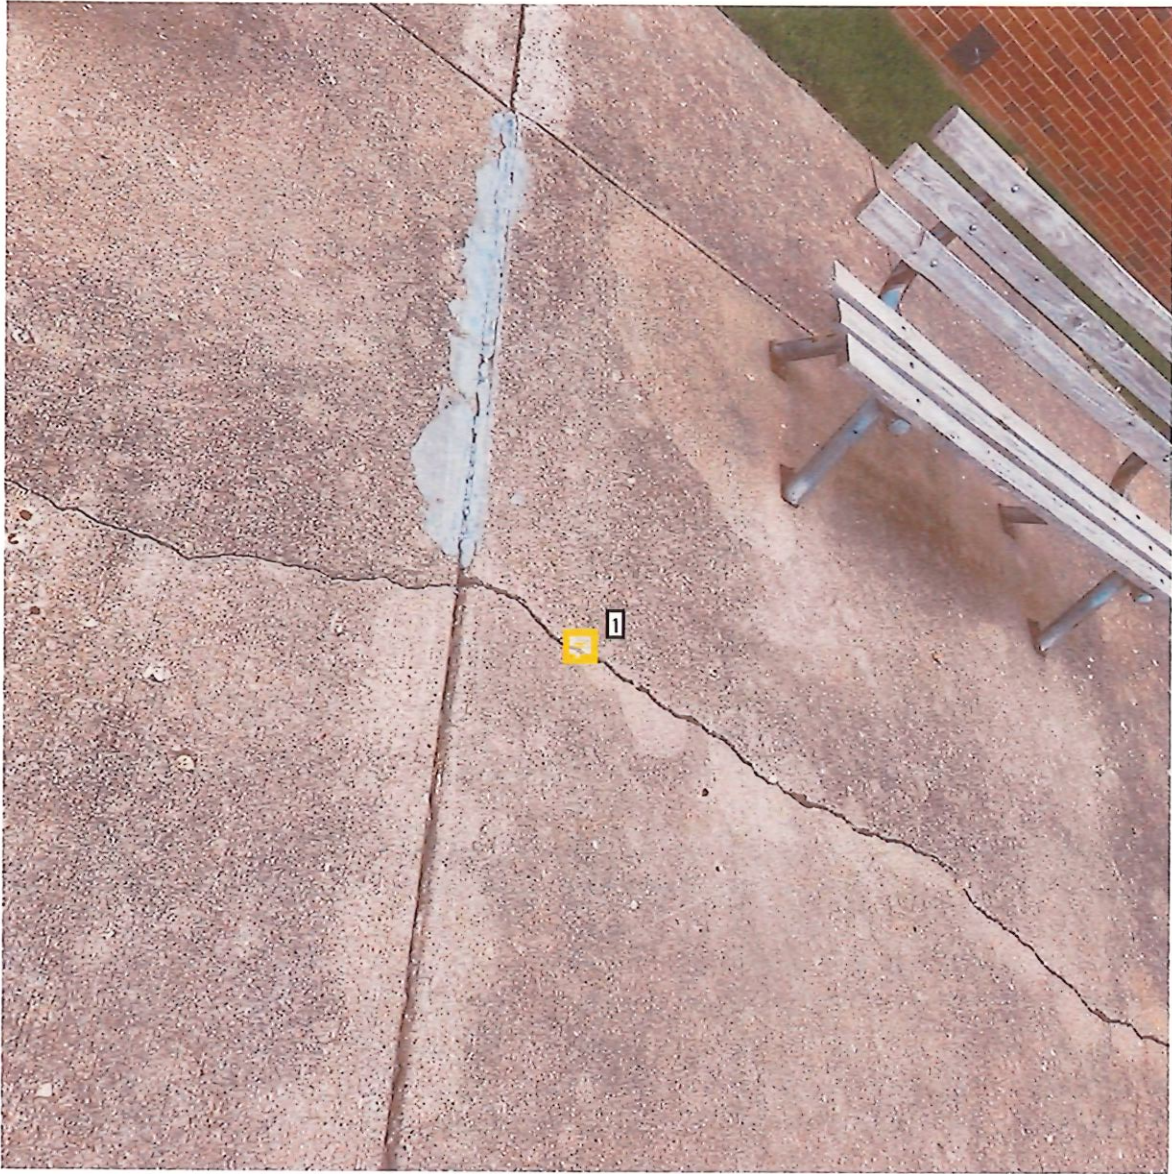
| Concrete slab at north east end of the building a common area for benches, bbqs, etc. cracking and deteriorated | | | |

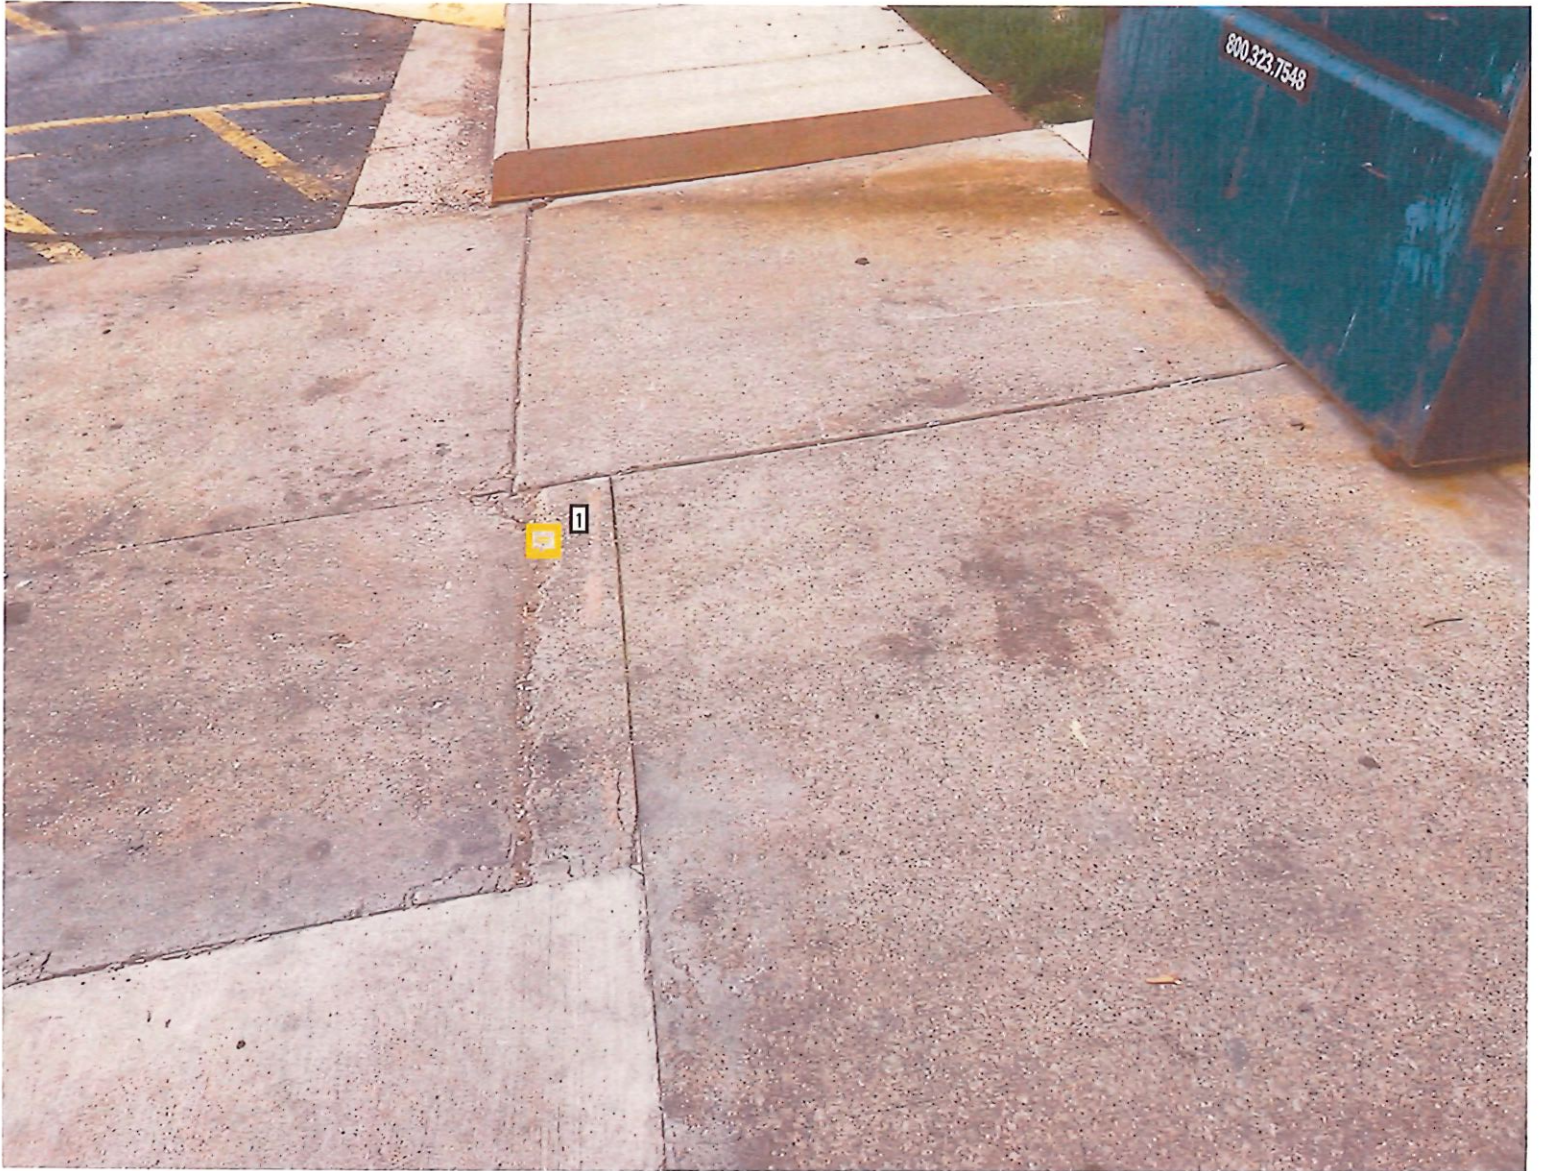
Number: 1 Author: Bethany.Collie Subject: Sticky Note Date: 5/8/2024 4:12:34 PM  
northside of the building- dumpster pad is deteriorating.

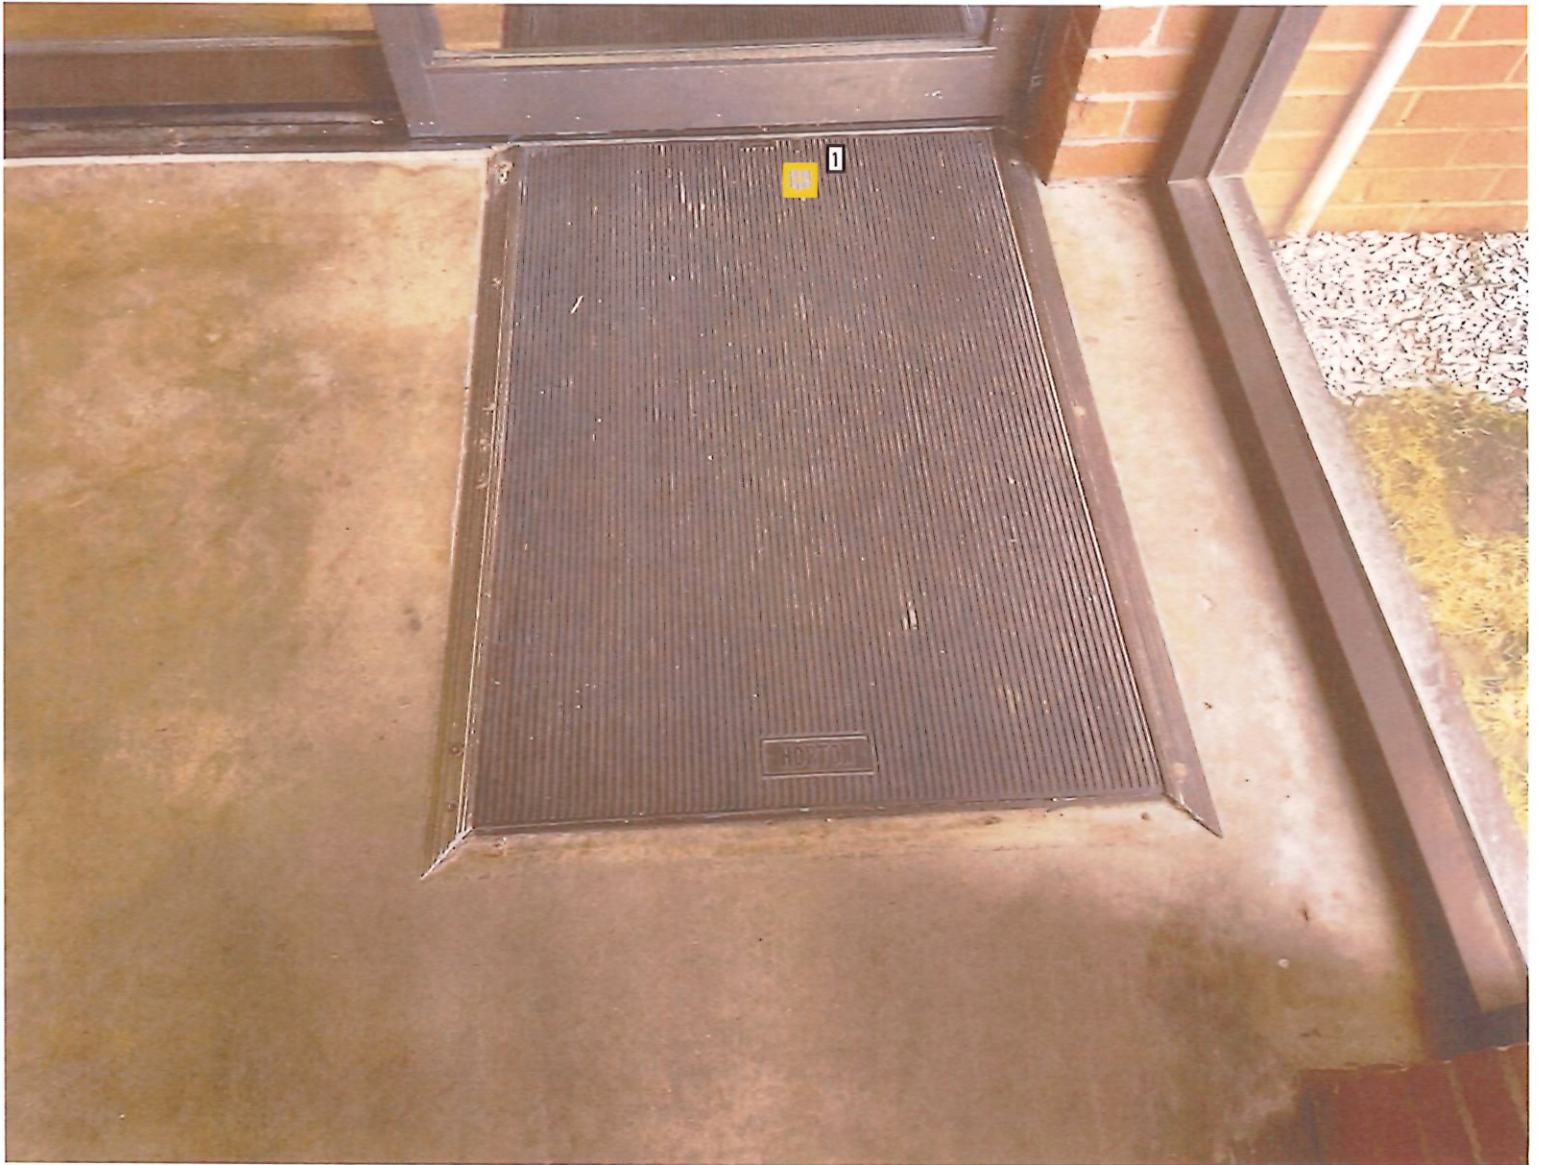
Number: 1      Author: Bethany.Collie      Subject: Sticky Note      Date: 5/8/2024 4:14:05 PM  
pieces are missing on the sliding door inside and out

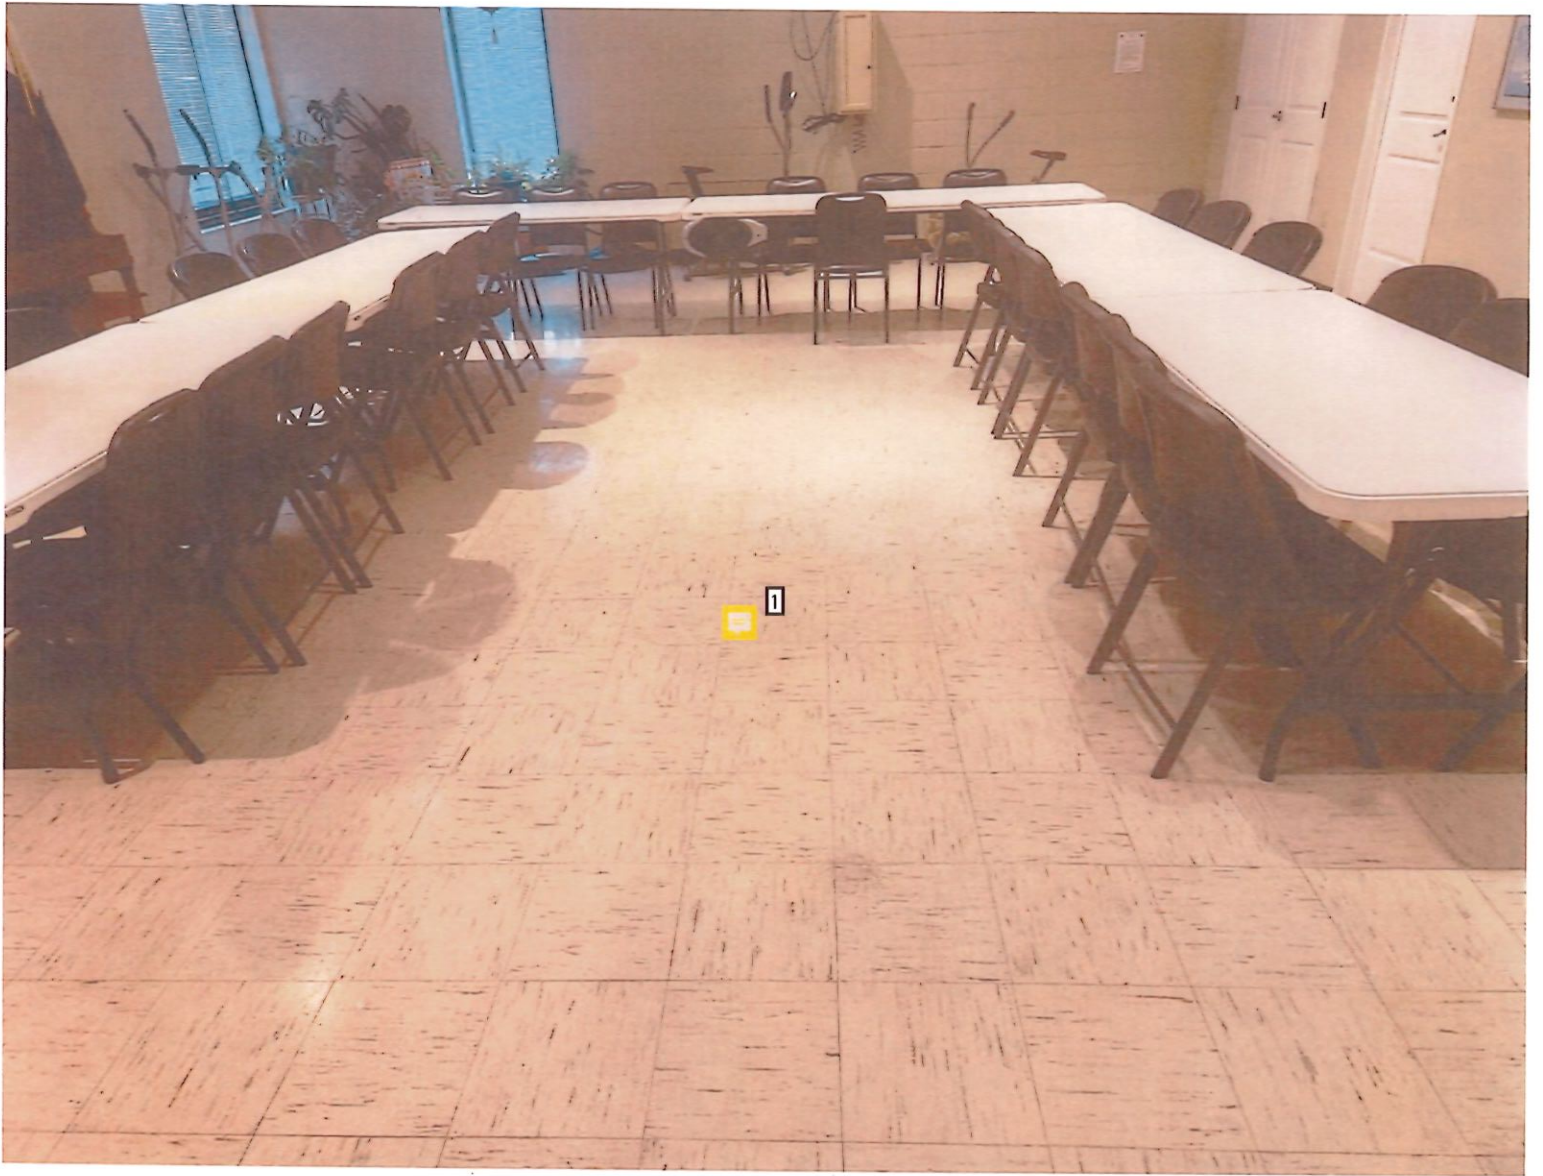
| Tile needs to be removed and replaced | | | |

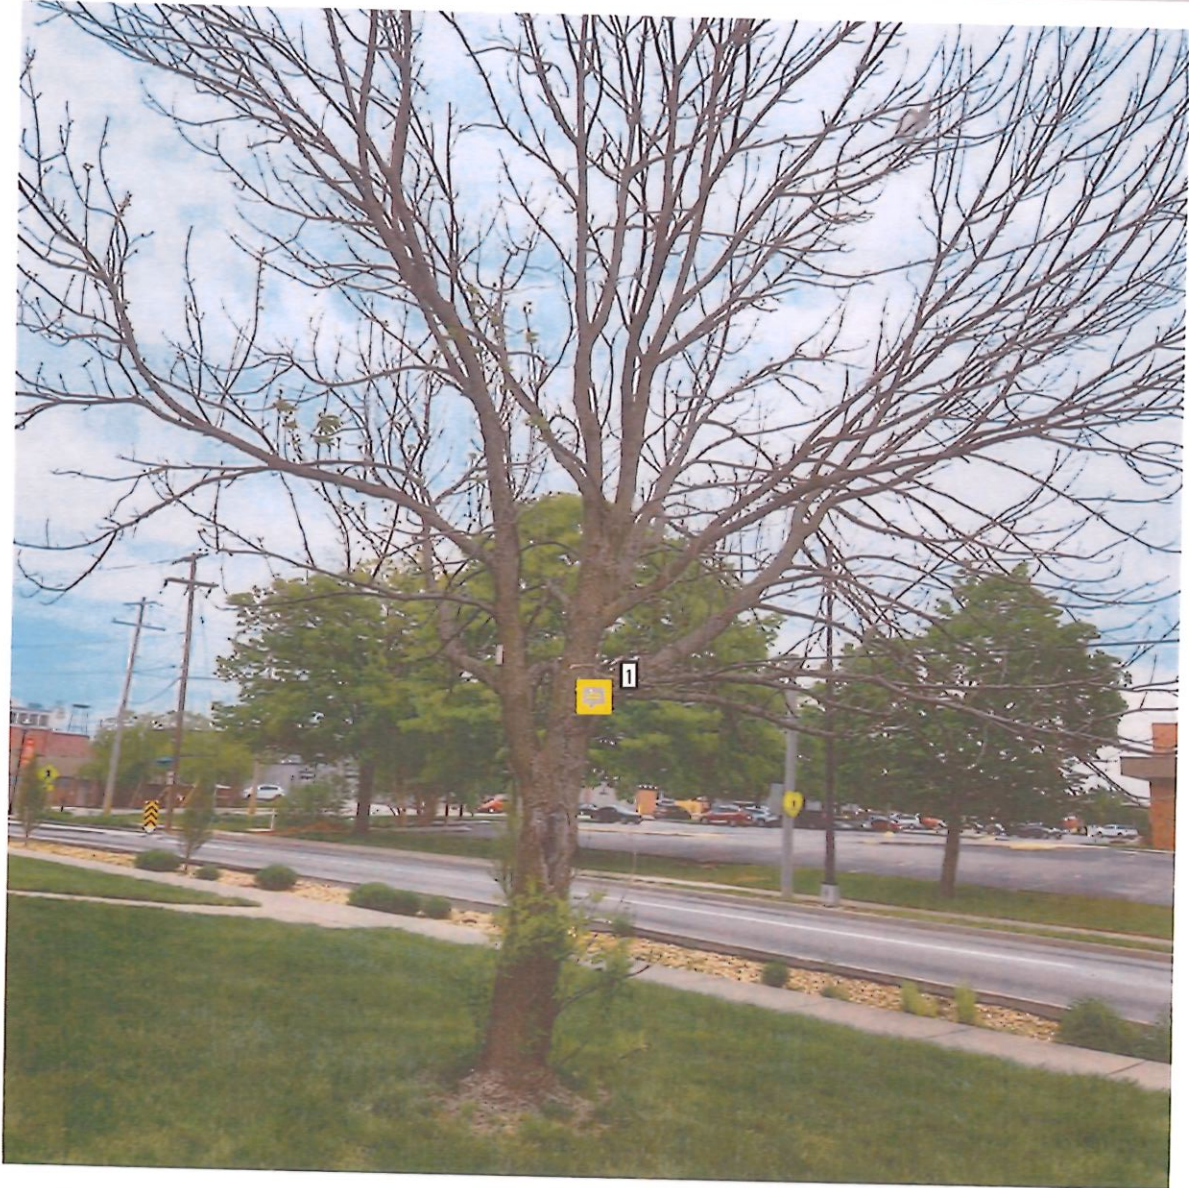
| dead tree on the south end of the property- hazard | | | |
