# LANDMARKS BOARD STAFF REPORT

**CASE:** Certificate of Economic Hardship

**LOCATION:** 323 South National Avenue

**APPLICANT:** Kirk A. Heyle Trust

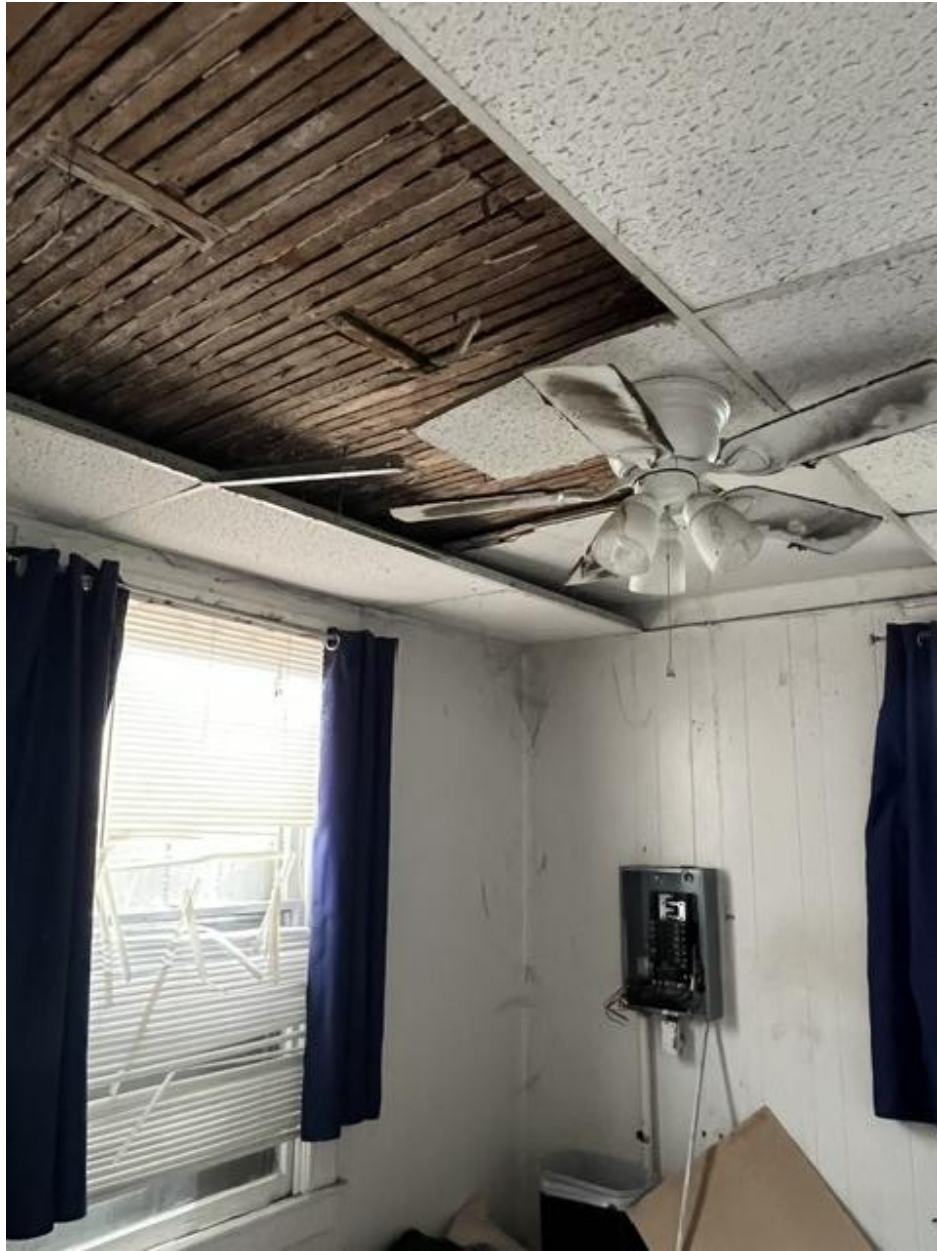
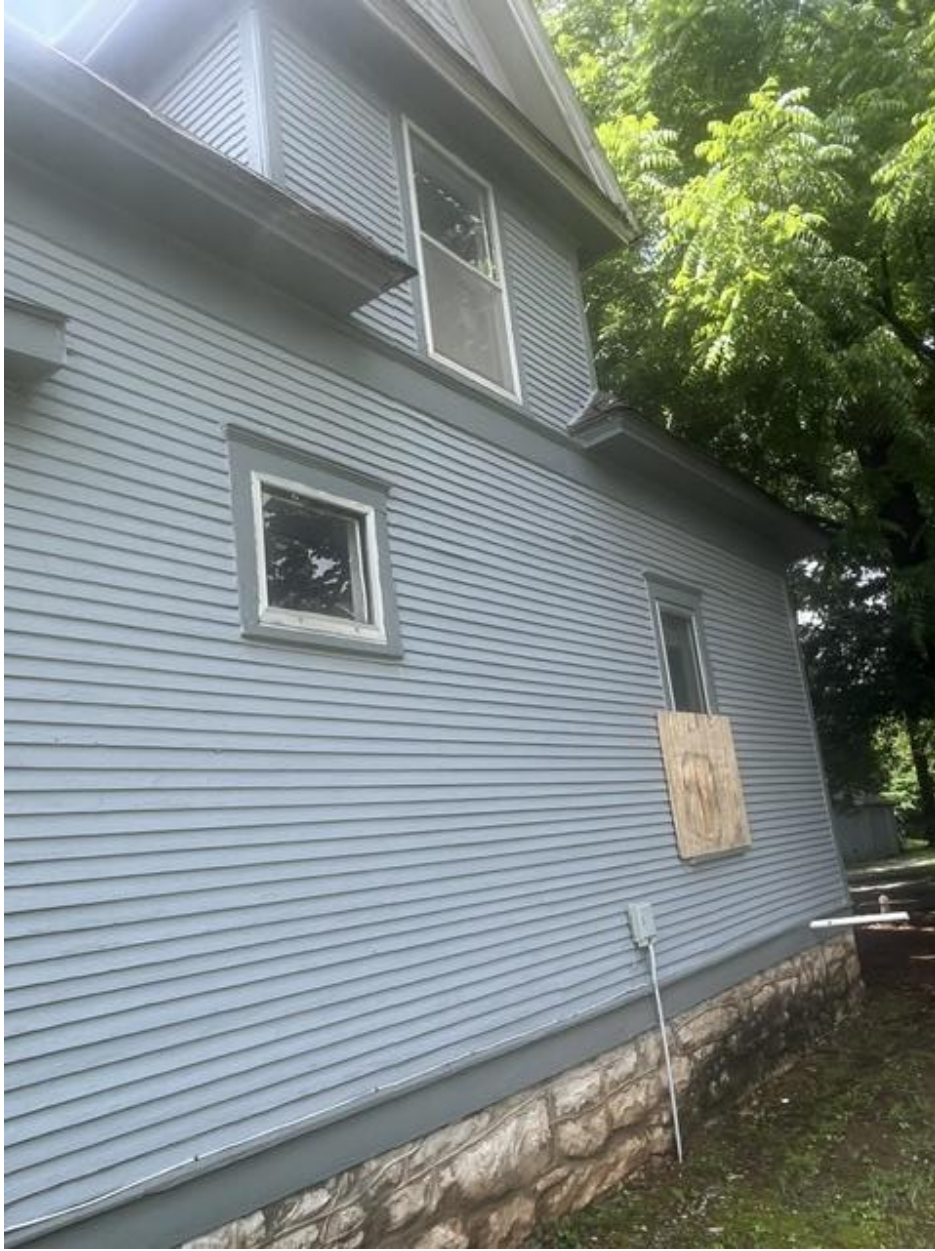
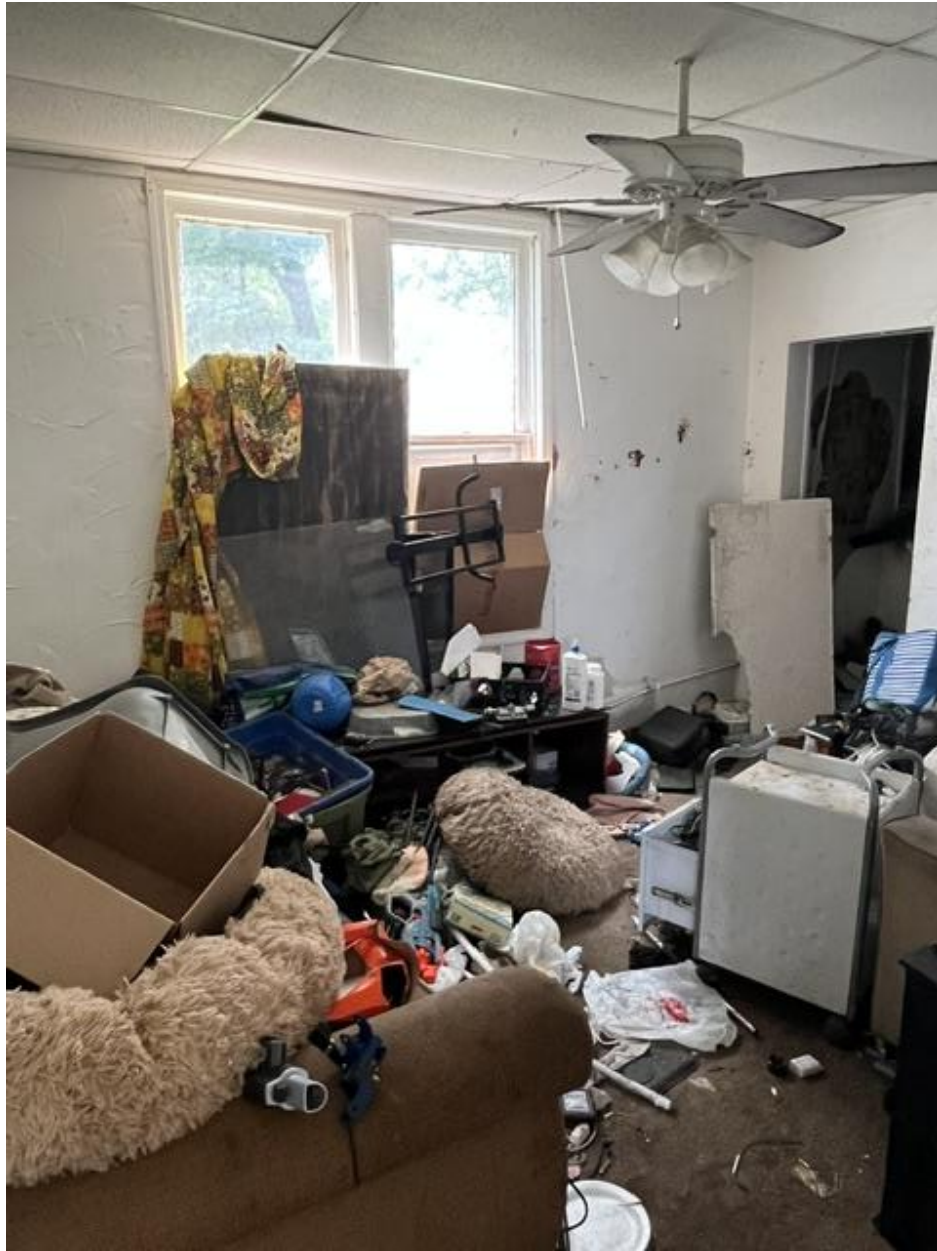
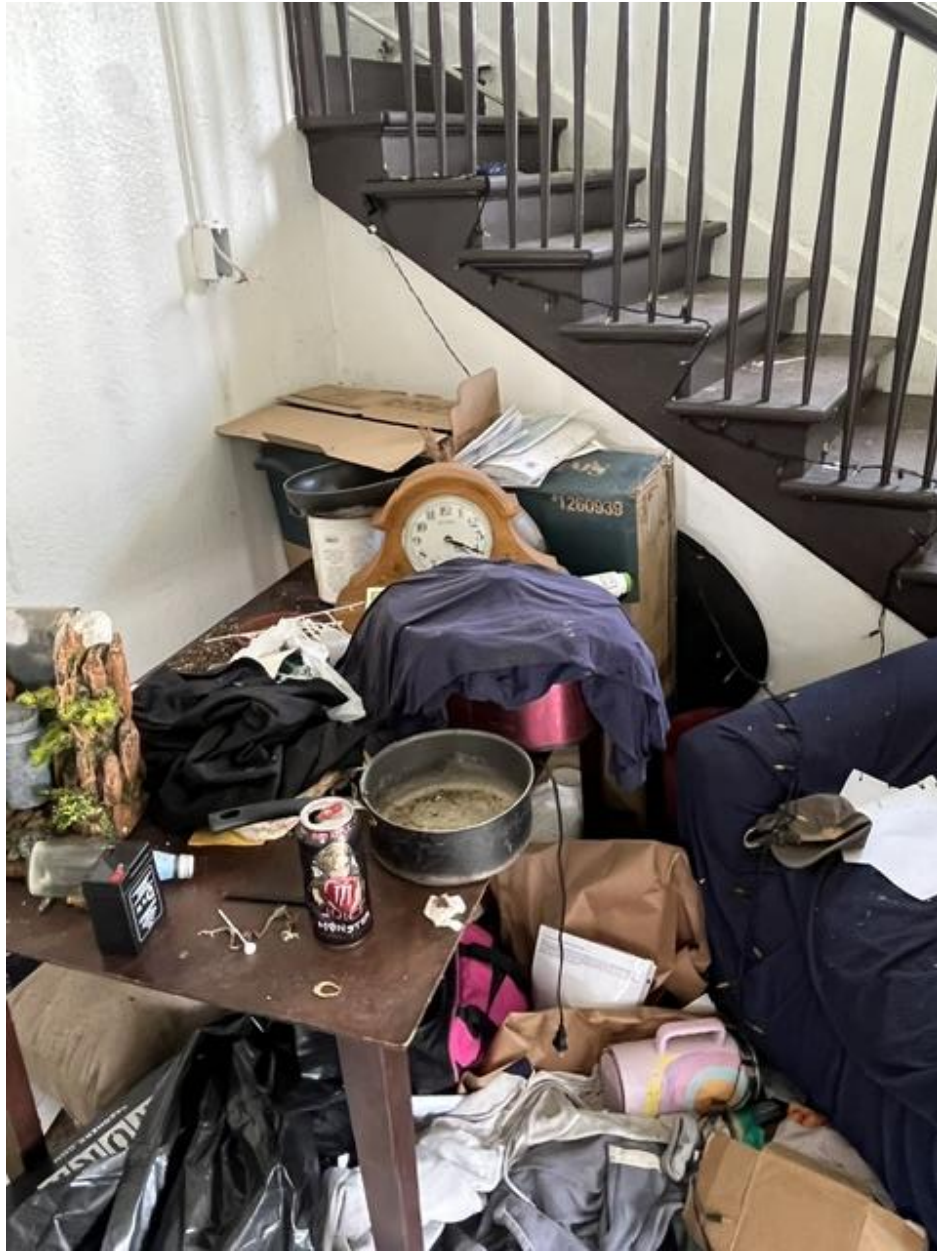
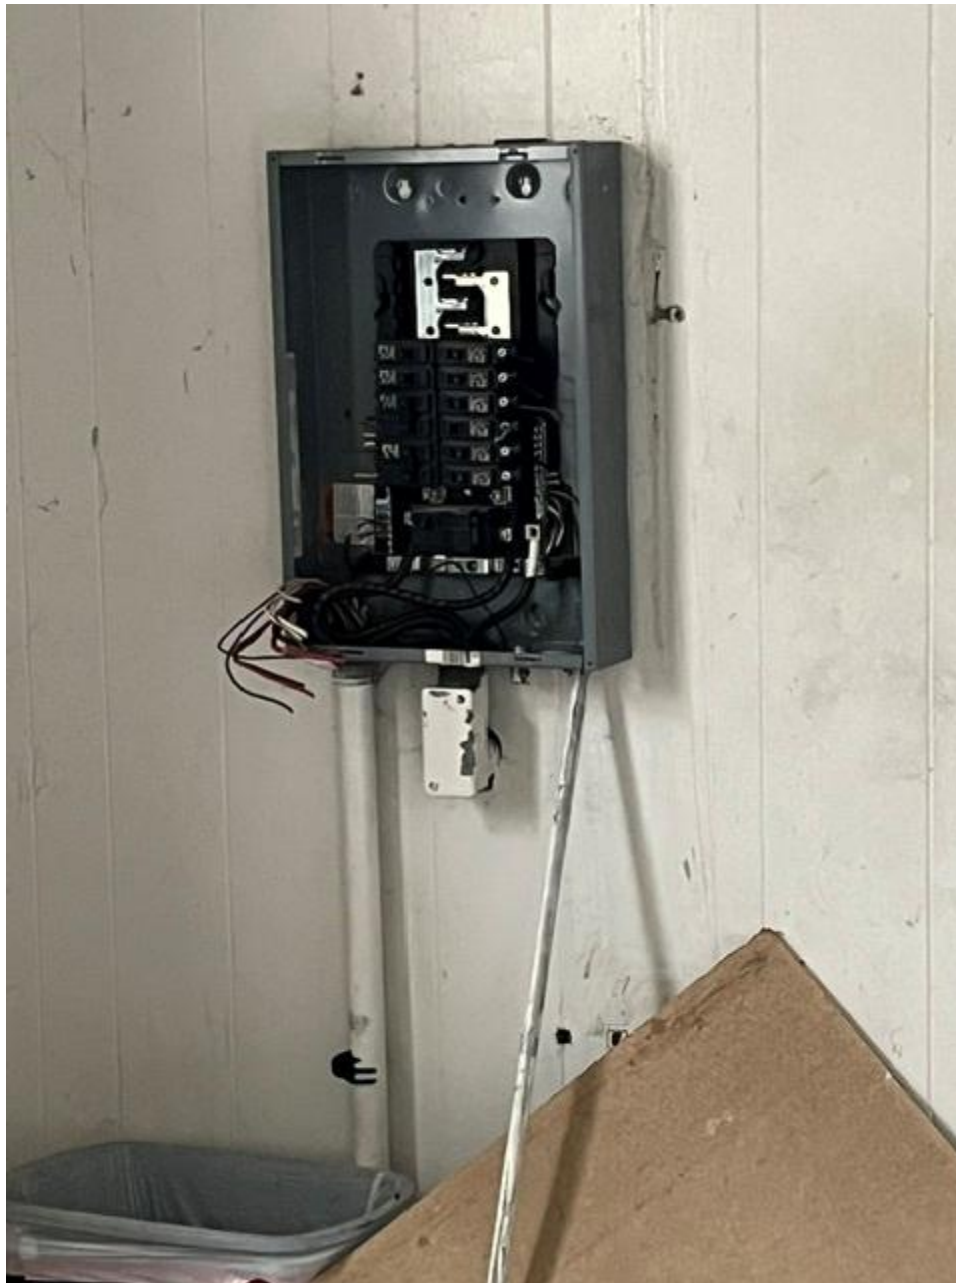
When our contractor walked through the property there were seen fleas, possibly lice, mice, rats, and bed bugs on the mattresses. He will not go back into the structure again. Windows and storm windows are broken out and removed in places for the metal as the structure was drastically vandalized. The main squatter came over to 309 S National, my office, next door to the 323 structures, demanding a \$1,000.00 extortion to move out or he would have every homeless person in the area damage, vandalize, and destroy our house. They did just that to our house. The squatters were very belligerent and none of our workmen or contractors could approach the property without threats. The property was deemed uninhabitable by the various City inspectors for health, safety and structural issues. No one will give us a firm bid to fix and replace all the damage; but dollar figures way over \$100,000.00, to unlimited have been discussed.

**Description:** IPMC section 304.5 foundation walls: foundation wall shall be maintained plumb, and free from open cracks and breaks, and shall be kept in such condition so as to prevent the entry of rodents and other pests. Section of foundation on northwest side of structure is failing. Crawl space access is open.

**Description:** IPMC 304.13 window, skylight, and door frames: Every window, skylight, door and frame shall be kept in sound condition, good repair, and weather tight. Window frames around structure are in disrepair.

**Description:** IPMC section 304.13.1 glazing: glazing materials shall be maintained free from cracks and holes. Upstairs window on east side of structure has broken glazing.

**Description:** IPMC 304.6 exterior walls: Exterior walls shall be free from holes, breaks, and loose or rotting materials, and maintained weatherproof and properly surface coated, Where required to prevent deterioration. Sections of siding around structure are deteriorating.
