## LANDMARKS BOARD

RE: Landmarks Board Meeting

| | | 1. 633 W. Walnut Street: Install new vinyl siding, replace guttering, soffits and fascia, and repair front deck. |

# 8 Preservation Briefs

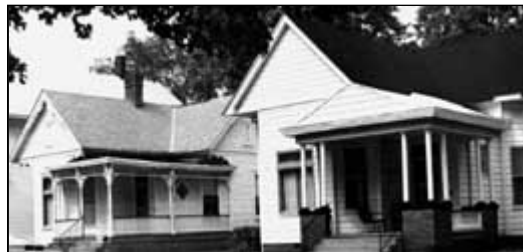
**When aluminum was installed on the house on the right, the barge boards, scrollwork, columns, and railings were removed. The**

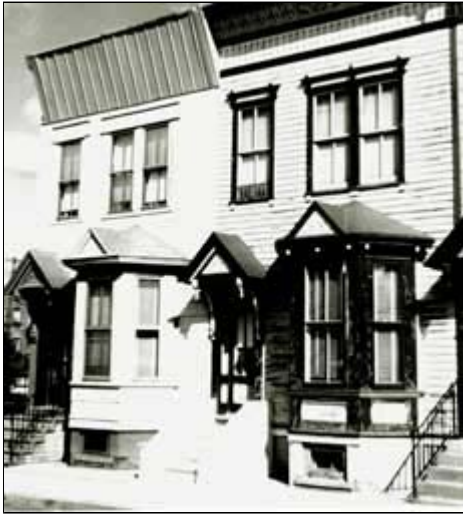
**When a building is in need of maintenance, such as the house on the right which needs painting, some owners consider installing aluminum or vinyl siding. The result (see left) can be a complete loss of architectural character due to the covering of details and change of scale due to inappropriate siding dimensions. Photo: NPS files.**

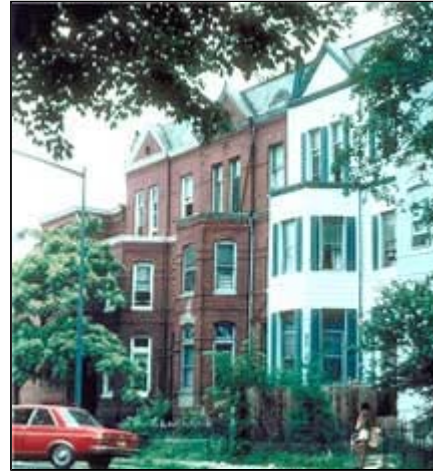
**The inappropriate siding applied to the house on the right has altered the character of the urban setting. Photo: NPS files.**

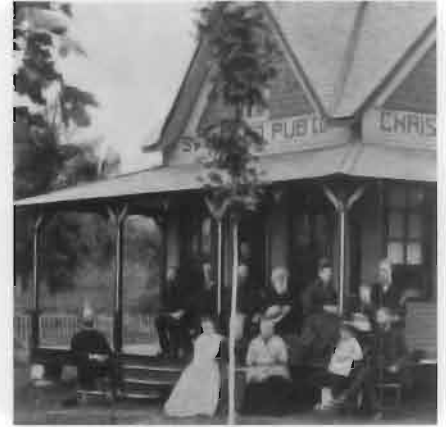
*Figure 1. Distinctive yet different, these front porches are important features along the street. The rhythm would be diminished if the front porch from one of the houses was dramatically altered or removed. Photo: Aleca Sullivan.*

Few architectural features evoke more romantic notions or do more to define a building's historic character than the American porch. The size, style, detailing, and location of a porch can tell volumes about the age and use of a building. Each component, from handrail or baluster to column or post, enhances the architectural character of the porch. Alter or remove the porch and a historic building or streetscape can lose its visual integrity and historic authenticity (Fig 1).

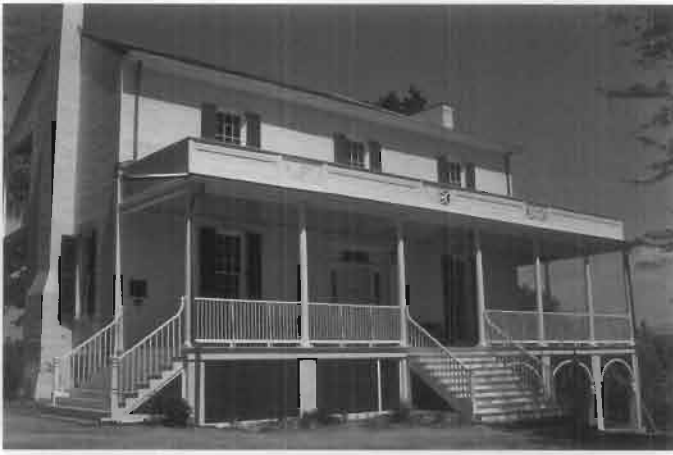
Figure 2. Porches not only help define the architectural character of a building but also serve as living areas. They can be designed to take advantage of surrounding views. Cedar Grove, the home of the nineteenth-century landscape painter Thomas Cole, has an L-shaped veranda on the front and a two-story porch on the rear, providing an enviable view of the Catskill Mountains. Photo: Marilyn Kaplan.

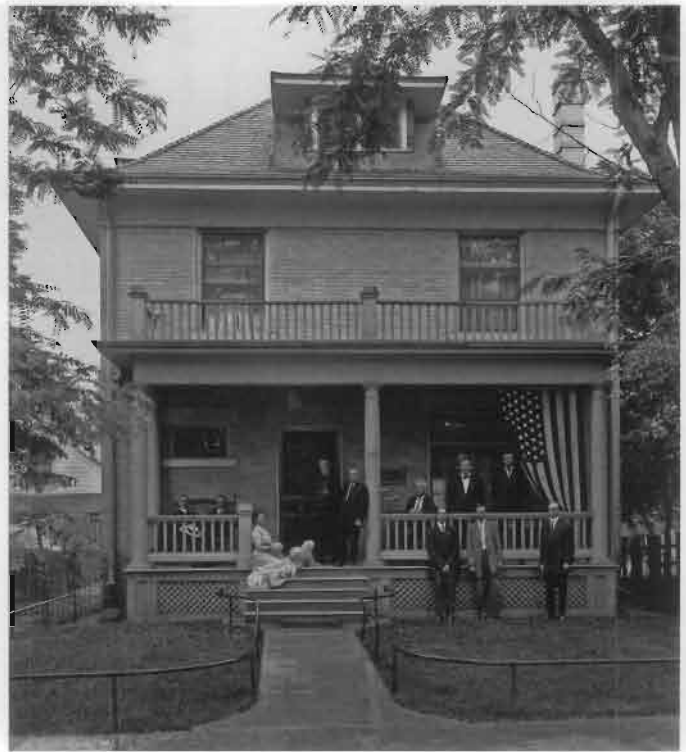
*Figure 4. Celebrating the 4th of July in 1912, this gathering of family and friends reflects the popularity of the porch as a social gathering place. While not overly ornate, each detail of the porch from the roof balustrade to the turned columns to the simple lattice work facing the deck contributes to its character, creating in effect the dominant architectural feature of the building. Photo: © Utah State Historical Society*

The open qualities are one of the key features of most historic porches. Overall size, shape and design are obviously important components as well. There are numerous other contributing features which may exist, including the shape of the porch roof, the way a large porch is divided into distinct bays as with columns, the nature of the supporting foundation, the style and size of columns and balustrade, and whether the porch is raised or largely at grade. The simplicity of a porch or its richness in detail will also help define it. Materials are usually important as well, not just the wood features, but also whether other materials exist such as masonry columns and steps (Fig 4).

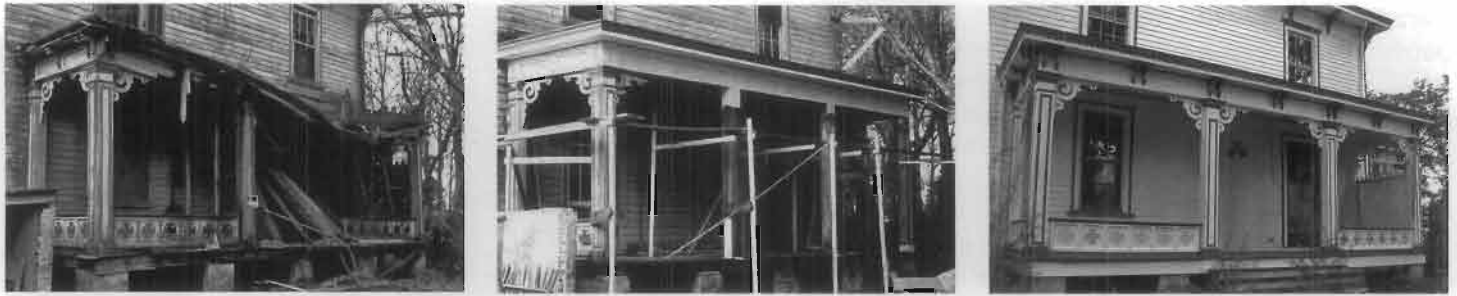
Figure 5. Even historic porches that appear to be in total disrepair may be repairable. While the roof needed replacement, much of this porch was repaired, including such features as the decorative columns, ornamental brackets, and balustrade. Photos: John Leeke.

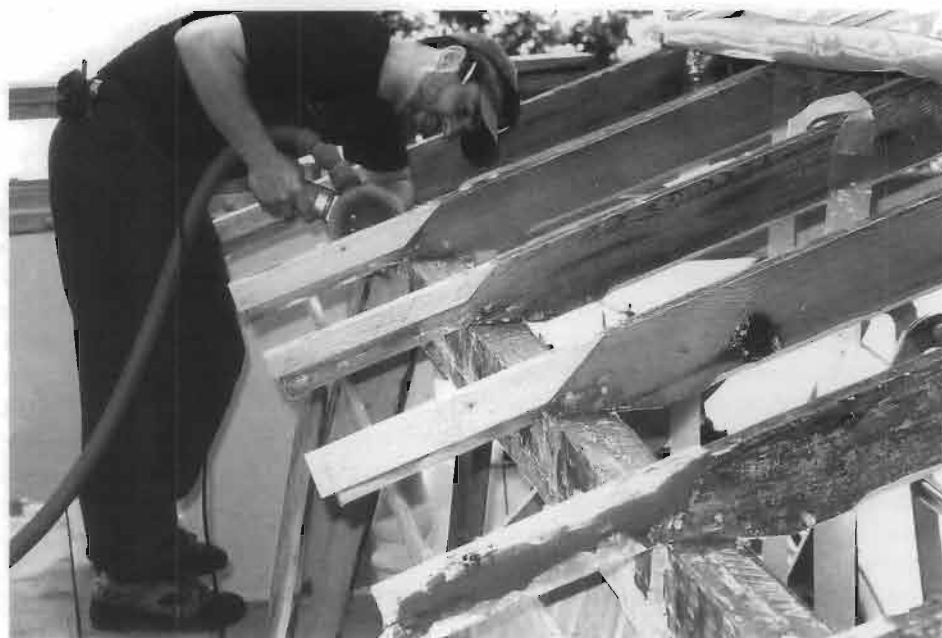
*Figure 9. The ends of porch roof rafters are often susceptible to moisture decay. When concealed by a soffit or ceiling, rafters can be repaired by adding new sister boards. Where roof rafter ends are exposed, splicing new wood onto the old (dutchman repair) and use of epoxy consolidants and fillers both preserve sound historic fabric while retaining the historic appearance.*

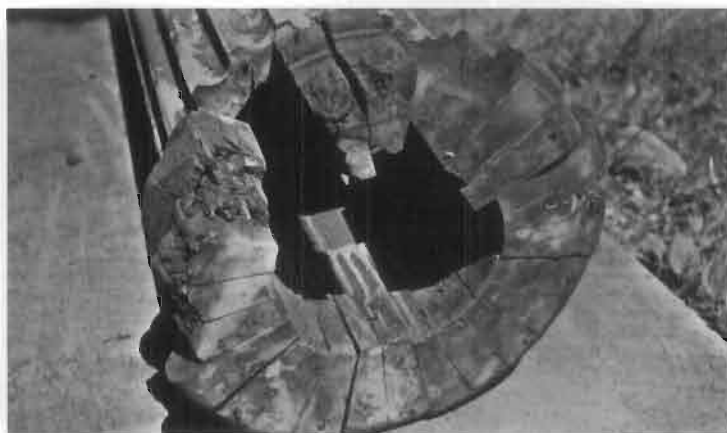
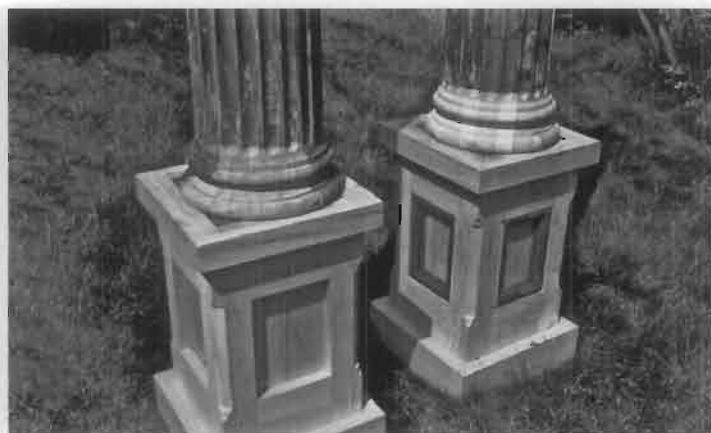
Figure 10. This nineteenth century porch column is made of wood staves, similar to the way a wood barrel is put together. After replacing the torus and making dutchman repairs to the apophyge along the base, the column and pedestal are ready to be reinstalled on the porch. Photos: NPS files.

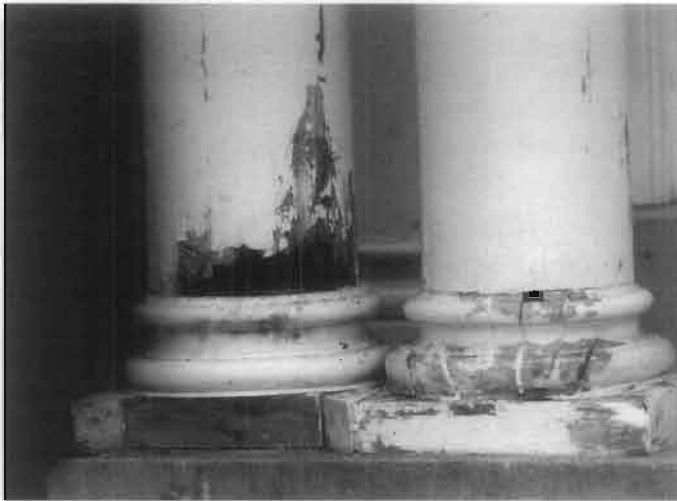
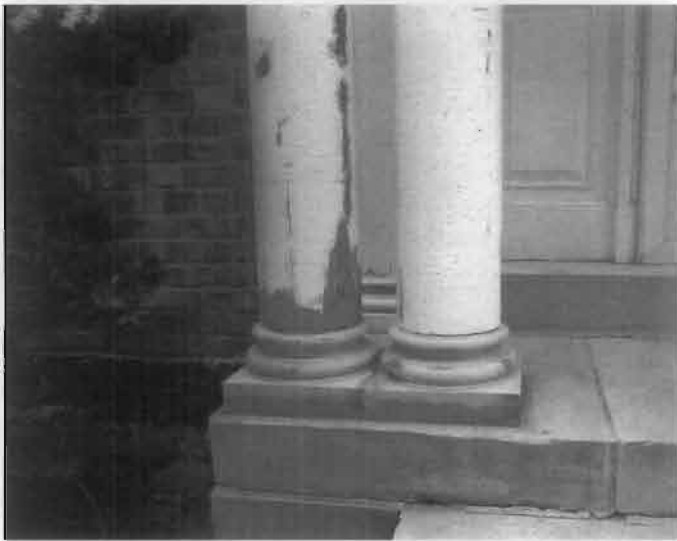
*Figure 11. The lower shaft of the porch columns had decayed as water wicked up through the end grain (top). The column shafts were repaired in place by cutting out the deteriorated wood and making repairs using epoxy consolidants and fillers. (bottom). The column bases were replaced. Photos: Paul Marlowe, Marlowe Restorations.*

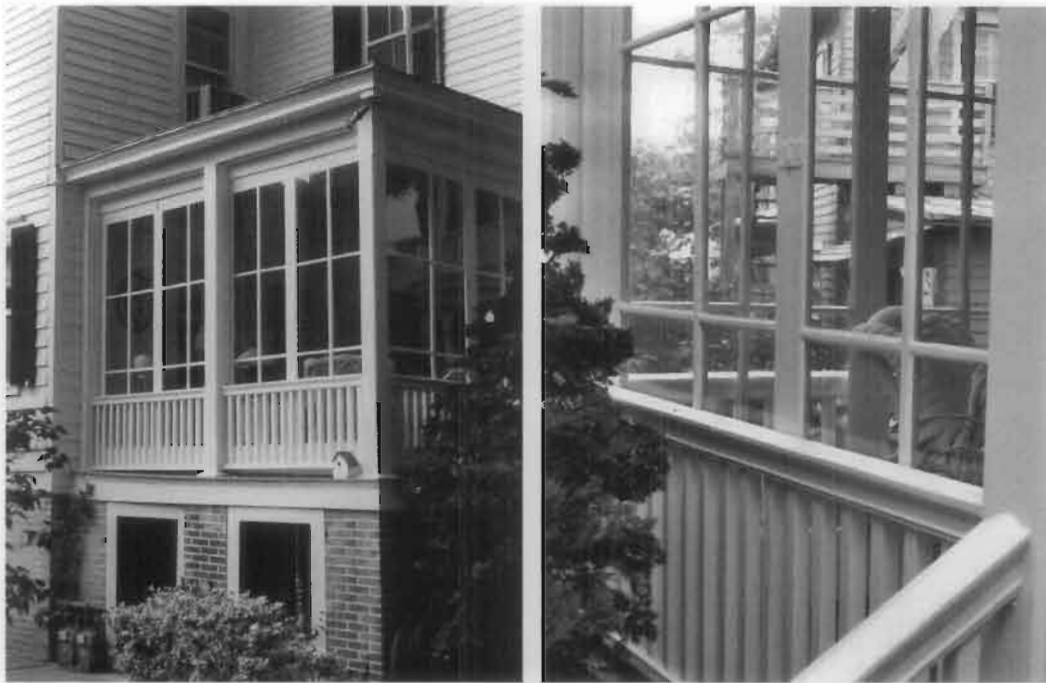
*Figure 12. This old porch enclosure, located on the back side of a house, has acquired significance over time and is remarkable both in the appropriateness of its detailing for use by others today, as well as its high degree of maintenance. The enclosure is set behind the columns; the balustrade has been retained; and the light divisions and the size of the glass panes echo that of the windows above. Within each bay there are two well-crafted, inward swinging doors, providing for greater seasonal use of the porch. Photos: Charles Fisher.*

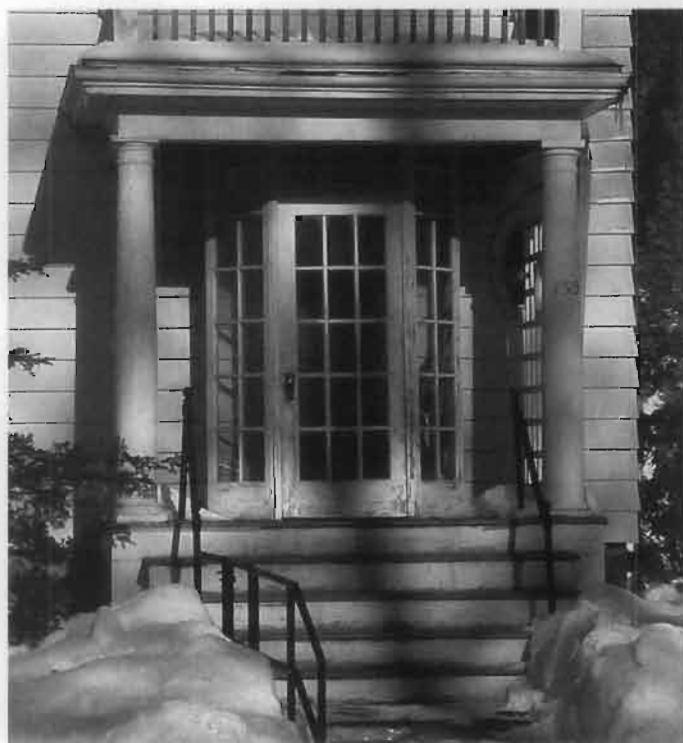
*Figure 13. Particularly in New England, there is a cold weather tradition of installing temporary glass and wood panels at entrance doors, thereby creating an enclosed vestibule. These enclosures with their small divided lights were generally removed in the spring.*

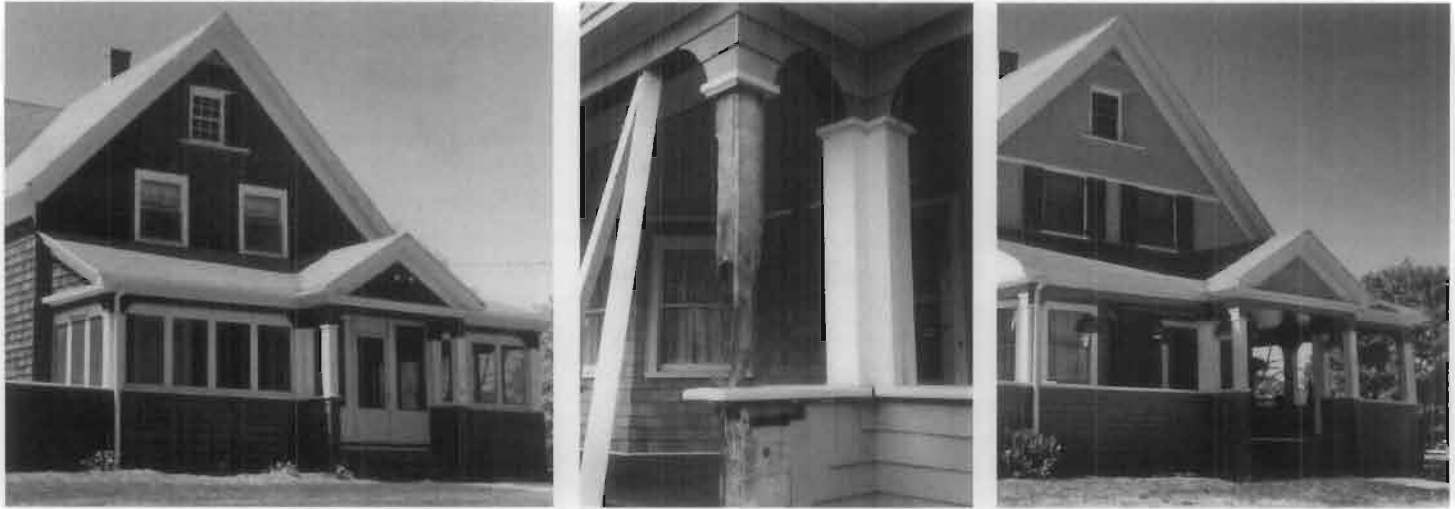
*Figure 14. The enclosure of a prominent porch can dramatically change the historic character of a building. The L-shaped porch on this 1896 Shingle-style New England residence was later enclosed with aluminum windows and screens. Recent owners elected to reopen the historic porch. Among the other work, it was necessary to correct structural damage, as with this post, where beneath the wood casing carpenter ants had done serious damage. In reopening the porch, the historic character of the residence has been brought back and the traditional use of the porch is once again enjoyed. Photos: Mark Landry, Landmark Services.*

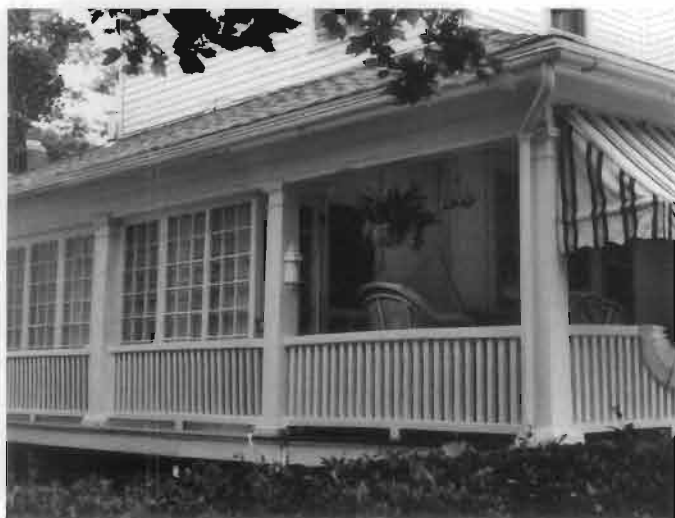
*Figure 15. A traditional technique of porch enclosures still used today involves the insertion in each column bay of one or more glass enclosures set in wood frames. This enclosure is properly set back an entire porch bay from the front of the house and utilizes traditional light divisions and wood frames. The balustrade, added here for illustration purposes, shows the importance of retaining this linear feature within the enclosed bays. Photo: Charles Fisher.*

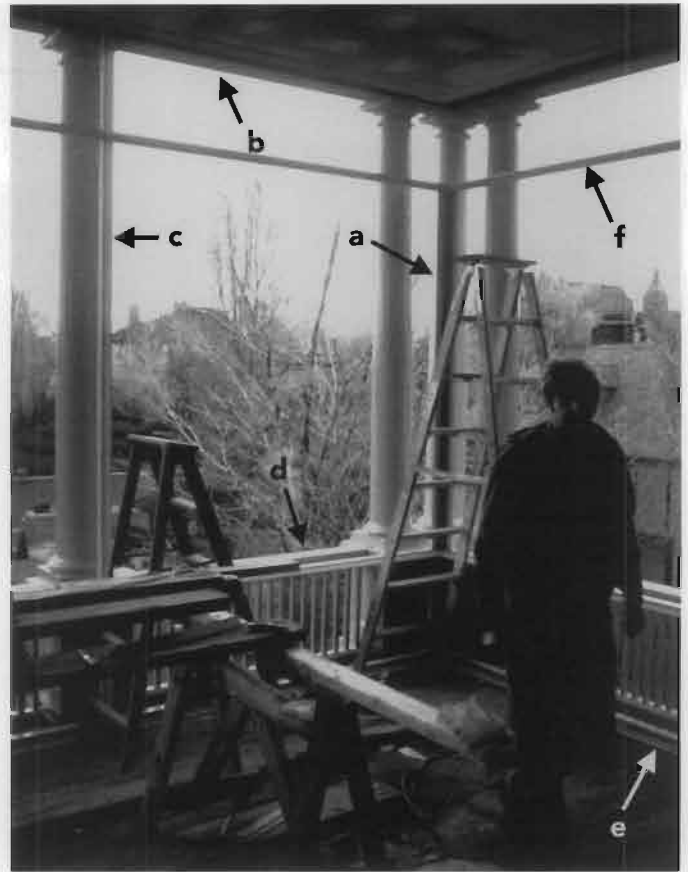
*Figure 16. The use of near full glazing to enclose a porch may be appropriate depending upon the historic character of the building, location of the porch, how the interior space is to be treated, and other factors. This enclosure of a rear porch to create a conference room successfully utilizes large expanses of glass and narrow metal framing set behind existing porch elements (a through e). Where an additional horizontal support was needed (f), the frame was placed at a location that is found in many traditional insect screen enclosures. Photo: Charles Fisher.*

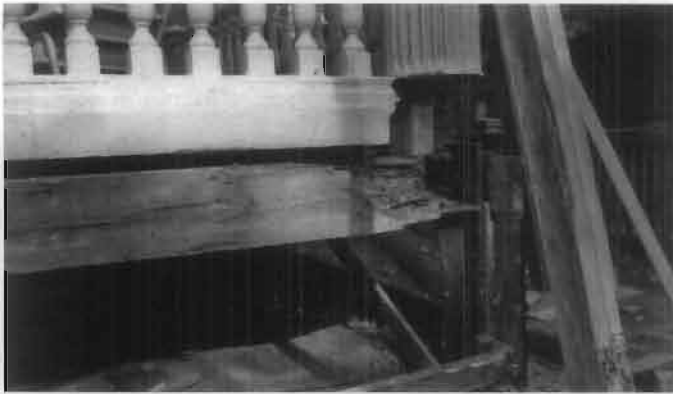
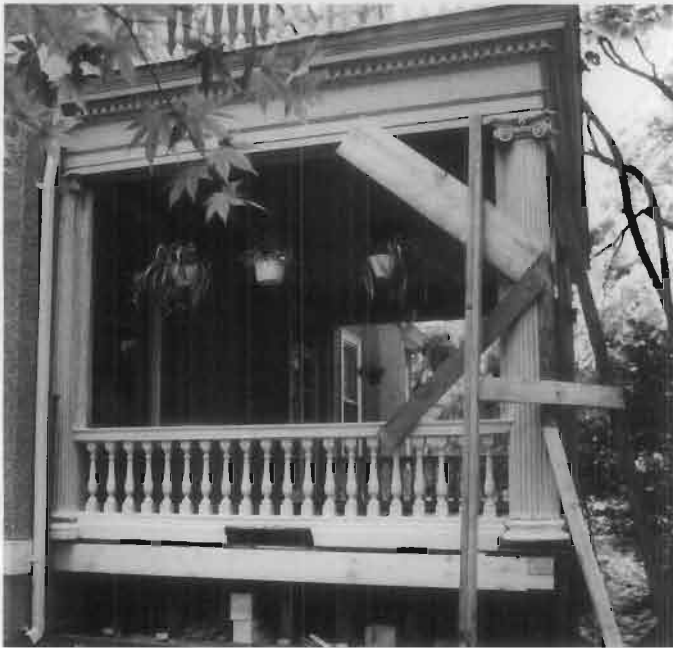
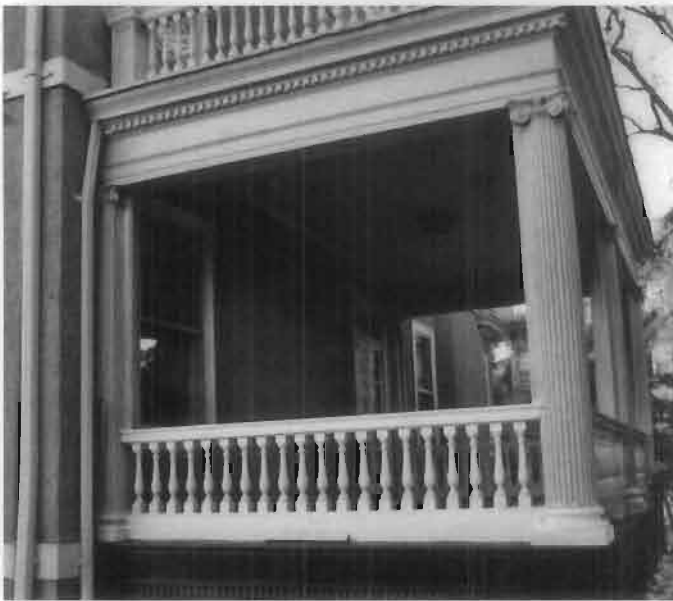
*Figure 17. The porch's structural system must be capable of supporting today's loads. In this case moisture led to the deterioration of the wood girder at the corner, creating a major structural deficiency (top). A new solid timber was installed to replace the girder (middle); alternatively a built-up girder could have been used since a fascia board would conceal it. The column base was repaired and portions replaced and the balustrade and column reset and secured (bottom). Photos: Paul Marlowe, Marlowe Restorations.*

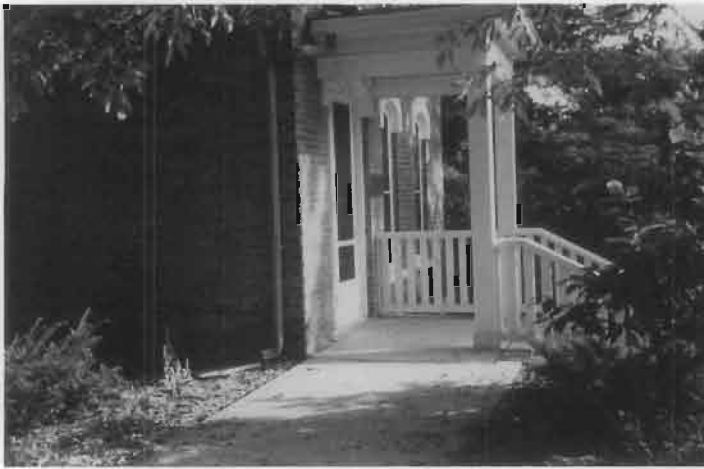
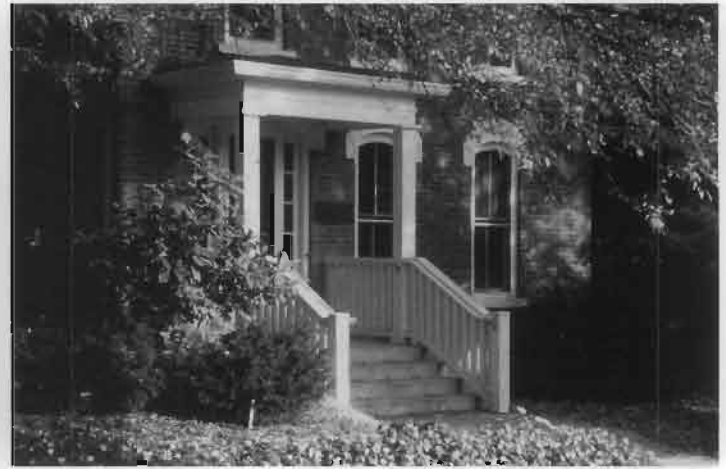
*Figure 18. When a porch is used as a wheelchair accessible entrance, it may be possible to retain the historic stairs by adding a ramp parallel to the building. Through plantings and some re-grading, the new ramp built parallel to the building (left) allows retention of the historic stairs and does not impact the historic character of the entrance (right). Photo: Iowa State University Extension.*

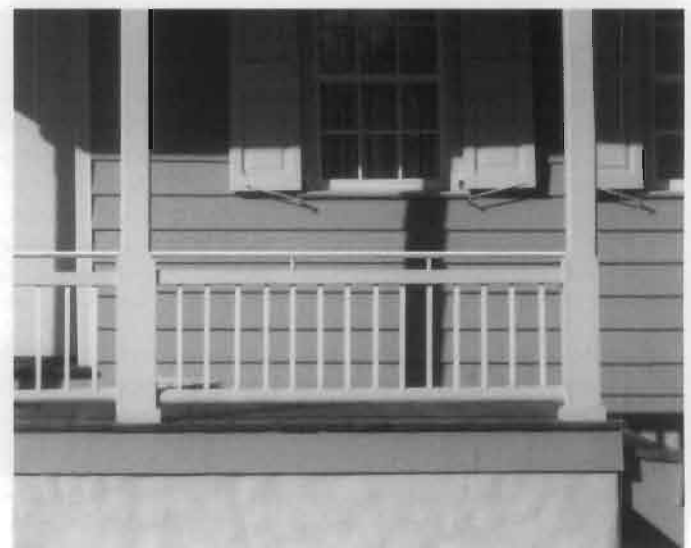
*Figure 19. Historic porches generally have railings that measure 28 to 30 inches in height from the floor. When additional height is necessary for safety, a simple rail, added for illustration purposes in this photograph, can usually be installed above the historic railing. Not only does this treatment allow retention of the historic balustrade, but it also has a minimum impact to the appearance of the porch. Photo: Charles Fisher.*
