# Landmarks Board

REQUEST FOR PERMISSION TO DEMOLISH  
530, 536 & 540 E. COMMERCIAL STREET

## FIELD OBSERVATION REPORT

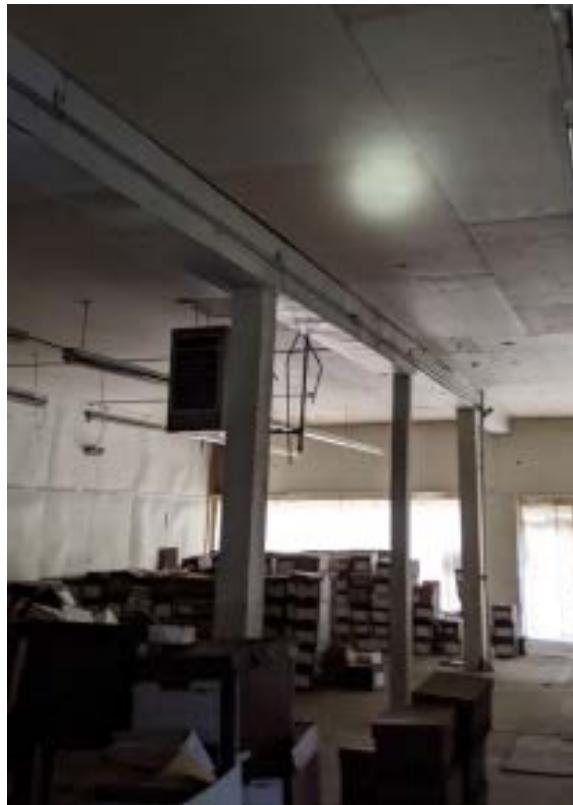
**Beam-Column Line on First Floor of West Suite**

The beam and column line in the west suite consists of six spans of a multi-ply 2x beam with various spans around 13' each. The beams are supported by solid 8x8 wood posts.

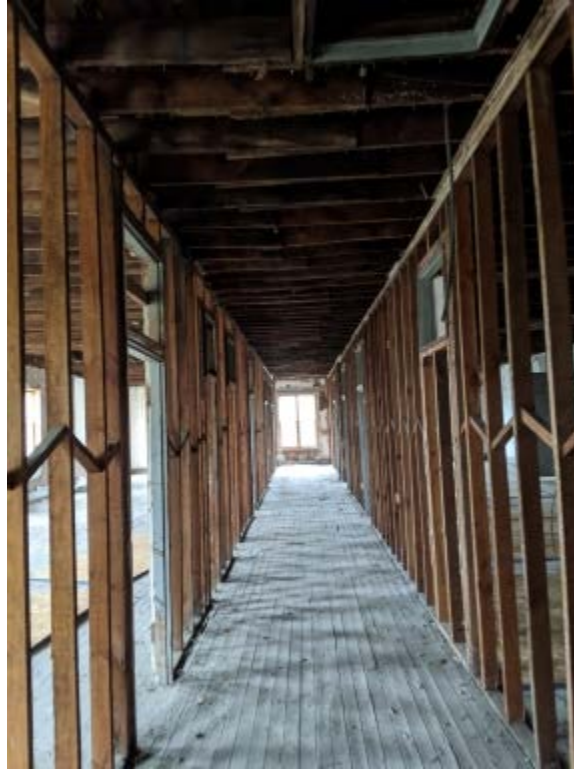
**Load-Bearing “Hallway” Walls on Second Floor of West Suite**

west), and are supported by two wood-framed load-bearing walls on the second floor. These load-bearing walls appeared to form a hallway in the center of the second floor of the west suite. These load-bearing walls develop an offset load path since they do not align with the beam and column line below. The roof trusses on the east side span the full width of the east suite similar to the floor framing below.

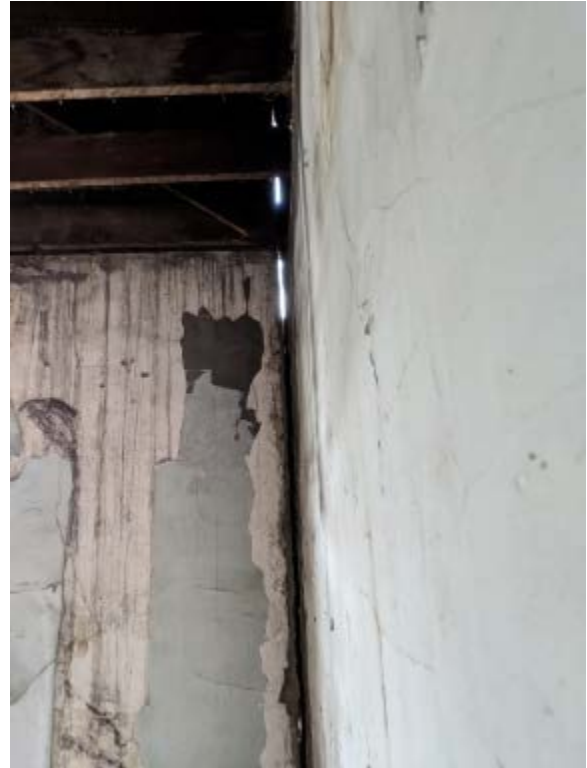
**Vertical Gap at North Wall of West Suite**

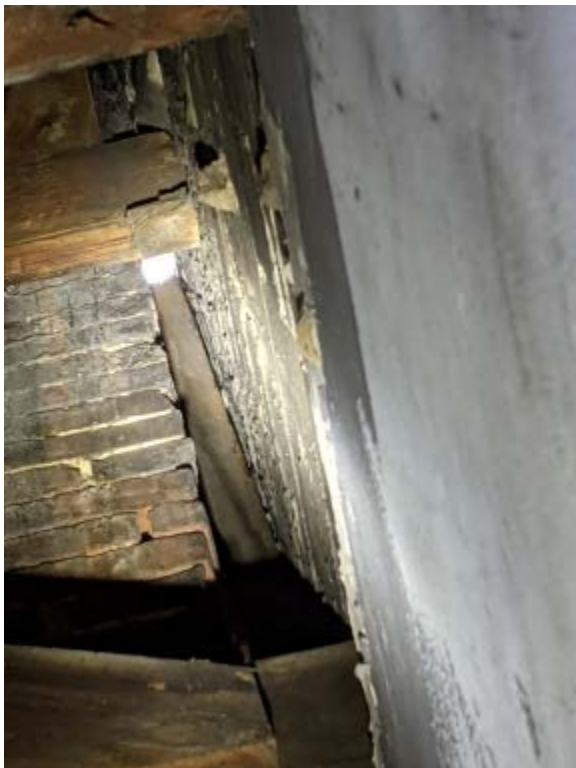
**Vertical Gap at North Wall of West Suite**

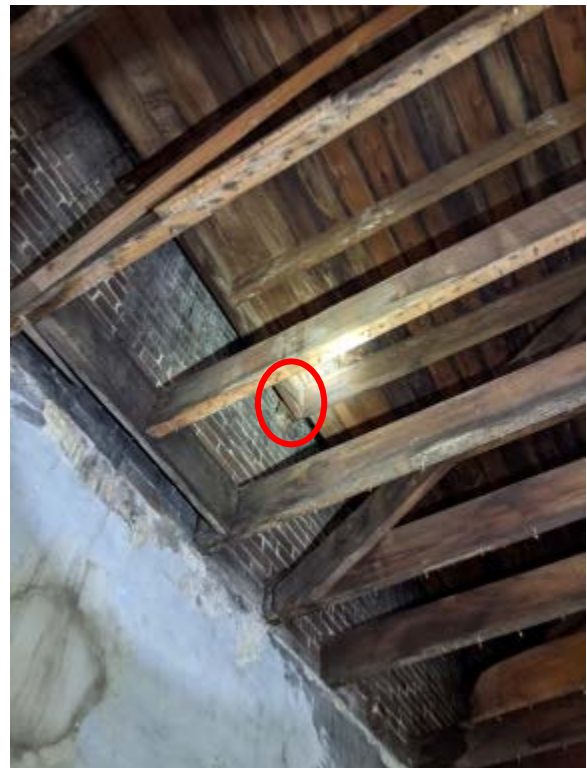
**Roof Truss Sliding out of Support Pocket**

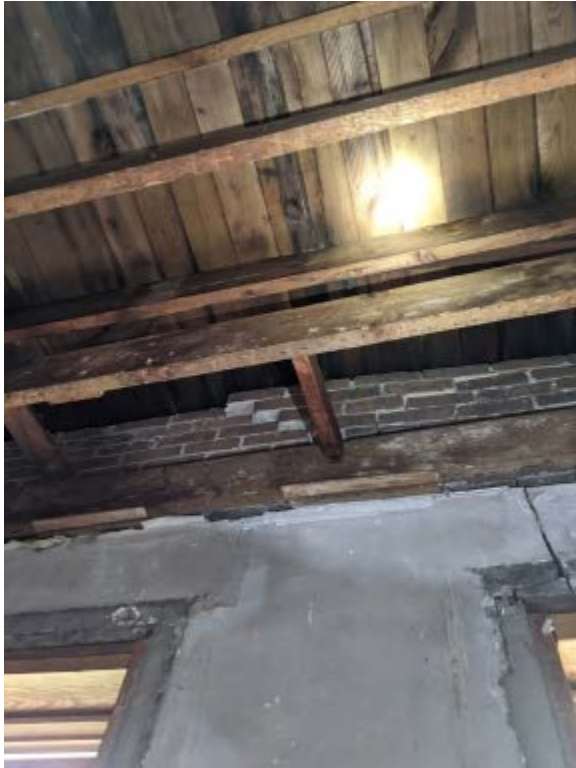
**Displaced Bricks at Top of South Wall of West Suite**

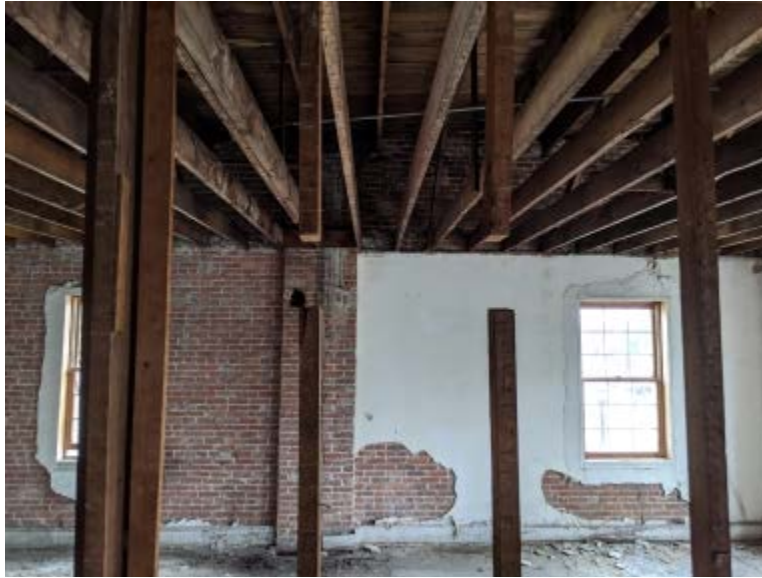
**Load-Bearing Studs Cut Off at West Suite**

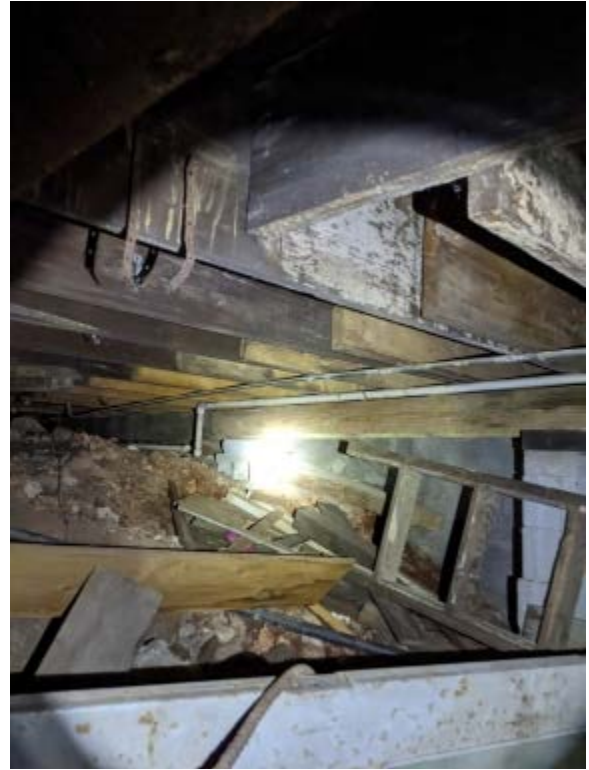
**Additional First-Floor Supports in Basement**

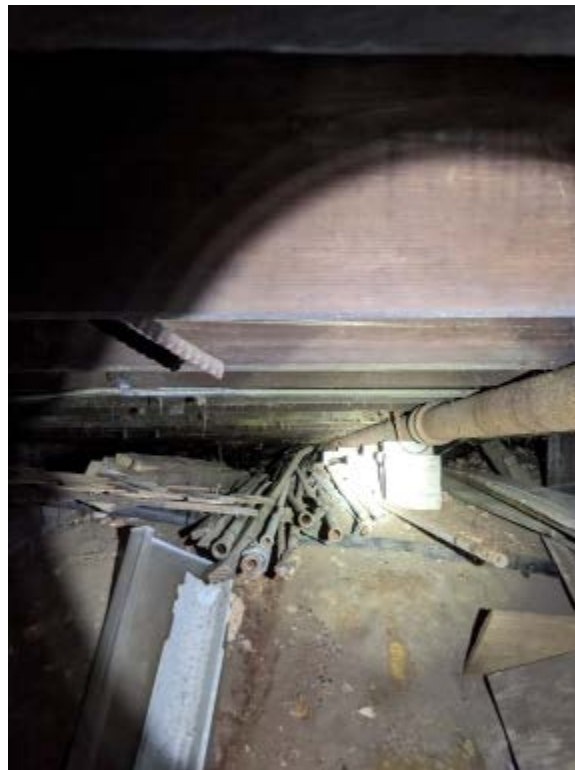
**Additional First-Floor Supports in Basement (Cast Iron Pipe Girder)**
