# Springfield Land Clearance for Redevelopment Authority

**4.III. Blight Report And Redevelopment Plan For The East Cherry Flats Redevelopment Area**

Documents: [EAST CHERRY FLATS BLIGHT REPORT AND REDEVELOPMENT PLAN.PDF](#)

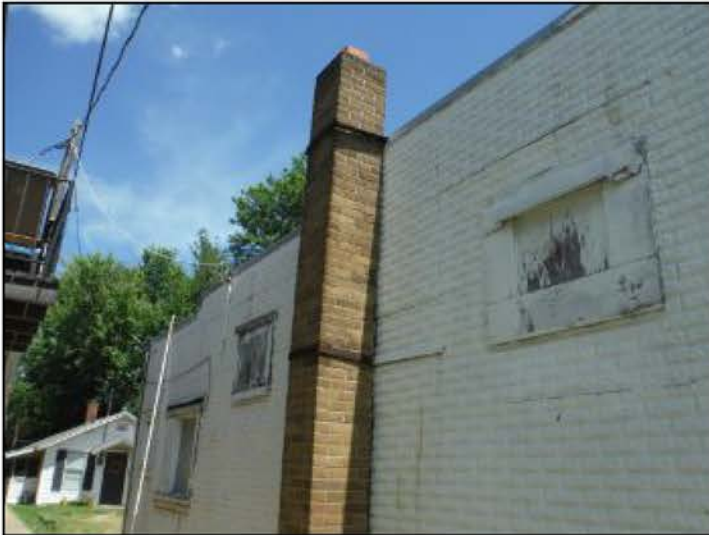
### 1. Chimney Observations

Deteriorated masonry, note gaps at wall and rusted steel anchoring

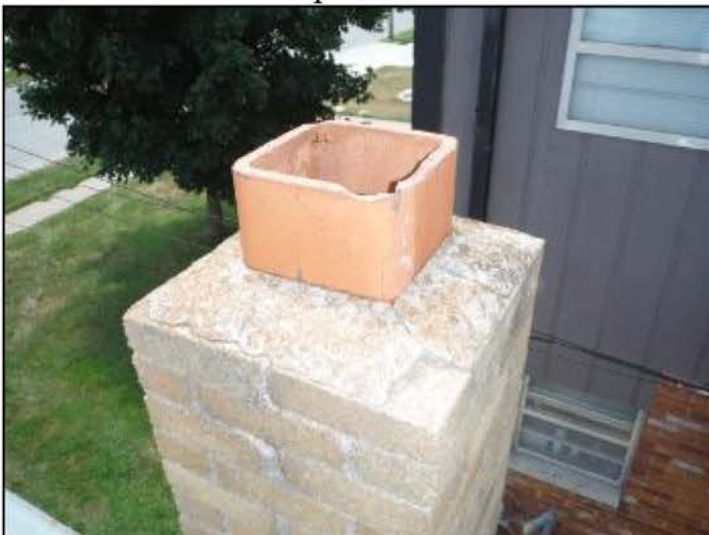
Missing rain cap and screen, water and birds can enter

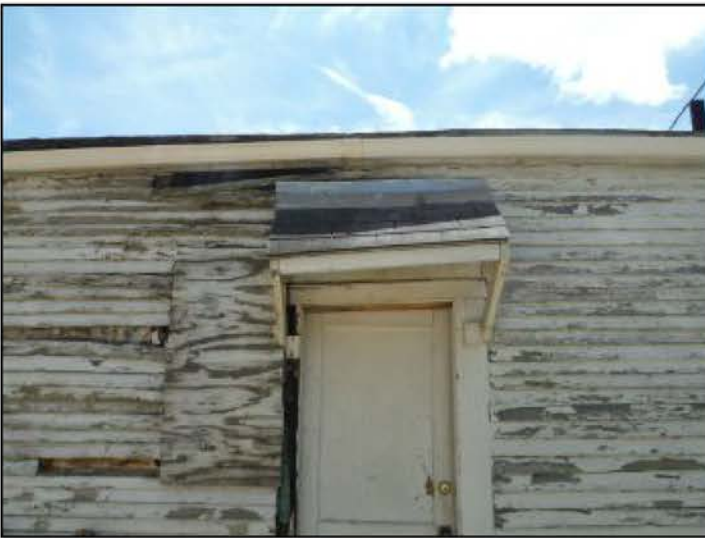
### 1. Exterior Walls

Damaged siding needs repair, moisture entering wall/s

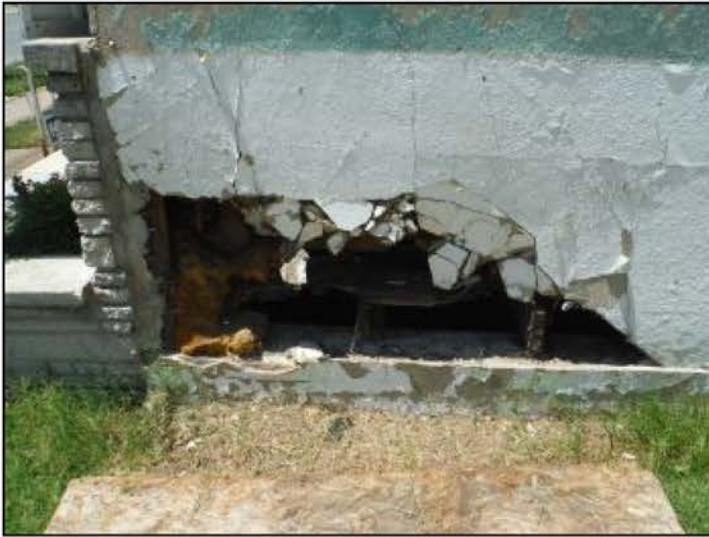
Vehicle damage is likely

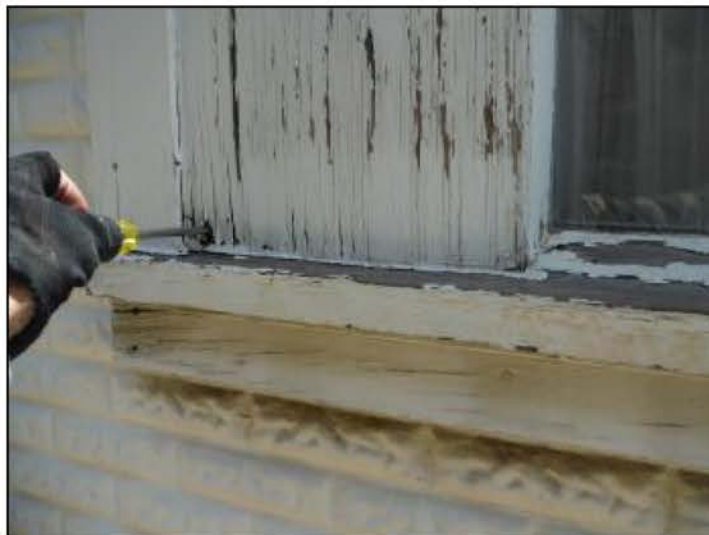
## 2. Trim

Wood trim needs a good paint job, rot in places

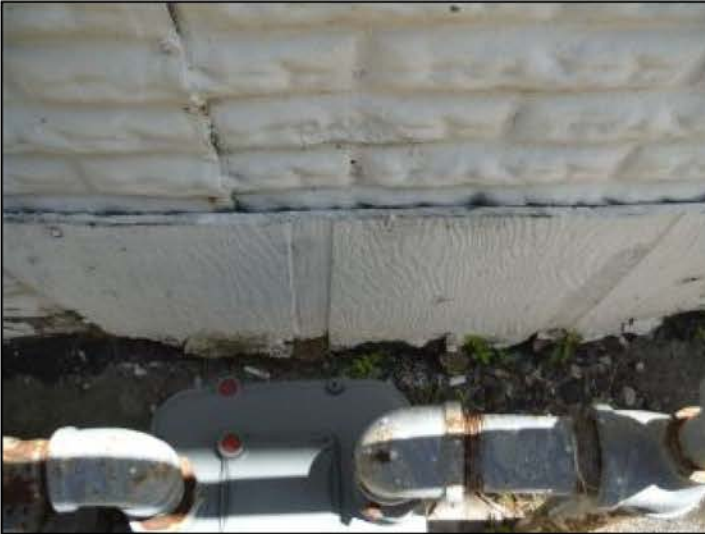
No access

Skirting/siding conceals access at back

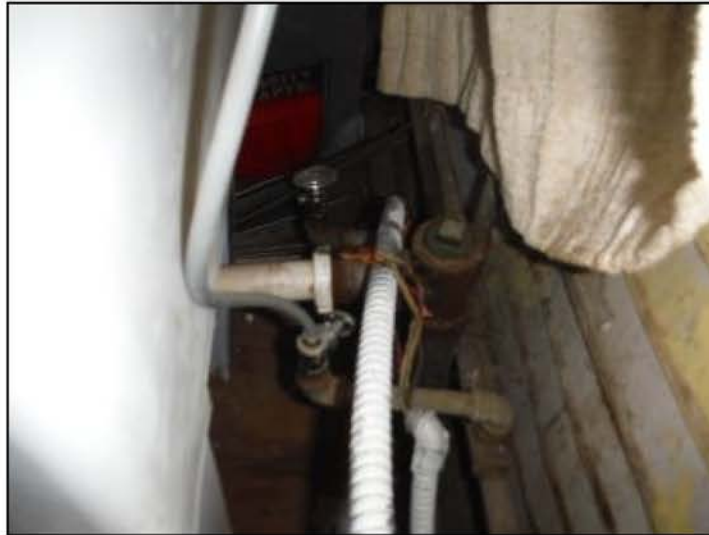
Older waste piping untested, water off

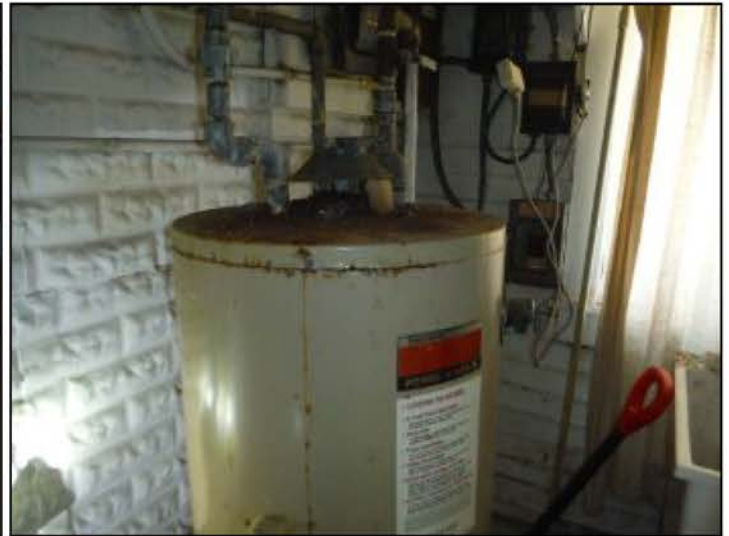
Disconnected (abandoned status)

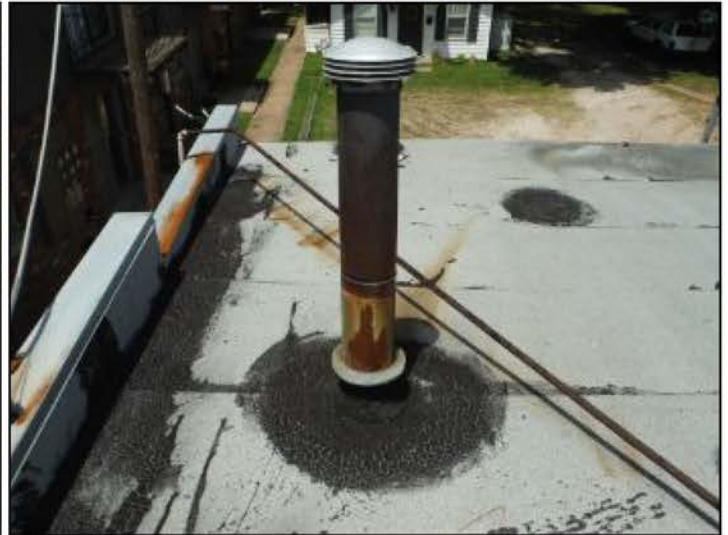
Disconnected (abandoned status)

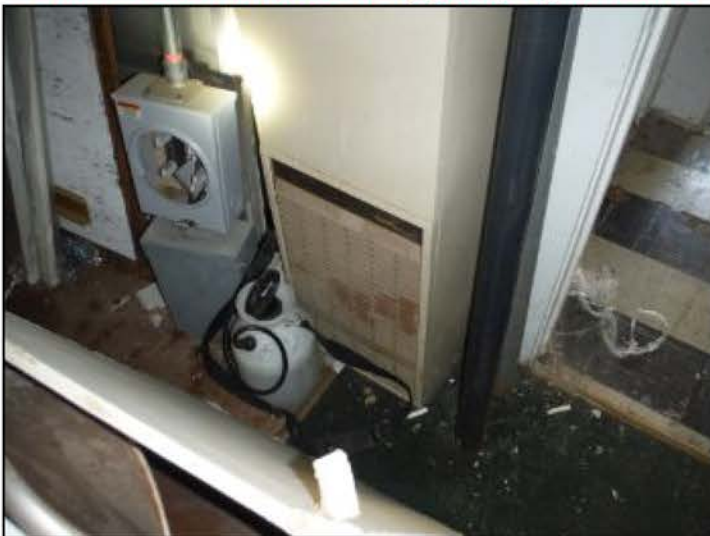
Untested older unit needs upgrade/replacement

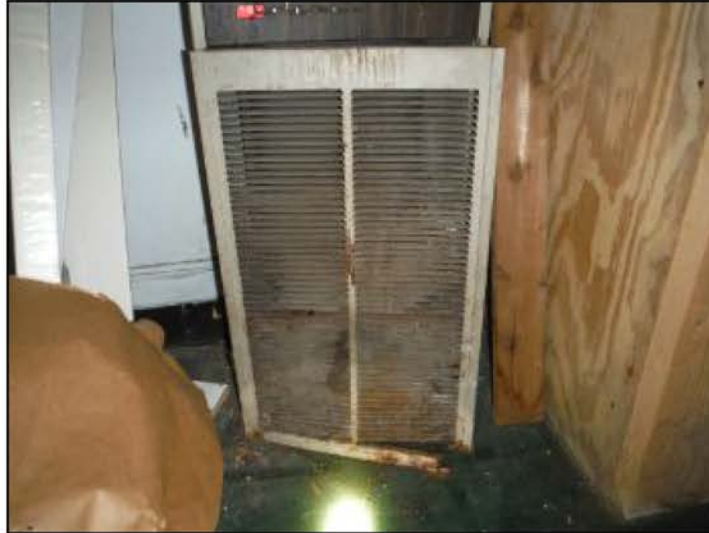
Old rusty unit needs to be replaced

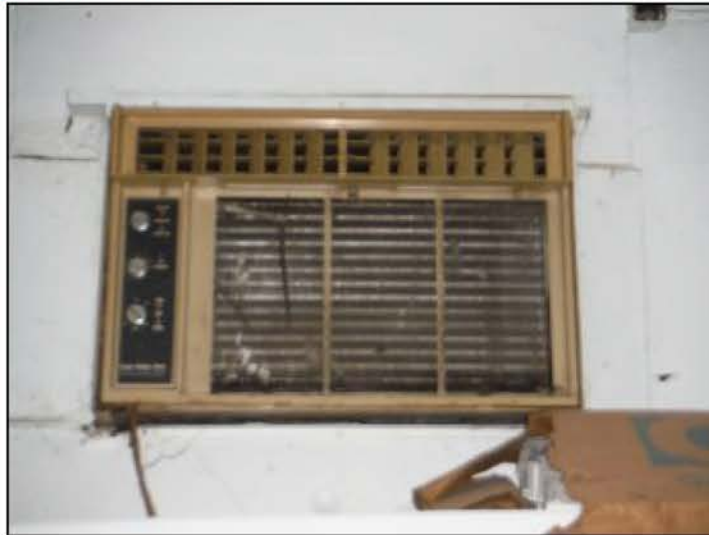
Inoperative older package/wall air conditioner

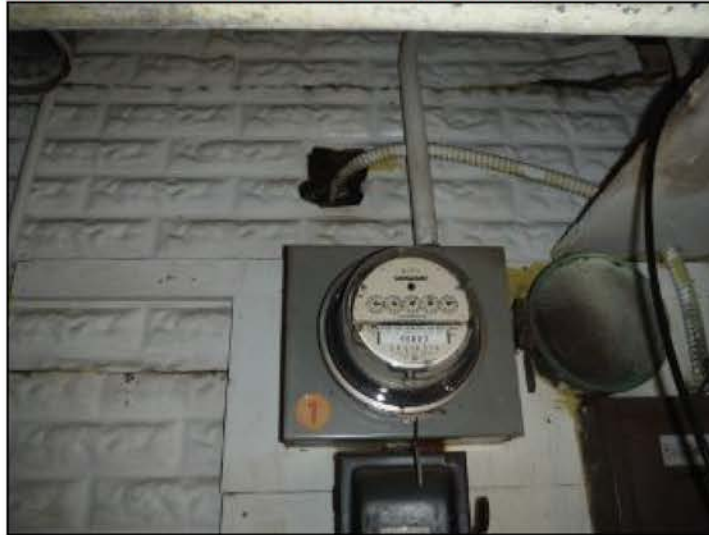
Meter inside, not to current standards for commercial property

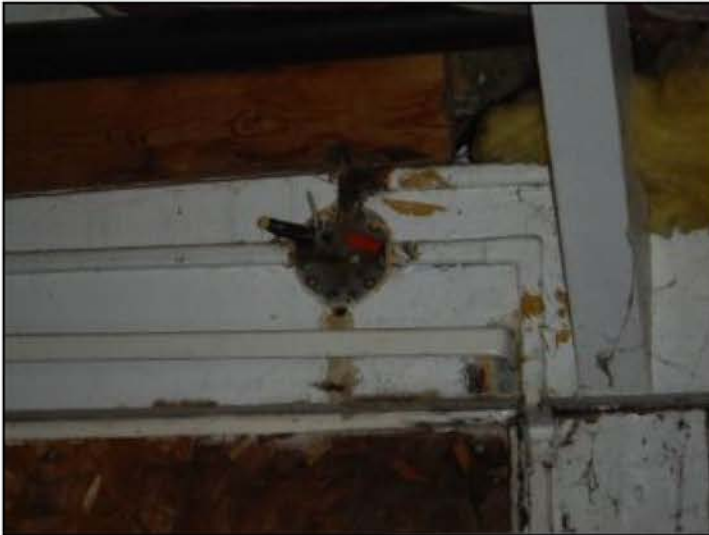
Unsecured wiring, refer to electrician

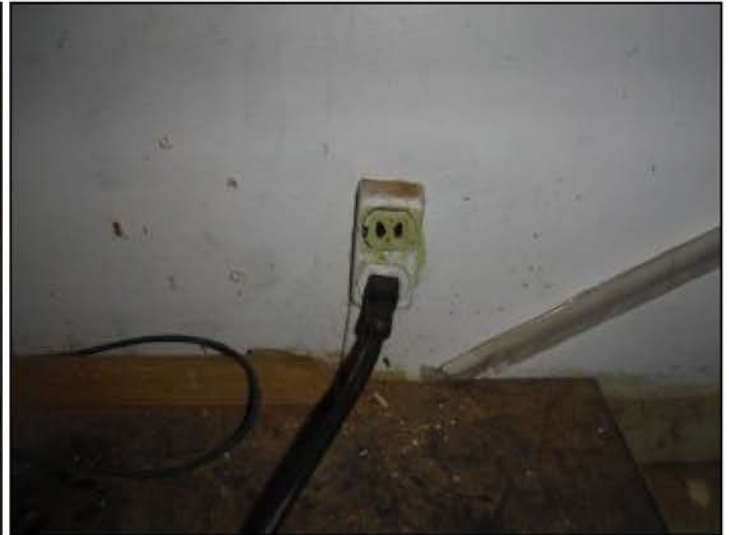
Dated two wire system, not to contemporary standards for commercial property

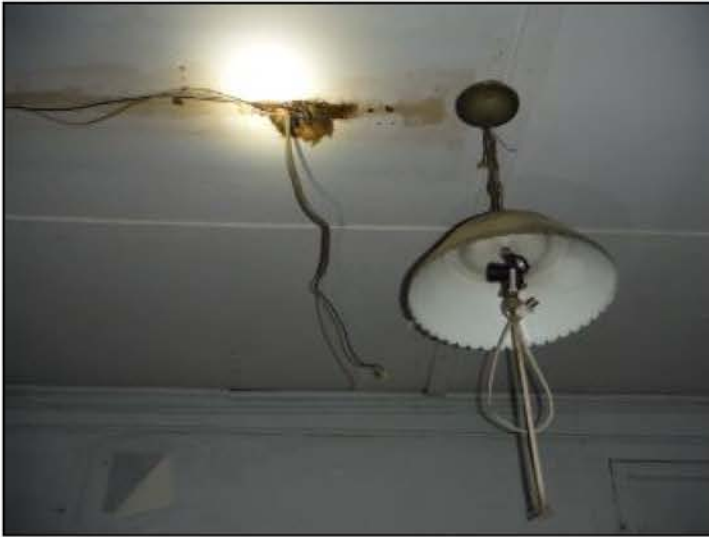
Unsecured wiring, refer to electrician

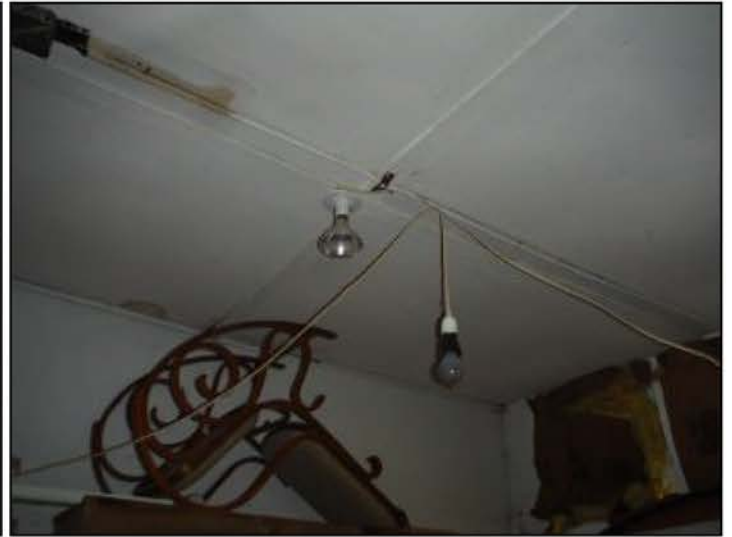
Unsecured wiring, refer to electrician

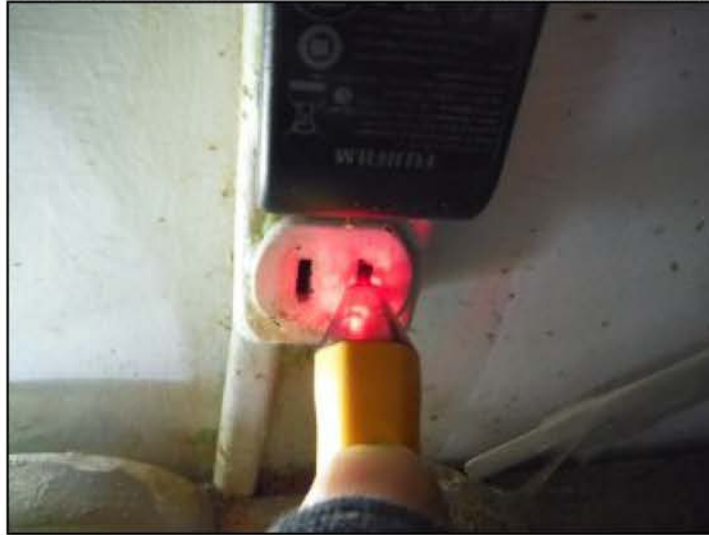
Miswired outlets, refer to electrician

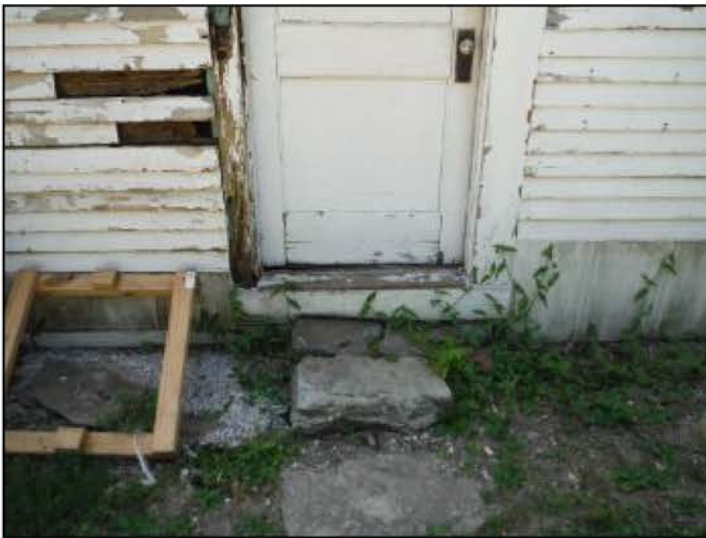
Trip hazards at back door, no proper stoop

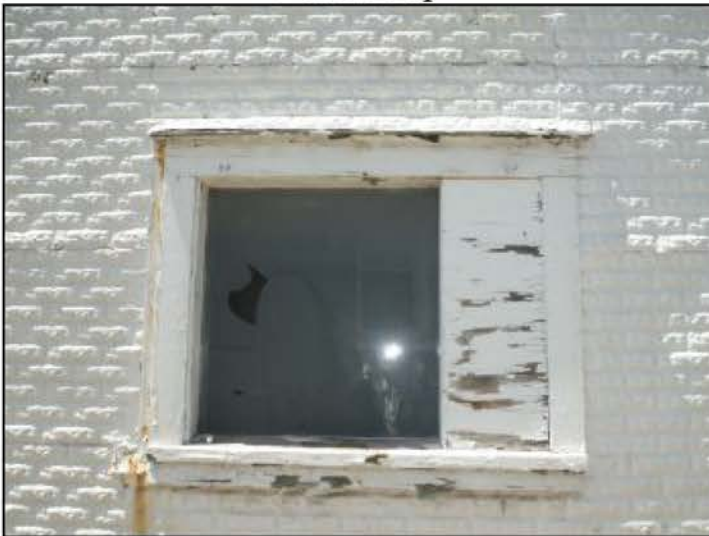
Broken unit/s are potential liability

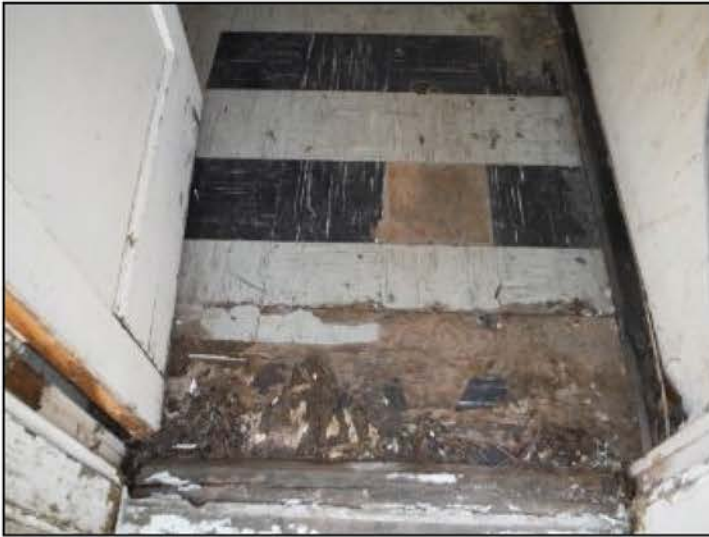
Damaged at back door

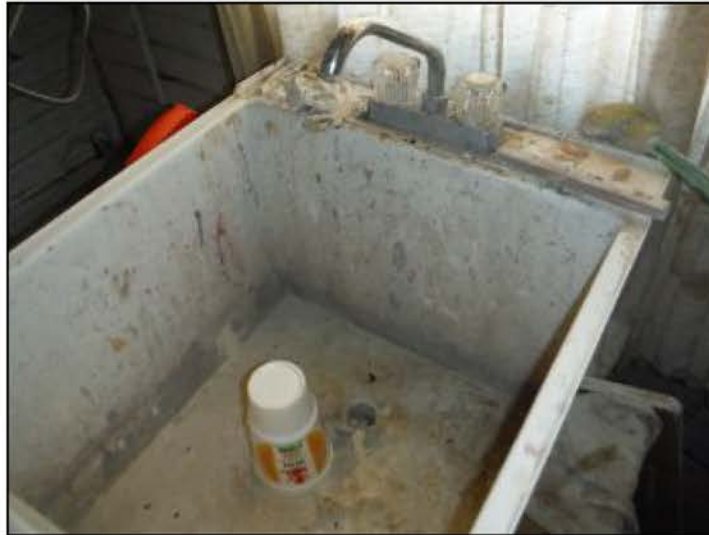
### 2. Sink A

Untested wash tub sink, water off

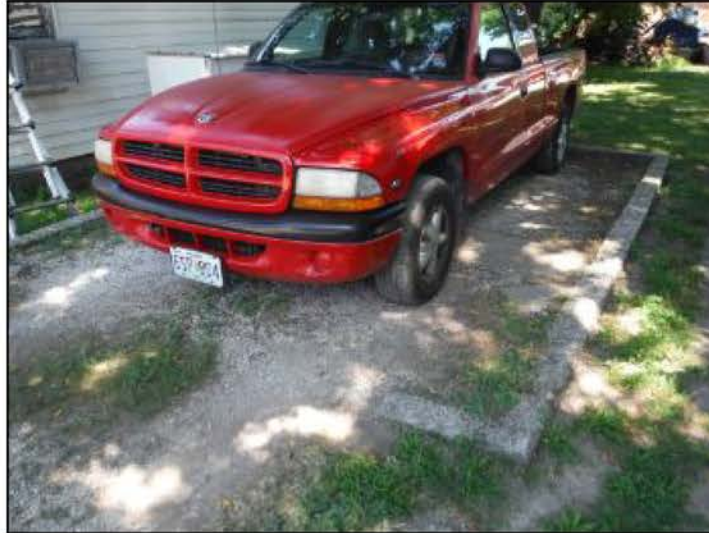
### 1. Driveway Observations

Parking at past garage location, note concrete curb is old foundation walls

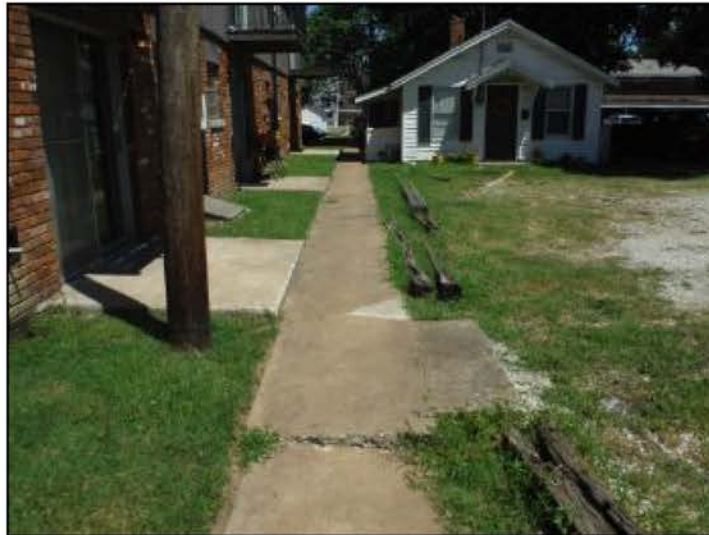
### 1. Sidewalk Observations

Very deteriorated, trip hazards

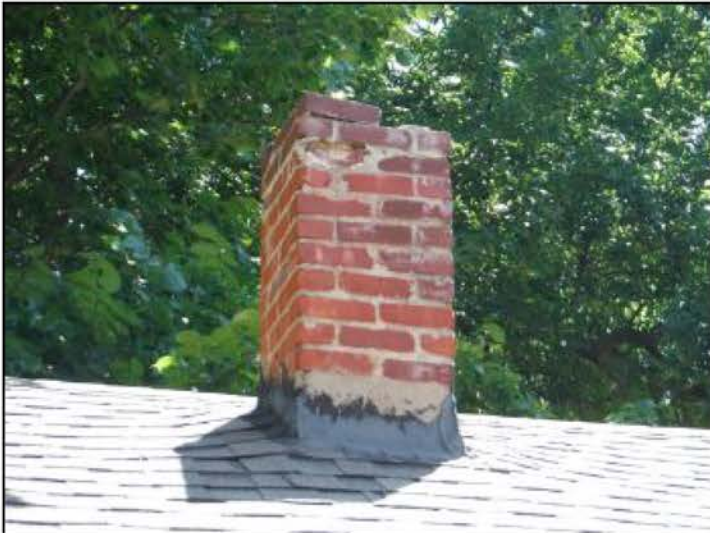
### 1. Chimney Observations

Water and birds can enter chimney

Very deteriorated, appears unlined brick masonry

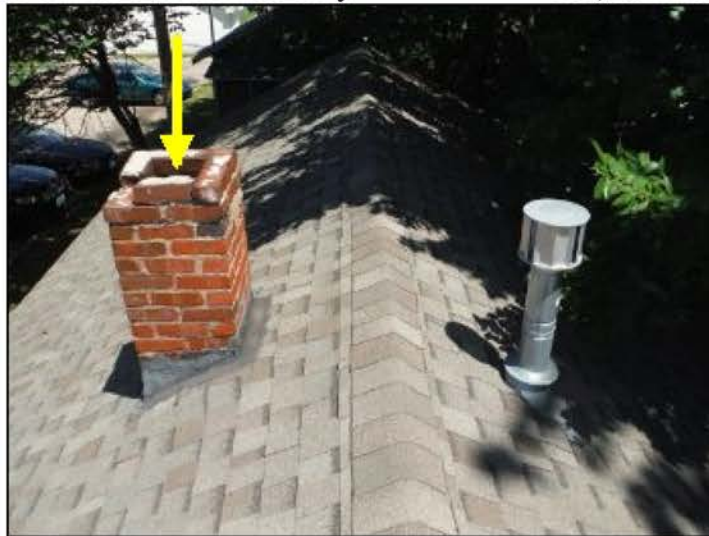
Water and birds can enter chimney

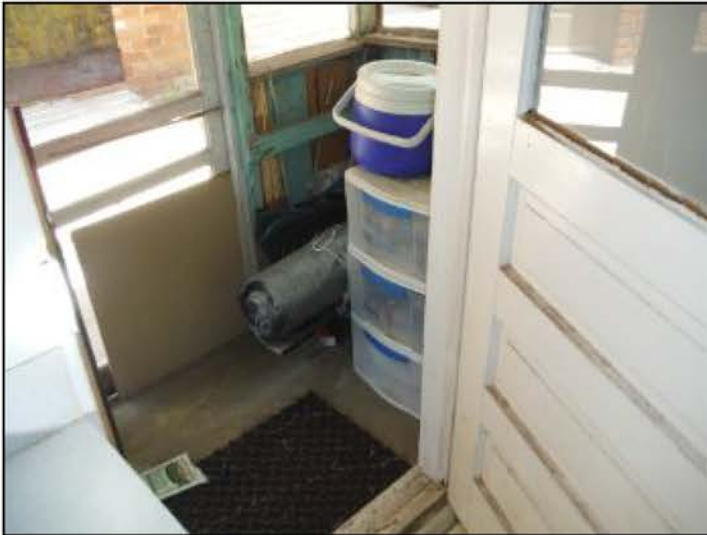
### 1. Patio Observations

Uneven/cracked concrete floor noted

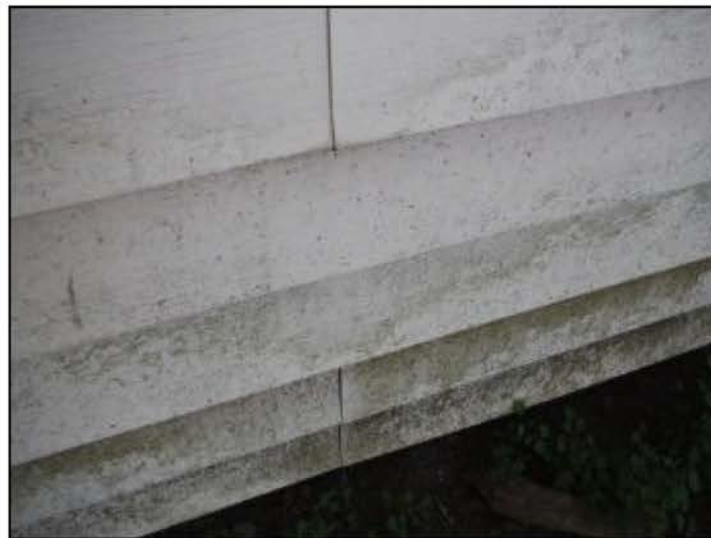
### 1. Exterior Walls

Fungal stains at vinyl siding need cleaning

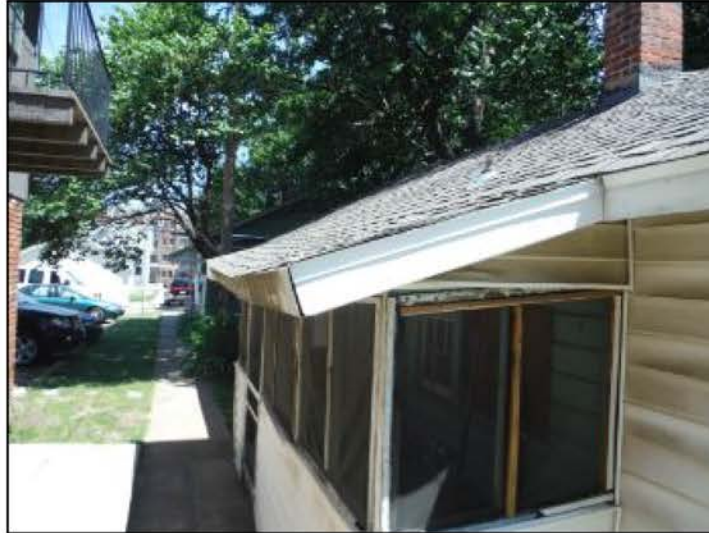
## Porch Roof

Same roofing as main roof

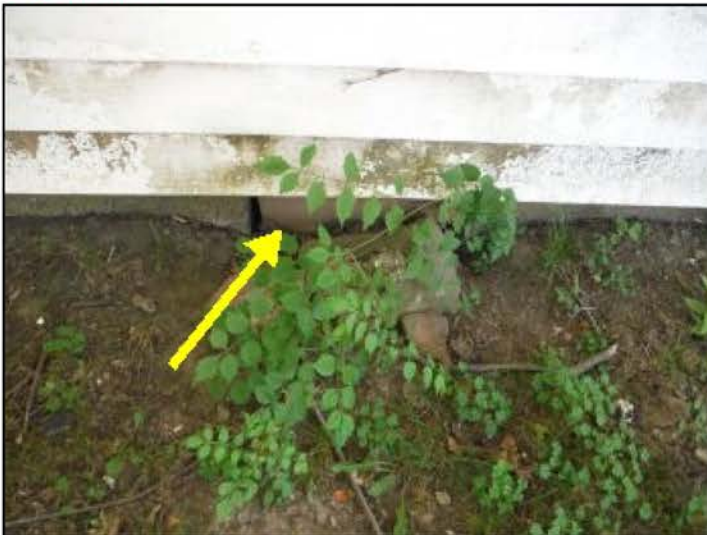
### 1. Foundation Observations

No access

View port --- otherwise inaccessible below floor

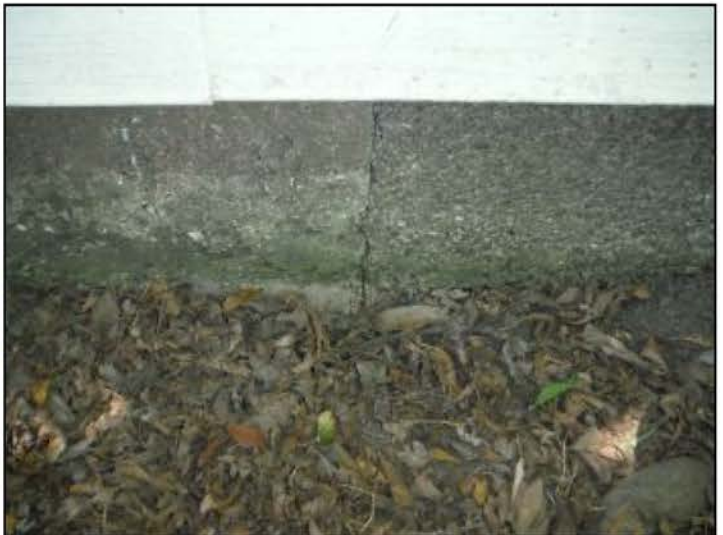
Cold joint means half is an addition

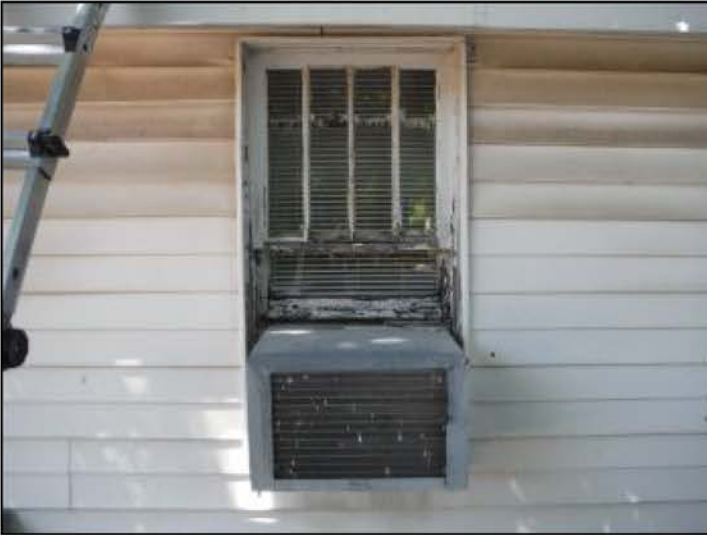
## 1. Condition

Older package air conditioner has limited life

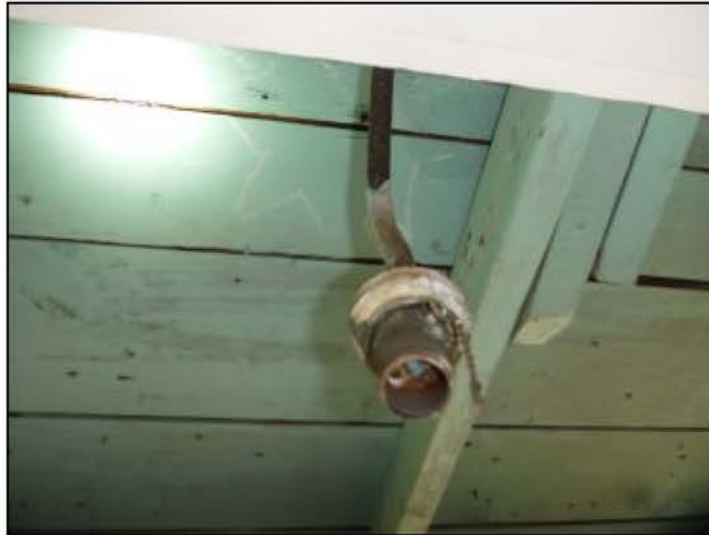
## 4. Conductors

| Page 16 Item: 6 | Wiring Notes | Old school light fixture is shock hazard |

Old school light fixture is shock hazard

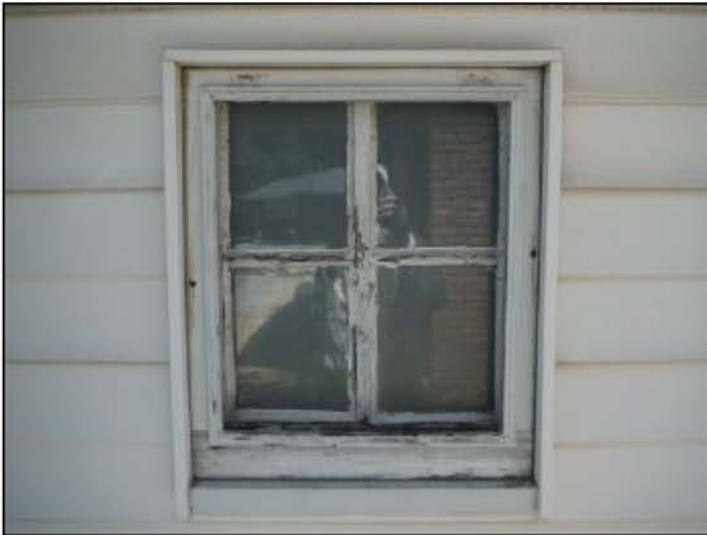
Older wood units need paint maintenance

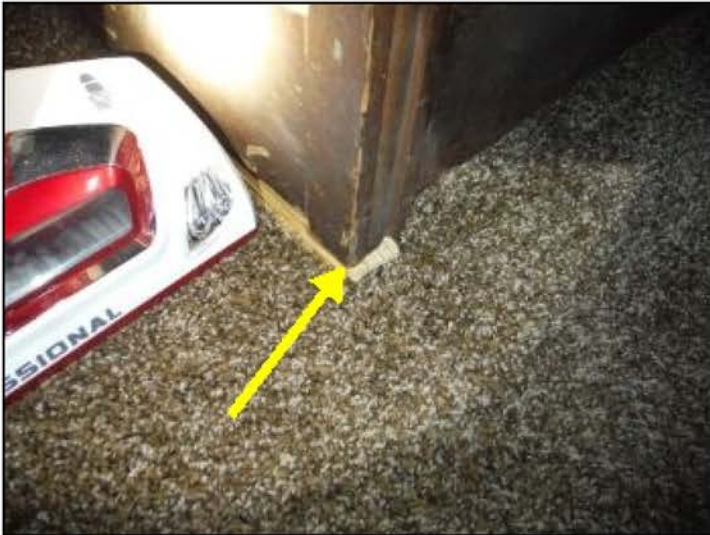
Uneven/sloped areas, photo is shim at tenants furniture

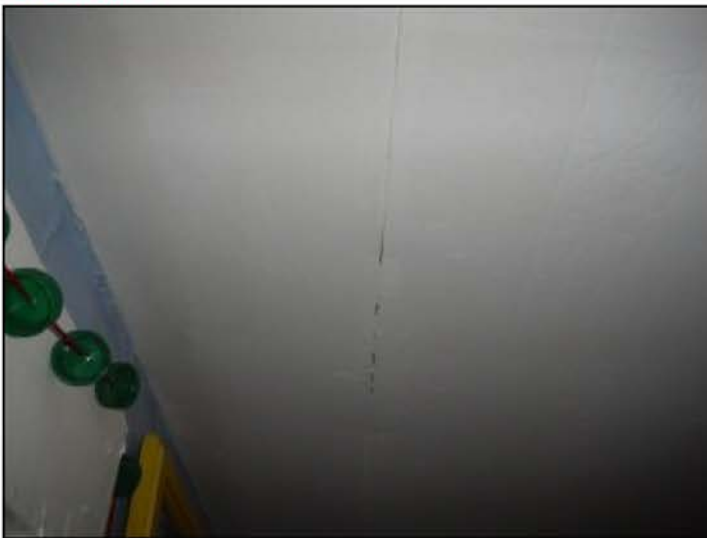
No access at ceiling, patched areas noted

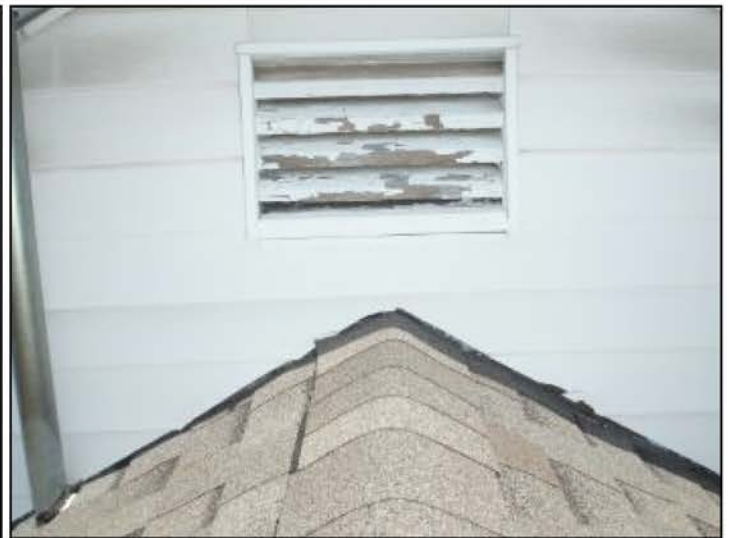
Limited view at gable vents

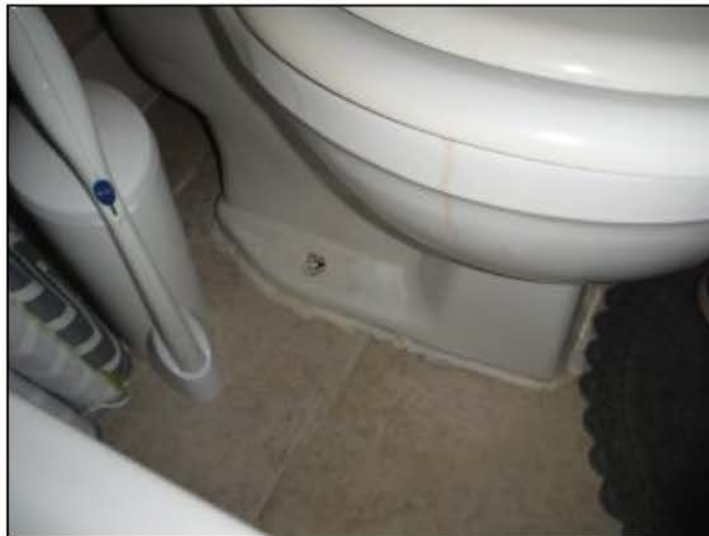
Caulked base not preferred

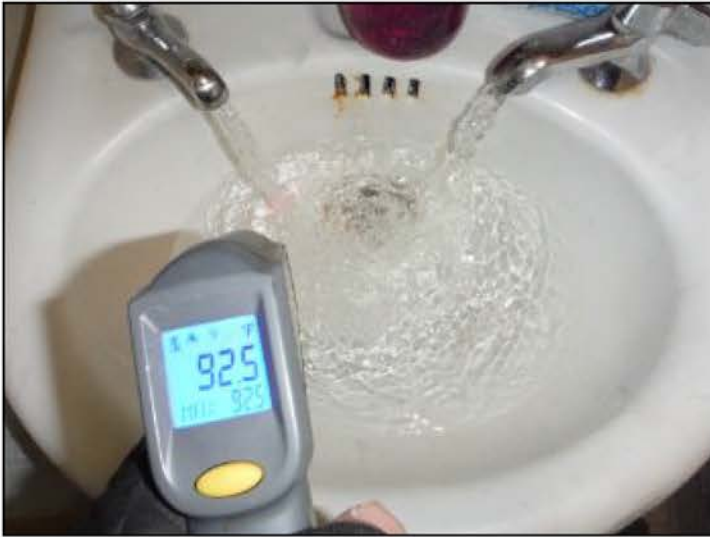
Not mixer valves, hot on left

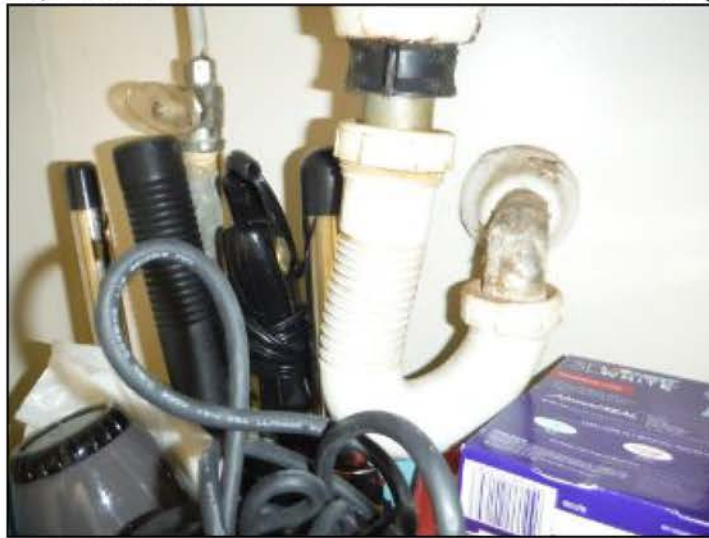
Tiny leak at loose trap

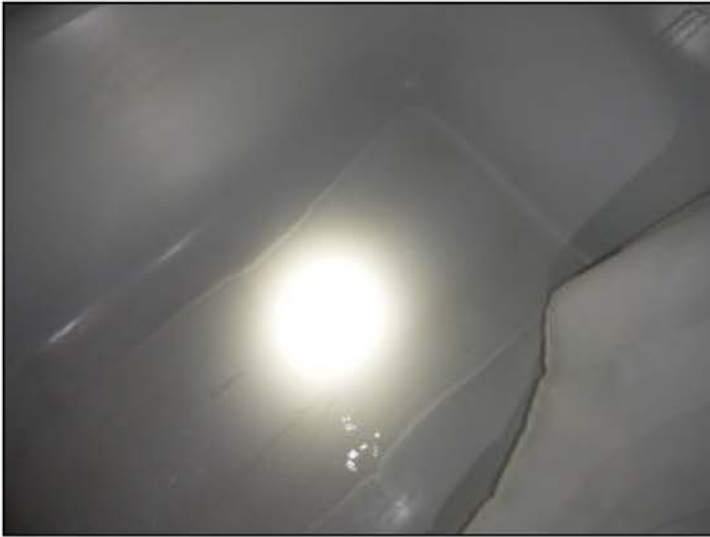
Does not drain properly, unit not level

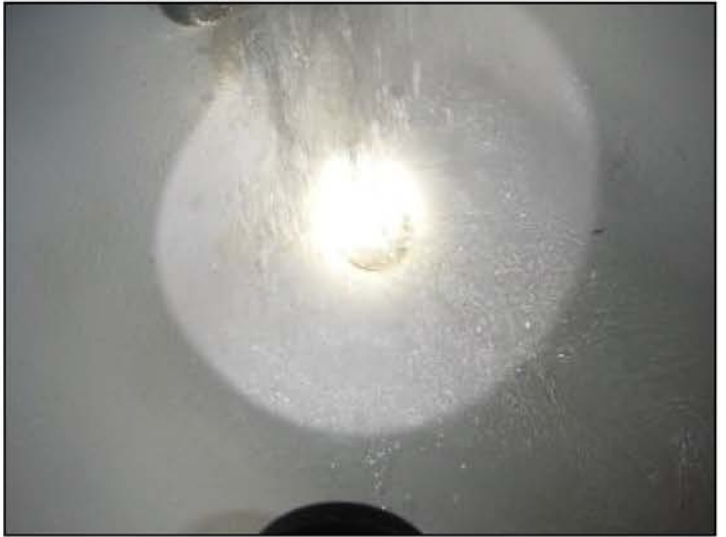
And stopper needs adjusting

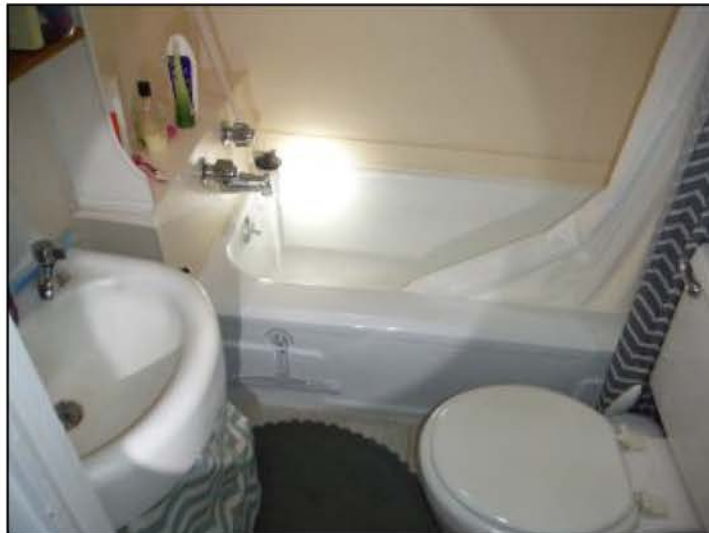
Undersized area/room, not universally accessible

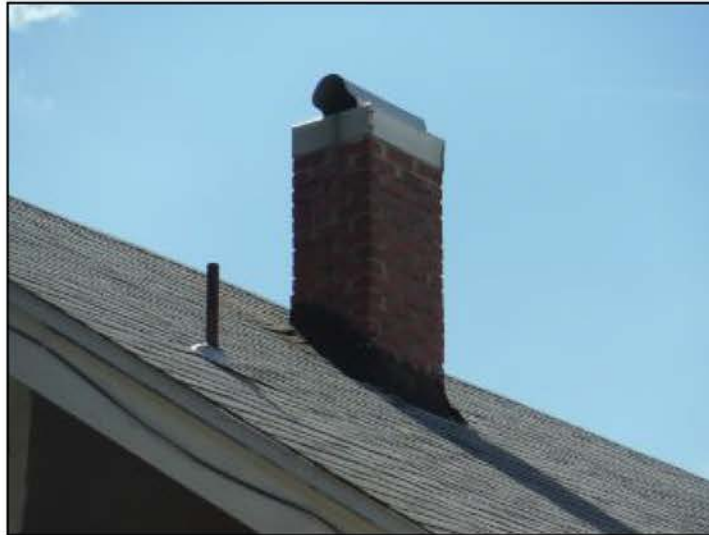
West roof slope  
Brick masonry  
Vents water heater and floor furnace  
Flashing and masonry maintenance requirement likely  
Has rain cap  
Did not verify whether it has clay tile liner  
**Water heater is back drafting, may be required to reline chimney for gas vent**

Vents water heater and floor furnace

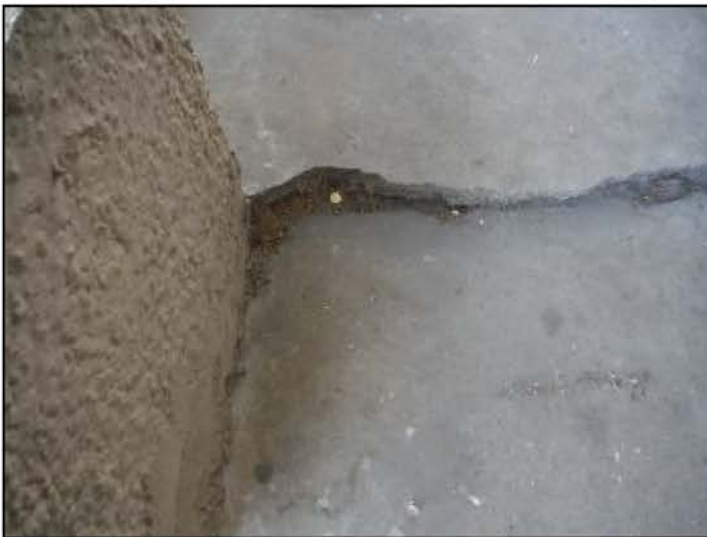
Serviceable concrete is cracked and settled (apx. one inch, both sides)

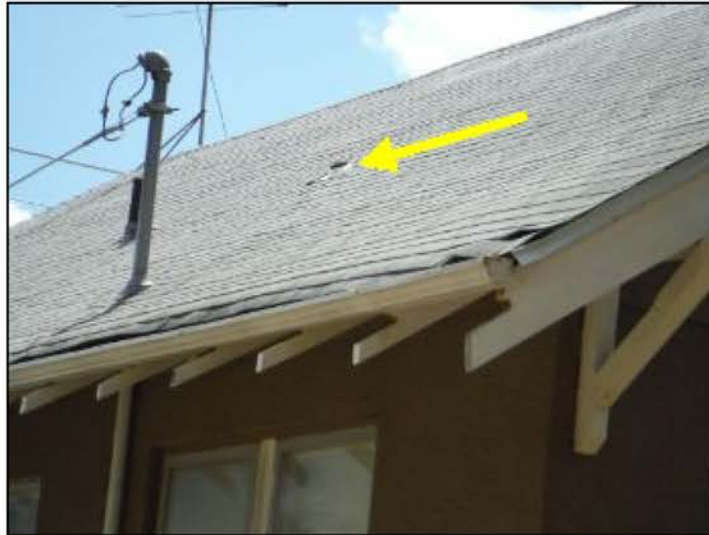
Plumbing vent and/or flashing need/s attention

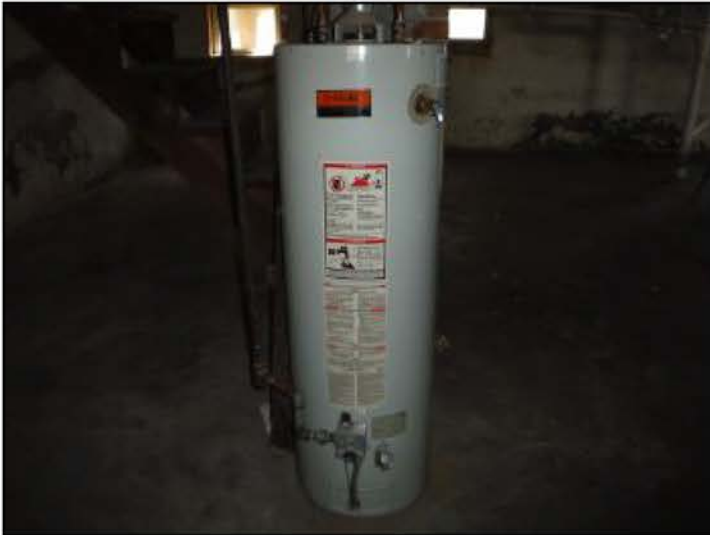
Old standard, burns basement air, suggest upgrade

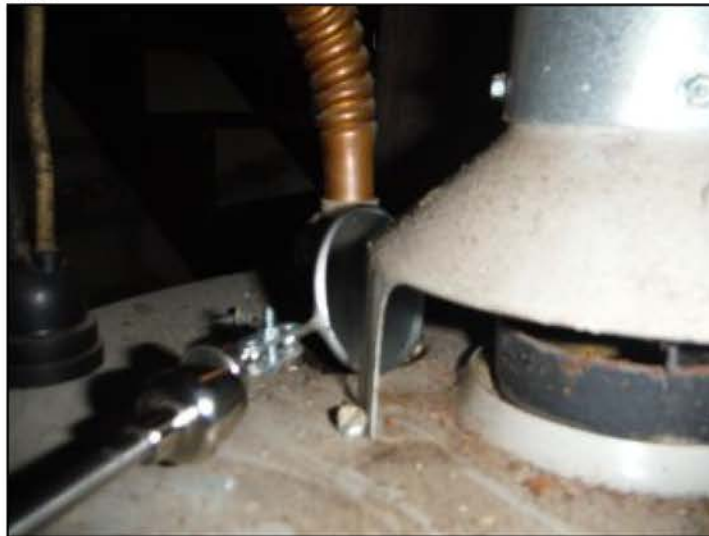
Persistent back drafting, related to being vented into masonry chimney

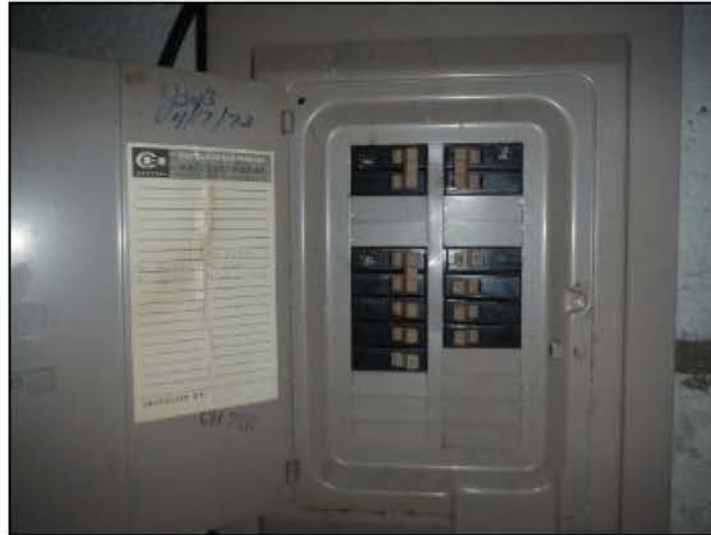
No main breaker, lug type panel (old school as installed)

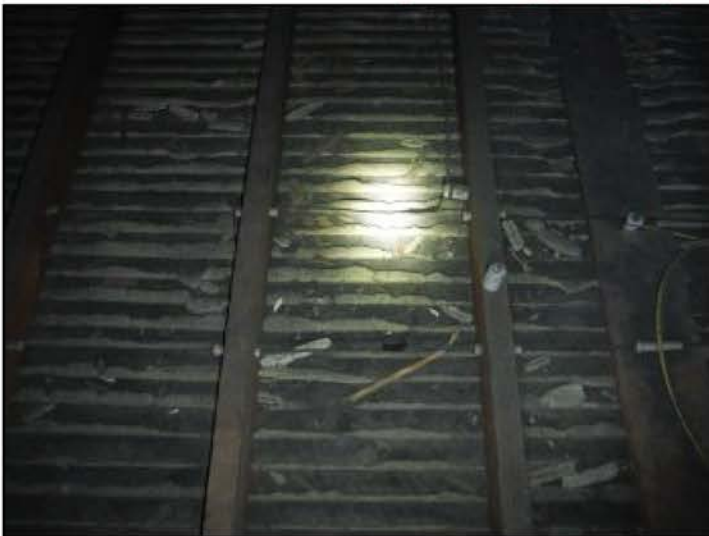
Active knob and tube wiring confirmed at attic, refer to qualified electrician to update

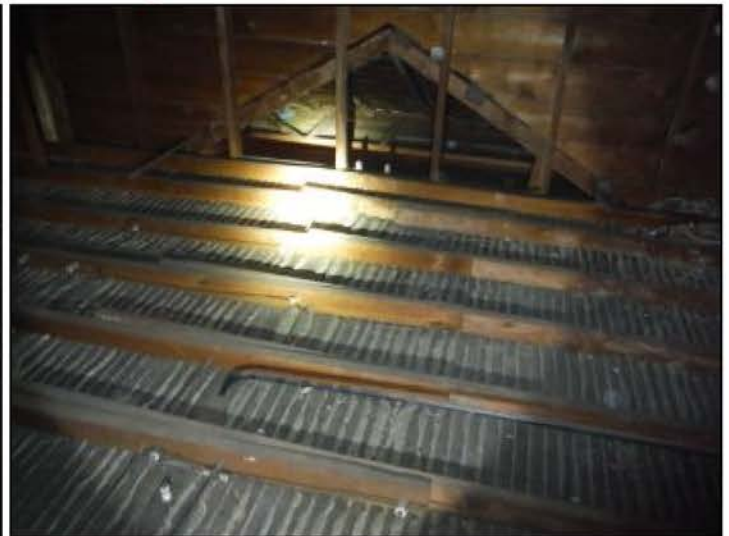
Active knob and tube wiring needs upgrading prior to adding insulation

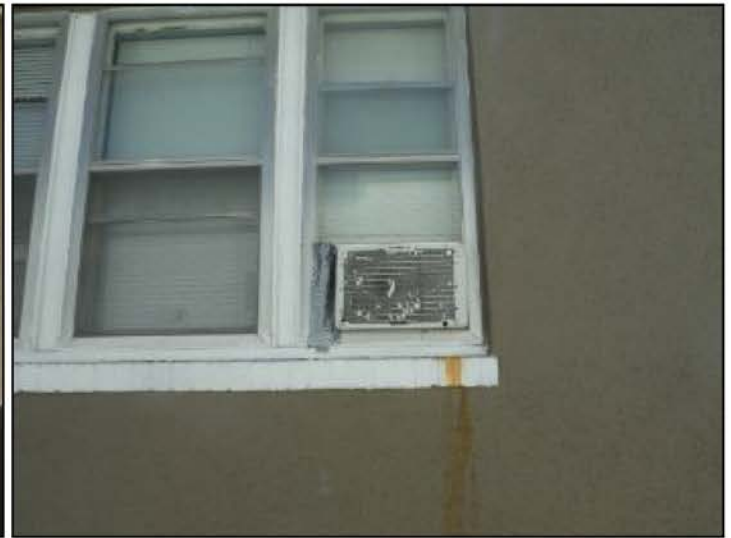
Missing screens/sashes noted

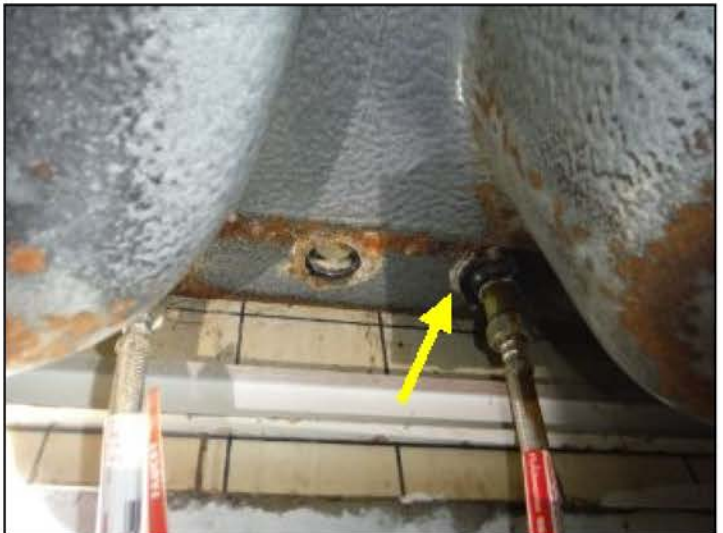
| Page 23 Item: 1 | Sink | Leak/s at supply/faucet below, refer to plumber |

Leak/s at supply/faucet below, refer to plumber

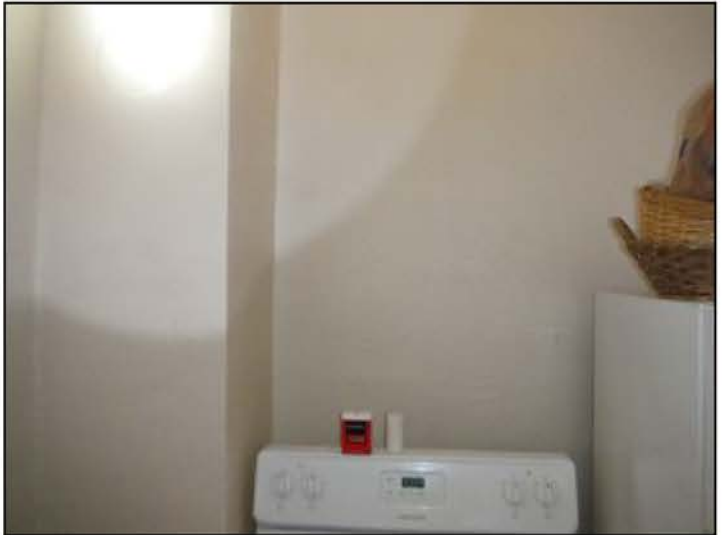
No exhaust hood provided

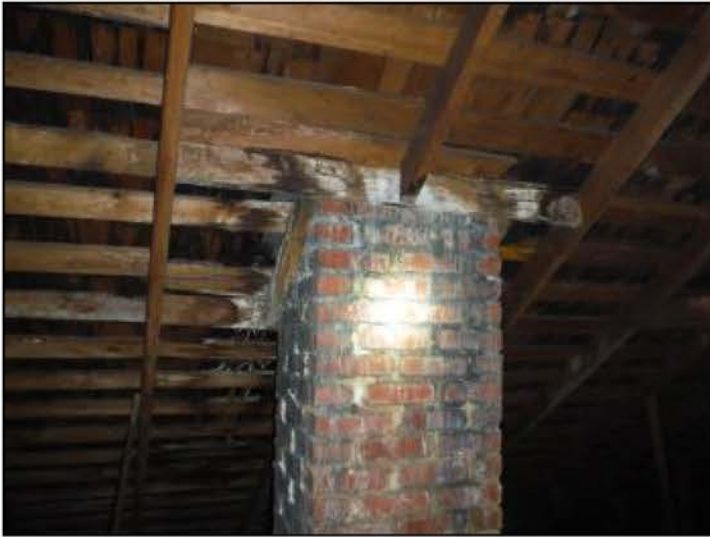
Stains appear dry

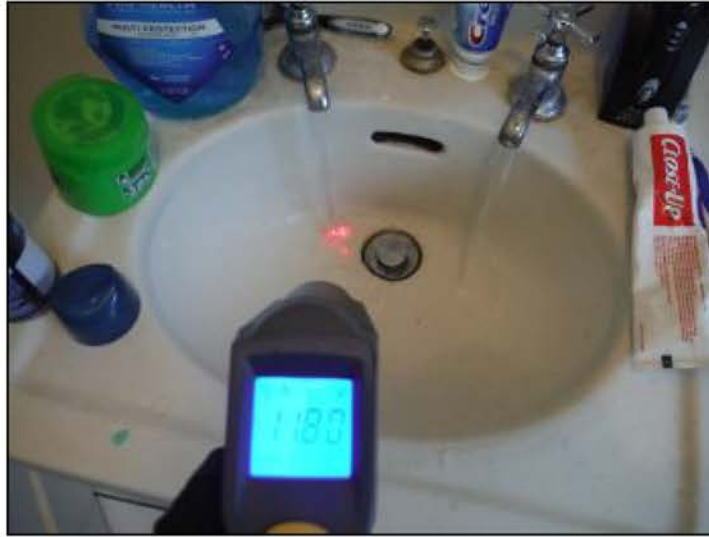
Old standard, separate hot/cold faucets

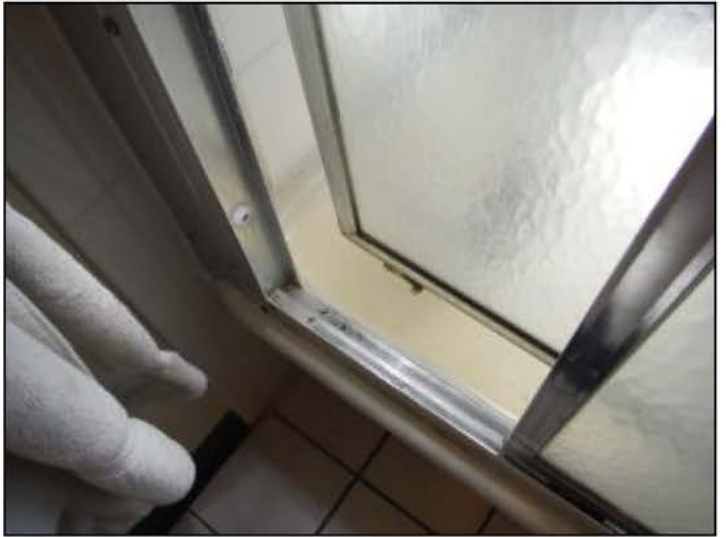
Missing guide needed

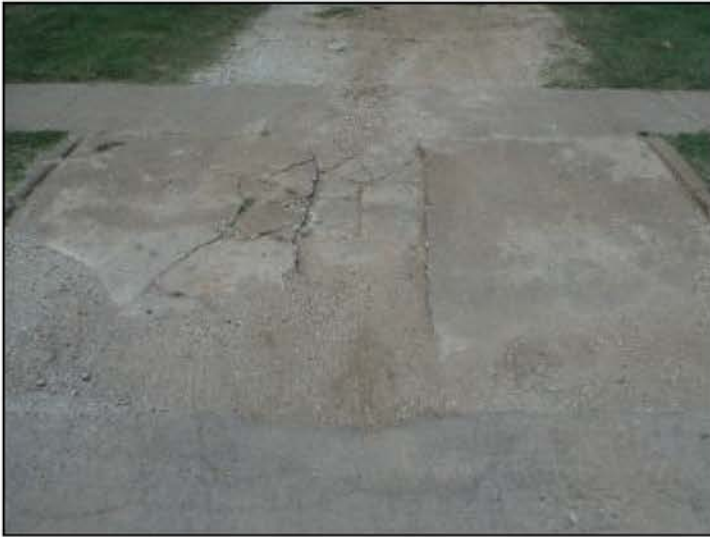
Deteriorated approach at shared driveway
