# Springfield Land Clearance for Redevelopment Authority

**4.III. Blight Report And Redevelopment Plan For The East Cherry Flats Redevelopment Area**

Documents: [EAST CHERRY FLATS BLIGHT REPORT AND REDEVELOPMENT PLAN.PDF](#)

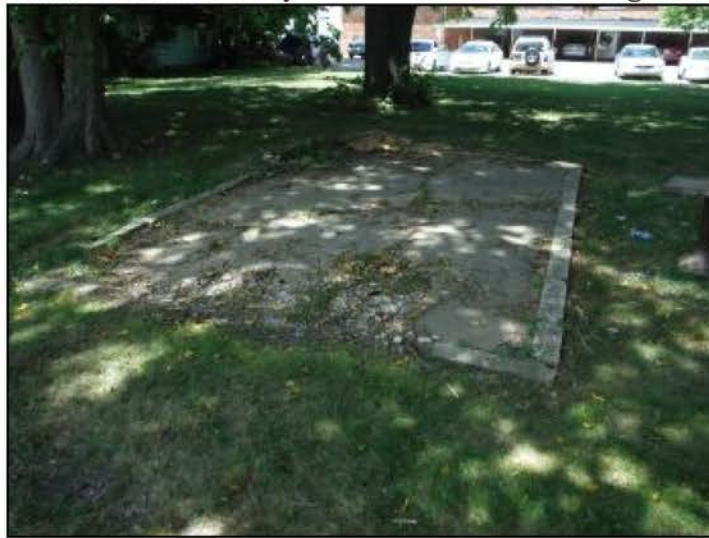
Deteriorated concrete parking pad is past garage floor/foundation

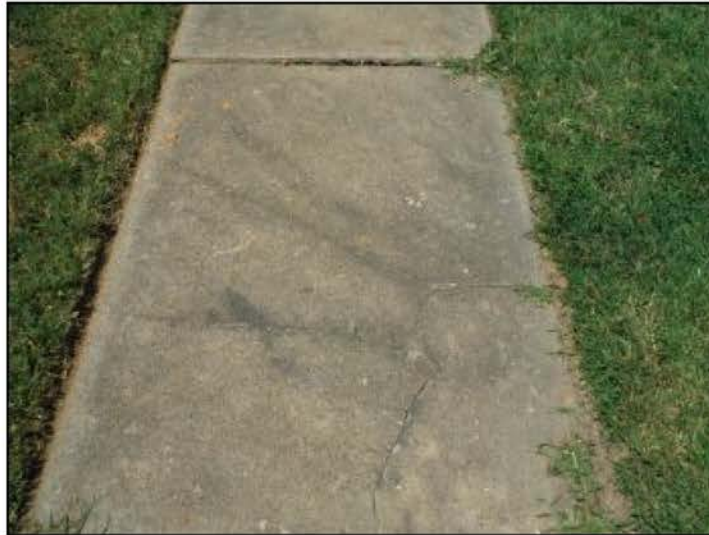
Trip hazards noted

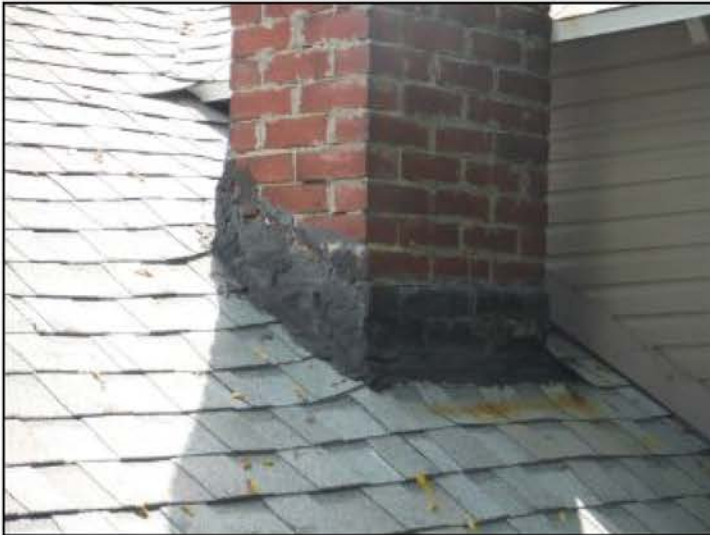
Flashing is mastic coated

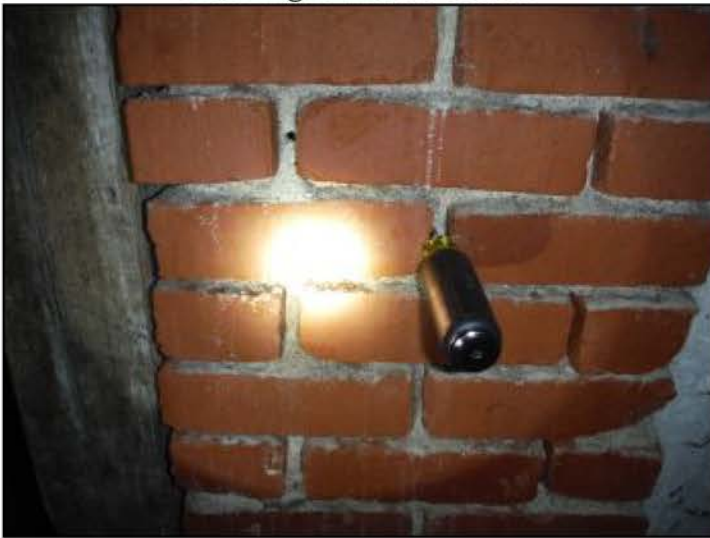
Deteriorated mortar at basement

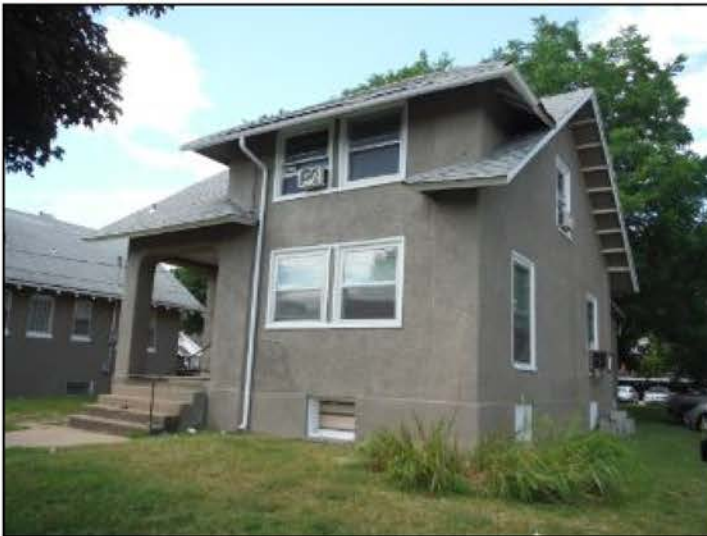
Real stucco needs regular maintenance

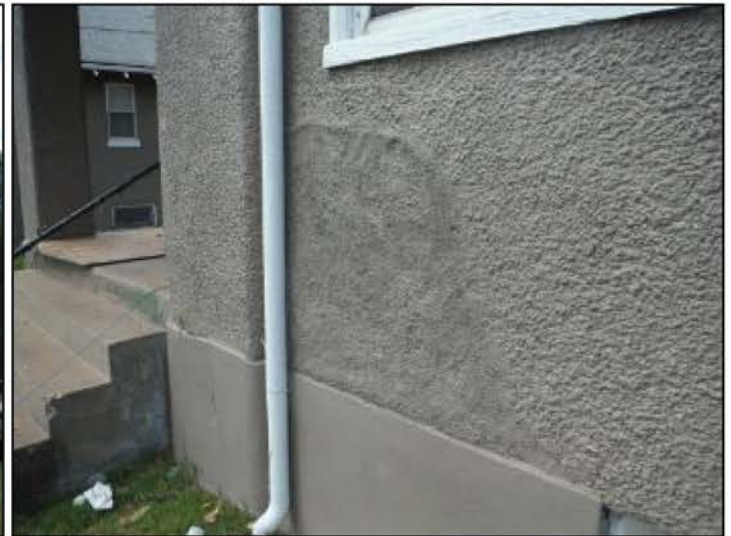
Patched stucco observed

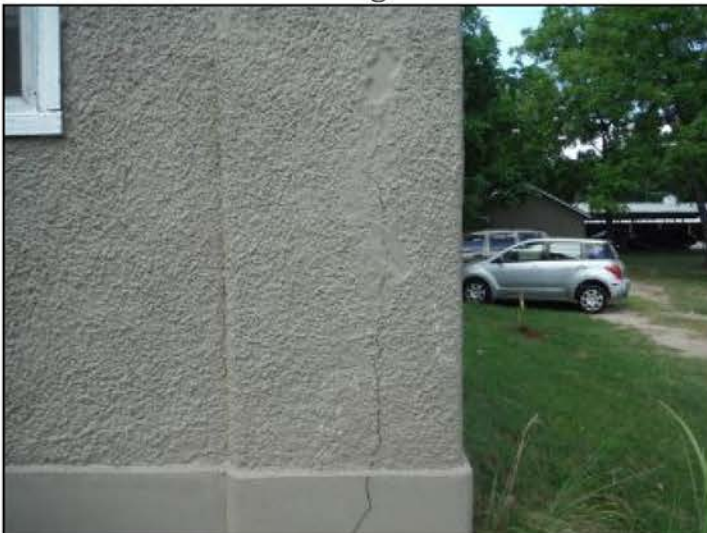
Common cracks at stucco

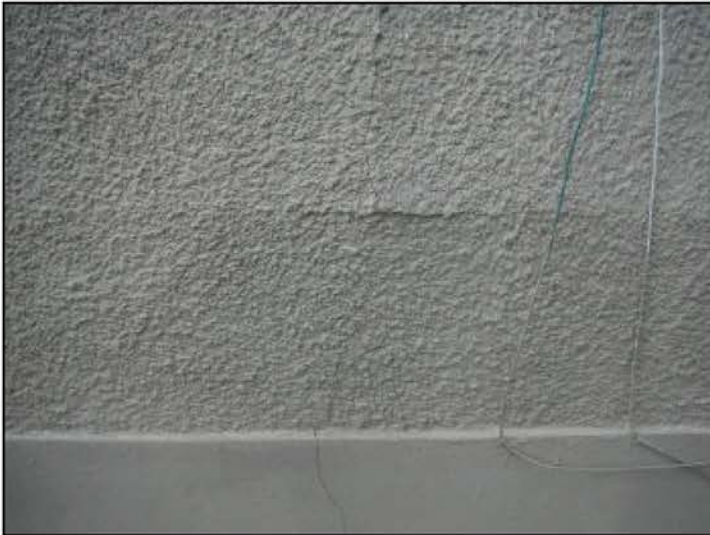
Loose/bulged at east side, refer to qualified stucco plasterer (closeup)

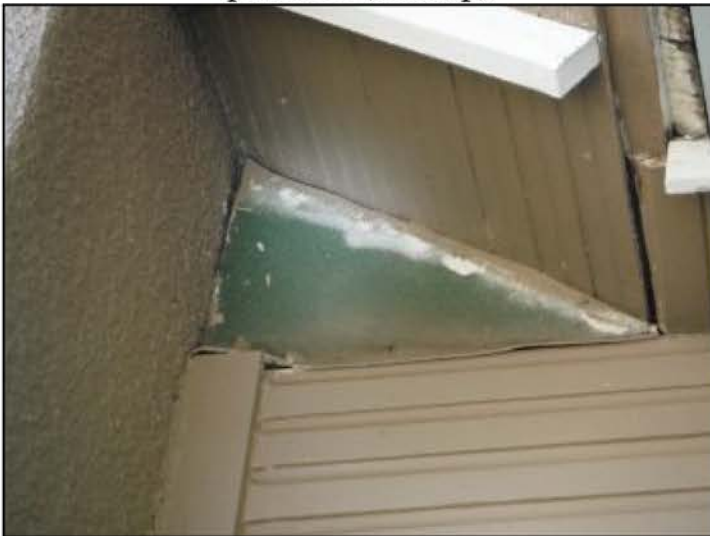
Missing wood lap siding at back eave

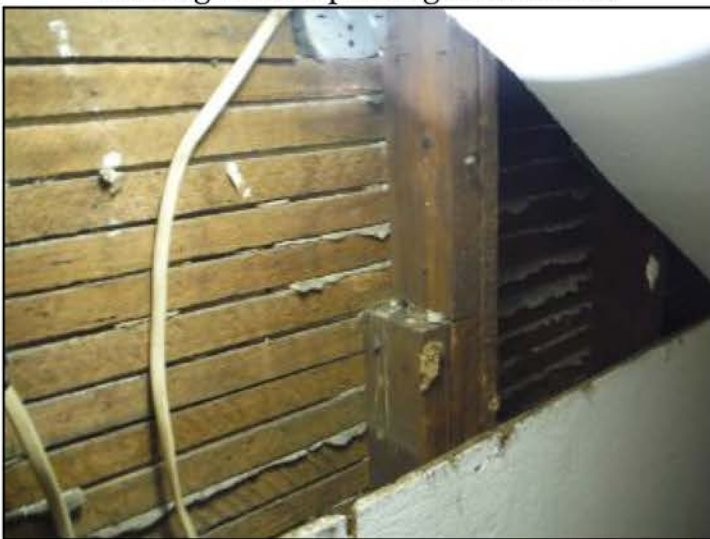
Uninsulated, old standard not yet upgraded

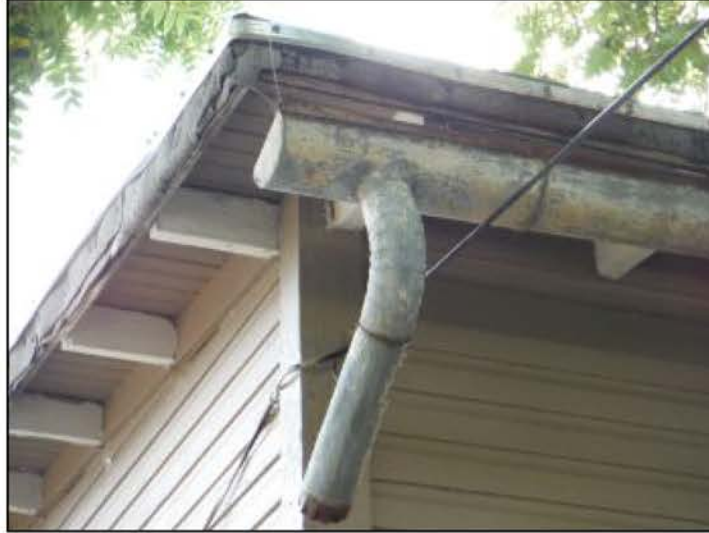
Partial system needs maintenance

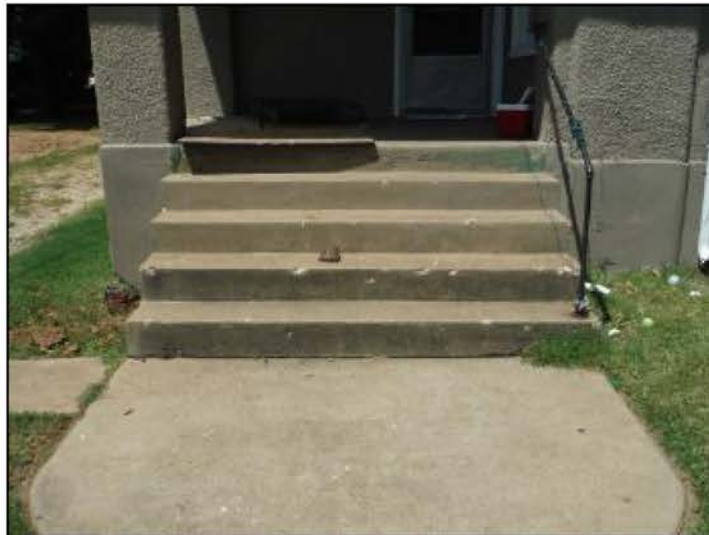
Hand railings not to current standards

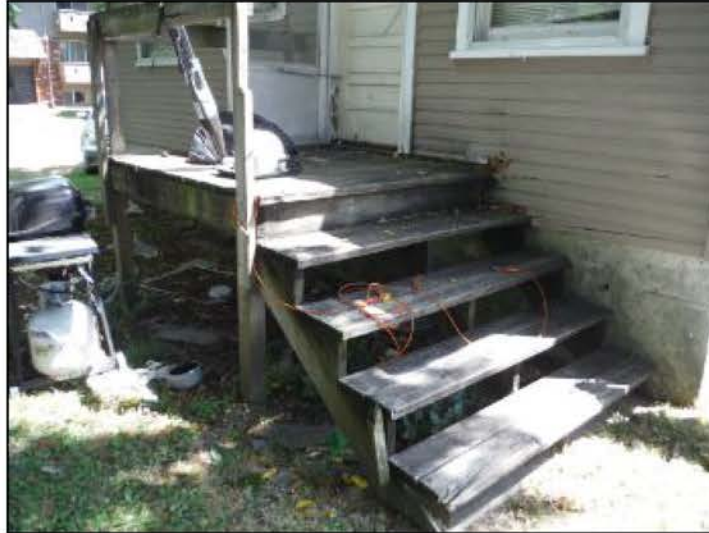
Missing railings, not to current standards

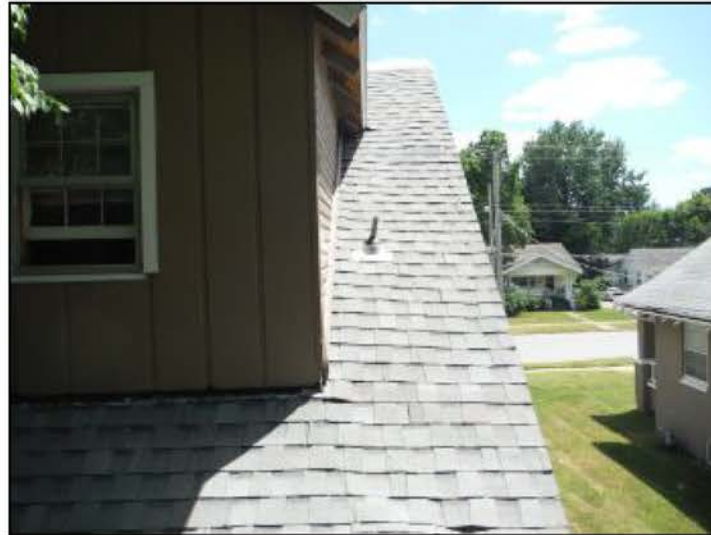
Limited inspection, not walked

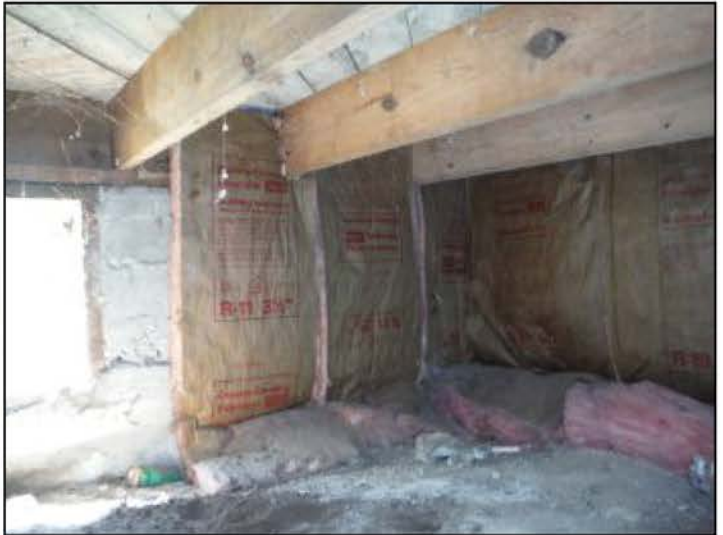
Insulation limits inspection

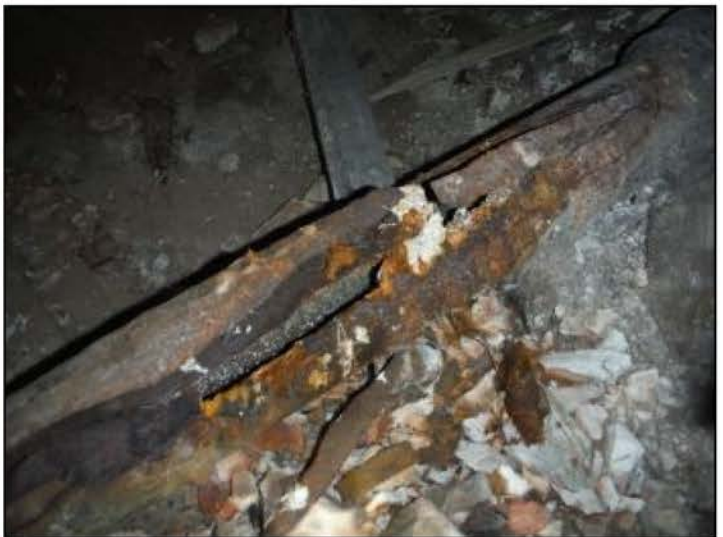
Wood debris needs removal (refer top termite inspection report)

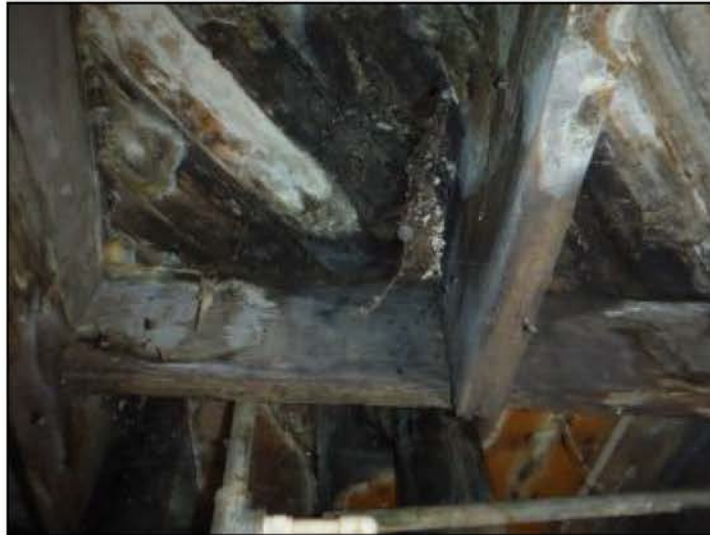
Unrepaired minor damage below half bath observed

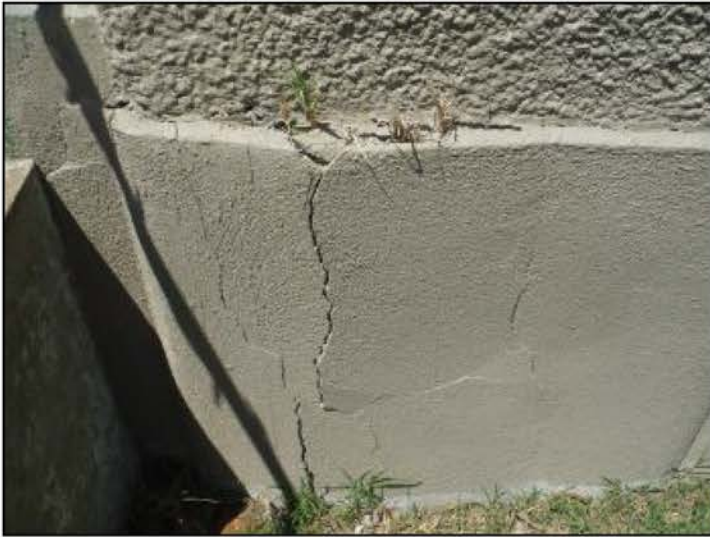
Common cracks relative to age

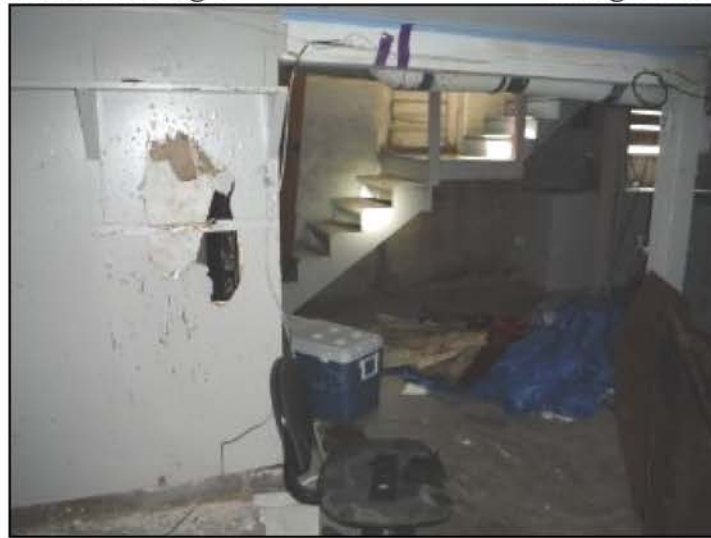
Damaged finish limits inspection

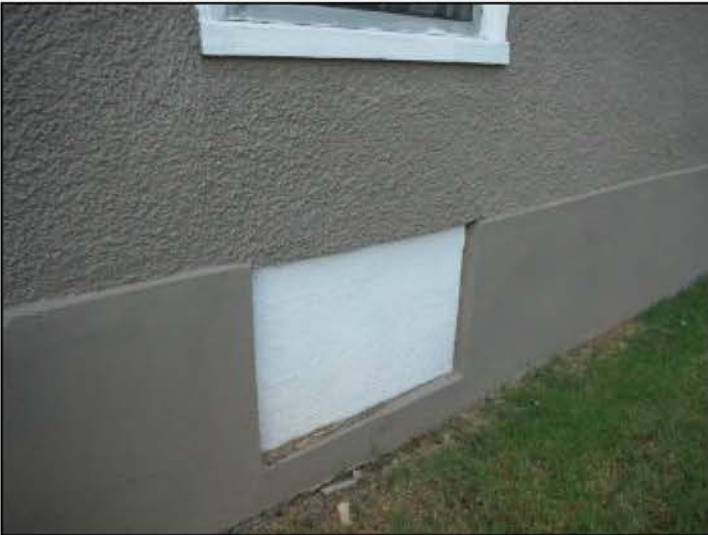
Windows boarded up

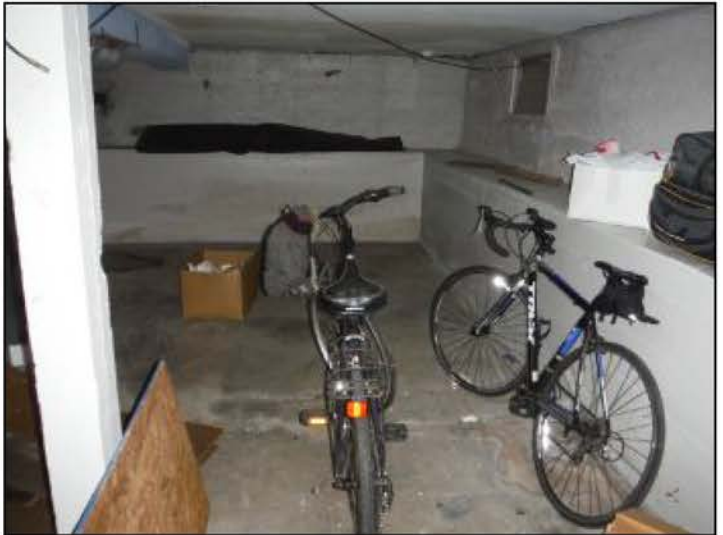
Dry today, signs of past dampness

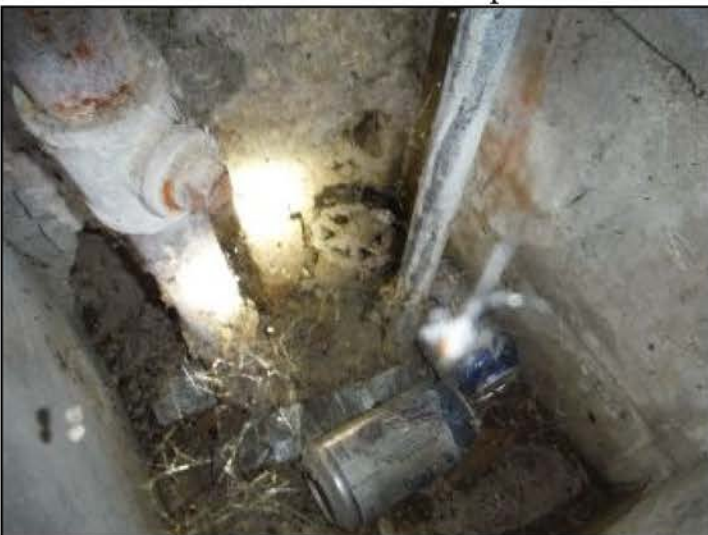
Older sump pump has limited life

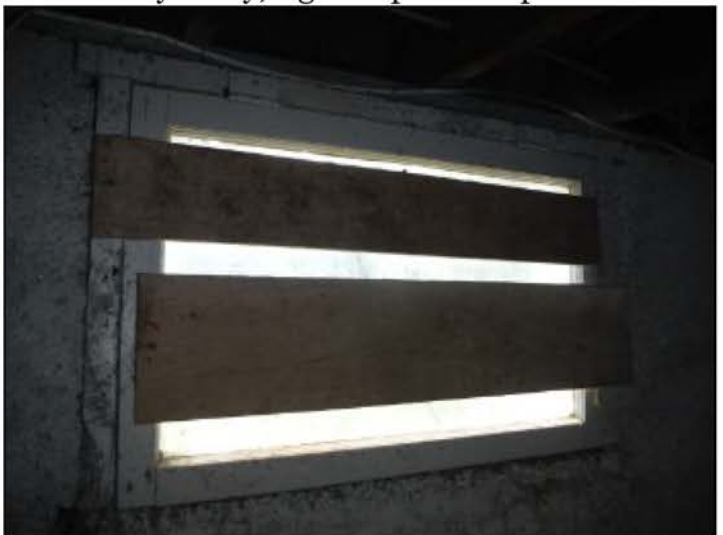
Windows boarded up

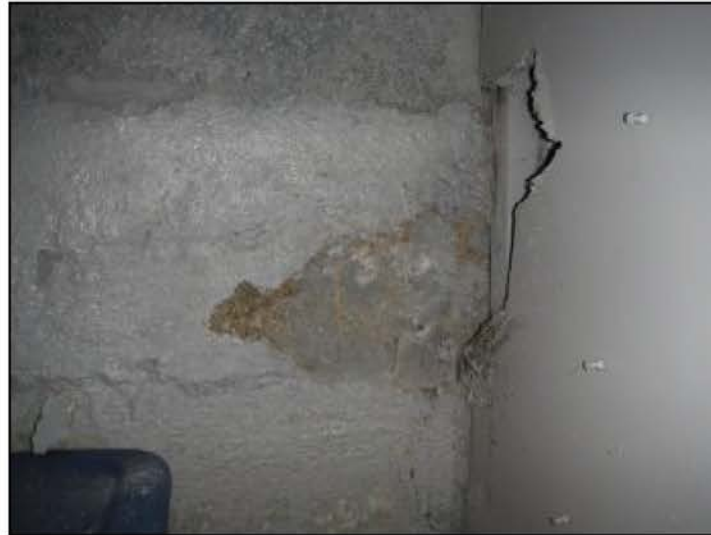
Peeling finish/stains are sign of moisture

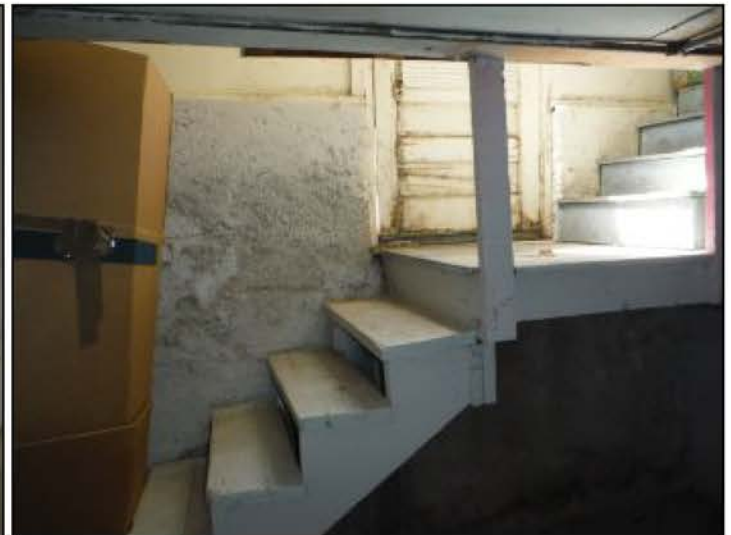
Older standards, low head clearance, under lighted, no hand rails and blocked by basement partition

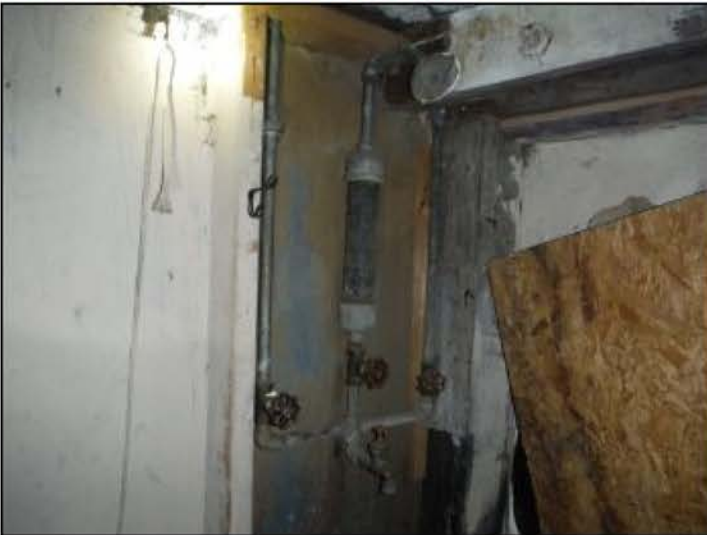
Untested abandoned shower in basement

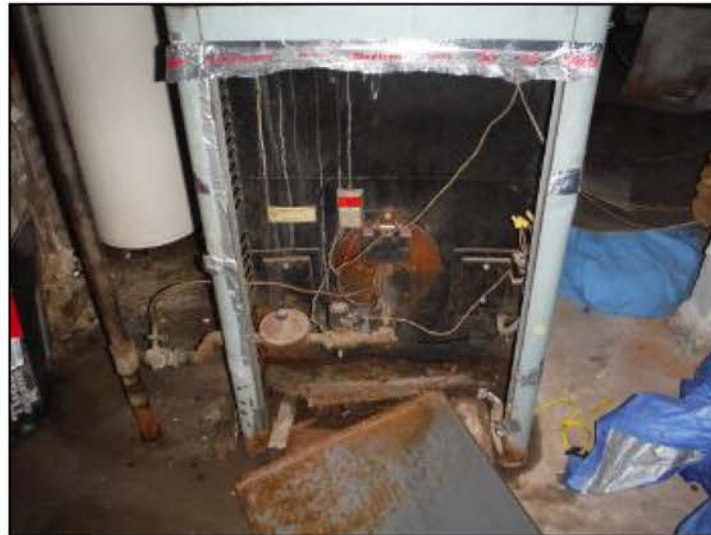
Poor maintenance, refer to HVAC technician

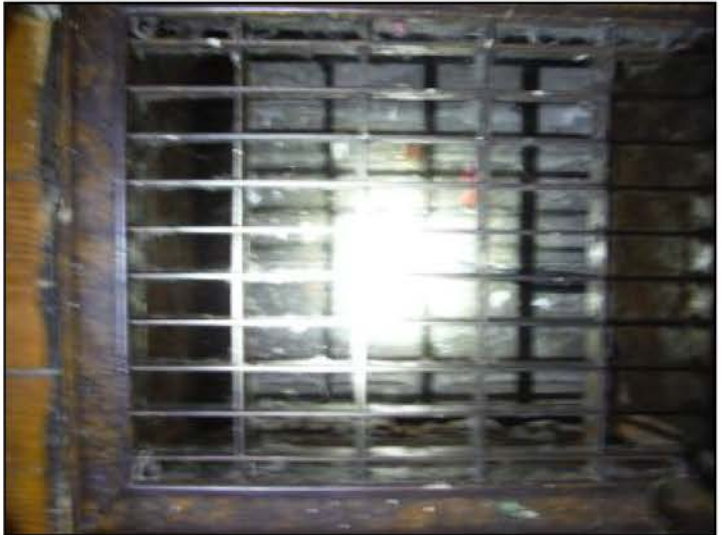
Some original ductwork needs cleaning

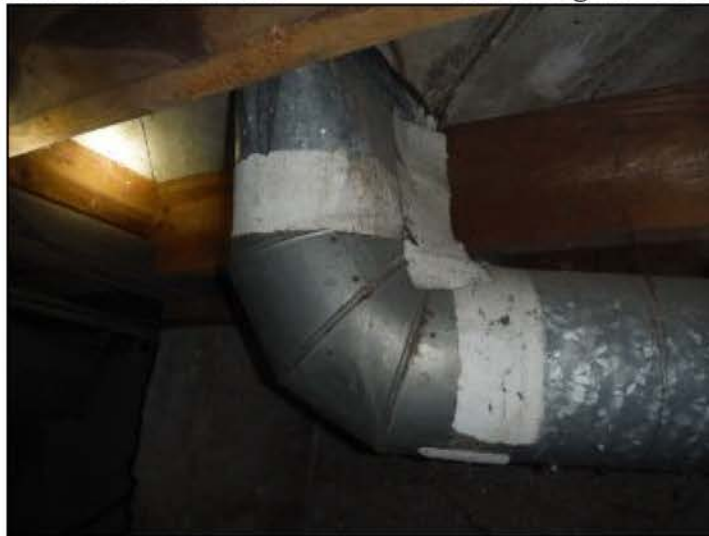
Suspect asbestos tape at ductwork noted

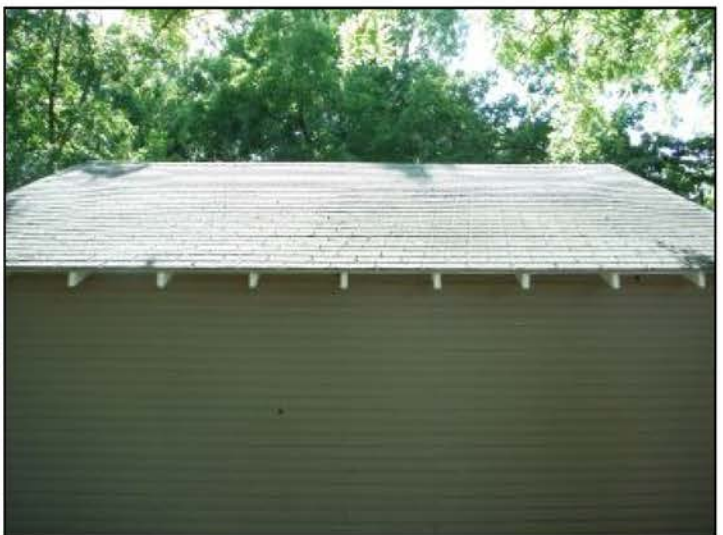
Older three tab composition roofing, limited evaluation

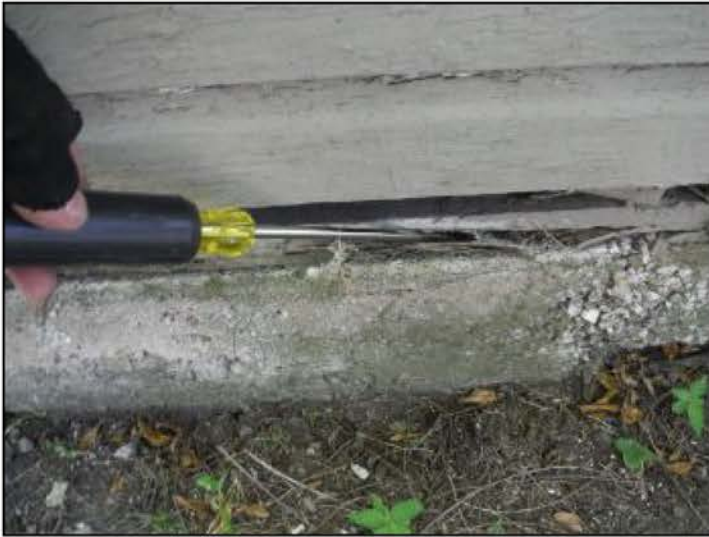
Refer to termite inspection report

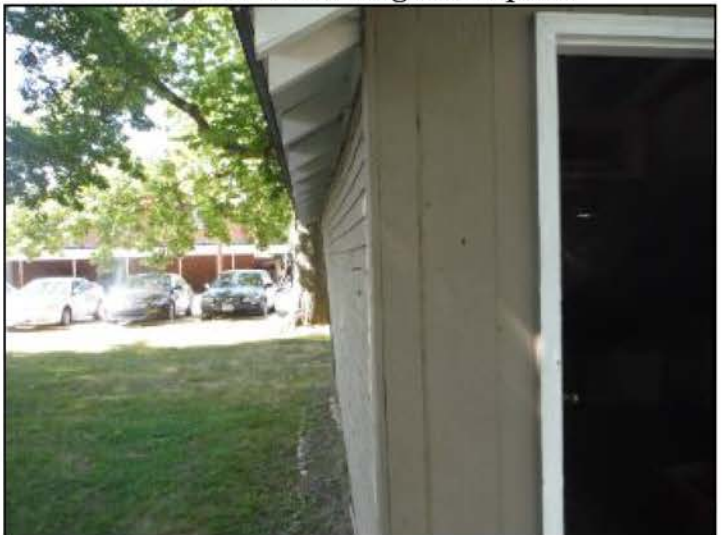
Side walls are leaning (building is wind racked)

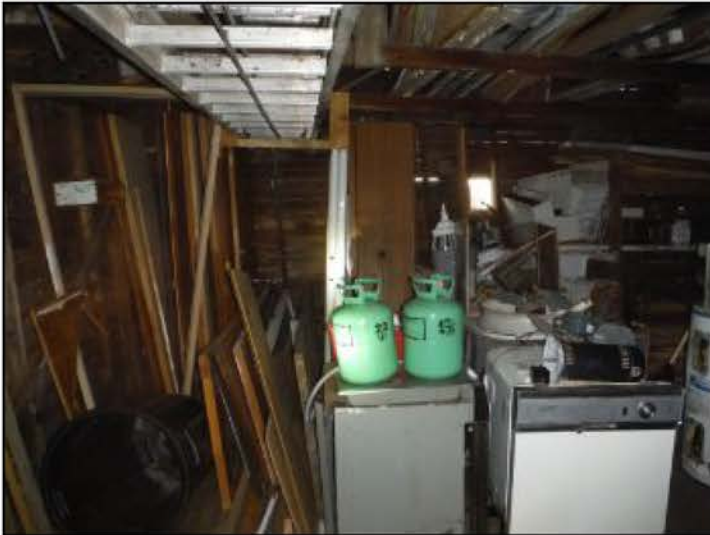
Storage limits inspection, some is hazardous

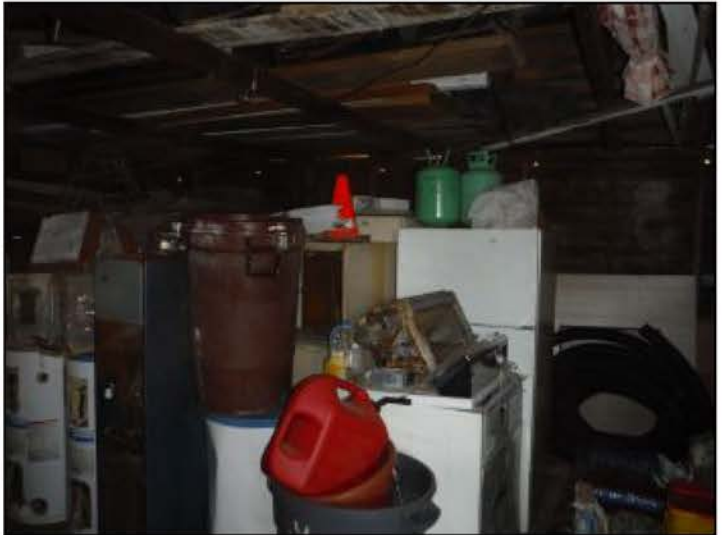
Storage limits inspection, some is hazardous

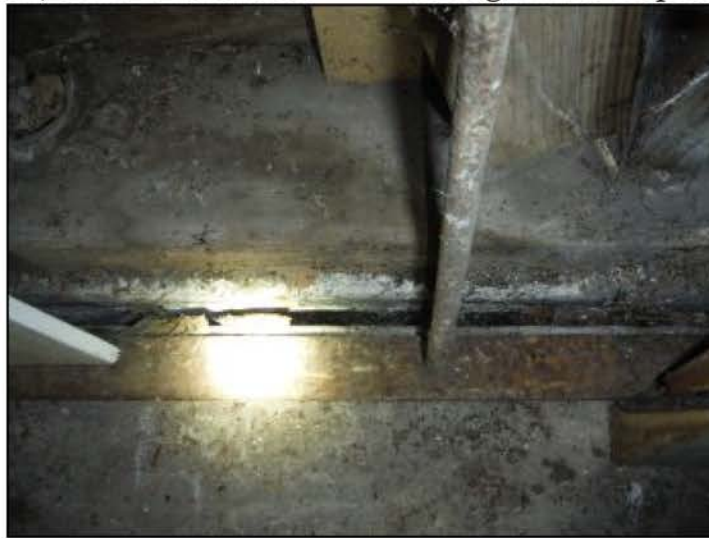
Refer to termite inspection report

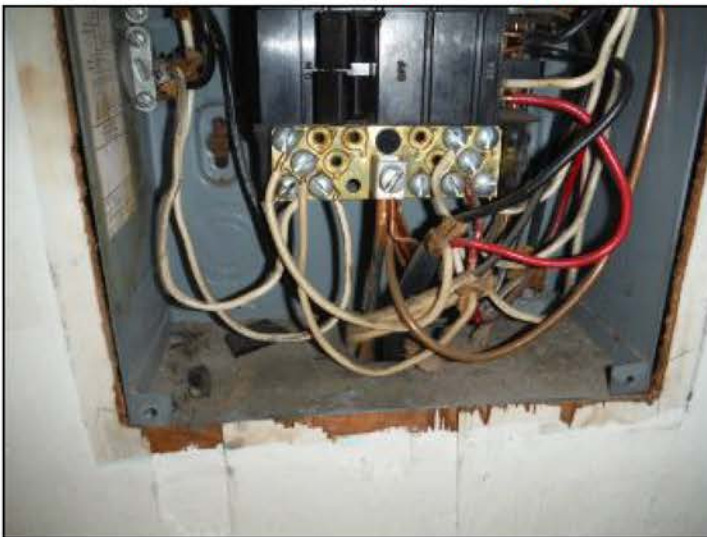
Most is two wire romex, cannot have grounded outlets unless rewired

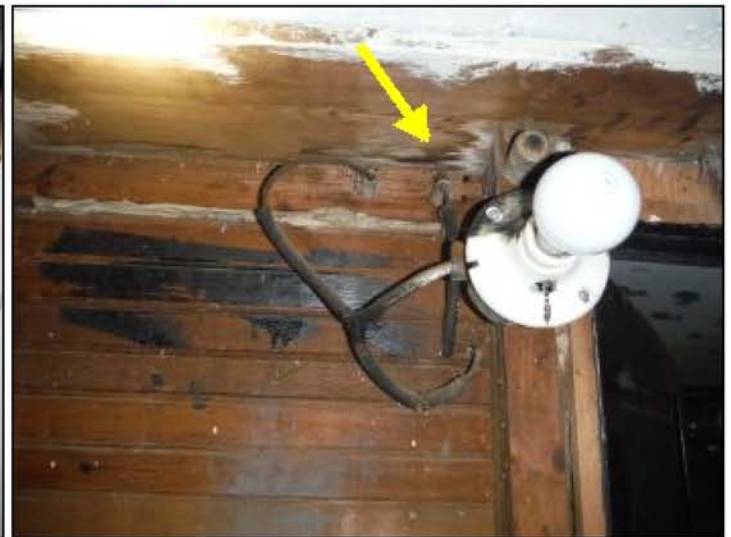
Active knob and tube wiring confirmed at basement and attic, refer to qualified electrician to update

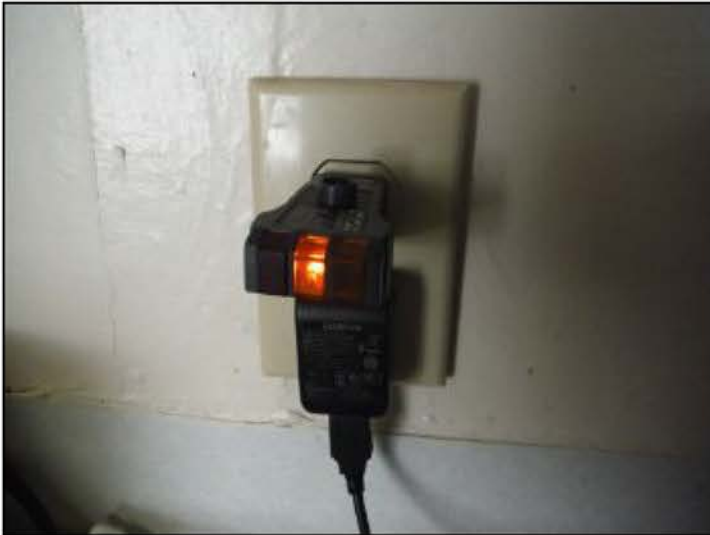
Ungrounded outlets found, refer to electrician

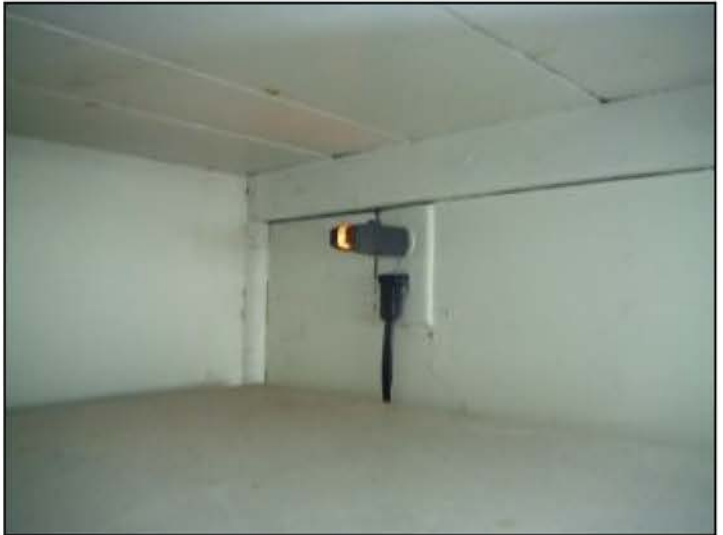
Ungrounded outlets found, refer to electrician

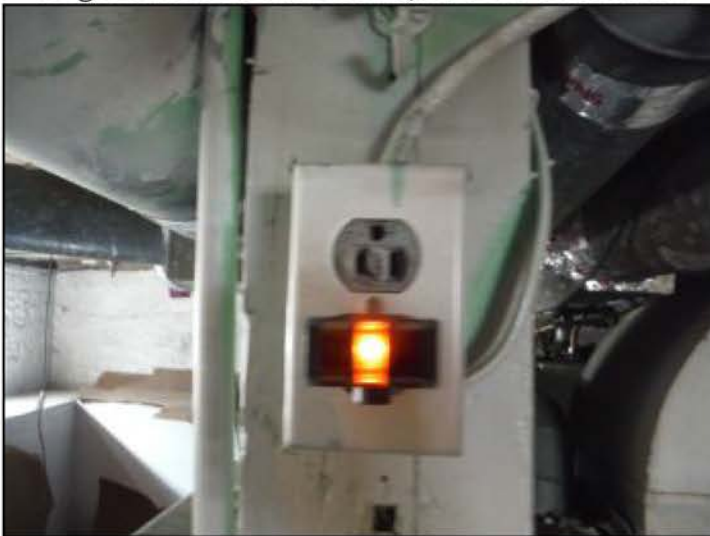
Ungrounded outlets found, refer to electrician

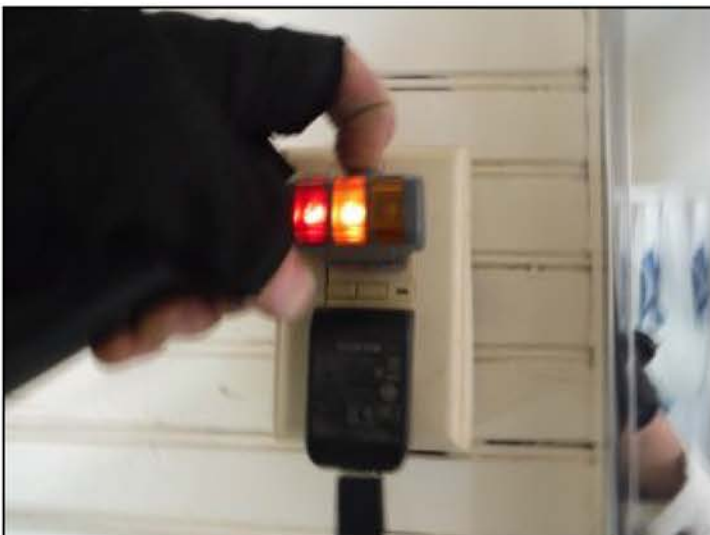
GFCI did not trip

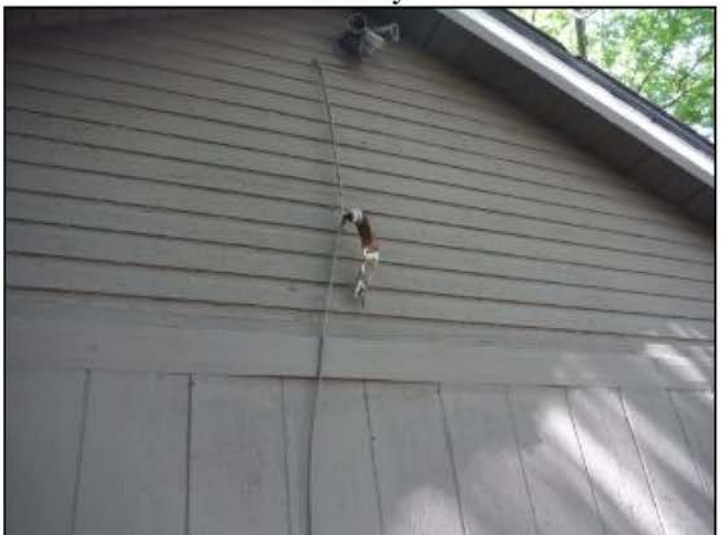
Disconnected out to detached garage (no power there)

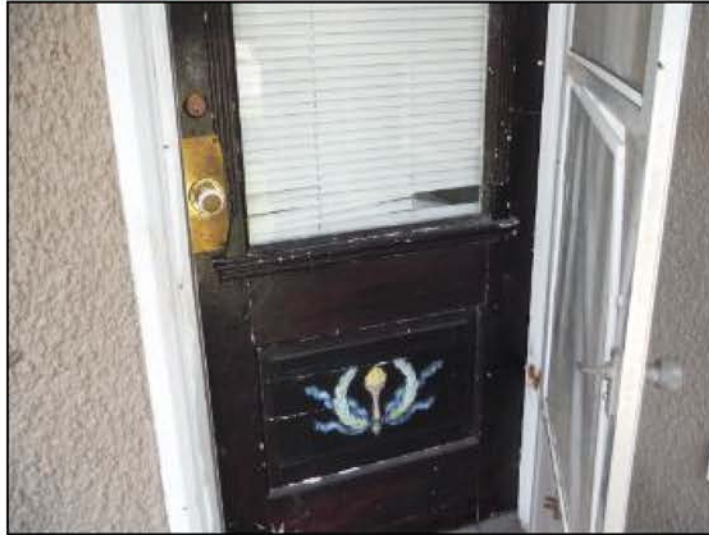
Untempered glass not to current standards

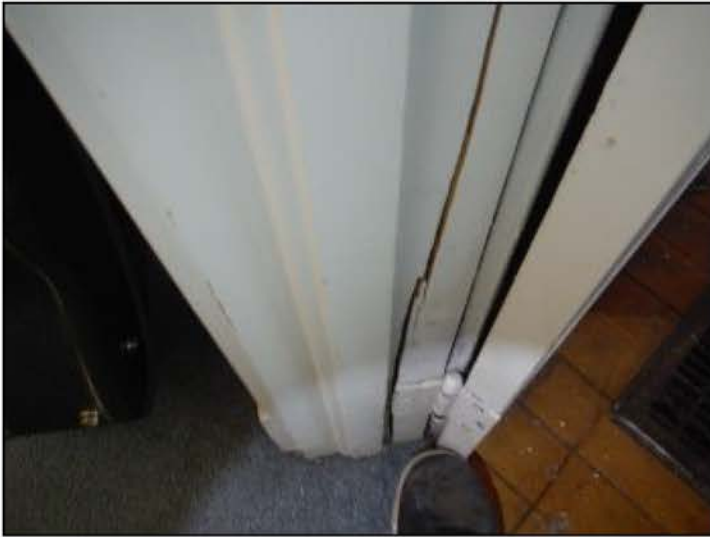
Damaged upstairs unit

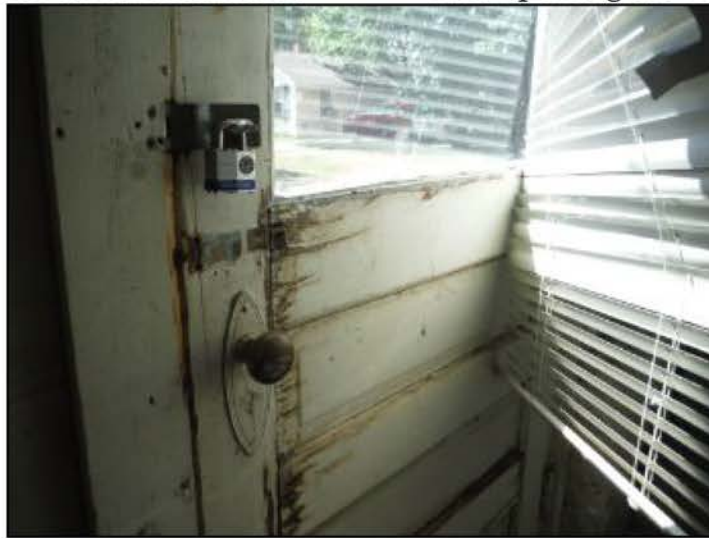
Basement unit is moisture damaged

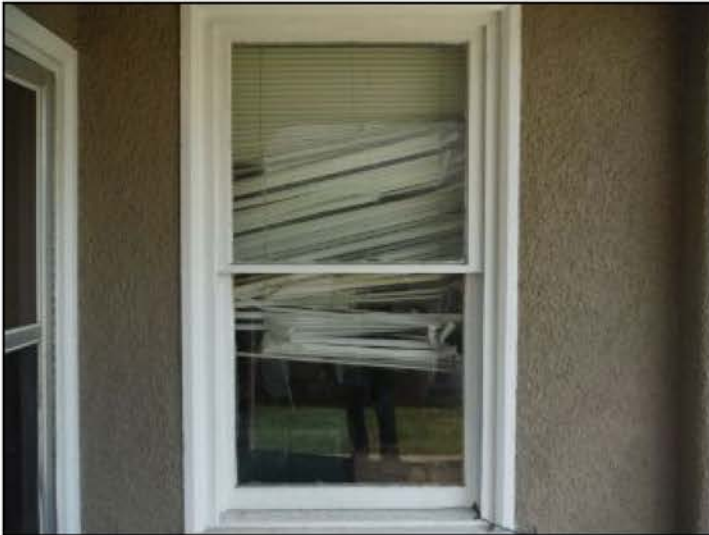
Recommend replacement of older wood units, missing storms/screens noted

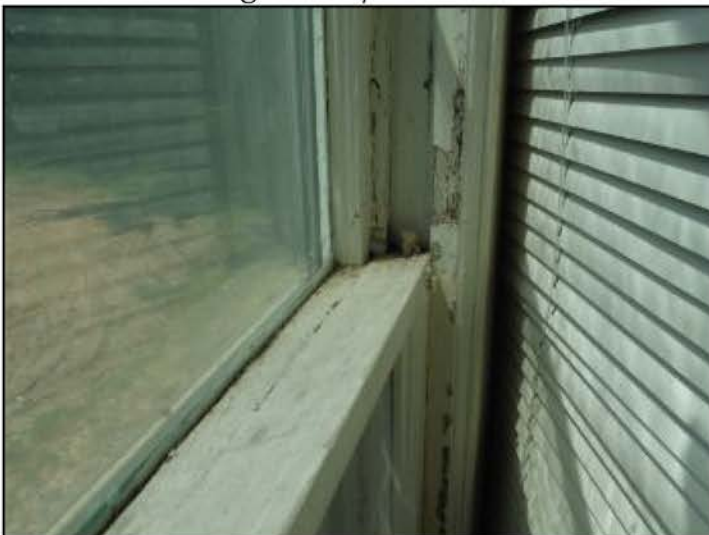
Missing sash cords, old style counterweight system

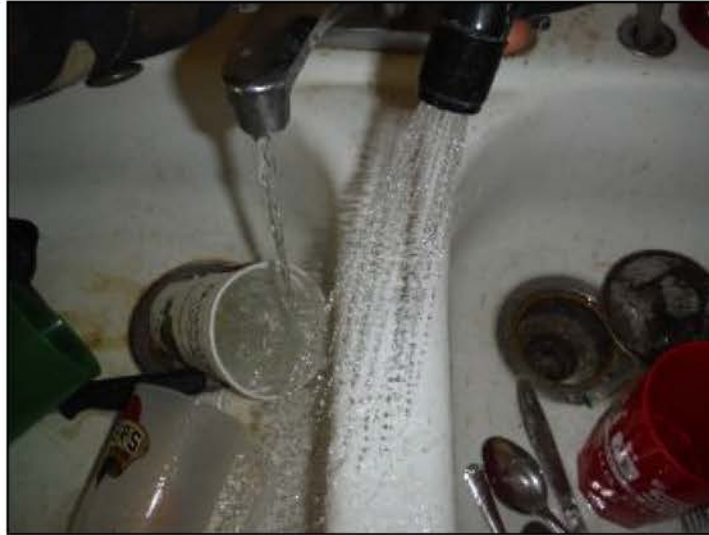
Worn sprayer diverter

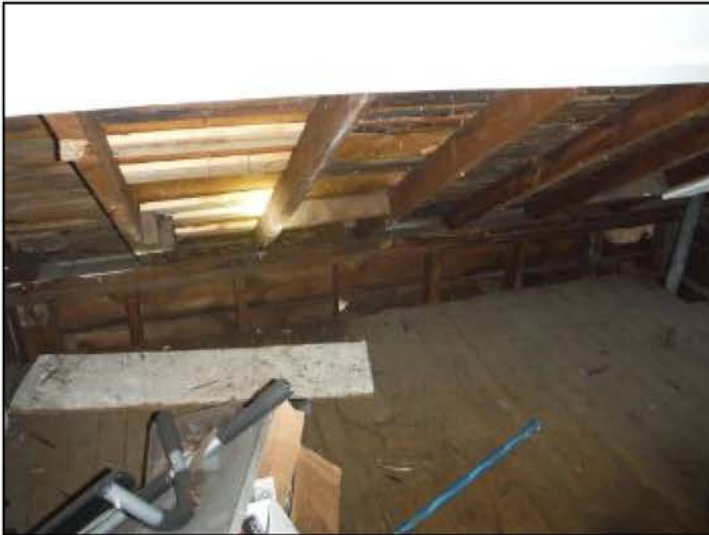
Partial access, this area is floored

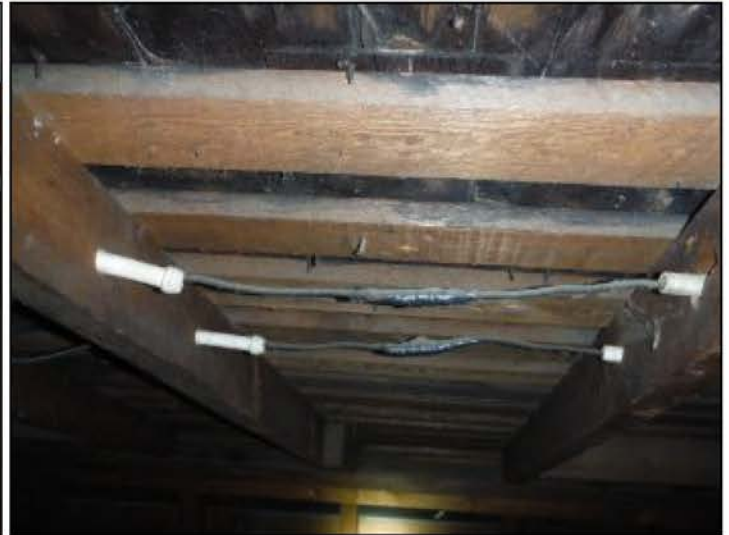
Multiple layers of roofing, first layer is wood (is sheathing/substrate for composition)

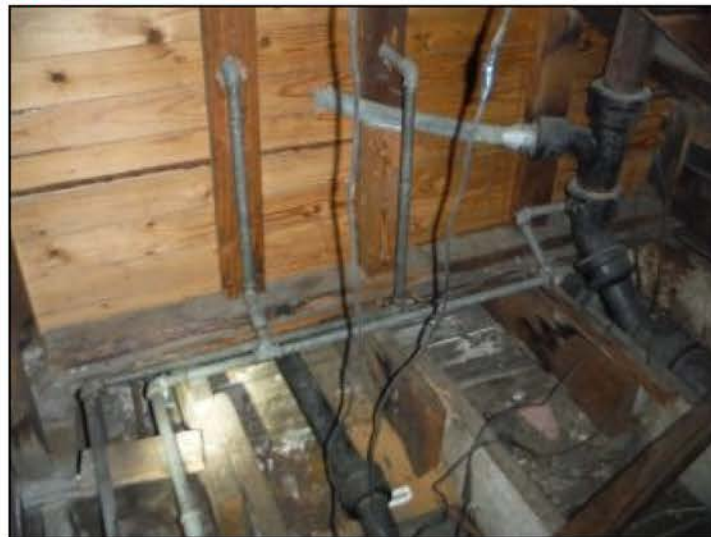
Plumbing needs insulating

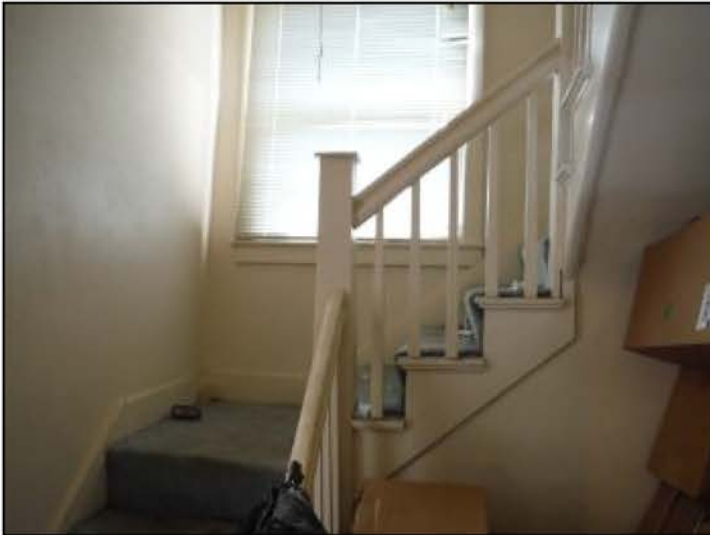
Winding stairs are to older standards, low head clearance noted

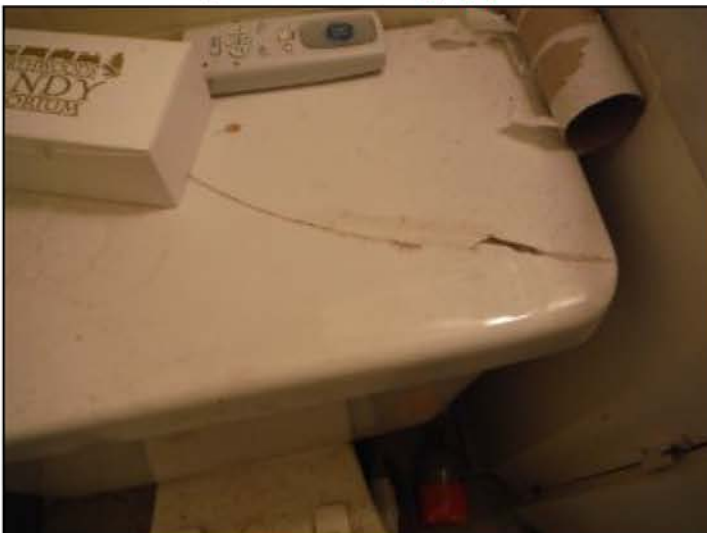
Damaged tank lid

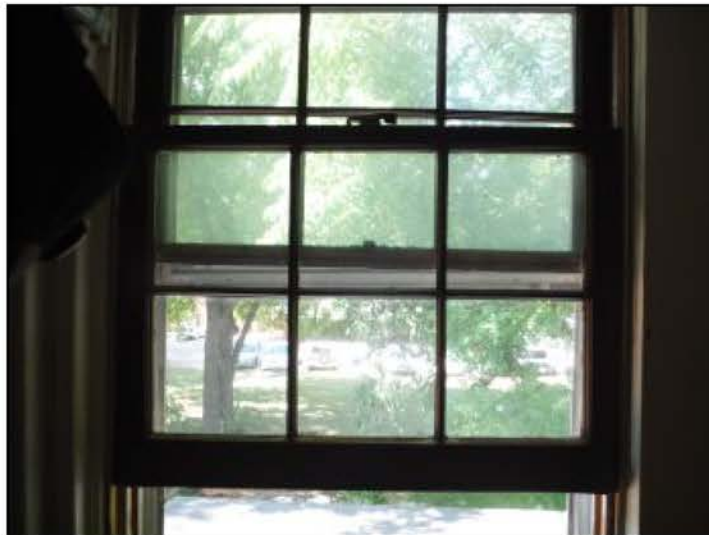
Window needs maintenance repairs

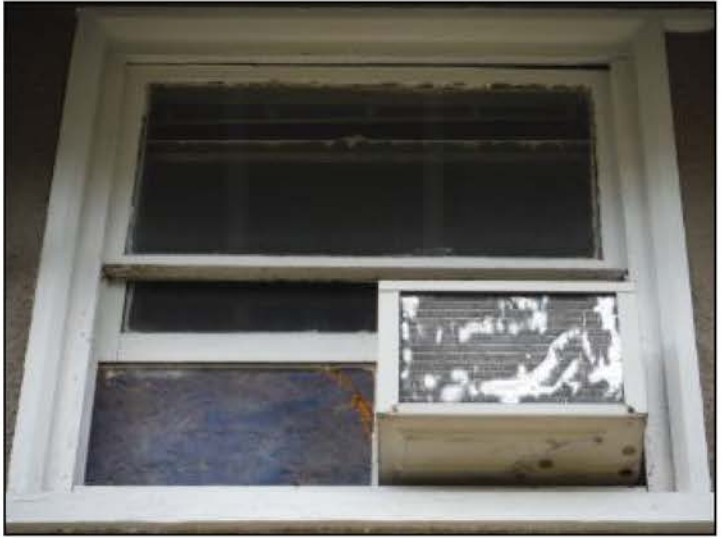
Window air conditioner untested, beyond scope

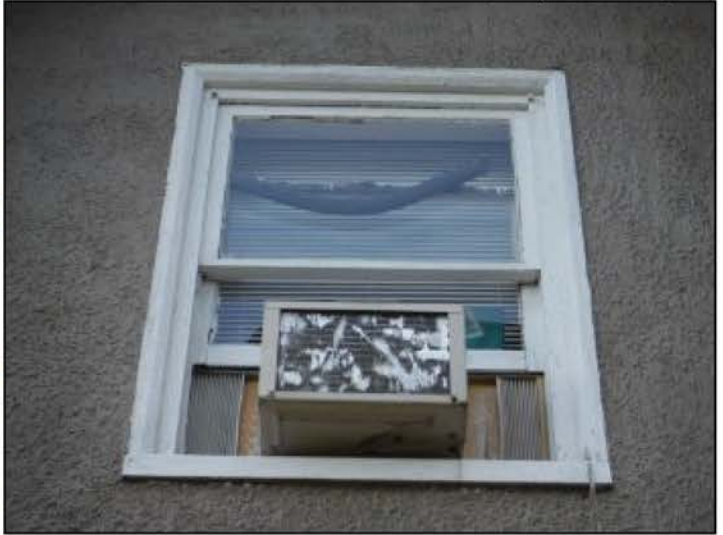
Window air conditioner untested, beyond scope

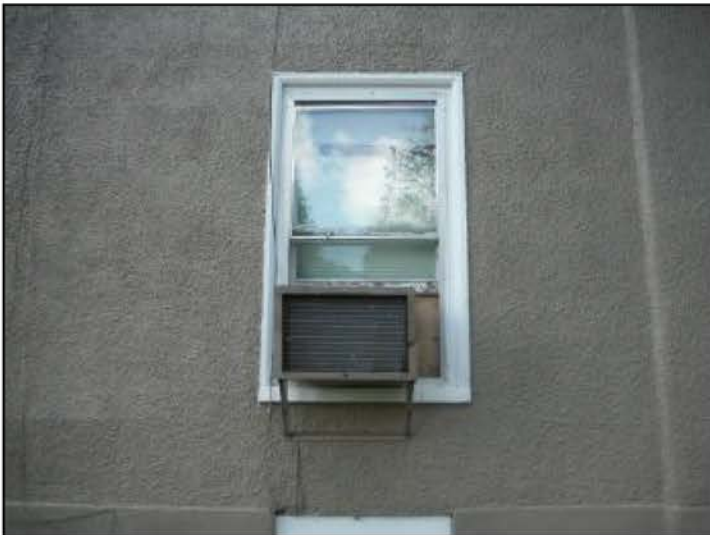
Window air conditioner untested, beyond scope
