# Springfield Land Clearance for Redevelopment Authority

**4.1. Blight Report And Redevelopment Plan For The East Cherry Townhomes Redevelopment Area, Generally Located At 1361 And 1365 East Cherry Street; Say You Can, LLC, Applicant**

This Blight Report for the East Cherry Flats Redevelopment Area (this “**Blight Report**”) is being submitted by Say You Can, LLC, a Missouri limited liability company (such entity, or its successors and assigns, is referred to as the “**Developer**”), for the purpose of demonstrating that the Redevelopment Area (as defined below) should be declared blighted pursuant to the LCRA Law. This Blight Report will demonstrate (i) that the Redevelopment Area is a “blighted area” under the LCRA Law due to the predominance of (1) deterioration of site improvements, (2) insanitary and unsafe conditions, (3) obsolete platting, and (4) the existence of conditions which endanger life and property by fire and other causes, and (ii) because of the aforementioned conditions, the Redevelopment Area hinders the provision of housing accommodations, constitutes an economic and social liability, and is a menace to the public health, safety, morals, and welfare in its pr

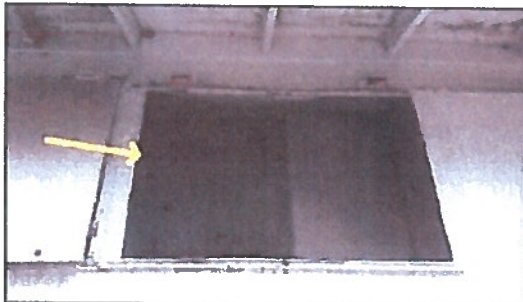
Missing shutter noted

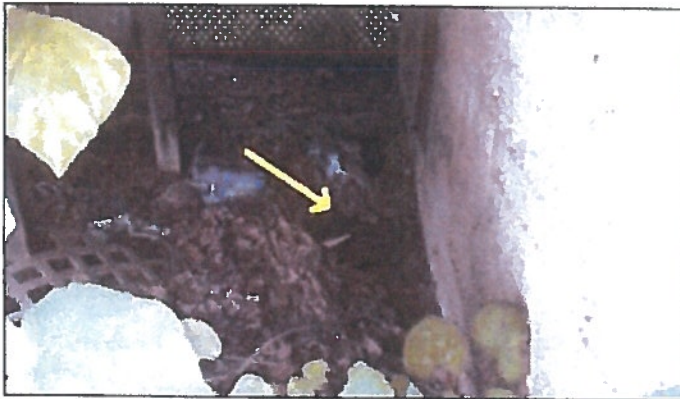
- Appears to drain fairly well.
- Overgrown landscaping noted; recommend trimming.
- Some erosion noted from water running over the guttering.
- Poor drainage noted below front porch; needs soil added.

Poor drainage below front porch

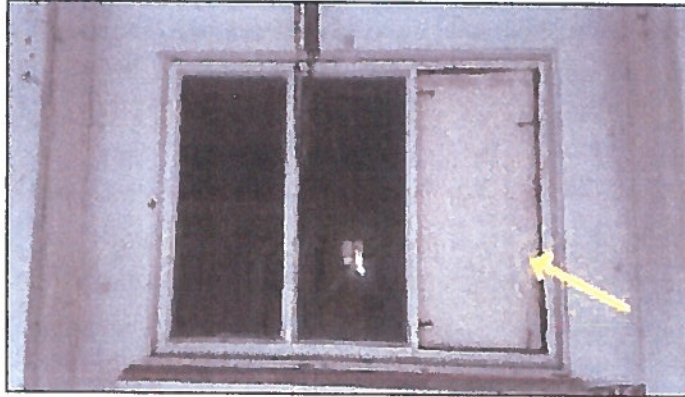
- Hardware is loose
- Weather stripping is missing
- Glass missing; needs repair.

Missing glass at front door

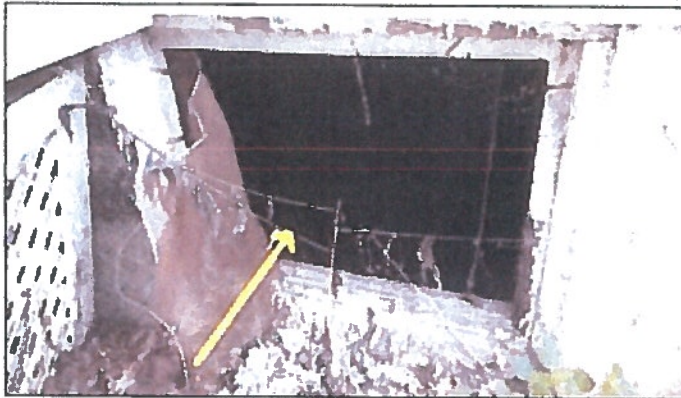
- Several windows appear to be painted shut and would not open.
- Several windows had broken ropes and will not stay open without assistance.
- Several screens were missing/not installed.
- Missing latch hardware noted in various locations.
- Dining room and three basement windows were missing; need replacement
- Four broken windows noted on main level of home; need replacement

Missing basement window bear back porch.

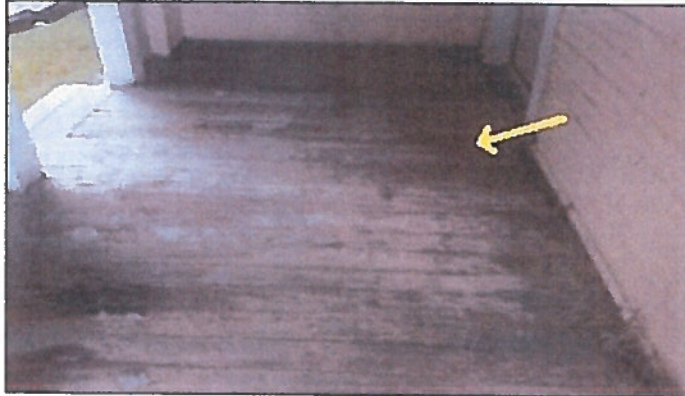
- The decks due to be sealed/painted and routine maintenance needed.

Back porch needs maintenance

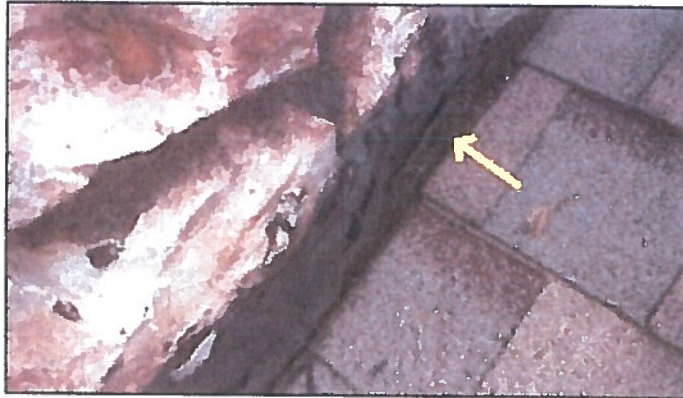
- plumbing flashings appear serviceable
- Not fully visible
- Caulk noted at electrical mast
- Heavy patching/repair observed at chimney flashing.
- Counter flashings at the chimney flashings are improper and loose; needs securing/repair.

Improper and loose flashing at front chimney

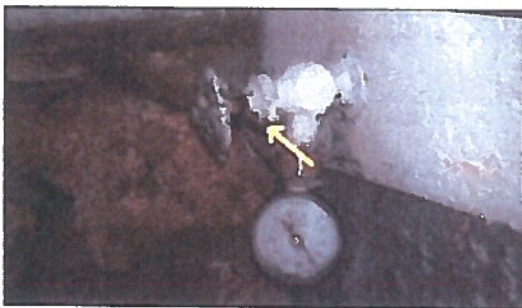
- Both hose faucets leak from the handles under pressure; need repair/replacement.

Front faucet leaks under pressure

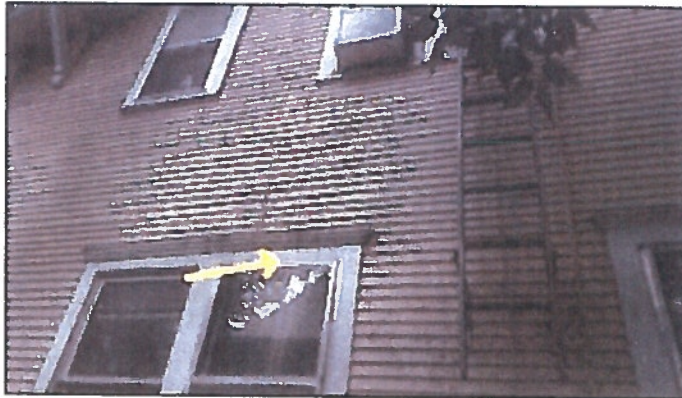
- Window units installed
- Operated normally today
- Condensation drips onto wall and windows below; recommend correction.
- AC unit at front of unit three is not functional; needs to be removed or replaced.

Condensation dripping down walls and window
