# Springfield Land Clearance for Redevelopment Authority

4.i. **Blight Report And Redevelopment Plan For The East Cherry Townhomes Redevelopment Area, Generally Located At 1361 And 1365 East Cherry Street; Say You Can, LLC, Applicant. Resolution No. 2017-3228**

## Report Summary of Defects

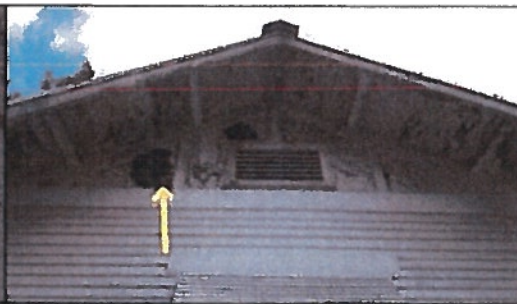
Holes in asphalt paper on West gable

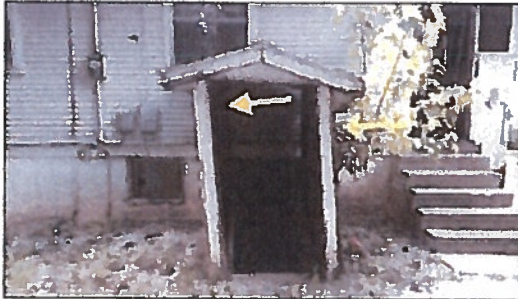
| Page 11 Item: 1 | Basement Stairs | <ul style="list-style-type: none"> <li>Basement exterior stairway walls and roof are damaged and leaning; need replacement by qualified contractor.</li> <li>Exterior basement door has been damaged and does not close; needs repair.</li> </ul> |

- Basement exterior stairway walls and roof are damaged and leaning; need replacement by qualified contractor.
- Exterior basement door has been damaged and does not close; needs repair.

Stairway covering damaged and leaning

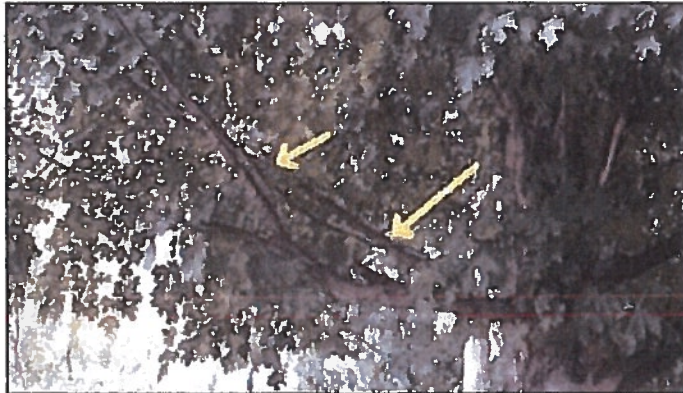
| Page 18 Item: 1 | Service | <ul style="list-style-type: none"> <li>Trees touch wires; recommend contacting utility company.</li> </ul> |

- Ground clamp/system not visible
- Trees touch wires; recommend contacting utility company.

Trees touch wires

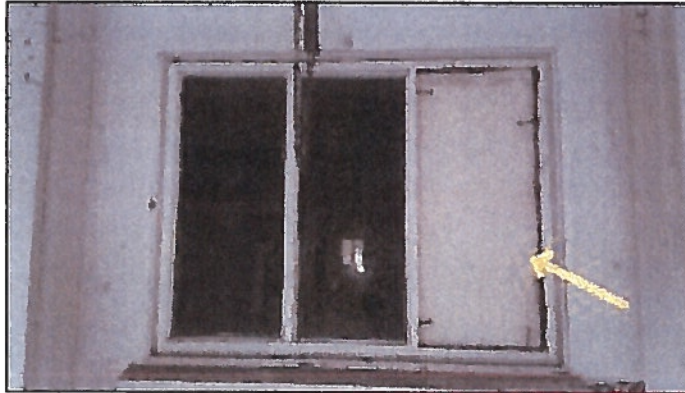
| Page 21 Item: 1 | Doors (Entry) | <ul style="list-style-type: none"> <li>• Glass missing; needs repair.</li> </ul> |

- Hardware is loose
- Weather stripping is missing
- Glass missing; needs repair.

Missing glass at front door

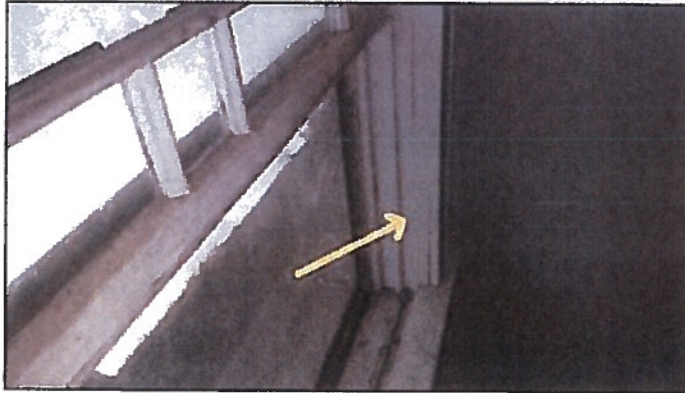
Lower dining room window is missing

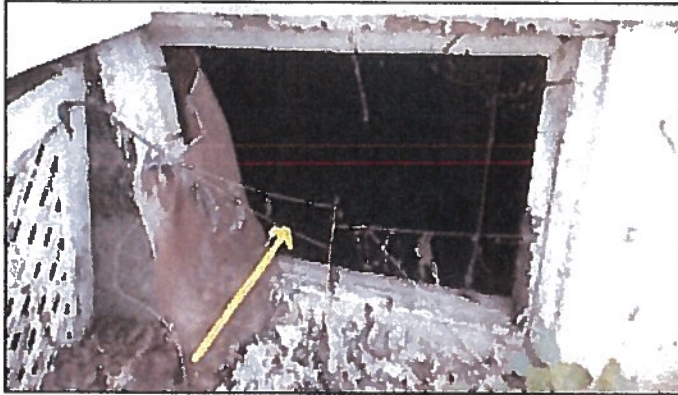
Missing basement window bear back porch.

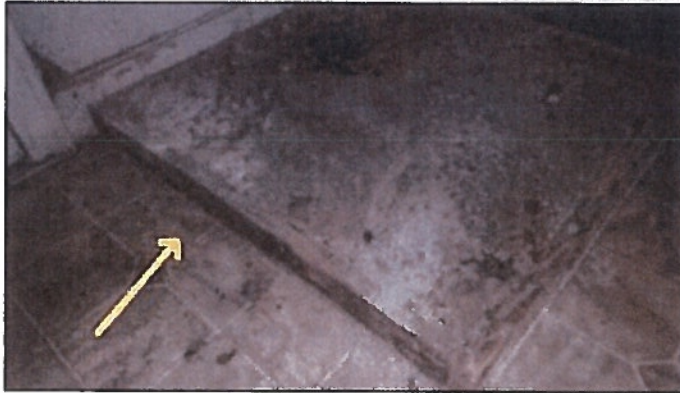
- Hearth and woodstove flue pipe noted in dining room; recommend removal.

Stone/concrete hearth in dining room

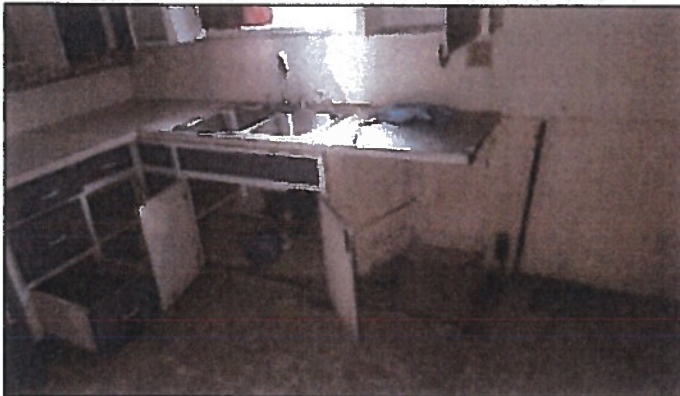
- General condition is poor.

Kitchen is in poor condition overall.

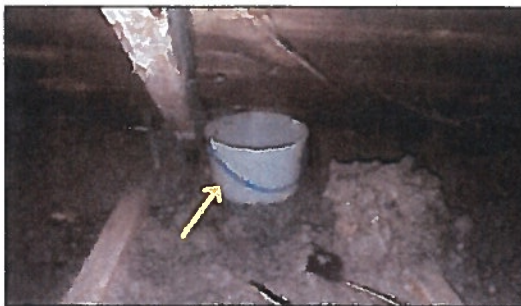
- Entered
- Vents provided
- Roof structure has solid 1x decking.
- Moisture stains observed on roof structure in various locations indicating past leaks (Dry today).
- Access too small, needs correction.

Bucket indicating past leak

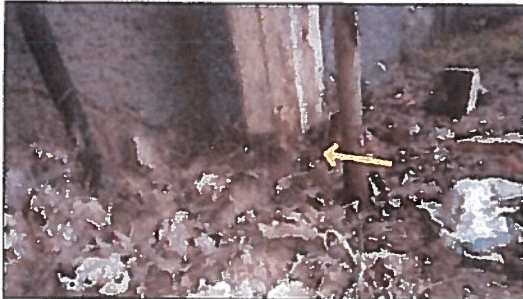
- Steps and handrail are in poor condition; need replacement.
- Handrail recommended at front and NW steps for safety.
- Footings are improper/temporary - Recommend correction with proper poured footing.
- Signs of settlement and loose footing observed; steps/deck to unit 3 need full evaluation and repair by qualified contractor.
- Glass at level of steps up to unit 3; needs to be protected by rail and spindles for safety.

Missing footing below stairway - Unit 3

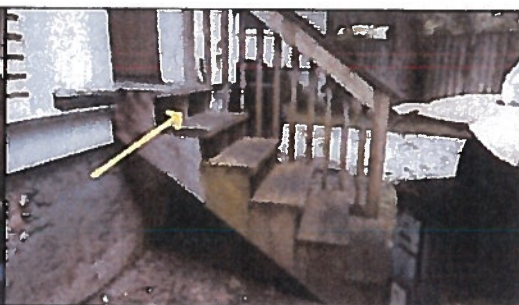
Handrail missing at back steps

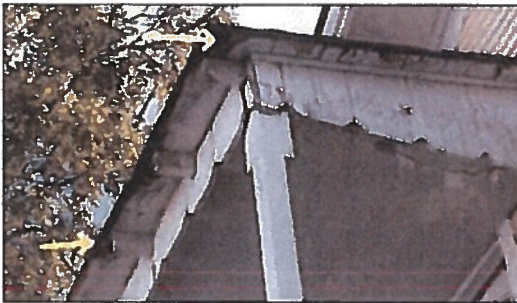
- Observed flaking/worn paint on wood trim; needs to be sealed/painted to prevent further deterioration.
- Eave damage noted, partially above door to unit three.

Deterioration above door to unit three

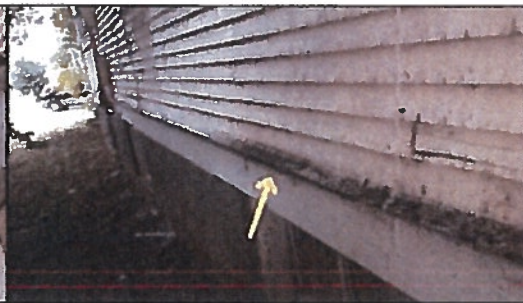
Deteriorated paint and trim below air conditioners.

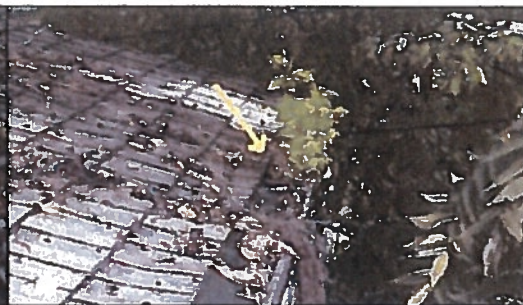
Missing gutter guard at SE corner

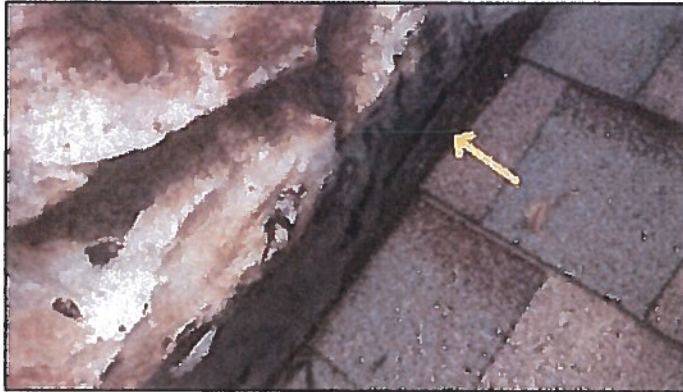
- plumbing flashings appear serviceable
- Not fully visible
- Caulk noted at electrical mast
- Heavy patching/repair observed at chimney flashing.
- Counter flashings at the chimney flashings are improper and loose; needs securing/repair.

Improper and loose flashing at front chimney

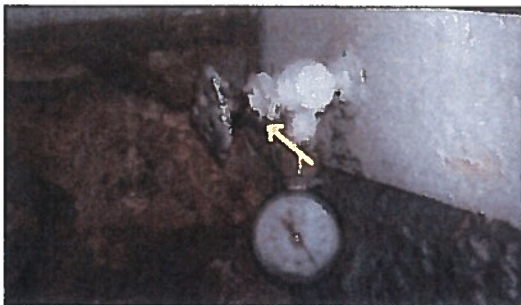
- Both hose faucets leak from the handles under pressure; need repair/replacement.

Front faucet leaks under pressure

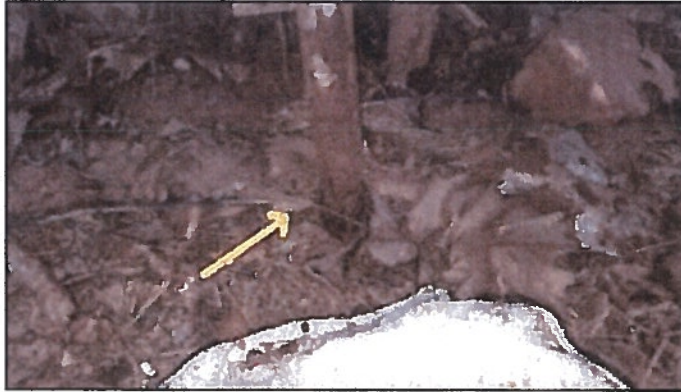
• Heavy rust/corrosion noted at gas main; needs evaluation/repair.

Heavily deteriorated main gas line

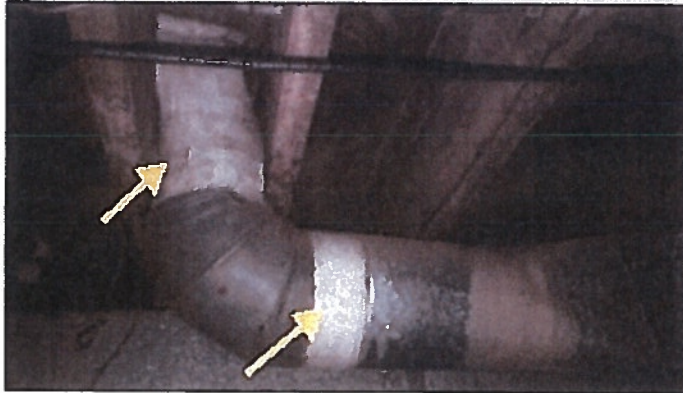
- Recommend ductwork cleaning by a qualified contractor.
- Not fully visible
- Noted tape that likely contains asbestos on outside of ductwork; recommend evaluation by certified asbestos contractor.

Tape on ductwork likely contains asbestos

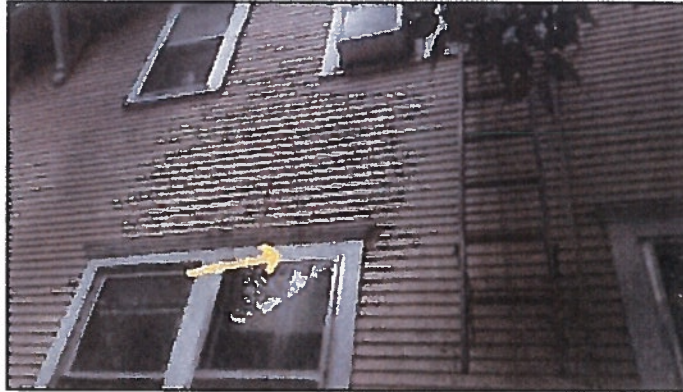
- Window units installed
- Operated normally today
- Condensation drips onto wall and windows below; recommend correction.
- AC unit at front of unit three is not functional; needs to be removed or replaced.

Condensation dripping down walls and window

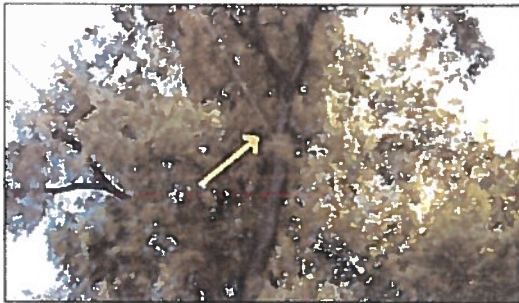
Trees touch wires

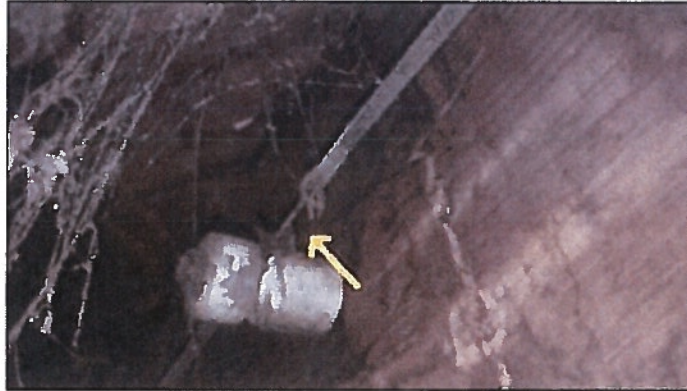
- Deteriorated knob and tube wiring observed in several areas - Recommend evaluation/removal by qualified electrician.

Knob and tube wiring with deteriorated insulator in SE portion of basement.

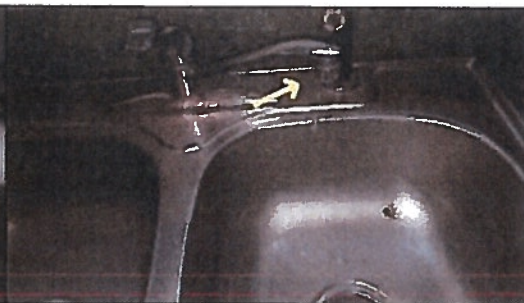
Leaky and loose faucet - Unit 2

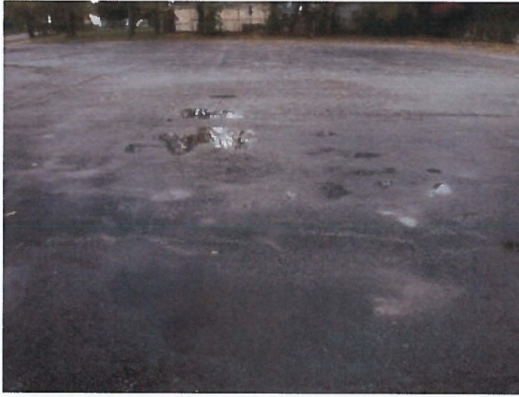
- Parking lot is in poor condition. Surface is deteriorating and low areas are allowing ponding water to collect. Needs repair, sealing, and striping by a qualified contractor.

Parking lot has several low areas and ponding water

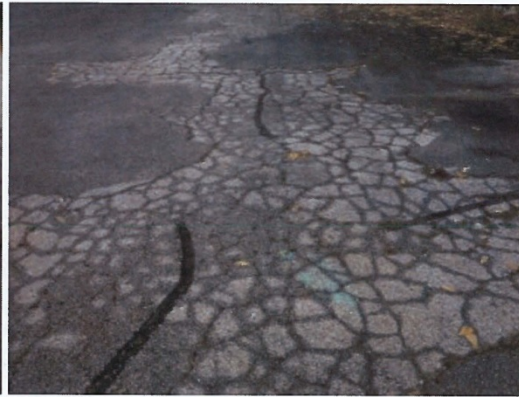
Asphalt parking lot is in poor condition; surface is alligating

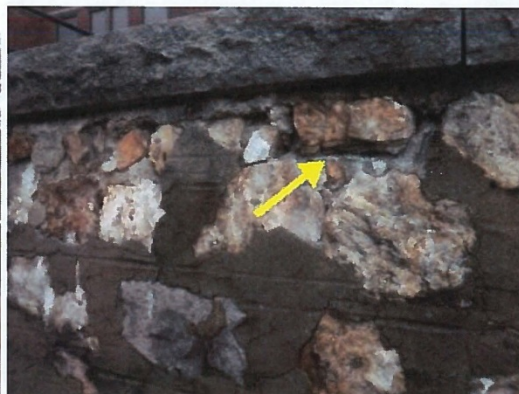
Areas of deterioration in a few areas of retaining wall

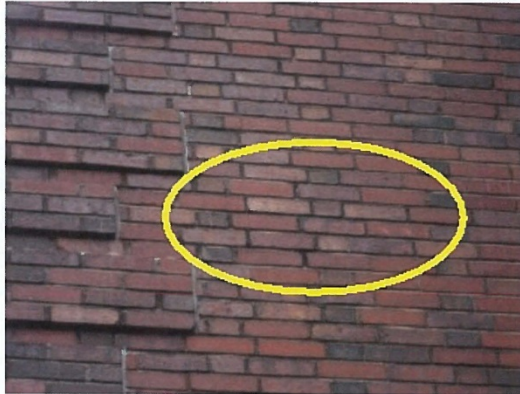
- Appears serviceable for age of building
- Some tuck pointing is needed in a few areas by a qualified mason.
- Water appears to be penetrating the brick and causing damage to the interior walls. Needs further evaluation and repair by a qualified contractor.

Area of tuck pointing needed at upper front west entry

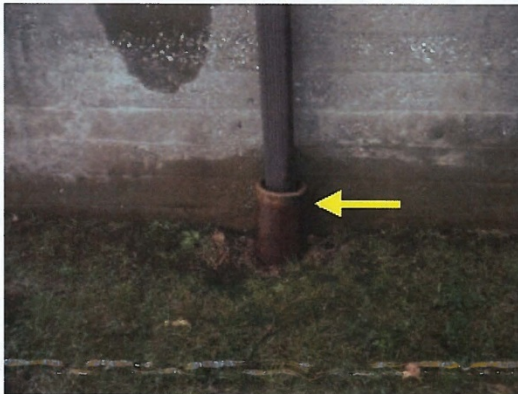
- Downspouts at the east corners of the building dispel into sub-surface drains. Unable to locate the discharge points.
- Gutting in back of gym and storage addition is full of rocks and leaves. Needs cleaning for proper drainage.

Downspouts at the east corners of the building dispel into sub-surface drains

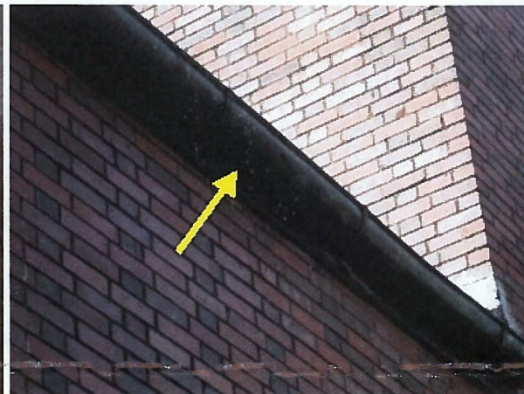
Water was running over at the guttering on back of the gym

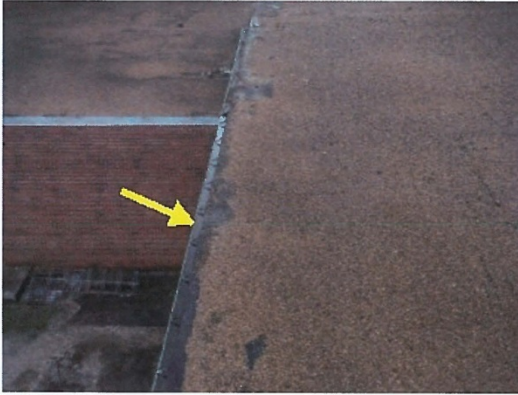
Guttering on back of gym is full of rock and water at time of inspection

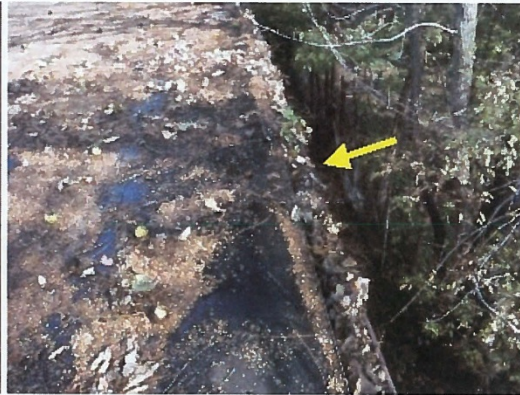
Guttering on back of addition is full of leaves/debris

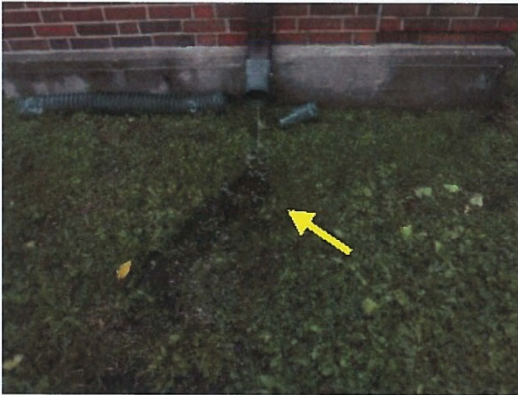
- Sub-surface drains present at the east downspouts and back of building; not tested, underground pipes cannot be judged during visual inspection.
- Low spot at the rear west end of the building needs to be filled with dirt to create the proper positive slope and drainage.
- Poor drainage and control of roof water observed at both west downspouts and at the back of the building. Corrective measures are needed.

Poor drainage at SW corner of building

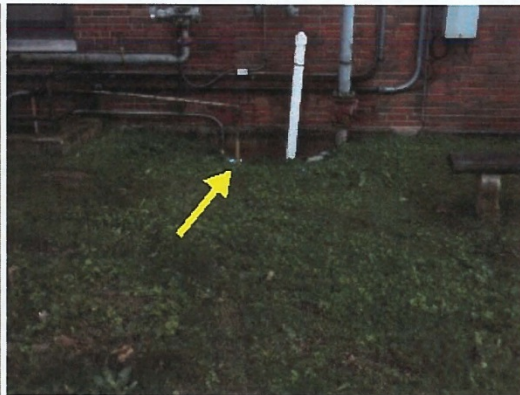
Low spot at the rear west end of the building

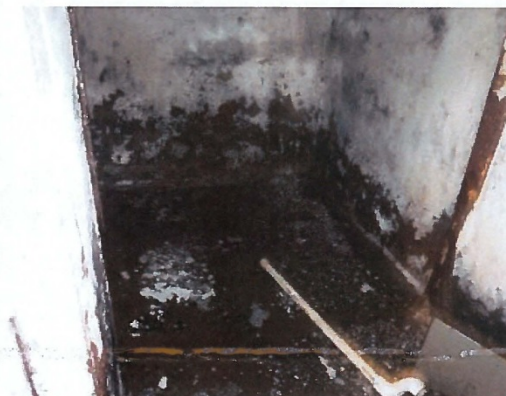
Water was leaking into the small cubby at the north wall in the basement

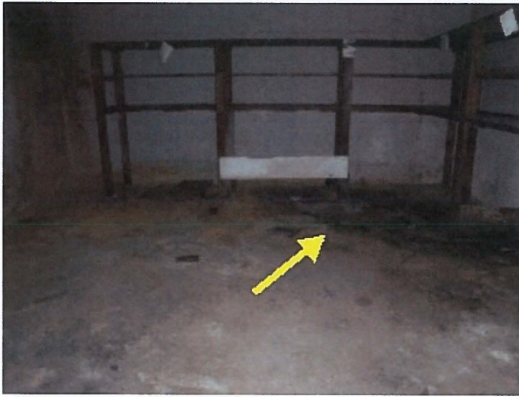
Stains from past water penetration at the NE basement room

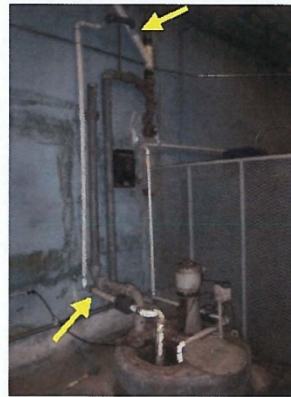
- Foundation and building structure appeared very solid.
- Stains from probable past water intrusion observed at the NE basement room.
- Typical cracks in basement floor slab.
- Water was leaking from an area at the north middle wall in the basement. Needs evaluating/repair by a qualified contractor.
- Mold/fungal growth is present on the boiler piping and cloth covering wiring in the basement areas. Needs cleaning/removing by a qualified mold contractor.
- Water was continually leaking into the large sump pit in the basement. Unable to determine where it was coming from. Needs further evaluation and correction.
- The sump pump drains improperly into the sanitary sewer. Needs correcting by a qualified plumber.

The sump pump dispels improperly into the sanitary sewer system

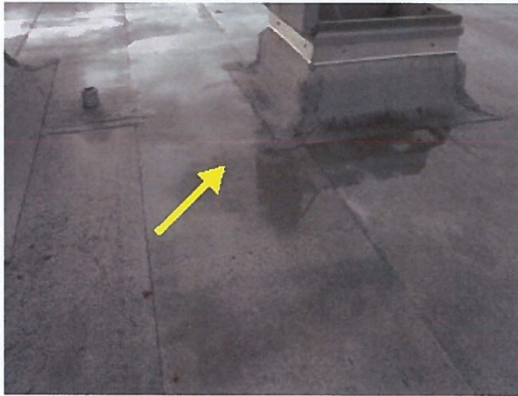
- Roof is showing some signs of weathering and age. A pile of granules are present near the middle east roof drain.
- Prior patching/repair observed at the several seams and corners of the parapet wall.
- Areas of ponding water present in several areas of the roof; mainly near the roof drains. Needs repair by a qualified roofer.
- One small hole at the rear east corner needs sealing/repair by a qualified roofer.

Ponding water around the roof access

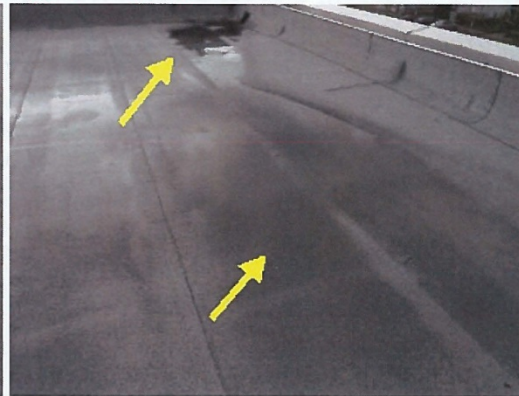
Standing water at west end near SW corner

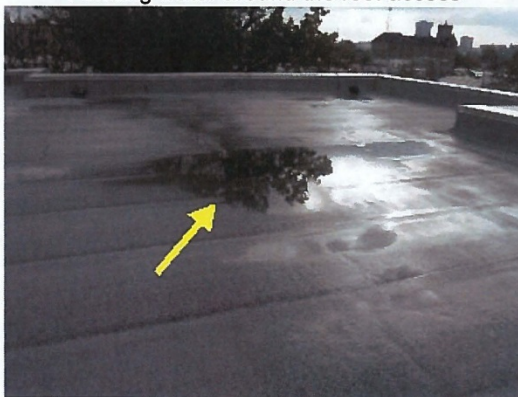
Ponding water at middle east part of roof

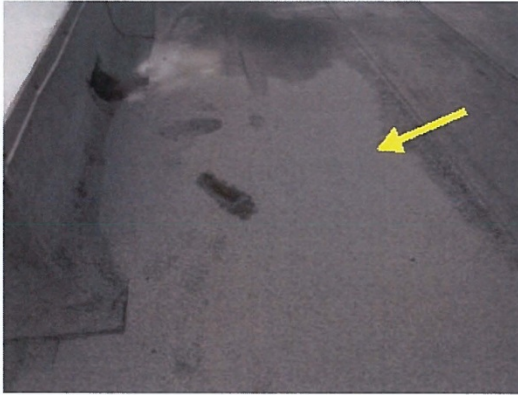
A pile of granules are present near the middle east roof drain

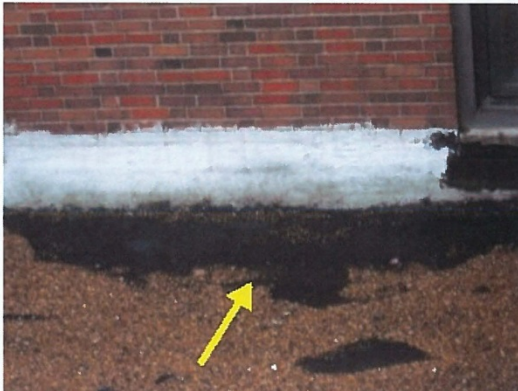
| Page 13 Item: 6 | Gym Roof | <ul style="list-style-type: none"> <li>• Areas of missing gravel along the north edge and at the SW corner. Needs repair by a qualified roofer.</li> </ul> |

Missing gravel at SW corner of the gym roof

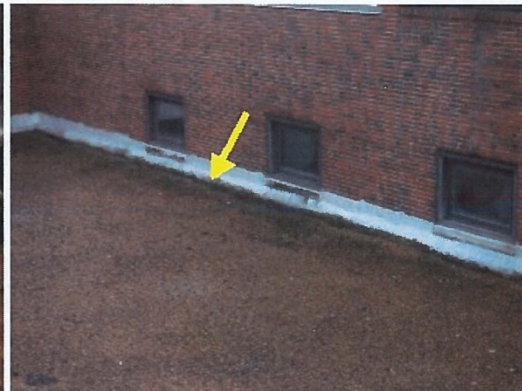
Prior patching/repair all along the roof wall connection

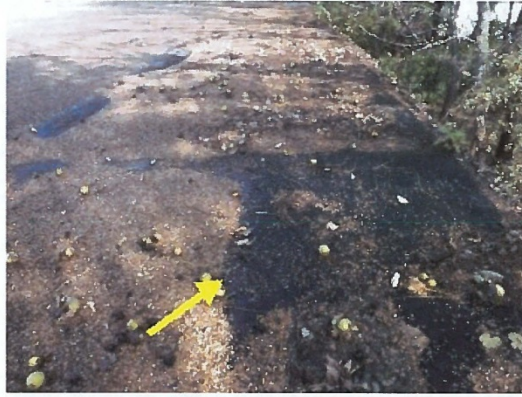
- Several bare areas are present along with air pockets in the material below the gravel. Needs evaluating/repair by a qualified roofer.

Missing granulars at middle east part of the storage building roof

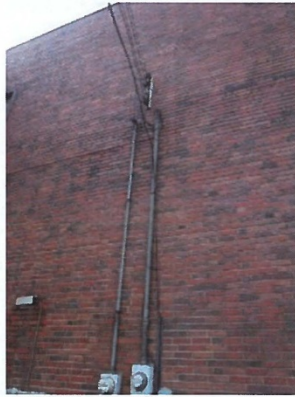
- Ground clamp/system not visible
- Electric service does not appear adequate for a building of this size. Needs further evaluation by a licensed electrician.

Electric service does not appear adequate for a building of this size

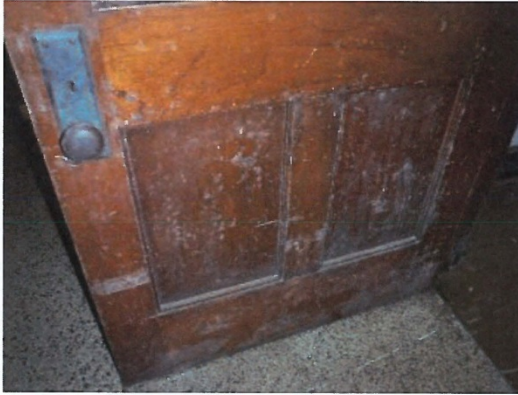
Mold growth on several doors

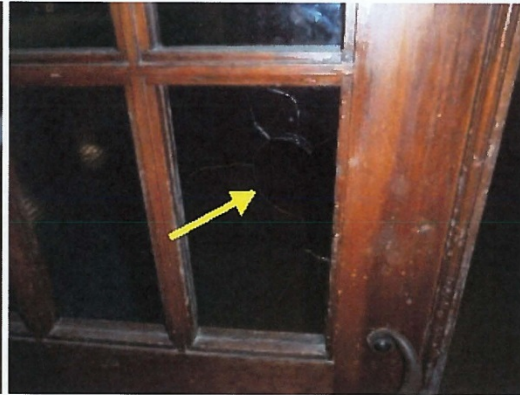
Broken glass panes on the doors to the gym

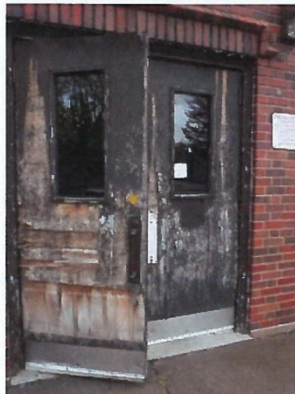
| Page 17 Item: 3 | Doors (exterior) | • The west doors are damaged/delaminated. Both need replacement. |

West exterior doors are damaged and delaminated

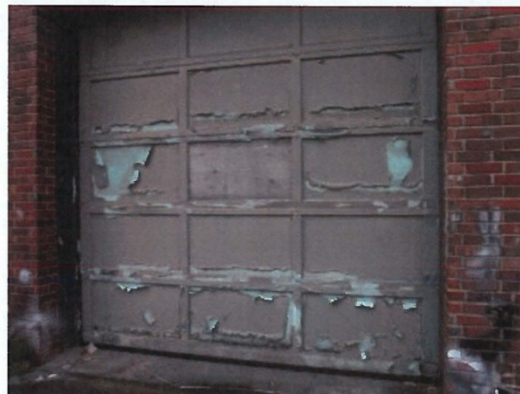
Heavy flaking/peeling paint on the roll up door on back of the gym

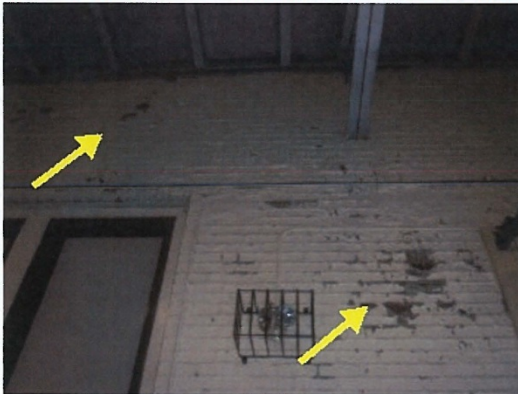
Peeling paint on the north gym wall

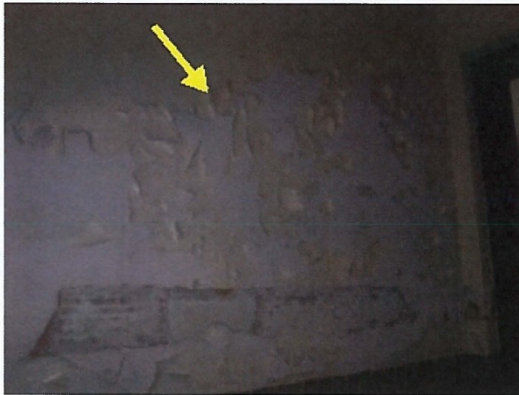
Heavy peeling finish at middle part of east stairway

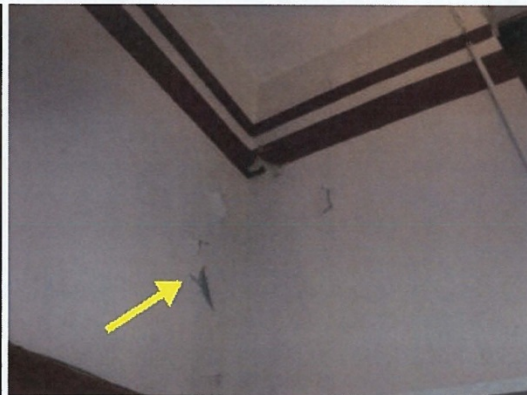
Peeling paint at SE corner of office area

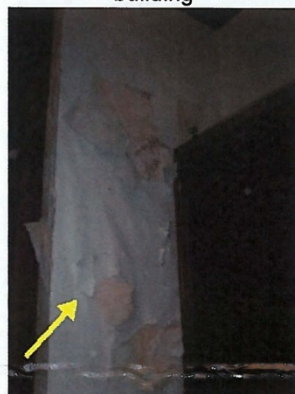
Water damage at SW corner of the upper middle classroom

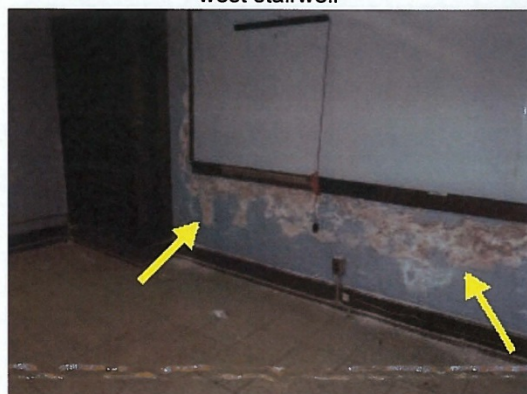
| Page 18 Item: 5 | Walls | • Water damaged plaster and abnormal moisture detected at both side entries and upper SE classroom. Needs evaluating/repair by a qualified contractor. |

Delaminating plaster at SE corner of upper SE classroom

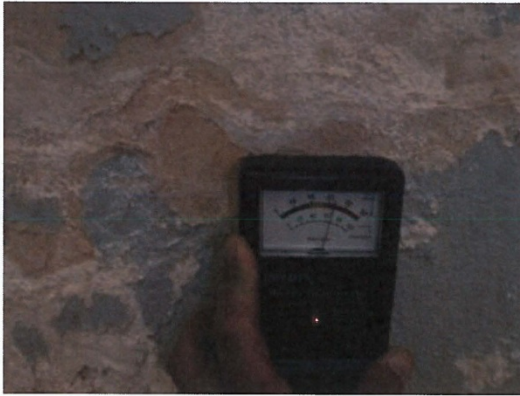
Abnormal moisture at water damaged wall in the upper SE classroom

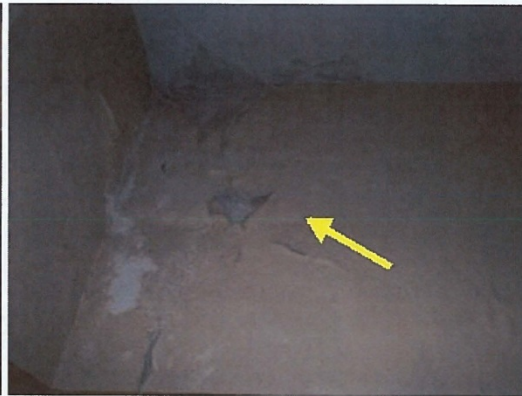
Moisture damaged plaster at the SE corner of the east entry

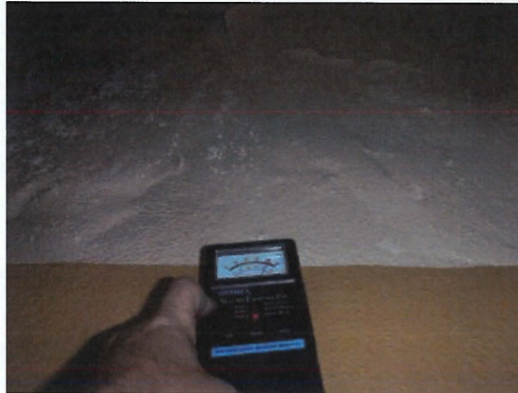
Abnormal moisture at south wall in the east entry

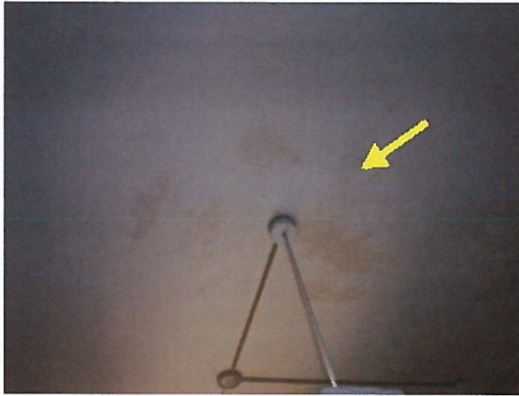
Old stains on ceiling in the upper SW classroom

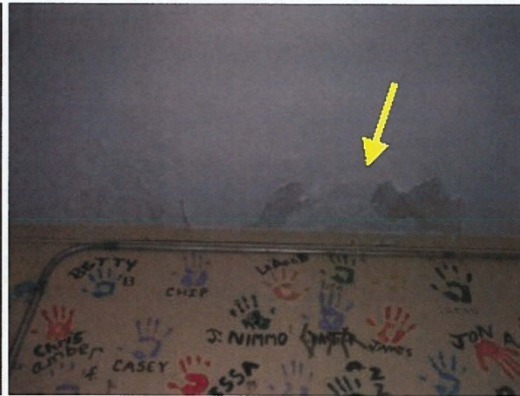
Water damage to ceiling at upper north hallway

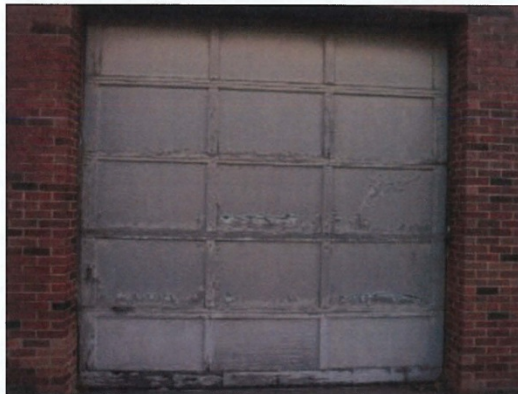
- Doors are operational
- Safety springs installed
- Heavy flaking/peeling paint observed on the exterior side of the doors. Needs attention/painting.

All vehicle doors have some flaking/peeling paint

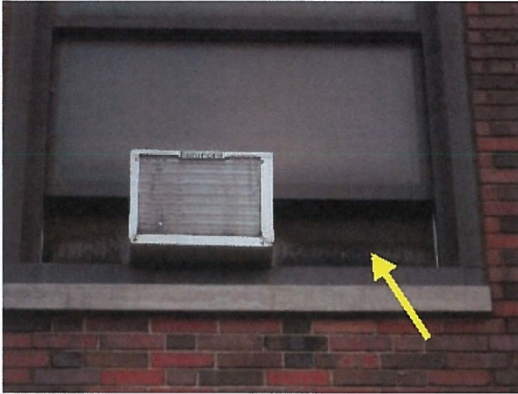
Mold growth on back of material at upper front east A/C unit

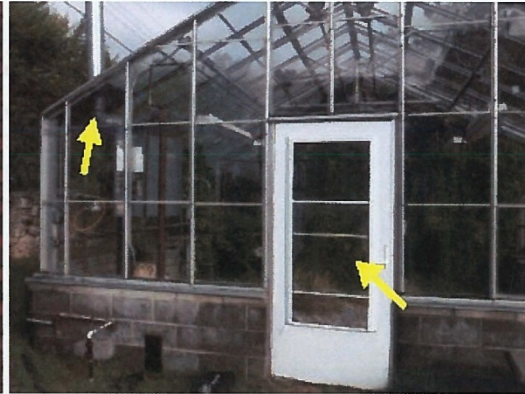
Broken glass in door and upper SW corner

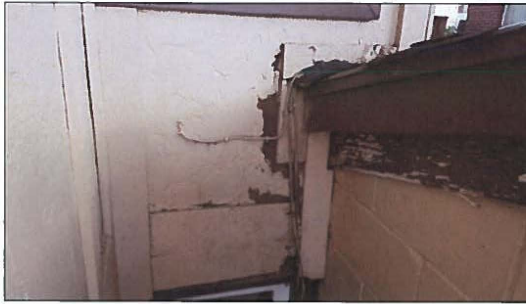
Moisture damage at basement stairway connection

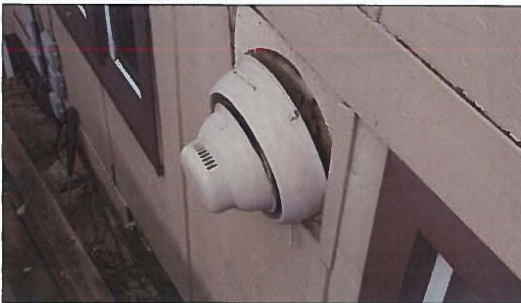
Vent too close to widow on East side

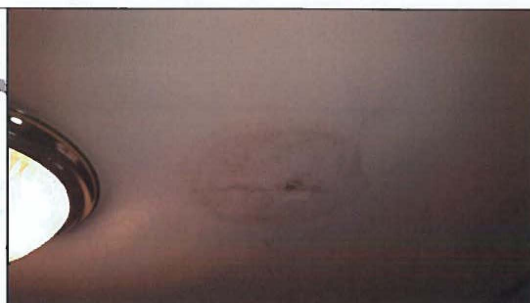
Moisture damage between sections on East side

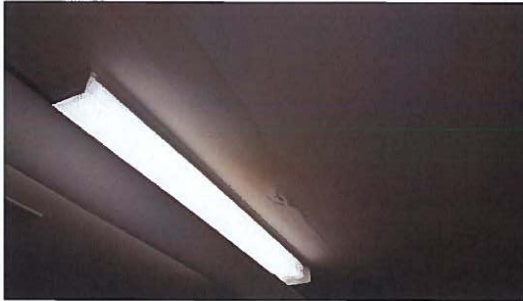
Moisture damage in office 202

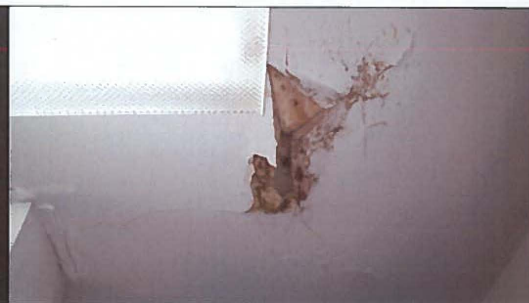
Mildew/fungal growth upstairs bathroom

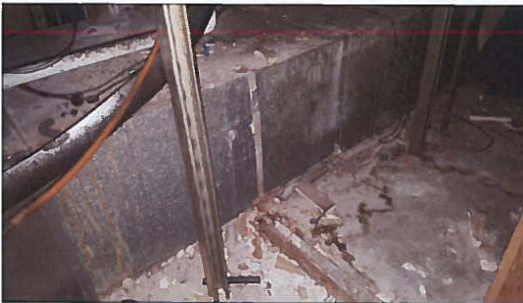
Leak detected on gas line near attic furnace

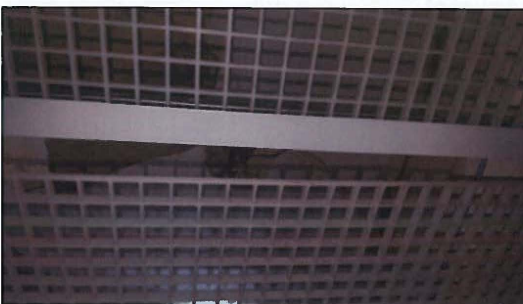
Exposed wires above door to Ingle's Treasures

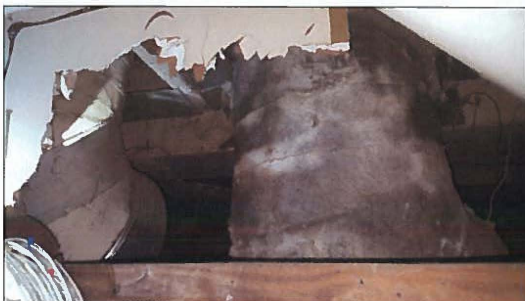
Exposed splices throughout basement

| Foundation | | |
|---|---|---|
| Page 9 Item: 6 | Wiring Notes | • Hot and neutral tested as reversed at NW dining room outlet; needs repair.<br>• Exposed splices in basement need to be put in proper junction boxes. |

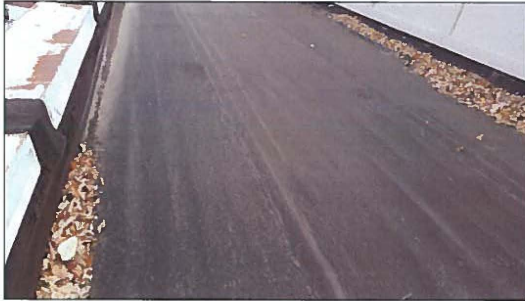
Damaged gutter on West side

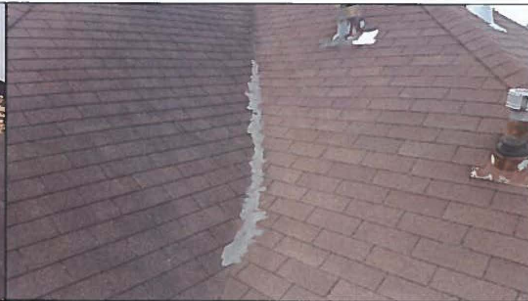
Middle section of roof dear end of lifespan

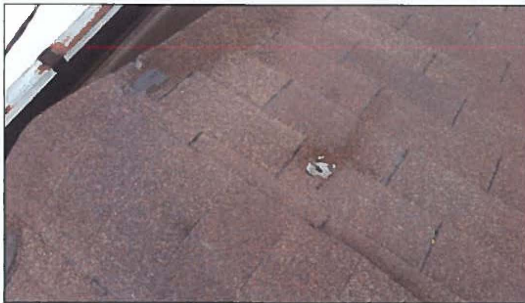
Past repair in rear valley

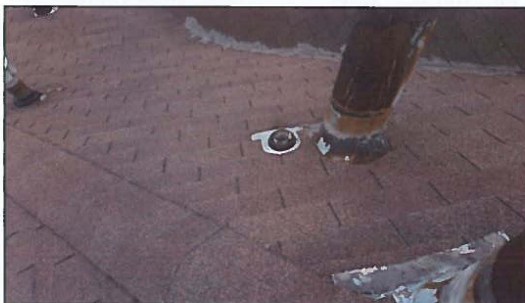
Granular loss/wear

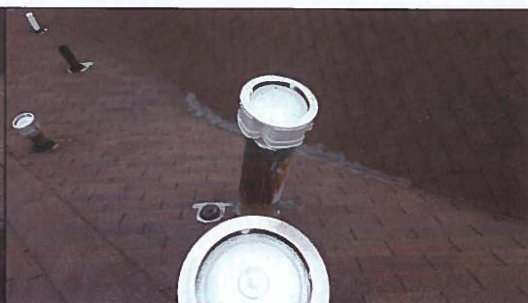
Improper height on plumbing vent

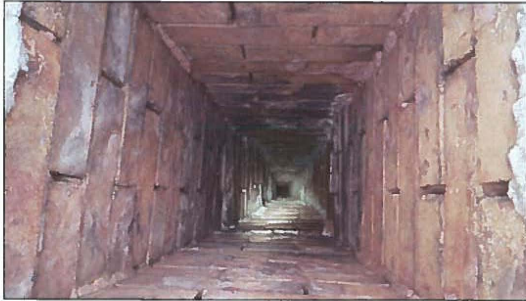
West chimney is unlined

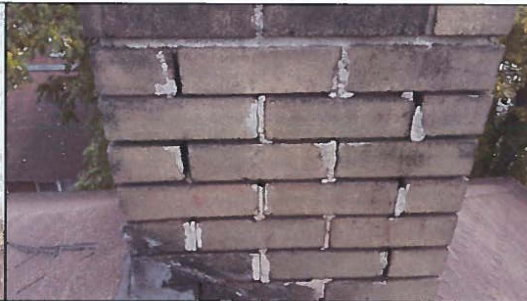
Spalling/missing mortar on chimneys

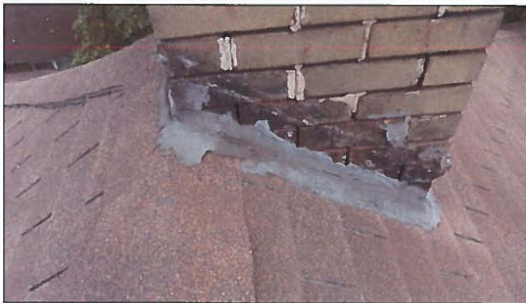
Improper flashing at east chimney

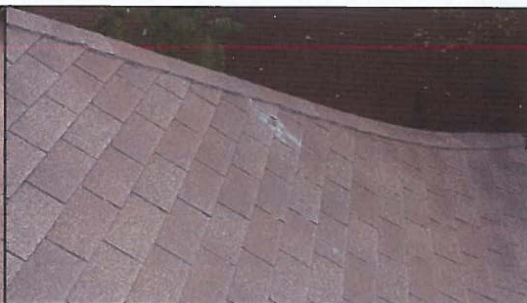
Damaged shingles near SE corner

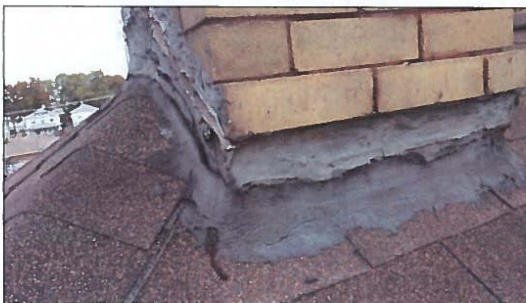
Loose/improper flashing at West chimney

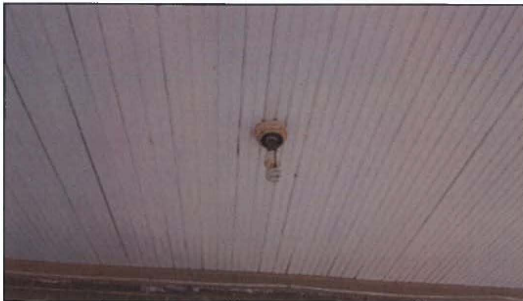
Missing globe at front porch

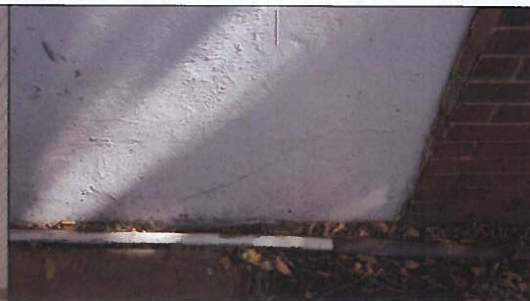
- Trees planted close to structure, not recommended as roots may cause damage to foundation.
- Common shrinkage cracks observed in foundation stem walls.
- Not fully visible; finished basement.
- Slab not fully visible due to carpet and floor covering.
- Typical cracks in basement floor slab.
- Sump pump was tested and appears serviceable.
- Evidence of past/present water in basement; recommend full evaluation/repair by qualified foundation contractor.

Typical cracks in foundation stem walls

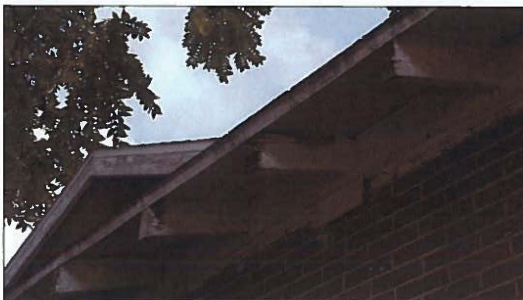
Damaged eaves on West side

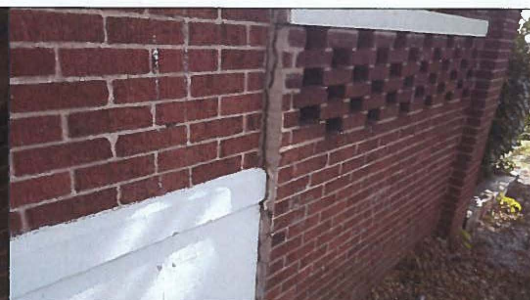
Settlement at front porch

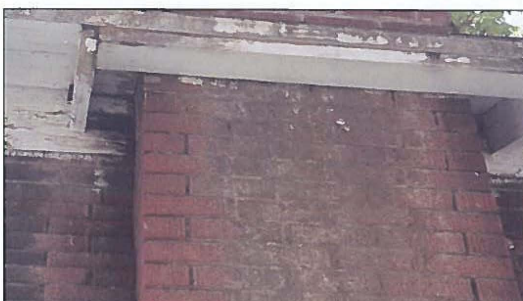
Damaged fascia at chimney

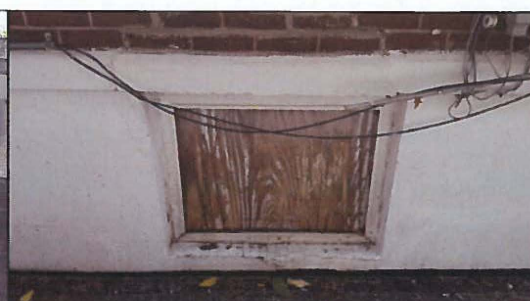
Basement windows have been replaced with plywood

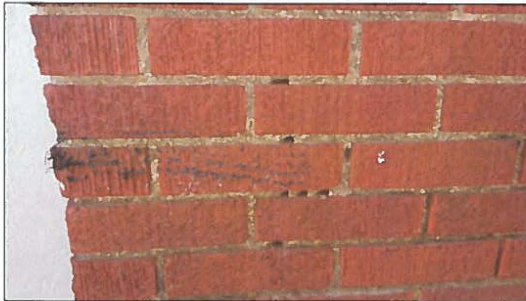
Spalling mortar at chimney

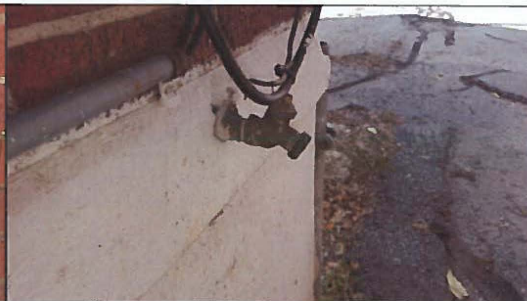
| Foundation | | |
|---|---|---|
| Page 4 Item: 1 | Hose Faucets | • Rear hose faucet drips; needs repair. |

Leaky faucet at NE corner

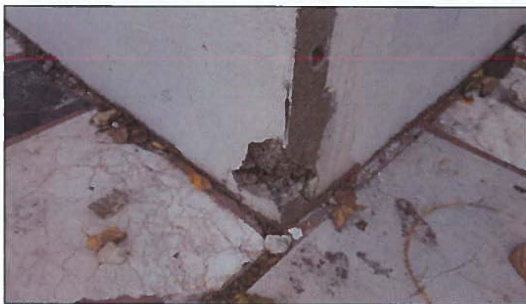
Damaged stem wall at back

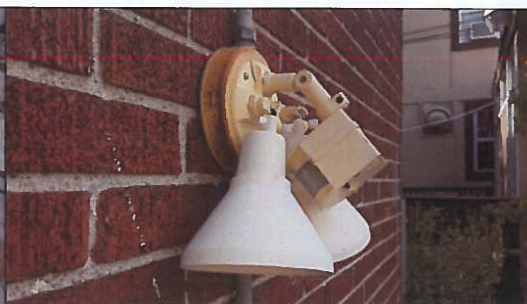
Damaged light at back porch

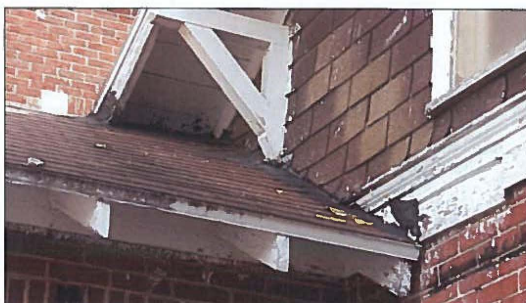
| Foundation | | |
|---|---|---|
| Page 4 Item: 6 | Exposed Flashings | • Counter flashings at the chimney flashings are improper and loose; needs securing/repair. |

Improper flashing and heavy sealant at back of roof

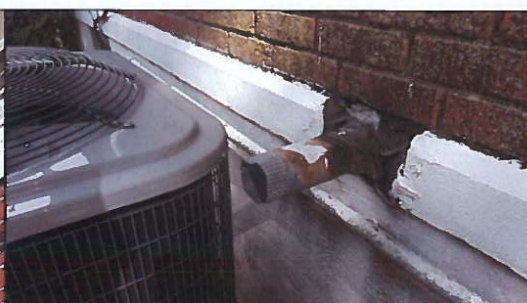
Vent pipe directed at AC unit

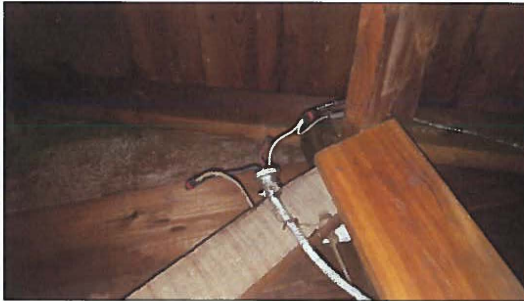
Exposed/improper splice above attic access

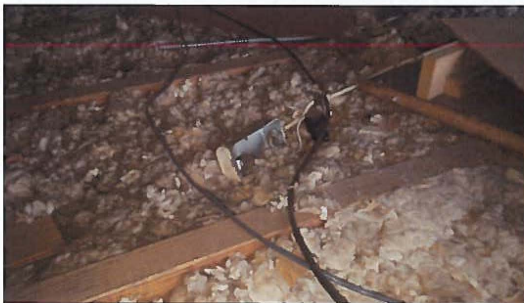
Exposed splices in attic

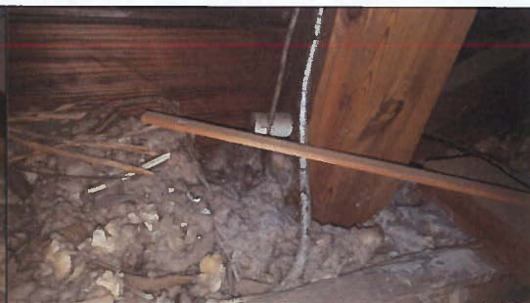
Knob and tube wiring in attic

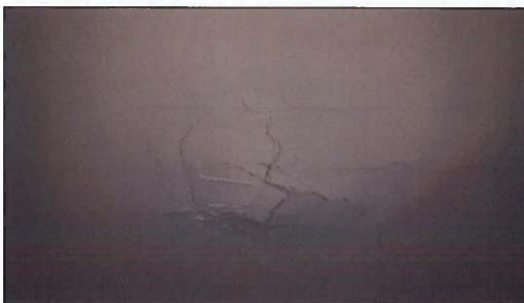
Damaged ceiling at back storage room

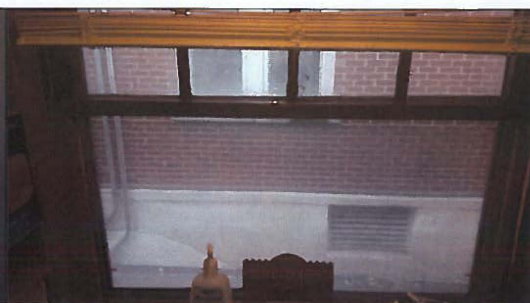
Broken Windows - Kitchen

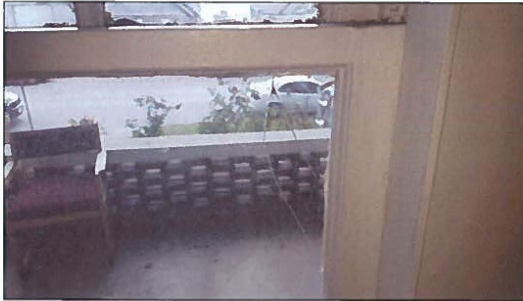
Broken window near front door

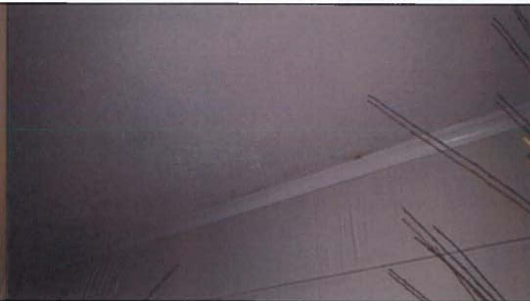
Moisture stains in main living area

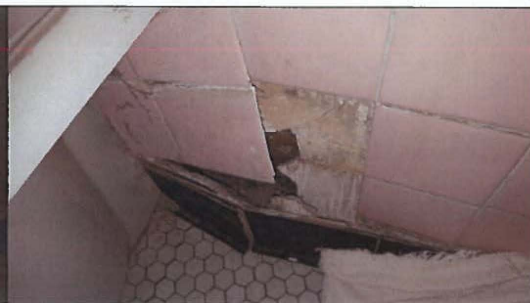
Moisture damage around shower

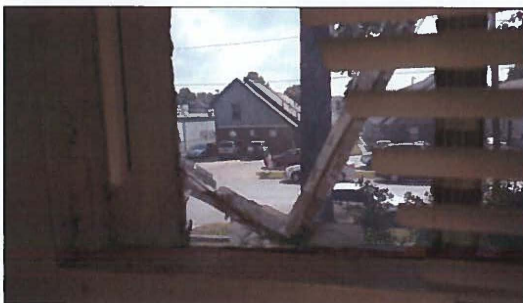
Broken window at front office

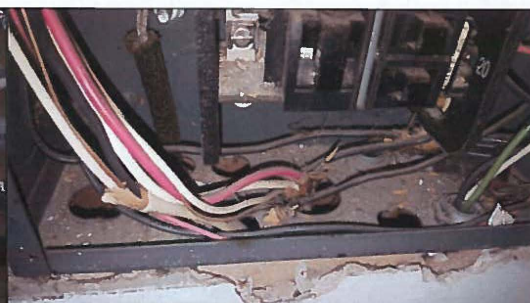
| Foundation | | |
|---|---|---|
| Page 9 Item: 5 | Panel Notes | • Missing bushing/clamp on wires observed; needs correction. |

Missing protective clamps in panel

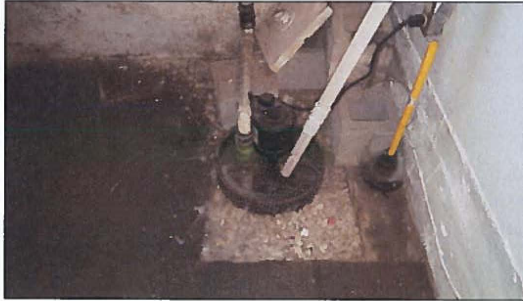
Sump pump installed

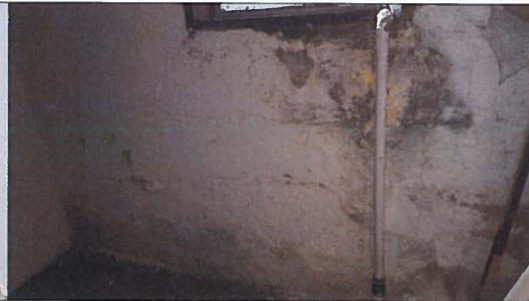
Moisture penetration/damage in main room of basement

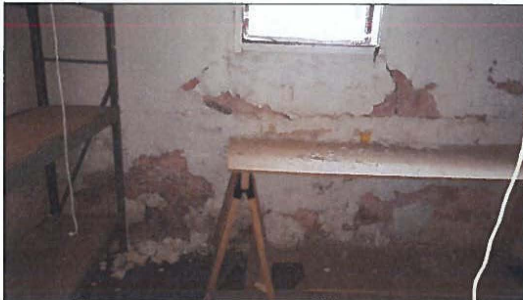
Moisture penetration/damage in SW room of basement

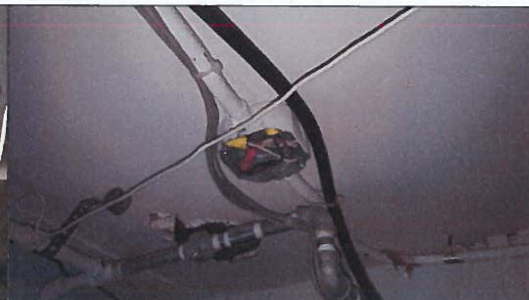
Missing junction box covers in basement

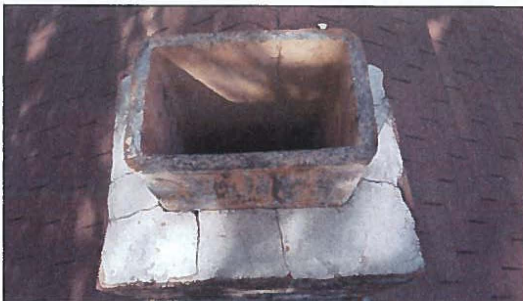
| Foundation | | |
|---|---|---|
| Page 4 Item: 8 | Chimney | • Chimneys are in poor condition. Observed cracked flue tile, damaged concrete crown and missing mortar; need full evaluation/repair by qualified chimney sweep. |

Cracks in crown and flue tile at West chimney

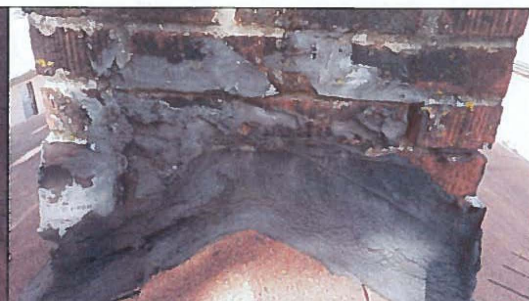
Improper/loose flashing and missing mortar at West chimney

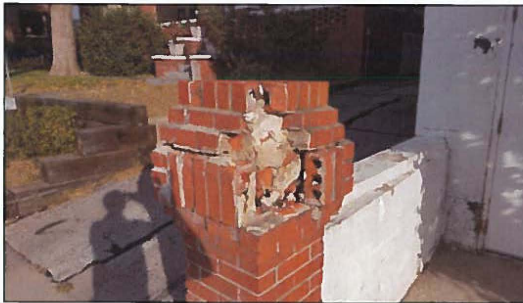
Damaged column on retaining wall - Front
