# Springfield Land Clearance for Redevelopment Authority

4.i. **Blight Report And Redevelopment Plan For The East Cherry Townhomes Redevelopment Area, Generally Located At 1361 And 1365 East Cherry Street; Say You Can, LLC, Applicant. Resolution No. 2017-3228**

## Report Summary of Defects

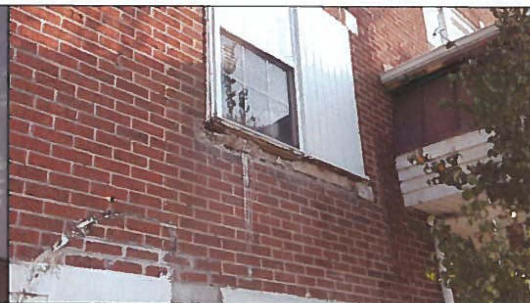
Deteriorated window ledge - Front

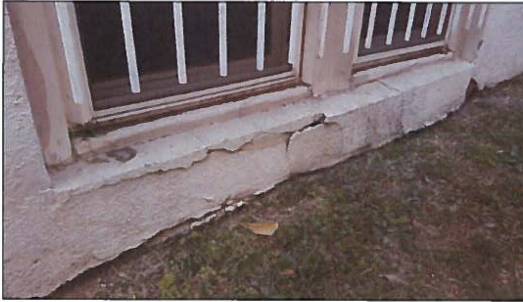
Cracks and deterioration - East Side

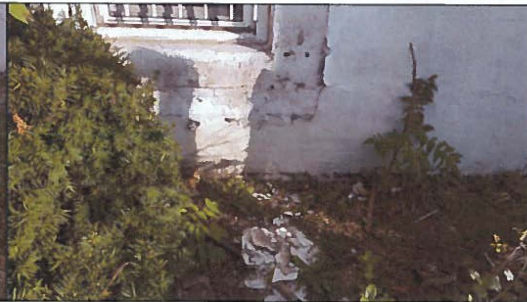
Deteriorated sparging - East side

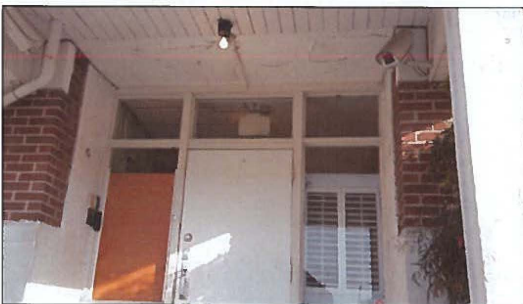
Spalling surfaces - Front

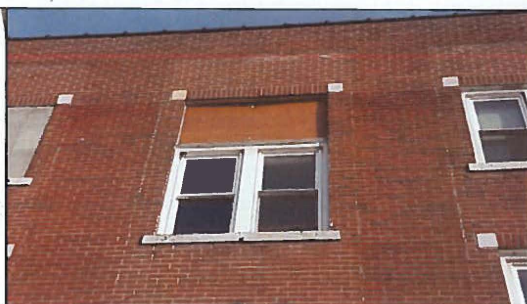
Boarded up window - Entry

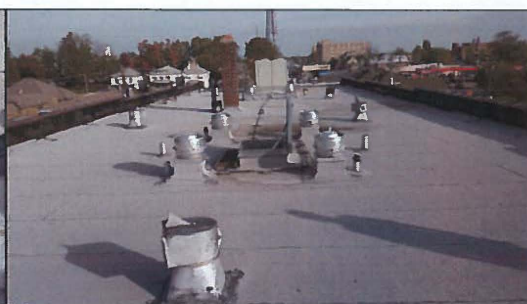
Signs of ponding on roof

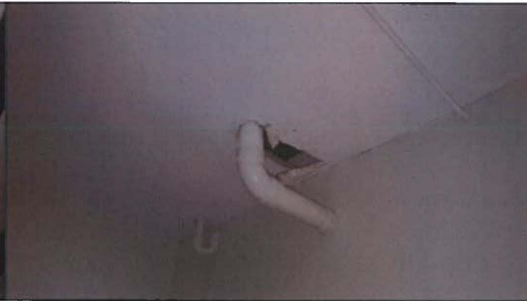
Moisture damage ceiling - 3rd Hall

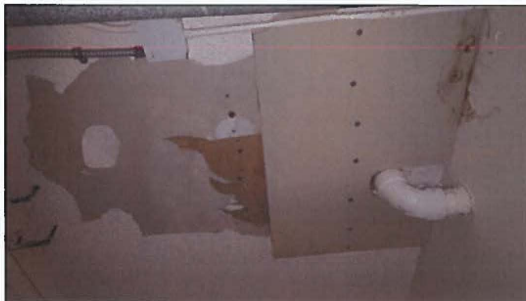
Ceiling damage - Bathroom 12

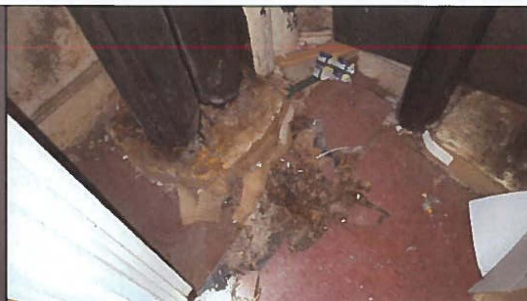
Moisture damage - Bath 23/25

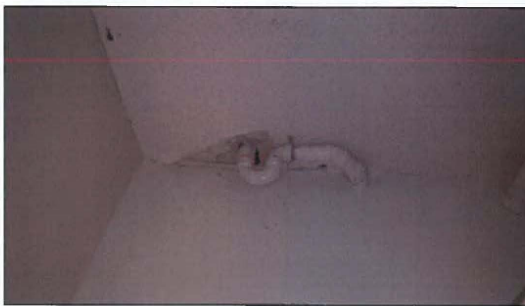
Missing light - Unit 13 Closet

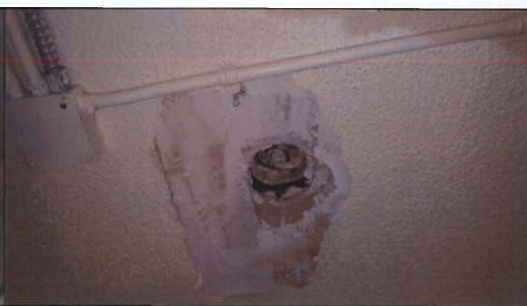
Moisture damage - Unit 13 Bath

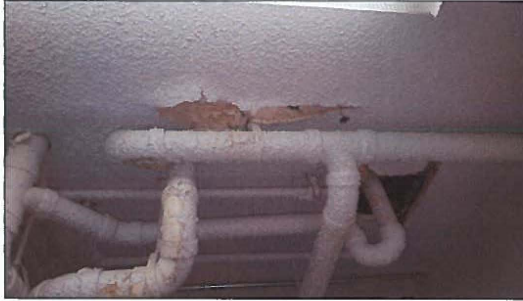
Moisture damage - Unit 8 Closet

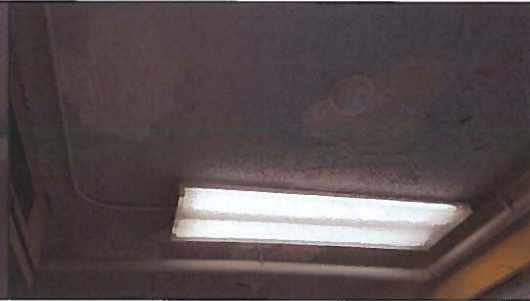
Moisture damage - Main kitchen ceiling

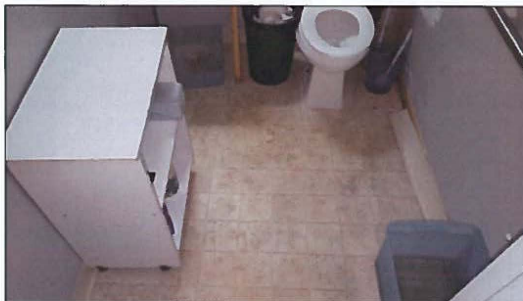
Mold/Mildew - Bath A

- Recommend installing exhaust fans in bathrooms (Mold/mildew growth observed.)

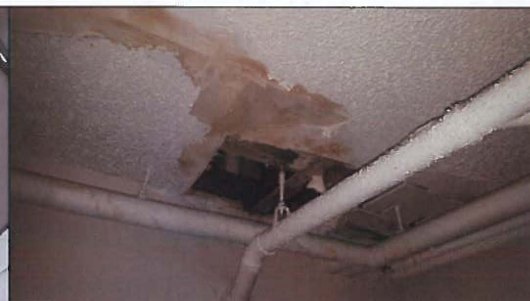
Tubs below plumbing leaks - Staff Bathroom

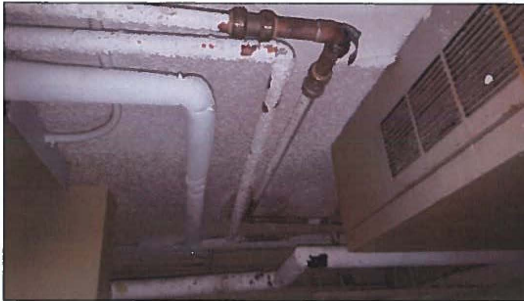
Plumbing drain leak - Kitchen Dry Storage (Basement)

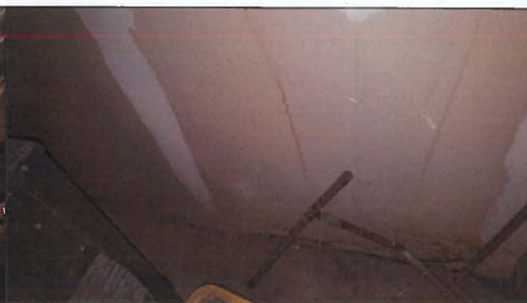
Multiple Plumbing leaks - boiler room
