*SPRINGFIELD LAND CLEARANCE FOR REDEVELOPMENT AUTHORITY*

*Tuesday, July 11, 2017 at 4:00 p.m.*

**4.II. Blight Report And Redevelopment Plan For The 1325/1329 East Cherry Redevelopment Area, Located At 1325 East Cherry Street; Roza Capital Group, LLC, Applicant**

**EXHIBIT B**  
**PICTURES OF THE BLIGHTING CONDITIONS**

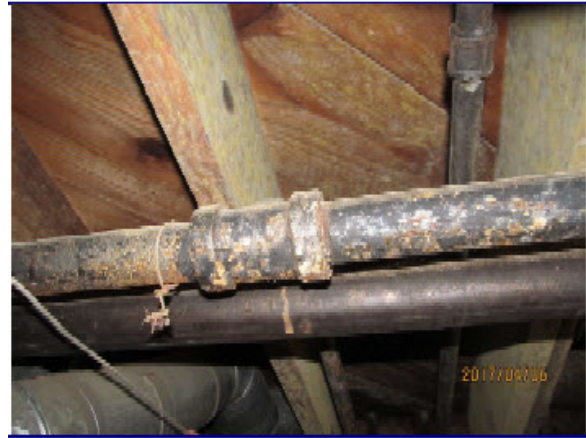
**B-12) Sewer and Plumbing is obsolete and does not connect to city sanitation services due to a broken sewer line.**

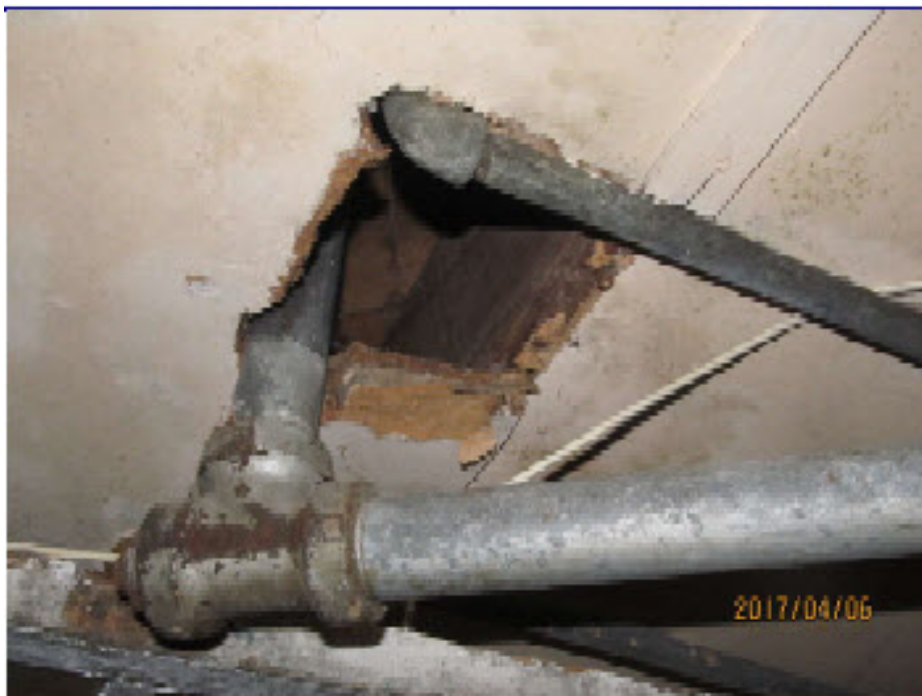
**B-2.24) Electrical knob and tube is exposed below lath and plaster. The outdated wiring is at High Risk of causing a fire.**
