# **Springfield Land Clearance for Redevelopment Authority**

### **4.II. Blight Report & Redevelopment For East Cherry Street Pocket Neighborhood**

#### *A1 Home Inspection* Property Inspection Report

1361 E Cherry St, Springfield, MO 65802  
Inspection prepared for: Elm House LLC  
Date of Inspection: 8/18/2016 Time: 2:00 p.m.  
Age of Home: 1920 Size: 1,408 sf. +/- (Several additions noted)  
Weather: Partly cloudy and 75 degrees

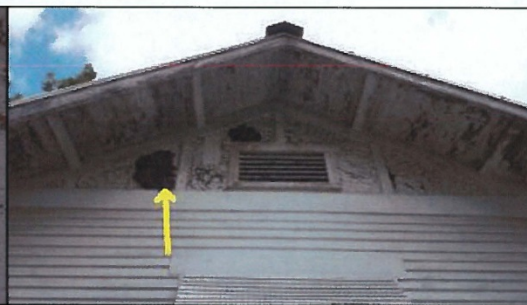
Holes in asphalt paper on West gable

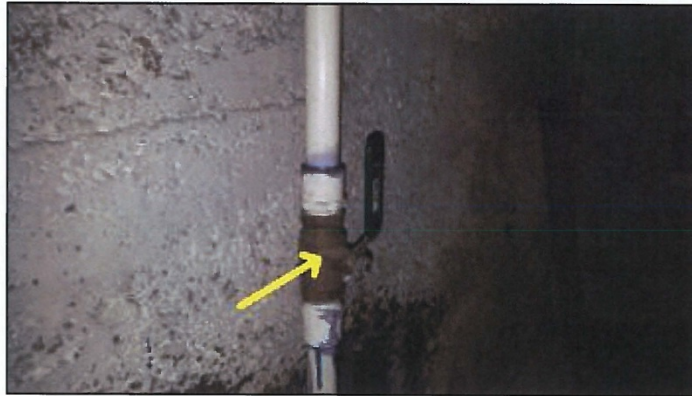
- NE corner of basement
- Meter

Main water shut off

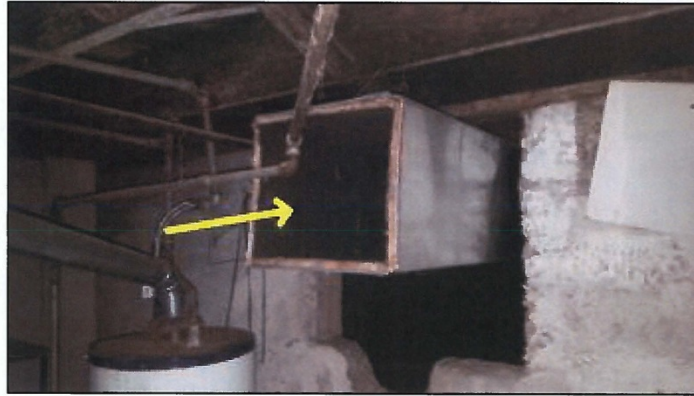
are located on the main level and gas logs lack modern features, which all of which is a safety hazard.<sup>17</sup> On top of all of the factors noted above, the 1361 House's furnace has been removed, utilities been inactivated<sup>18</sup>, and lacks air conditioning units.<sup>19</sup>

- Furnace has been removed; no hear source installed.

Furnace and majority of ductwork has been removed.

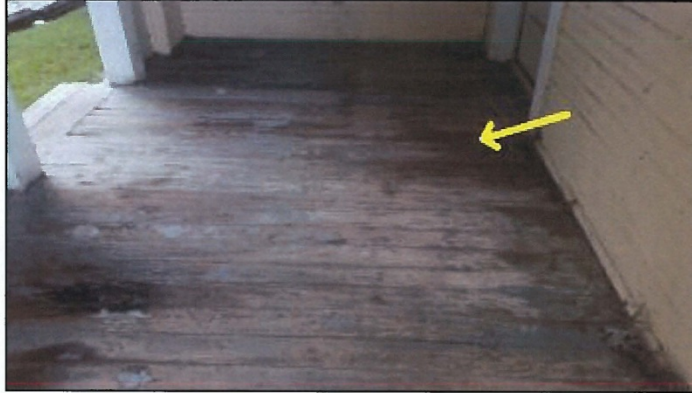
- The decks due to be sealed/painted and routine maintenance needed.

Back porch needs maintenance

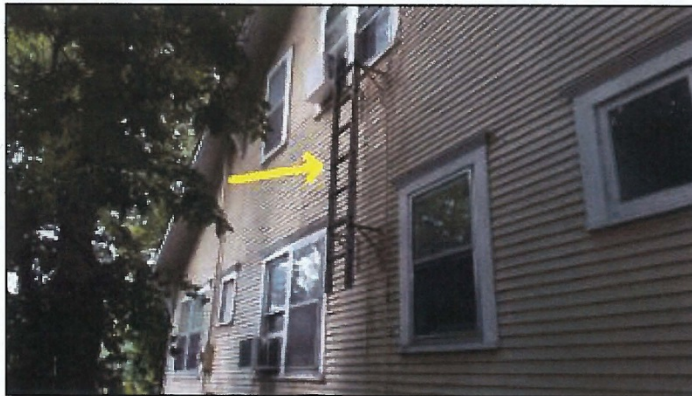
- Appears serviceable

Fire escape ladder noted on East side

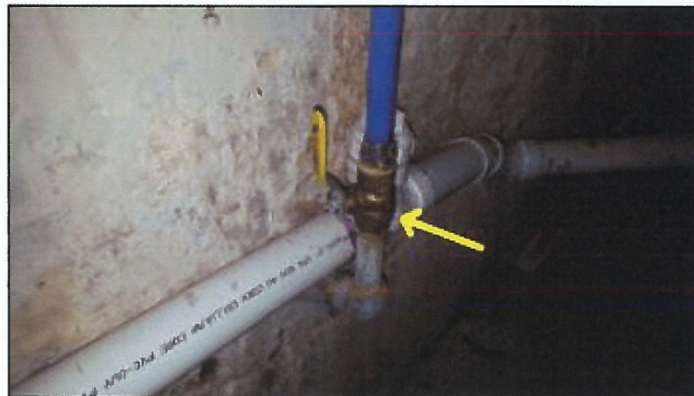
- East side of basement

Main water shut off
