# **Springfield Land Clearance for Redevelopment Authority**

**Blight Report**  
**Stillwell Columns Redevelopment**

#### Stillwell Columns

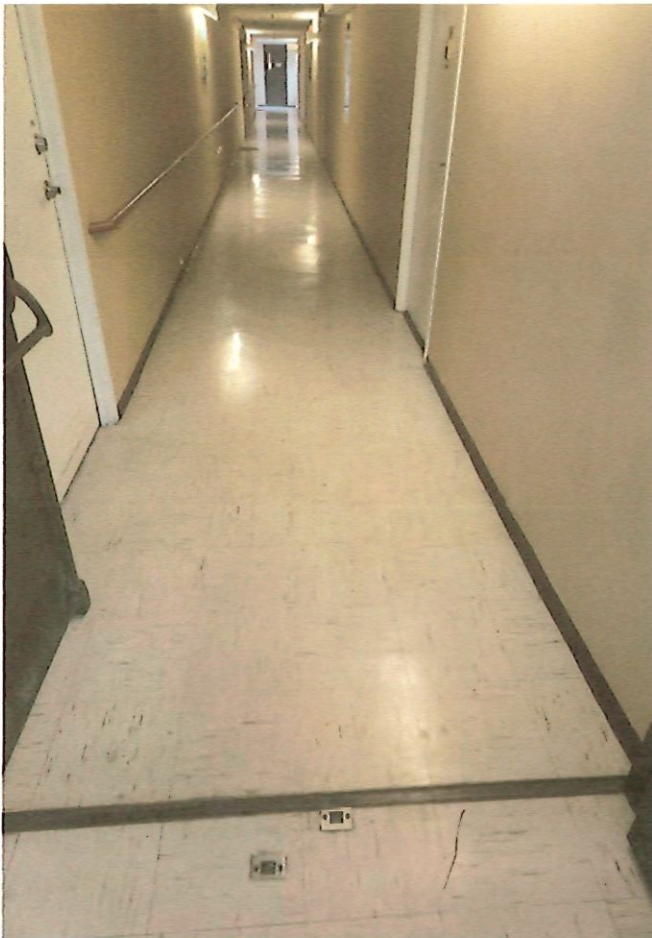
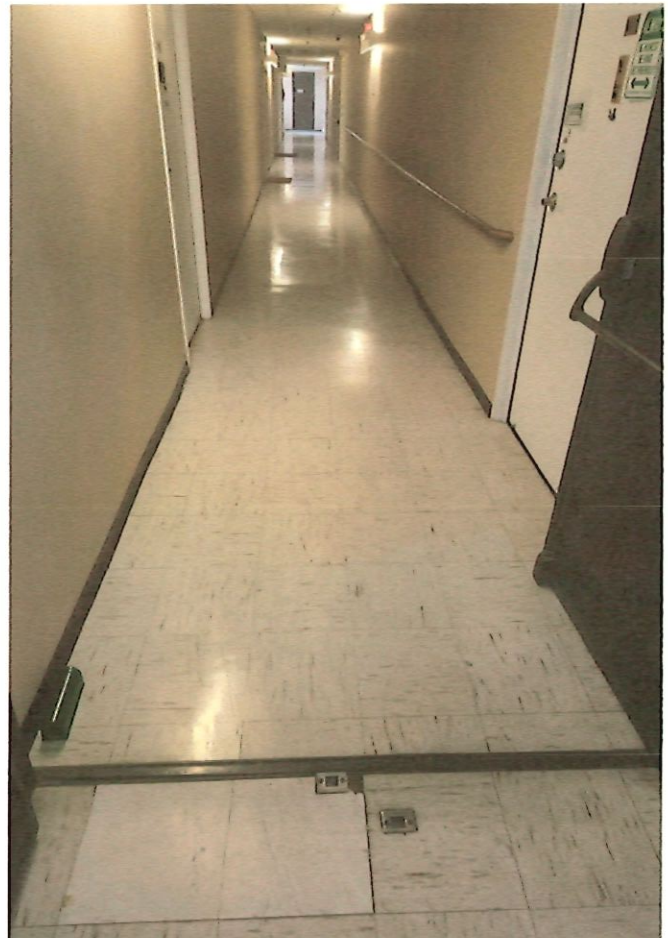
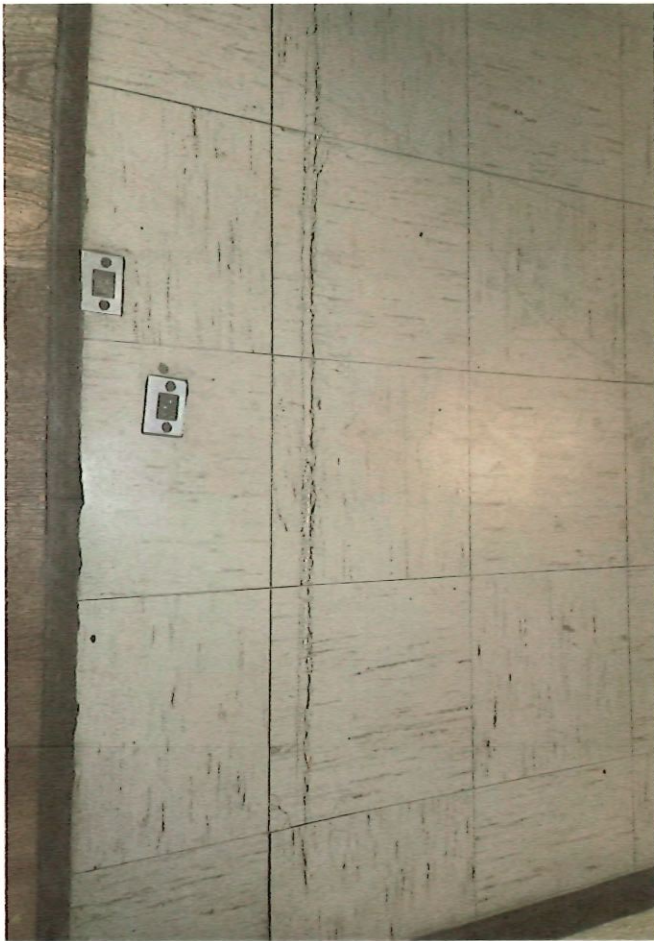
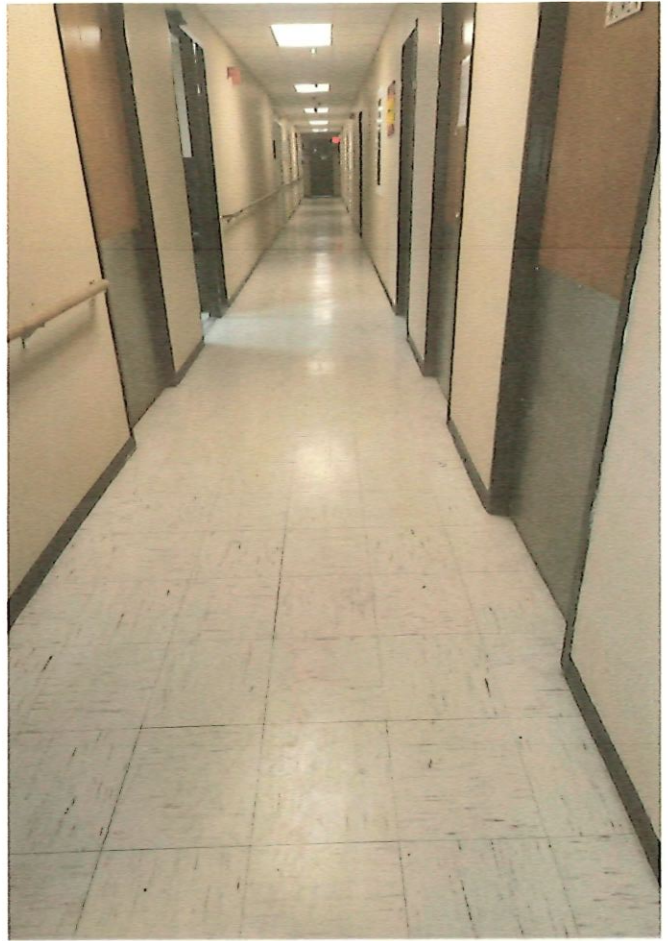
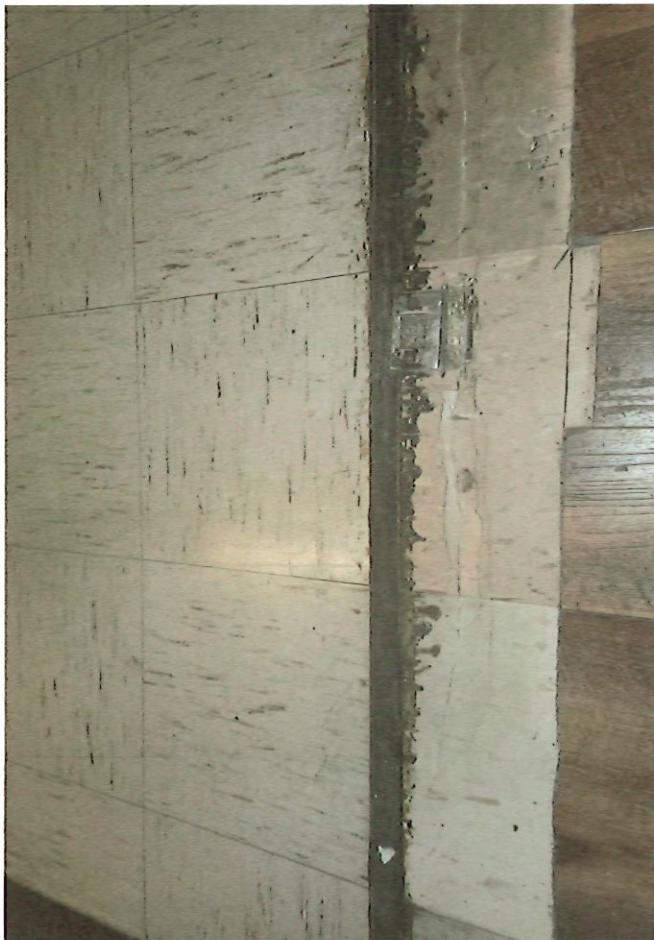
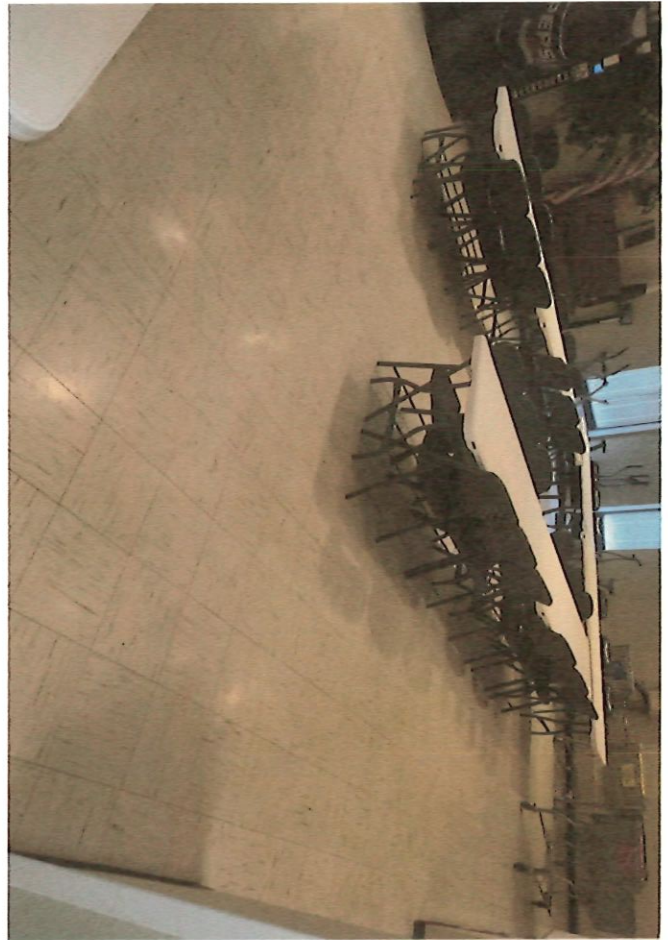
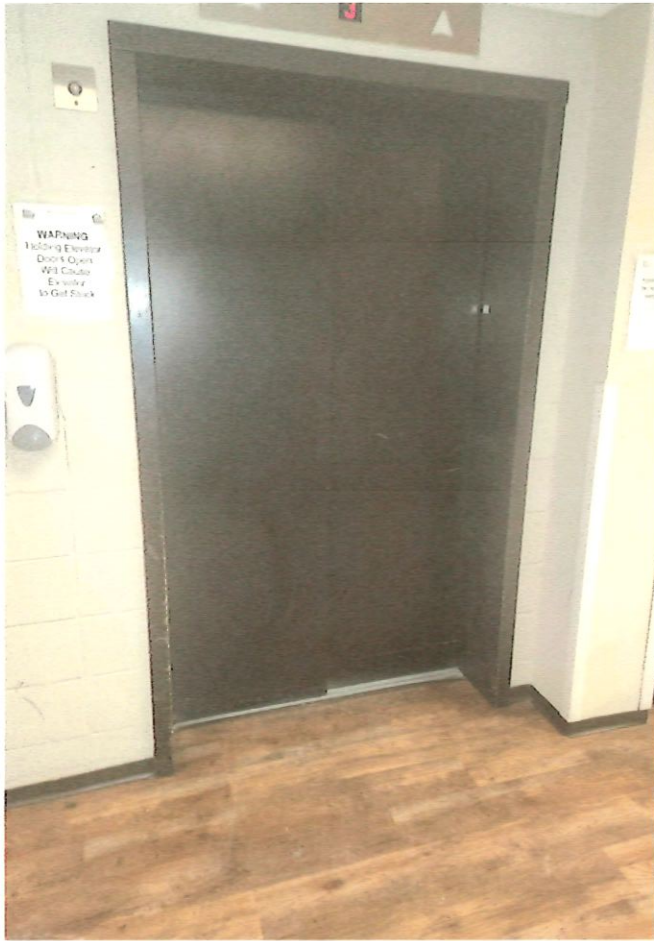
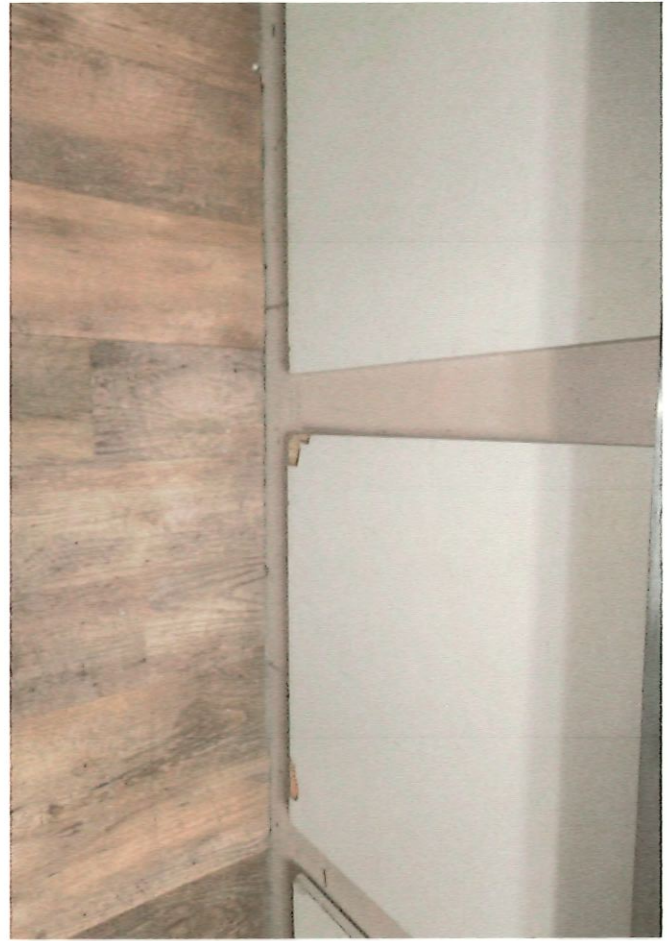
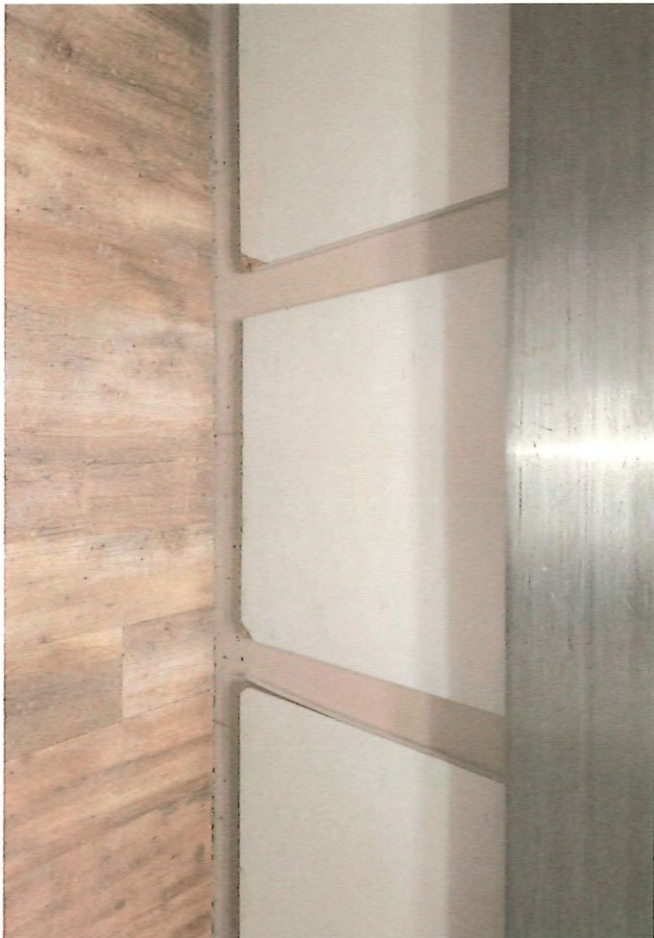
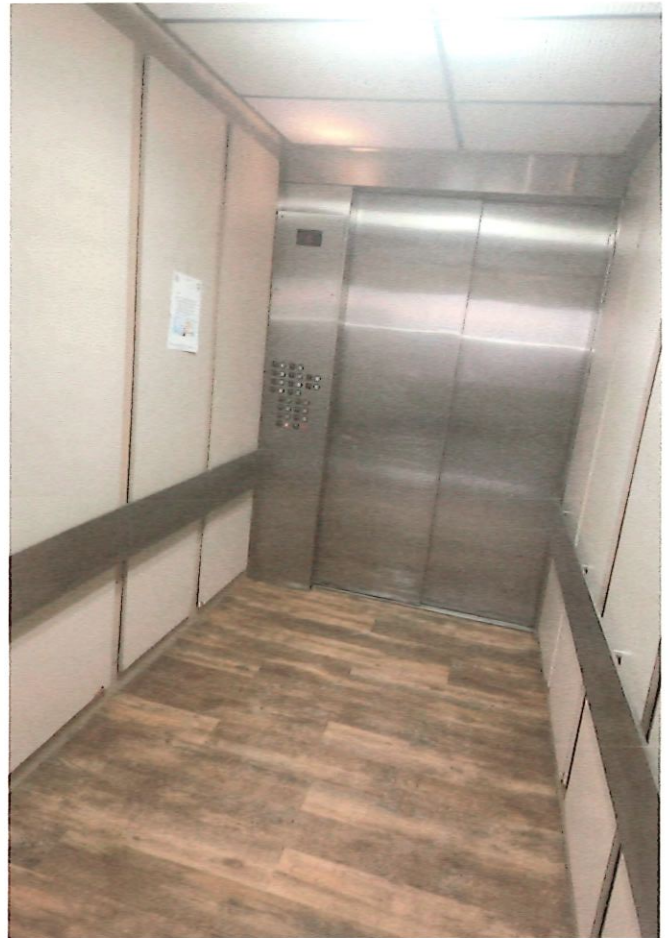
Several areas of the flooring in the building tested positive for asbestos, including public and private spaces. These areas will be abated and removed or encapsulated as required by law.

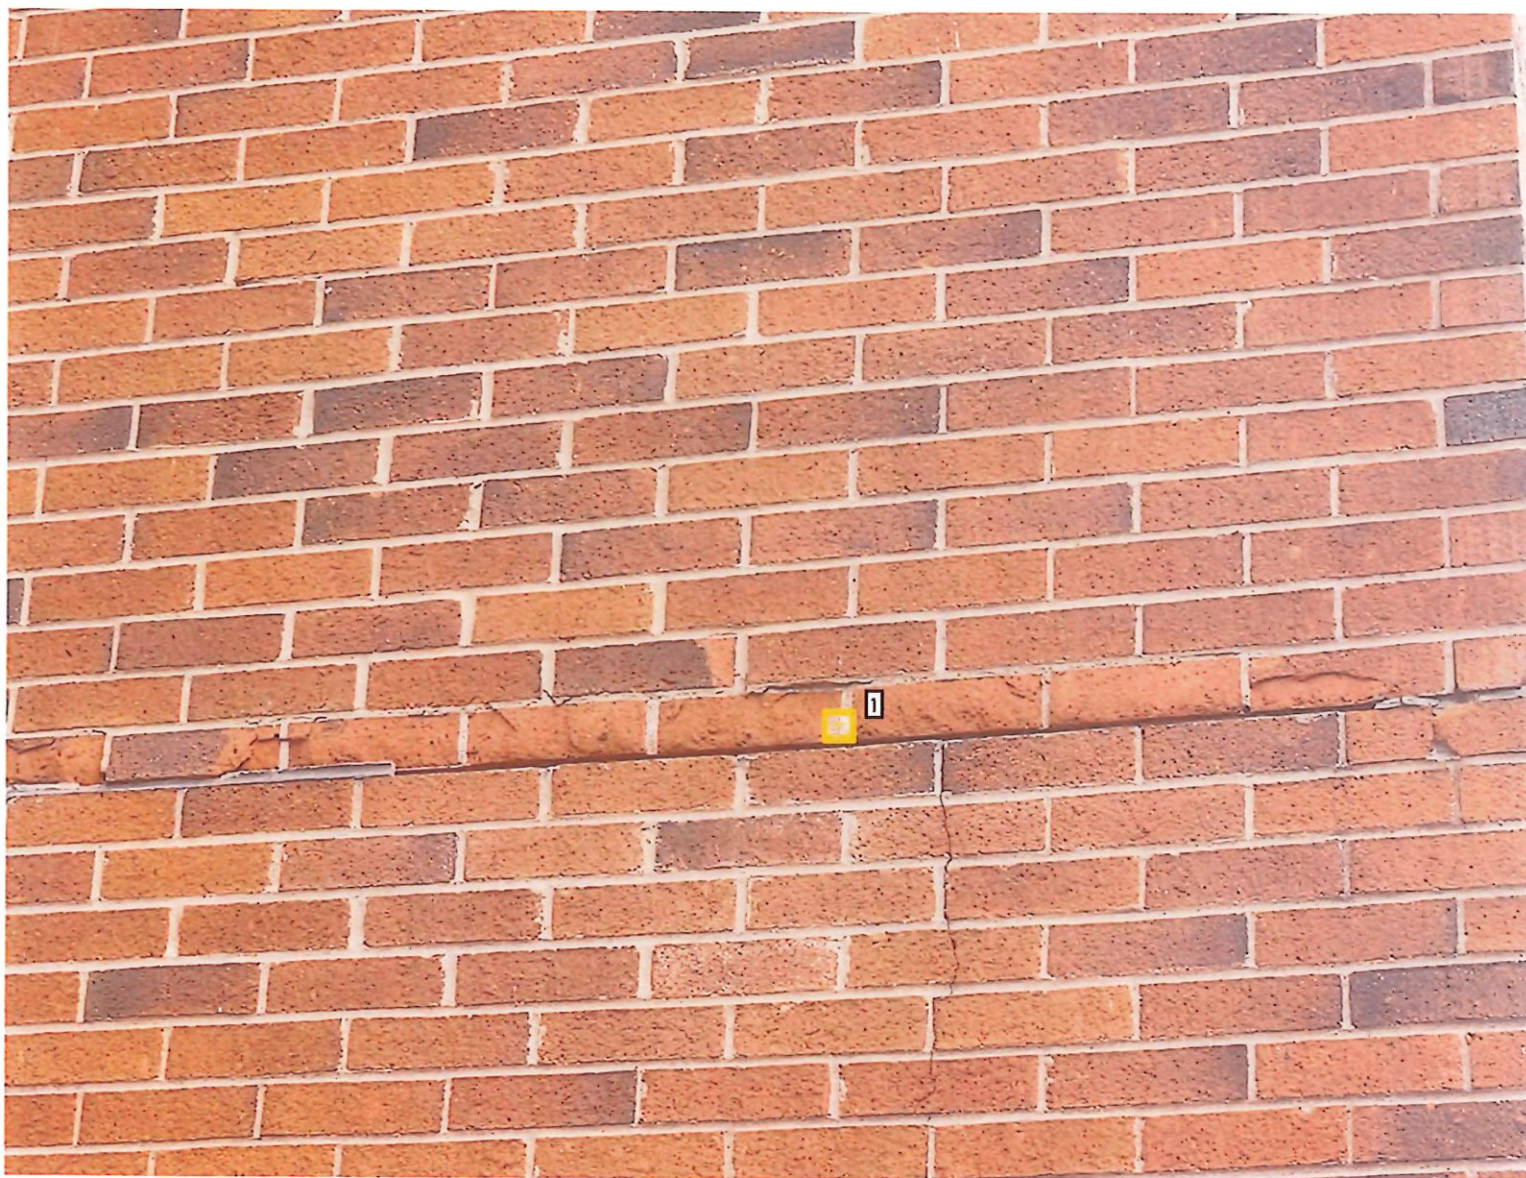
Number: 1      Author: Bethany.Collie      Subject: Sticky Note      Date: 5/8/2024 3:58:38 PM  
missing a piece of exterior wall brick- south exterior wall

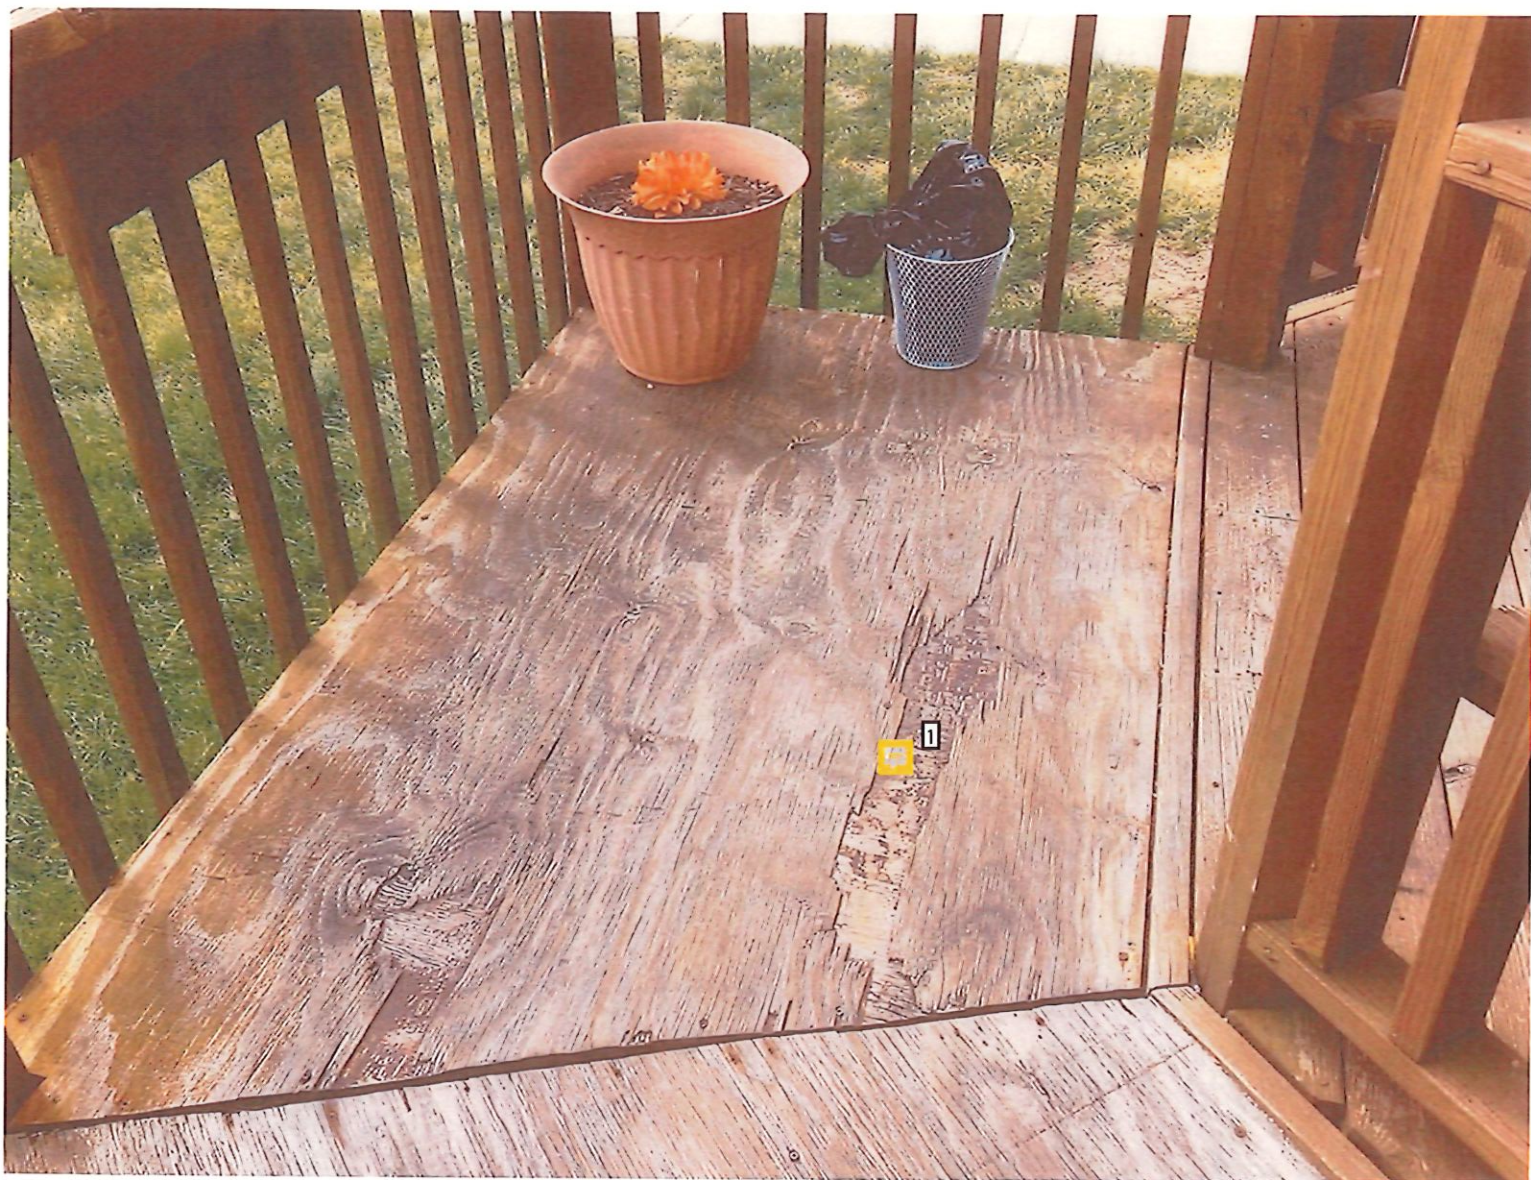
| Deterioration of the sidewalk at the main entrance on the north end | | | |

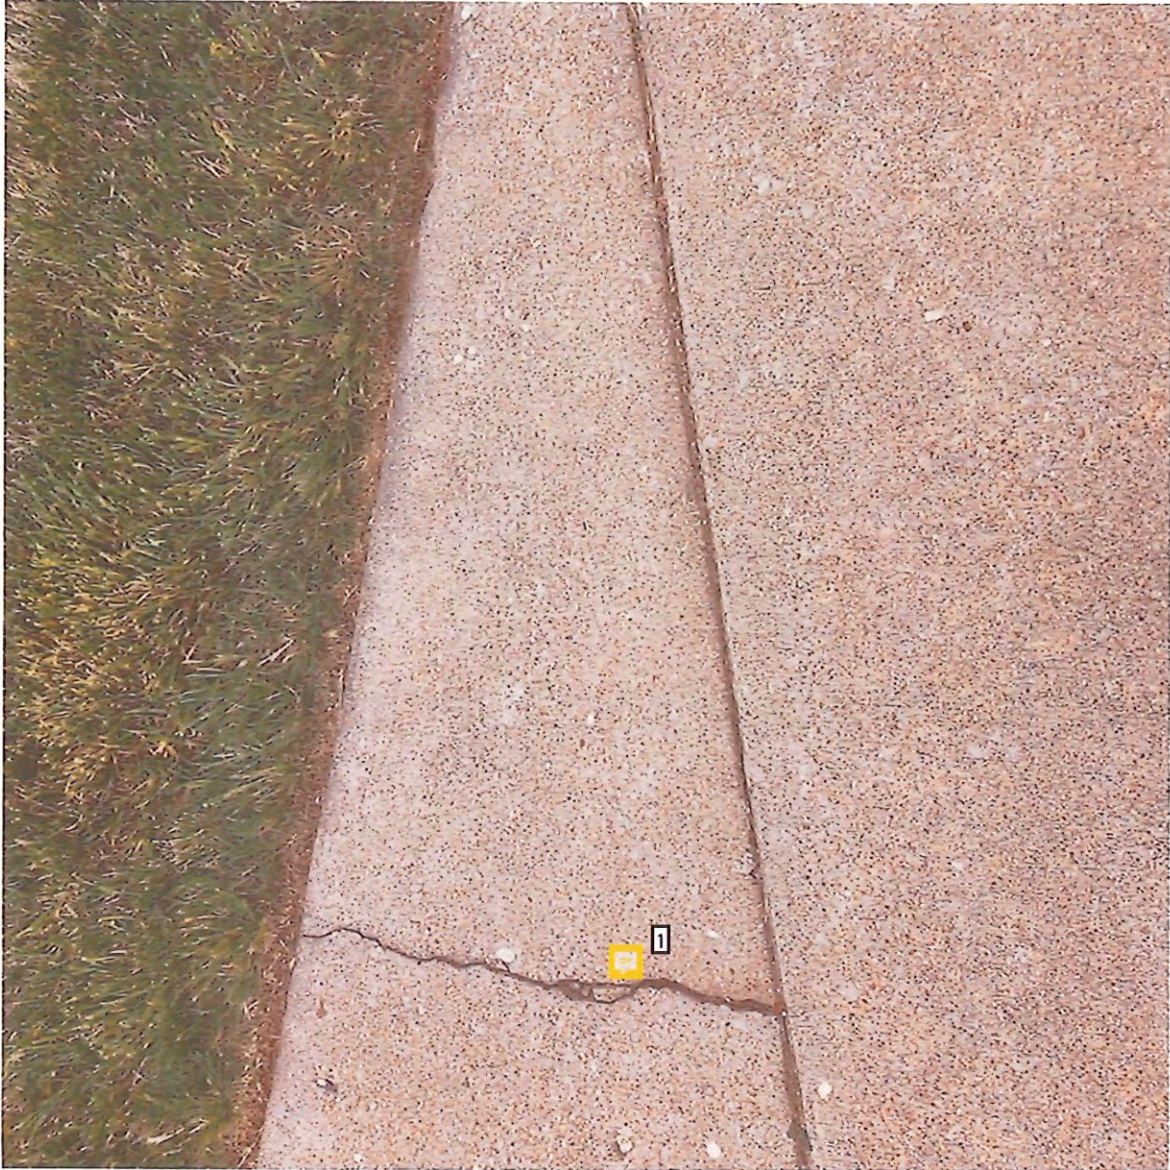
Number: 1      Author: Bethany.Collie      Subject: Sticky Note      Date: 5/8/2024 4:10:03 PM  
Brick deterioration on the Southwest end of the building

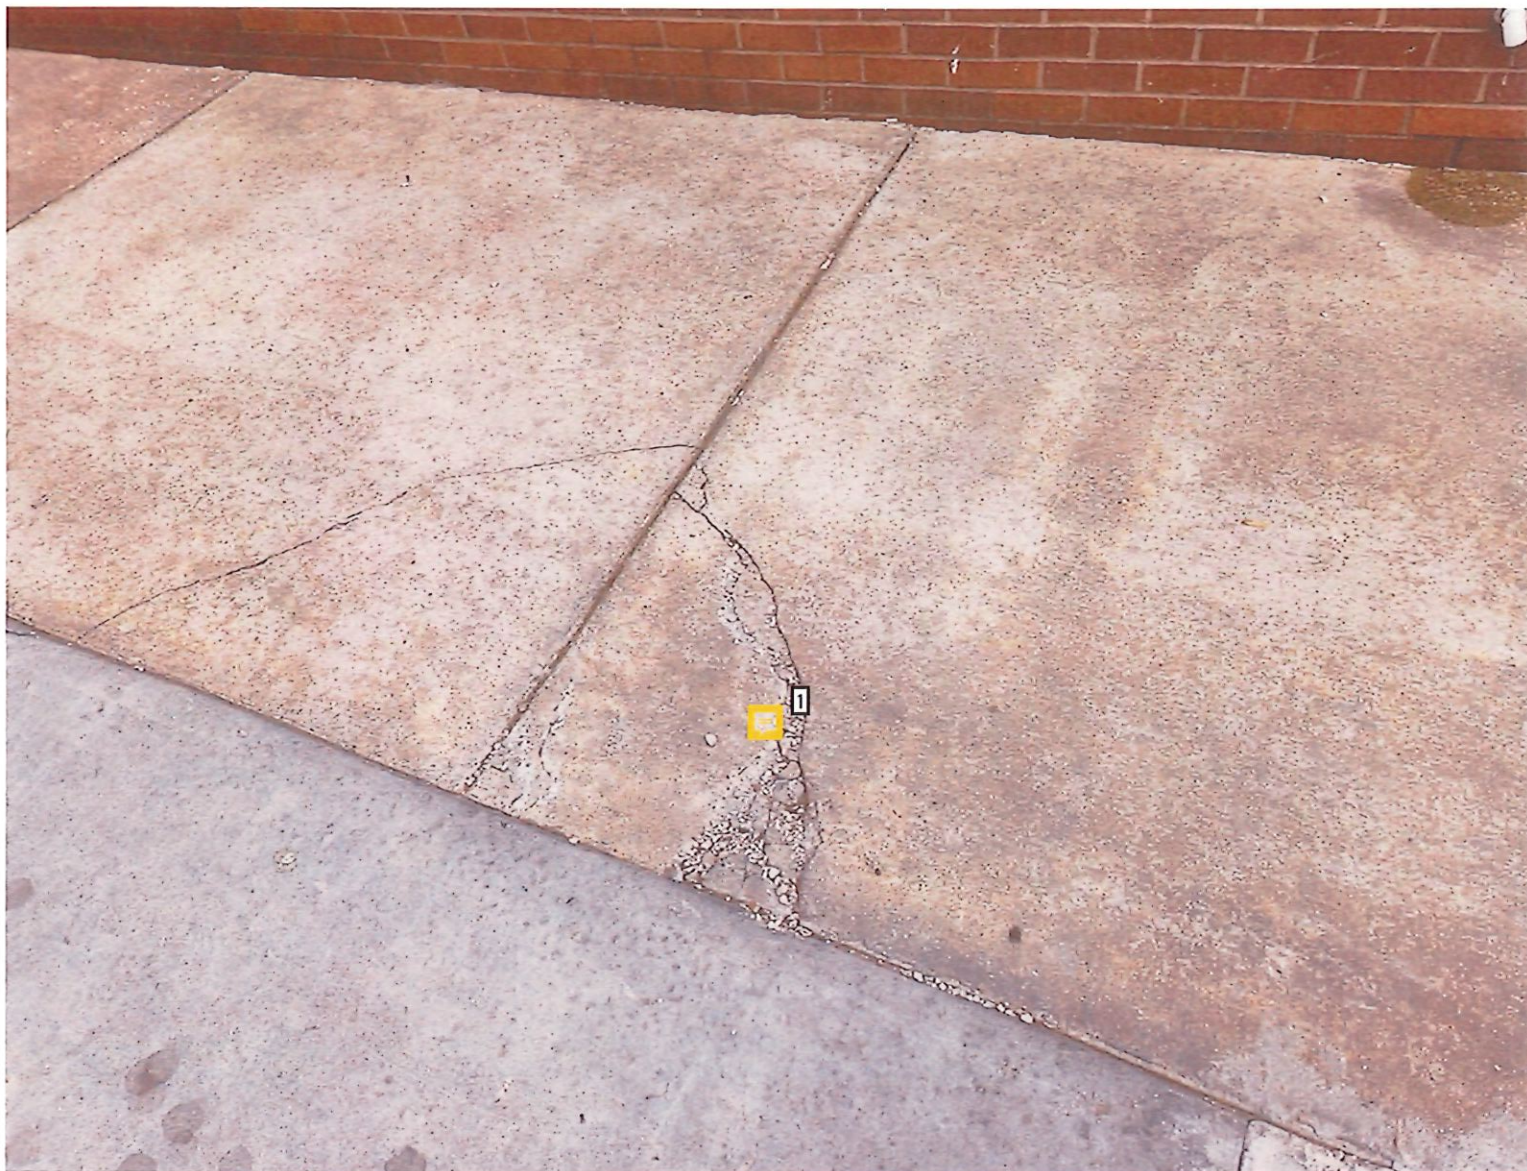
Number: 1 Author: Bethany.Collie Subject: Sticky Note Date: 5/8/2024 4:12:34 PM  
northside of the building- dumpster pad is deteriorating.
