# LANDMARKS BOARD

| DAVID MAGGARD<br><i>At Large Representative</i> | | B. Certified Local Government Review<br>1. 308 W. Commercial – Install a new storefront system. |

GENOTECA - WINE BAR - 308 WEST COMMERCIAL STREET.

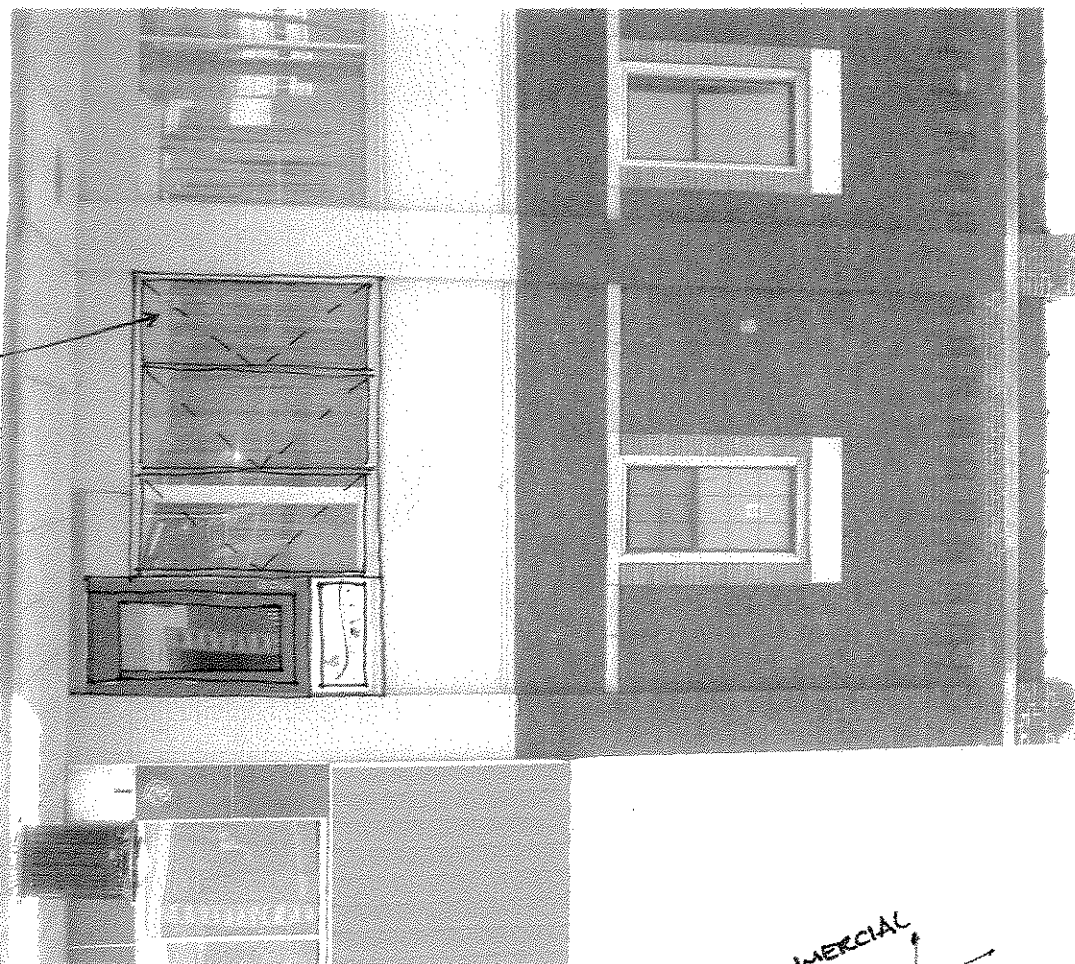
Provide (3) new insulating wood  
casement windows. (PAINT)  
REMOVE EXISTING, DAMAGED SINGLE  
PAVE WINDOW SYSTEM IN ITS  
ENTIRETY.

308 COMMERCIAL  
STREET.  
PROJECT SITE.

Ms. Lipscomb said she understands what they are trying to do but the sill is rotted and it needs to be replaced no matter what, and from the photograph it looks like it is rotted halfway across, it has completely failed.
