# Landmarks Board

REQUEST FOR PERMISSION TO DEMOLISH  
530, 536 & 540 E. COMMERCIAL STREET

## FIELD OBSERVATION REPORT

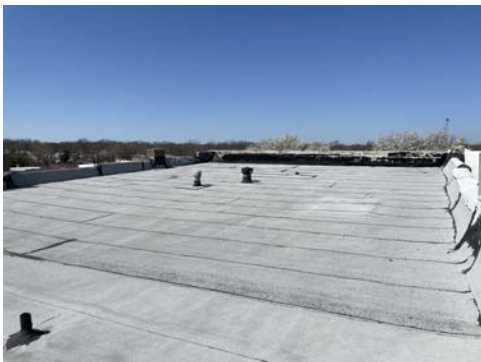
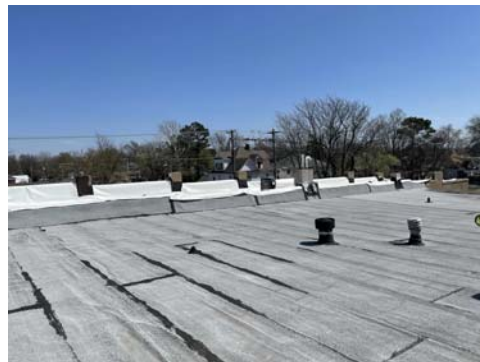
Most of the roofing system along the North side has come unattached to the parapet wall allowing moisture in this area to enter the building.

- Remove all existing roofing systems down to existing deck. Repair or replace deck as needed.
- Build plywood cants around perimeter of building to get water shedding away from roof to wall joints.

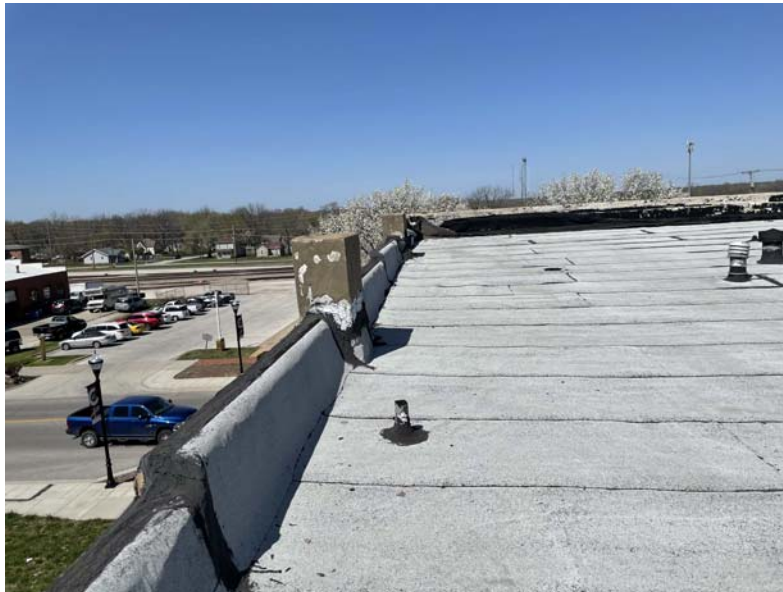
All existing pilasters are hollow with exposed tops allowing the element enter the wall cavities with a select few used for the mechanical system.
