# Springfield Land Clearance for Redevelopment Authority

**4.III. Blight Report And Redevelopment Plan For The East Cherry Flats Redevelopment Area**

Documents: [EAST CHERRY FLATS BLIGHT REPORT AND REDEVELOPMENT PLAN.PDF](#)

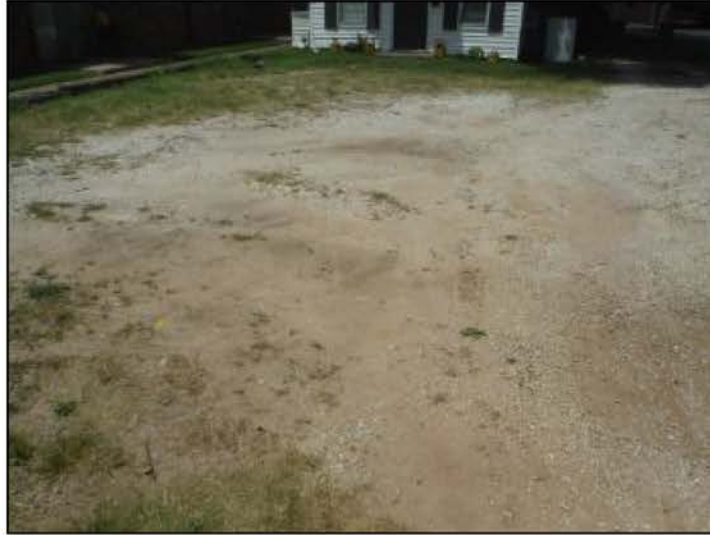
### 1. Driveway Observations

Eroded shared gravel driveway and parking area in back need upgrading, not to current standards

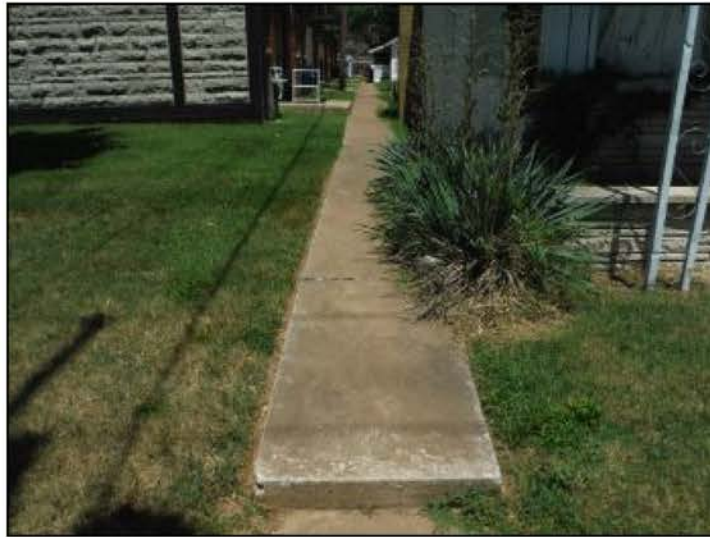
### 1. Sidewalk Observations

Trip hazards along west

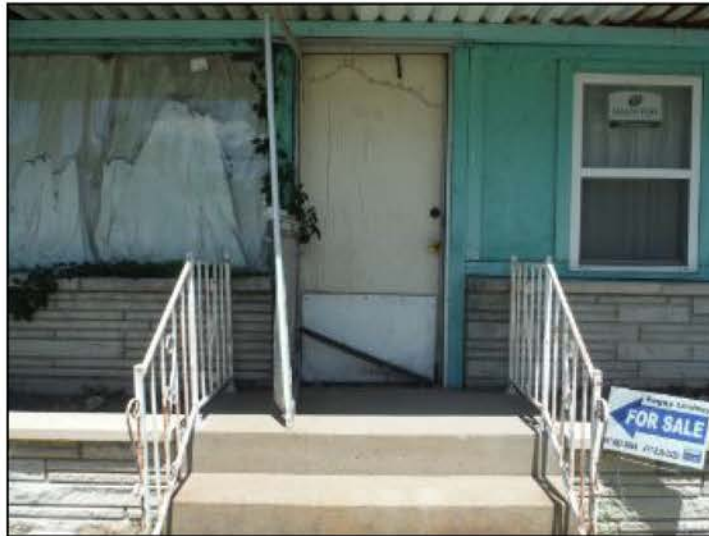
### 1. Porch Observations

Vacant status, undetermined time

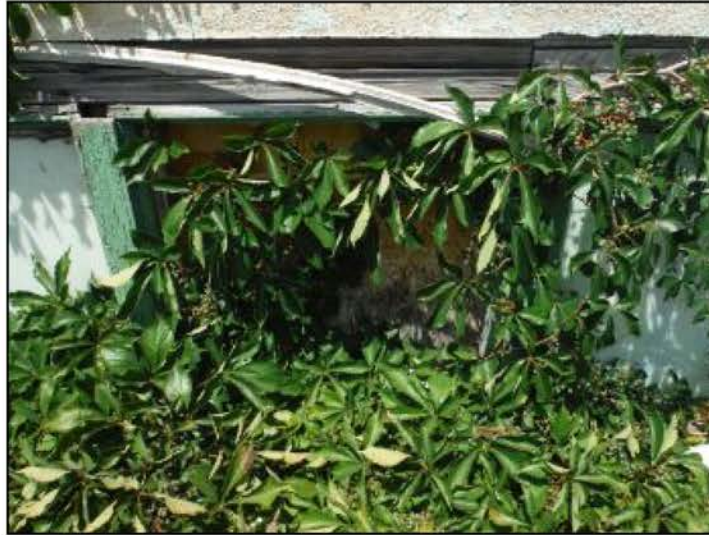
Foliage limits access

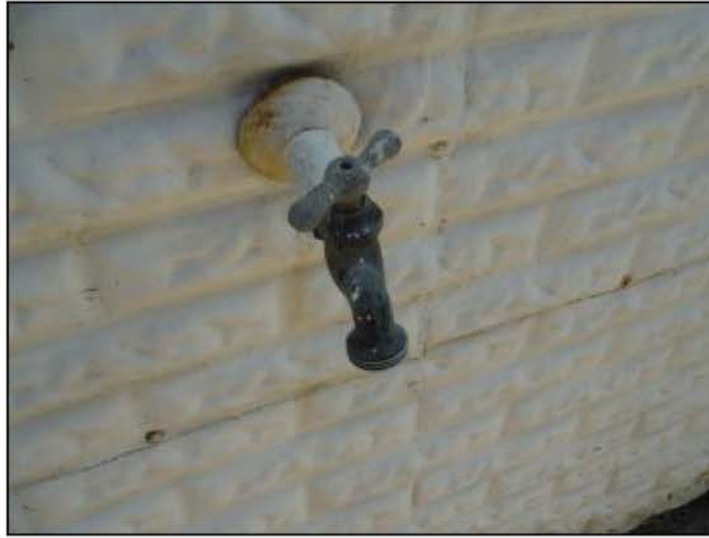
### 3. Hose Faucets

Not frost free type, untested (no water)

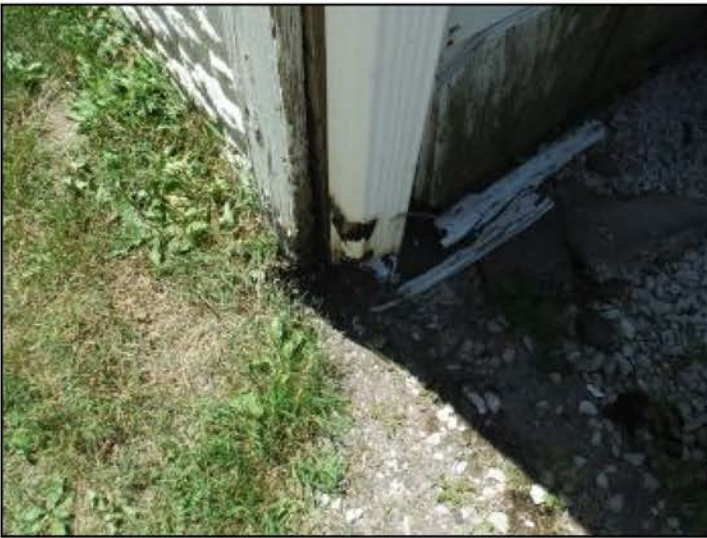
### 4. Gutters and Downspouts

Lone downspout needs splash block

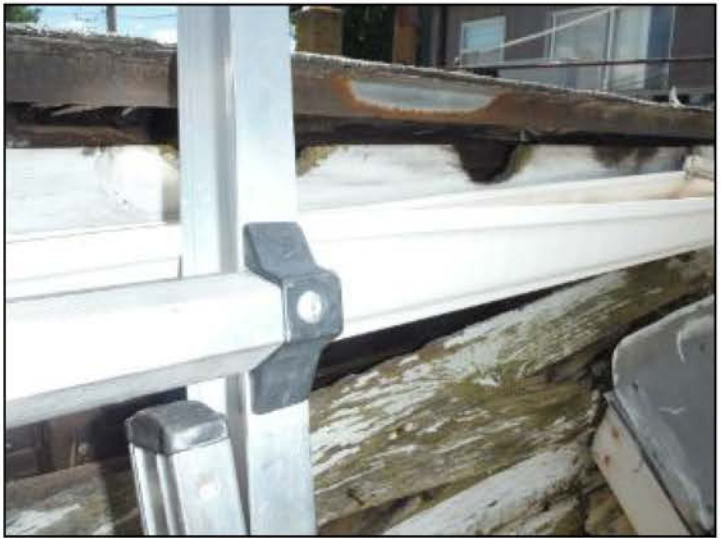
Lone gutter needs maintenance

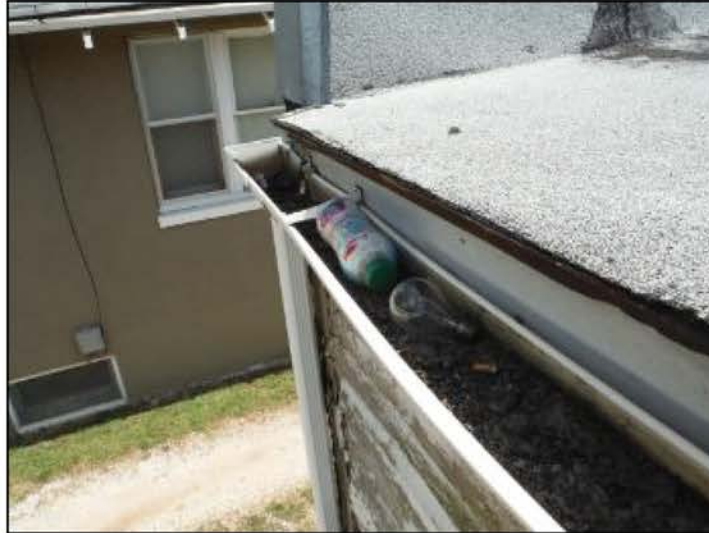
Note how gutter related to roof drip edge, may leak

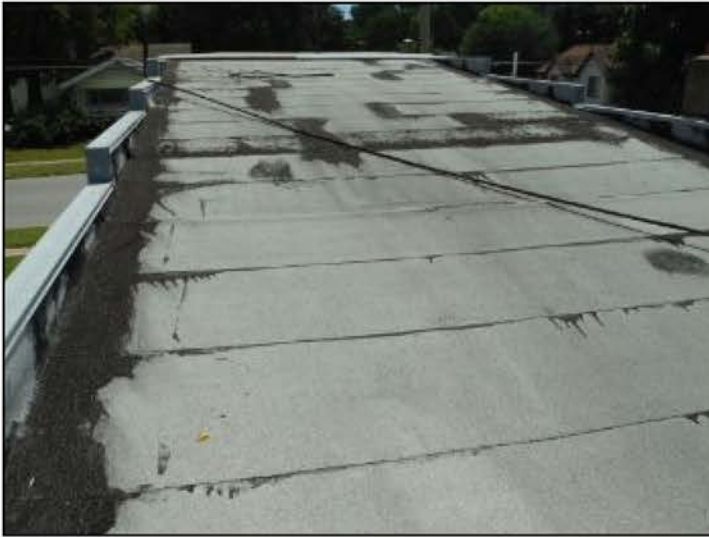
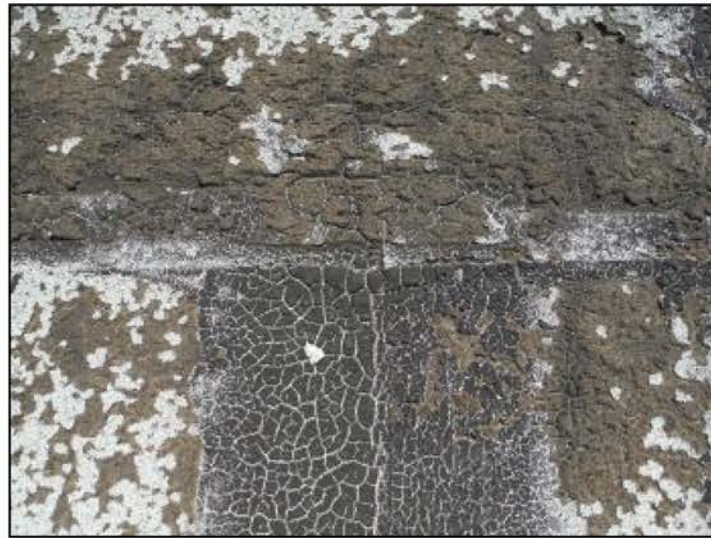
### 5. Main Roof

At end of life, needs stripping and replacement  
ASAP

At end of life, needs stripping and replacement ASAP

The flat roof on the 1235 Structure is at the end of its useful life and needs to be stripped and replaced immediately in to prevent further leaks.<sup>14</sup> In connection with the reroofing, all vents and seams need to be resealed. The awning over the back door is not square and needs to be reattached.<sup>15</sup> The gutters are bent, loose and full of debris.<sup>16</sup> As a result, new gutters and downspouts are warranted.

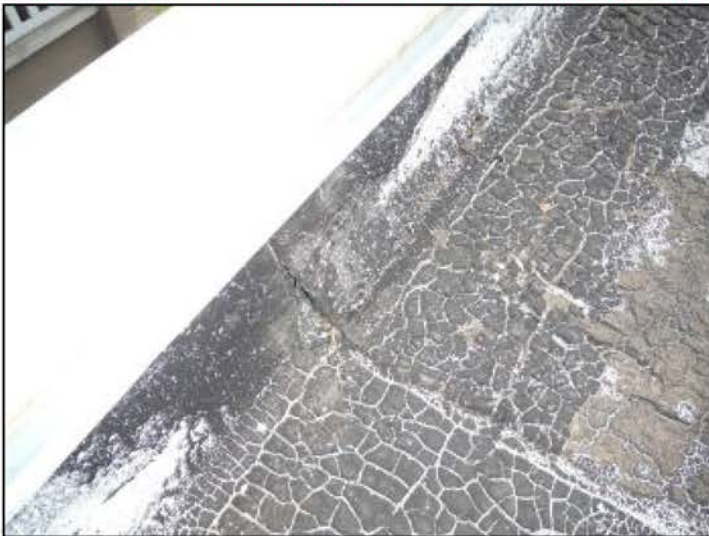
At end of life, needs replacement when reroofed

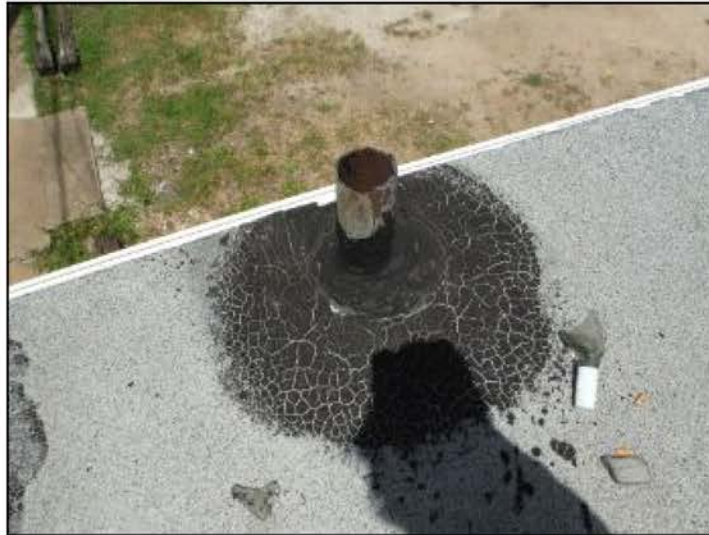
At end of life, needs replacement when reroofed

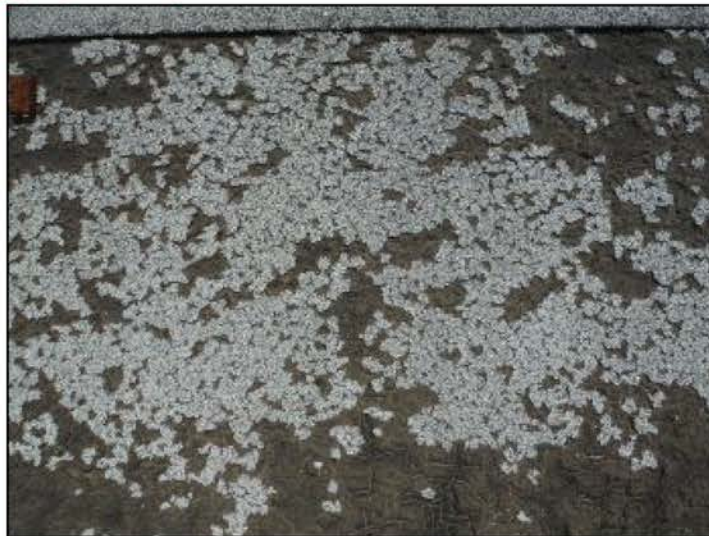
At end of life, needs stripping and replacement ASAP

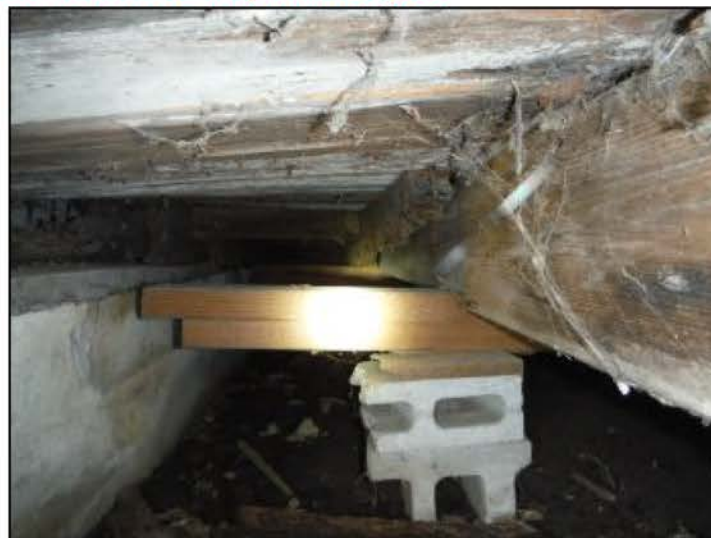
Signs of past termites, refer to termite inspection report

Too low to crawl, this view from damage/hole

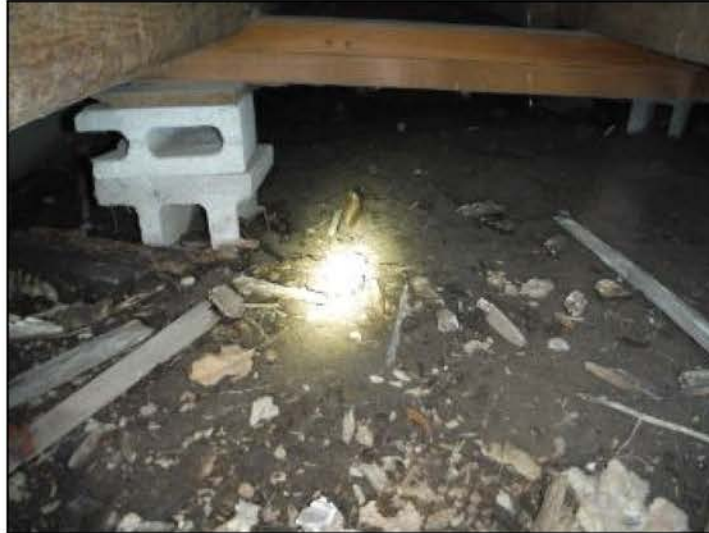
No access

Too low to crawl, this view from damage/hole

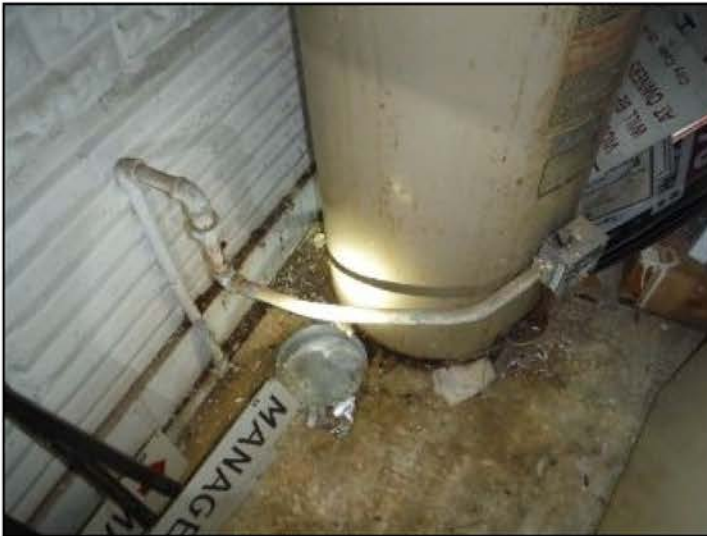
Disconnected (abandoned status)

Untested/no gas

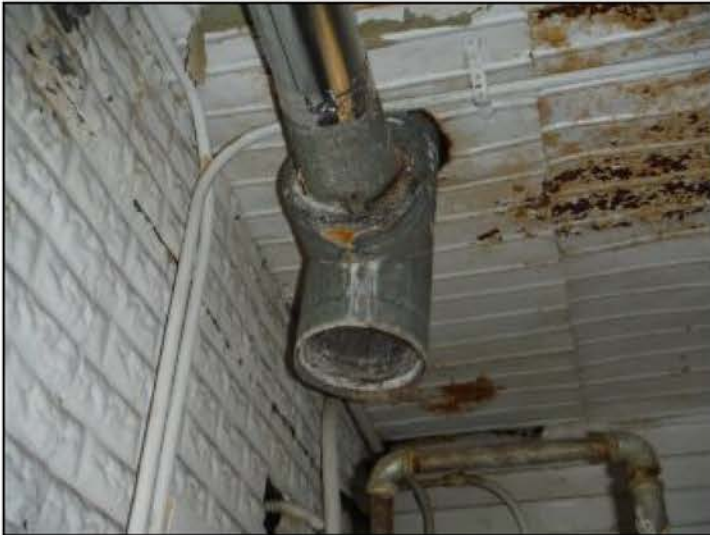
Disconnected (abandoned status)

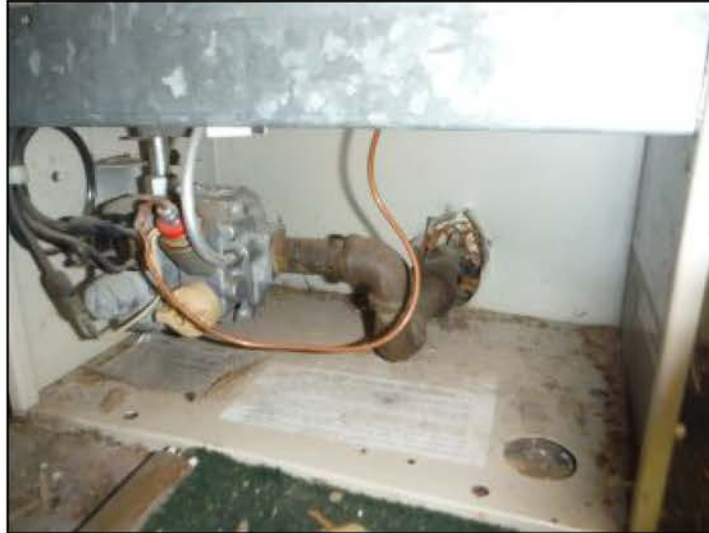
Untested older unit needs upgrade/replacement

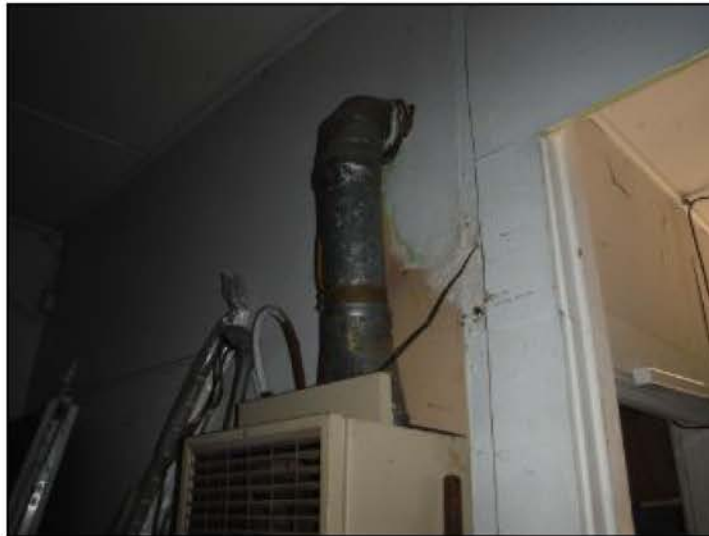
Untested, gas off

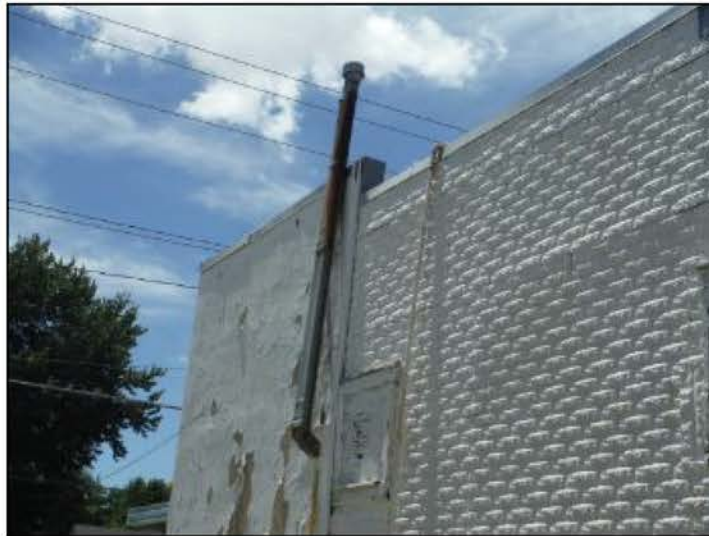
Untested flue

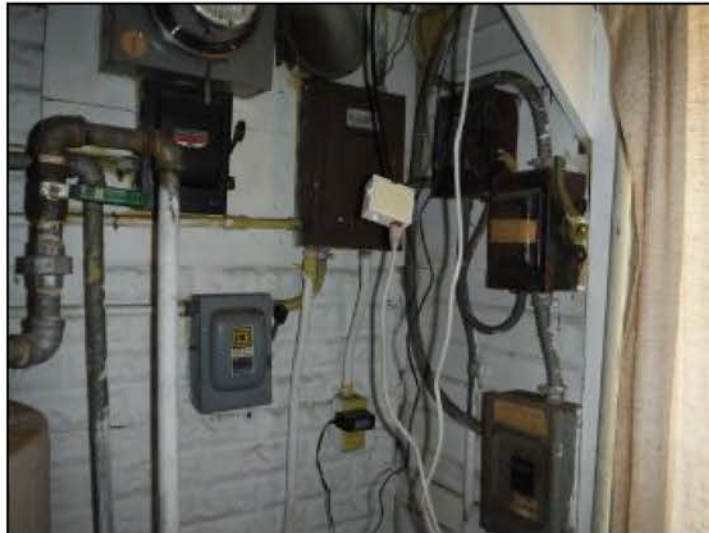
Multiple fuse panels/subpanels, not to current standards for commercial property

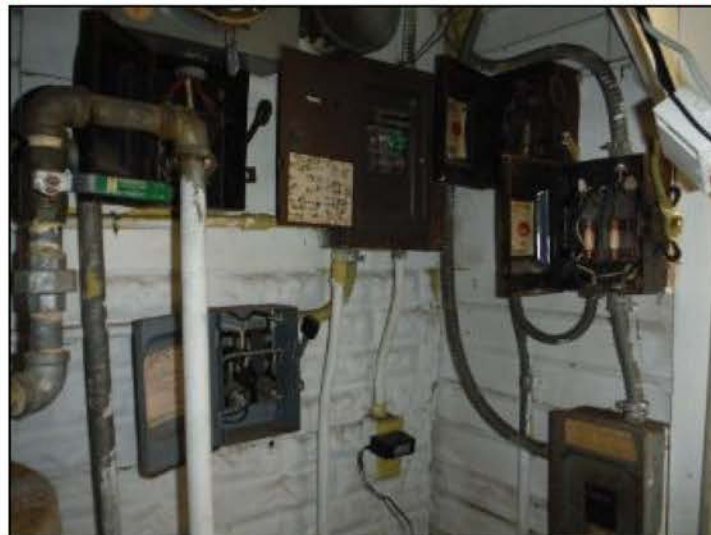
Multiple fuse panels/subpanels, not to current standards for commercial property

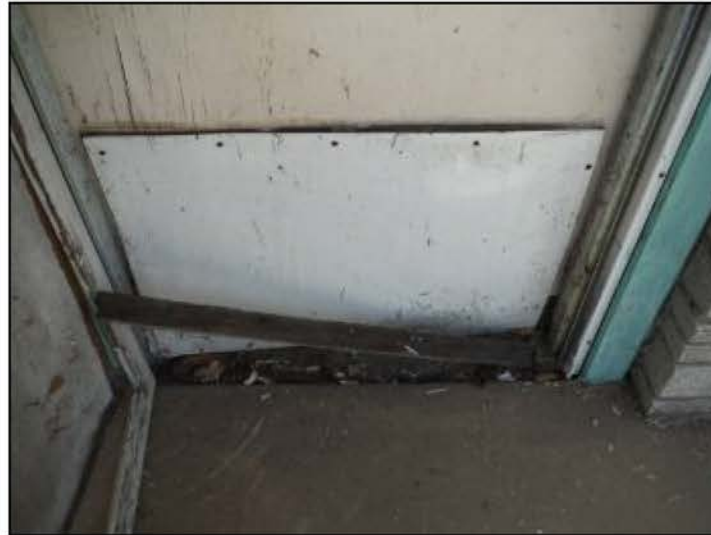
Blocked/untested/inoperative

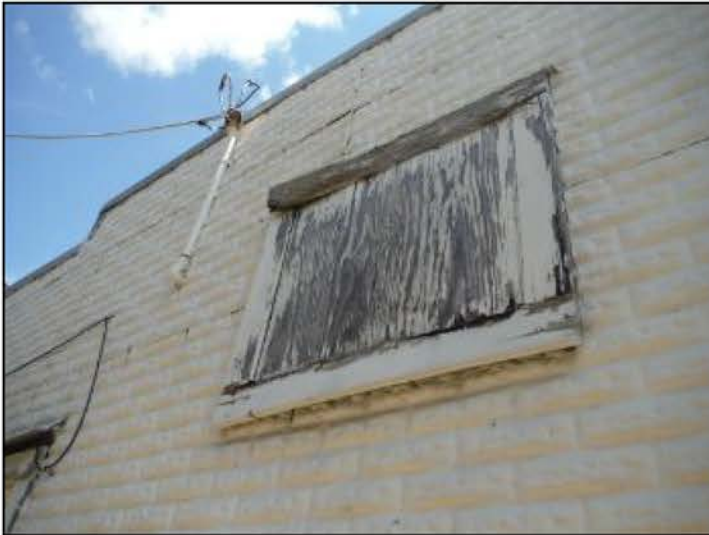
Boarded up

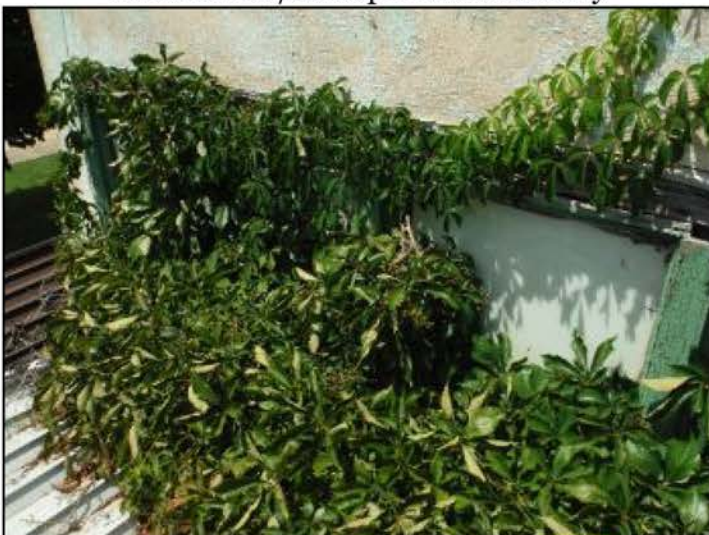
Foliage limits access

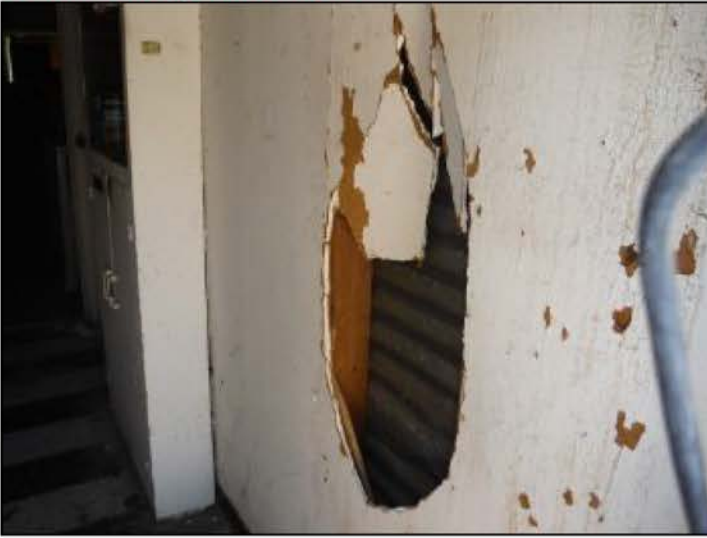
Damaged drywall

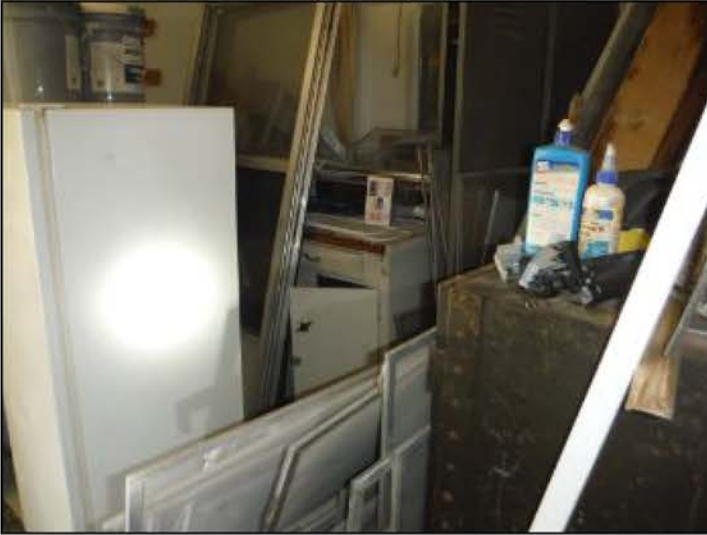
Some storage is hazardous

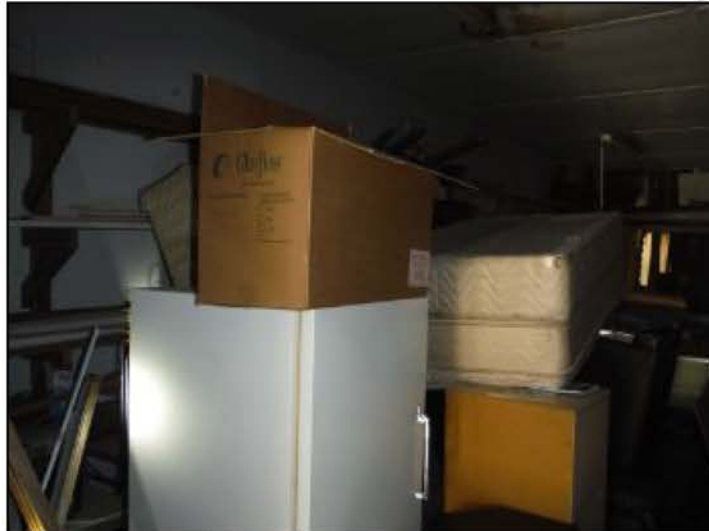
Some storage is hazardous

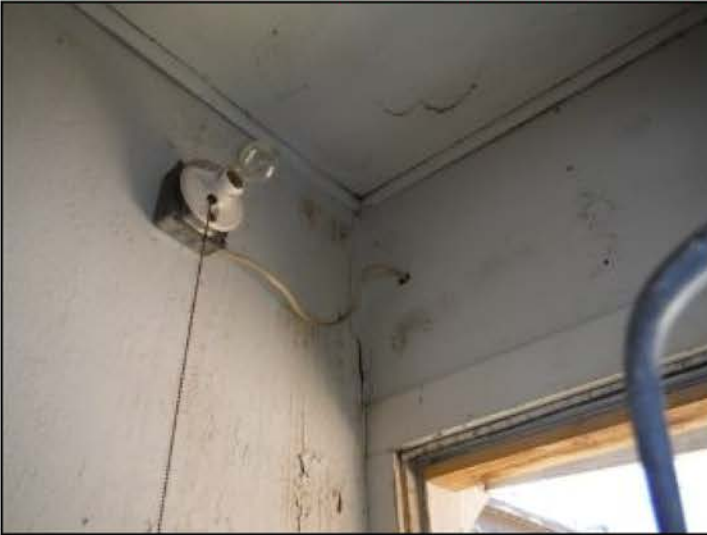
Numerous stains

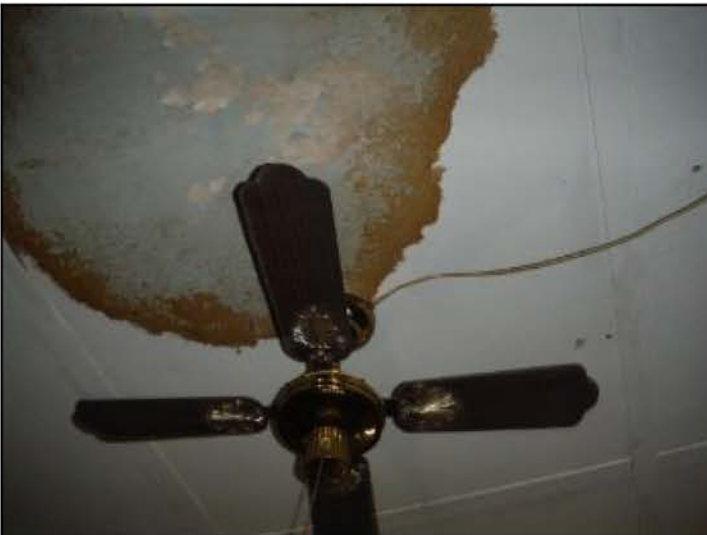
Stains and water damaged ceiling, sign of roof issues

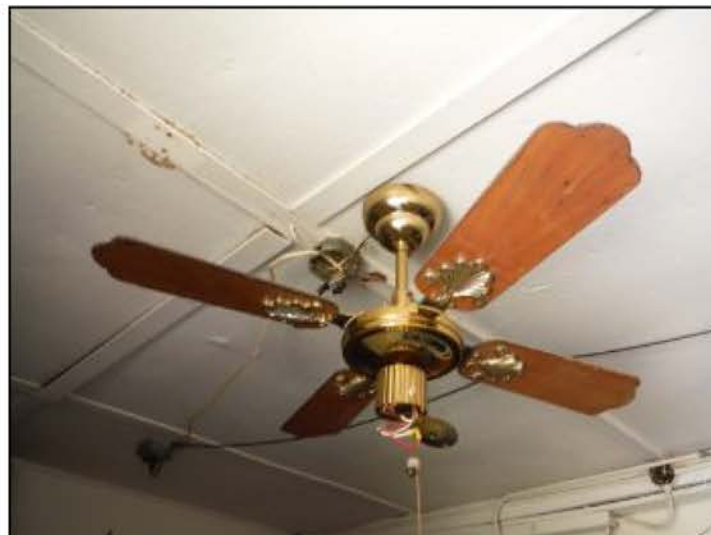
Inoperative fan (or switch not found)

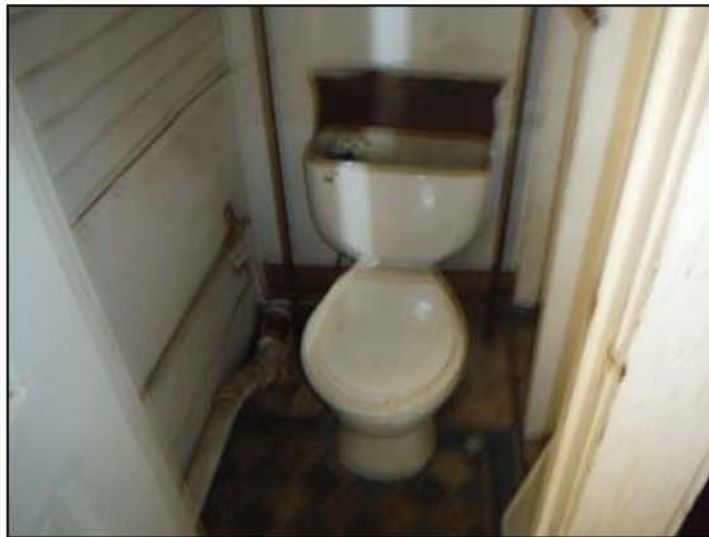
Untested, no water

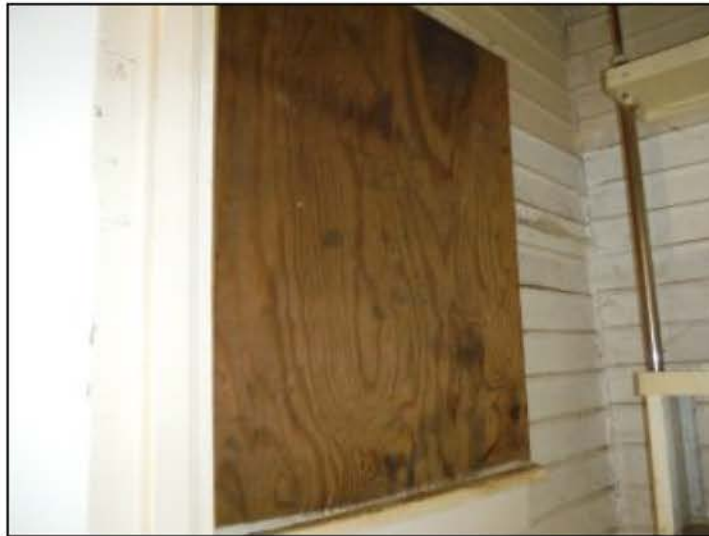
### 3. Vent/Heat

Unvented space, not to current commercial standards

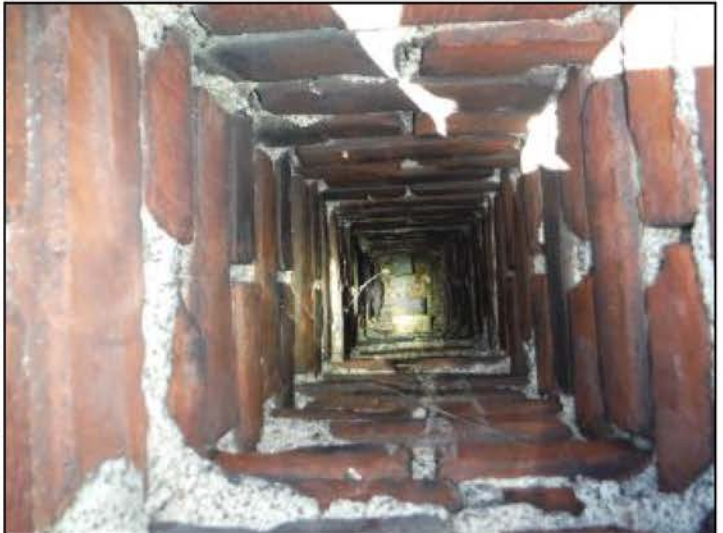
Yes, unlined (old school)

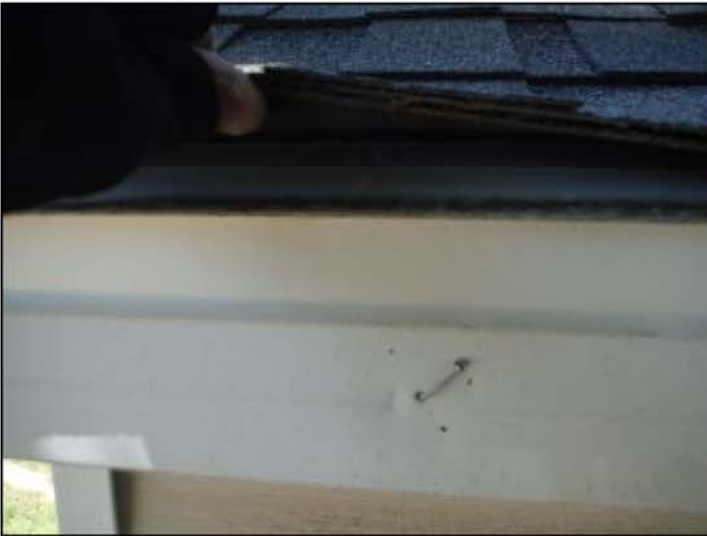
## 5. Main Roof

Single layer laminated composition

Periodic inspections recommended, reseal exposed fasteners

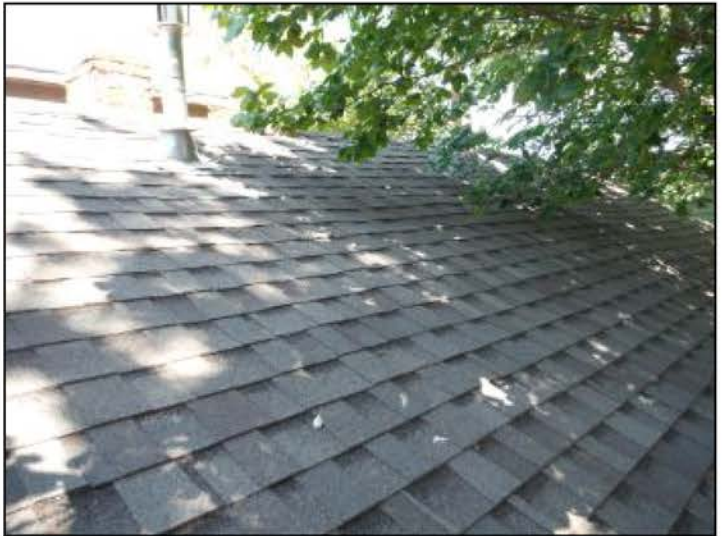
Tree limbs need trimming

Use qualified and insured roofer if/when repairs are needed  
Please do not do your own roof/guttering maintenance  
Tree limbs touch/overhang roof edge, suggest trim them

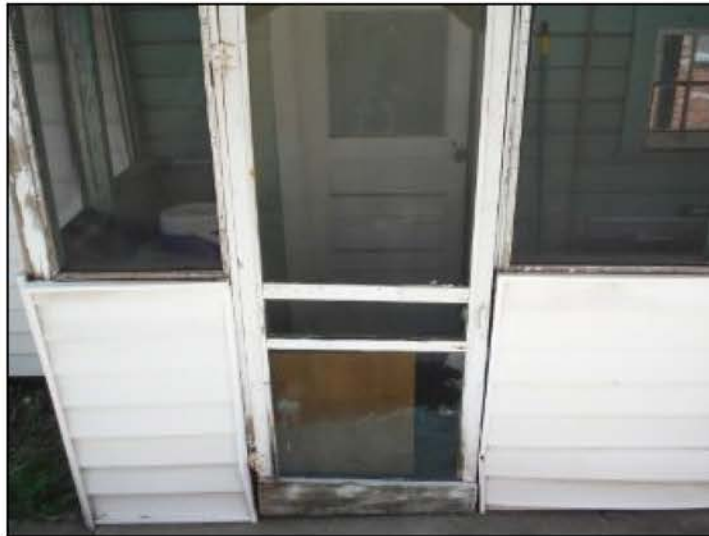
Sagged

Teeny tiny screened enclosure being used for storage

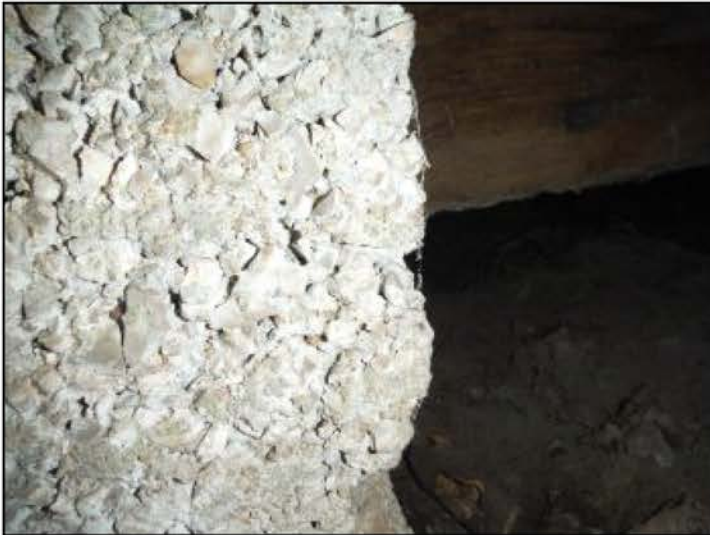
Limited view from vent, east side

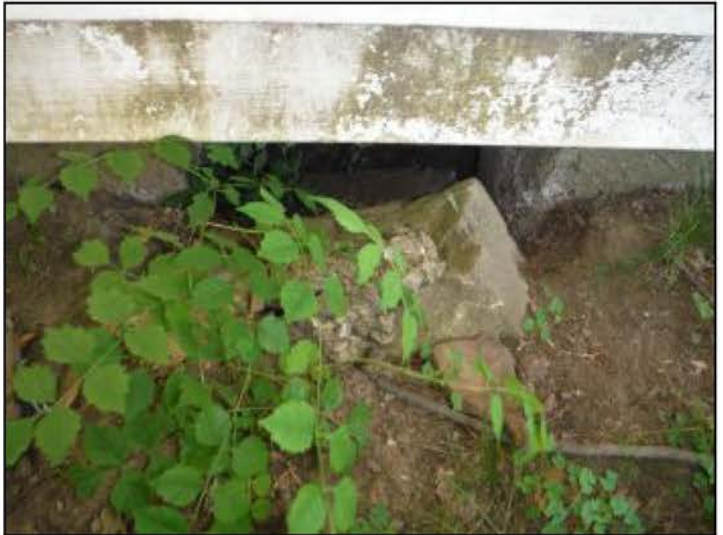
Limited view from vent, east side

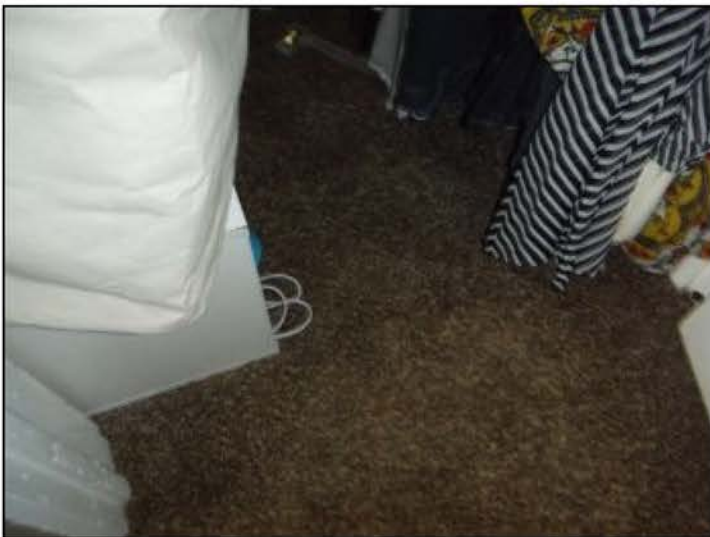
## 2. Floor Construction

Sloped/uneven areas, common for age/design

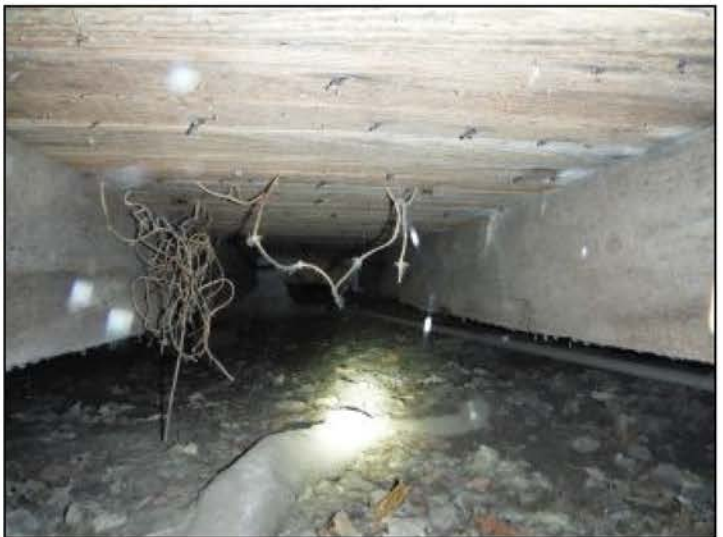
Limited view from vent, east side

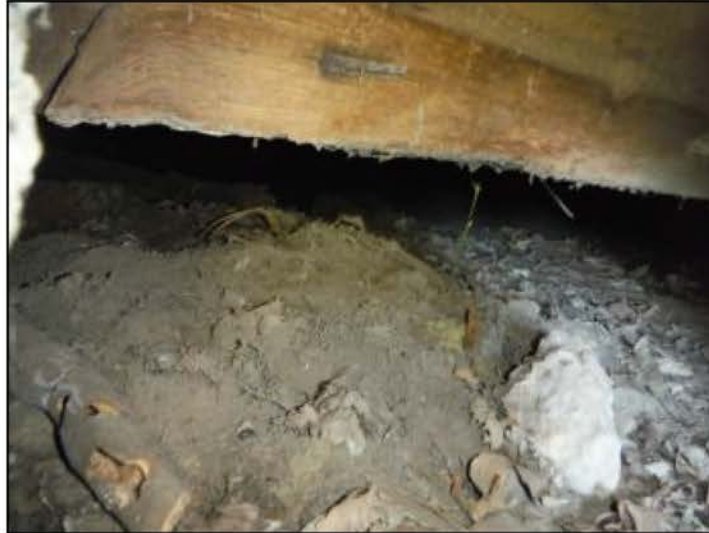
## 3. Moisture Control

Limited view from vent, east side

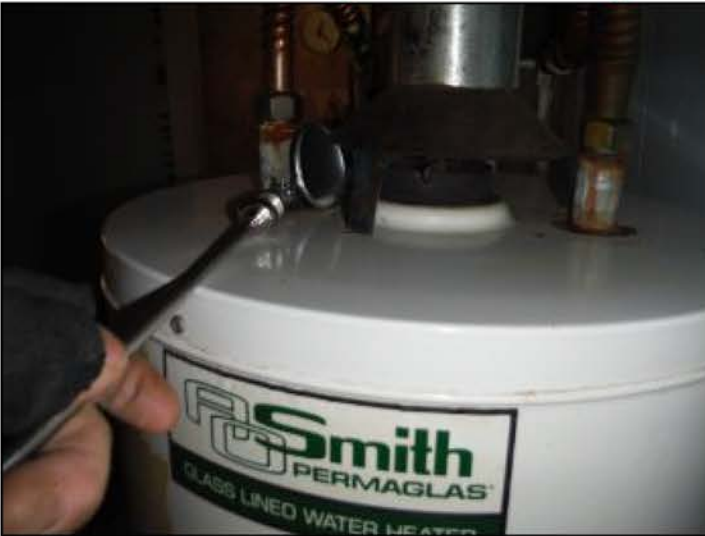
## 3. Observations:

| Page 11 Item: 3 | Observations: | Backdraft measured, is persistent, refer to plumber for repair ASAP (health and safety hazard) |

Backdraft measured, is persistent, refer to plumber for repair ASAP (health and safety hazard)

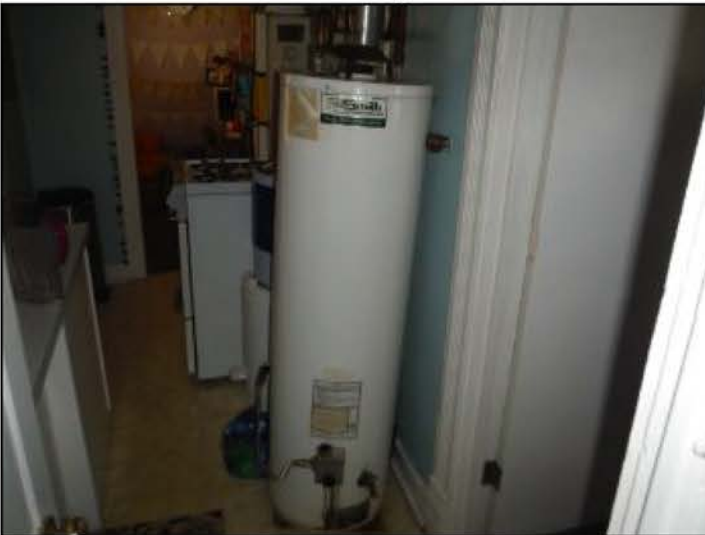
Older unit has limited life

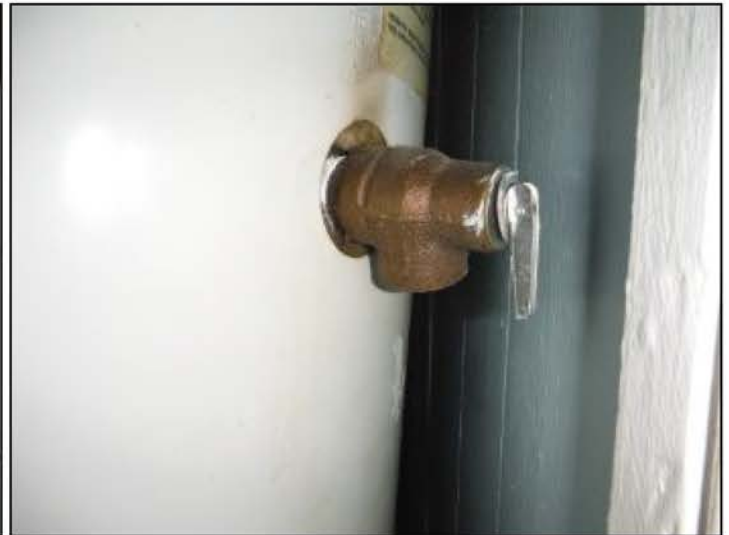
TPR valve lacks overflow tube

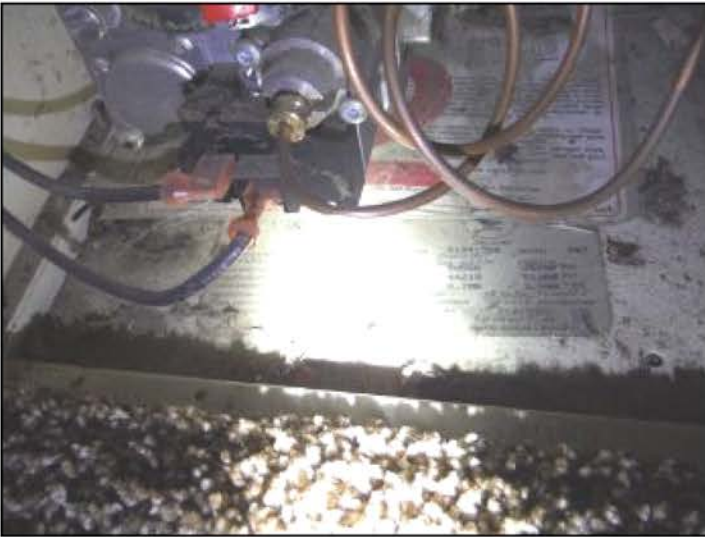
## 5. Conditon

Carpet floor not prudent

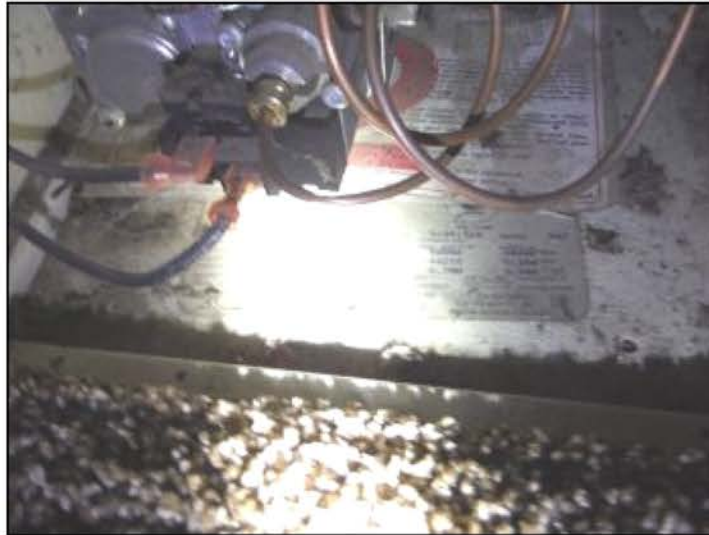
## 7. Combustion Air

Burns room/conditioned air (inefficient)

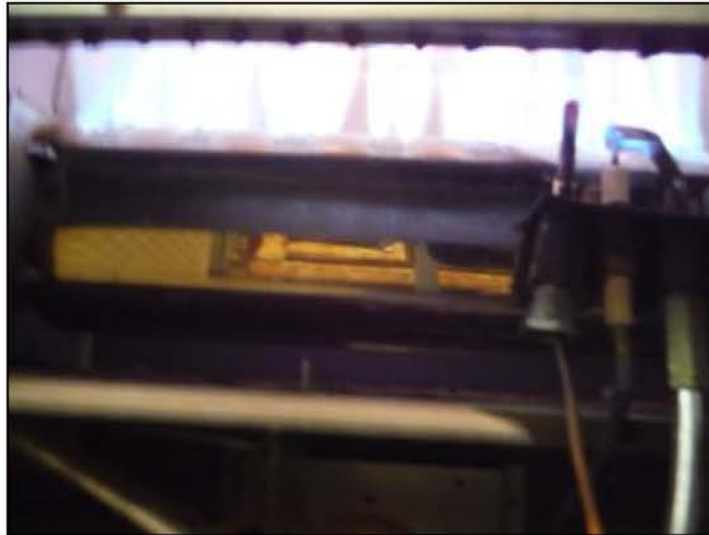
## 8. Burners

Old school but serviceable nonetheless

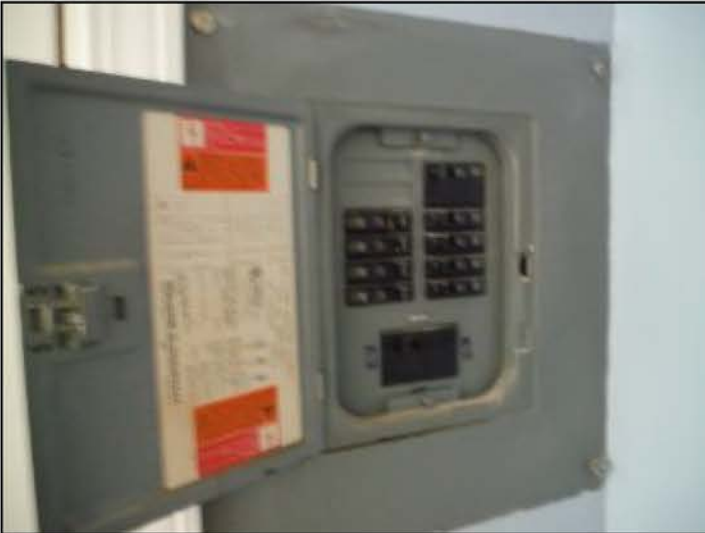
## 3. Main Panel

Excellent upgrade

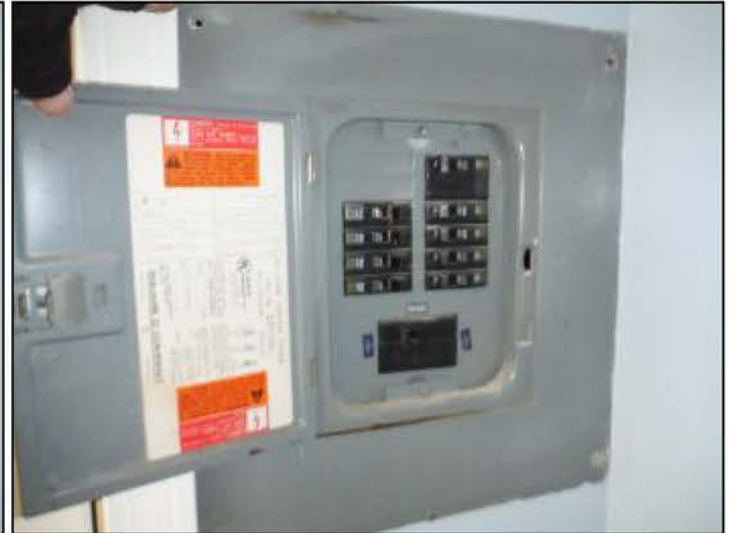
Outlaw, no tags

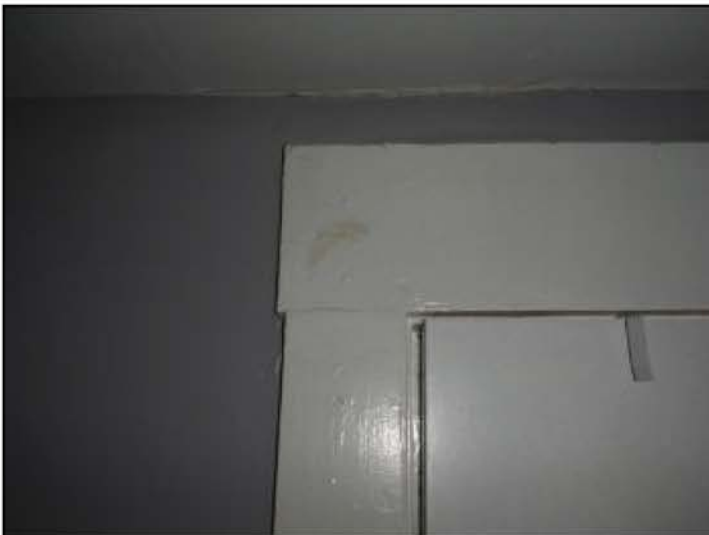
Frames out of square, typical for age

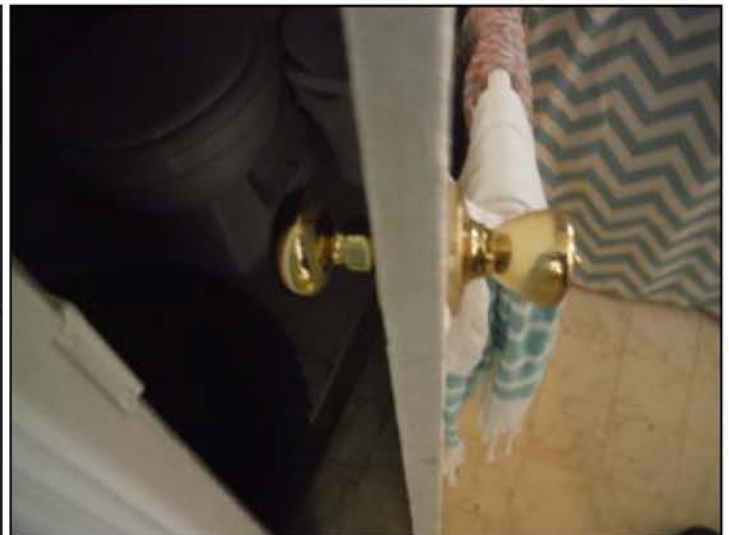
No latch this unit

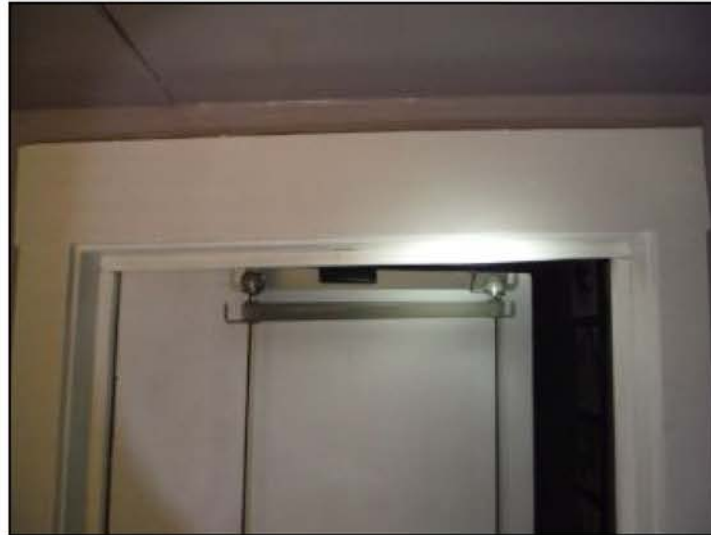
Slider off track

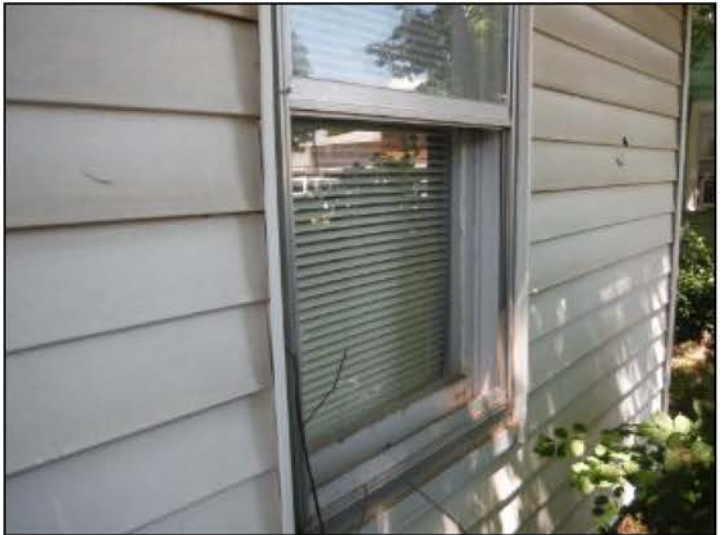
Most windows are inoperative or have serviceability issues

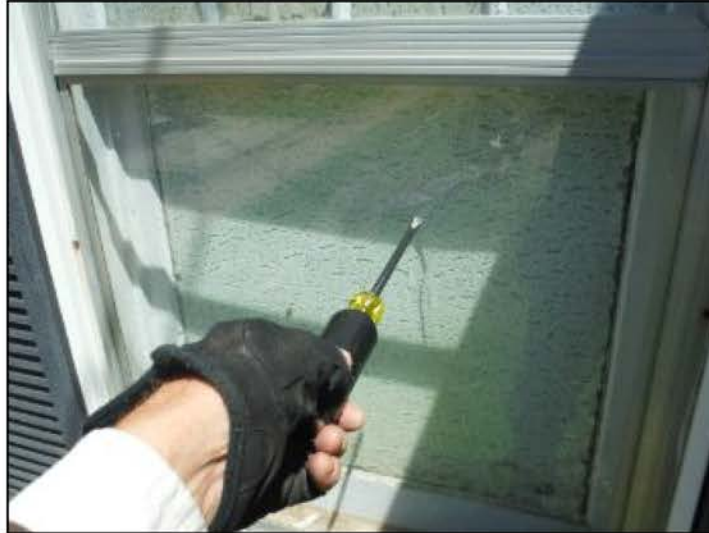
Cracked glass needs repair

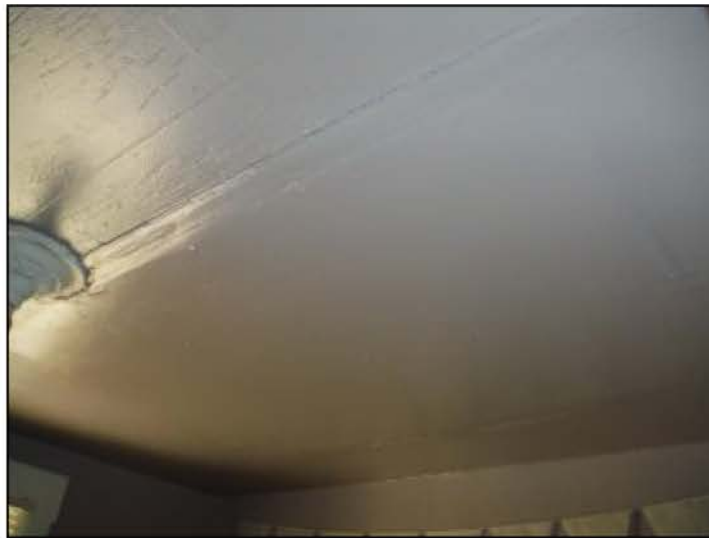
No attic access at ceiling, patched areas noted

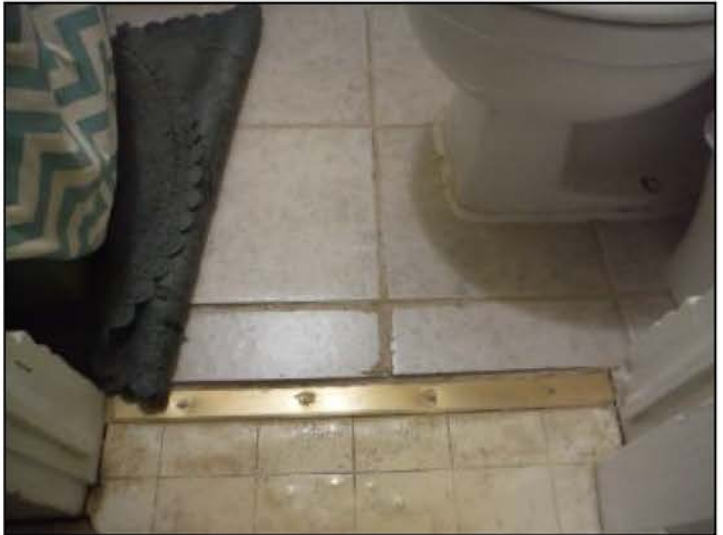
Tacker strip (amateur flooring)

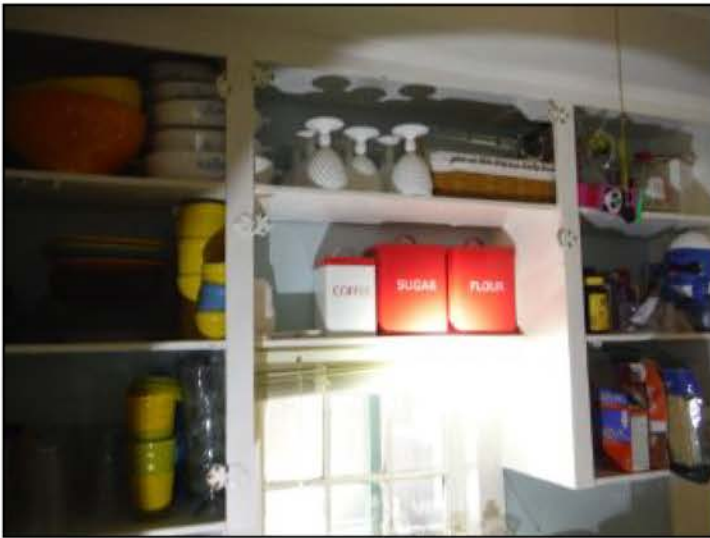
Missing cabinet doors
