# Springfield Land Clearance for Redevelopment Authority

**4.III. Blight Report And Redevelopment Plan For The East Cherry Flats Redevelopment Area**

Documents: [EAST CHERRY FLATS BLIGHT REPORT AND REDEVELOPMENT PLAN.PDF](#)

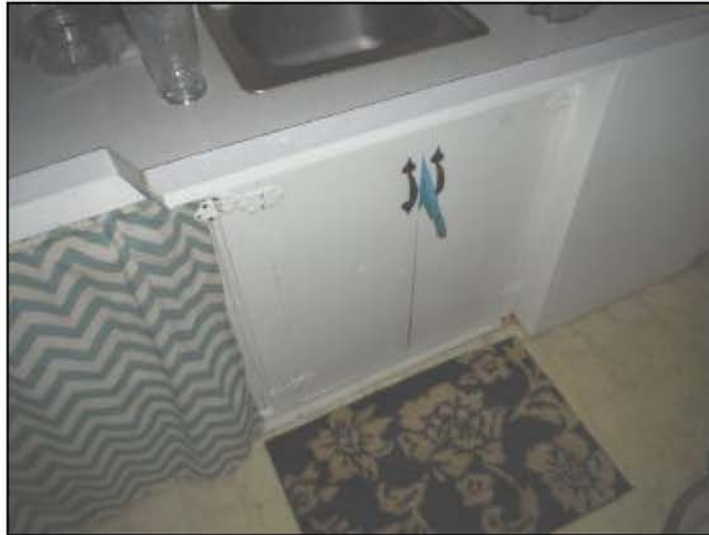
No toe space at sink cabinet

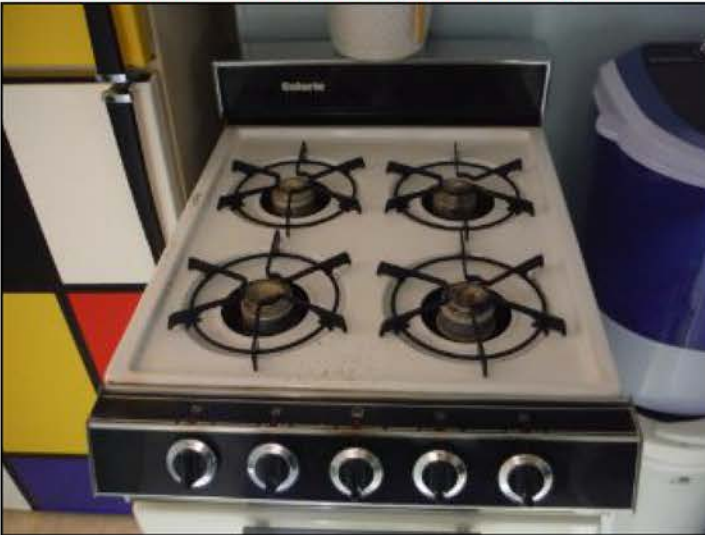
Did not self light, safety hazard, needs immediate repair

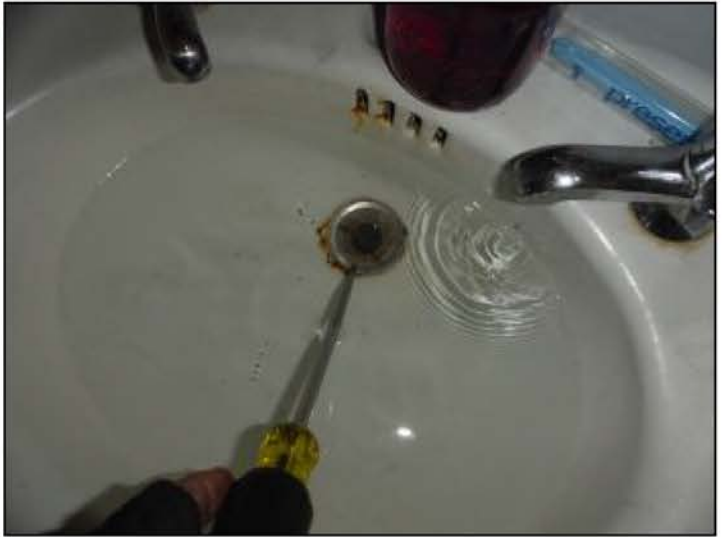
Missing stopper

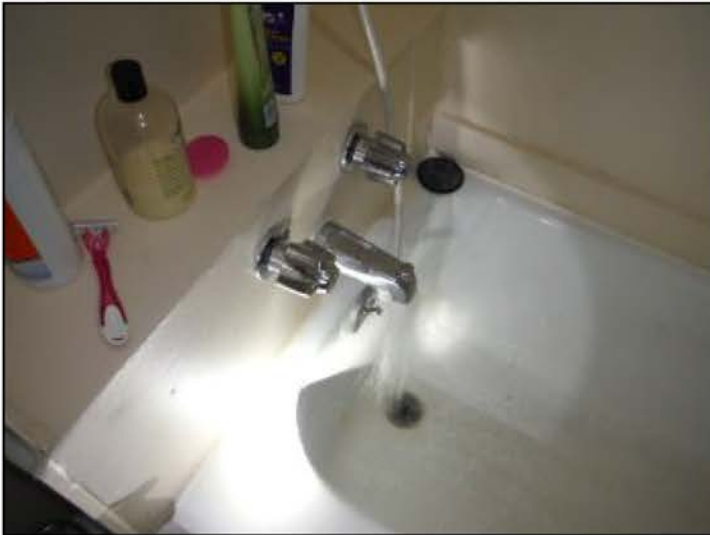
Old school, valves not balance type

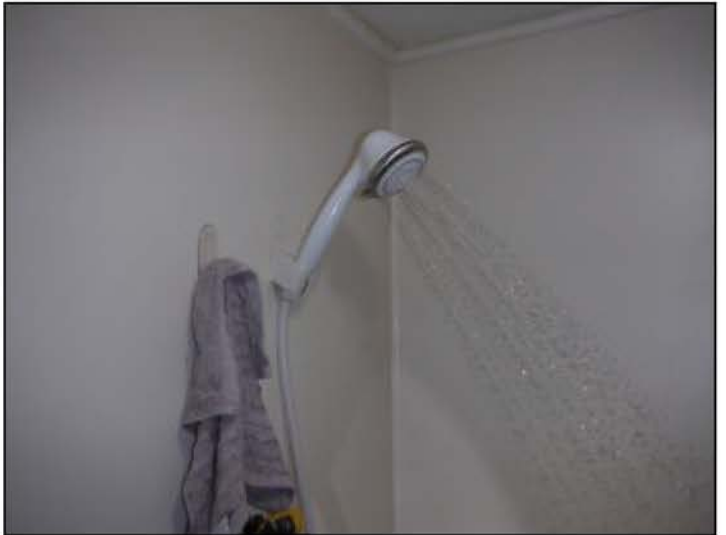
Flex sprayer added

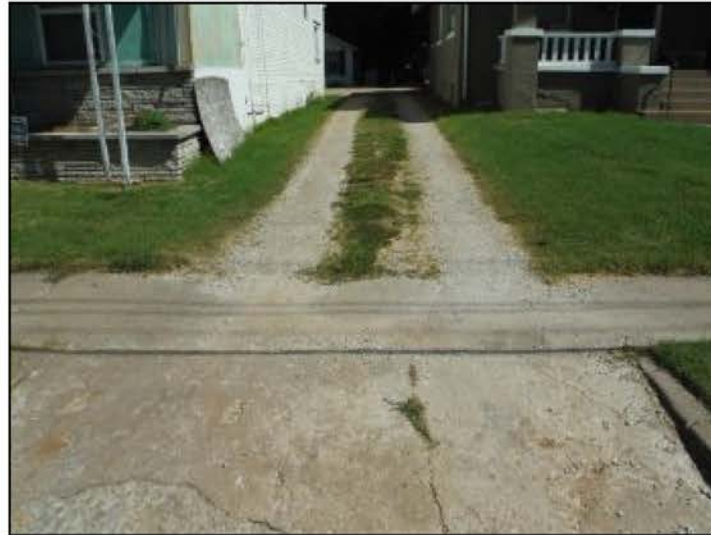
Approach/es not to today's standard

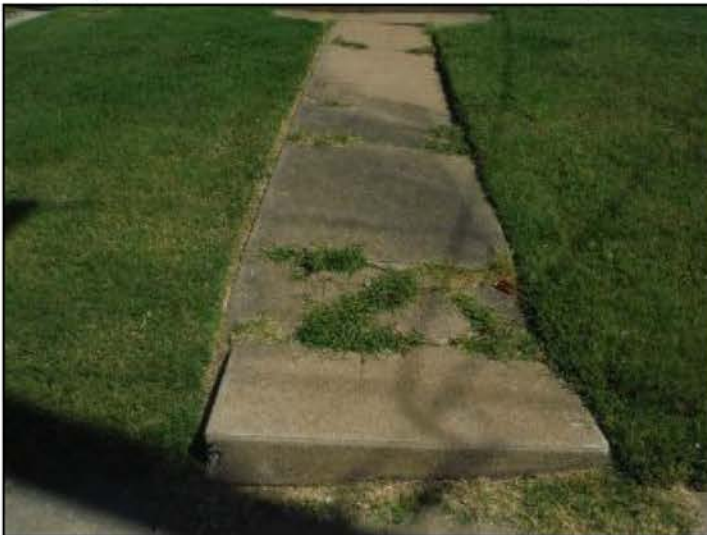
Common and larger cracks with lifting/settling to 1-2 inches, trip hazards

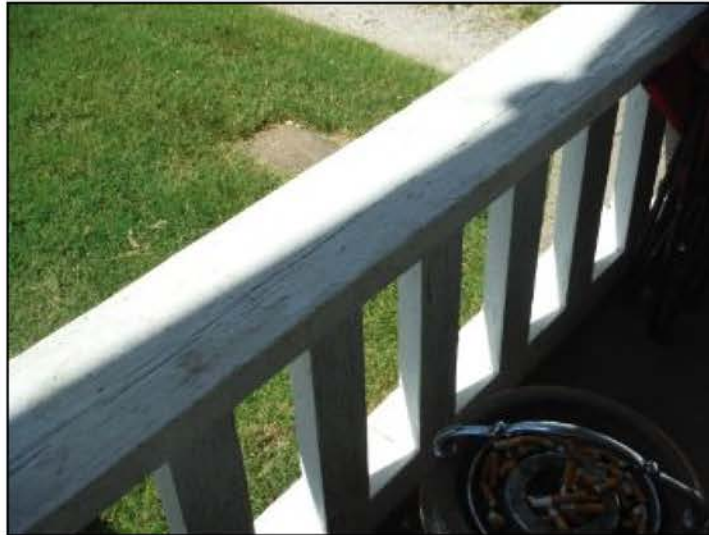
Wood railings are too short be today's standard (people can use as seating, then tip over)

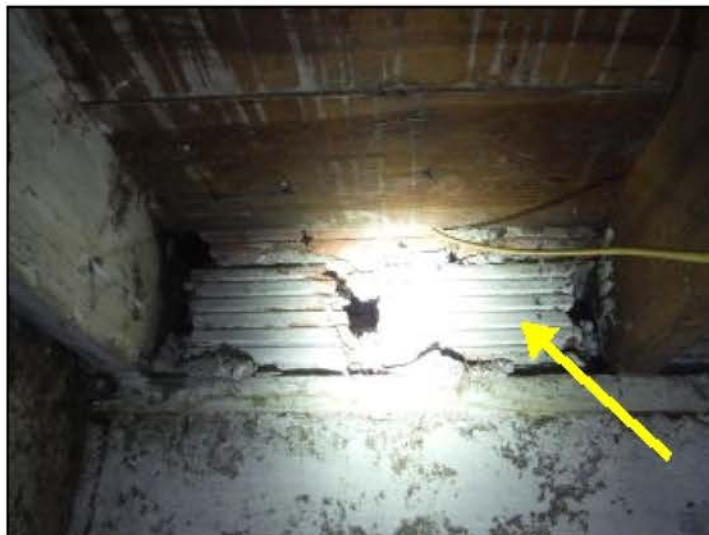
No insulation at outside walls, common issue with true masonry (clay tile and stucco/plaster finish)

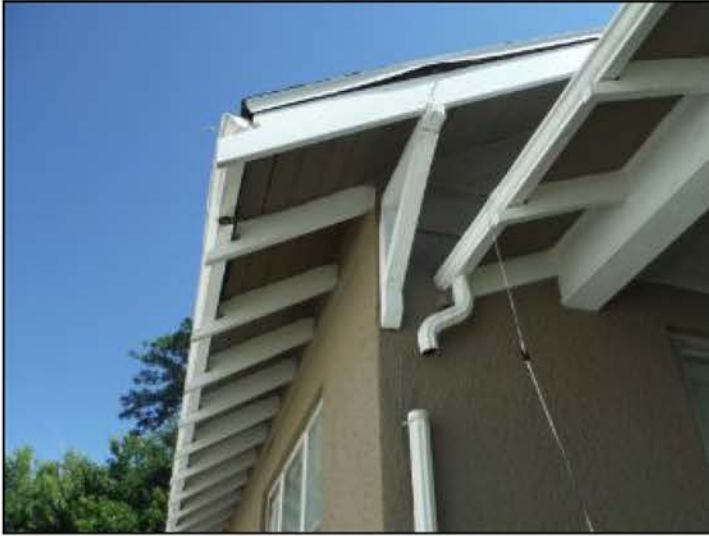
Rusted/damaged/incomplete guttering needs removal/replacement

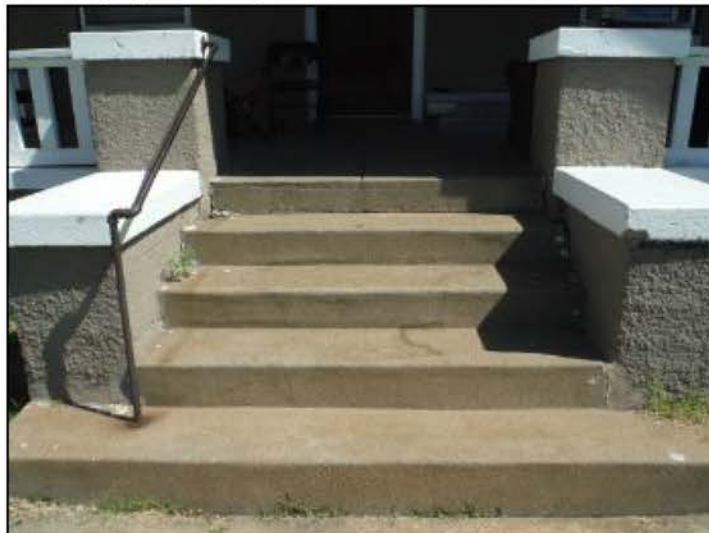
Serviceable concrete has a steel pipe railing one side

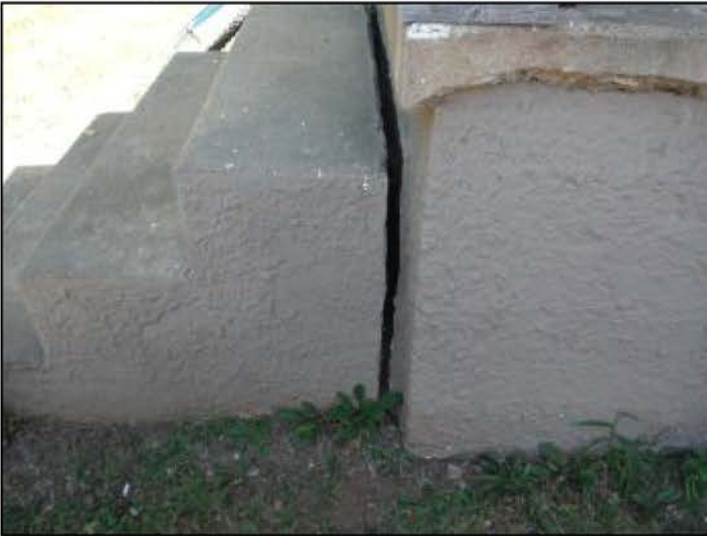
Settling has caused wide gap to develop at stoop,  
no action needed

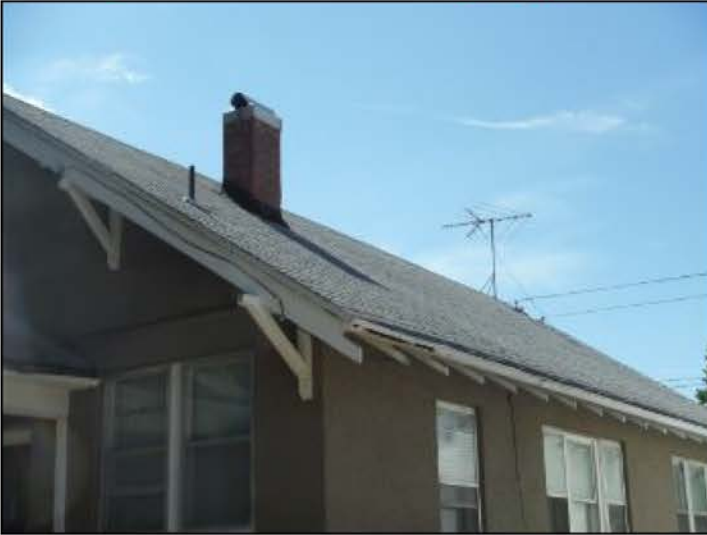
Two layers is limit since February 1995, this house has three

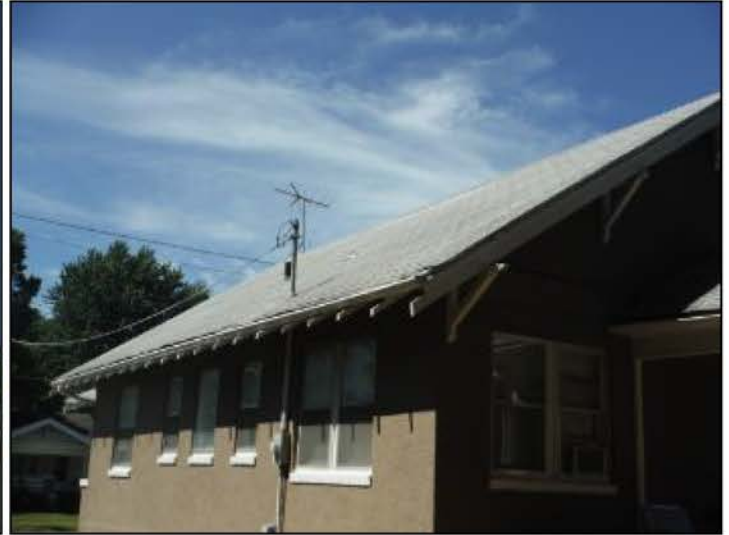
Two layers is limit since February 1995, this house has three

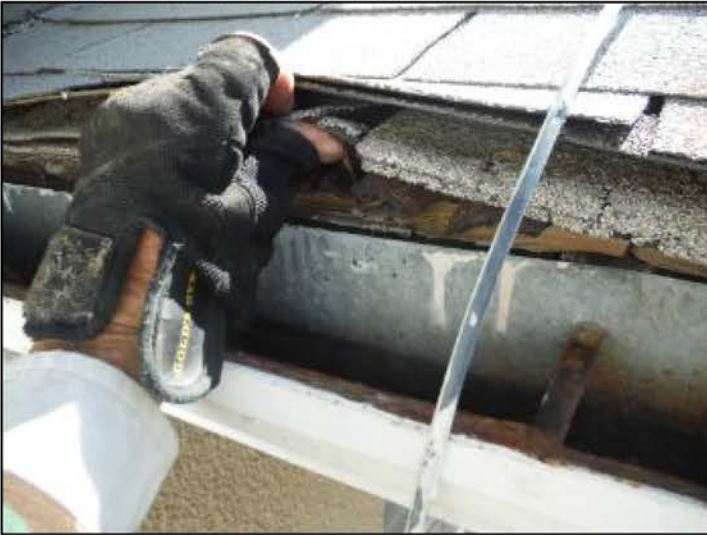
Multiple layers: Two or more composition overlay original wood shingles (which with gapped sheathing are substrate for composition)

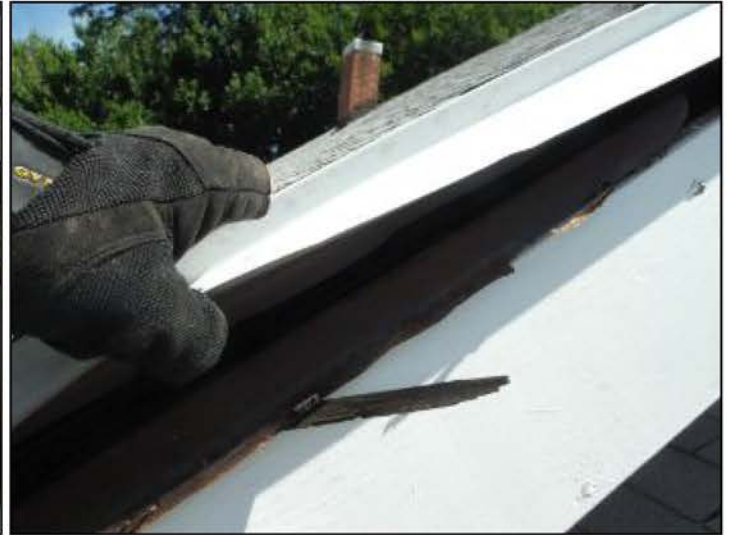
Multiple layers: Two or more composition overlay original wood shingles (which with gapped sheathing are substrate for composition)

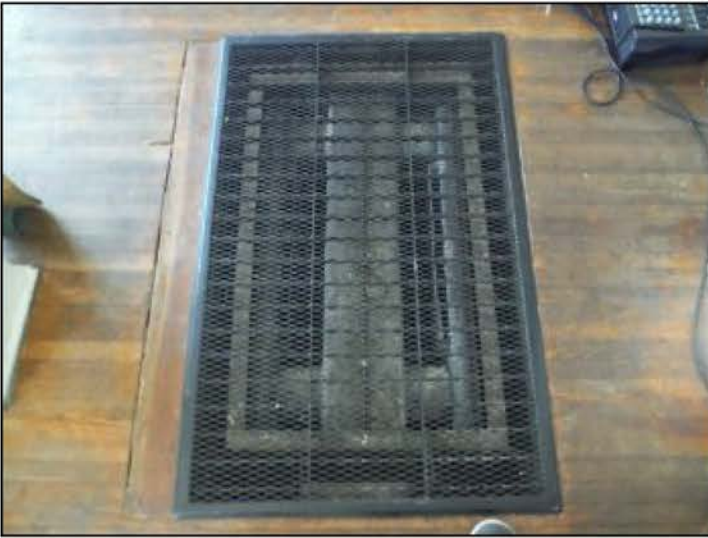
Dated system needs upgrading when central air conditioning is to be installed

Recommend regular cleaning by HVAC technician

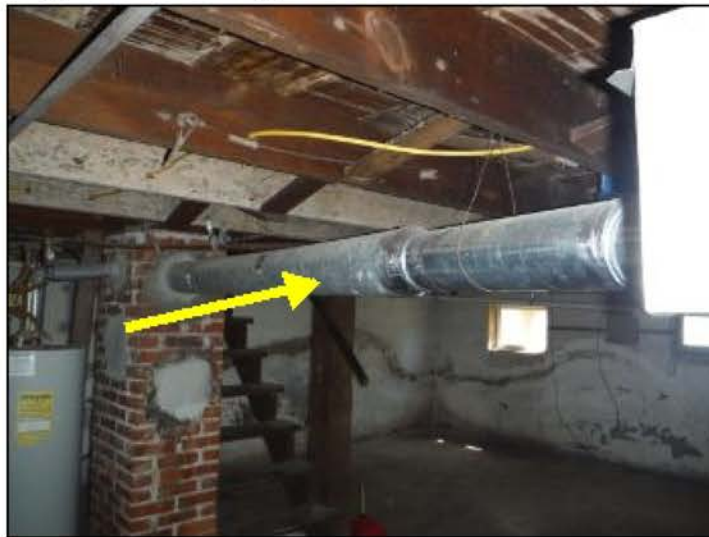
Vents into masonry chimney, this is no longer allowed

Long near horizontal piping at basement noted

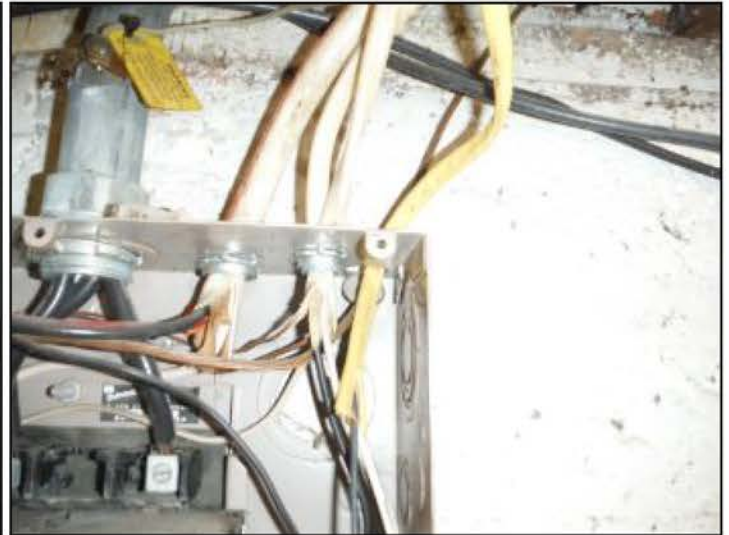
Missing wire clamps as installed

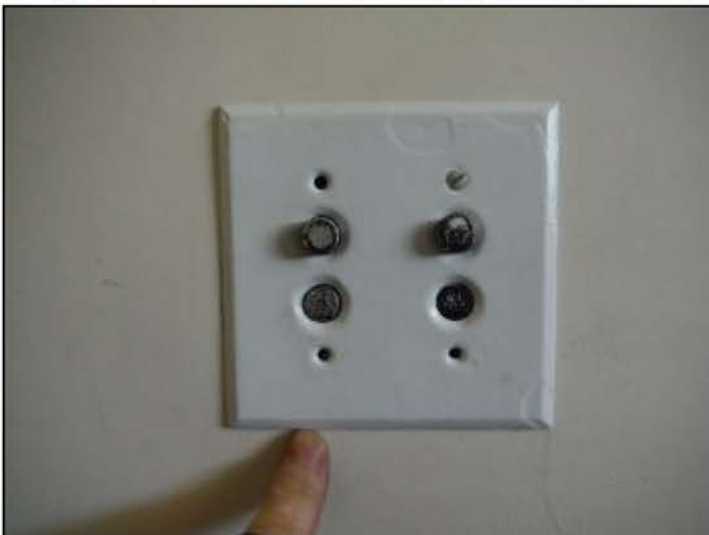
Some push button switches have mercury in them

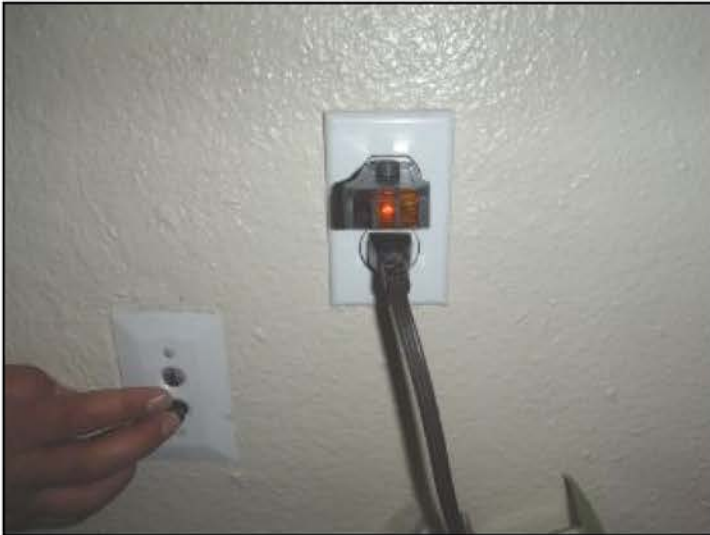
Ungrounded/miswired (reverse polarity) outlet/s found, suggest all be checked and corrected

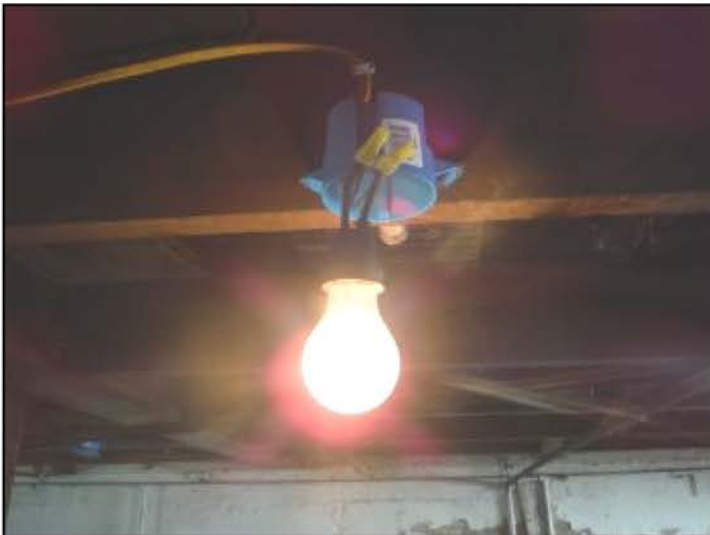
Unsecured wiring (exposed wiring/splices/open junction boxes) observed at basement and attic, refer to electrician to cleanup/secure

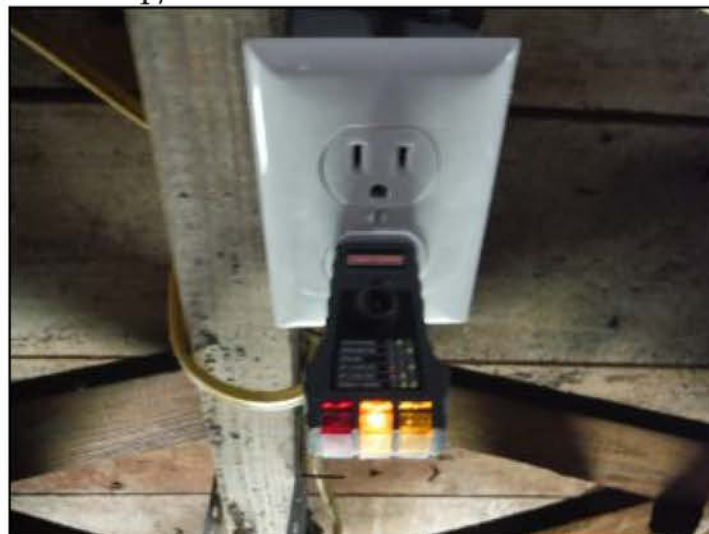
Ungrounded/miswired (reverse polarity) outlet/s found, suggest all be checked and corrected

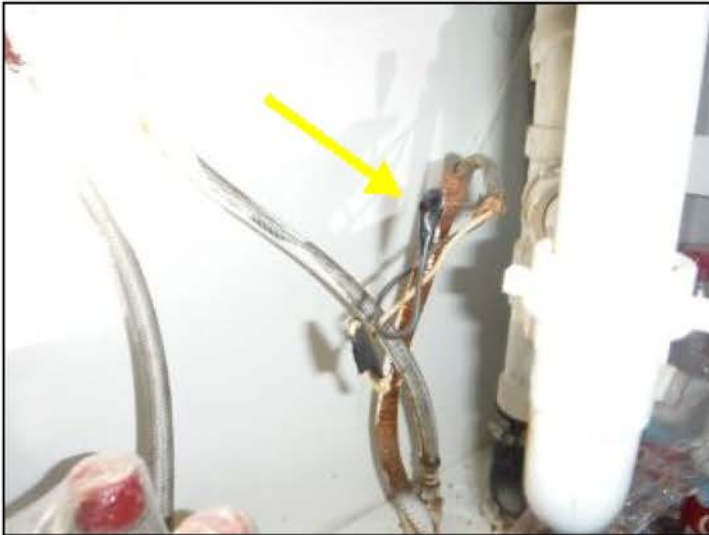
Leak/s at supply/faucet below, refer to plumber Note pro vent below, ess trap noted (old standard)

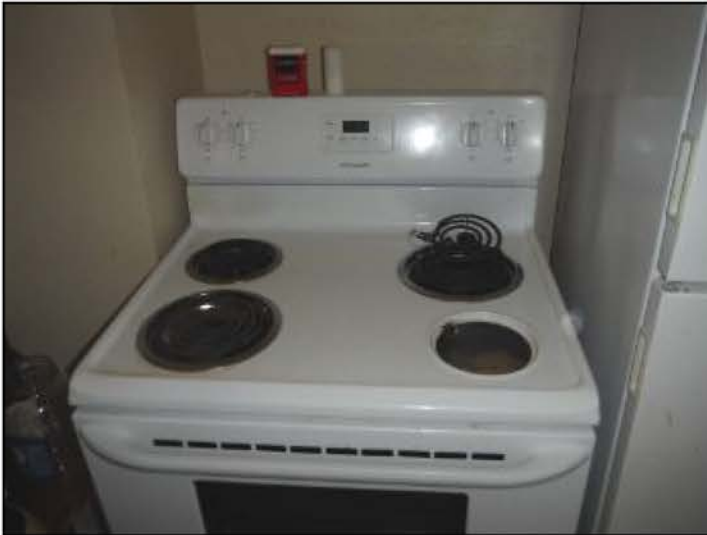
Verify anti tilt or upgrade for child safety

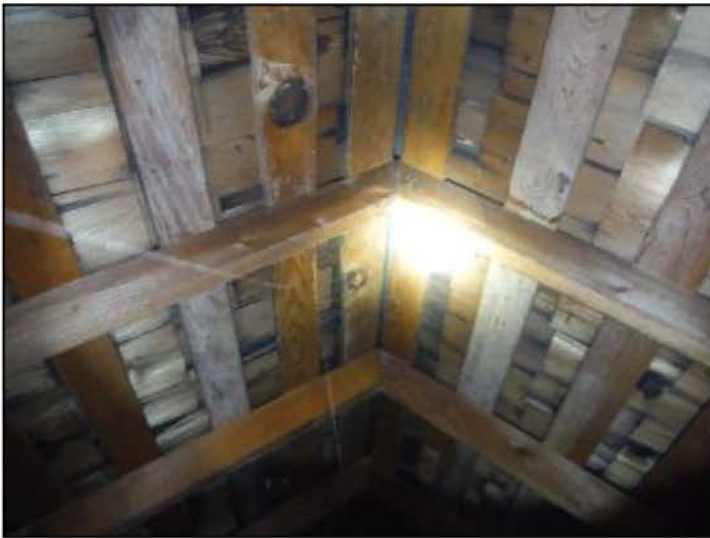
Minimal ventilation

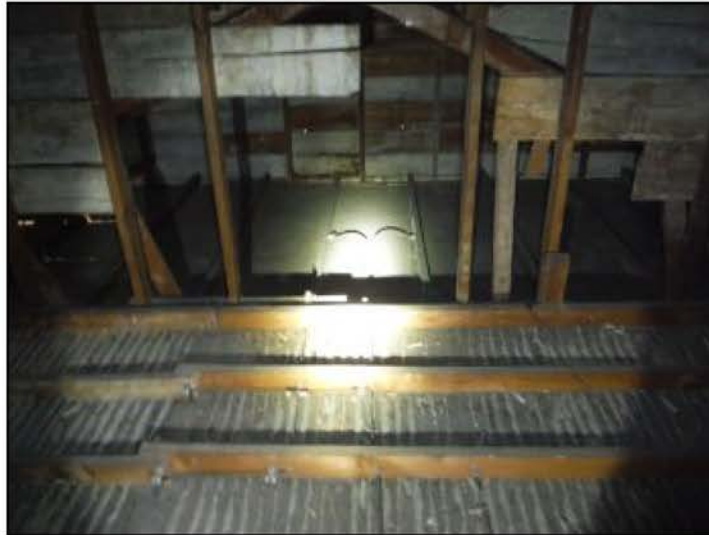
Has never been upgraded, no insulation at attic or exterior walls, needed

Recommend upgrade with cellulose, contemporary goal is R-50 average

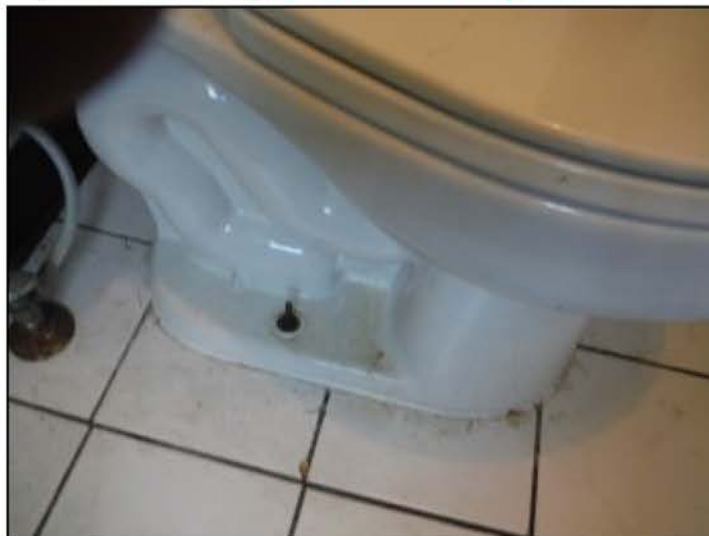
| Page 27 Item: 1 | Toilet | Monitor, loose at floor, may need resetting with new wax ring soon |

Monitor, loose at floor, may need resetting with new wax ring soon

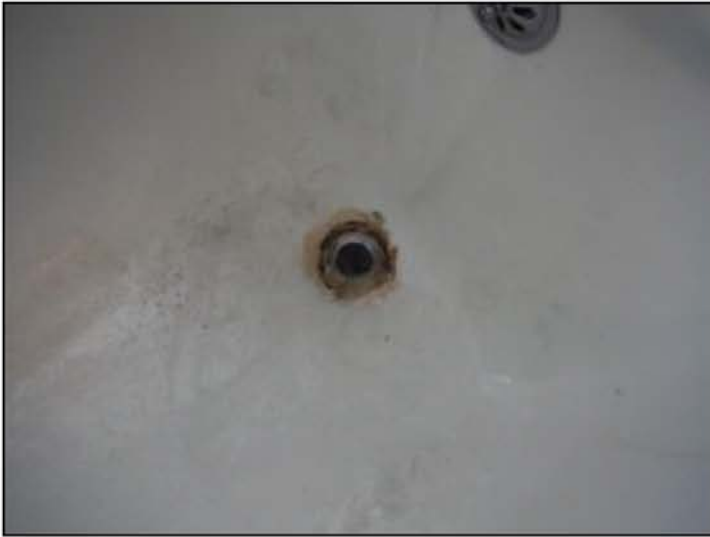
Serviceable though stopper missing and stains/wear noted

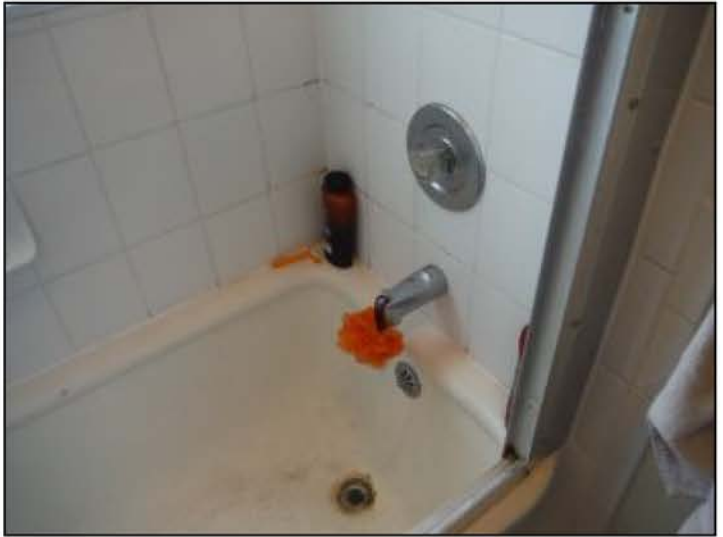
Material unfamiliar to me, a resin concrete related casting

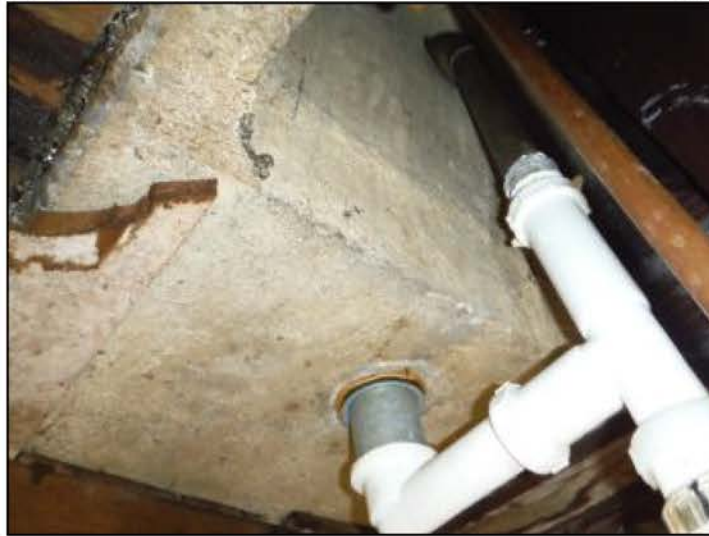
Material unfamiliar to me, a resin concrete related casting

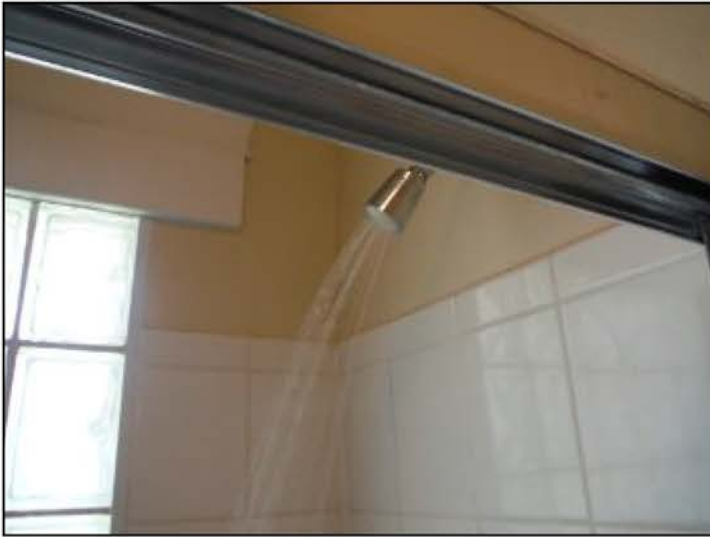
Low head clearance noted at top door track

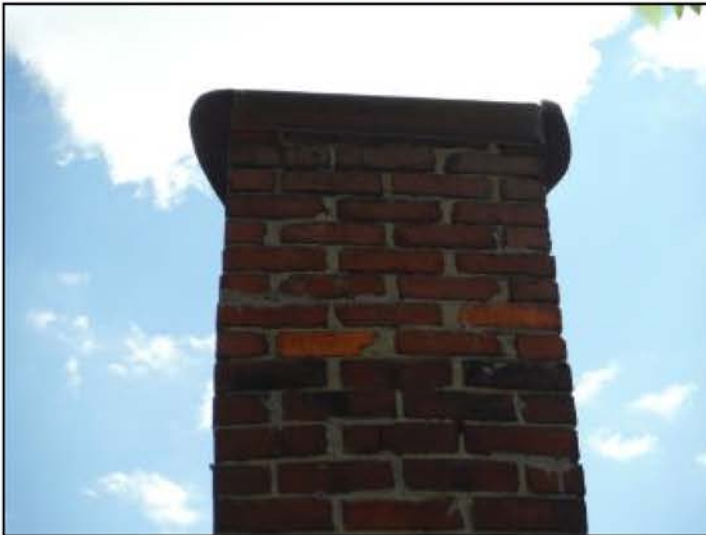
Refer to qualified mason for maintenance

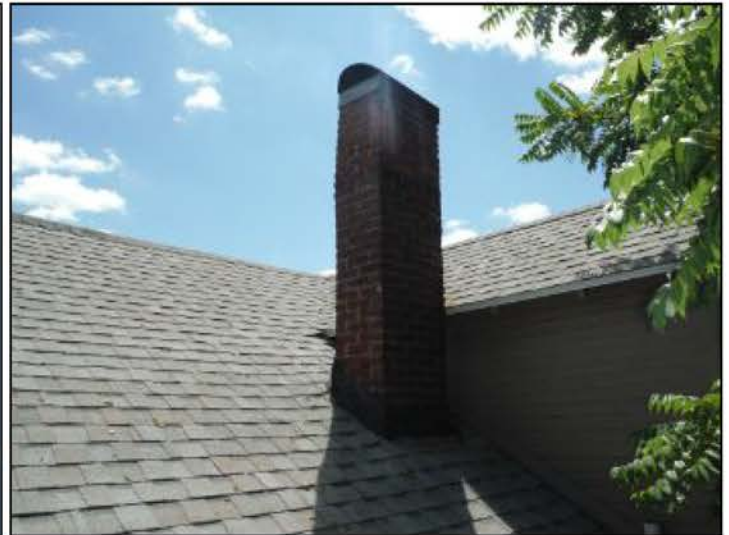
Vents gas water heater and furnace, old standard may not be allowed

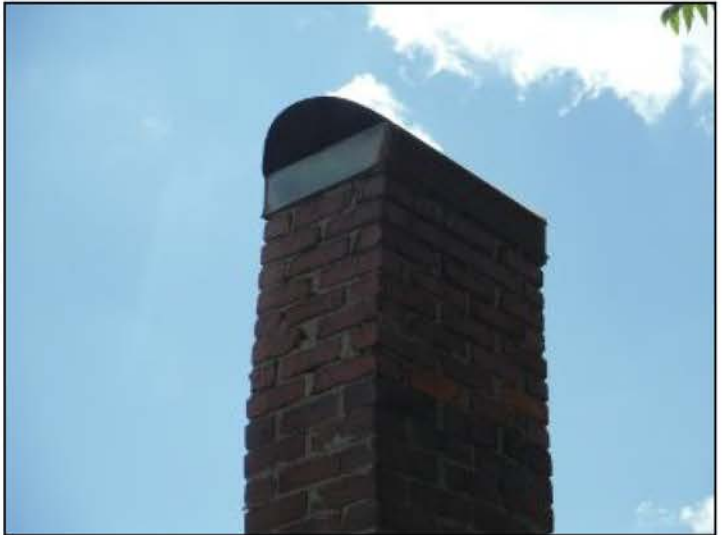
Limited inspection

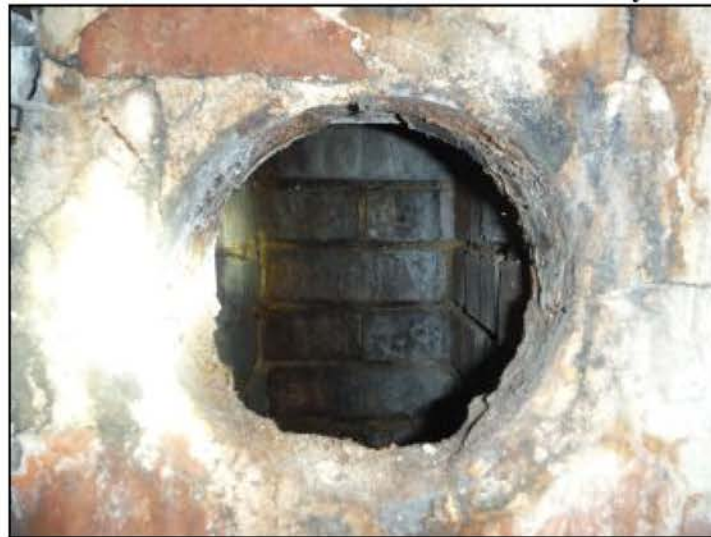
| Page 6 Item: 1 | Chimney Observations | Vents gas water heater and furnace, old standard may not be allowed<br>Deteriorated mortar at basement<br>Open flue connection, needs capping off at attic (fire hazard) |

Open flue connection, needs capping off at attic (fire hazard)

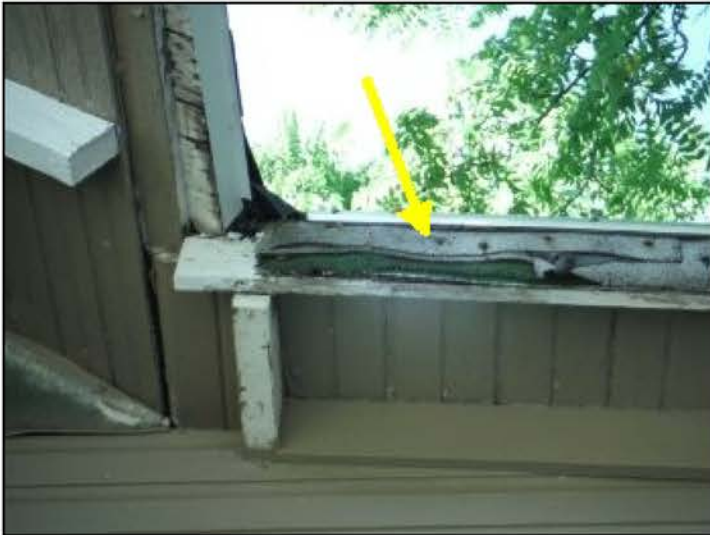
EPDM top layer recover over multiple layers of composition

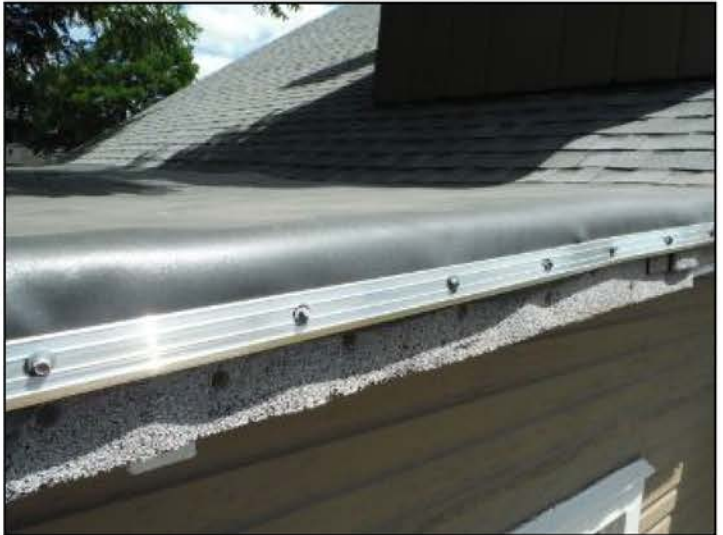
EPDM top layer recover over multiple layers of composition

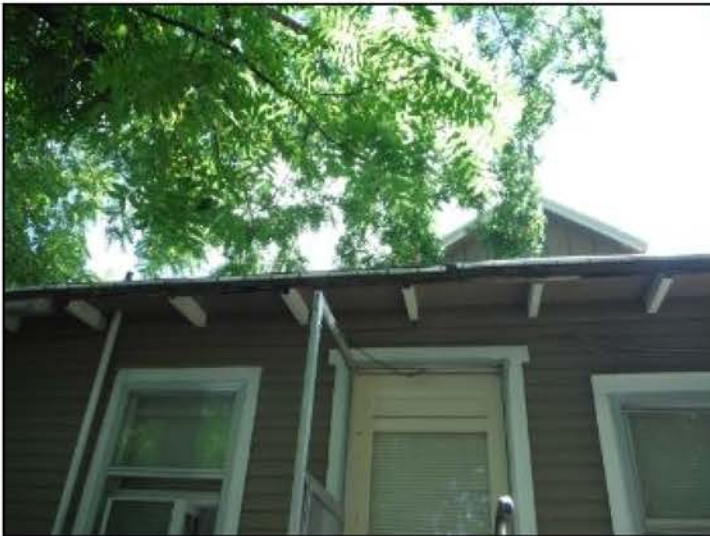
Tree limbs need trimming

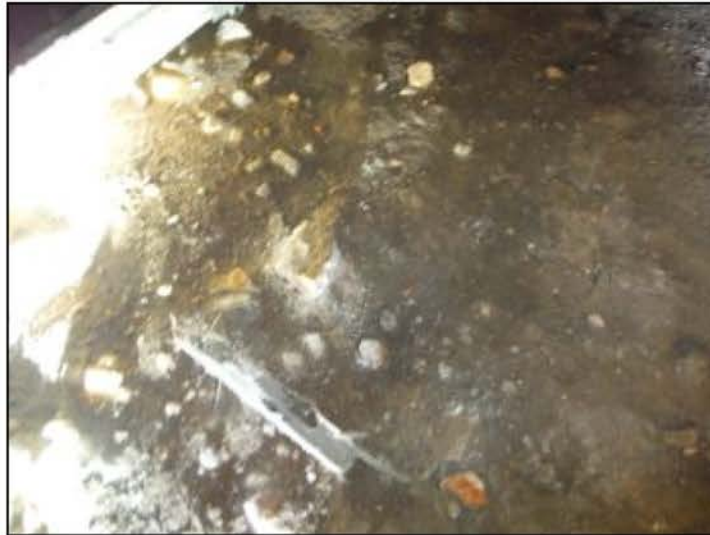
Dry ground, partial plastic film

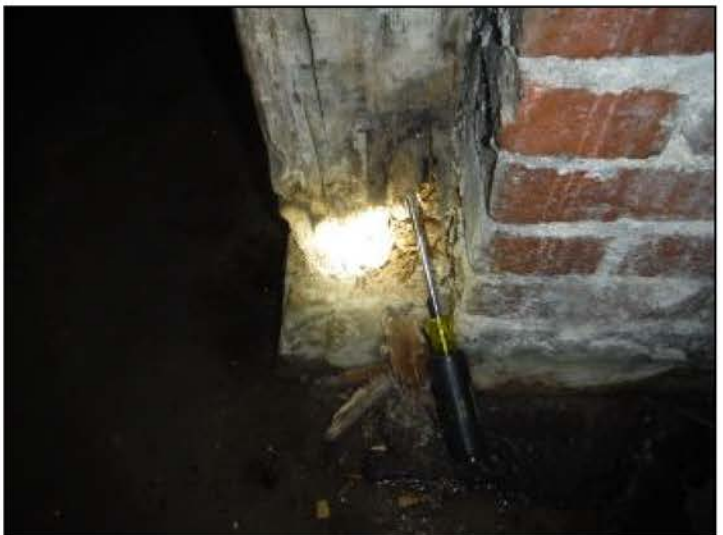
Rotted posts, refer to termite inspection report

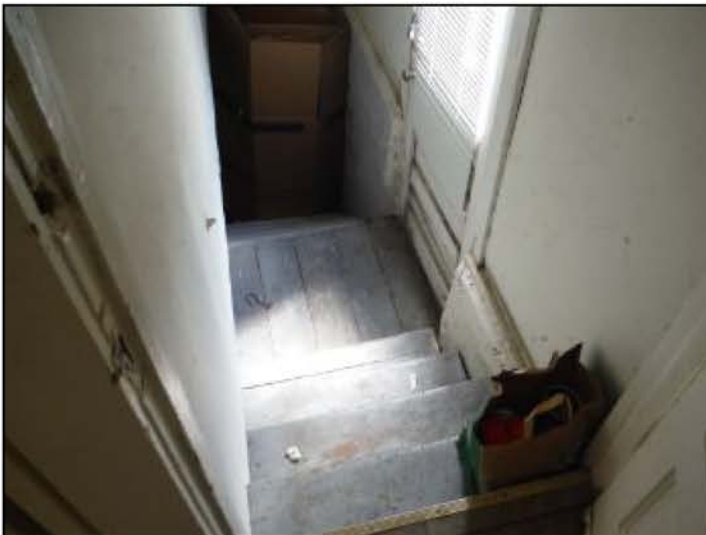
Older standards, low head clearance, under lighted, no hand rails and blocked by basement partition

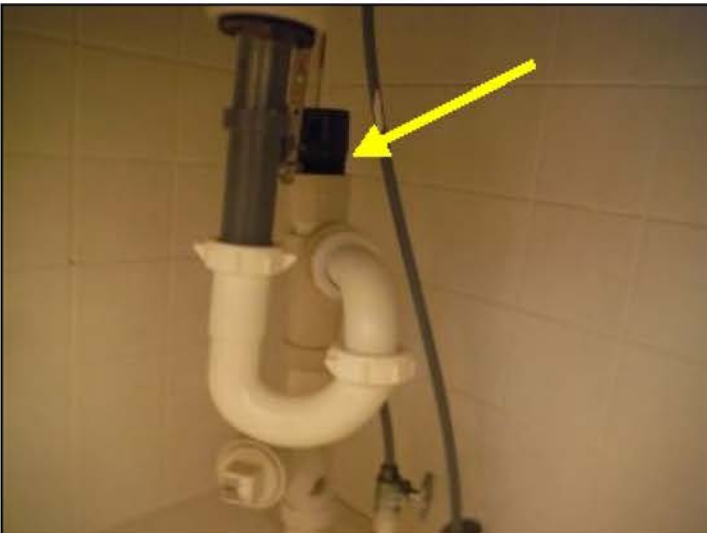
Pro vent below half bath sink, sign of modified system

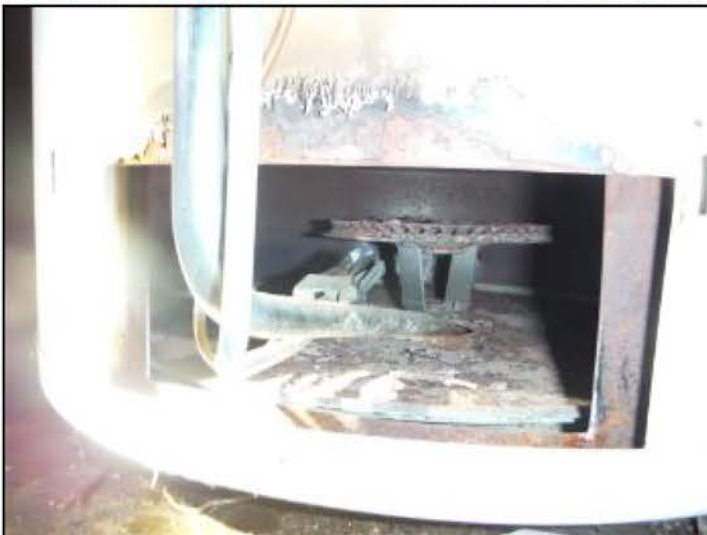
Rusted older unit has limited life

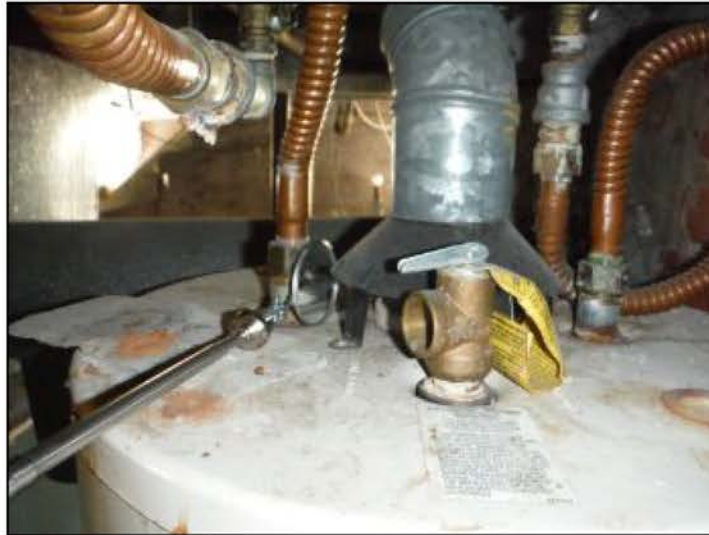
| Page 20 Item: 3 | Observations: | Tank drain valve leaks, needs a cap<br>Persistent back drafting measured at flue piping, health and safety hazard, needs repair ASAP |

Persistent back drafting measured at flue piping, health and safety hazard, needs repair ASAP

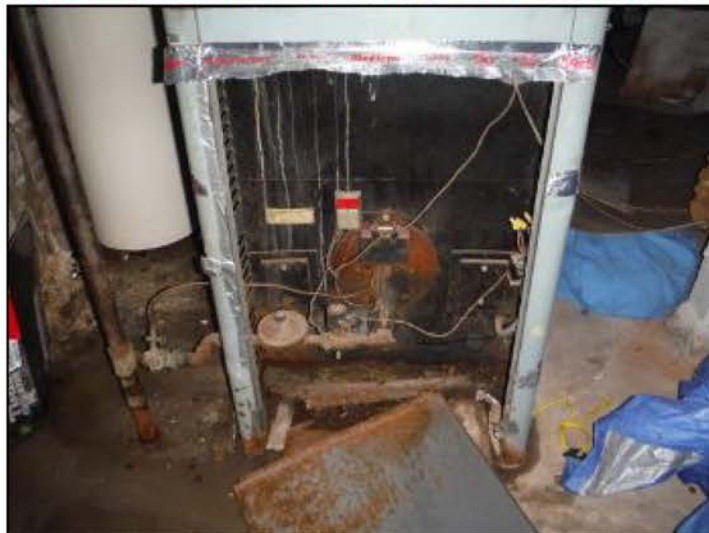
| Page 21 Item: 5 | Condition | Old rusty furnace needs replacement, low efficiency type is at end of practical life |

Old rusty furnace needs replacement, low efficiency type is at end of practical life

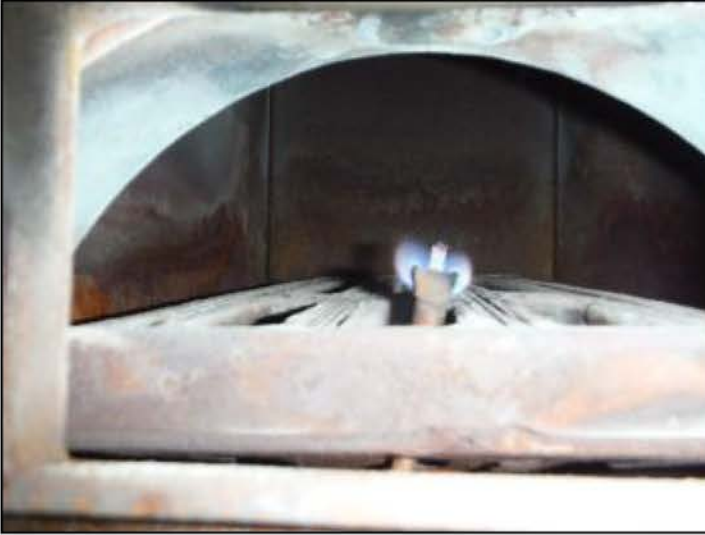
Rusty barrel type heat exchanger might be 50% efficient

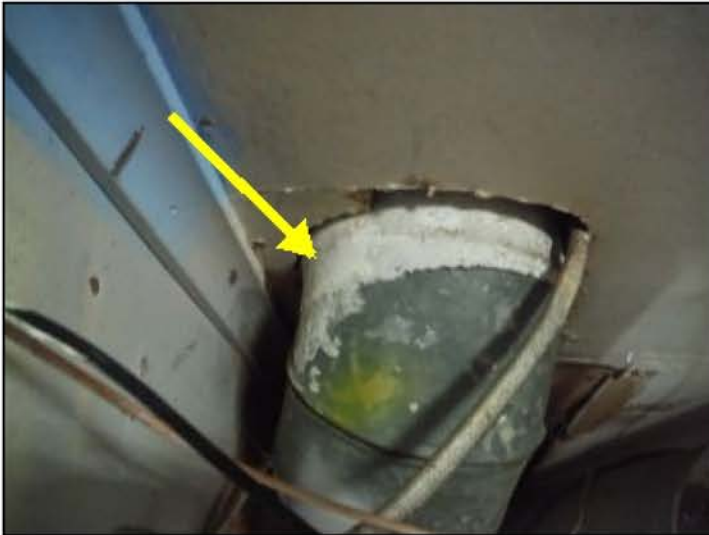
Suspect asbestos tape at ductwork noted

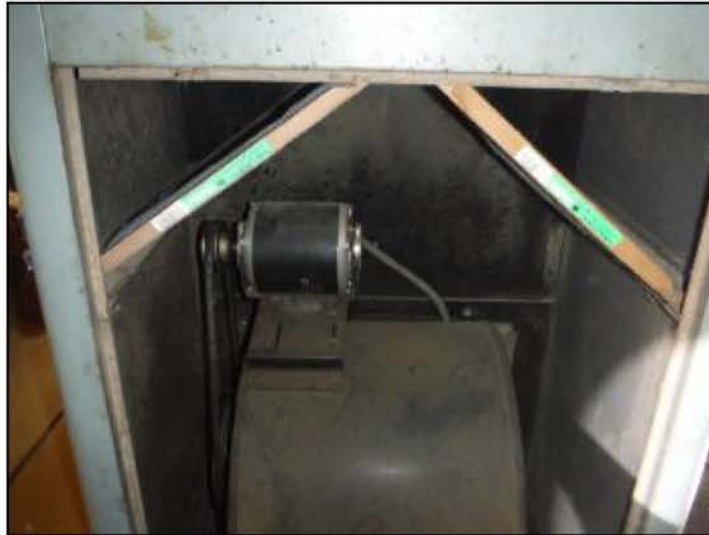
Disposable type, cover found off

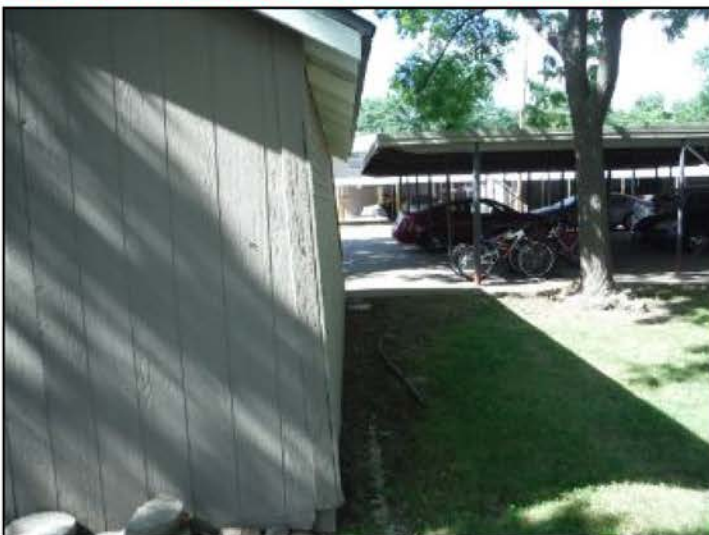
| Page 25 Item: 3 | Walls/Ceiling | Side walls are leaning (building is wind racked)<br>Refer to termite inspection report<br>Storage limits inspection, some is hazardous |

Side walls are leaning (building is wind racked)

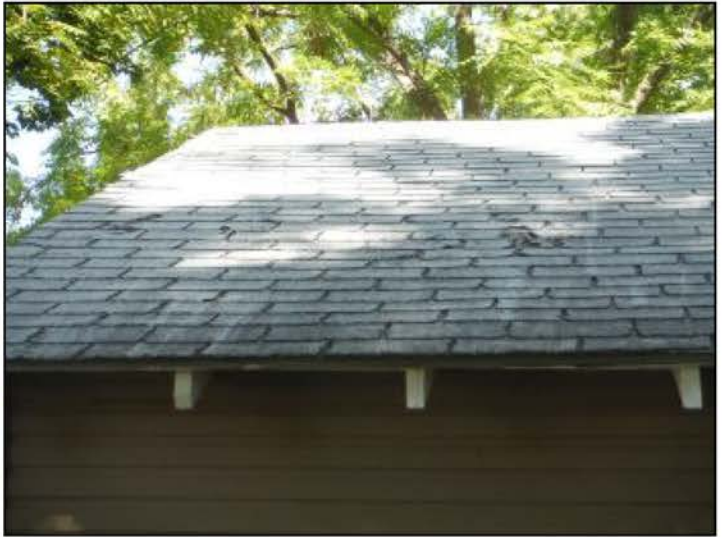
Trees need trimming

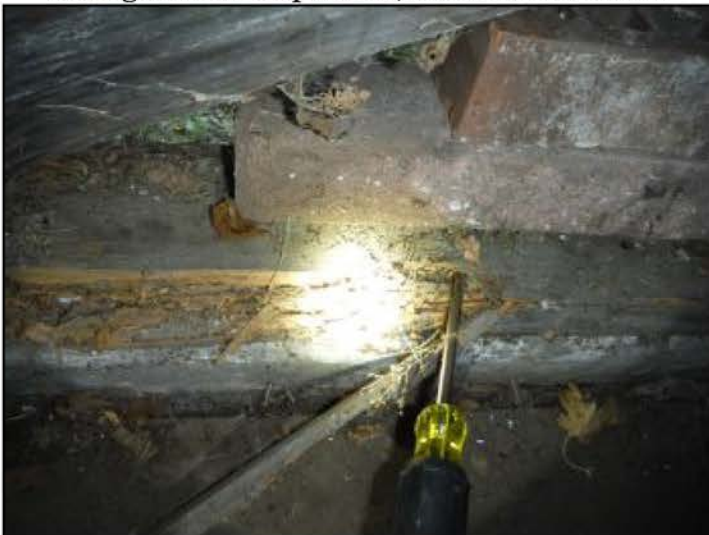
Refer to termite inspection report

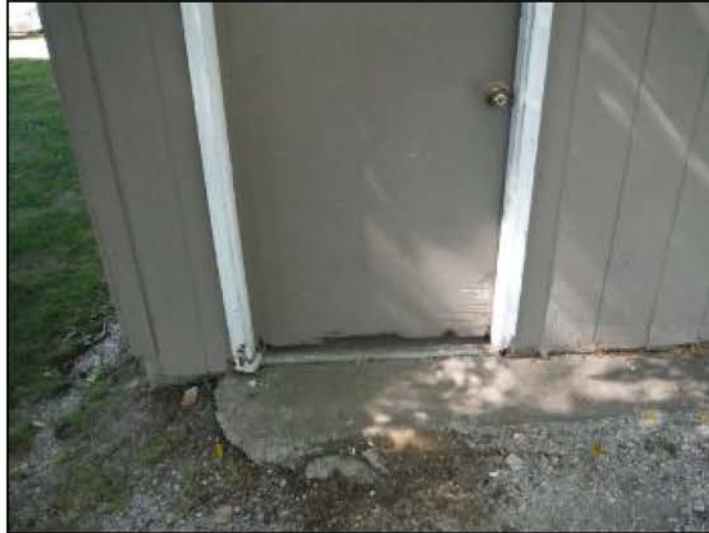
Water damaged

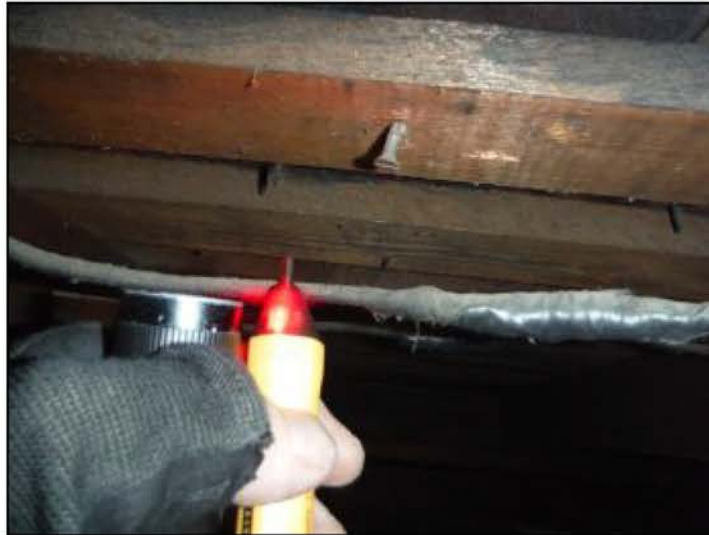
Active knob and tube wiring confirmed at basement and attic, refer to qualified electrician to update

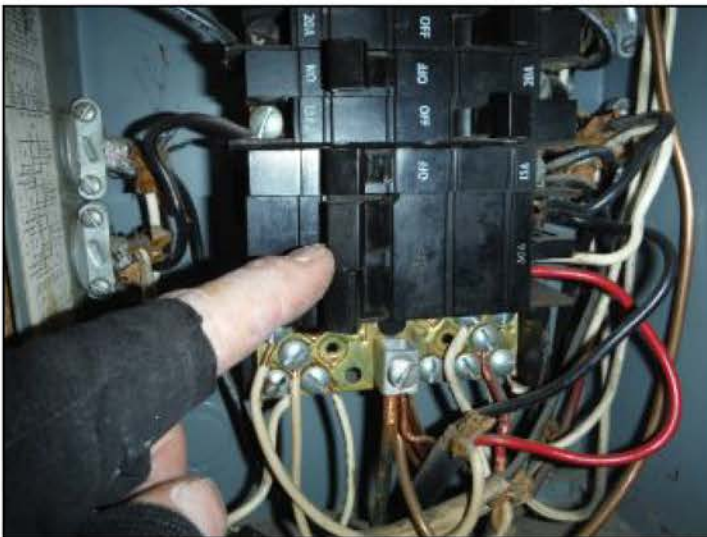
| Page 28 Item: 5 | Panel Notes | One 220 Volt breaker is weak, missing bridge, refer to electrician<br>Furnace fused disconnect not child safe |

One 220 Volt breaker is weak, missing bridge,  
refer to electrician

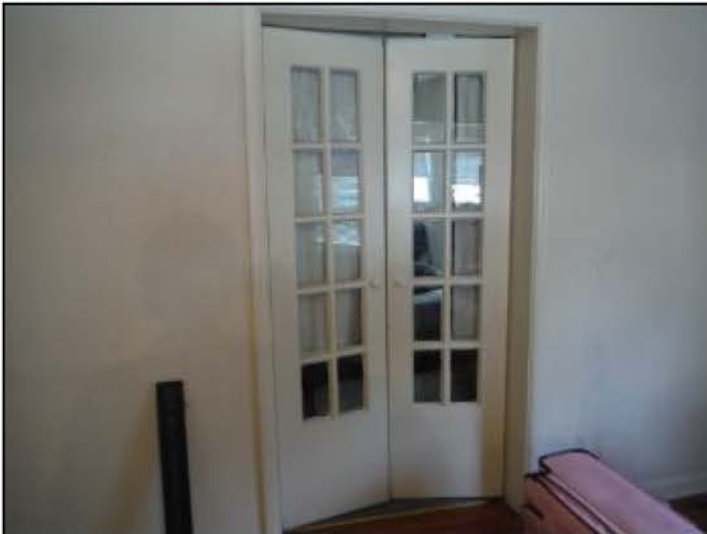
Untempered glass not to current standards at French set

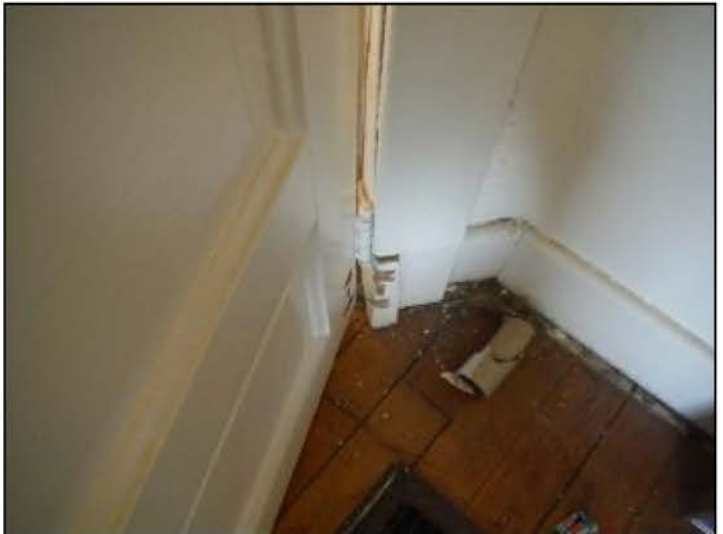
Damaged upstairs unit
