# Springfield Land Clearance for Redevelopment Authority

**4.III. Blight Report And Redevelopment Plan For The East Cherry Flats Redevelopment Area**

Documents: [EAST CHERRY FLATS BLIGHT REPORT AND REDEVELOPMENT PLAN.PDF](#)

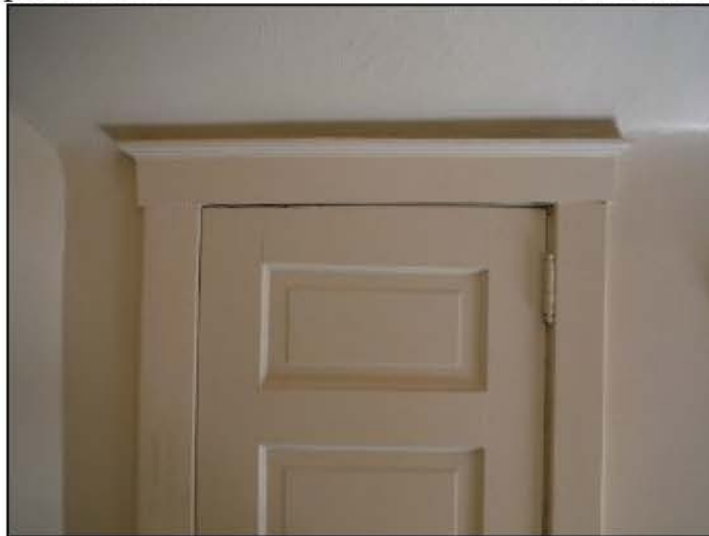
Some are shorter than contemporary standard

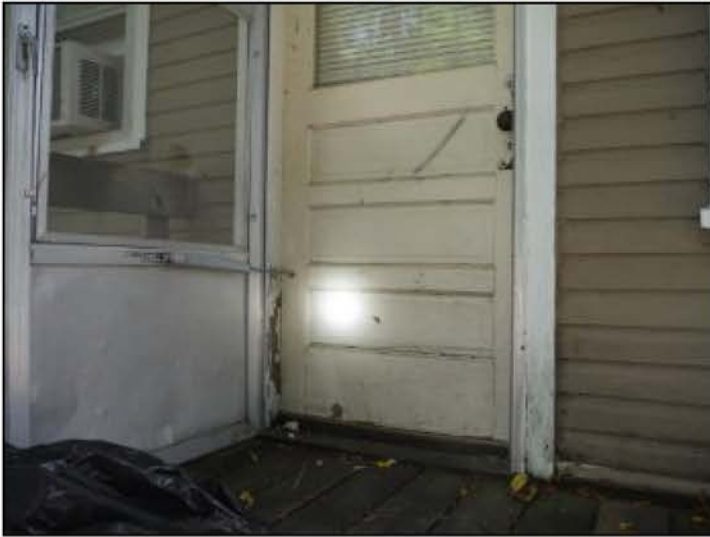
Untempered glass not to current standards

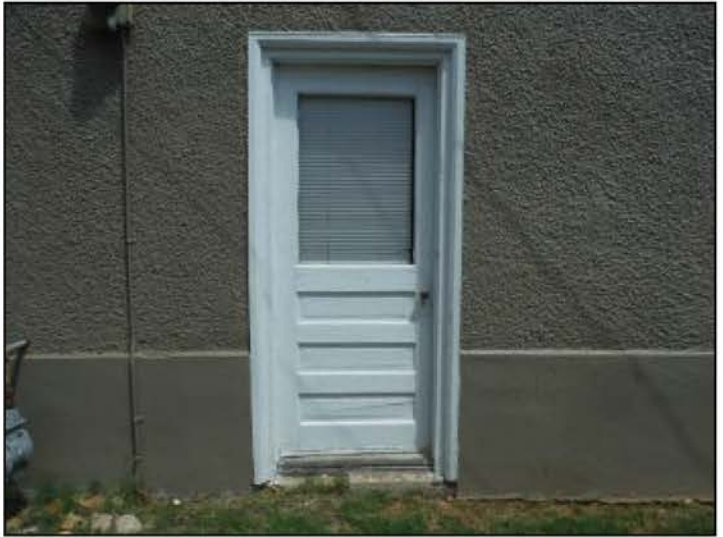
Untempered glass not to current standards

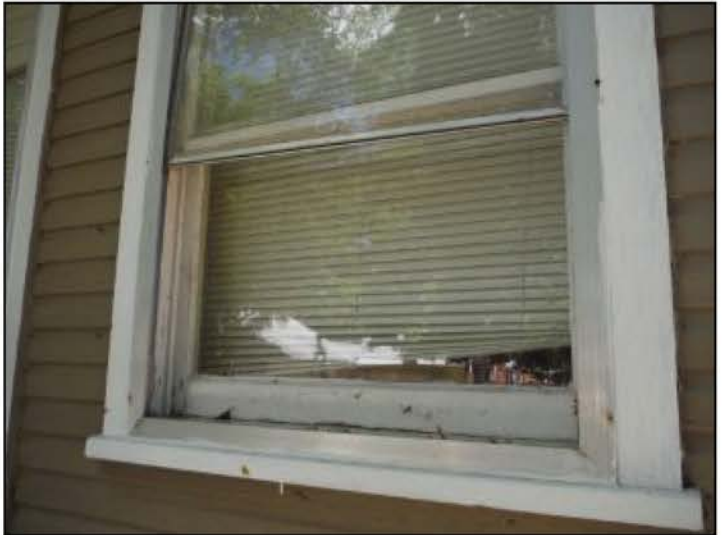
Recommend replacement of older wood units, missing storms/screens noted

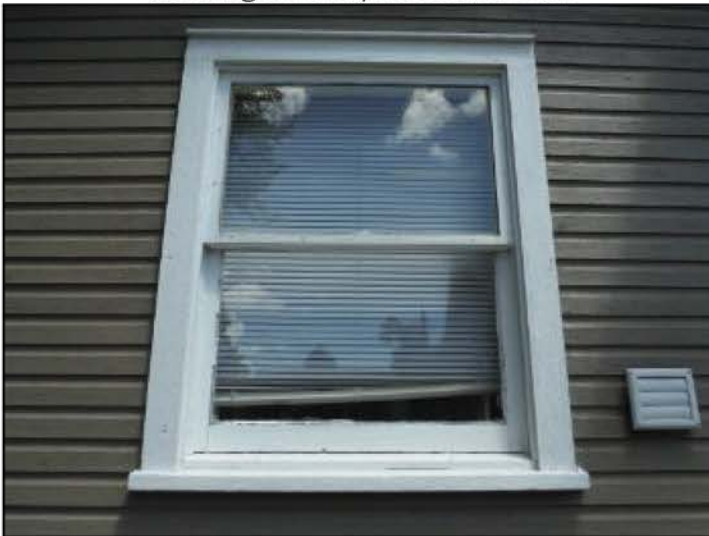
Recommend replacement of older wood units, missing storms/screens noted

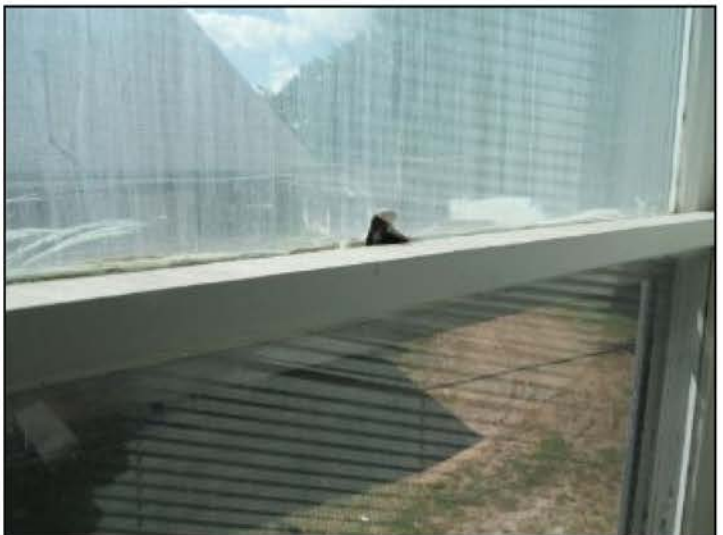
| Page 34 Item: 1 | Window Observations | Broken window is hazard/liability |

Broken window is hazard/liability

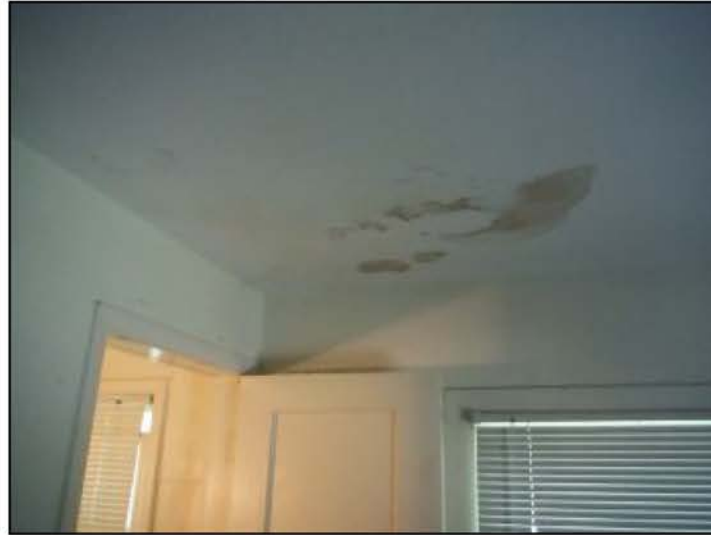
Stains appear dry

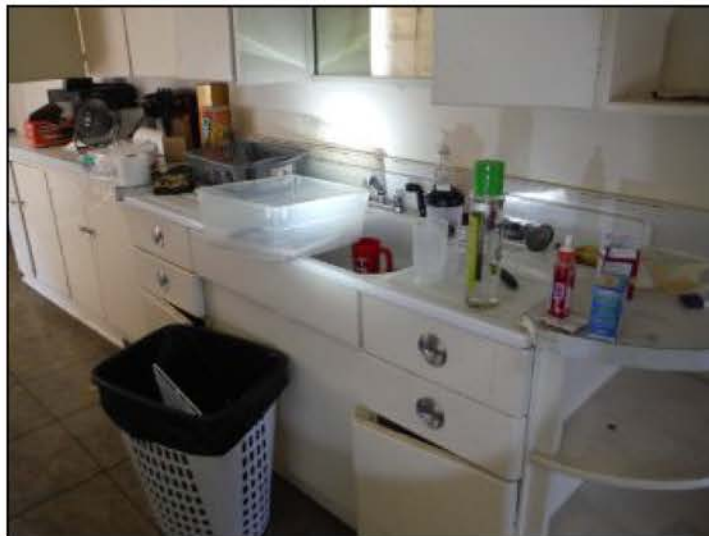
Minimal kitchen facilities, some is prefab steel

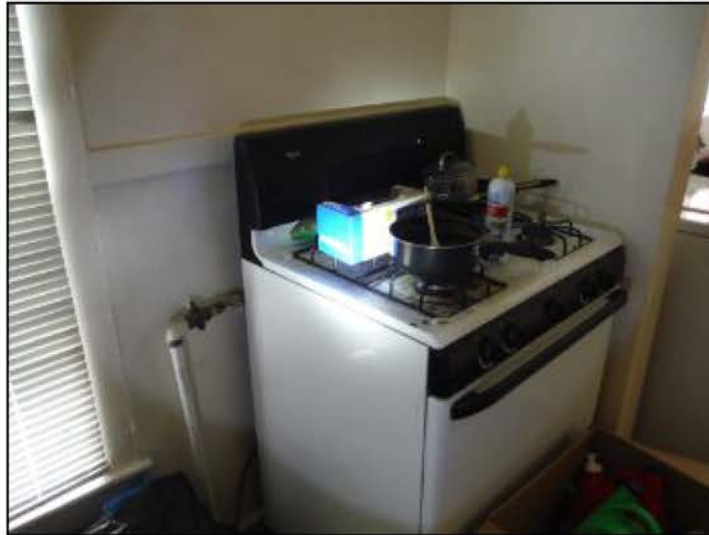
Blocked, untested. Note no exhaust hood (needed for gas units)

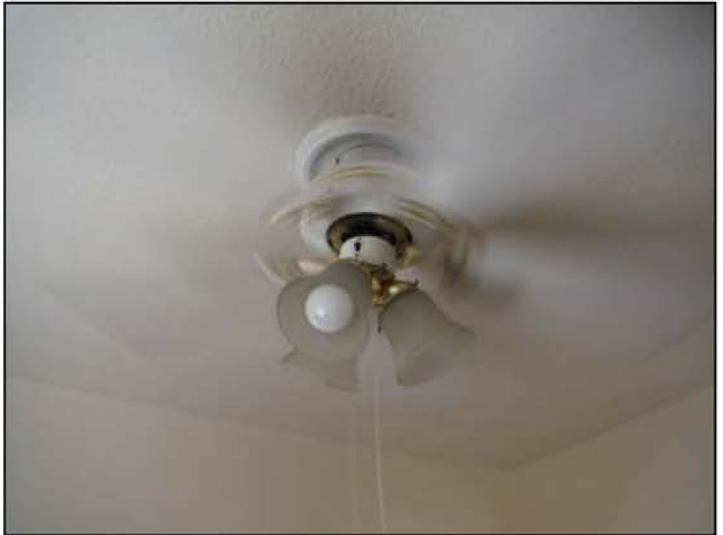
Check blades yearly

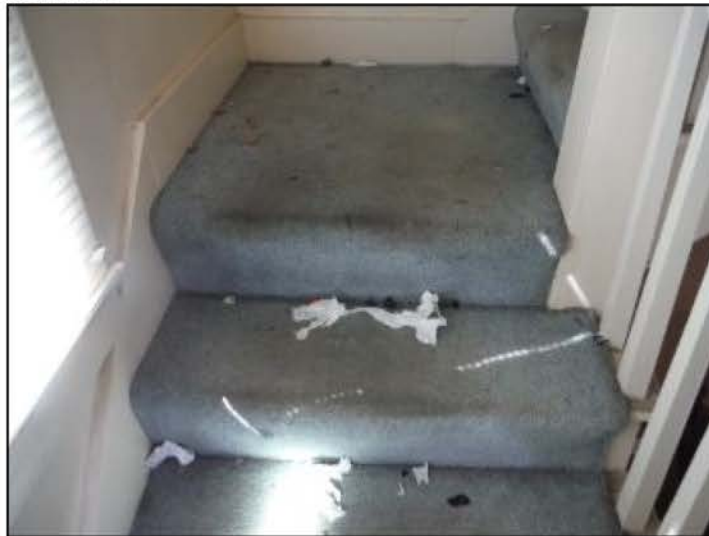
| Page 38 Item: 1 | Additional Interior Features and Miscellaneous | Damaged carpet at main stairs is trip hazard issue, needs correction |

Damaged carpet at main stairs is trip hazard issue, needs correction

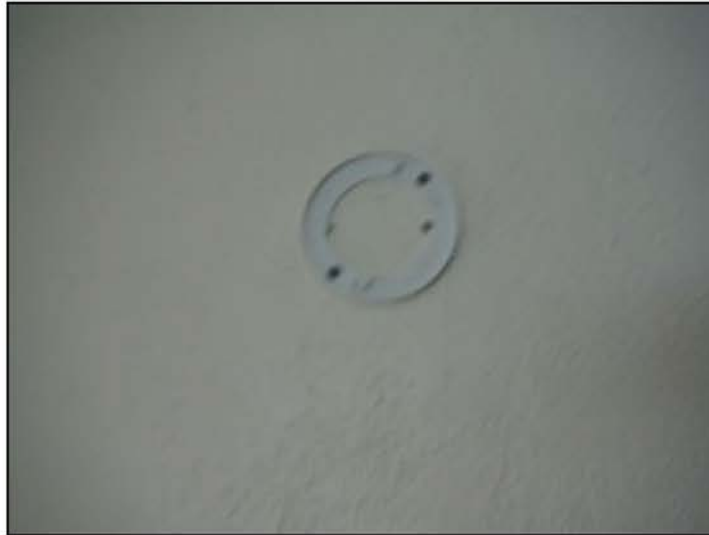
Insufficient quantity, needed in each bedroom, hall and level

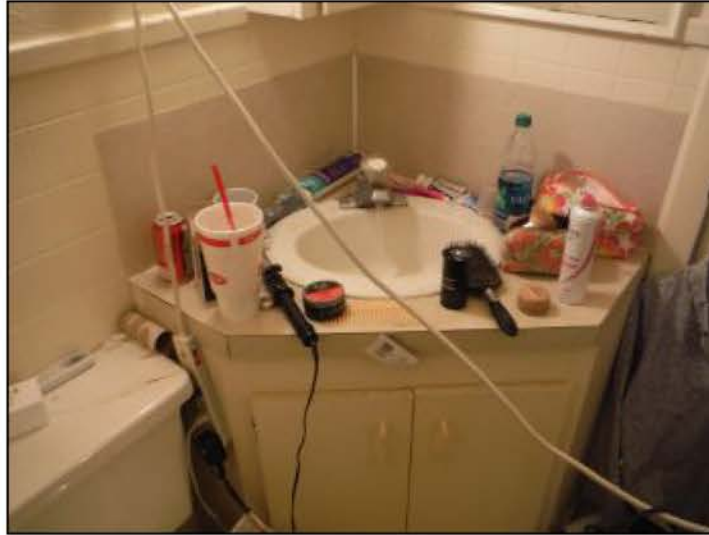
Serviceable

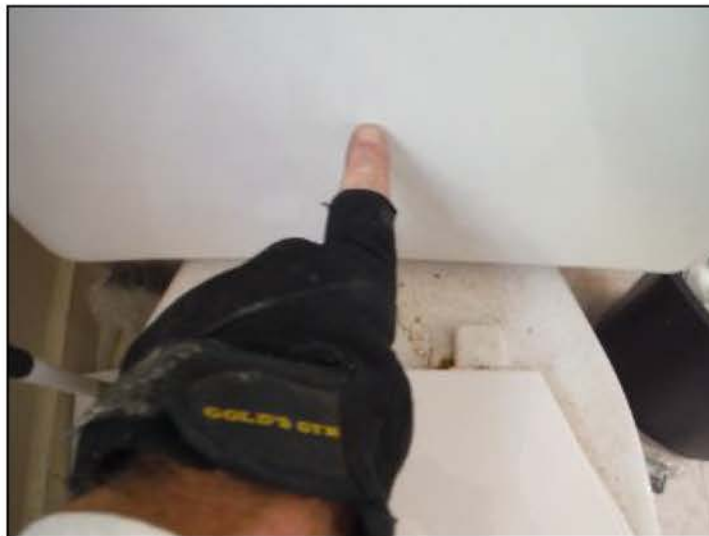
Loose tank

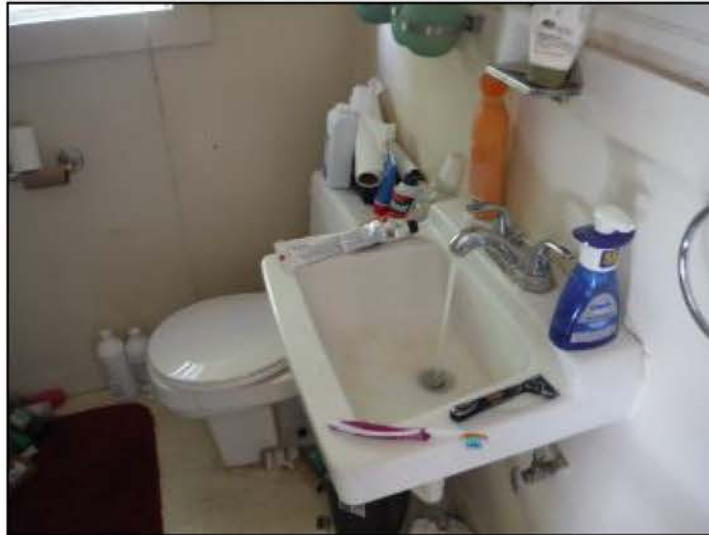
Serviceable wall hung type

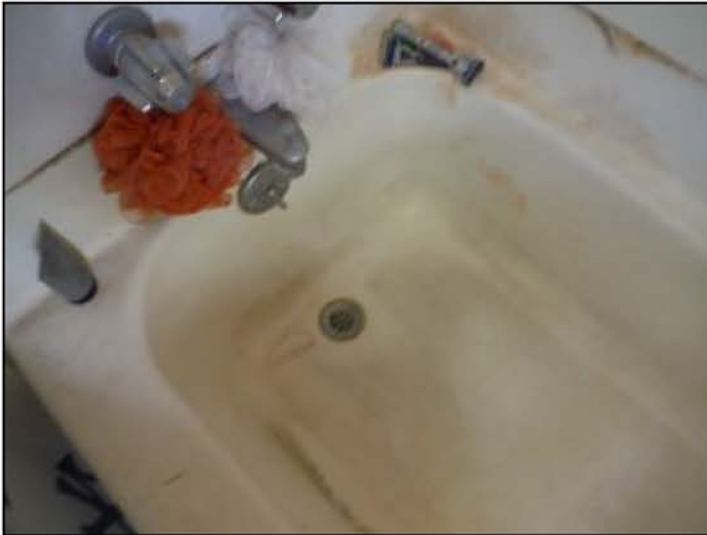
Stains, missing stopper

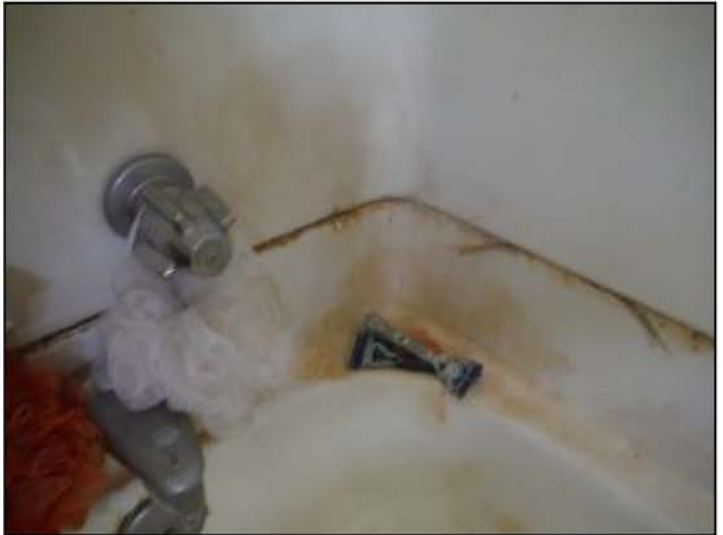
Seam needs recaulking

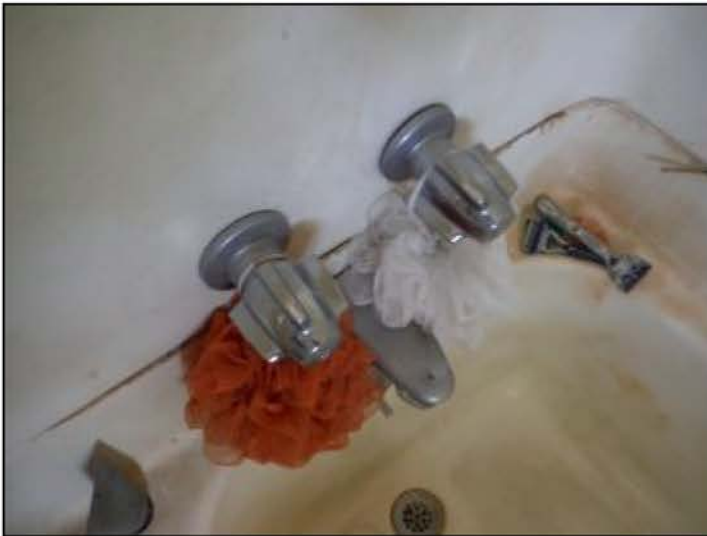
Note valves not balance type

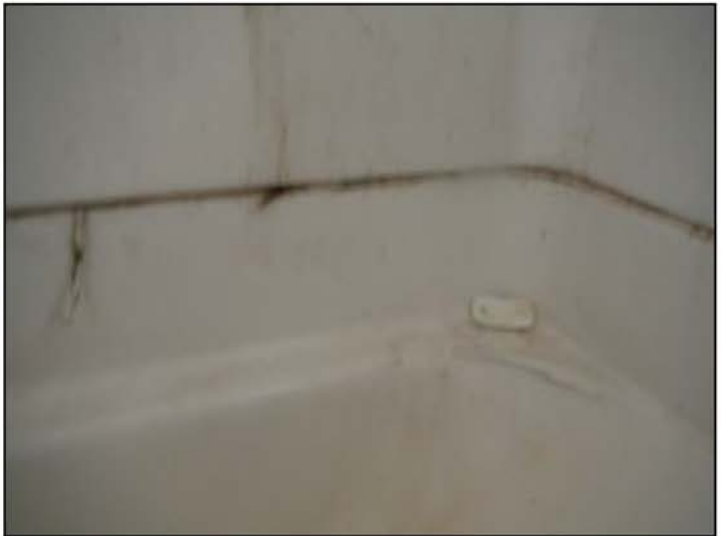
Seam needs recaulking

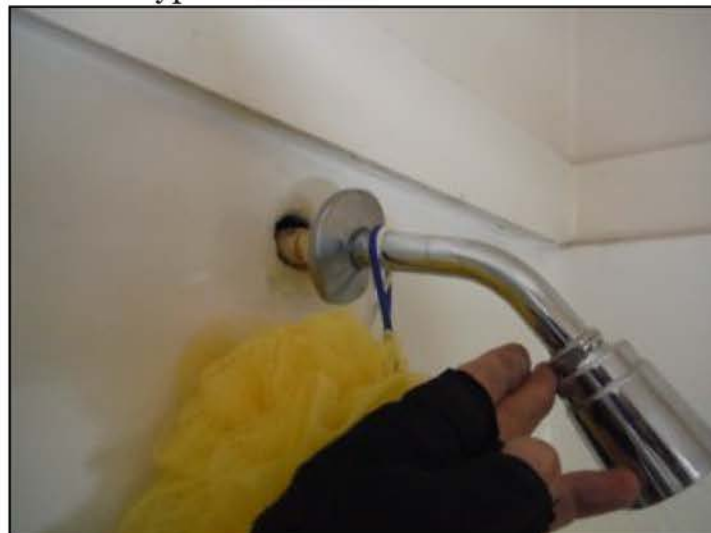
Showerhead is loose, leaks
