# Springfield Land Clearance for Redevelopment Authority

**4.1. Blight Report And Redevelopment Plan For The East Cherry Townhomes Redevelopment Area, Generally Located At 1361 And 1365 East Cherry Street; Say You Can, LLC, Applicant**

This Blight Report for the East Cherry Flats Redevelopment Area (this “**Blight Report**”) is being submitted by Say You Can, LLC, a Missouri limited liability company (such entity, or its successors and assigns, is referred to as the “**Developer**”), for the purpose of demonstrating that the Redevelopment Area (as defined below) should be declared blighted pursuant to the LCRA Law. This Blight Report will demonstrate (i) that the Redevelopment Area is a “blighted area” under the LCRA Law due to the predominance of (1) deterioration of site improvements, (2) insanitary and unsafe conditions, (3) obsolete platting, and (4) the existence of conditions which endanger life and property by fire and other causes, and (ii) because of the aforementioned conditions, the Redevelopment Area hinders the provision of housing accommodations, constitutes an economic and social liability, and is a menace to the public health, safety, morals, and welfare in its pr

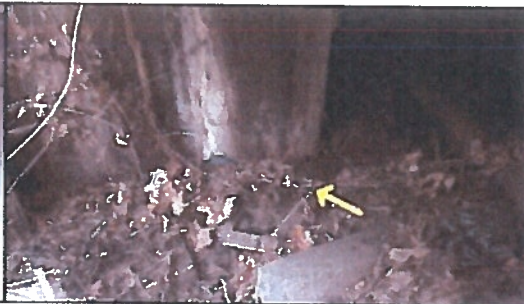
- Floor is sloped away from home, appears to have settled.
- Unheated/Cooled
- Exterior door is missing
- Wood to earth contact noted, not recommended as this may provide direct access for termites.

Wood to earth contact
