# Springfield Land Clearance for Redevelopment Authority

4.i. **Blight Report And Redevelopment Plan For The East Cherry Townhomes Redevelopment Area, Generally Located At 1361 And 1365 East Cherry Street; Say You Can, LLC, Applicant. Resolution No. 2017-3228**

## Report Summary of Defects

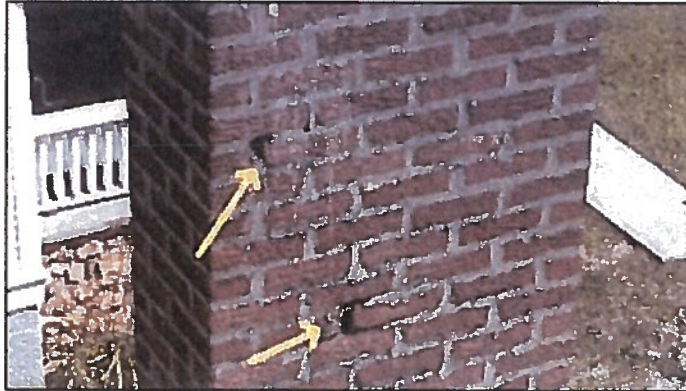
| Page 12 Item: 8 | Chimney | <ul style="list-style-type: none"> <li>Mortar missing; needs to be repaired/tuckpointed by a professional. Recommend coating brick with a waterproofing sealer.</li> </ul> |

- Rain cap/spark screen installed.
- Mortar missing; needs to be repaired/tuckpointed by a professional. Recommend coating brick with a waterproofing sealer.

Missing mortar

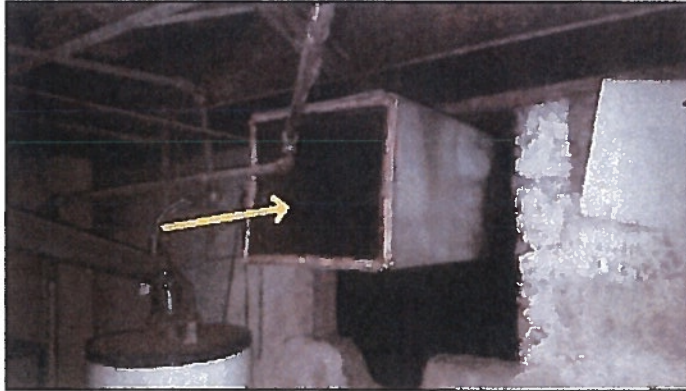
| Page 16 Item: 1 | Condition | <ul style="list-style-type: none"> <li>Furnace has been removed; no hear source installed.</li> </ul> |

- Furnace has been removed; no hear source installed.

Furnace and majority of ductwork has been removed.

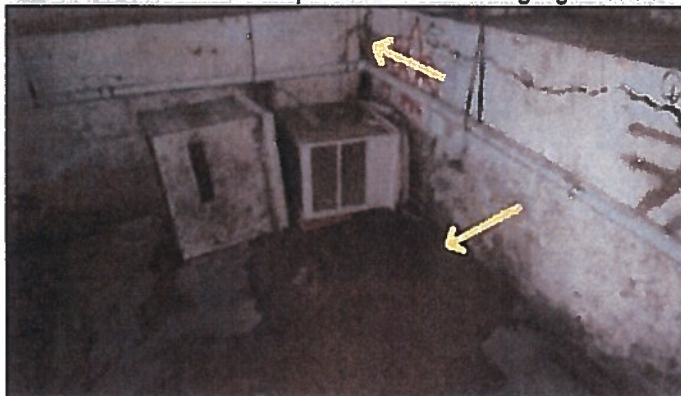
Signs of moisture penetration at NE corner (below downspout)

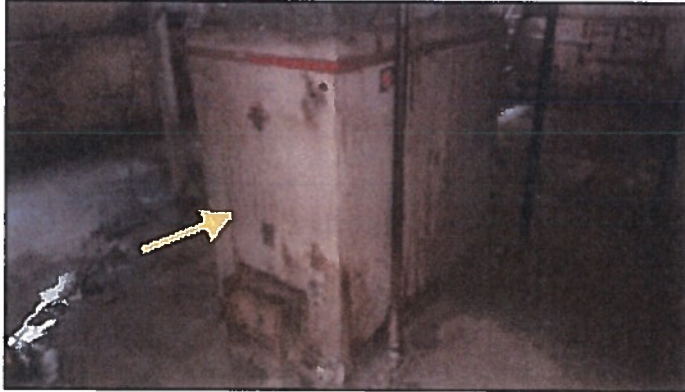
- Observations:
- Unit operated normally today.
  - Noted stains and rust, particularly at lower edge.
  - Dusty inside unit; recommend servicing.
  - Furnace is the original unit and well beyond its normal life, may need replacement. Recommend full evaluation by qualified HVAC technician.

Furnace beyond its normal life.

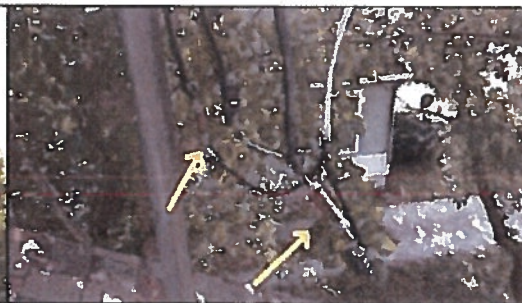
- Ground clamp/system not visible
- Trees touch wires; recommend contacting utility company.
- Wires: Exposed connections noted; recommend correction by utility company.

Exposed contacts

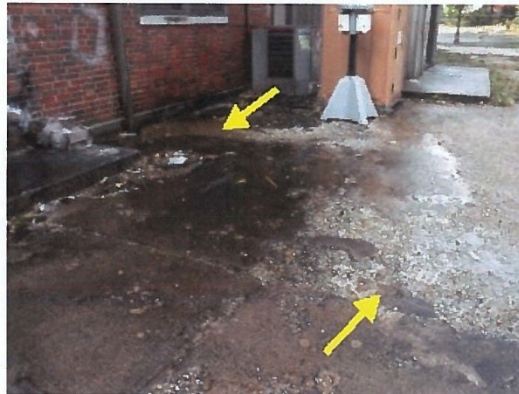
- Concrete at back of building is deteriorated and ponding water was present. Needs replacement with proper slope away from the building.

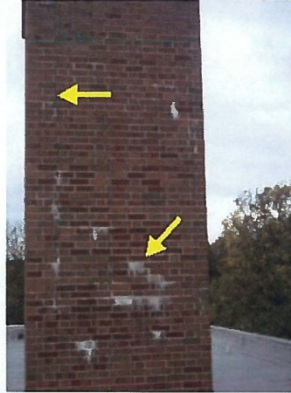
- Chimney chase was not completely visible due to its height.
- One crack and signs of past water penetration observed at the east side of the chimney. Needs sealing/tuck pointing by a professional.

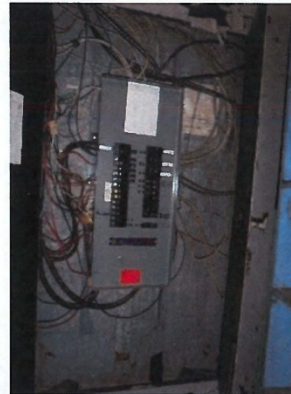
| Page 15 Item: 3 | Main Panel 1 | • Basement panels are too large and wires are exposed when opened; potentially unsafe. Needs correction. |

- Basement panels are too large and wires are exposed when opened; potentially unsafe. Needs correction.

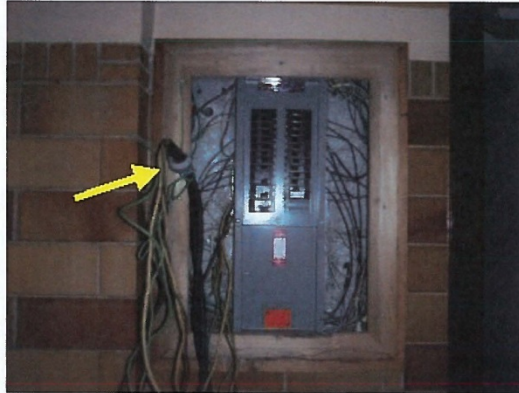
| Page 16 Item: 5 | Panel Notes | • Panel cover is missing and exposed wiring is present for a portable furnace in middle of main level hallway. Needs repair for safety. |

- Breakers are not fully labeled
- Panel cover is missing and exposed wiring is present for a portable furnace in middle of main level hallway. Needs repair for safety.

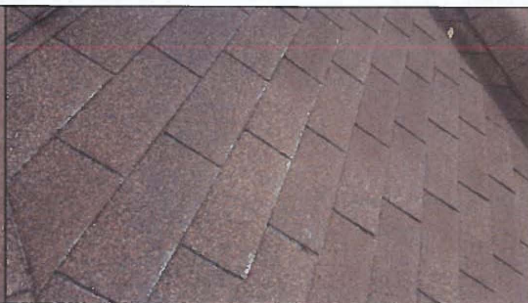
Damage at North end of ridge

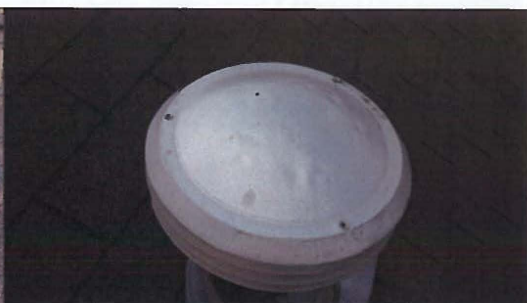
Signs of past hail

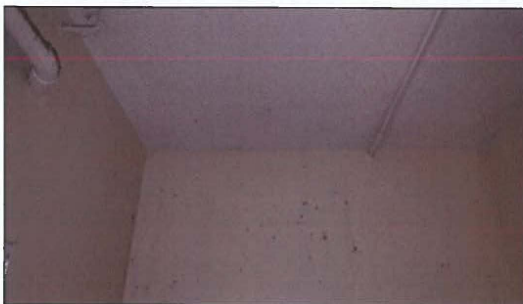
Holes/damage - Linen Storage
