*SPRINGFIELD LAND CLEARANCE FOR REDEVELOPMENT AUTHORITY*

*Tuesday, July 11, 2017 at 4:00 p.m.*

**4.II. Blight Report And Redevelopment Plan For The 1325/1329 East Cherry Redevelopment Area, Located At 1325 East Cherry Street; Roza Capital Group, LLC, Applicant**

**EXHIBIT B**  
**PICTURES OF THE BLIGHTING CONDITIONS**

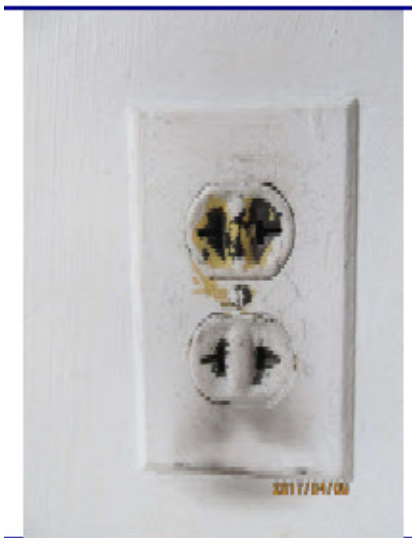
**B-9) Electrical throughout the house is outdated, improperly installed, and is at High Risk of causing a fire.**

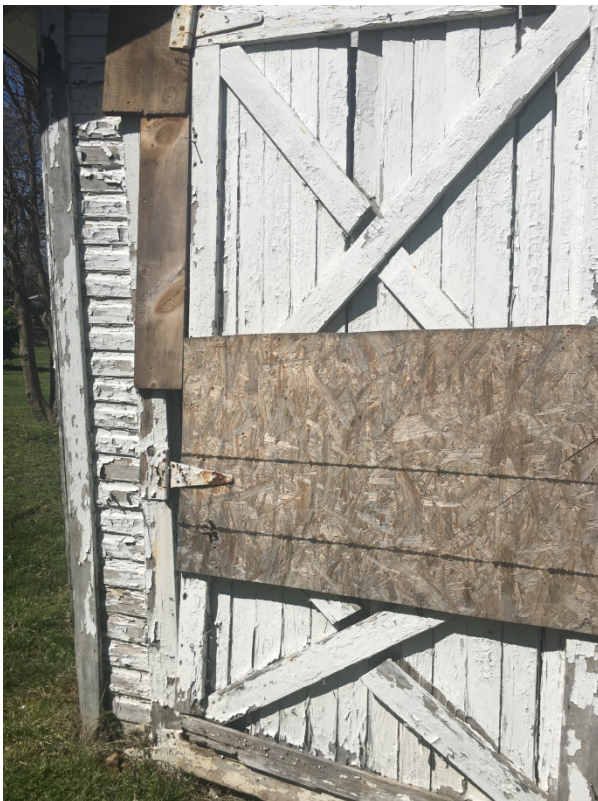
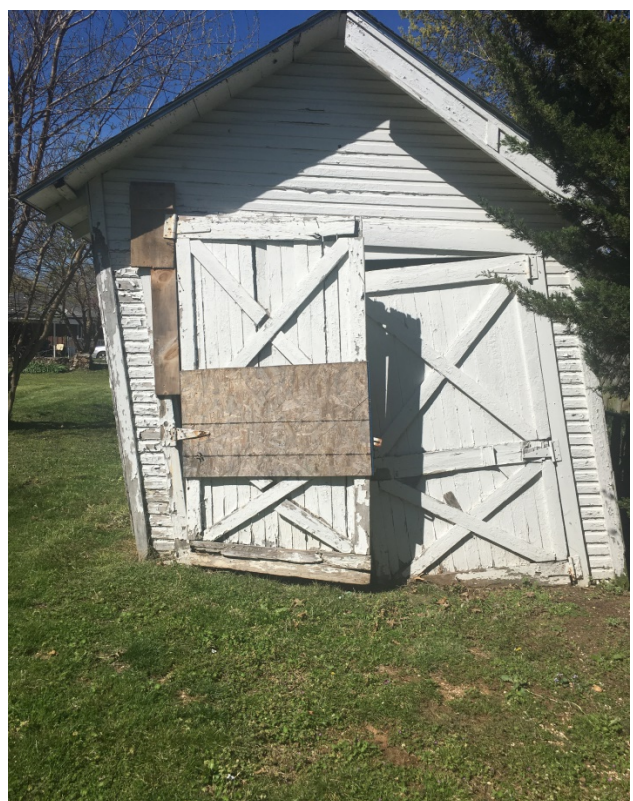
**B-3.1) Exterior structure garage is falling over and unsecured. Vagrants have broken into the structure.**

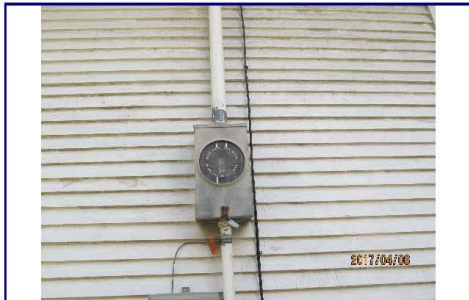
Picture 23

#43) Panel is outdated (2)(4). Recommend updating to today's building standards.

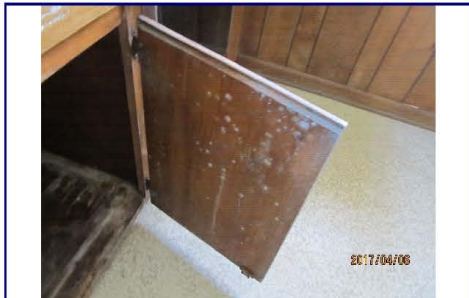
Picture 27

#51) Floors covered in microbial organism growth. Tile floor in bathroom shows signs of settlement cracks (2)(4). Recommend evaluation by qualified environmentalist before removal/ replacement.

#67) Could not test sink due to water being off at the time of the inspection. Cabinets and countertop covered in microbial organism growth (2)(4). Recommend evaluation by qualified environmentalist.

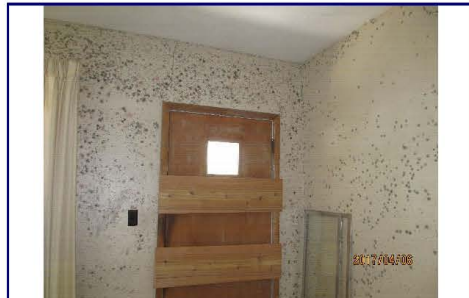
Picture 28

#45) Front door was boarded up at the time of the inspection. Recommend replacement.
