# **Springfield Land Clearance for Redevelopment Authority**

### **4.II. Blight Report & Redevelopment For East Cherry Street Pocket Neighborhood**

#### *A1 Home Inspection* Property Inspection Report

1361 E Cherry St, Springfield, MO 65802  
Inspection prepared for: Elm House LLC  
Date of Inspection: 8/18/2016 Time: 2:00 p.m.  
Age of Home: 1920 Size: 1,408 sf. +/- (Several additions noted)  
Weather: Partly cloudy and 75 degrees

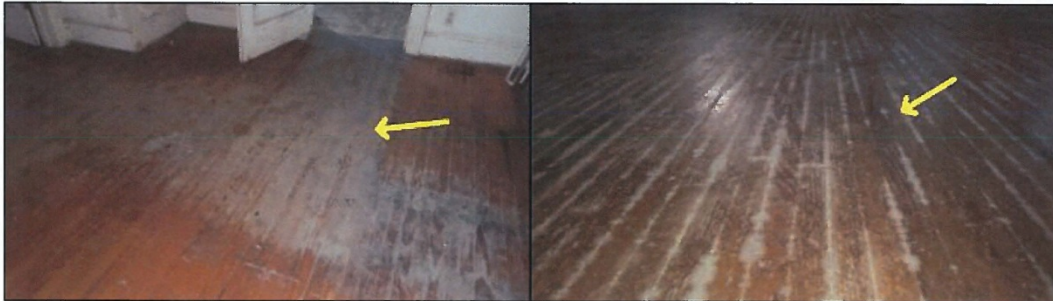
Kitchen

NE bedroom hardwood
